WATER LICENCE INSPECTION FORM

Licensee	Licensee Representative
Agnico Eagle	Guy Dufour
Licence No. / Expiry	Representative's Title
2AM-DOH1335	Environment General Supervisor
Land / Other Authorizations	Land / Other Authorizations
	--
Date of Inspection	Inspector
November 16, 2022	Jonathan MESHER
Activities Inspected	
<input checked="" type="checkbox"/> Camp	<input type="checkbox"/> Drilling
<input type="checkbox"/> Roads/Hauling	<input type="checkbox"/> Other:
<input checked="" type="checkbox"/> Mining	<input type="checkbox"/> Construction
	<input type="checkbox"/> Other:
	<input type="checkbox"/> Reclamation
	<input type="checkbox"/> Fuel Storage

On November 16, 2022, I Jonathan Mesher of CIRNAC conducted inspections of the facilities licenced under the Water licence 2AM-DOH1323, during the inspection I was accompanied by Guy Dufour(licensee representative )

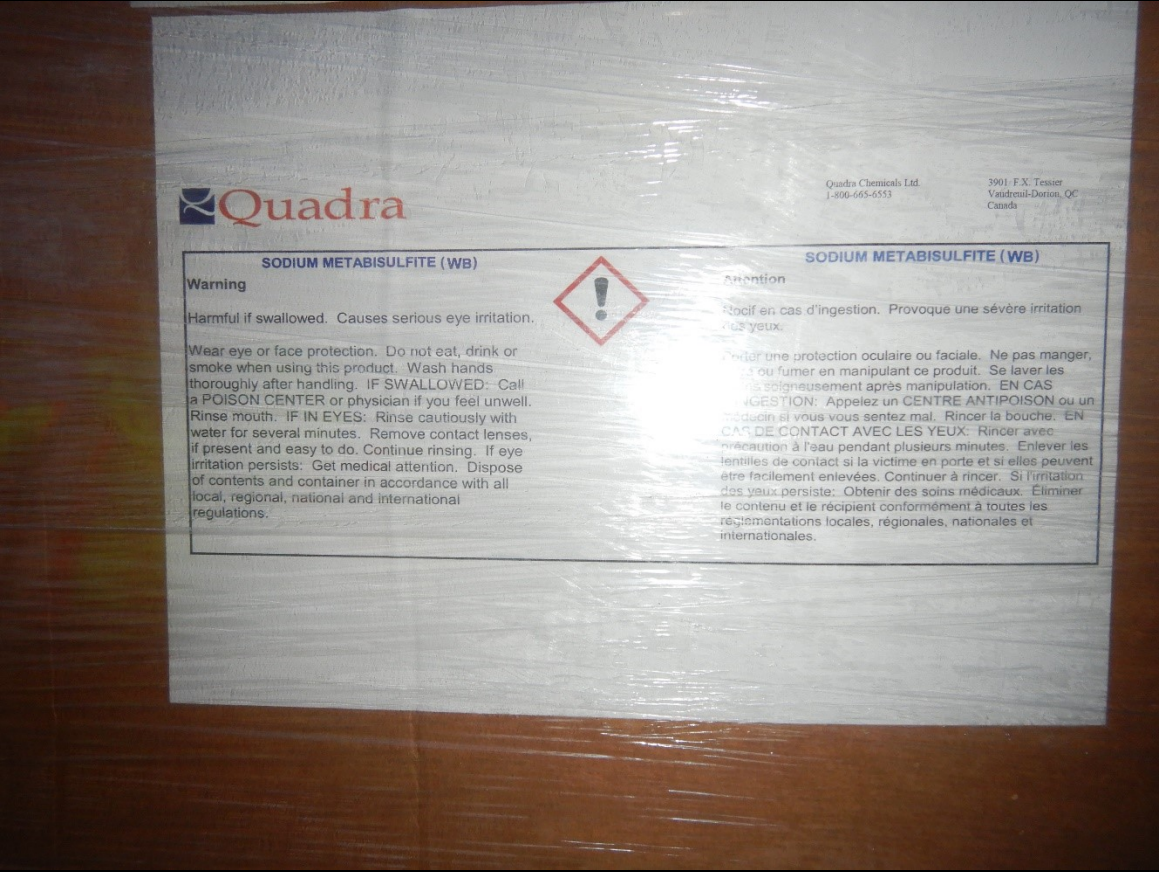
Date	Camera	Inspector	Authorization
November 16, 2022	Sony Cyber-shot	J.Mesher	2AM-DOH
Photo Log			
Photo 2

Description: Sodium Metabisulfite in secans not in secondary containment.

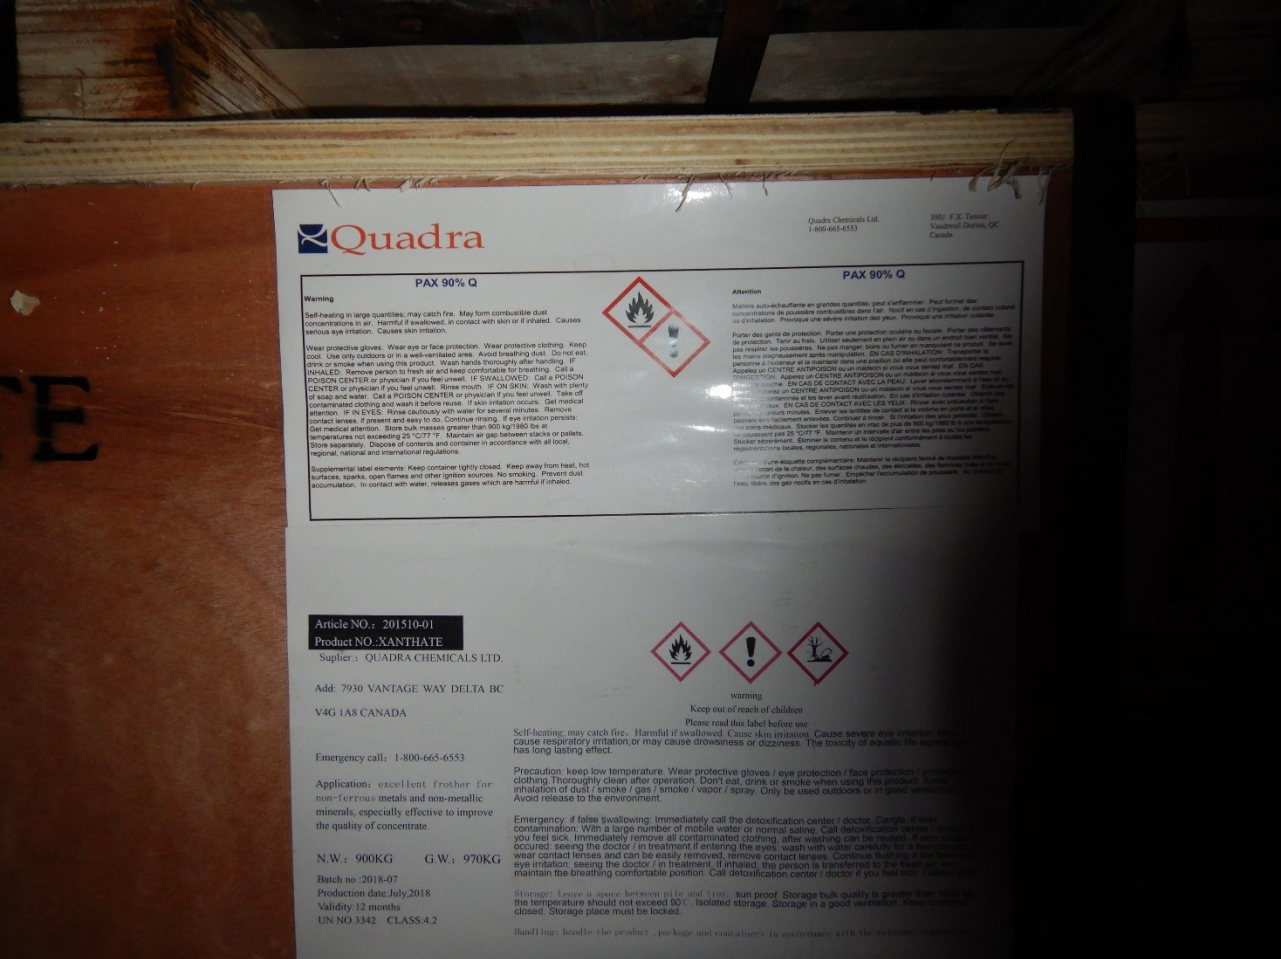
Date	Camera	Inspector	Authorization
November 16, 2022	Sony Cyber-shot	J.Mesher	2AM-DOH
Photo Log			
Photo 3

Description: PAX 90% Q in seacans not in secondary containment.

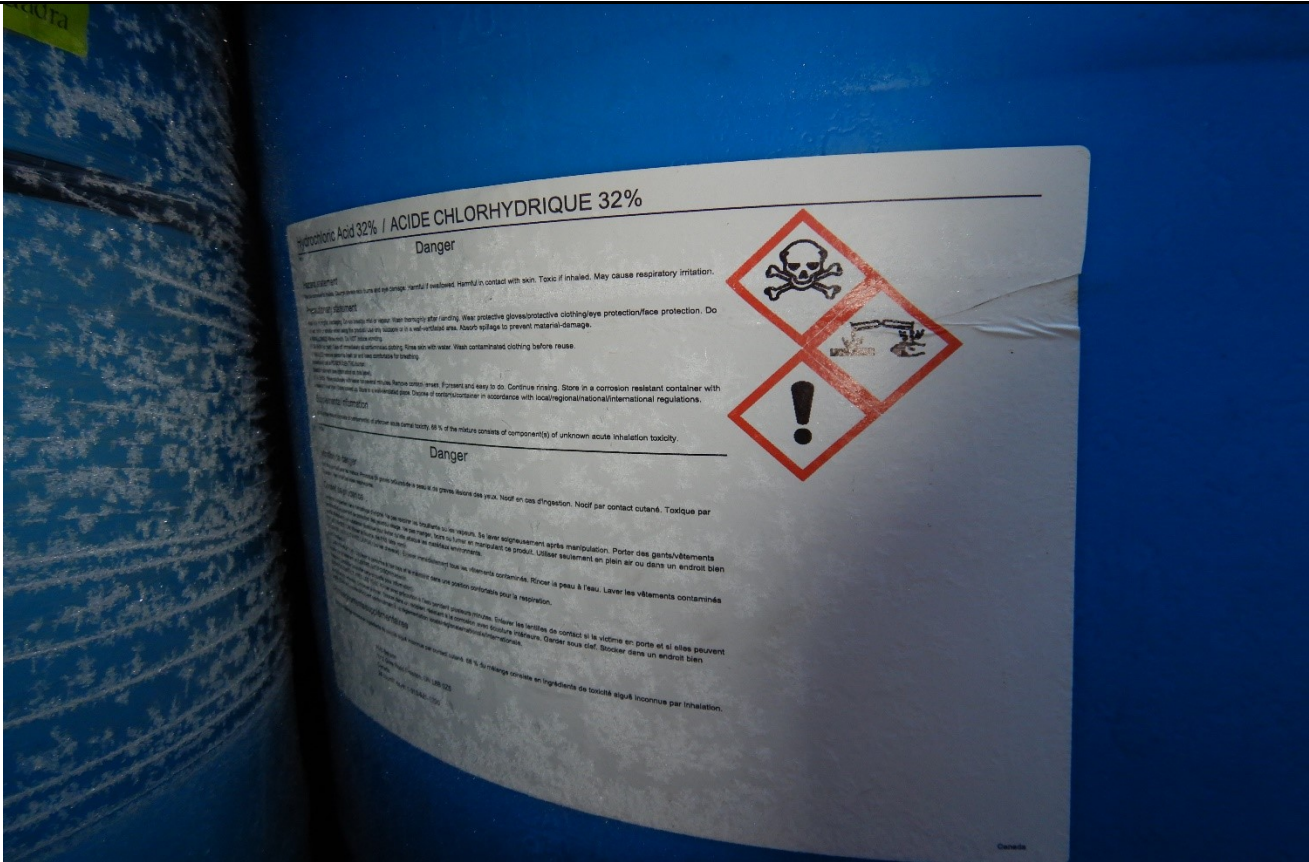
Photo 4

Description: hydrochloric acid 32% outside of secondary containment

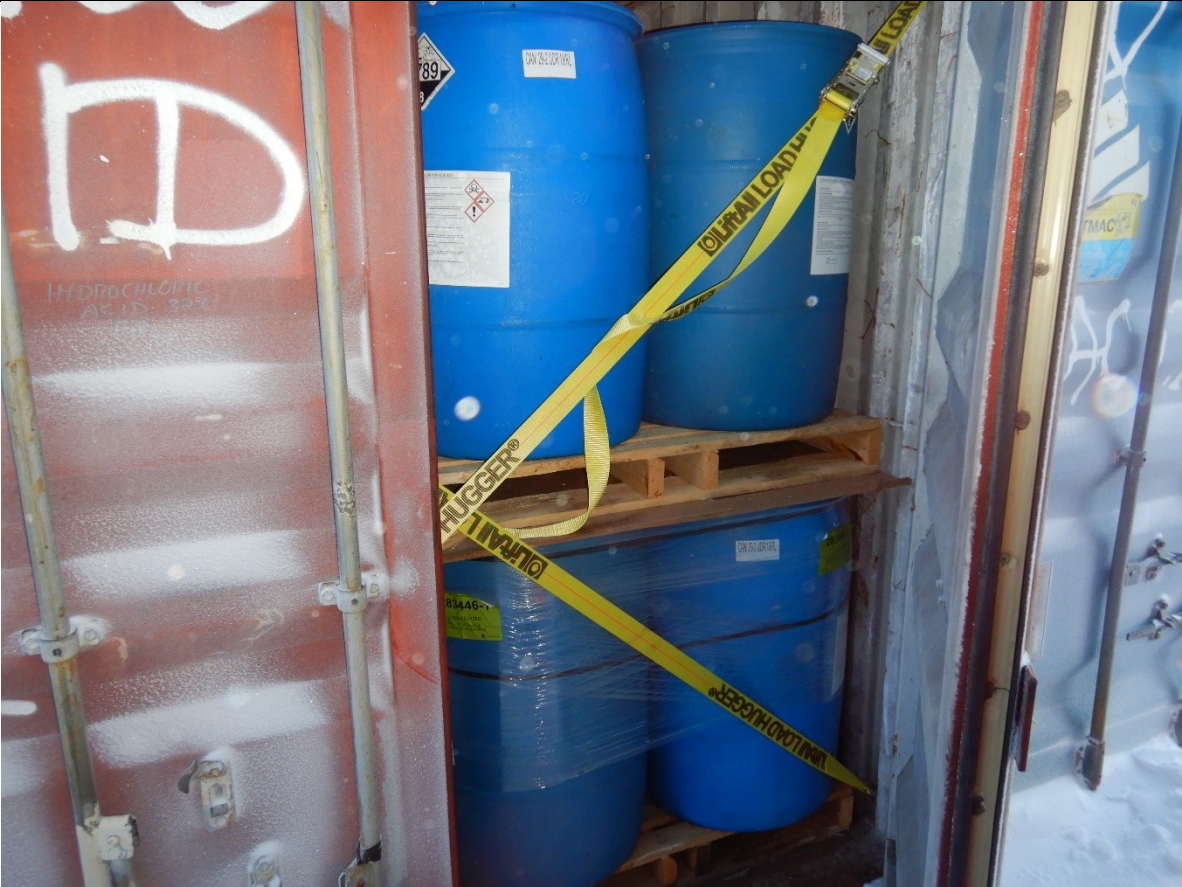
Date	Camera	Inspector	Authorization
November 16, 2022	Sony Cyber-shot	J.Mesher	2AM-DOH
Photo Log			
Photo 7

I. On page 2 of the document “Re: Agnico Response to CIRNAC Inspection Report June 20, 2022” the licensee stated that; “The sulfuric acid drums in the open seacan racks were repackaged into lined seacans and relocated to the upper laydown area see photo 4, 5 and 6.” During the inspection the inspector discovered unlined seacans full of Sulfuric Acid. On the same page the licensee also stated that; “2. Glycol totes at the powerhouse were relocated into lined seacan and the tote that remains at the powerhouse was placed on a secondary containment, see photo 2.”, the glycol totes at the power house was not in secondary containment therefore the licensee has made two false statements in the response to the previous email. Section 88(obstruction), subsection (2) of the Nunavut Waters and Nunavut surface rights tribunal Act (NWNSRTA) states that; “No person shall knowingly make a false or misleading statement, either orally or in writing, to an inspector or other person engaged in carrying out functions under this Part.” Continued obstruction or misleading statements will lead to the punishments described in Section 90, subsection (2) of the NWNSRTA.

Description: sulfuric acid in unlined seacans.
