WATER LICENCE INSPECTION FORM

Licensee	Licensee Representative
Agnico Eagle	Nancy Duquet Harvey
Licence No. / Expiry	Representative's Title
2AM-DOH1335	Environmental superintendent
Land / Other Authorizations	Land / Other Authorizations
	--
Date of Inspection	Inspector
February 28, 2023	Jonathan MESHER
Activities Inspected	
<input checked="" type="checkbox"/> Camp	<input type="checkbox"/> Drilling
<input type="checkbox"/> Roads/Hauling	<input type="checkbox"/> Other:
<input checked="" type="checkbox"/> Mining	<input type="checkbox"/> Construction
	<input type="checkbox"/> Other:
	<input type="checkbox"/> Reclamation
	<input type="checkbox"/> Fuel Storage

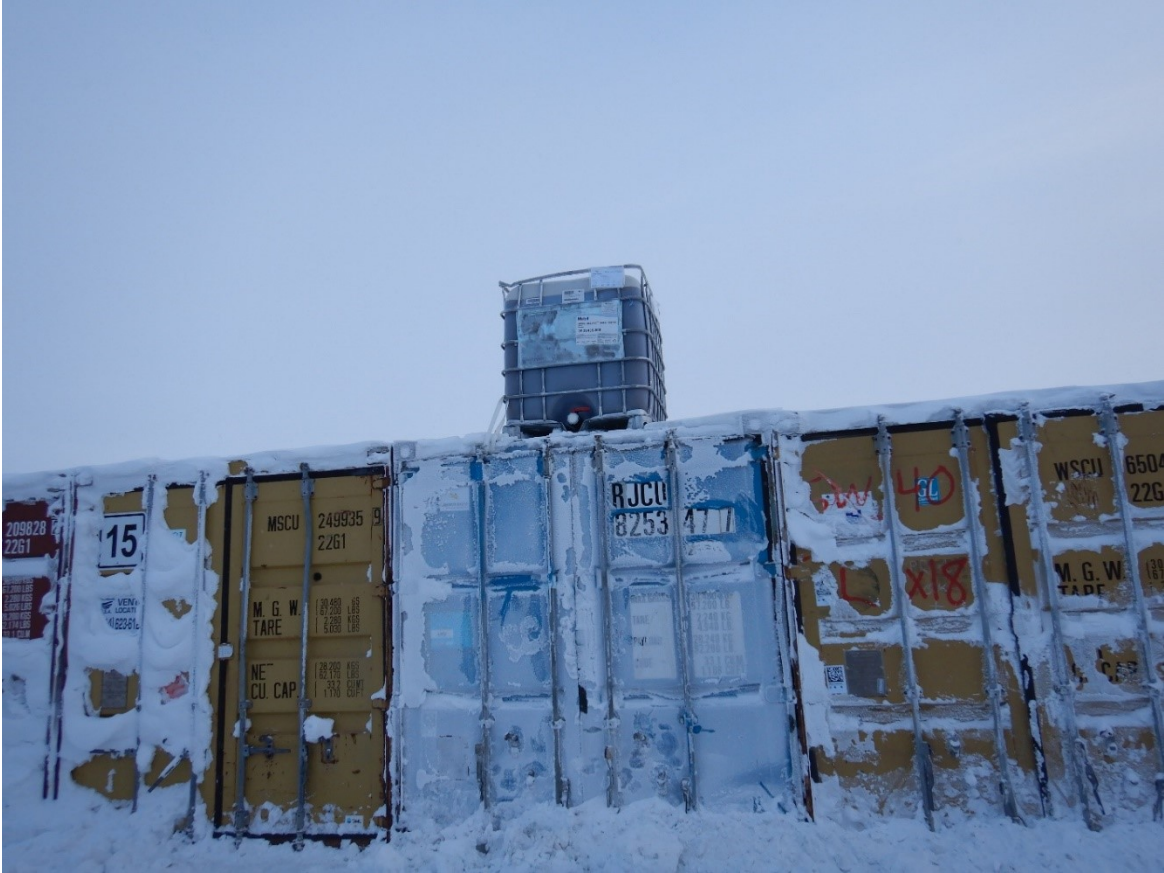
Photo 4

a. Waste Storage			
I. During the inspection there did not appear to be any drip trays under any heavy equipment at the following locations; windy lake Nuna shop, Major drilling at KM8 and the mobile and the heavy equipment mobile yard.			
II. GeoTech drill #4, during the inspection the licensee was remediating a spill and while on site there was significant amounts drill slurry on the drill pad, drill #12 was in similar condition with significant staining around the drill. See photo 1 and 2 for concerns at the drill sites.			
III. During the inspection the inspector noted a leak from the line leading into the Tailings impoundment area adjacent to the new water treatment plant. See photo 3 for the leak noted.			
IV. During the inspection the licensee had placed a full totes of hazardous material on top of sea cans not in a lined facility. See photos 4 and 5 for the totes stored on top of the seacans.

Description: Motor oil stored on top of seacans.

Section 2	<input type="checkbox"/> Comments	<input checked="" type="checkbox"/> Non-Compliance with Act or Licence	<input checked="" type="checkbox"/> Action Required
<p><b><u>The licensee is to provide a response 3 weeks after receiving the report to ensure the following concerns are addressed.</u></b></p> <ul style="list-style-type: none"><li>a) The licensee is to provide photos of the “Lined containment” at the waste storage facility.</li><li>b) PART I, Item 19 states the following “ Additional monitoring may be imposed by the Inspector.”. Due to the staining around the drill sites the inspector is requesting the licensee provide before and after photos of all the drill sites on ice.</li><li>c) The licensee is to update their Spill contingency plan to reflect the factual location of the items listed to be stored at the Upper Laydown TIA Reagent Berm and provide justification/approval for storing these chemicals in a unapproved manner/location.</li><li>d) Update their spill contingency plan to include the storage of glycols, motor oils and any other toxic and poisonous substances.</li><li>e) During the last 3 inspection the inspector noted the significant amount of Hazardous materials outside of containment, the licensee has submitted a plan to ship out hazardous materials not in use while the project is in care and maintenance. The licensee has not provided a plan for the storage of required hazardous materials such as lubricants and glycols, The licensee also stated that if the Hazardous materials is not shipped off site it will be stored on the Doris Camp Pad. Please provide the lined and contained location were the licensee intents to store this hazardous materials on the Doris camp pad and where the licensee intends to store all other Hazardous materials not being shipped off site.</li><li>f) The inspector is requesting the licensee provide a inventory list of all hazardous materials, their storage location and weather or not it is in secondary containment.</li><li>g) PART I, item 3 of the licence 2AM-DOH states; “The Licensee shall provide secondary containment for fuel and chemical storage as required by applicable standards and acceptable industry practice.” And Section 4.3.7 of the Environmental Code of Practice for metal mines: chapter 4 states the following; R 326:“ The chemical storage and containment facilities used at each mine should be designed and constructed to meet the appropriate standards, regulations and guidelines of pertinent regulatory agencies and the owner/operator's environmental policy, objectives and targets. As a minimum, chemical storage and containment facilities should:  <u>-be managed to minimize the potential for spills;</u> <u>-provide containment in the event of spillage and be managed to minimize opportunities for spillage;</u></li></ul> <p>With the above information and the fact that the licensee has been storing hazardous materials on top of seacans and not in a lined contained facility it appears the licensee has failed to minimize the potential for spills and comply with PART I, Item 3 of the licence 2AM-DOH1335.</p>

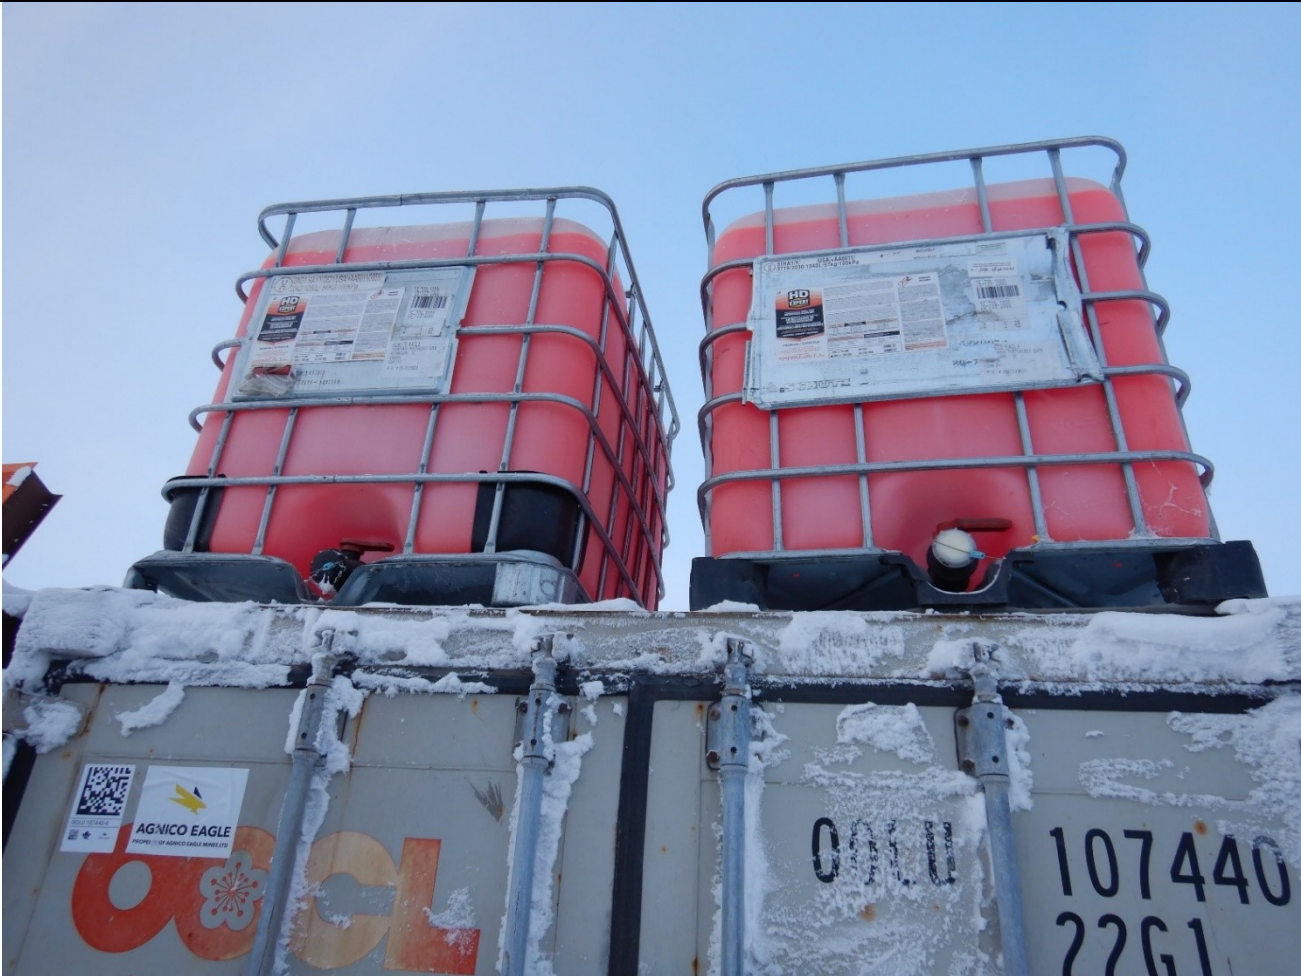
Photo 5

Description: Glycol stored on top of seacans.

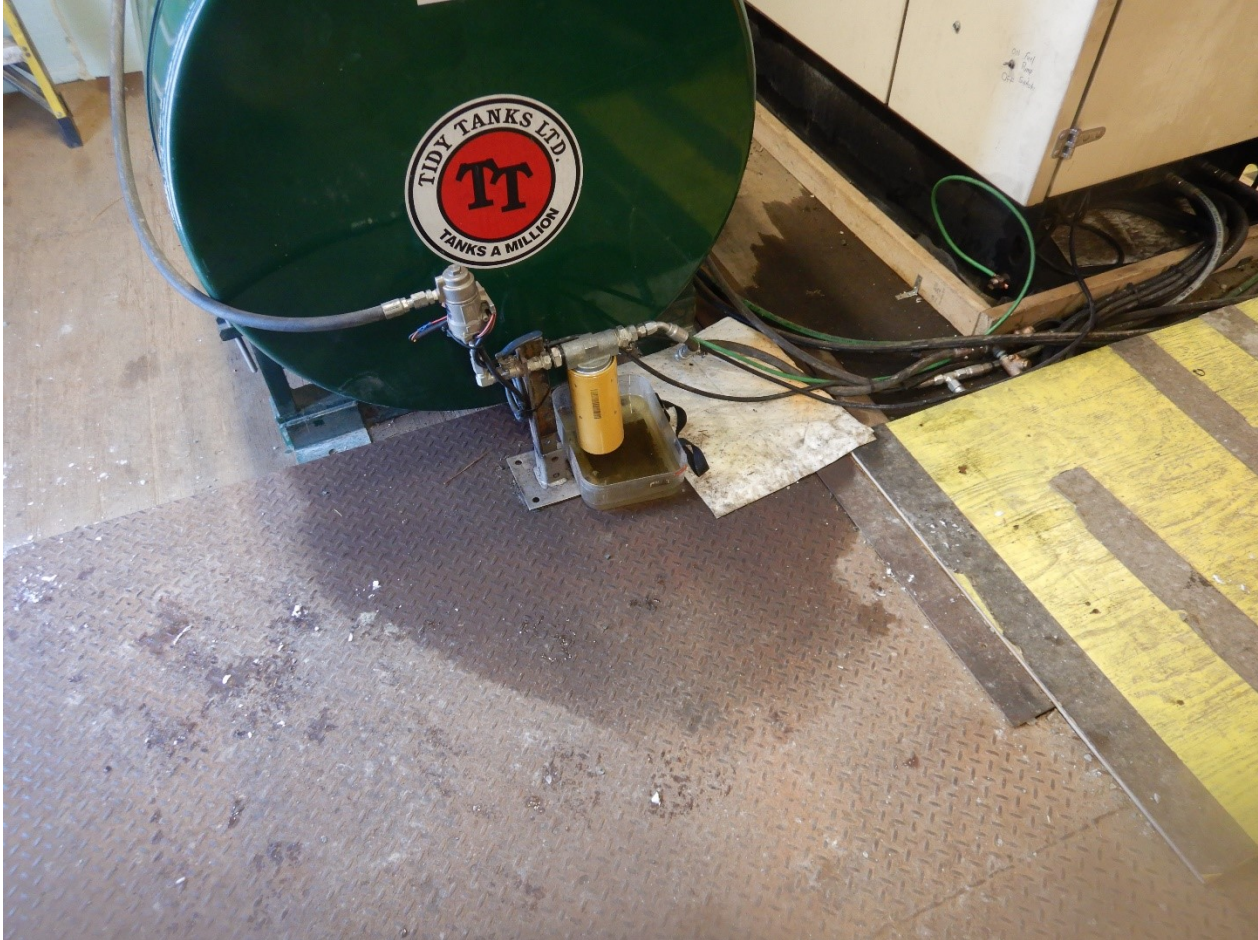
- I. During the inspection it appeared the flow meter at windy lake was installed and operational.
- II. While inside the windy lake pump house there was a strong smell of diesel, absorbent pads on the floor and what appeared to be a food container under the fuel filter full of diesel. See photo 6.

Description: spill within 31m of water at windy lake pump house.
