WATER LICENCE INSPECTION FORM

Licensee	Licensee Representative
Agnico Eagle	Guy Dufour
Licence No. / Expiry	Representative's Title
2AM-DOH1335	Environmental General supervisor
Land / Other Authorizations	Land / Other Authorizations
	--
Date of Inspection	Inspector
April 10, 2024	Jonathan MESHER
Activities Inspected	
<input checked="" type="checkbox"/> Camp	<input type="checkbox"/> Drilling
<input type="checkbox"/> Roads/Hauling	<input type="checkbox"/> Other:
<input checked="" type="checkbox"/> Mining	<input type="checkbox"/> Construction
	<input type="checkbox"/> Other:
	<input type="checkbox"/> Reclamation
	<input type="checkbox"/> Fuel Storage

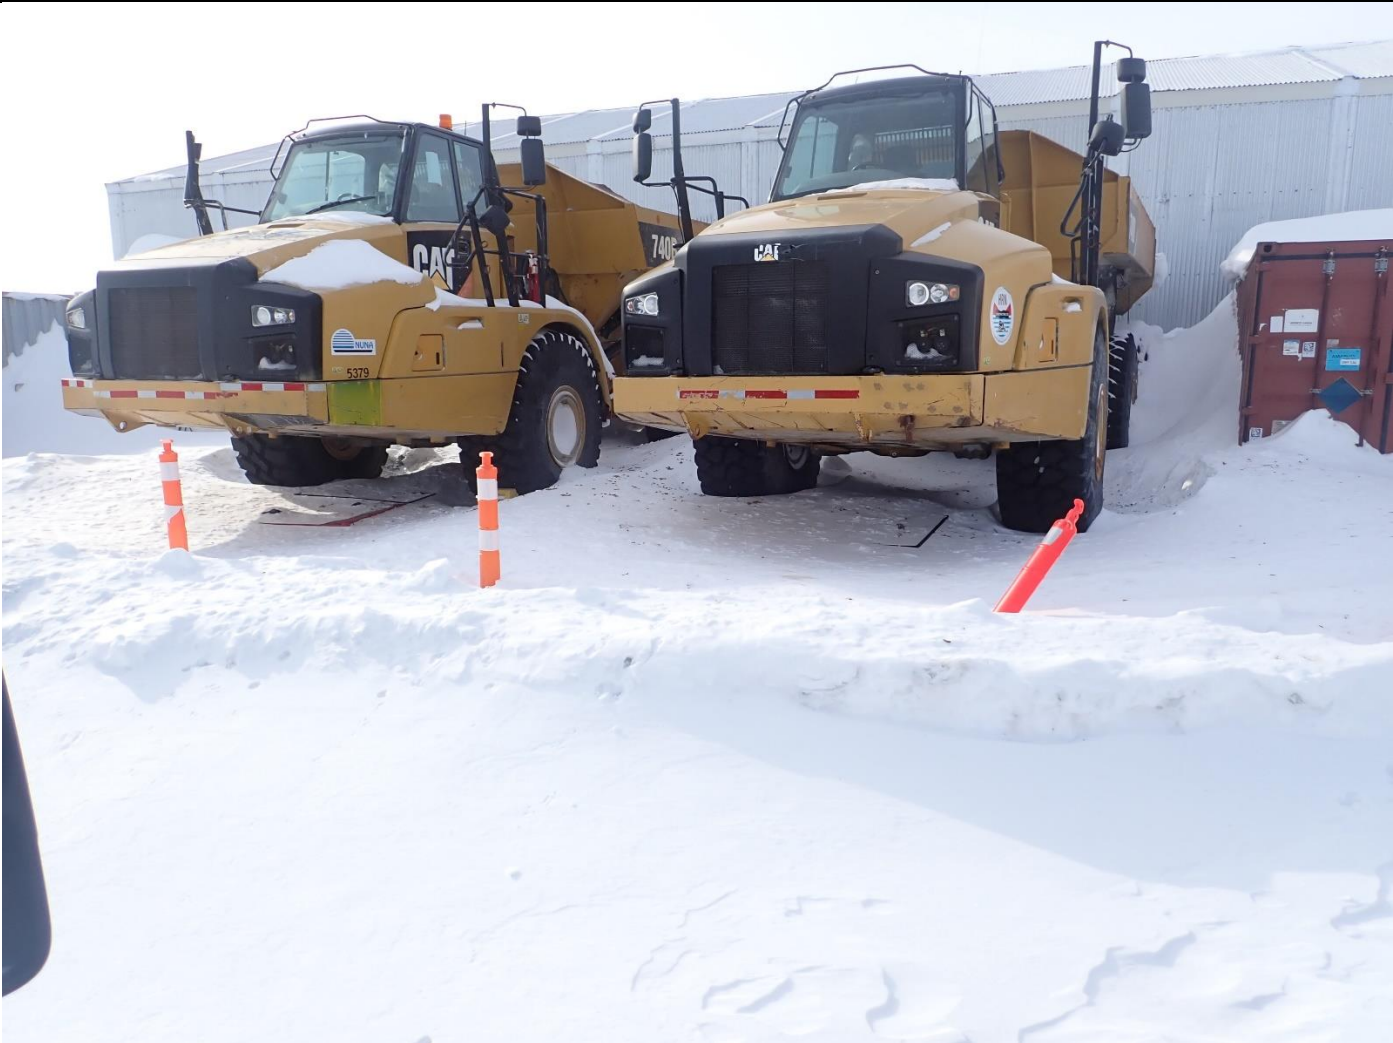
Photo 1

Description: Drip trays full of snow.

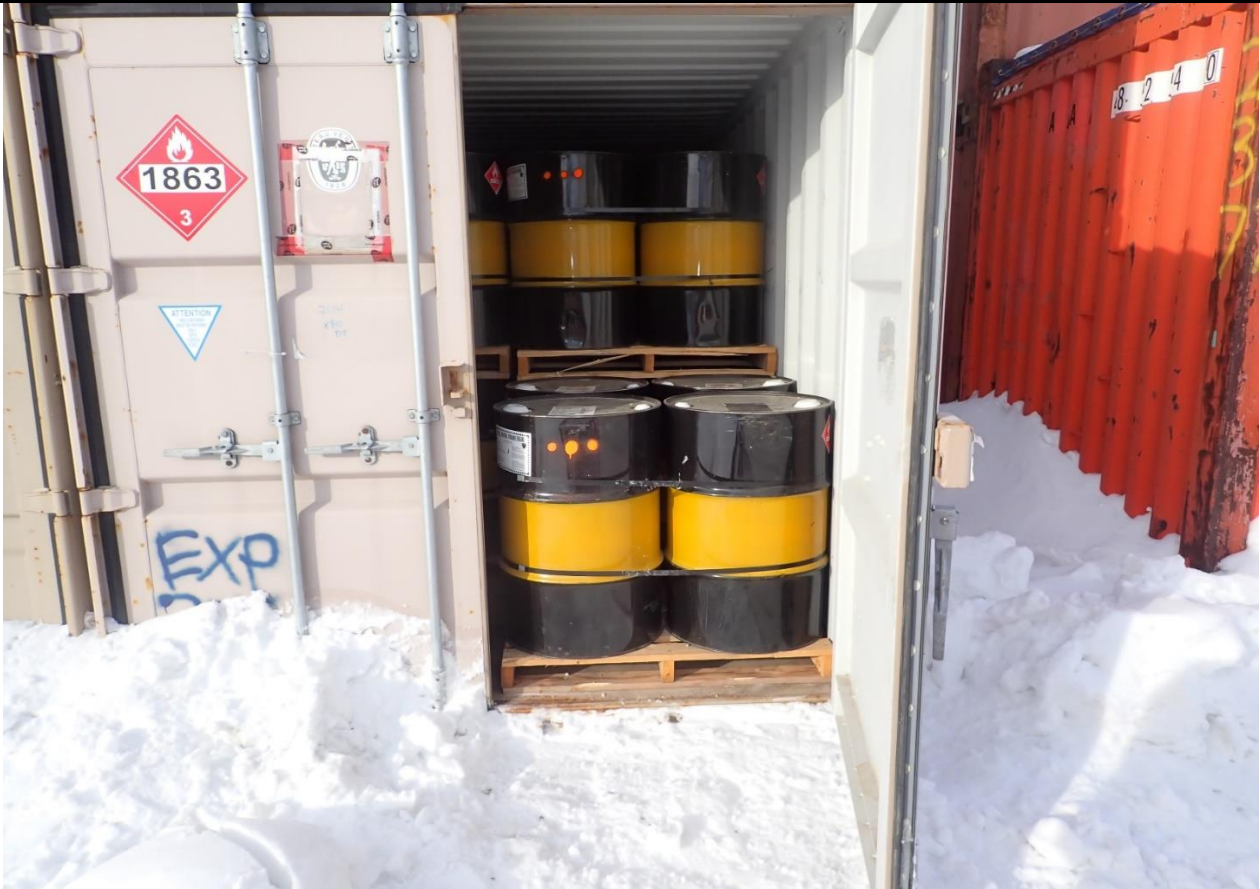
Photo 2

Description: seacan full of expired jet fuel.

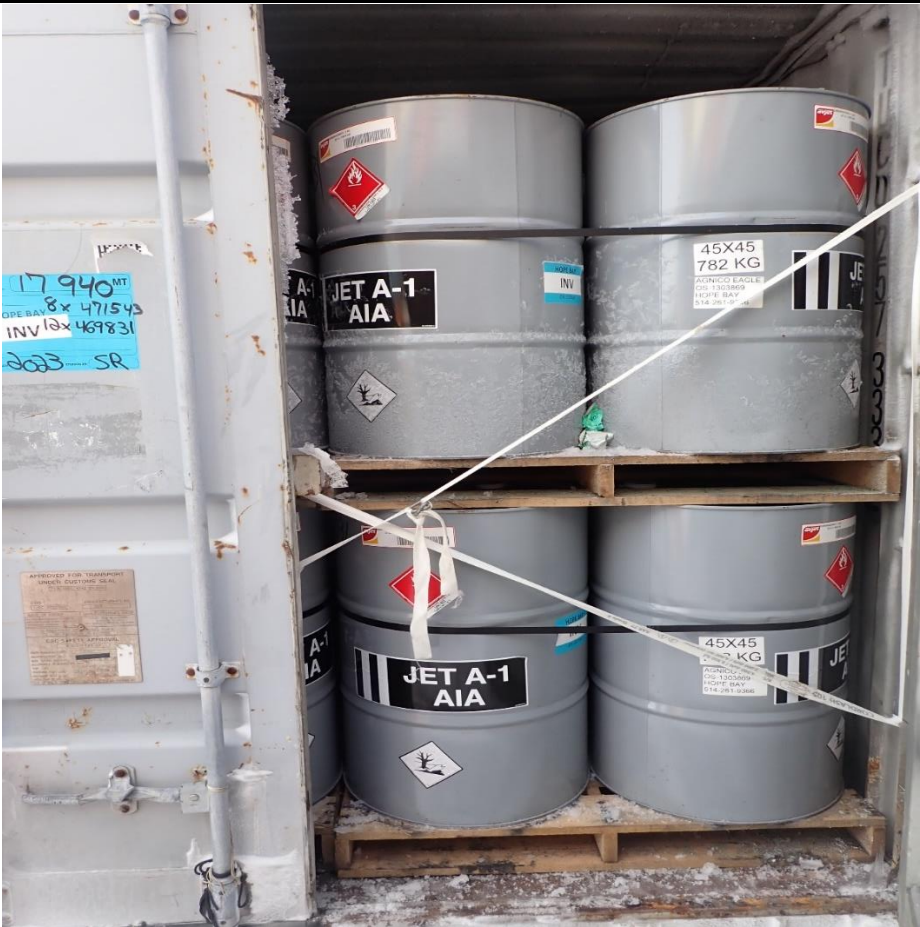
Photo 3

Description: seacan full of expired jet fuel.

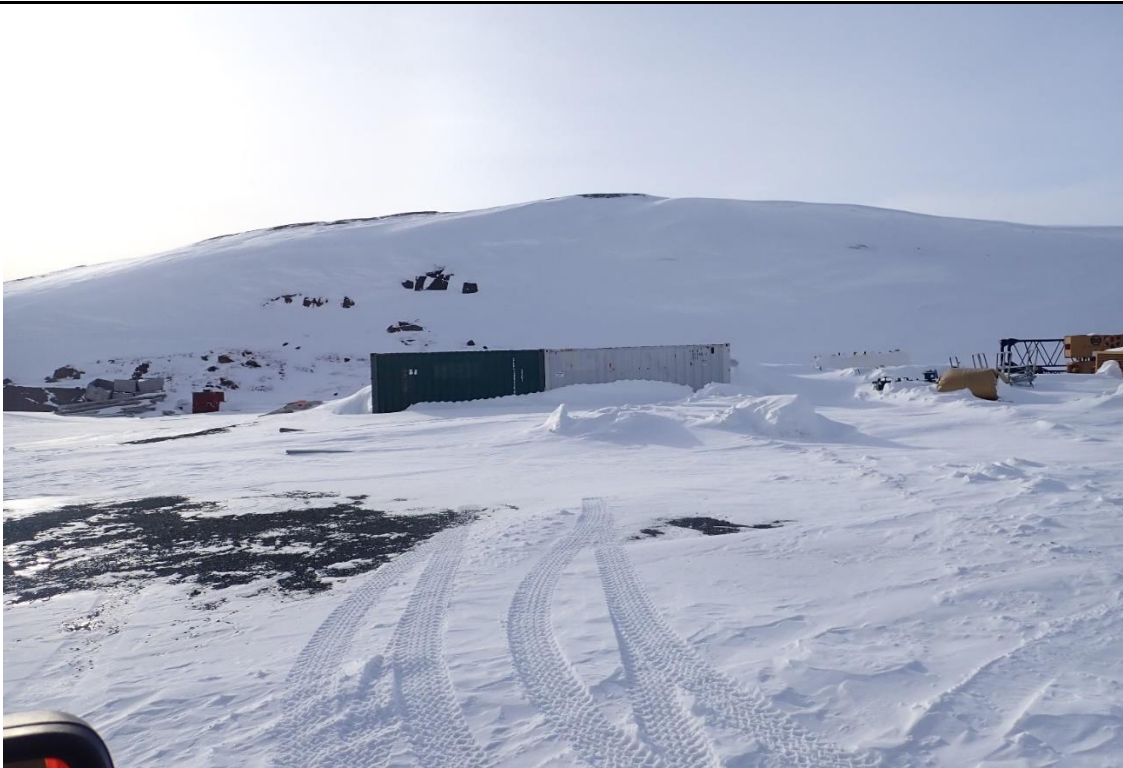
Photo 4

Description: Sea can in “Lined bermed area”.

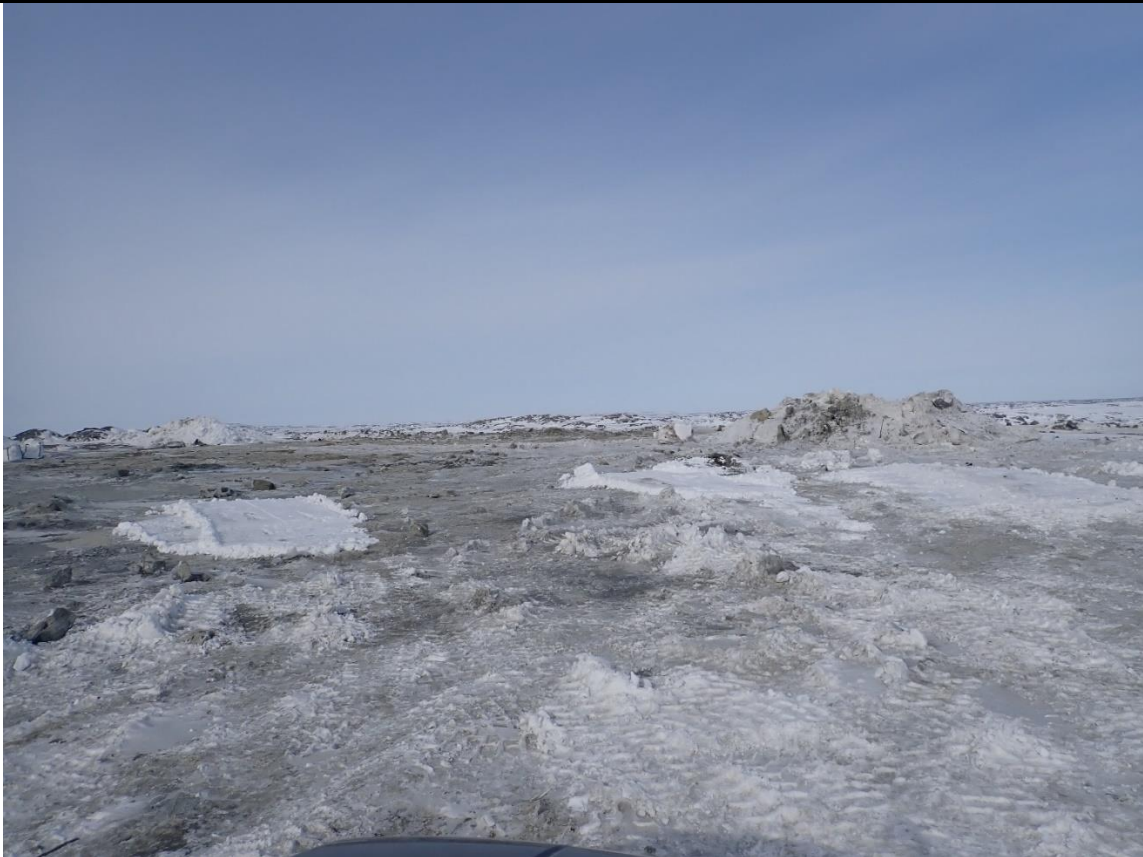
Photo 5

Description: Waste Rock Stockpile.
