WATER LICENCE INSPECTION FORM

Licensee	Licensee Representative
Agnico Eagle	Nancy Duquet Harvey
Licence No. / Expiry	Representative's Title
2AM-DOH1323	Environmental superintendent
Land / Other Authorizations	Land / Other Authorizations
	--
Date of Inspection	Inspector
June 20, 2022	Jonathan MESHER
Activities Inspected	
<input checked="" type="checkbox"/> Camp	<input type="checkbox"/> Drilling
<input type="checkbox"/> Roads/Hauling	<input type="checkbox"/> Other:
<input checked="" type="checkbox"/> Mining	<input type="checkbox"/> Construction
	<input type="checkbox"/> Other:
	<input type="checkbox"/> Reclamation
	<input type="checkbox"/> Fuel Storage

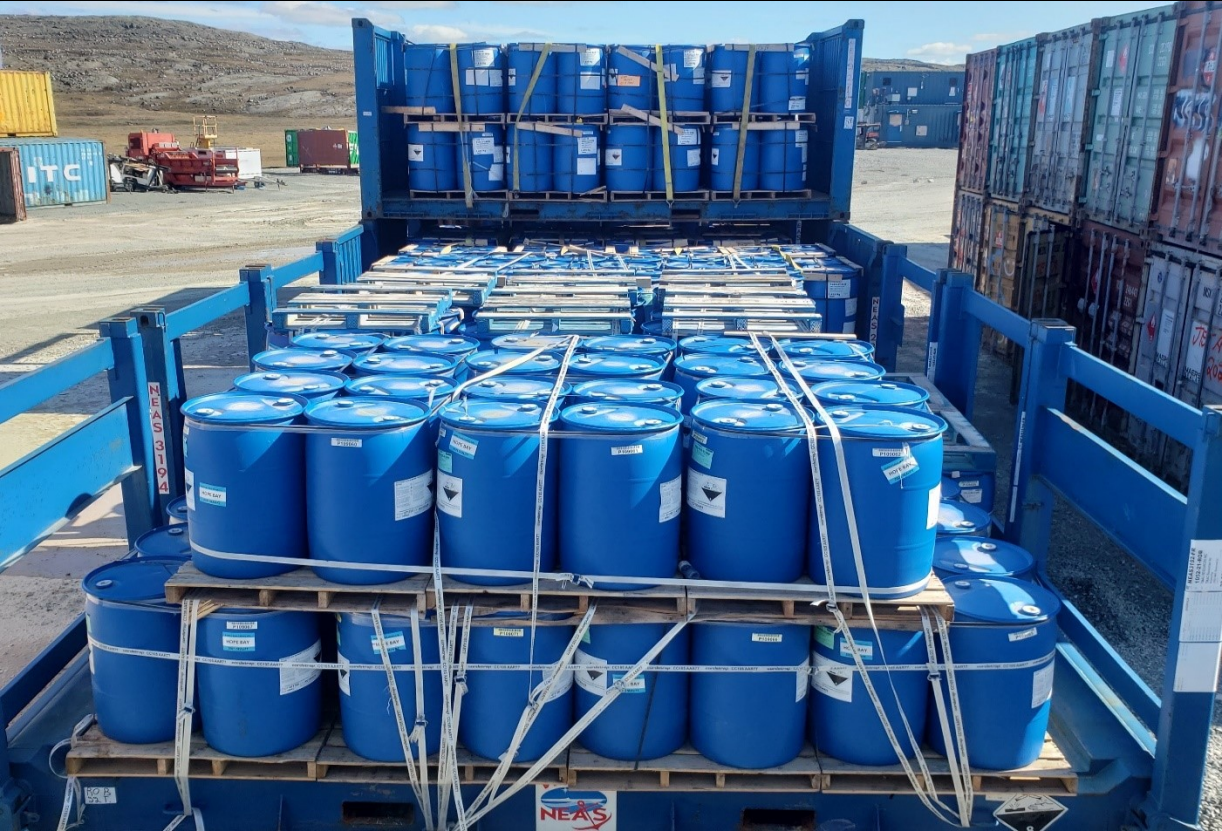
Photo 1

Description: sulfuric acid outside of containment.

1. The inspector is requesting the licensee explain where the “lined containment at the waste at the waste storage facility is and ensure all waste is managed and contained in a way approved by the NWB. The licensee appears to have failed to properly store Waste fuels, Glycol and Consumable Chemicals, based upon the information in “**Table 4.0-1, of the Hope Bay Project Hazardous Waste Management Plan**” which states the following;
- Waste Fuels will be stored in “Steel containers stored within lined containment at Waste Management Facility.

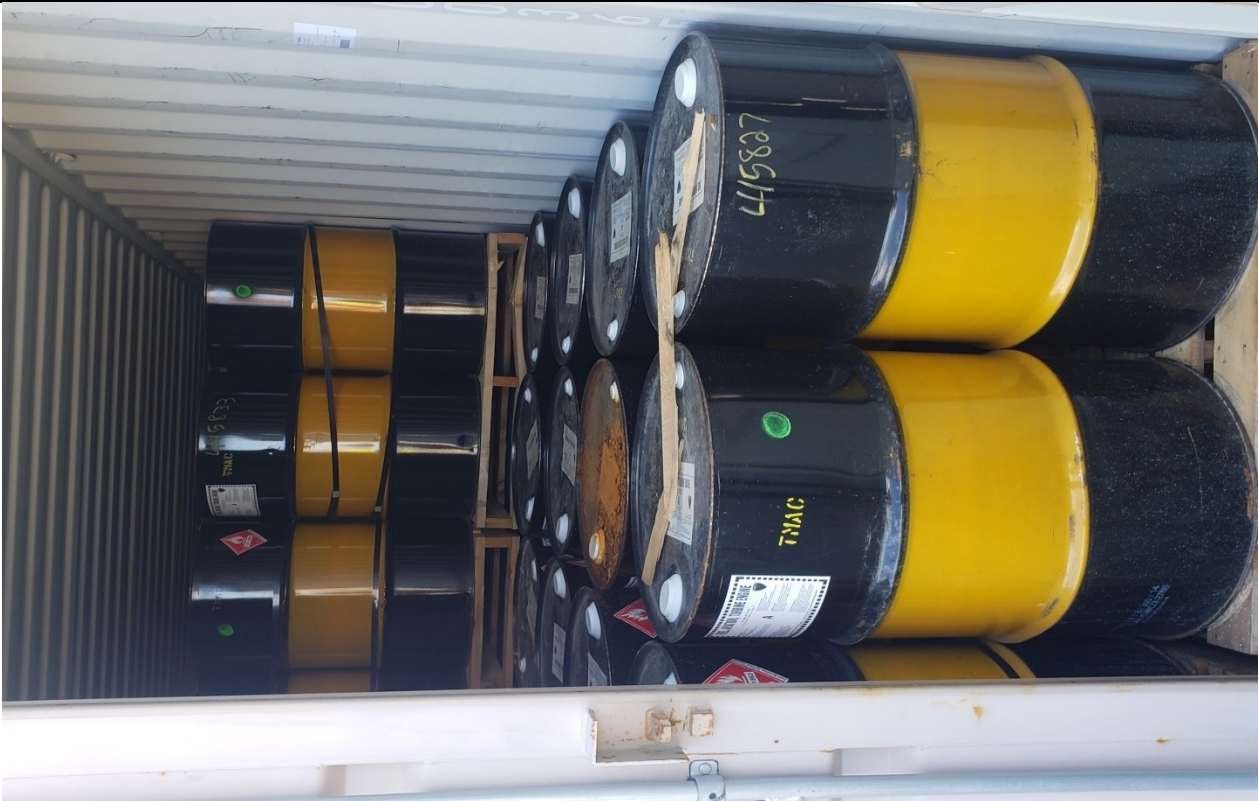
Photo 2

Description: one of the sea cans full out expired JET A outside of containment.

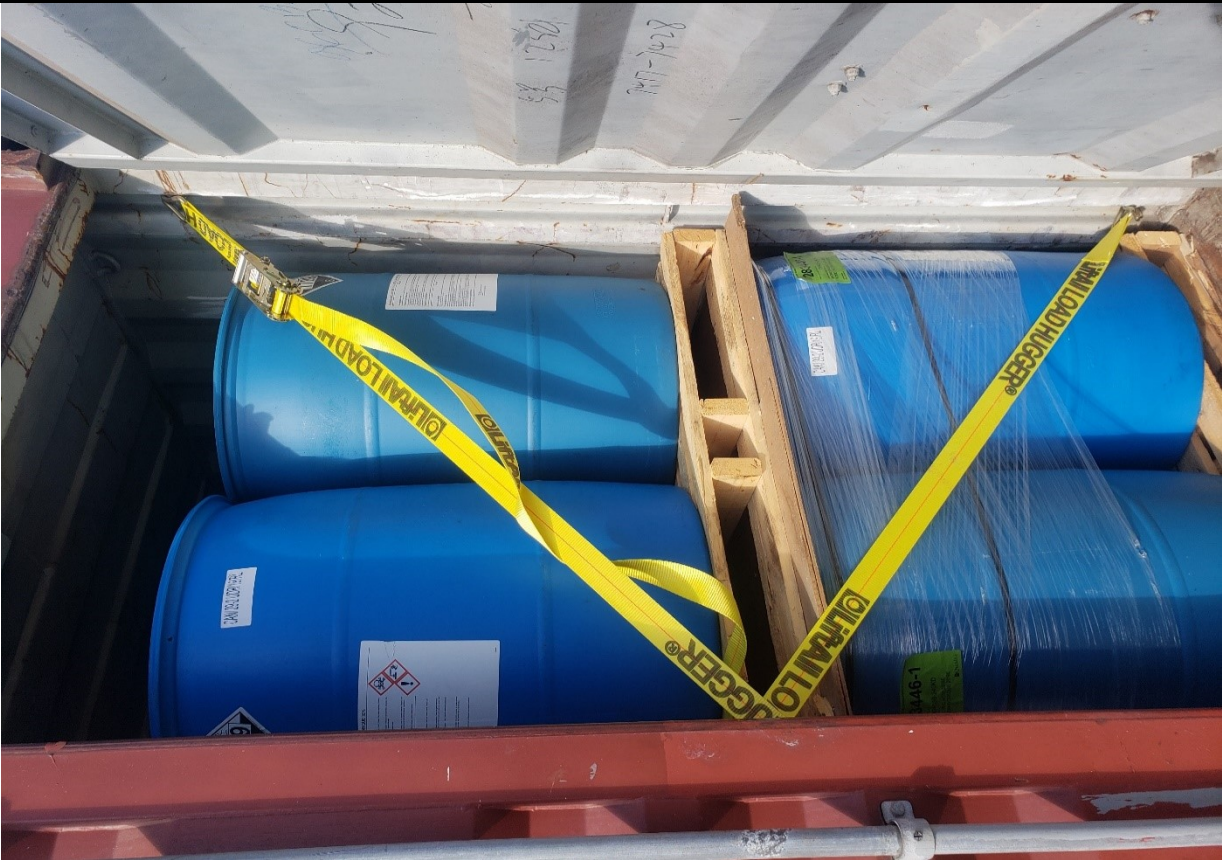
Photo 3

Description: hydrochloric Acid outside of containment, near the edge of a storage pad.

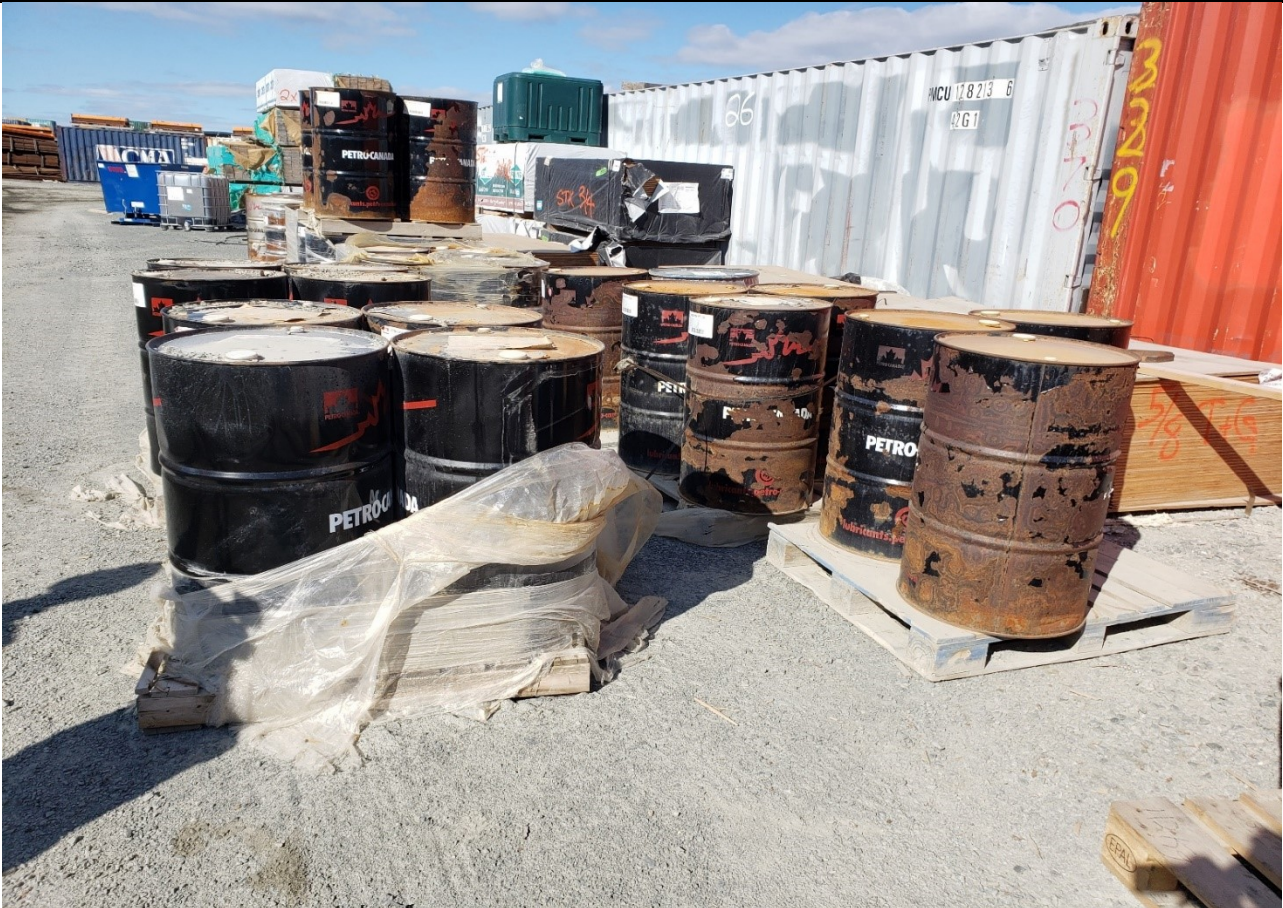
Photo 4

Description: Hazardous material outside of secondary containment

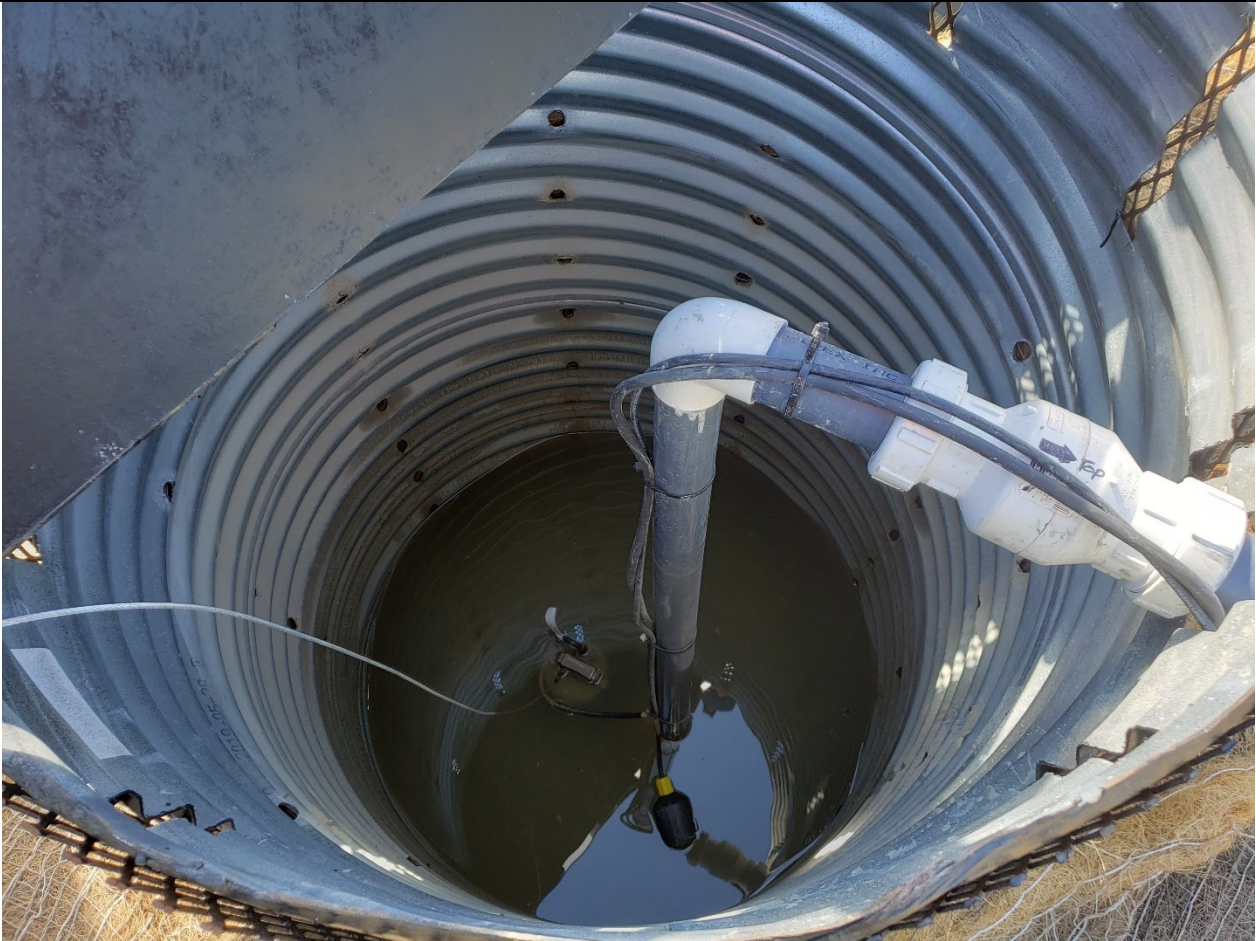
Photo 5

Description: well to designed to capture the leak from the Waste Rock Stockpile

2. PART D, Item 27. Of the licence 2AM-DOH states that; “The Licensee shall direct all runoff and seepage from the Temporary Waste Rock Pad to the Pollution Control Pond for collection and transfer to the Tailings Impoundment Area. The licensee is to show what work is being done to ensure all waste water from the Waste Rock Stockpile is being contained and no waste is flowing past the installed sumps.

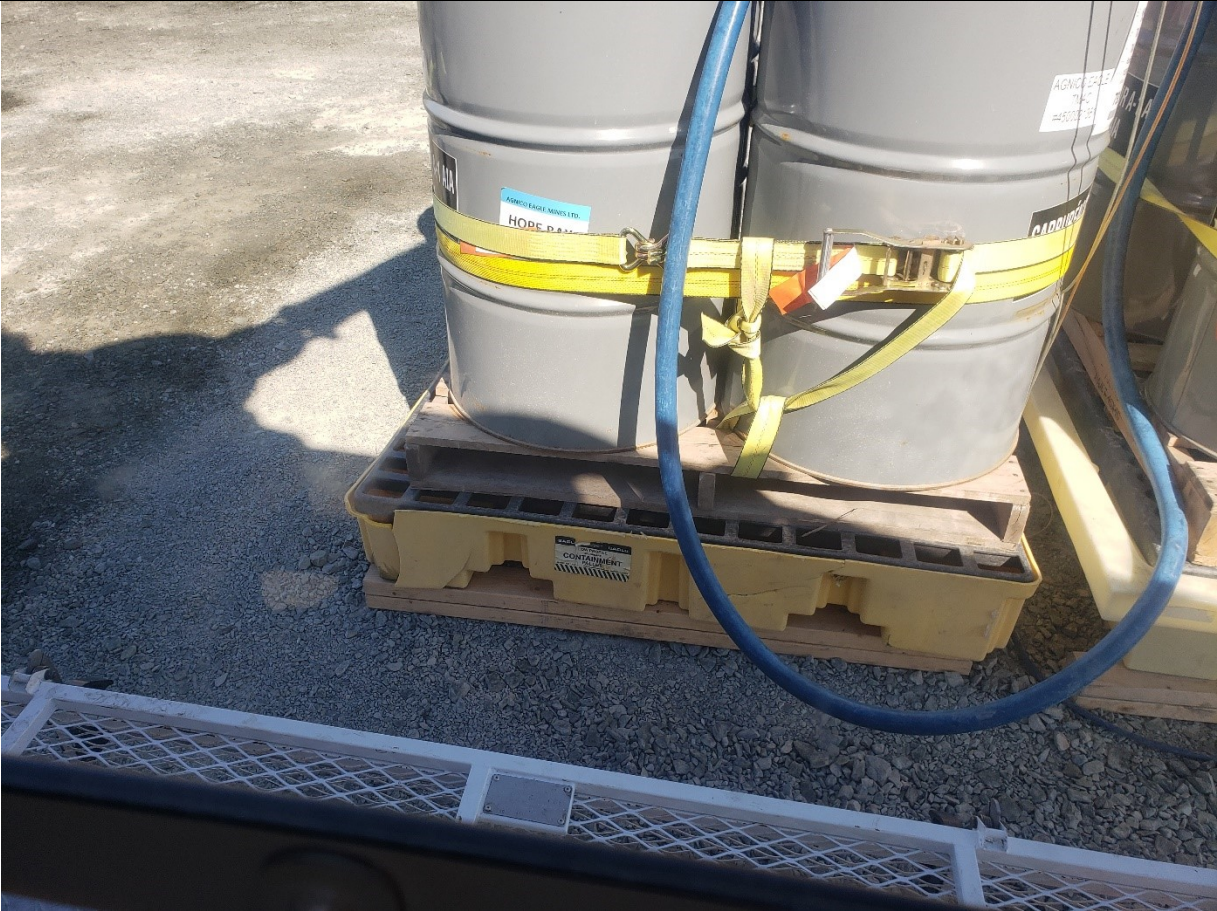
Photo 6

Description: Helicopter Pad fuel broken secondary containment.

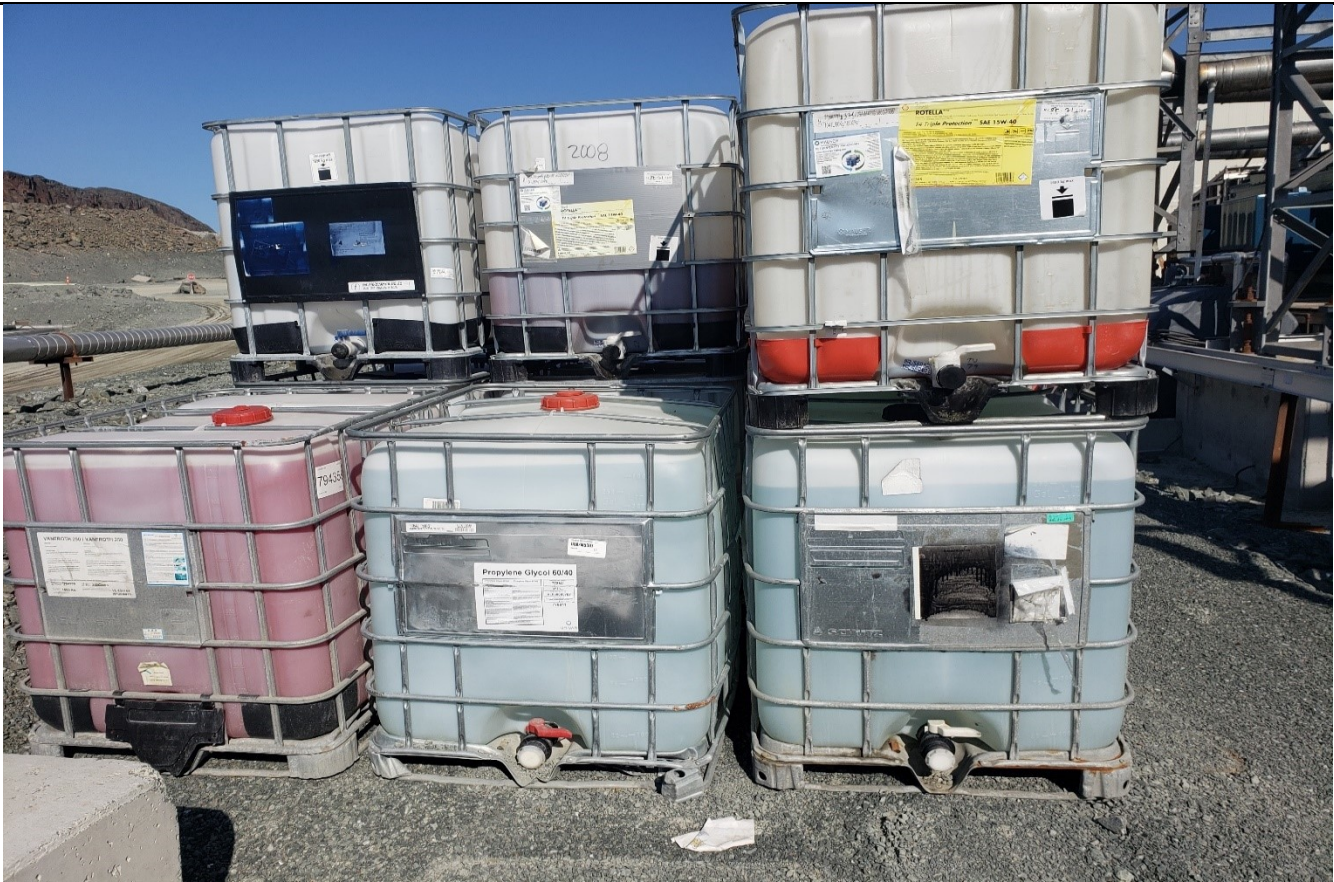
Photo 8

- VI. Adjacent to the Generator there was multiple totes of glycol and motor oil outside of containment. See photo 8 for the improperly stored glycol.
- VII. Staging area for Madrid portal, the licensee placed aggregate to build a pad and the material used leached chemicals upstream of a creek, while on site there was visible damage for the flora. See photo 9 for the Madrid portal pad, damaged flora and photo 10 for pooling water in the area.

Description: glycol outside of containment.

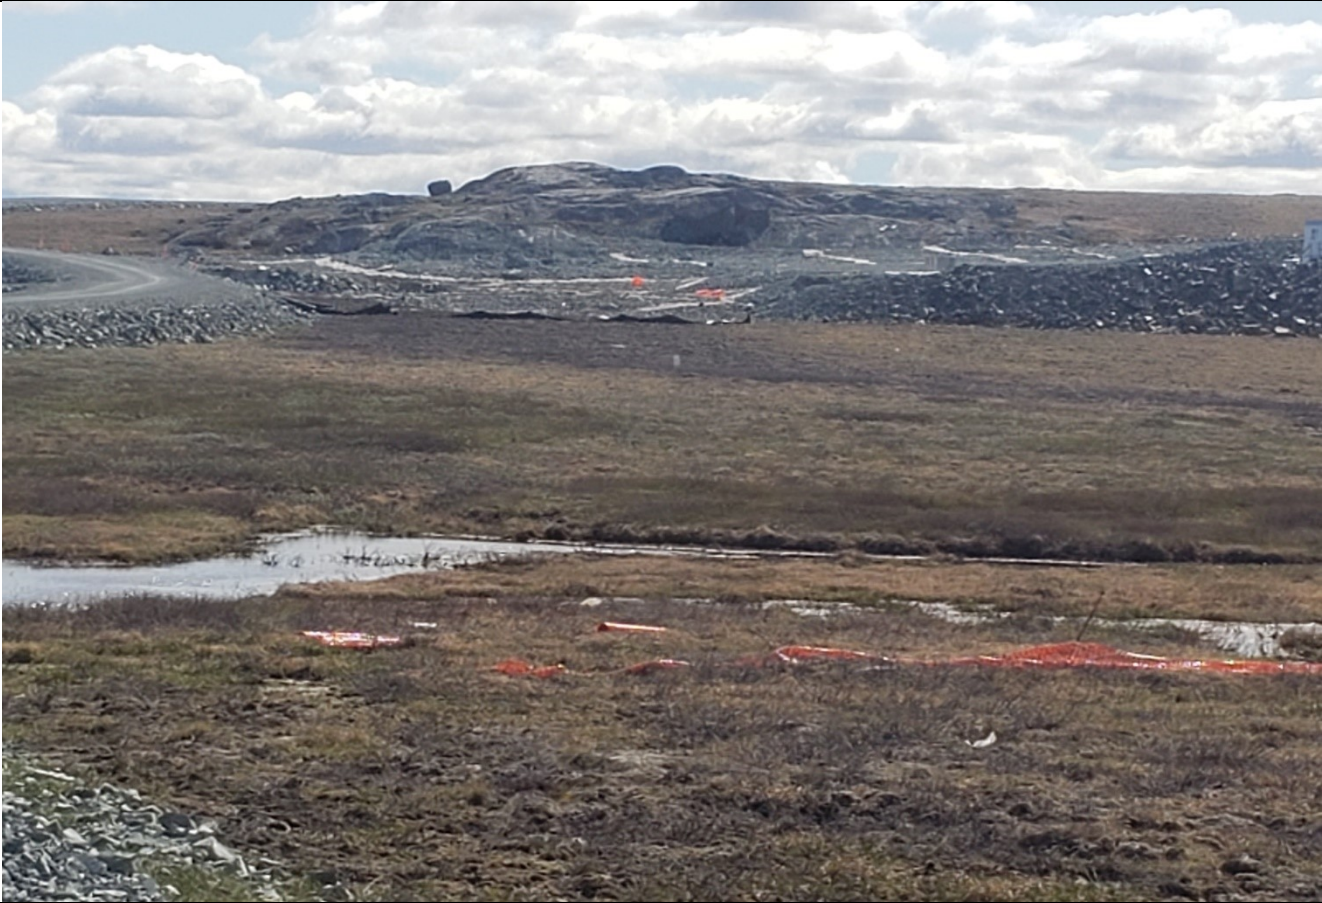
Photo 9

Description: damaged flora from chemical leaching rock used as fill.

3. The licensee is to submit a spill report for the leaking containment at the generator oil storage.
4. Based upon discussions with the licensee and the visible damage to the flora at the Madrid portal laydown from the construction material used it appears that the licensee has failed to follow the condition PART D, Item 1, of the licence 2AM-DOH which states; “The Licensee shall use fill material for construction from an approved source that shall be free of contaminants.” The licensee is to provide evidence that the construction material was approved and free of contaminants.

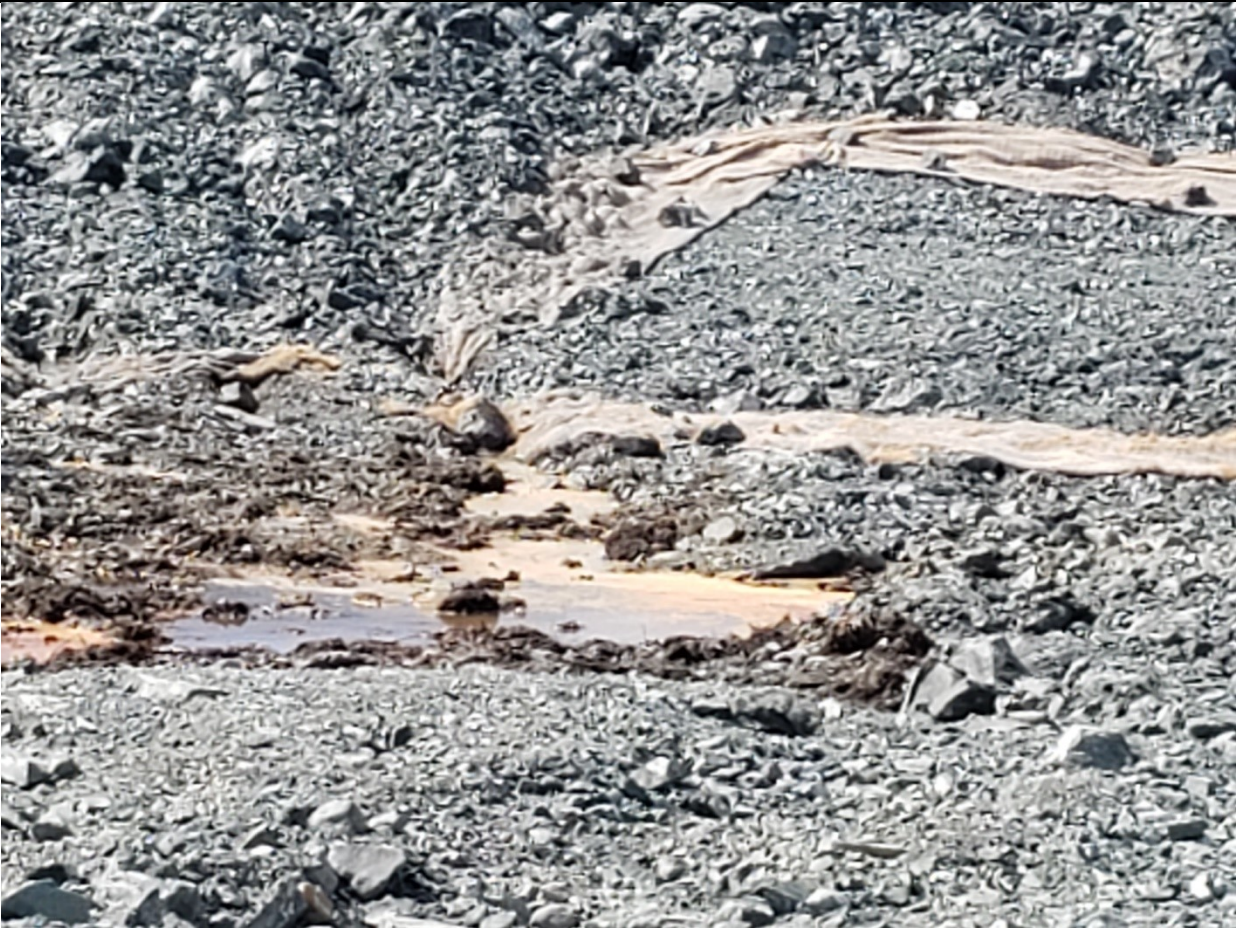
Photo 10

Description: pooling water in the area where the chemical leaching aggregate was used.

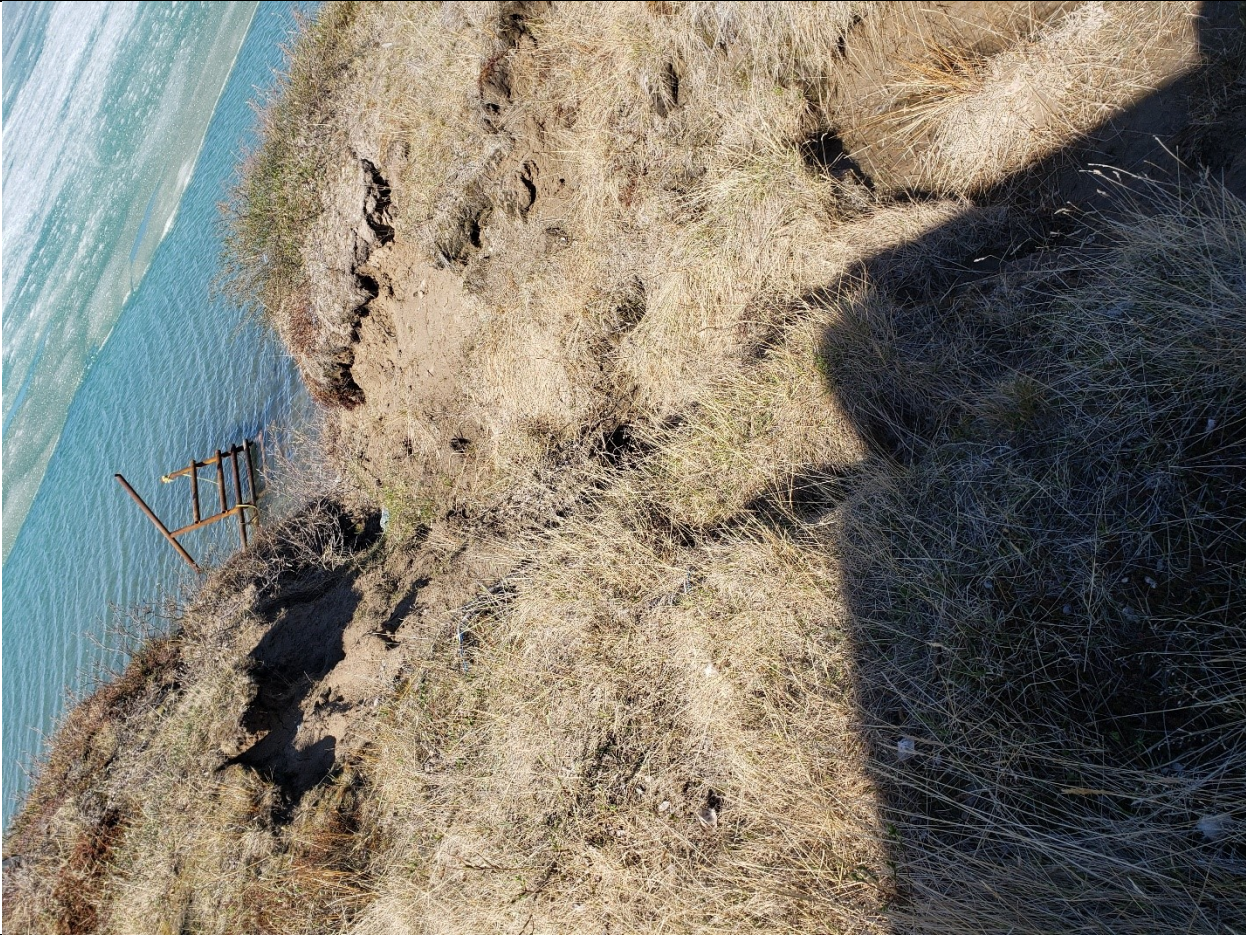
- I. At the time of the inspection the licensee did not have an operating Flow meter for the withdrawal location at Windy Lake, The licensee is currently calculating water usage by the amount of truck loads. While reviewing the water records there was multiple days recorded as 20,000L, single trucks capacity is approximately 16,000L and the licensee stated they use multiple truck loads a day. This leads the inspector to believe they are not accurately recording water usage. See photos 11 and 12 for the water records.
- II. While at windy camp the inspector noted erosion on the shore line which appears to be a result of a discharge from the camp facility, see photo 13 for the erosion noted.

Description: Erosion on the banks of windy lake which appear to be a result of a discharge from the camp discharge.

6. PART E, Item 7 of the licence 2AM-DOH states; “The Licensee shall provide the controls necessary to prevent erosion to the banks of any body of water. Sediment and erosion control measures shall be implemented prior to and maintained during the operation to prevent entry of sediment into water.” The inspector is requesting the licensee implement sediment and erosion controls to prevent entry of sediment in the water.
