**Re: 2021 Annual Geotechnical Inspection Report for the Doris and Madrid Sites, Hope Bay Project, Nunavut**

**Attention**      **Nancy Duquet Harvey**  
**Subject**        **Doris and Madrid - 2021 Annual Geotechnical Inspections**  
**Project**        1CT022.077

## Summary of Primary Observations and Recommendations - Table 1: Doris Project - 2021 Annual Geotechnical Inspection

**Summary of Recommendations - Table 2: Madrid Project 2021 Annual Geotechnical Inspection**

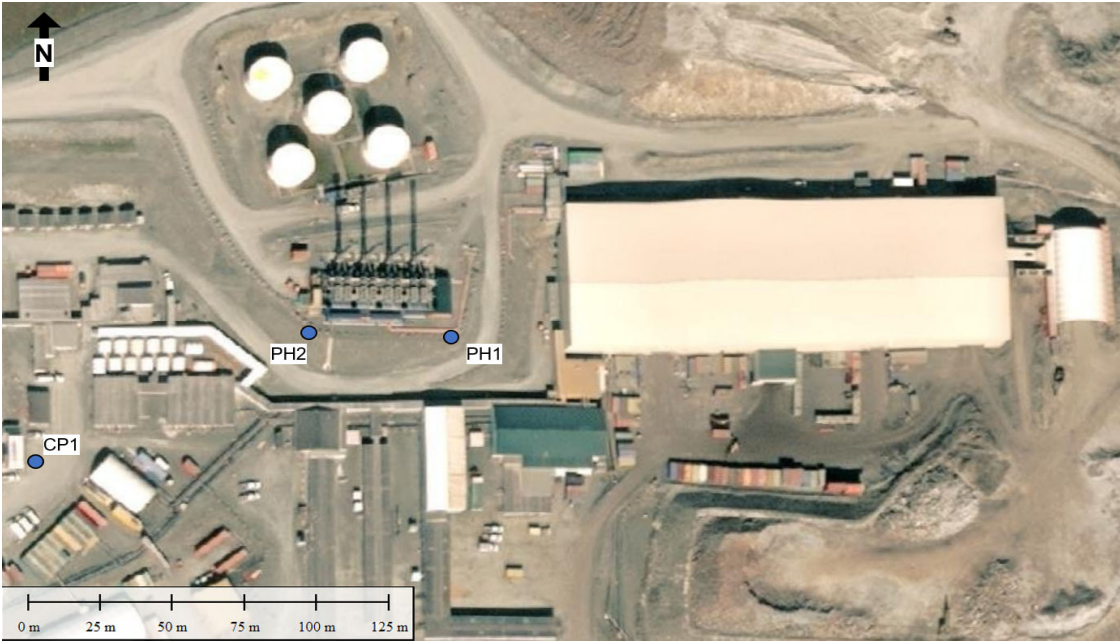
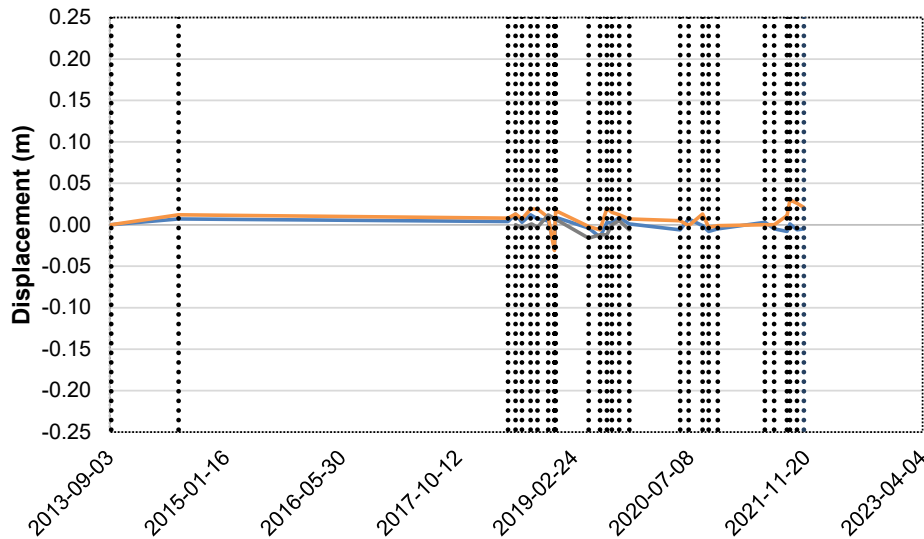
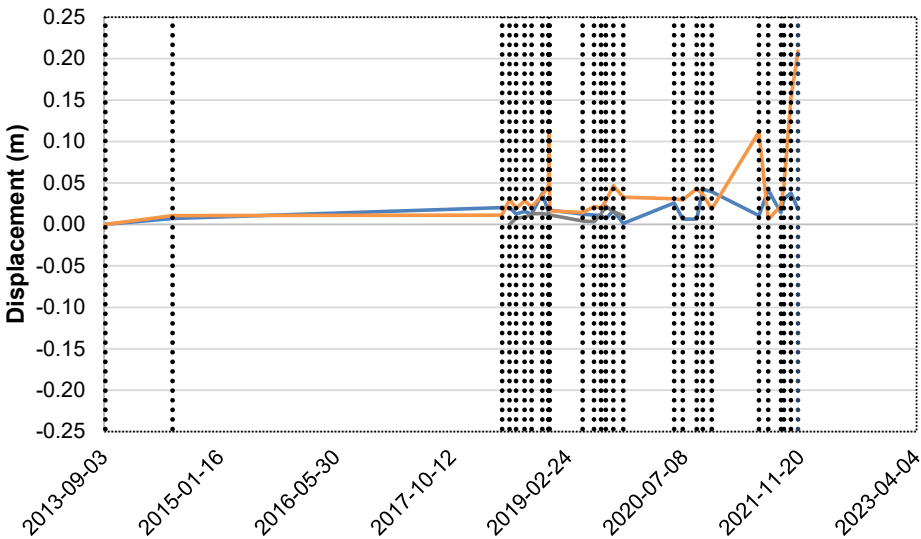
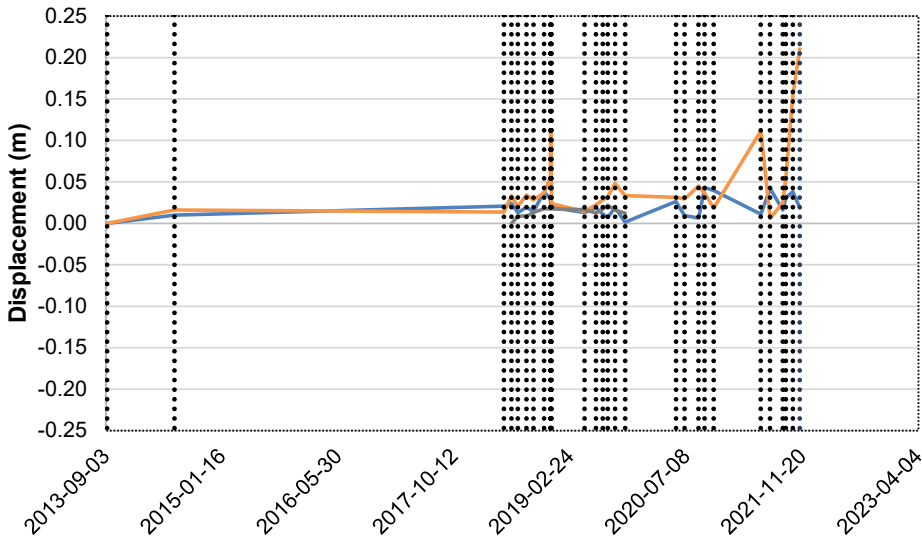
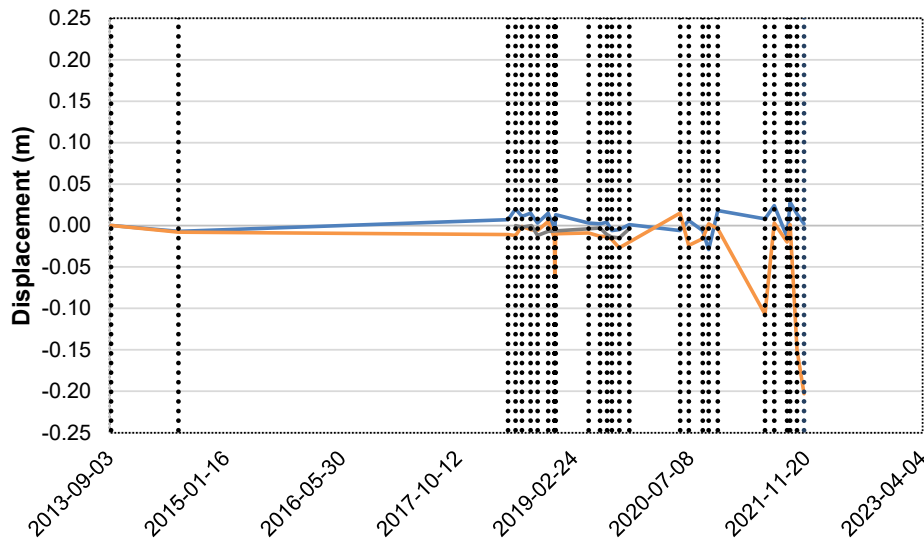
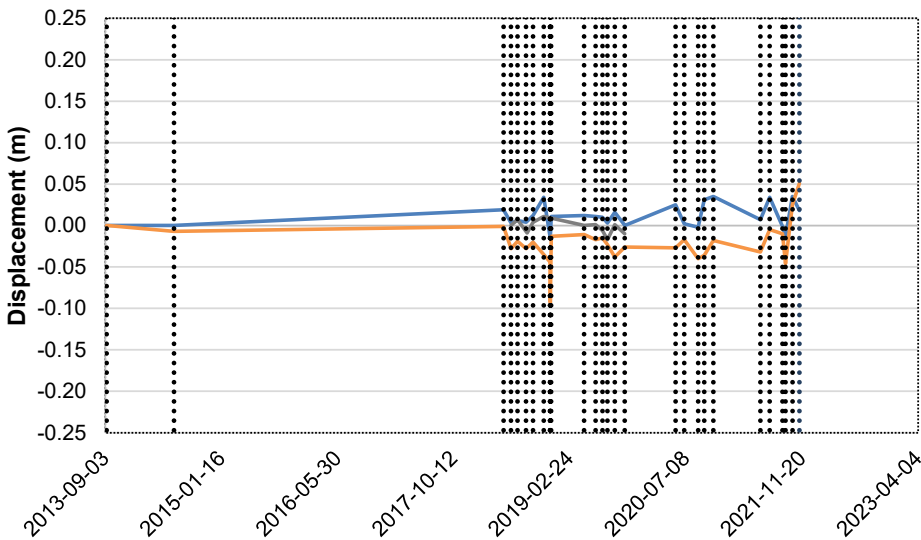
Date: November, 2021  
Approved: PL  
Figure: 1

Observation	Comments and Recommendation
<p><b>PAD B</b></p> <p>Agnico Eagle has conducted surveys of the monuments on Pad B 2021. There was an improvement in the data collection in 2021.</p> <p>Horizontal displacement has been indicated by the last two surveys at Pad B (October and November 2021 - note this is after the AGI site visit, but data up until the end of 2021 was included in the data review when producing this memorandum).</p>	<p>The Pad B area should be continued to be monitored. The monuments should be resurveyed in May including a survey of the control point (CP1), and once the ground is snow free, the Pad B should be inspected for signs of tension cracking and the points PH1 and PH2 should be inspected for signs of accidental movement of the monitoring point itself.</p> <p>Attachment 3 presents a summary of the recent Pad B survey data.</p>
<p><b>DORIS CREEK BRIDGE ABUTMENTS</b></p> <p>The original rock gabion construction, done at each of the Doris Creek Bridge abutments, was done in a manner that deformed the welded mesh gabion cages (moved into place rather than built in place). The deformed state of the rock gabion cages makes it difficult to visually assess if ongoing deformations are occurring at these gabions.</p> <p>Review of the ground temperature cable (GTC) data at the Doris Creek Bridge location shows that there are no anomalous data suggesting any undue warming trend.</p>	<p>The abutment of the bridges should continue to be monitored. Specifically monitoring checks should look for any new or reoccurring depressions that might develop in the area.</p> <p>Permanent survey monitoring points should be placed near the corners of each rock gabion abutment. These points would allow monitoring of the abutments for movement and potential identification of the mechanism (tilting, vertical or lateral displacement). Surveys of these new monitoring markers are suggested to be completed at least in May and August 2022 to set up a monitoring baseline.</p> <p>At the time of the 2021 inspection no notable changes in the conditions around this abutment were observed since the last site visit.</p> <p>Attachment 4 includes an overview of the ground temperature data at the Doris Creek Bridge location.</p>

Inspection Item	Recommendation	Agnico Response
Pad B	The Pad B area should be continued to be monitored. The monuments should be resurveyed in May including a survey of the control point (CP1), and once the ground is snow free, the Pad B should be inspected for signs of tension cracking and the points PH1 and PH2 should be inspected for signs of accidental movement of the monitoring point itself.	Agnico will conduct additional surveys of Pad B at the outlined frequency in 2022.
Doris Creek Bridge Abutments	<p>The abutment of the bridges should continue to be monitored. Specifically monitoring checks should look for any new or reoccurring depressions that might develop in the area.</p> <p>Permanent survey monitoring points should be placed near the corners of each rock gabion abutment. These points would allow monitoring of the abutments for movement and potential identification of the mechanism (tilting, vertical or lateral displacement).</p> <p>Surveys of these new monitoring markers are suggested to be completed at least in May and August 2022 to set up a monitoring baseline.</p> <p>At the time of the 2021 inspection no notable changes in the conditions around this abutment were observed since the last site visit.</p>	<p>Agnico will continue to monitor the abutment of the Doris Creek bridge.</p> <p>Agnico has established survey monitoring points in 2021 and will continue to survey the monuments on the rock gabions of this bridge during the snow free period of 2022.</p>

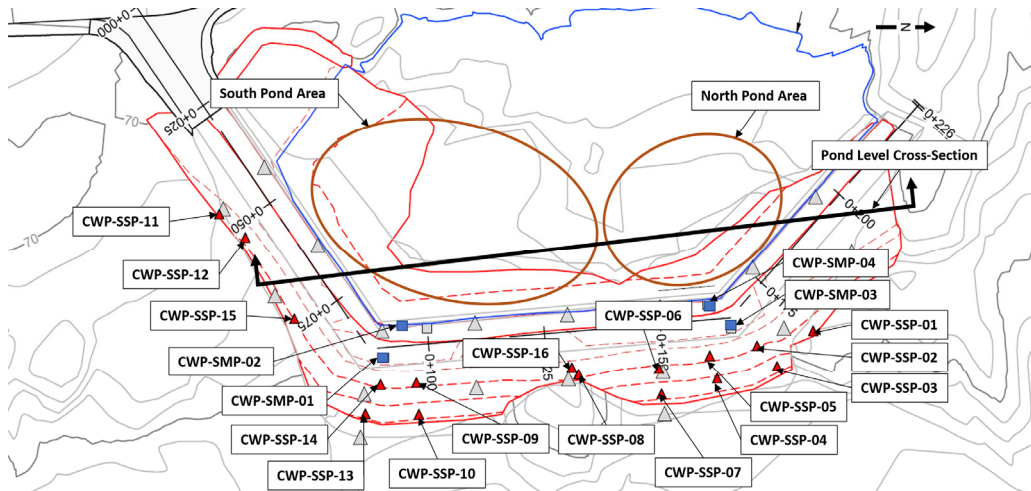
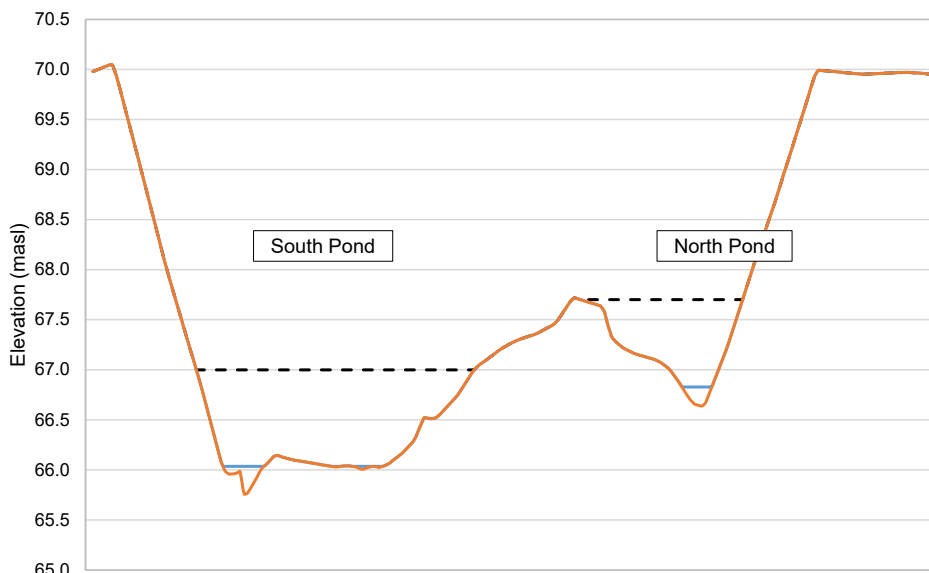
### North and South Pond Water Levels

Observation	Recommendation
<p><b>MADRID NORTH – CONTACT WATER POND Survey</b></p> <p>Survey settlement monitoring plates and surface settlement points were installed in 2019 and should continue to be monitored at the Madrid North CWP.</p>	<p>Survey monitoring should continue at the Madrid North CWP from around May to December each year.</p> <p>Overall, the largest movements at the Madrid CWP correspond with the two areas where the foundation is on overburden permafrost. The current deformations are within design limits but should be continued to be monitored.</p> <p>An overview of the survey monitoring results from 2021 are presented in Attachment 3.</p>
<p><b>MADRID NORTH – CONTACT WATER POND Seepage</b></p> <p>Interim remediation measures (placement of fine overburden near the liner bedrock interface) were completed in late 2020 to help stretch out the seepage pathways below and at the liner to bedrock contact the CWP. This was suggested to help stretch out seepage pathways below the CWP. This has had some minor positive improvement but not eliminated the seepage noted from the CWP.</p> <p>The latest monitoring and visual inspections indicated that the main seepage pathway is most likely through the natural fractured bedrock at the liner tie in and further within the facility. Somewhat as expected, the seepage at this contact water pond is noted to increase with increased water levels (increased head).</p>	<p>The monitoring and diligent management of the Madrid CWP remains a top priority. The CWP should be operated as a 'dry pond' with any water being removed from the pond over the course of a few days or less. Ideally ponded water would be left in the pond for less than 48 hours.</p> <p>Seepage should be monitored below the pond (North), specifically around freshet. If any seepage is noted the flow rates should be estimated, the location should be marked (to look for potential deepening of the active layer in these areas) and periodic water samples should be collected and tested in accordance with site water sampling procedures (if possible).</p> <p><i>UPDATE: Issued for Construction (IFC) designs have been generated in 2022 (post the AGI inspection) and plans are in place to install a sump downstream of the existing Madrid CWP. This sump would be installed to assist with additional seepage control at the Madrid area.</i></p>

Pond Elevation Date **2021-10-06**

North Pond Elevation	66.83	masl
Estimated North Pond Water Volume	2	m <sup>3</sup>
North Pond Max. Elevation**	67.7	masl

Inspection Item	Recommendation	Agnico Response
Madrid North – Contact Water Pond	<p>Survey monitoring should continue at the Madrid North CWP from around May to December each year.</p> <p>Overall, the largest movements at the Madrid CWP correspond with the two areas where the foundation is on overburden permafrost. The current deformations are within design limits but should be continued to be monitored.</p>	Agnico will conduct survey monitoring at the recommended frequency.
Madrid North – Contact Water Pond	<p>The monitoring and diligent management of the Madrid CWP remains a top priority. The CWP should be operated as a 'dry pond' with any water being removed from the pond over the course of a few days or less. Ideally ponded water would be left in the pond for less than 48 hours.</p> <p>Seepage should be monitored below the pond (North), specifically around freshet. If any seepage is noted the flow rates should be estimated, the location should be marked (to look for potential deepening of the active layer in these areas) and periodic water samples should be collected and tested in accordance with site water sampling procedures (if possible).</p> <p><i>UPDATE: Issued for Construction (IFC) designs have been generated in 2022 (post the AGI inspection) and plans are in place to install a sump downstream of the existing Madrid CWP. This sump would be installed to assist with additional seepage control at the Madrid area.</i></p>	Agnico has submitted Issued for Construction (IFC) for the construction of a sump downstream of the Madrid North Contact Water Pond. The installation is currently scheduled to occur prior to freshet 2022. This sump would be installed to assist with additional seepage control at the Madrid area.

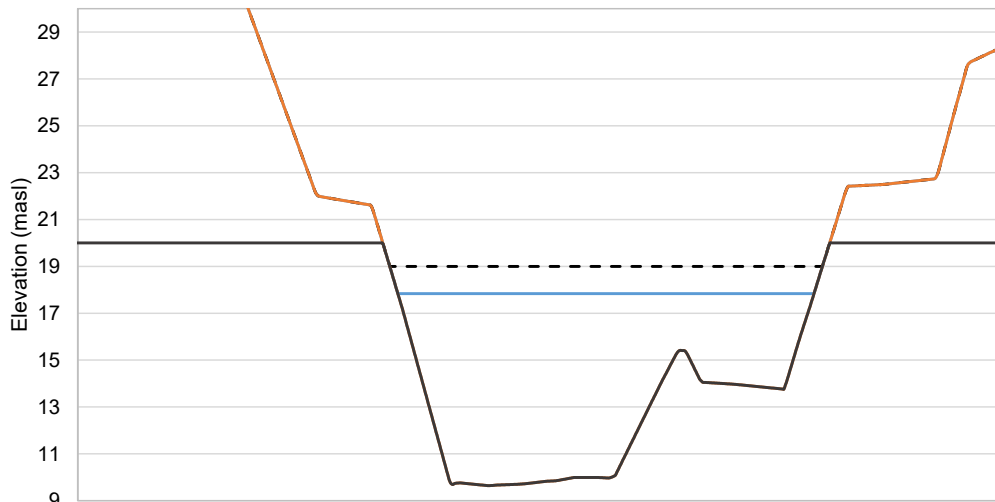
#### Pit Water Level

Pit Water Elevation Date	2021-11-10
Pit Water Elevation	17.84 masl
Estimated Water Volume	24,088 m <sup>3</sup>
Min. Frozen Ovb. Elevation	20.0 masl
Available Freeboard	2.2 m

Within normal conditions (>5 m)
Start to implement dewatering plans (1 m to 5 m)
Immediate action is required (< 1 m)
Frozen Overburden Surface
Pit/Bedrock Surface
Surveyed Water Level
Maximum Allowable Level
