CONSTRUCTION SUMMARY REPORT: Madrid North CWP Sump 1

Type "A" Water Licence 2AM-DOH1335 Hope Bay Phase 2 Project Agnico Eagle Mines Ltd. June 6, 2022

Agnico Eagle Mines

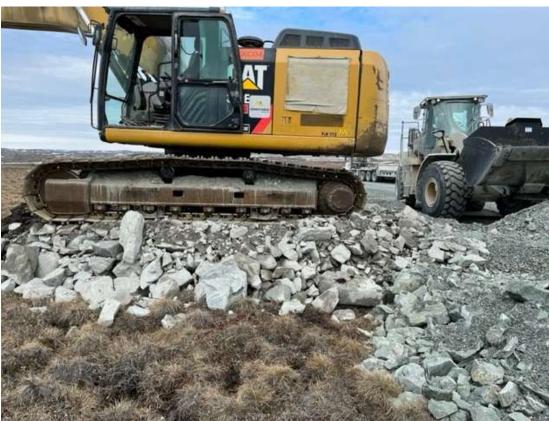
Photo 1 - Pad constructed with non-acid generating ROQ for equipment access from Windy Road to the sump location

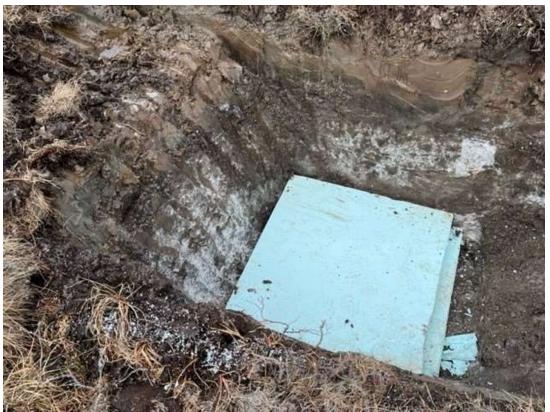
Photo 2 - Excavation completed, and rigid installation installed to the base of the excavation. Excavation side slopes were carefully cut to the required dimensions with an excavator equipped with a ditching bucket.

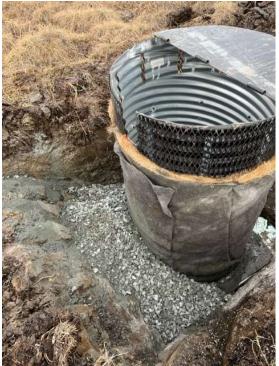
Photo 3 - Sump and non-woven geotextile installed. Backfill with bedding material in progress. The liner bedding material was placed in lifts.

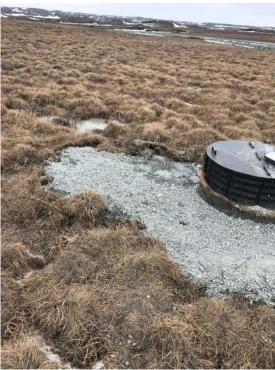
Photo 4 - Backfill with bedding material is complete.

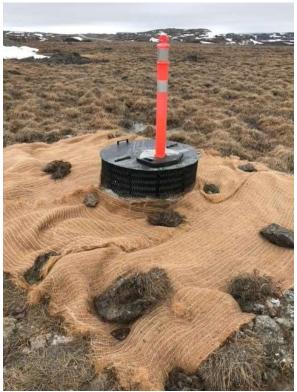
Photo 5 - Sump installation complete. Lid placed on top of sump to remove hazard to humans and wildlife. Coconut matting placed over bedding material.
