Memo

To: Oliver Curran, VP Environmental Affairs Client: TMAC Resources Inc.

From: Ryan Williams, Senior Consultant, PEng Project No: 1CT022.055

Subject: Hope Bay Project: Doris and Madrid 2019 Construction Summary Report

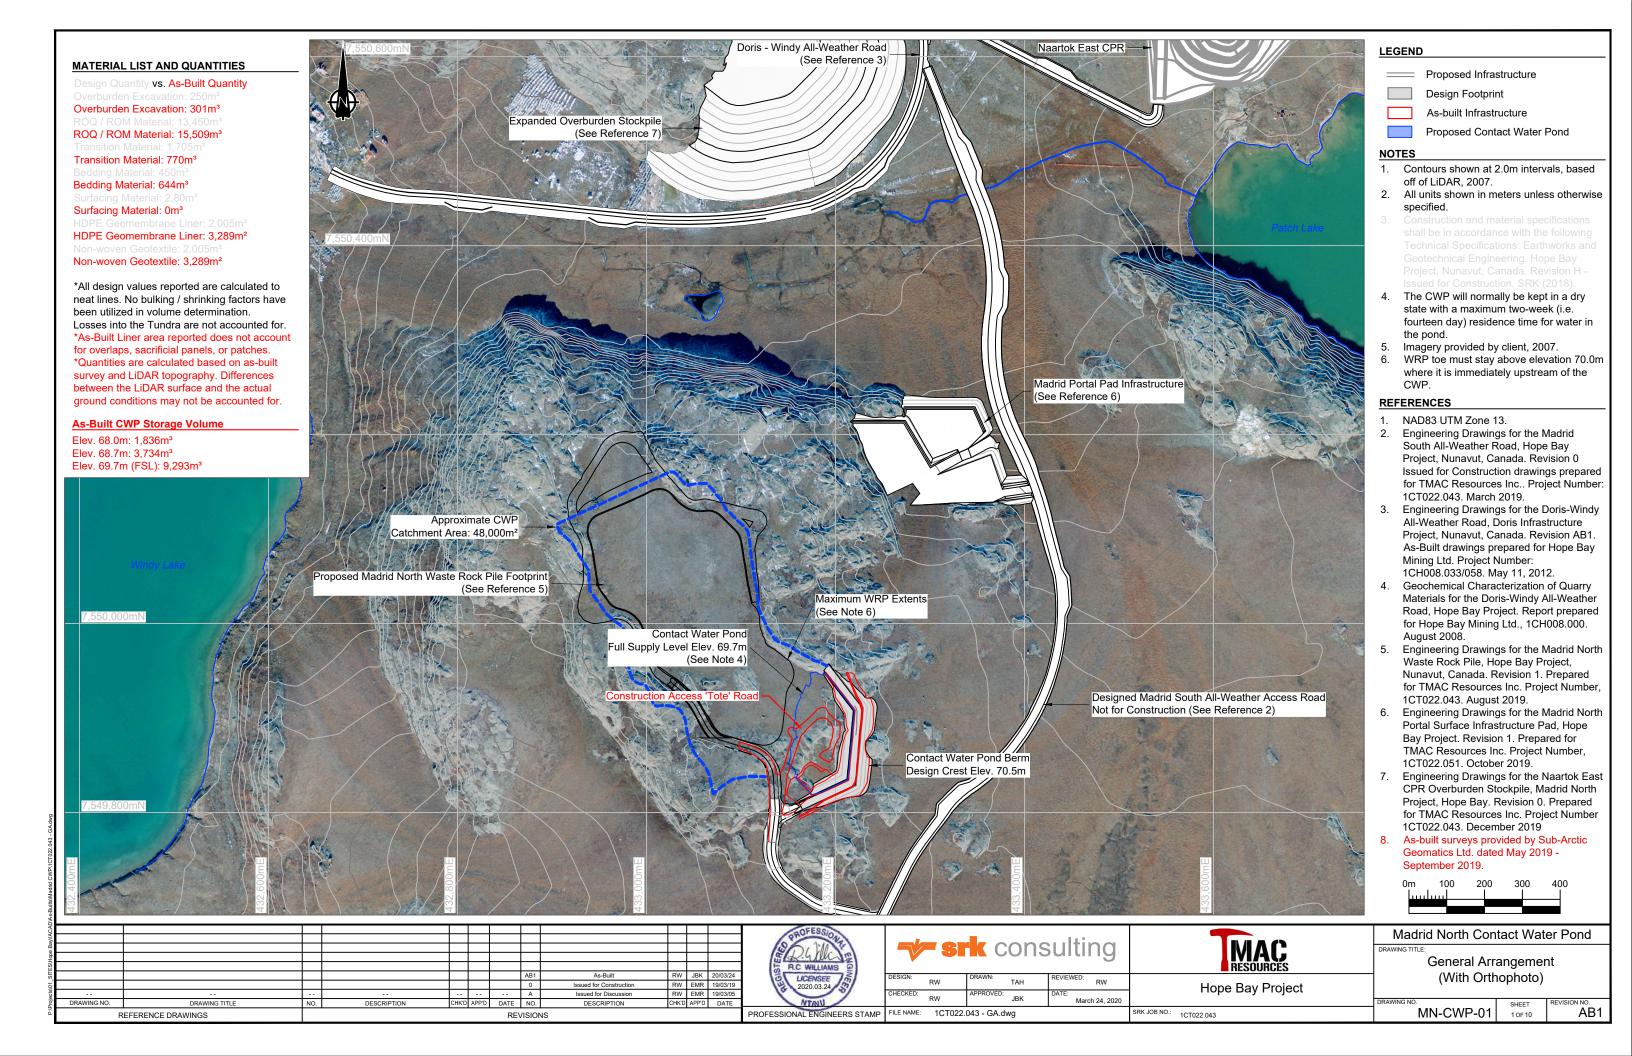
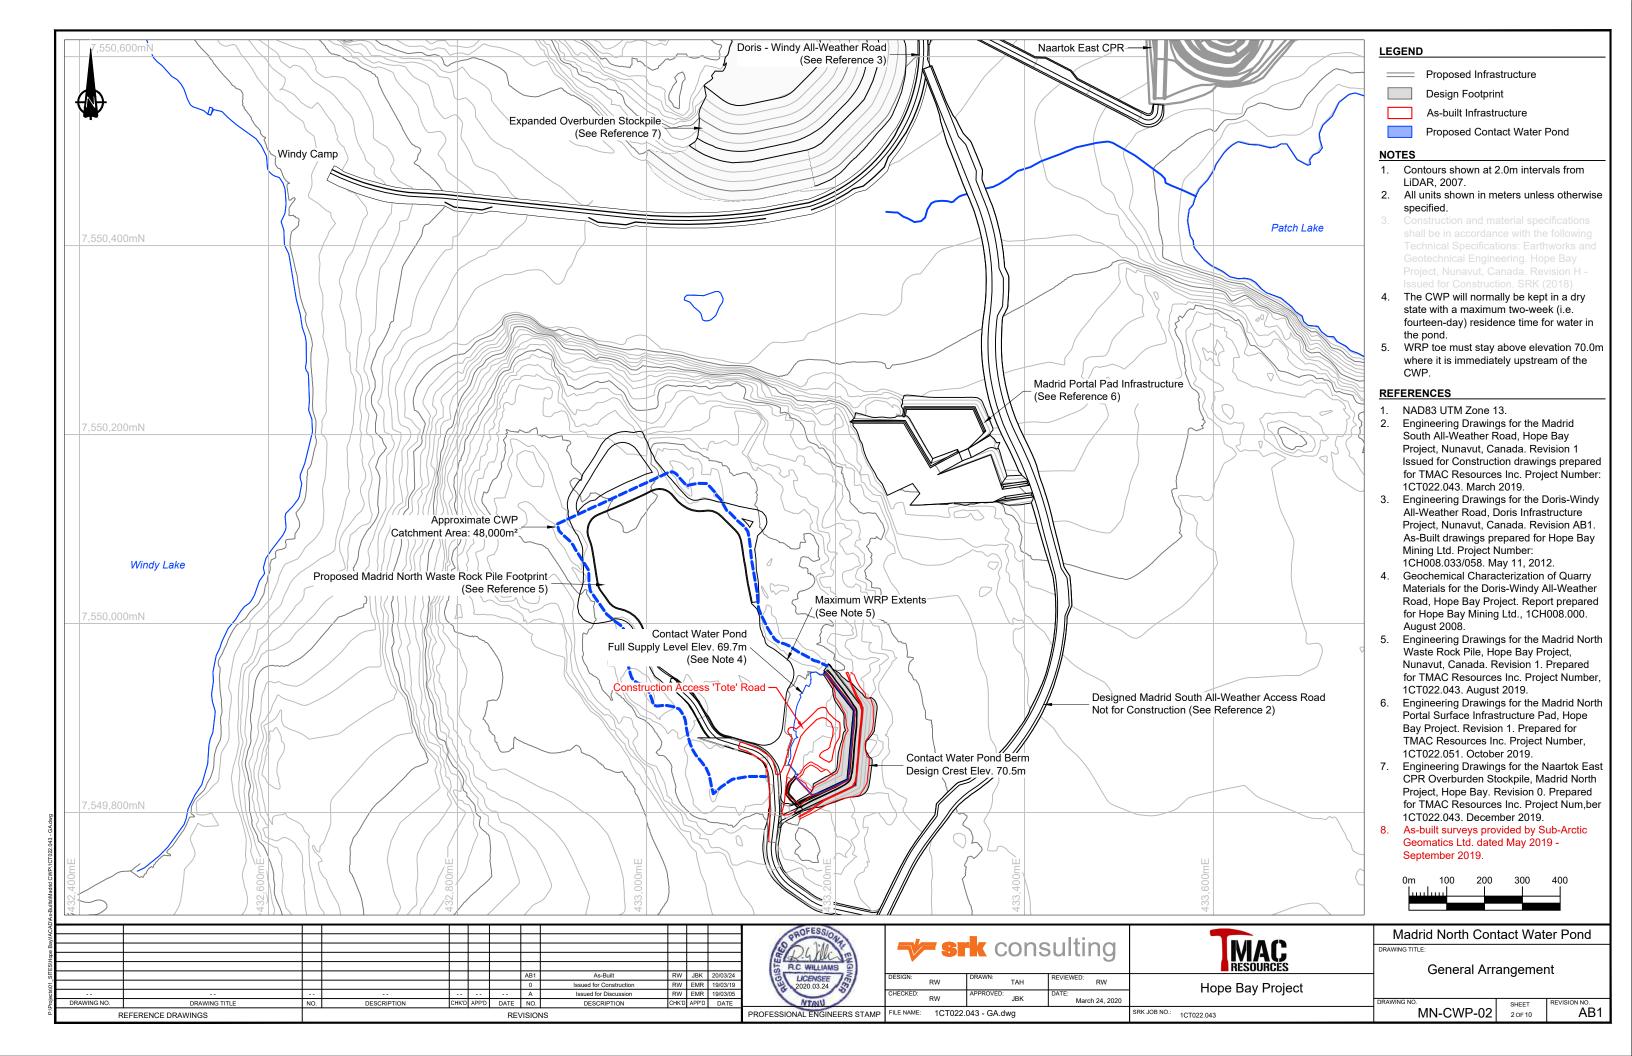
MN-CWP-03

During excavation of overburden to expose bedrock for the HDPE liner tie-in, a significant pocket of overburden material was encountered at the southern end of the CWP berm. This overburden pocket was found to be approximately 5 m deep. As a result, a decision was made in the field by TMAC and the SRK Site Engineer to backfill the excavated overburden pocket with ROQ and shift the liner tie-in point to higher ground upstream. Deeper than anticipated overburden was also encountered in the northern end of the CWP. Overburden was up to 4 m deep at its deepest. However, concrete plinths were able to be used and the liner to bedrock tie-in did not shift significantly from the original projected design.

These two deeper than anticipated overburden areas resulted in two main design deviations. Firstly, in the southern section, it resulted in the overburden excavation area being backfilled and moving the alignment of the liner tie-in further north into the CWP basin. Secondly in the northern section, it resulted in taller than anticipated concrete plinths. Both changes, while noteworthy, do not impact the overall design intent of the CWP.
