Subject: Doris North Project

Project #: 1CH008.033

SRK Consulting (Canada) Inc. (2011). <u>Robert's Bay Tank Farm Slope Remediation</u>, Doris North Project, Nunavut, Canada. Technical Memo prepared for Hope Bay Mining Limited, Project Number 1CH008.033.0201, August 3, 2011

Subject: Robert's Bay Tank Farm Slope Remediation

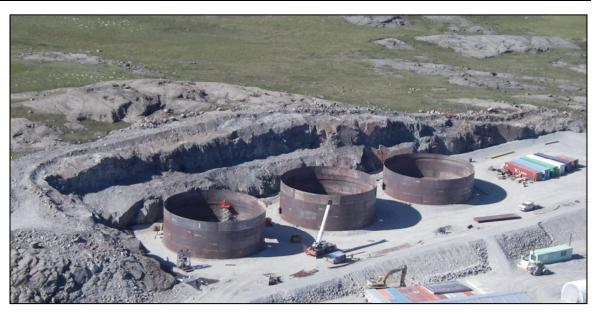
Figure 2: Oblique aerial view of RBTF, looking south-eastward (in mid-July)

- J₂ forms the crest angle (and the full bench-face angle in some areas) for a large part of both the lower and upper benches;
- There are three areas of concern on the upper bench crest, all involving rock blocks bounded on their lower surfaces by J2, as illustrated in Figure 2;

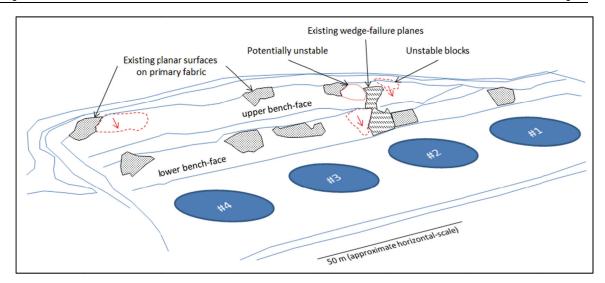
- An area of concern on the lower bench, between tanks #3 and #2, involves a partially disturbed rock block bound by opened joints;
- There is evidence of a high-angle wedge failure that occurred behind tank#2. It extends the full height of the wall;

- The tank#2 wedge-failure destroyed the continuity of the mid-slope berm, and essentially isolates the southern two-thirds of the berm from road access in the west, and;

Figure 3: Main slope features (20110728) with blocks identified for remediation.

- There is evidence of a high-angle wedge failure that has already occurred behind tank#2. It extends the full height of the wall;
- The tank#2 wedge-failure destroyed the continuity of the mid-slope berm, and essentially isolates the southern two-thirds of the berm from road access in the west, and;
- The north-western third of the slope is relatively low and stable, having already broken on the dominant joints.

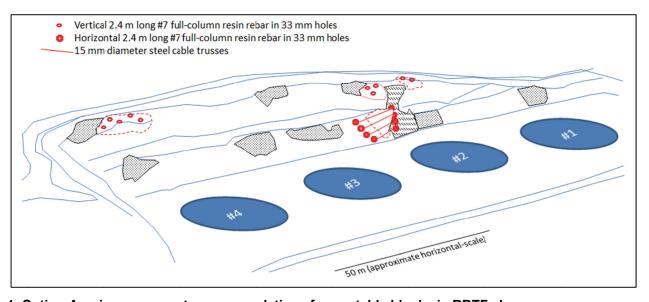
Figure 4: Option-A, primary support recommendations for unstable blocks in RBTF slopes.

- Two main options exist to stabilize the lower-bench block behind tank#2 both of which depend
 on the availability of suitable equipment and trained personnel on-site, and;
- Option-A (as illustrated in Figure 4) suggests rock-bolting of the upper bench crest blocks at a spacing to be determined on-site and cable trusses across the lower-bench block.

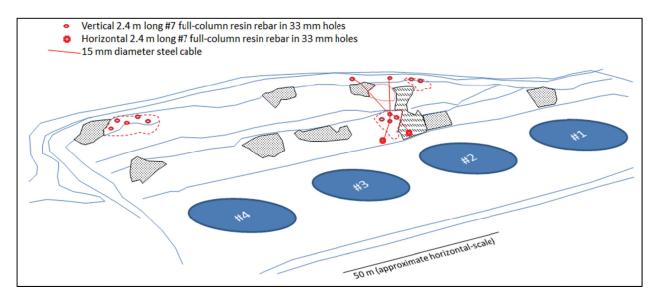
Figure 5: Option-B, primary support recommendations for unstable blocks in RBTF slopes.

Option-B (as illustrated in Figure 5) suggests rock-bolting of the upper bench crest blocks at a spacing to be determined on-site, and cables spanning the full slope height across the bolted lower-bench block, and;

• The second option depends on access to the berm between the benches and is only suitable if safe access to this level can be achieved.

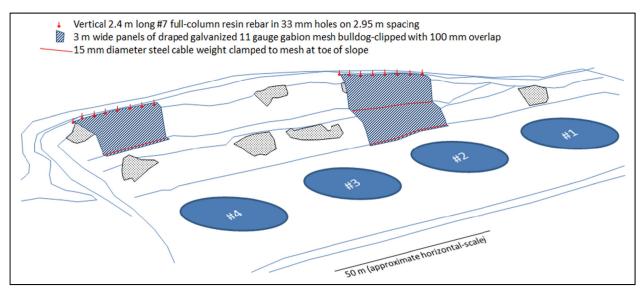
Figure 6: Containment of potential loose and fall-material on RBTF slopes.

- The main areas identified with risks should be contained with draped wire mesh, weighted at the toe and mid-line in the case of the tank#2 drape, and;
- Draped areas may need to be extended if further loose is found along the slopes.
