<b>To:</b>	Chris Hanks	<b>Date:</b>	August 17, 2011
<b>Company:</b>	Hope Bay Mining Limited	<b>From:</b>	Maritz Rykaart
<b>Copy to:</b>	Melanie Smith, Angela Holzapfel, Kevin Mather, Calvin Goldschmidt	<b>Project #:</b>	1CH008.033
<b>Subject:</b>	Doris North Project Water Management – Remedial Measures for Leaking Pollution Control and Sedimentation Ponds

<b>To:</b>	Bob Princewright	<b>Date:</b>	June 8, 2011
<b>Copy to:</b>	Greg Blaylock, Kevin Mather, Calvin Goldschmidt, Doug Fielding, Jerry Graham, Ishan Fechter	<b>From:</b>	Maritz Rykaart
<b>Subject:</b>	Pollution Control Pond Liner Extension	<b>Project #:</b>	1CH008.033.213

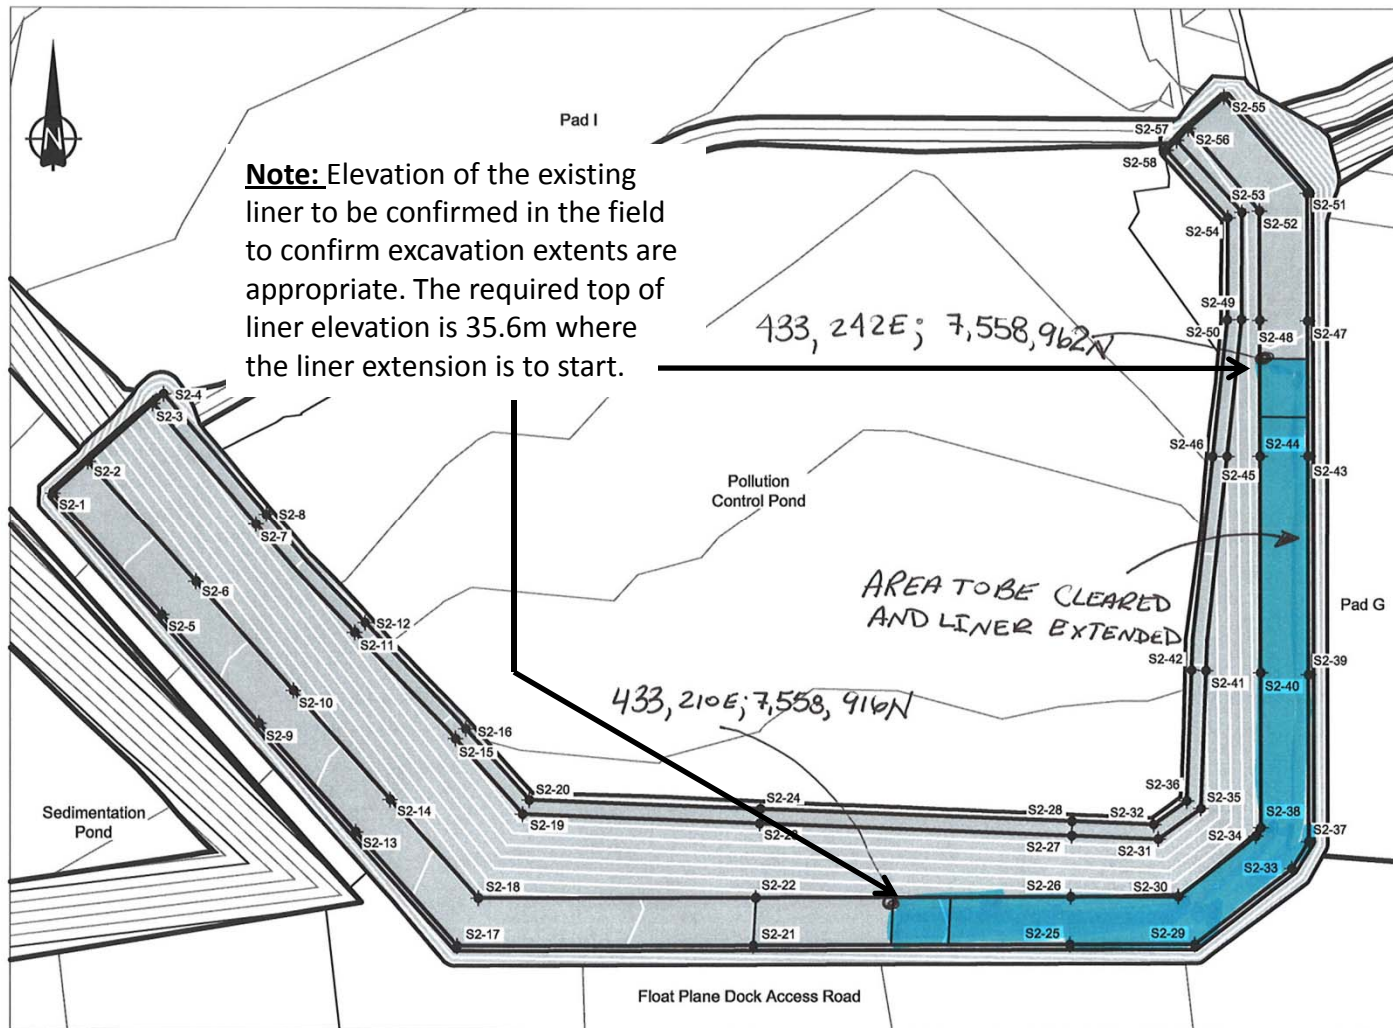
**1**

As stipulated in an email from Maritz Rykaart (SRK) to Kevin Mather (JDS) on May 31, 2011, SRK identified a design error in the crest elevation of the Pollution Control Pond. The pond design Full Supply Level (FSL) elevation is 35.3m with a freeboard elevation of 0.3m. This translates to a minimum design liner elevation in the Pollution Control pond of 35.6m. A review of the as-built survey of the liner crest has confirmed that the liner has been installed in accordance with the IFC drawings, but that approximately between stake-out points S2-22 and S2-48 (Drawing DN-DMC-16, Rev. 0) the crest of the liner is lower than the required 35.6m elevation. The variance ranges between 0.1m to 0.5m over a distance of about 65m.

**Liner Extension Zone**

- **STEP 1:** For a distance of about 75m, as shown in Figure 1, the liner must be carefully exposed. The extent of the required excavation is schematically illustrated on Figure 2. The excavation should start about 1m from the crest of the RipRap and the cut slope should be approximately 1H:1V (or as steep as practical bearing in mind the slope needs to be safe for people to work below the cut). Mechanical excavation methods can be adopted up to the point where the  $\frac{3}{4}$ " inch protective crush layer has been placed over the liner. Note this point is marked with a geotextile and should thus be easily identified in the field. Hand excavation techniques, or partial careful mechanical removal with a cleaning bucket should be adopted from that point on to remove the  $\frac{3}{4}$ " crush and expose the liner system. The base of the excavation should be between 2m and 3m wide.

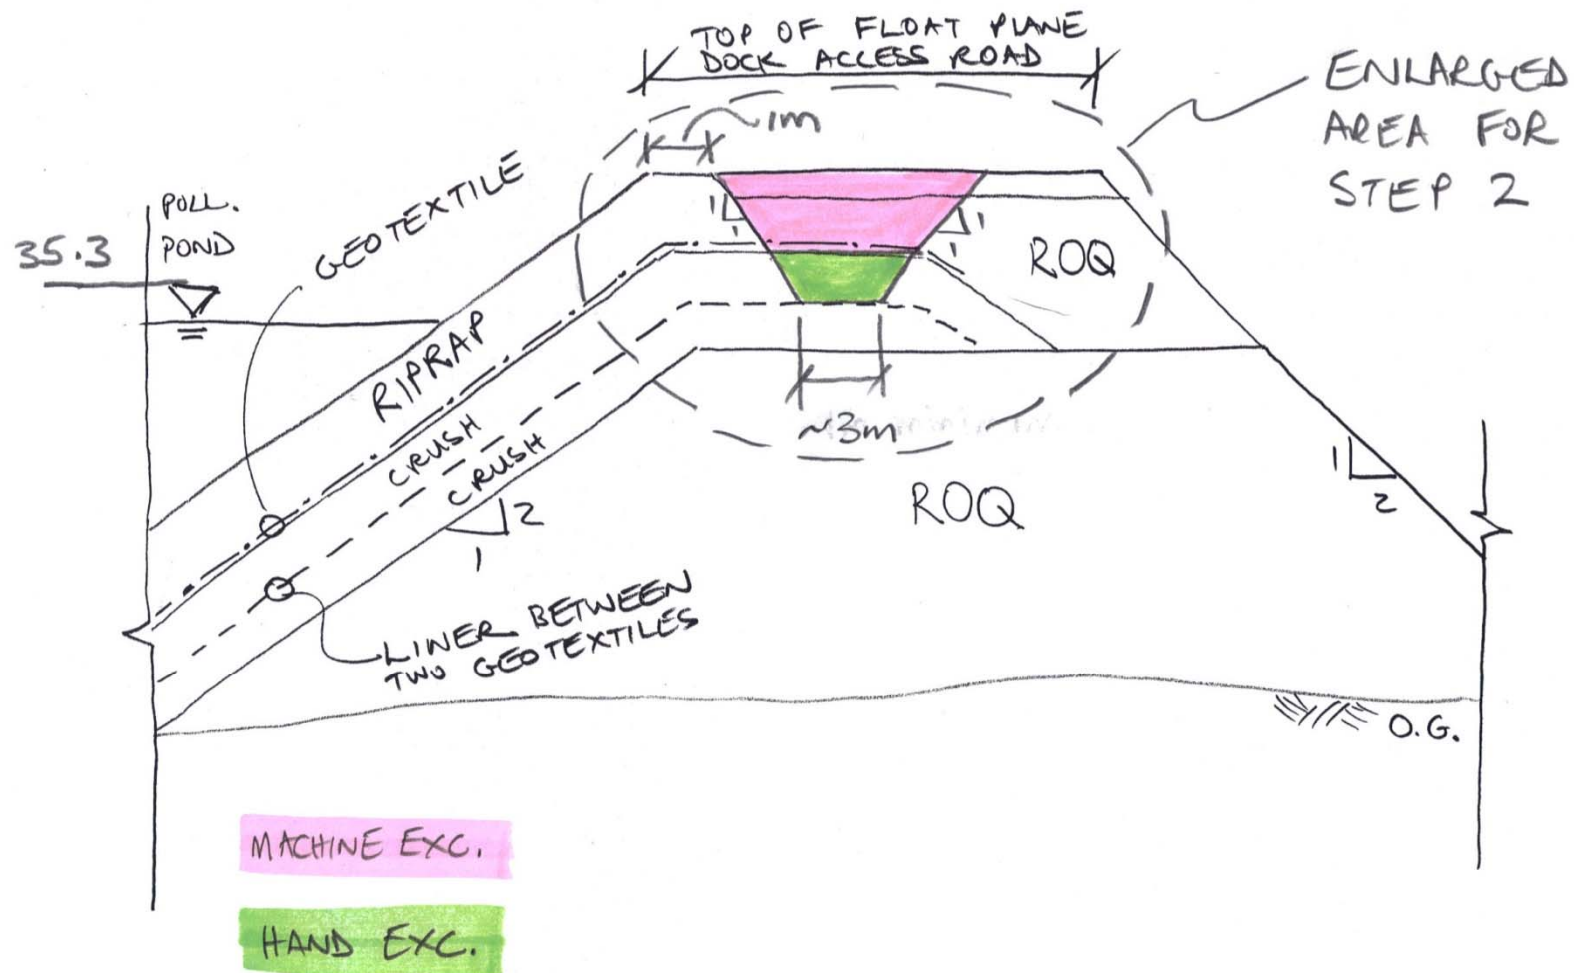
Figure:  
2

Step 1: Exposing Liner
