Subject: Hope Bay - Tail Lake Discharge Pipe

HOPE BAY MINING LTD.

North Dam Tail Lake Discharge Pipe

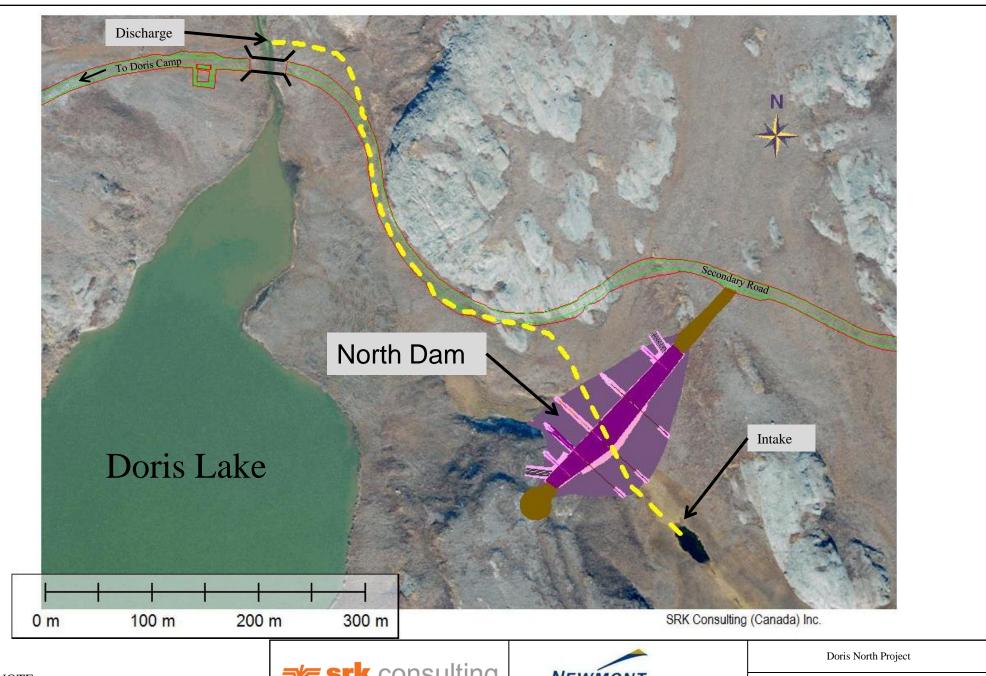
Based on our observations and discussions with the Contractor, the pipeline constructed to discharge water from Tail Lake into Doris Creek is routed over the North Dam and along the Secondary Road. The yellow line on the attached figure shows the approximate alignment of the pipeline as understood by SRK.

SRK wishes to express its concerns regarding the possibility of a leak from the Victaulic pipe joints located within the dam footprint. An uncontrolled supply of water to the frozen core could induce localised thawing and degradation of the core material. Any degradation will have to be remediated before the raise of the core to its final elevation can resume this coming winter.

To ensure that any leaks are detected in a timely manner, continuous monitoring of the pipeline should be implemented during pumping. If a leak occurs, pumping shall be stopped immediately and the source of the leak eliminated before pumping can resume.

No excavation into the ROQ cover protecting the frozen core shall be made without the approval of the SRK Site Engineer.
