#### RE: Glycol Spill at Dam 2 Gallons April 4/11

Please find attached the completed 'preliminary report' for the small propylene glycol spill that occurred in the key trench on April 4<sup>th</sup>,

## **Preliminary Accident / Incident Report (for small spill)**

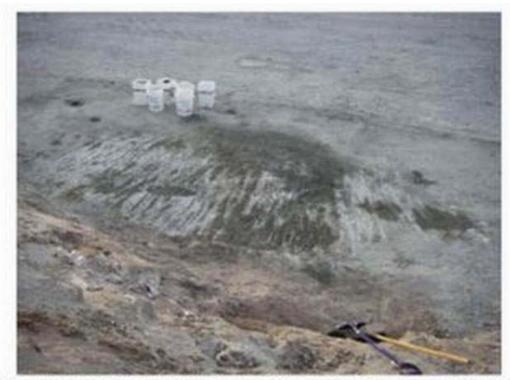
The spill was propylene glycol and not ethylene glycol. The propylene glycol was spilled within the key trench of the dam.

This area has since been covered with another lift of frozen core material.

Photo 5: The surface of the frozen material in the area of the glycol spill was scraped up with the teeth of the excavator. The material was placed in buckets to be taken to the Waste management Facility for proper disposal.
