DAILY REPORT #02 – DORIS NORTH INFRASTRUCTURE/ NORTH DAM

Prepared by:	Lowell Wade	Date:	2012.01.07
Reviewed by:		Project #:	1CH008.058.0340
Role	Company	Personnel – Position	On Site
Client	Hope Bay Mining Limited (HBML)	David Vokey – ESR Coordinator Don Ethelston – HSLP Advisor Jill Turk – ESR Coordinator Katsky Venter – ESR Manger Stirling Kelly – HSLP Advisor Angela Holzapfel – ESR Compliance Manager Michelle Tanquay – ESR Site Manager	No No No Yes Yes No No
	JDS	Lloyd Jackson – Mechanical Superintendent Doug Fielding – Construction Manager Ishan Fechter – Construction Coordinator Jerry Graham – Construction Manager Kevin Whieldon – Project Coordinator Mark Valeriote – Construction Manager	Yes No No Yes Yes No
Engineering Design Consultants	SRK Consulting (Canada) Inc.	John Kurylo – Site Engineer Megan Miller – Site Engineer Lawrence Borowski – Site Engineer Murry McGregor – Site Engineer Lowell Wade – Senior Engineer	No No No No Yes
	EBA Engineering Consultants Ltd.	Jeff Orr – Project Manager Jennifer Stirling – Geologist John Jaramillo – Eng. Technologist Thomas Bradshaw – Junior Engineer	No No No No

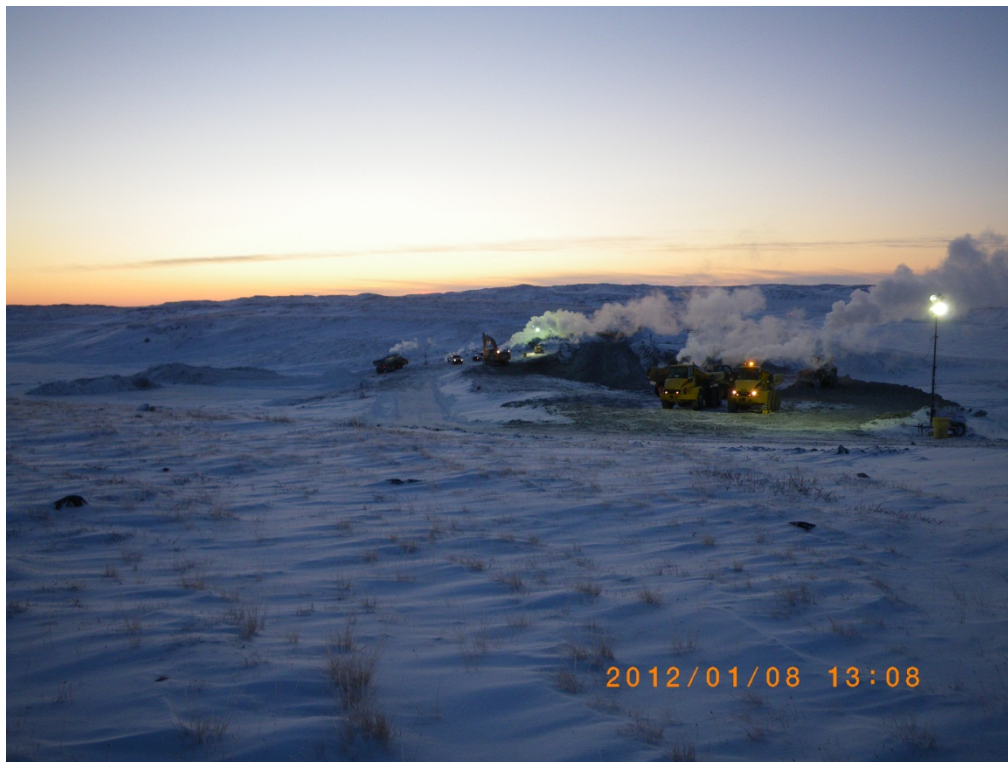
Photo 1: Removal of the 5/8" clear material and the ROQ from the upstream side of the keytrench. The mixed material is placed within the downstream footprint of the dam. The dirty snow pile, within Tail Lake, is visible on the left side of the photo.

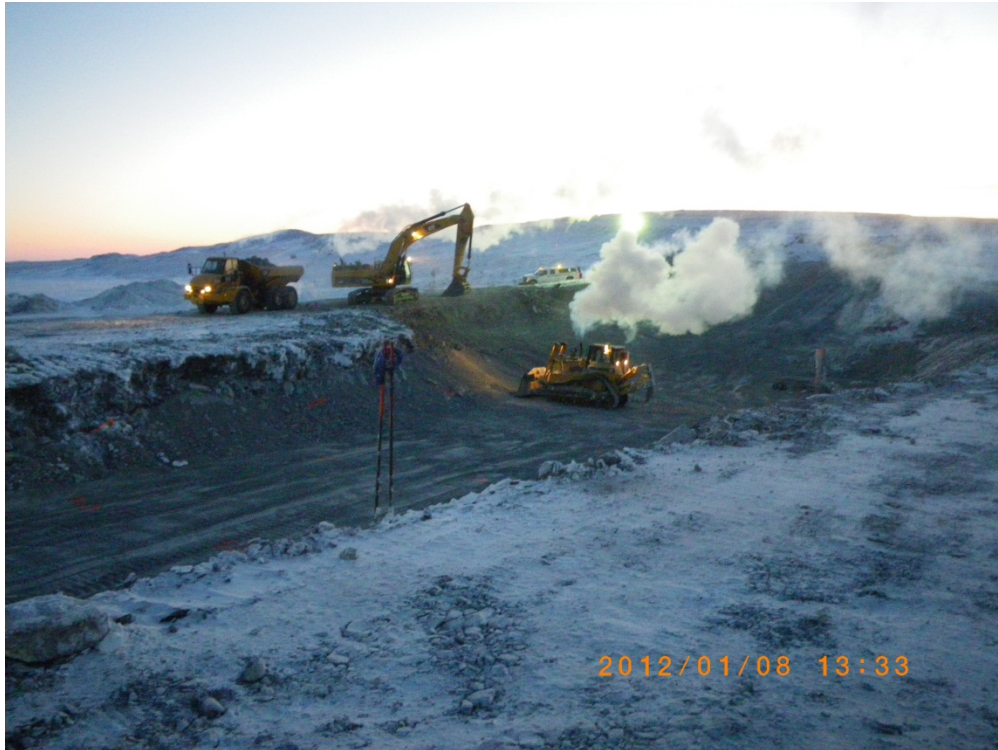
Photo 2: The dozer pushing the 5/8" clear material to the excavator with then mixes it with ROQ when loading the haul truck.

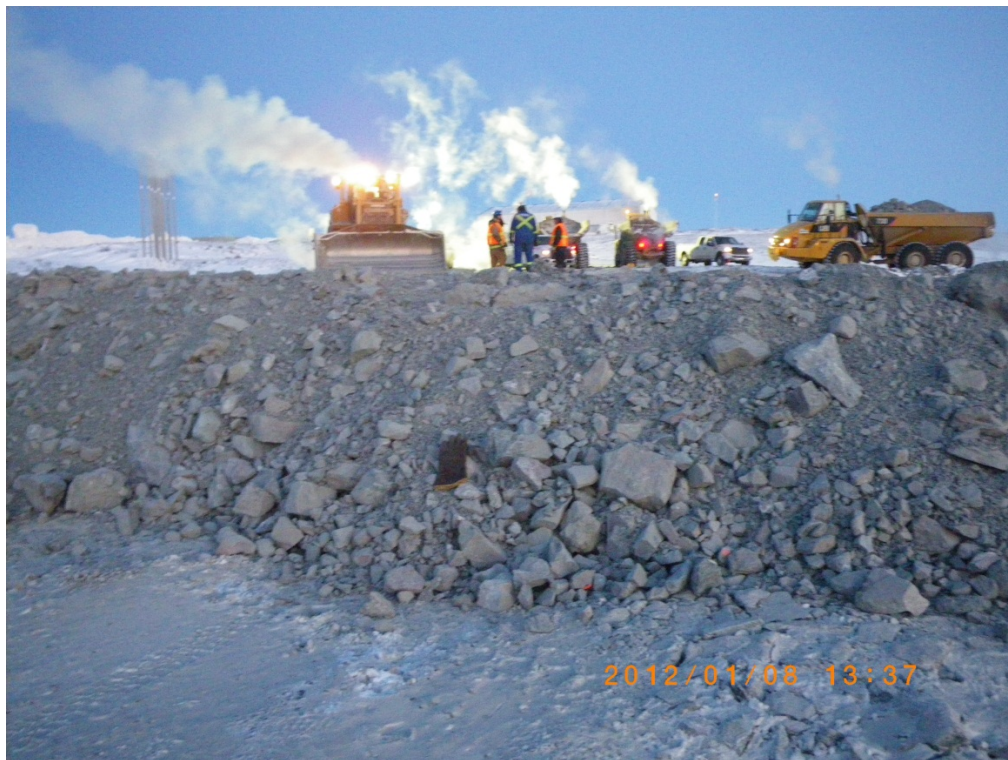
Photo 3: The blended material being placed in lifts within the downstream footprint of the dam.

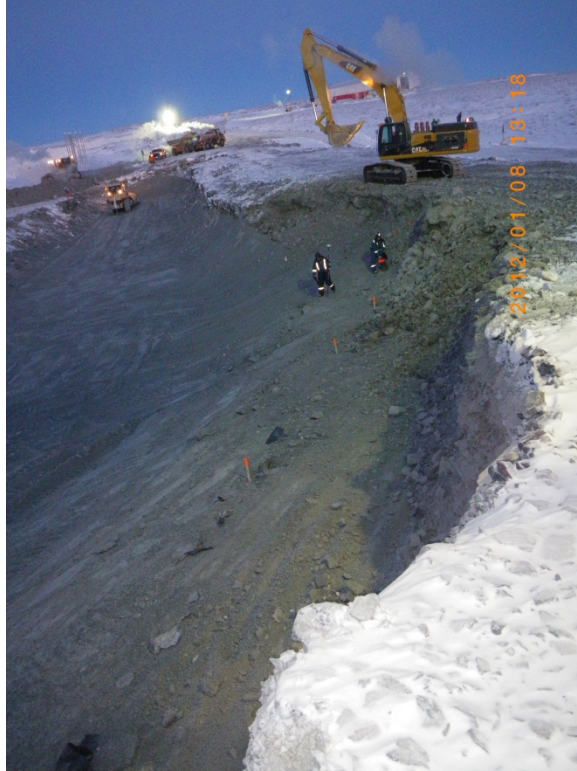
- During Night Shift the HDPE protective liner and the GCL liner along the upstream crest of the key trench was exposed and torn.
- The extent of the damage is unknown at this time. Where damaged GCL liner has been observed is shown on the attached sketch at the end of this report. The liner will be exposed to evaluate the extent of the damage and to repair the GCL.
- During the Night Shift two Ground Temperature Cables supported by vertical steel pipes fell over. The cables were not physically damaged and readings were taken to confirm all thermistor beads functioned.
- The Geotechnical Laboratory is ready to be put into operation.
- Based on accessibility, some of the ground temperature cables installed in the North Dam were read.

Photo 4: Exposed HDPE and GCL are shown in the foreground. At this point in time the extent of the damage is unknown.

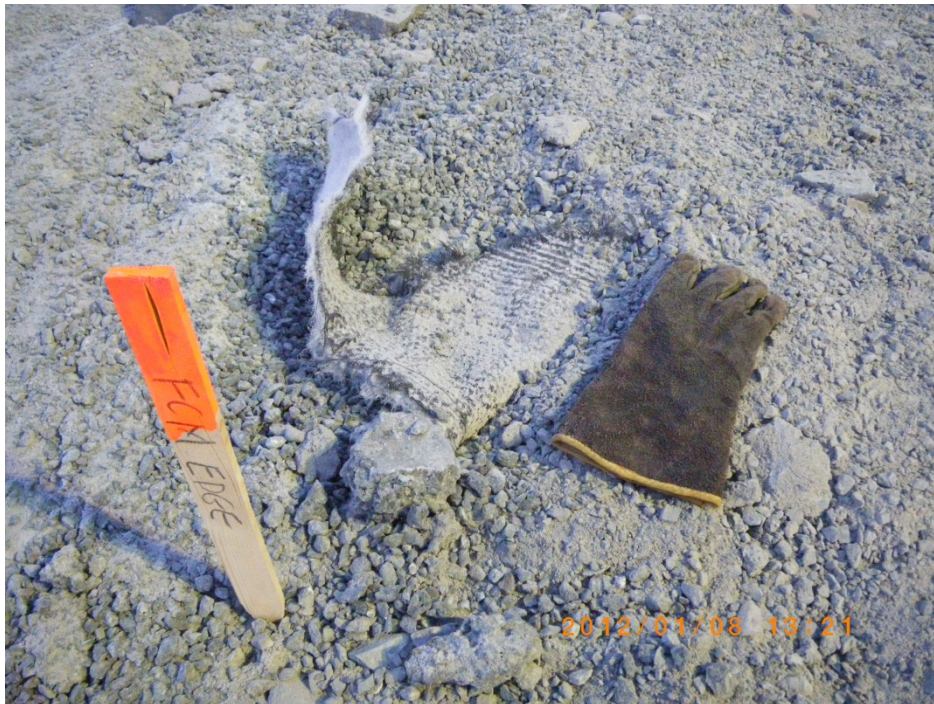
Photo 5: A closer inspection of the exposed GCL.

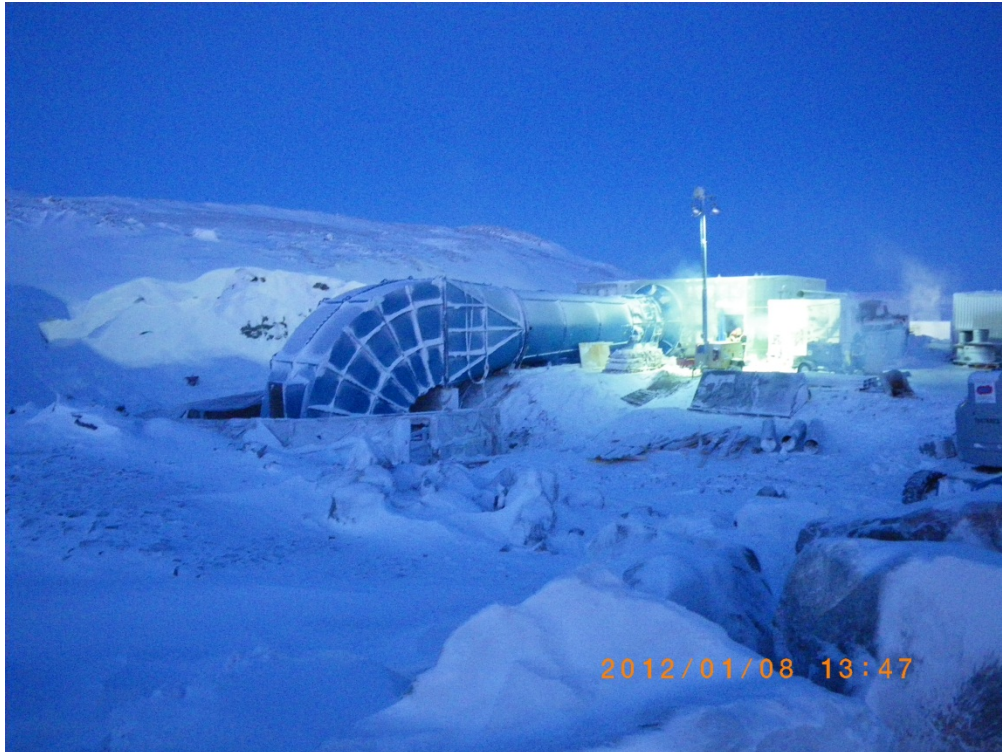
Photo 6: Work on the infrastructure at the Primary Vent Raise continues.

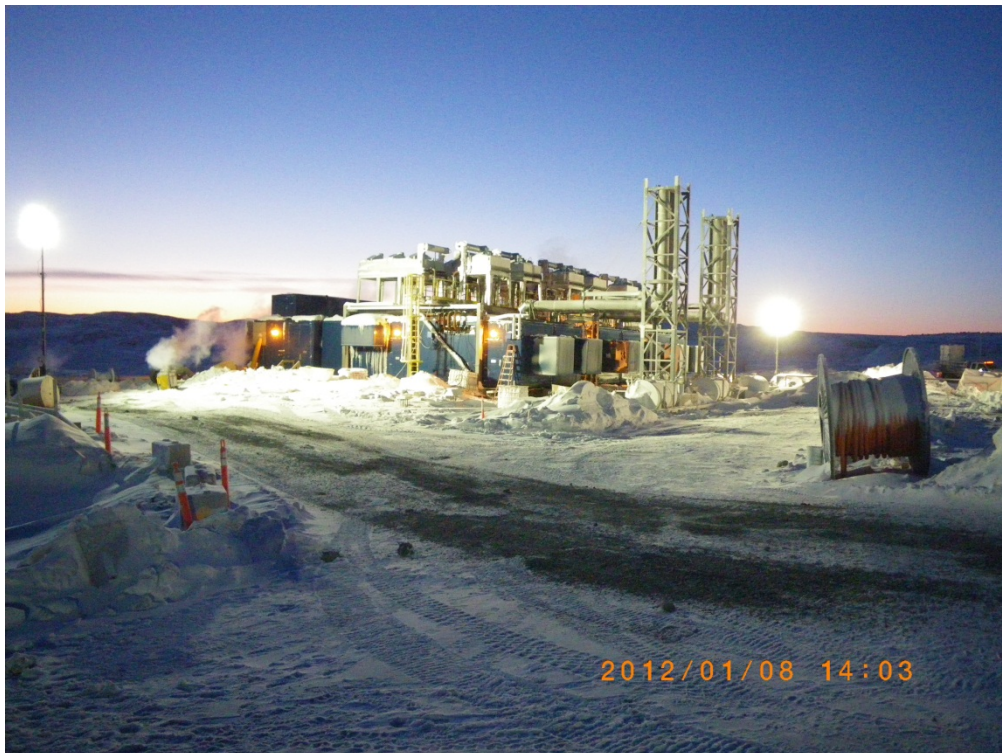
Photo 7: Work on the Permanent Power Plant also continues.

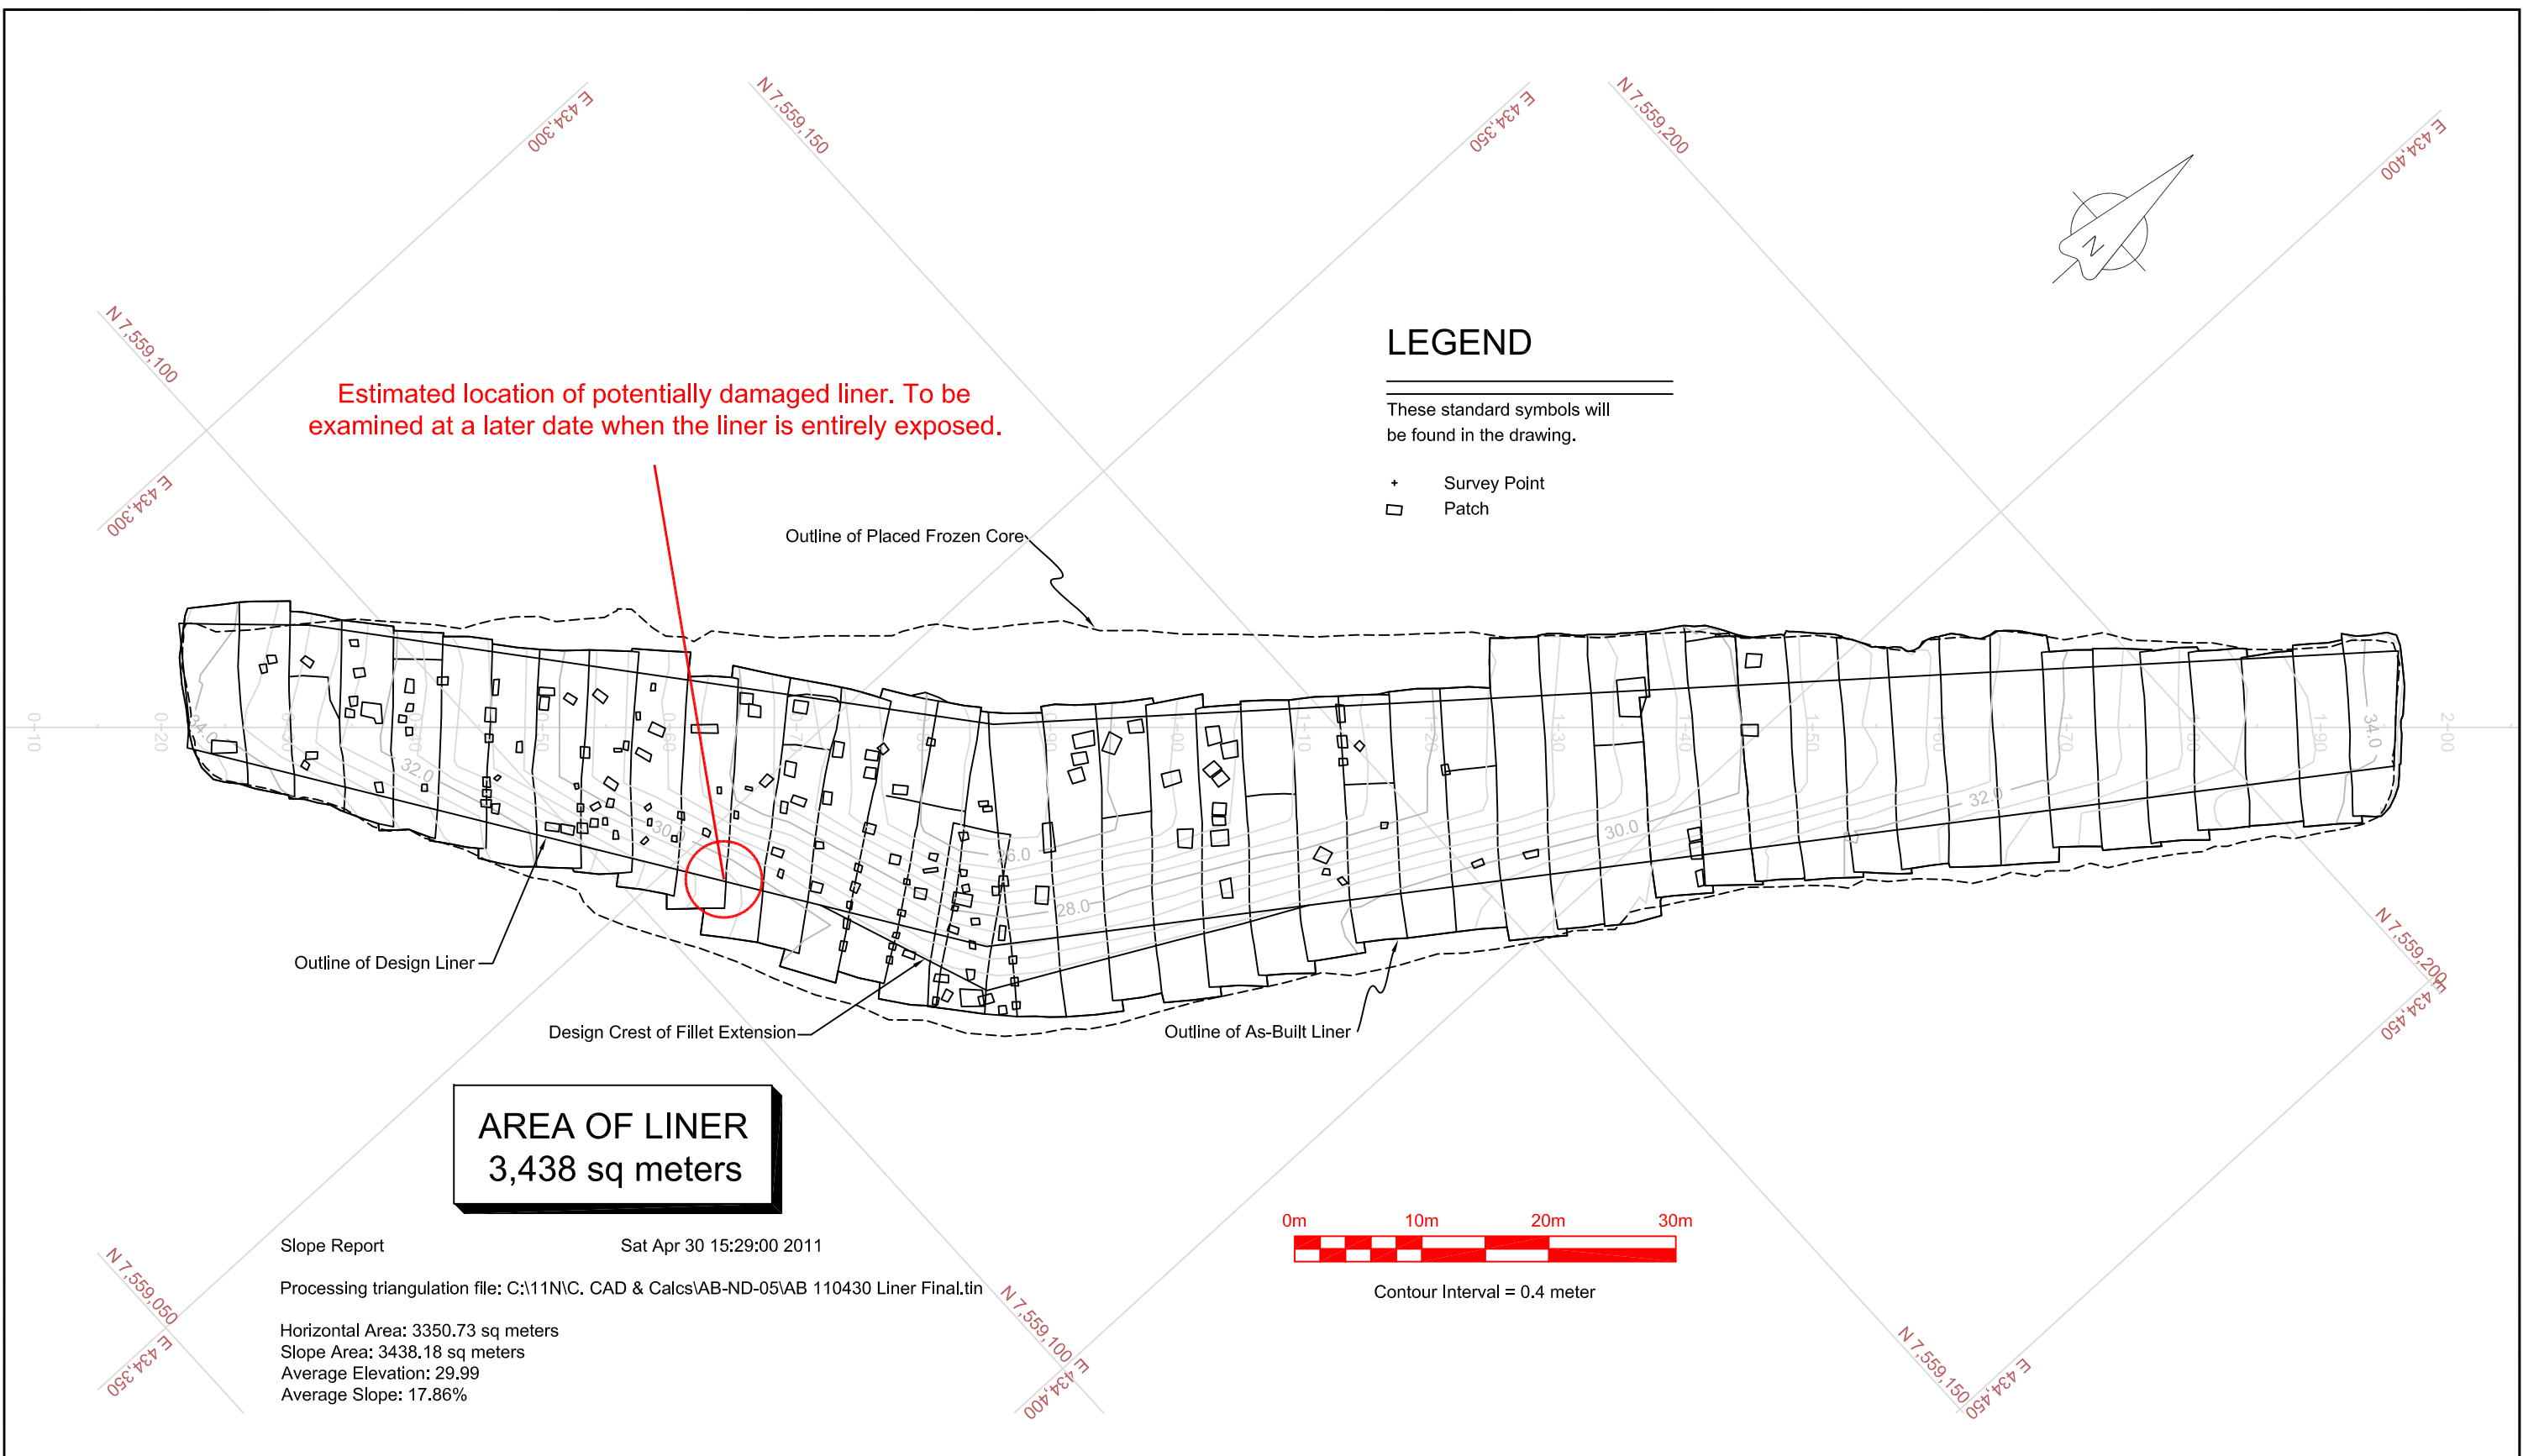
Estimated location of potentially damaged liner. To be examined at a later date when the liner is entirely exposed.
