## DAILY REPORT #06 – DORIS NORTH INFRASTRUCTURE/ NORTH DAM

<b>Prepared by:</b>	Lowell Wade	<b>Date:</b>	2012.01.11
<b>Reviewed by:</b>		<b>Project #:</b>	1CH008.058.0340
<b>Role</b>	<b>Company</b>	<b>Personnel – Position</b>	<b>On Site</b>
Client	Hope Bay Mining Limited (HBML)	David Vokey – ESR Coordinator	No
		Don Ethelston – HSLP Advisor	No
		Dean Wold - Safety	Yes
		Jill Turk – ESR Coordinator	No
		Katsky Venter – ESR Manger	Yes
		Stirling Kelly – HSLP Advisor	Yes
		Angela Holzapfel – ESR Compliance Manager	No
		Michelle Tanquay – ESR Site Manager	No
	JDS	Lloyd Jackson – Mechanical Superintendent	Yes
		Sven Archimowtiz – Electrical Superintendent	Yes
		Doug Fielding – Construction Manager	No
		Ishan Fechter – Construction Coordinator	No
		Jerry Graham – Construction Manager	Yes
		Kevin Whieldon – Project Coordinator	Yes
Mark Valeriote – Construction Manager		Yes	
Engineering Design Consultants	SRK Consulting (Canada) Inc.	John Kurylo – Site Engineer	No
		Megan Miller – Site Engineer	No

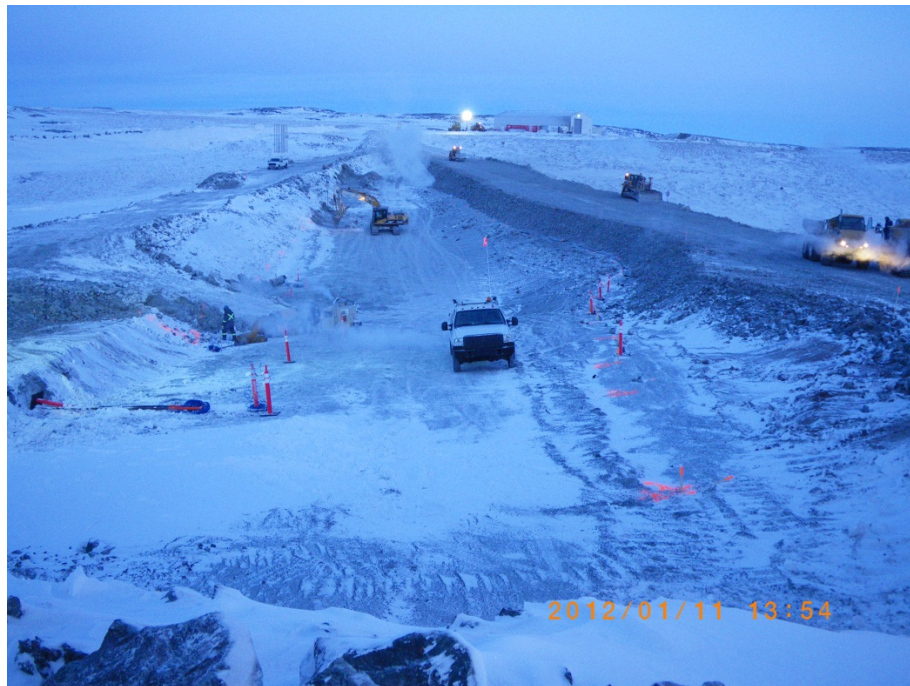
**Photo 1:** The 325 excavator is removing protective cover material along the downstream face of the key trench in the background. The temporary sump has been removed in the centre of the photo. The person standing next to ground temperature cables ND-HTS-060-28.8 and ND-VTS-060-KT. Ground temperature cables ND-VTS-040-KT and ND-HTS-040-31.5 have been cordoned off by traffic delineators in the foreground.

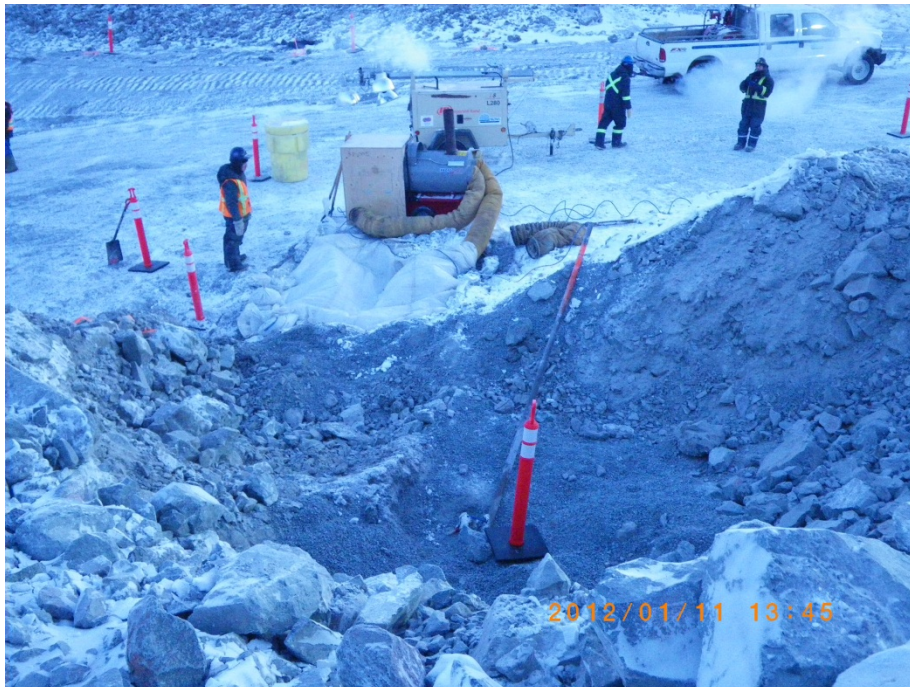
- Traffic delineators have been placed around the Ground temperature cables laying within the key trench.
- Late in the day, yesterday, the ROQ around ground temperature cables ND-HTS-060-28.8 and ND-VTS-060-KT was removed. While the steel pipes protecting the ground temperature cables were being lowered to the ground, ground temperature cable ND-HTS-060-28.8 was severed at the bottom of the protective steel pipe.

**Photo 2:** The traffic delineator, in the foreground, marks the location where ground temperature cable ND-VTS-060-KT comes out of the frozen fill. Ground temperature cable ND-HTS-060-28.8 has been severed, below the surface of the key trench. Hoarding is being applied to the frozen fill so enough cable can be exposed to allow for a splice to be made.

- The frozen material around the cable is currently being hoarded so it can be removed to provide access to the end of the cable still in the ground for a splice to be made

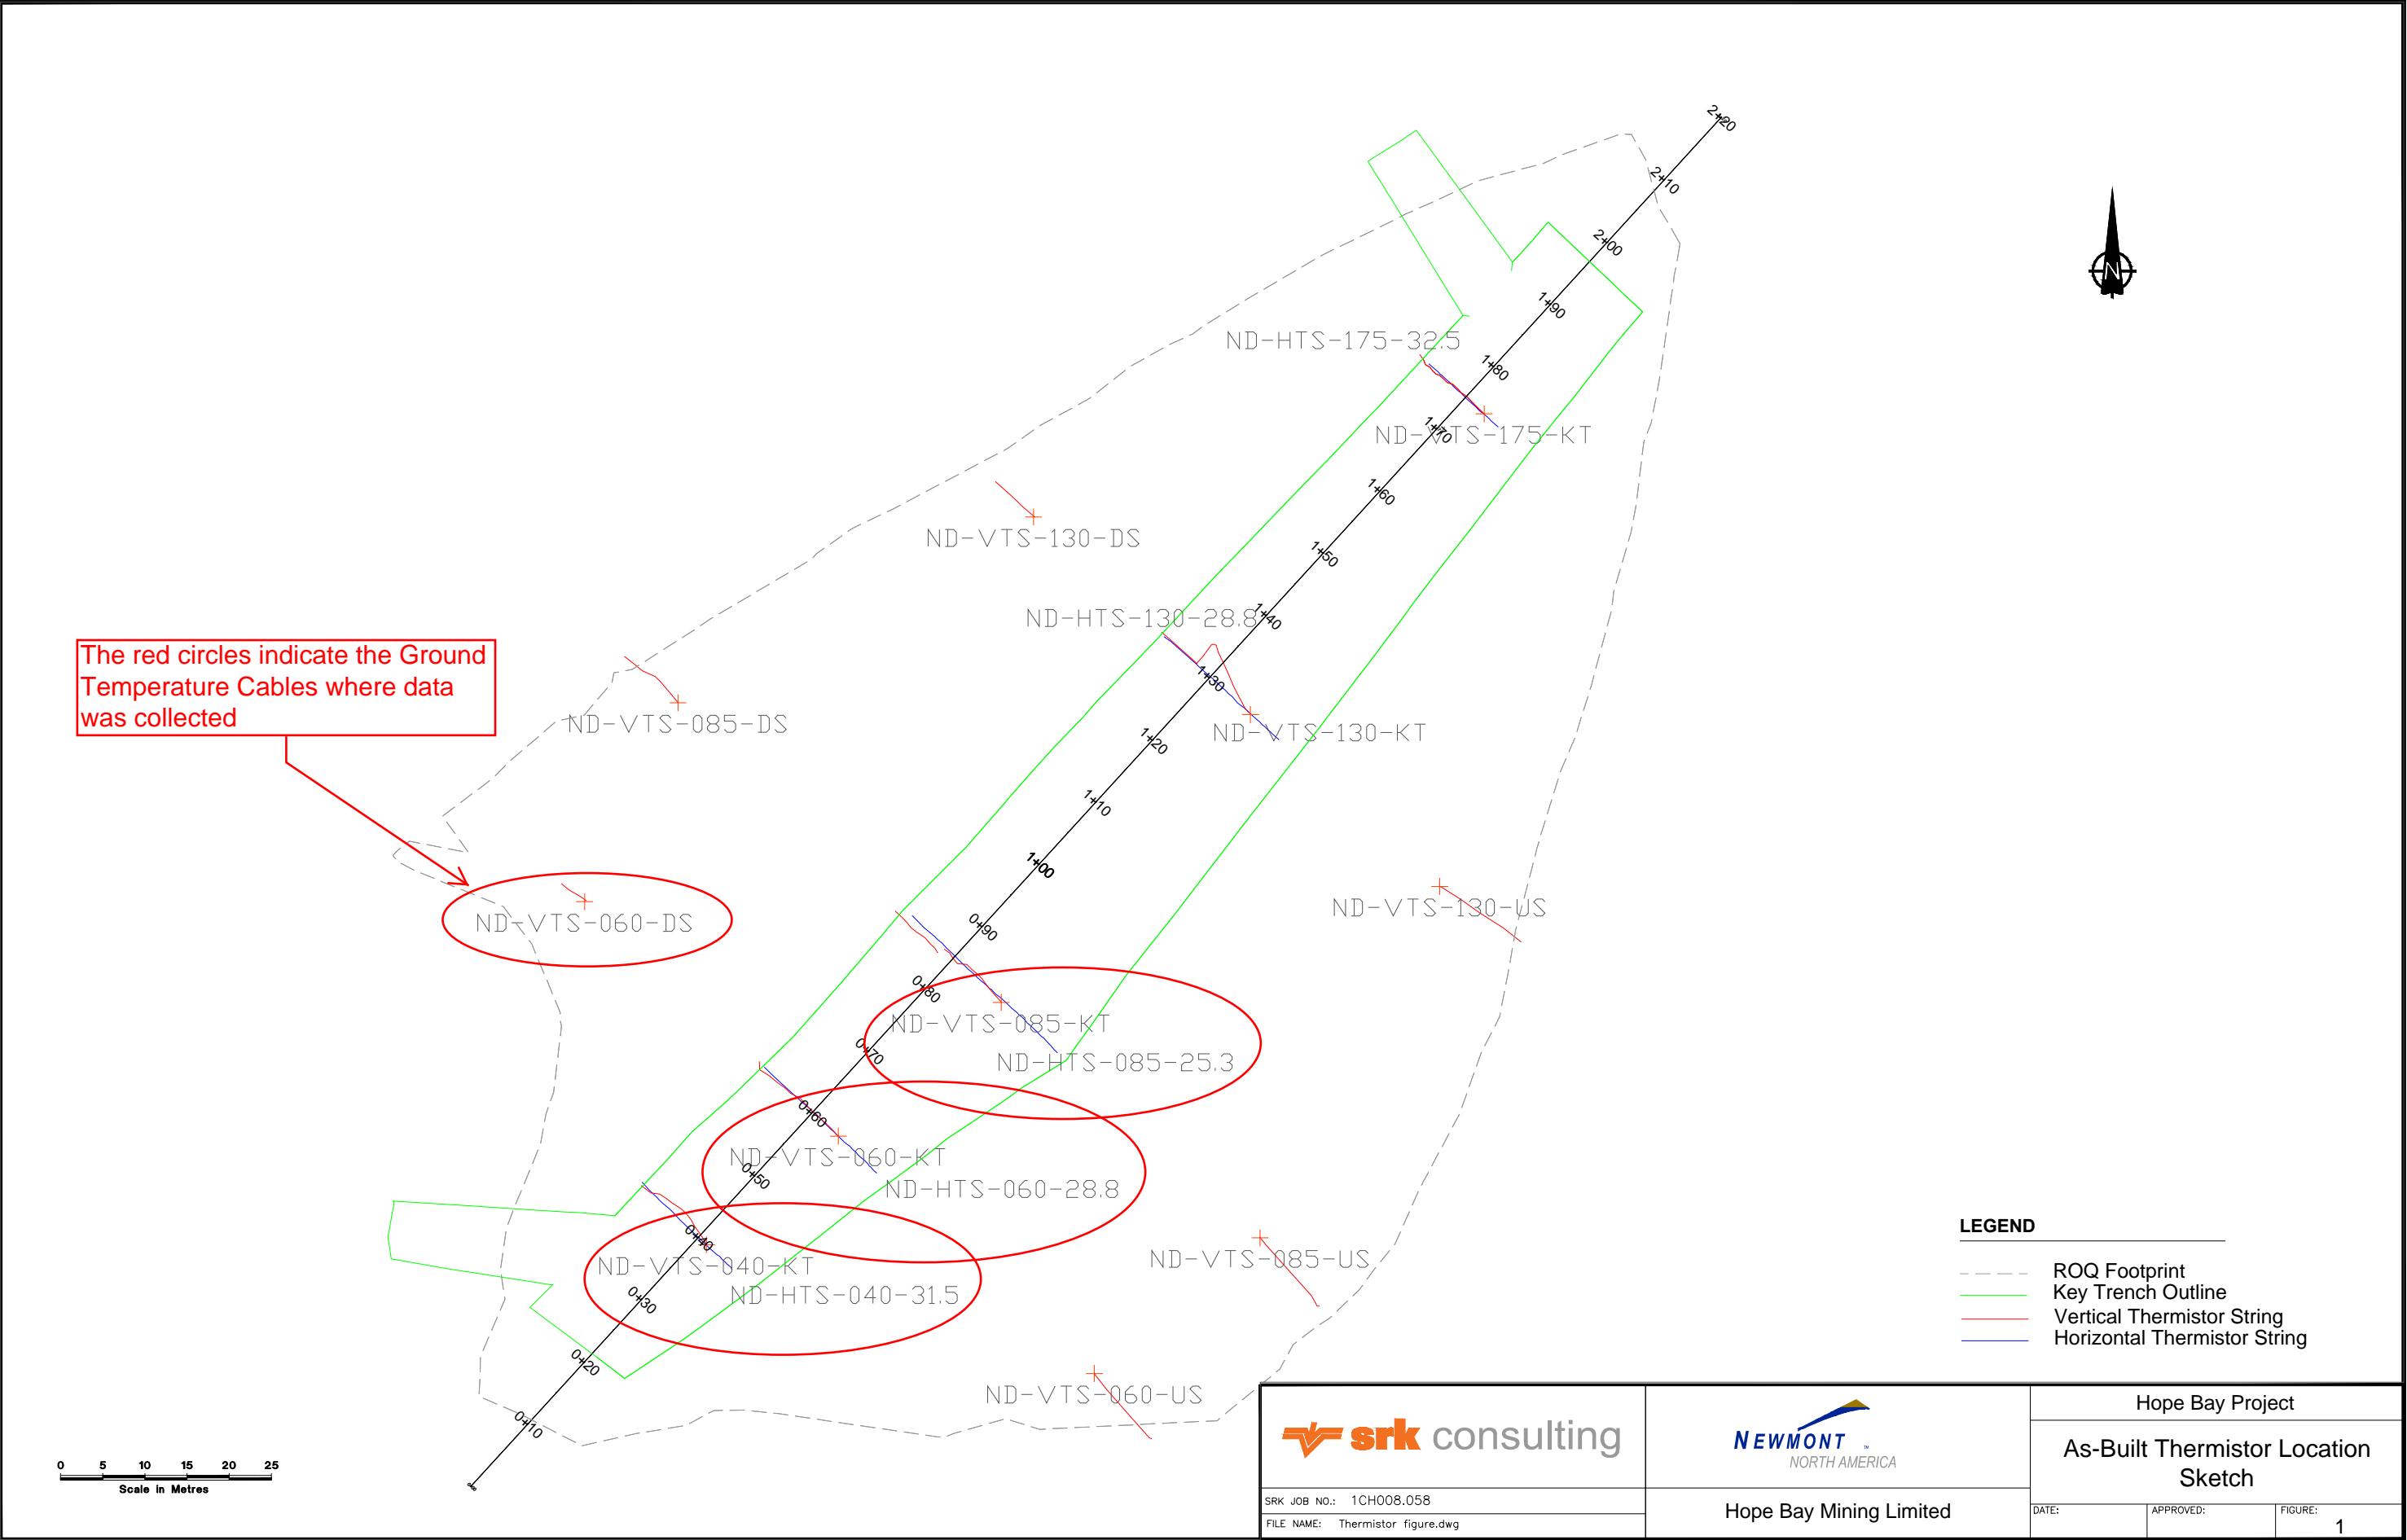
- Based on accessibility, some of the ground temperature cables installed in the North Dam were read. The current location of the ground temperature cables are shown on the sketch at the end of the report.
