DAILY REPORT #08 – DORIS NORTH INFRASTRUCTURE/ NORTH DAM

Prepared by:	John Kurylo/ Jeff Orr	Date:	2012.01.13
Reviewed by:		Project #:	1CH008.058.0320
Role	Company	Personnel – Position	On Site
Client	Hope Bay Mining Limited (HBML)	Angela Holzapfel – ESR Compliance Manager David Vokey – ESR Coordinator Don Ethelston – HSLP Advisor Dean Wold - Safety Jill Turk – ESR Coordinator Katsky Venter – ESR Manger Michelle Tanquay – ESR Site Manager Stirling Kelly – HSLP Advisor	Out In No Out No Out In Yes
	JDS	Lloyd Jackson – Mechanical Superintendent Sven Archimowtiz – Electrical Superintendent Doug Fielding – Construction Manager Ishan Fechter – Construction Coordinator Jerry Graham – Construction Manager Kevin Whieldon – Project Coordinator Mark Valeriote – Construction Manager	Yes Yes No In Yes Out Out
Engineering Design Consultants	SRK Consulting (Canada) Inc.	John Kurylo – Site Engineer Megan Miller – Site Engineer Lawrence Borowski – Site Engineer Murry McGregor – Site Engineer Lowell Wade – Senior Engineer	In No No No Out

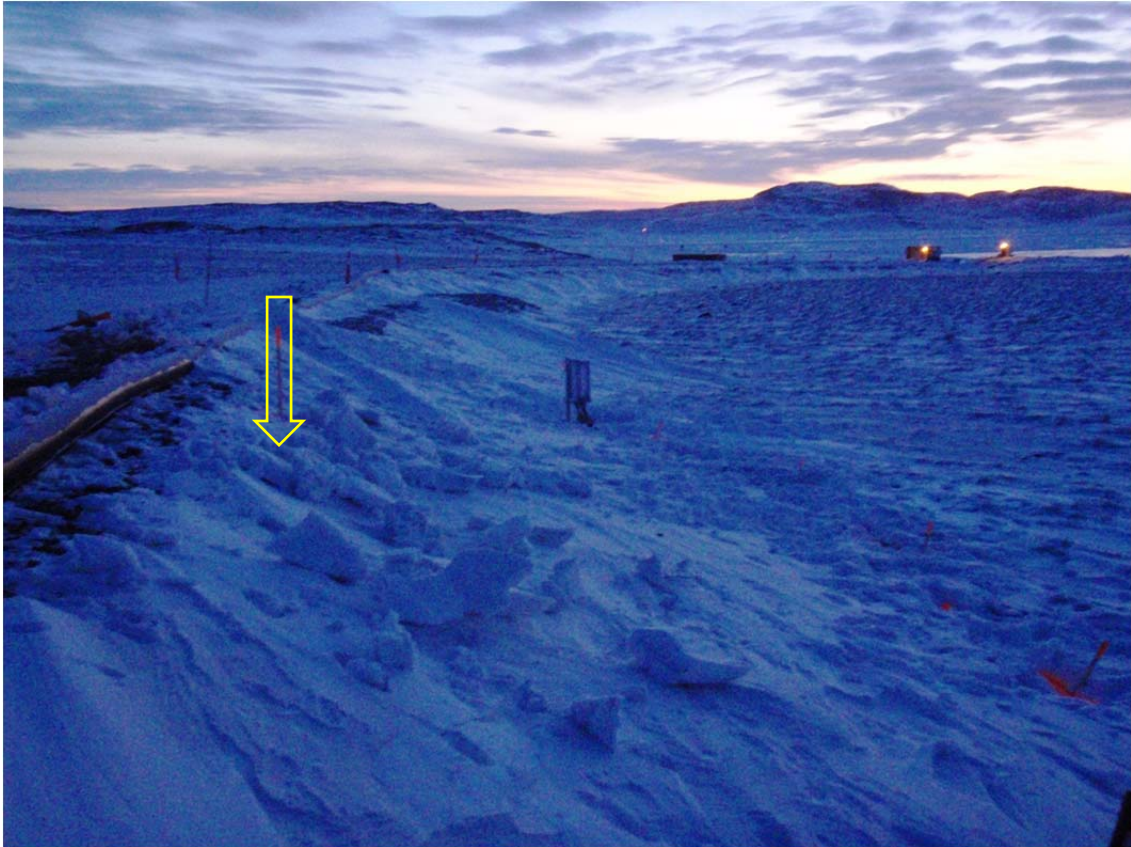
Photo 1: ESE view down S shoulder of the Float Plane Dock Access Road. Note that the surveyed location of Doris Camp Sump #1 (see dwg DN-DMC-045) is highlighted by the yellow arrow

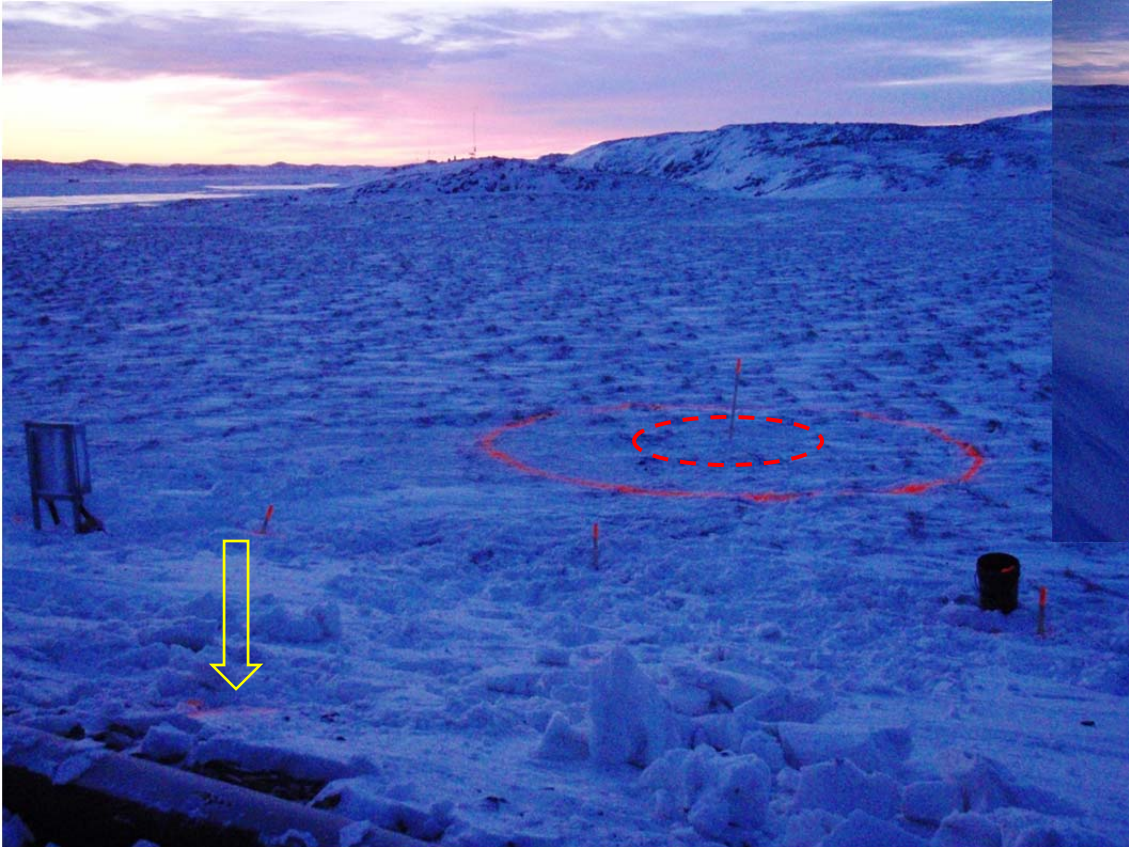
Photo 2: ~ SE view from the S shoulder of the road towards a marked new estimated/proposed location for Sump #1 (red dashed circle). The original Sump #1 location is highlighted by the yellow arrow.

- With the assistance of Nuna Survey, SRK estimated a new location for Sump #1. The center of Sump #1 was moved/ resituated ~ 5m to the SSE of the IFC stakeout point.

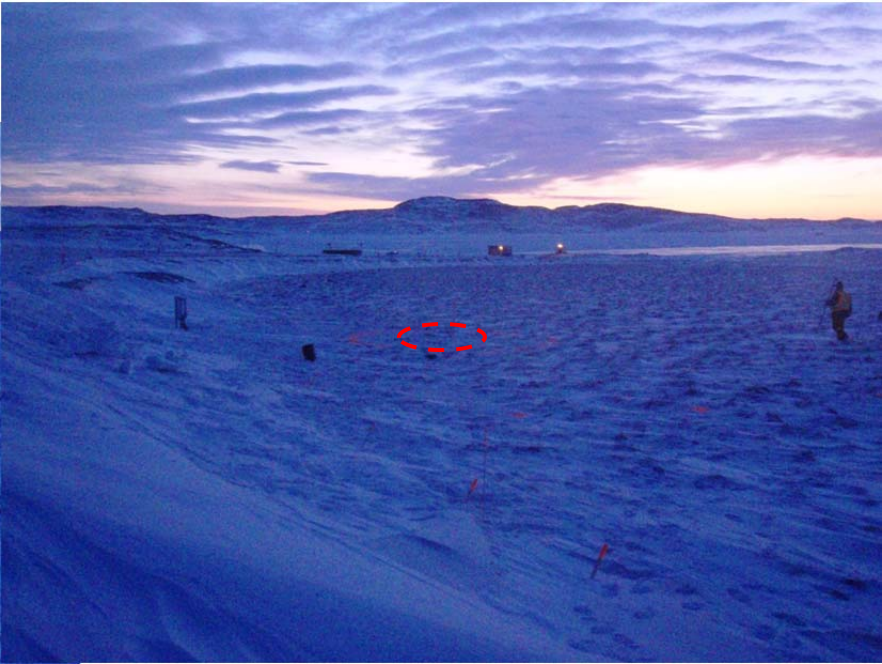
Photo 3: ~ E view down the S shoulder of the expanded Float Plane Dock Access road towards the proposed new location for Sump #1. Final sump location to be determined after review of survey data.

- One the requested survey information is available (see 'Survey' section of this daily) then a final check will be done to confirm that the proposed location meets the design intents.

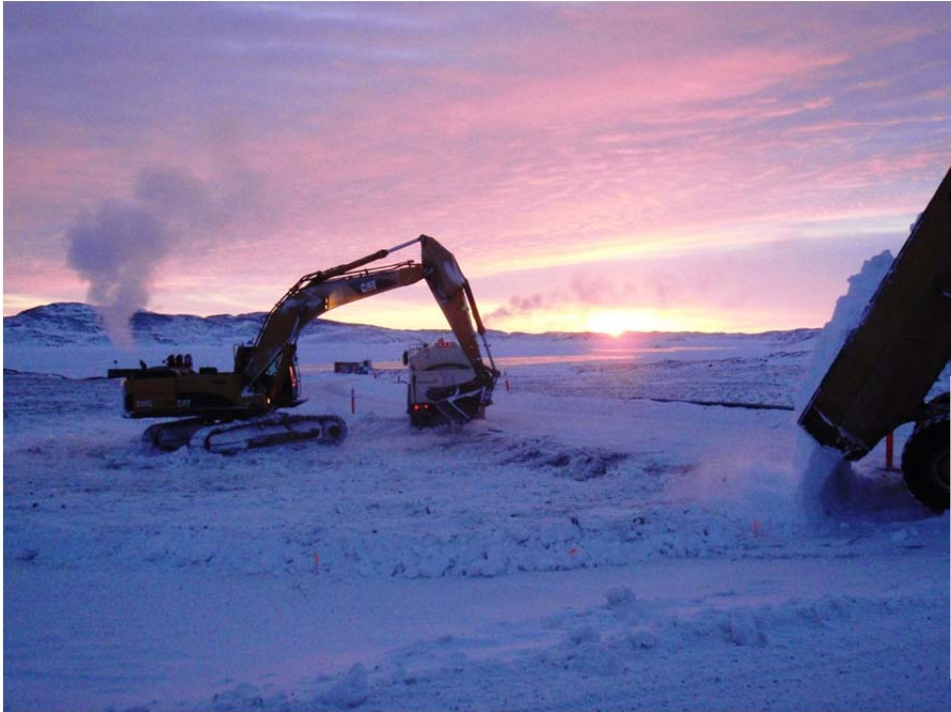
Photo 4: View of excavator preparing snow pad around Sump #2 location (sump location outlined on DN-DMC-045)

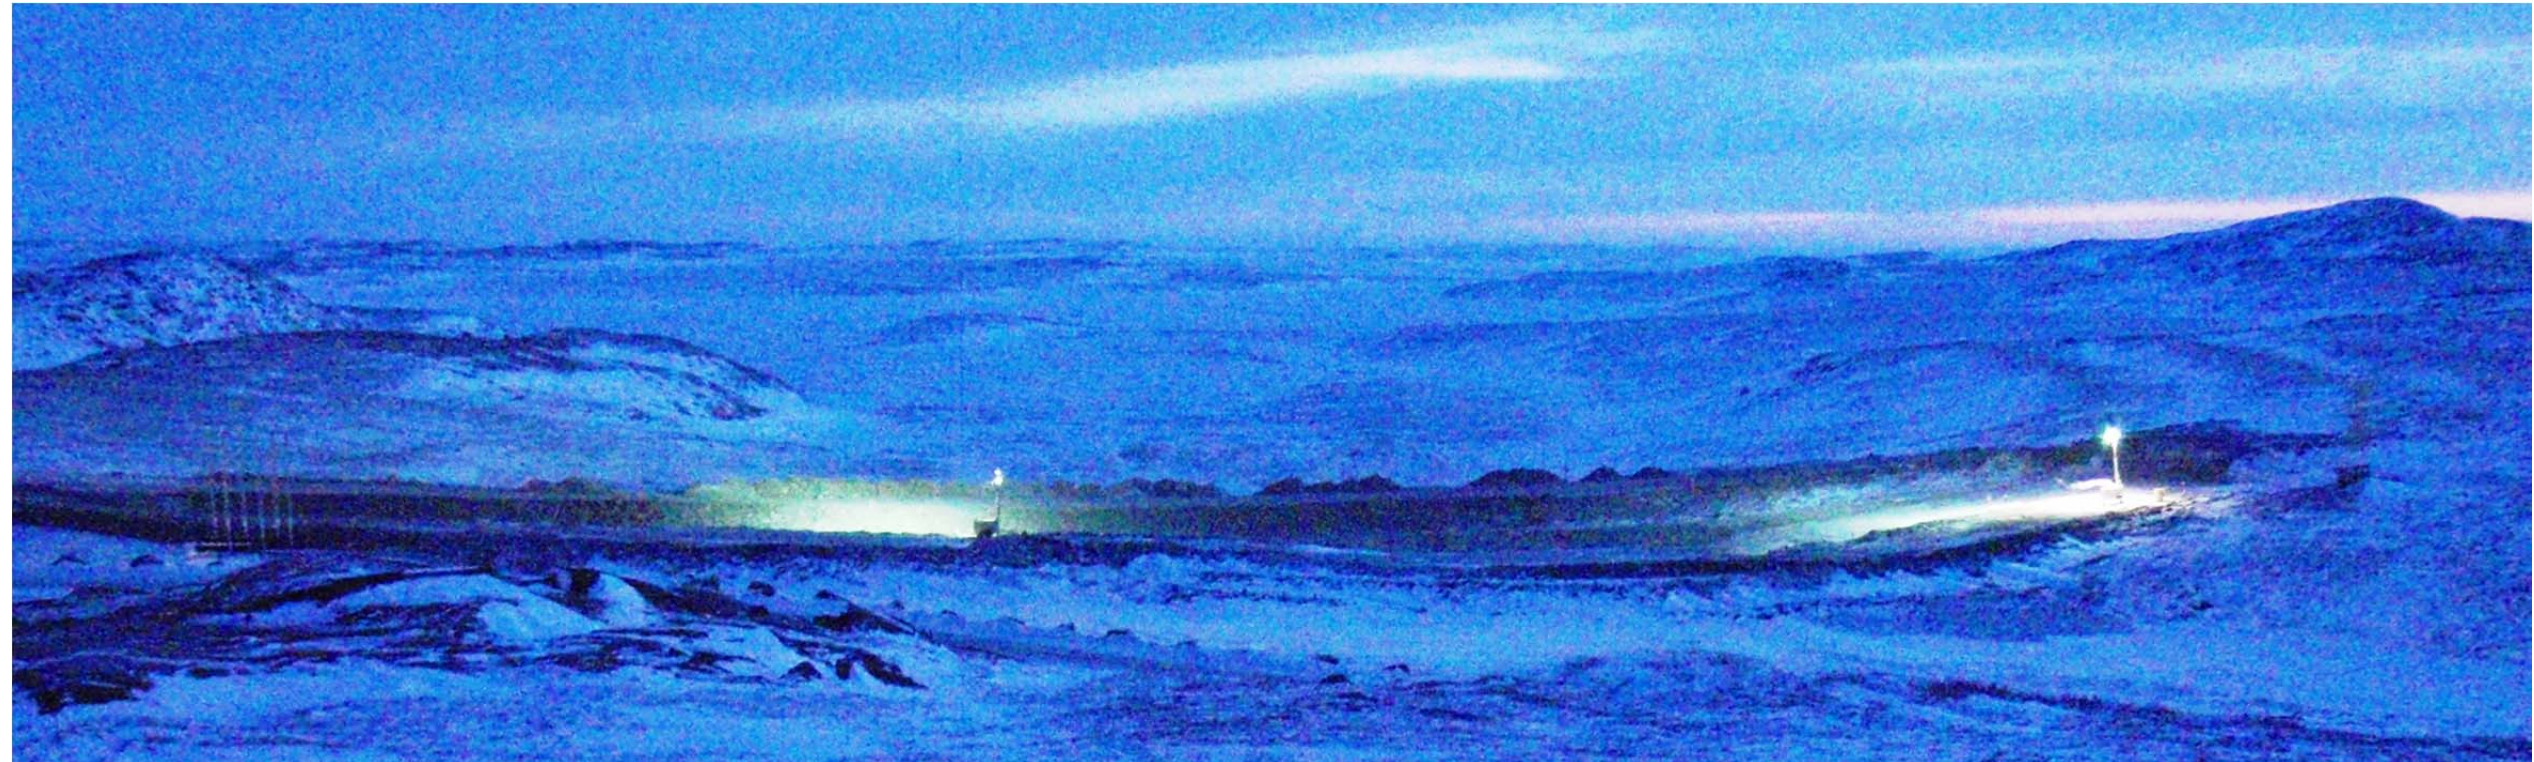
Photo 6: Progress photo of the North Dam construction. Photo taken from Photo Point 1, looking ~ south-east.

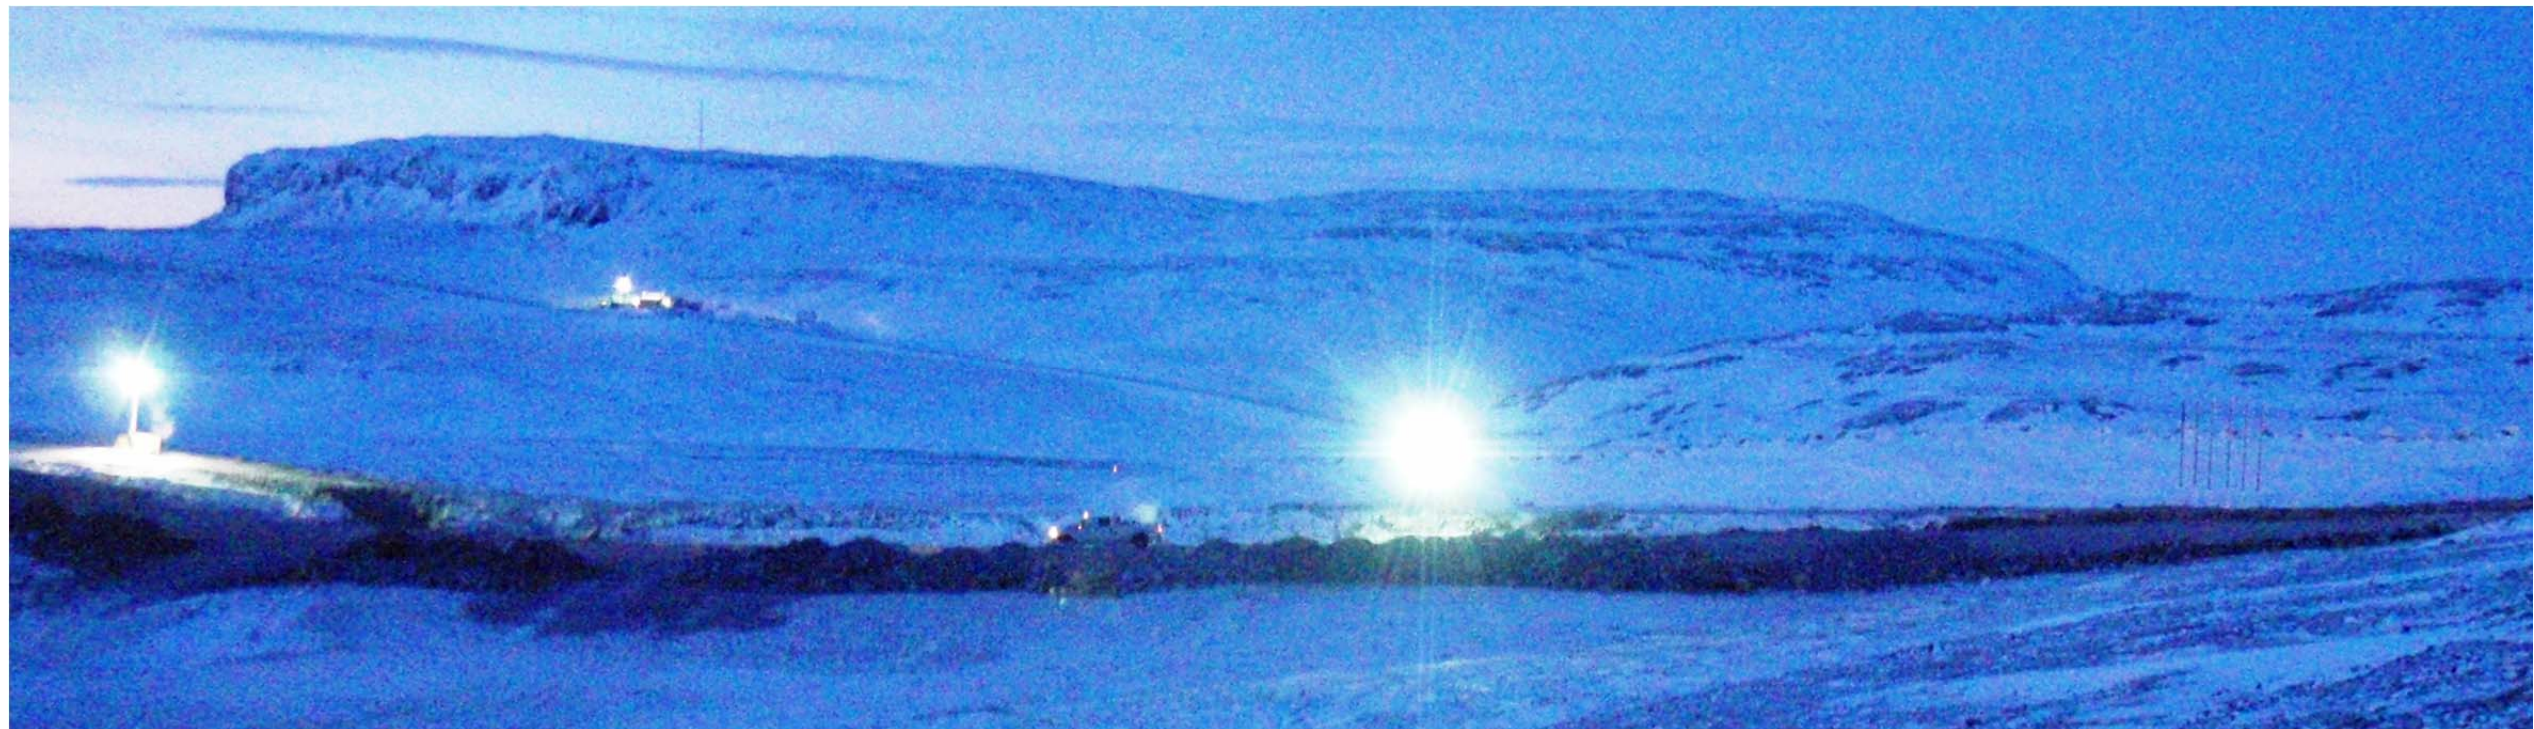
Photo 7: Progress photo of the North Dam construction. Photo taken from Photo Point 2, looking ~ northwest

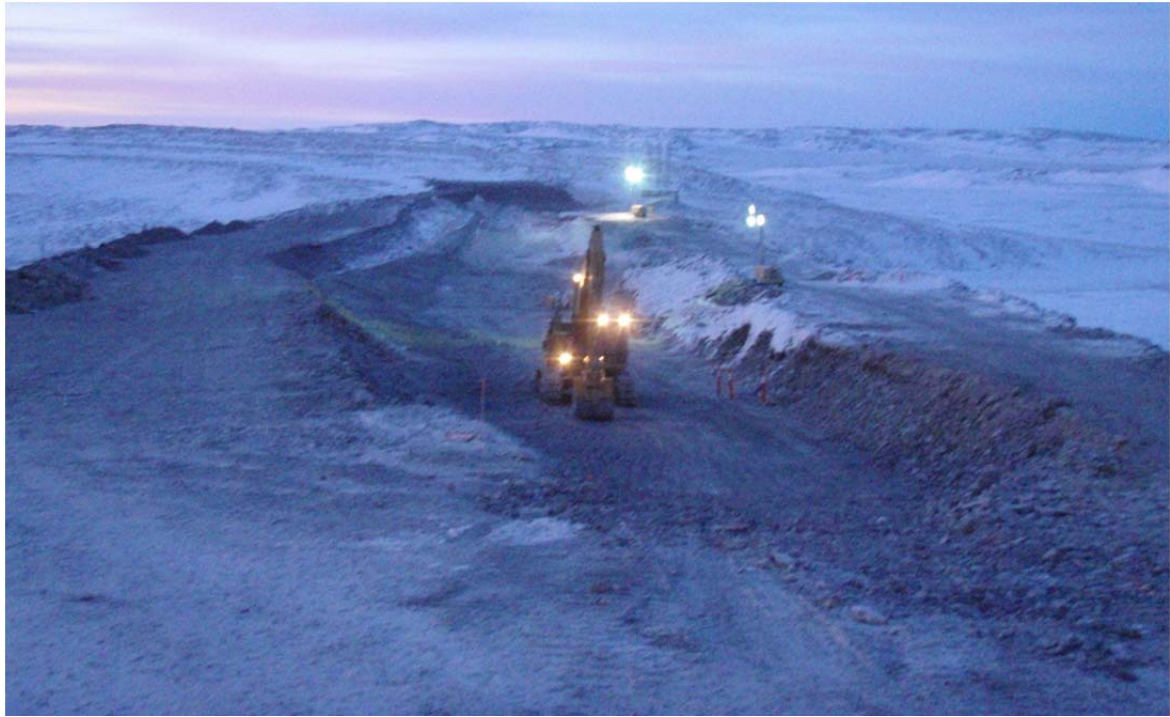
Photo 8: ~SSW view down key trench. Note excavator scratching/ removing 5/8” material in foreground.

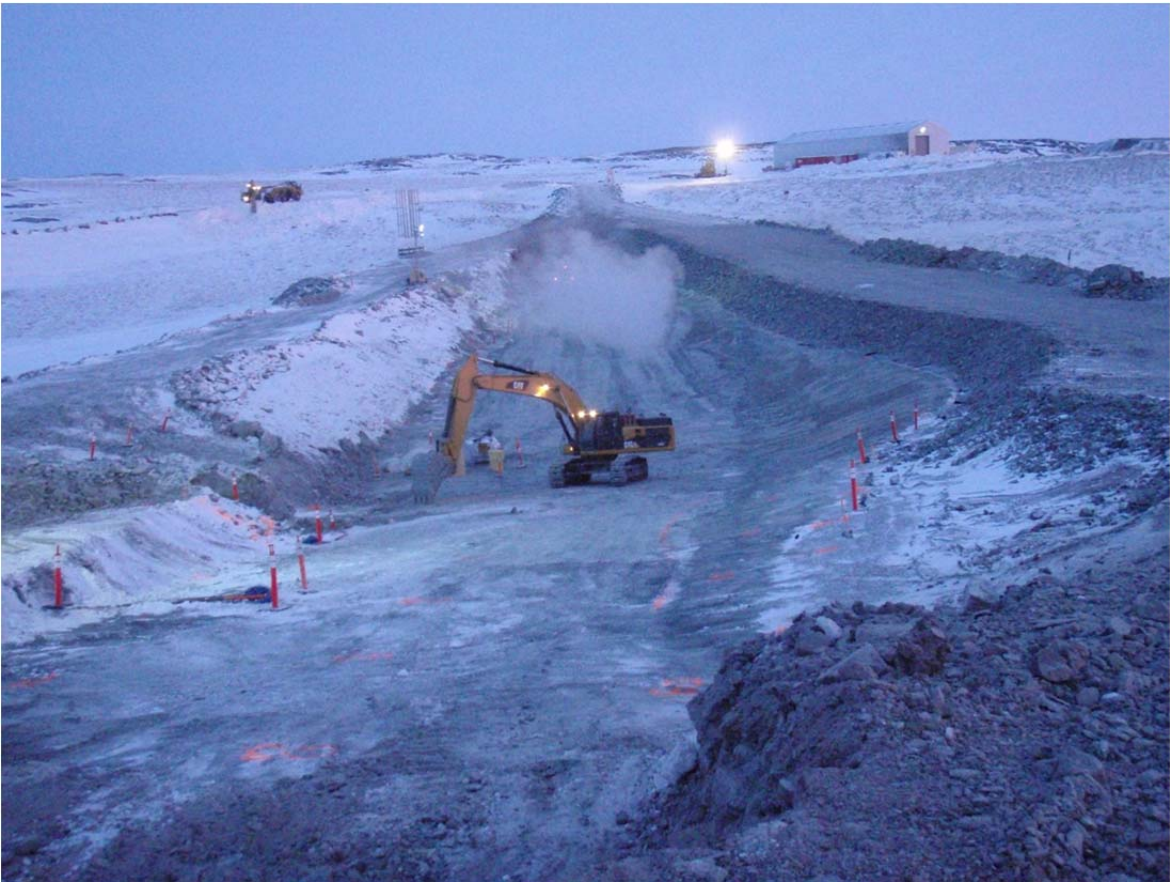
- Additional removal of 5/8" clear material is required on the SW and NW ends. Frozen 5/8" material is on the order of 0.2 to .3m thickness in areas.
- Material removed from the key trench (primarily frozen 5/8" material) was loaded into a 730 haul and end dumped on the upstream side of the dam. The 5/8" end dump piles still require blending with ROQ on the upstream.

Photo 9: View of construction progress in the North Dam key trench, ~NE view down trench. Note the end dump piles of 5/8” material on the upstream of the dam.

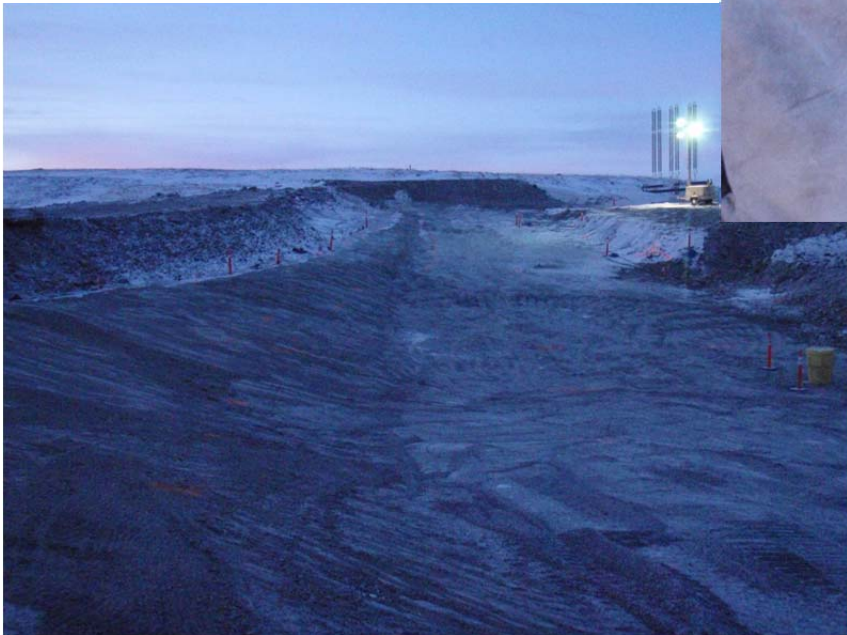
Photo 10 (bottom left): View of the central portion of the key trench, as scratching/ 5/8” material removal progresses; ~ WSW view.

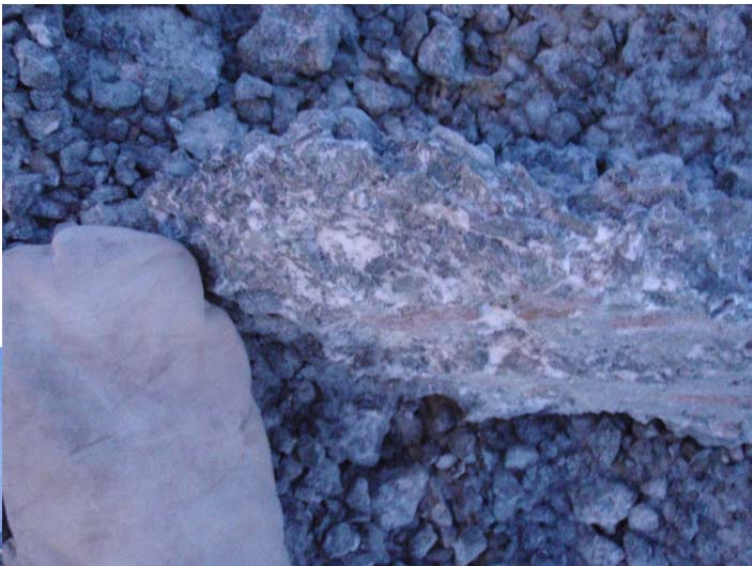
Photo 11 (mid left): Close up view of frozen 5/8” clear material being excavated in the North Dam key trench.

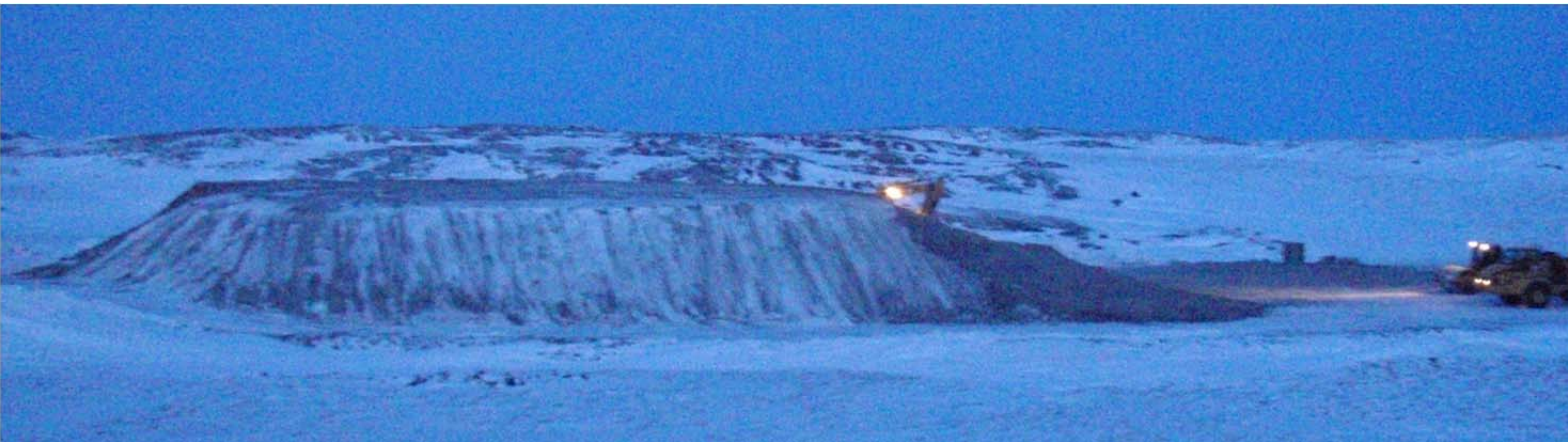
Photo 12 (bottom right): Excavator working on breaking/ mixing up frozen core material stockpile, ~NE view.

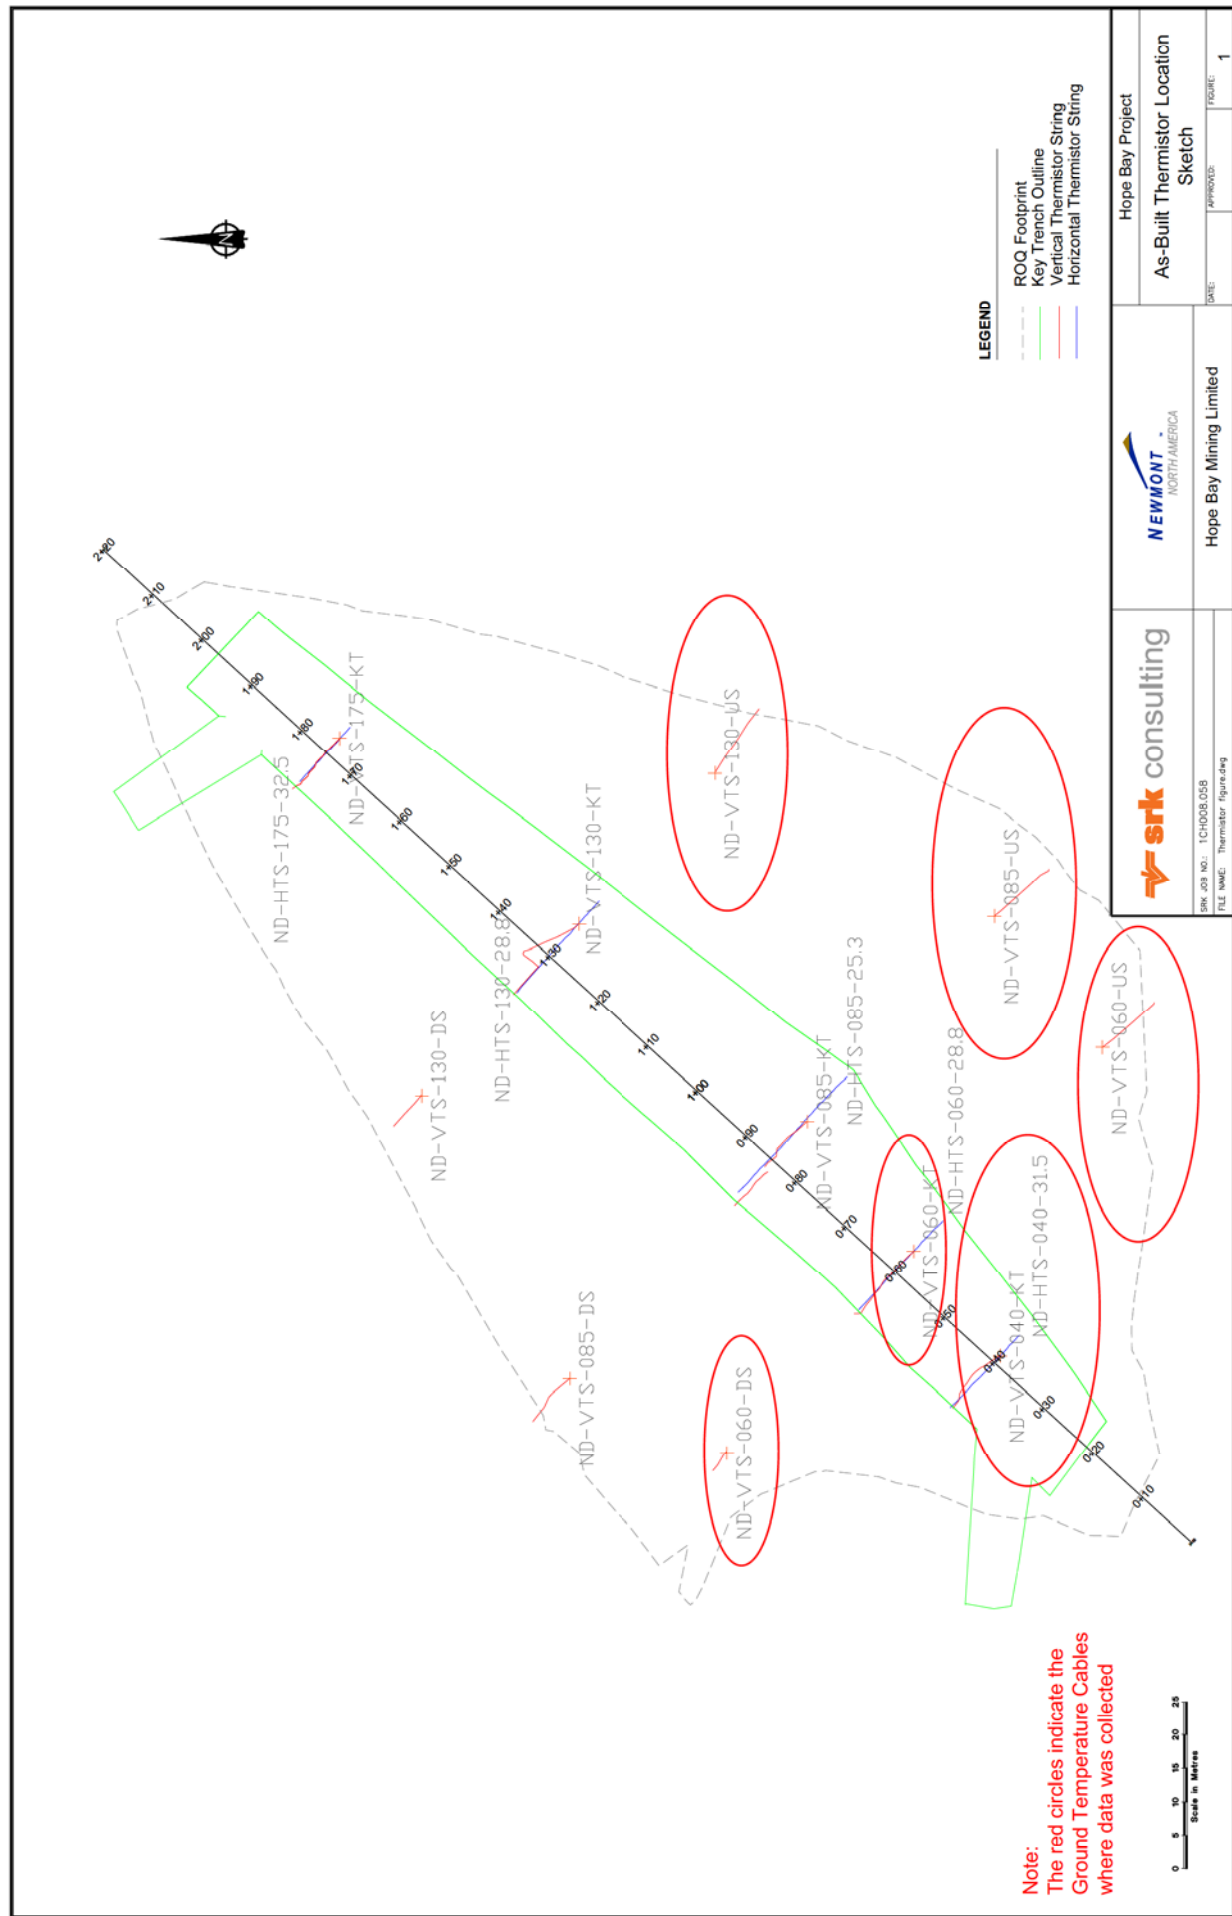
- Some of the ground temperature cables, installed in the North Dam, were read. The current location of the ground temperature cables are shown in Figure 1 (found at the end of the report). Today's readings are provided below.
