## DAILY REPORT #09 – DORIS NORTH INFRASTRUCTURE/ NORTH DAM

| Prepared by: | John Kurylo | Date: | 2012.01.14 |
| Reviewed by: | | Project #: | 1CH008.058.0320 |

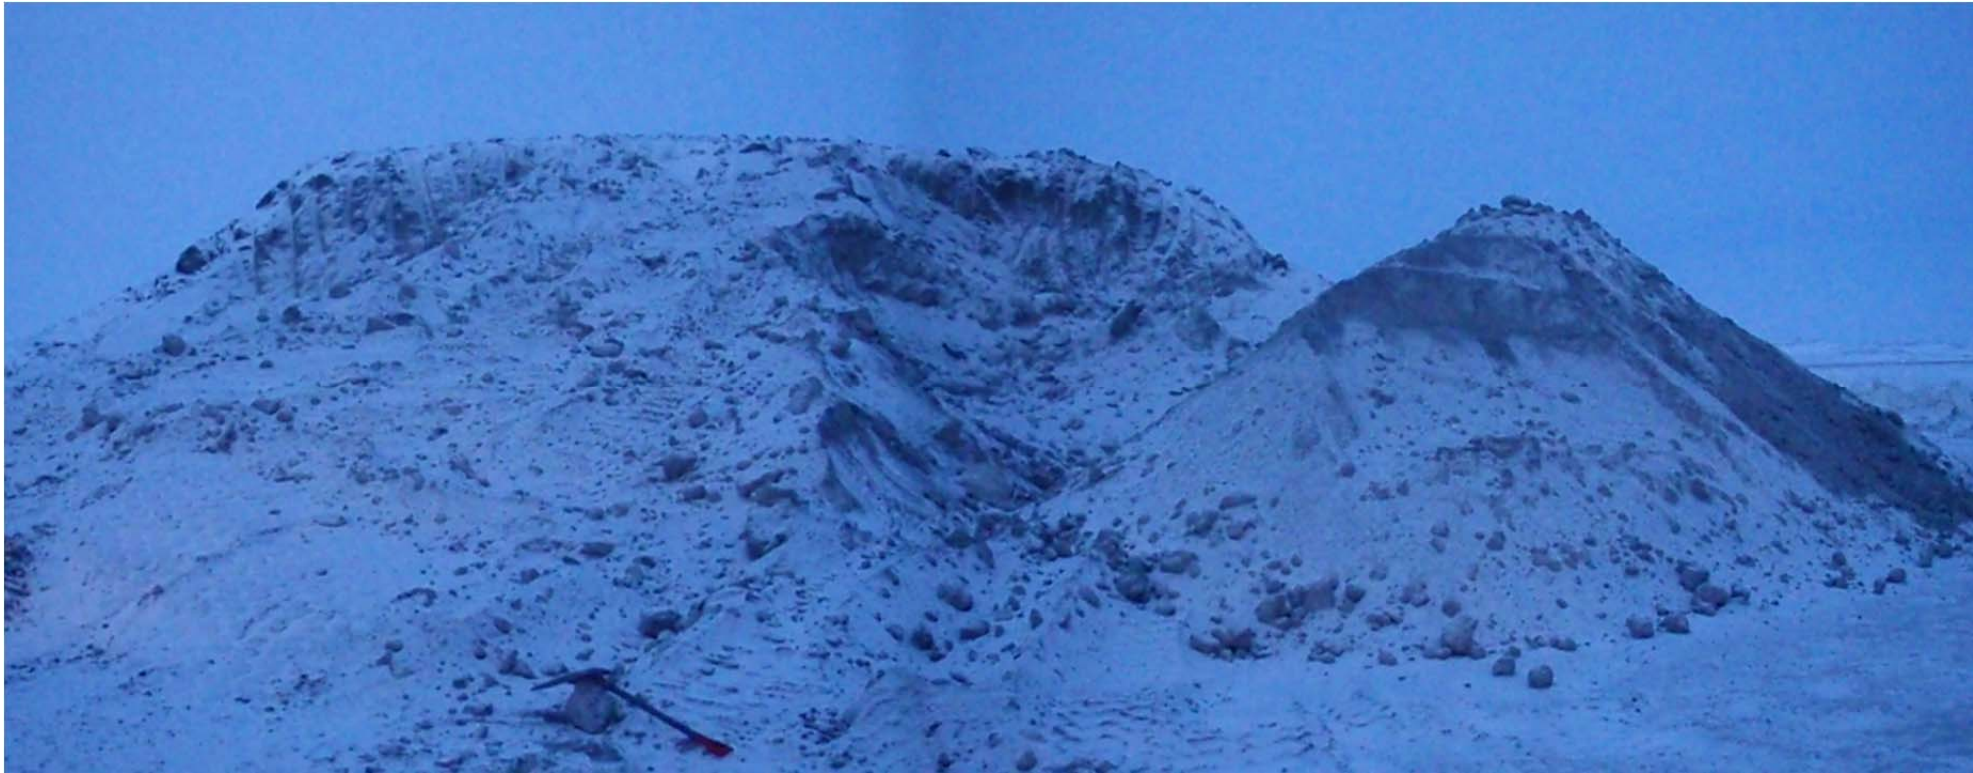
**Photo 1:** ~NW view of the frozen core material stockpile at the FCP Plant pad.

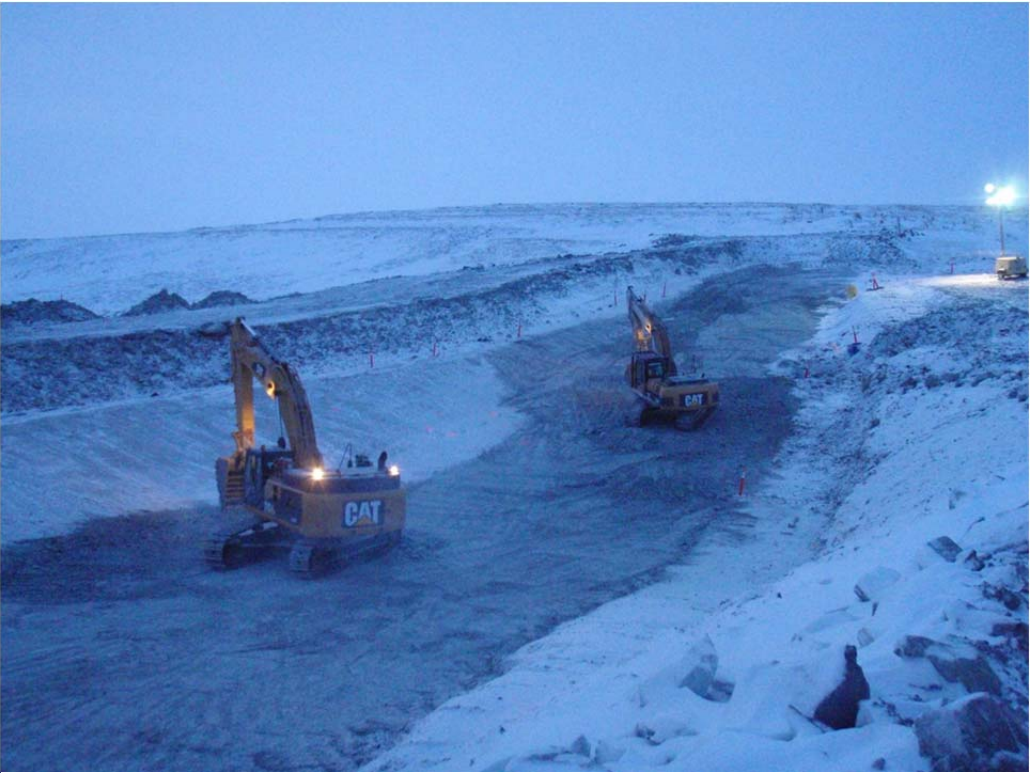
**Photo 2:** ~SW view of the excavators removing frozen 5/8" material from the key trench.

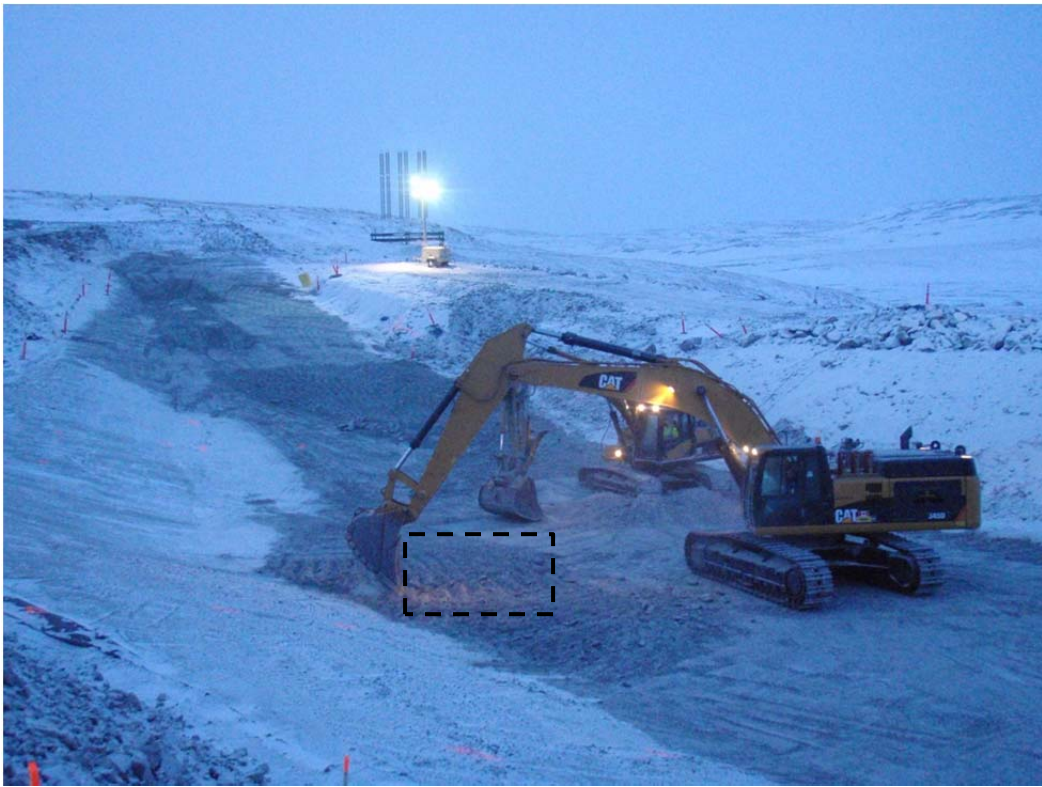
**Photo 3 (bottom left):** ~WNW view of the excavators removing frozen 5/8" material from the key trench.

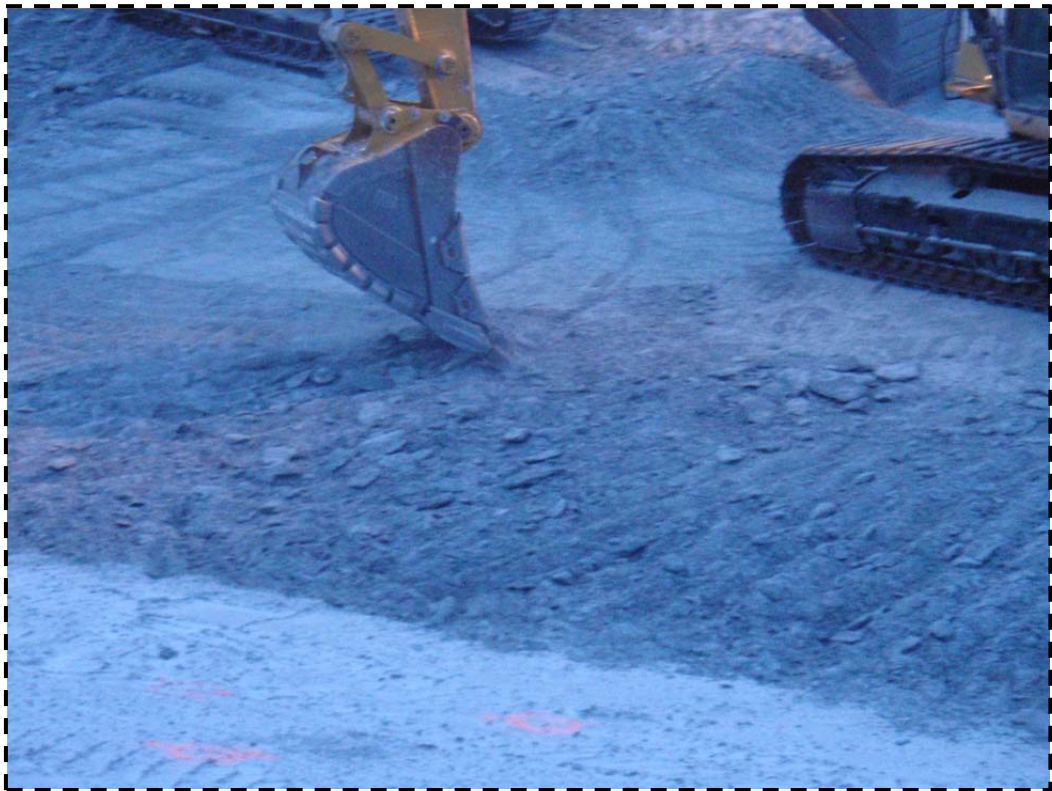
**Photo 4 (bottom center/ right):** Close-up view of frozen 5/8" material being ripped with the toothed excavator bucket.

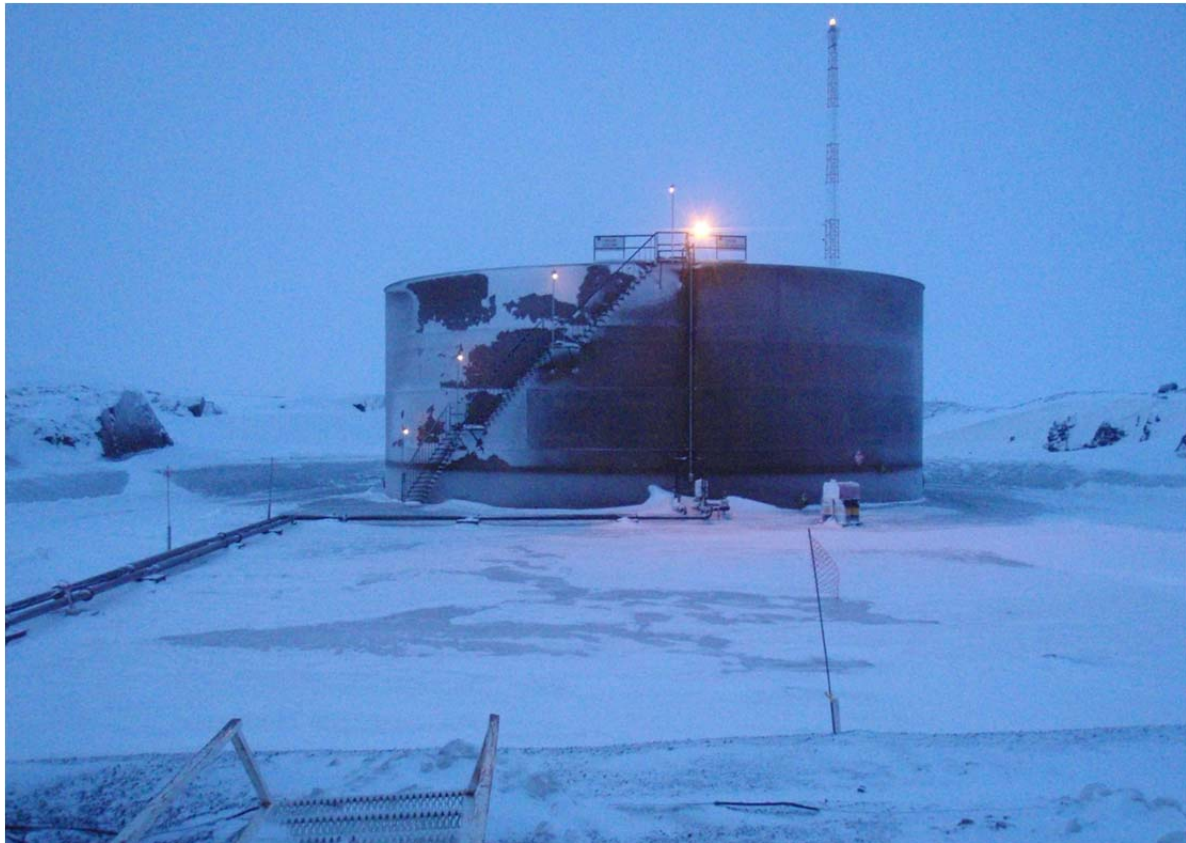
**Photo 5 (above/ top right):** View of the Roberts Bay Quarry #1 Tank Farm.

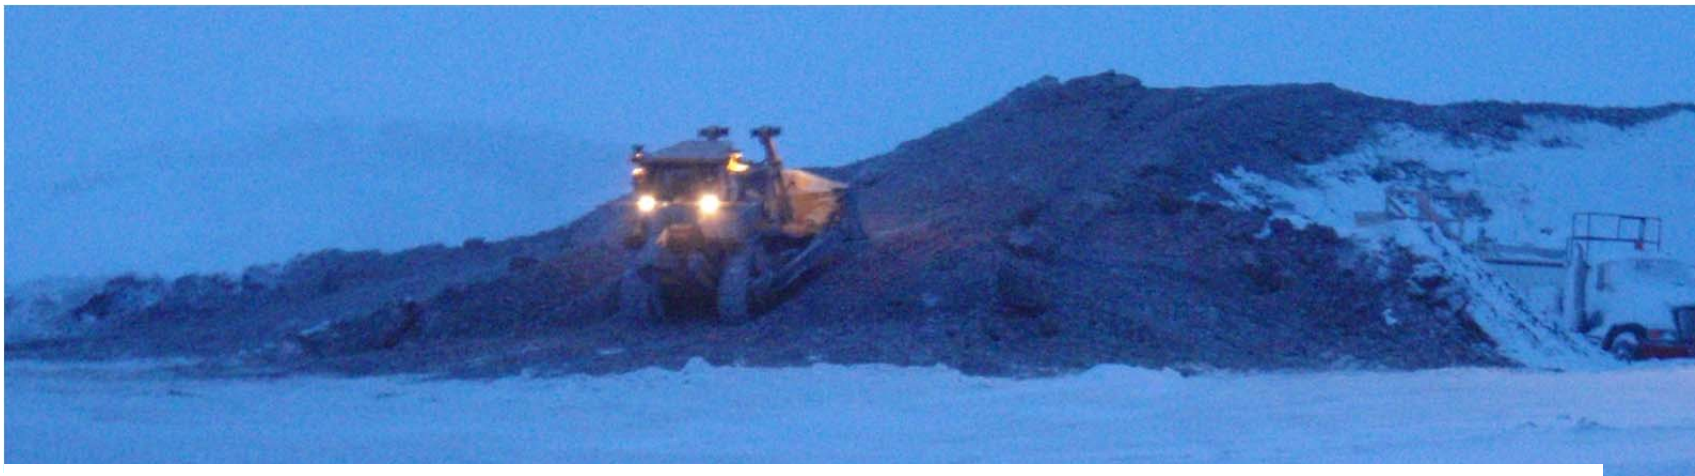
- A D9 dozer worked the Transition material stockpile (dug in and moved material around), stockpile located near the Batch Pant area.

**Photo 6 (above/ top right):** Dozer working transition material stockpile by the Batch Plant (near Quarry #2)

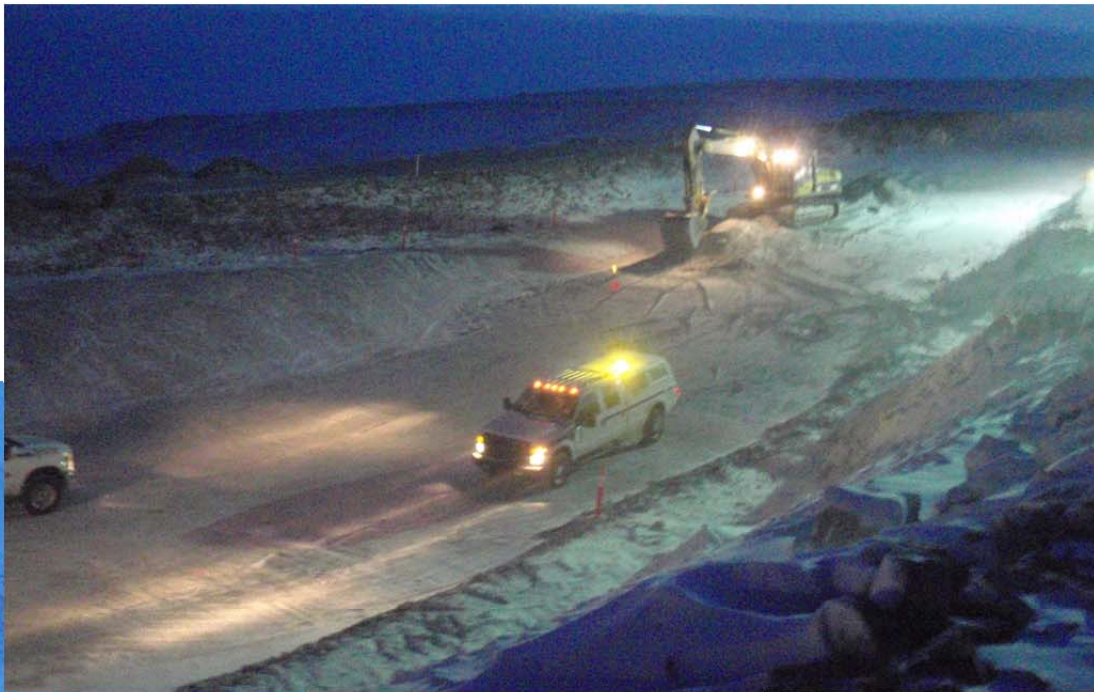
- Nuna survey has been making grade to the FCM (grade based on a DEM created from the 2011 frozen core elevations) until grades are less than 0.05 m.
- A small area, ~ 7x2m, near the location of the old central ramp (around chainage 0+080) was cleaned for Transition material placement.

- See photo 9 for details on aforementioned area.
  - The ROQ at the toe of this ramp was previously pulled back out of the Transition zone, cutting off the central access route into the key trench.

- Night shift placed a couple loads of transition material around 0+080 and re-established the central access ramp.
  - Compaction of the Transition material placed at the toe of the central access ramp is still required.

**Photo 8 (center):** View of excavator working on 5/8" material and survey checking grades in the central portion of the key trench.

**Photo 9 (bottom right):** Close up view of the area where ROQ was pulled back (near the area where the central ramp was previously location, ~ around chainage 0+080). Note that the snow was removed from the transition material before night shift placed additional material at this location.

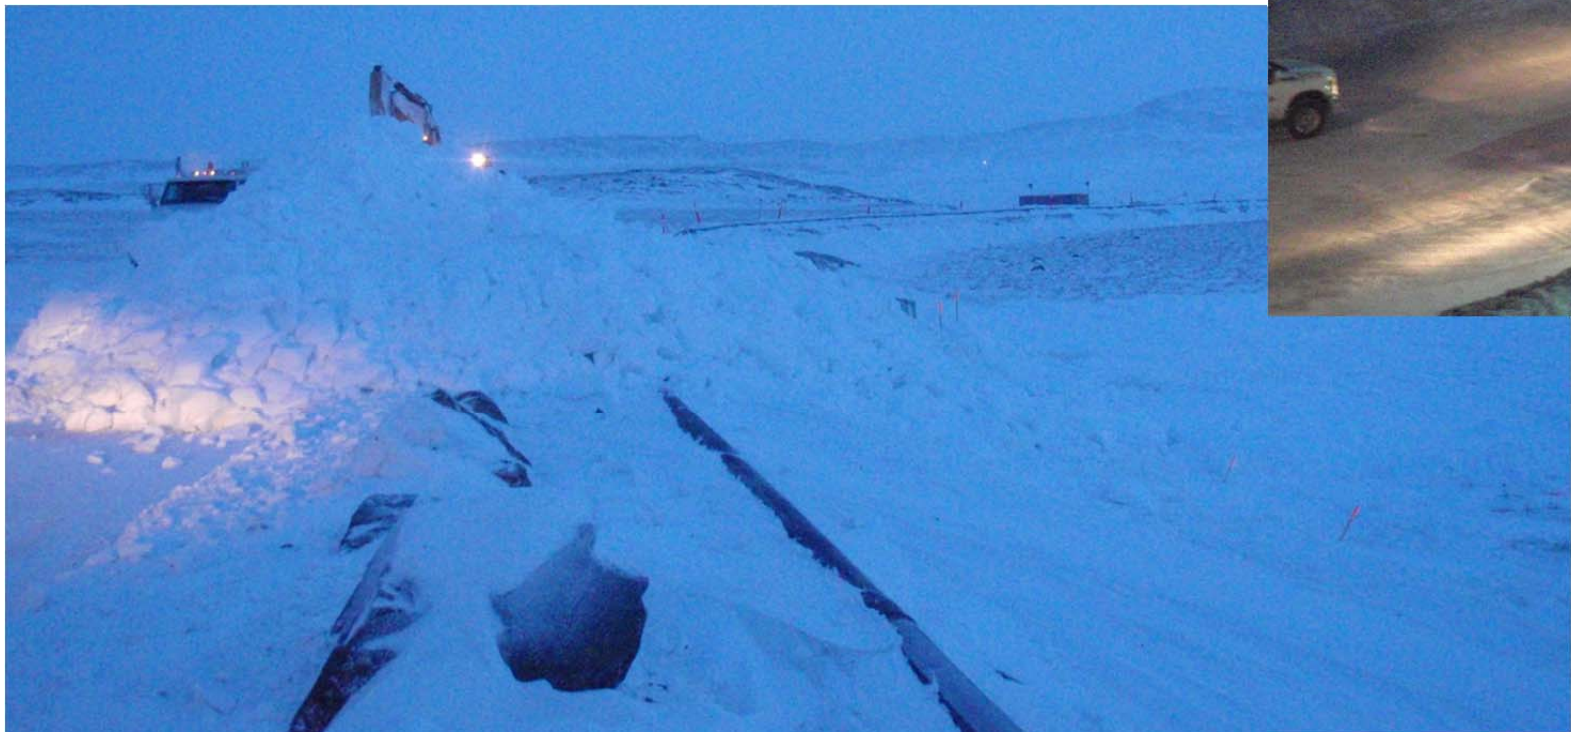
- The construction of snow pads around the Doris North Camp sump locations 1 and 2 continued today. Lifts of snow were spread with an excavator and sprayed with water.

**Photo 7 (above/ top right):** ~ ESE view of snow pad construction around the Sump 1 location.

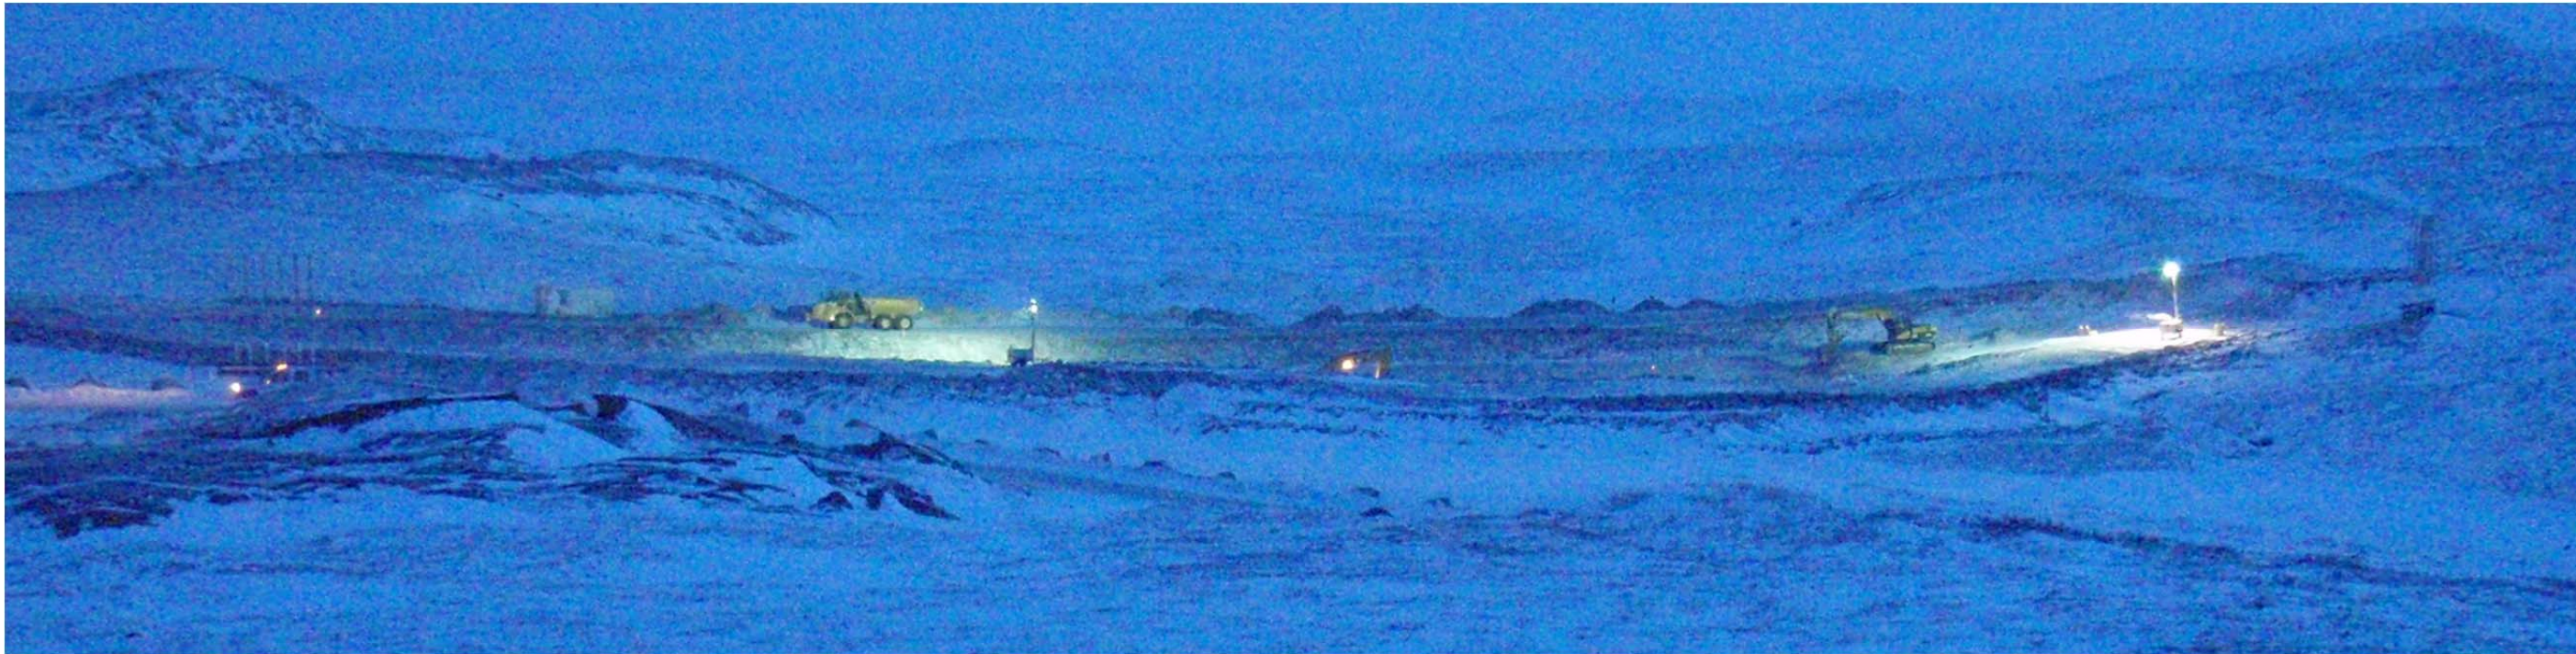
**Photo 10:** Progress photo of the North Dam construction. Photo taken from Photo Point 1, looking ~ south-east.

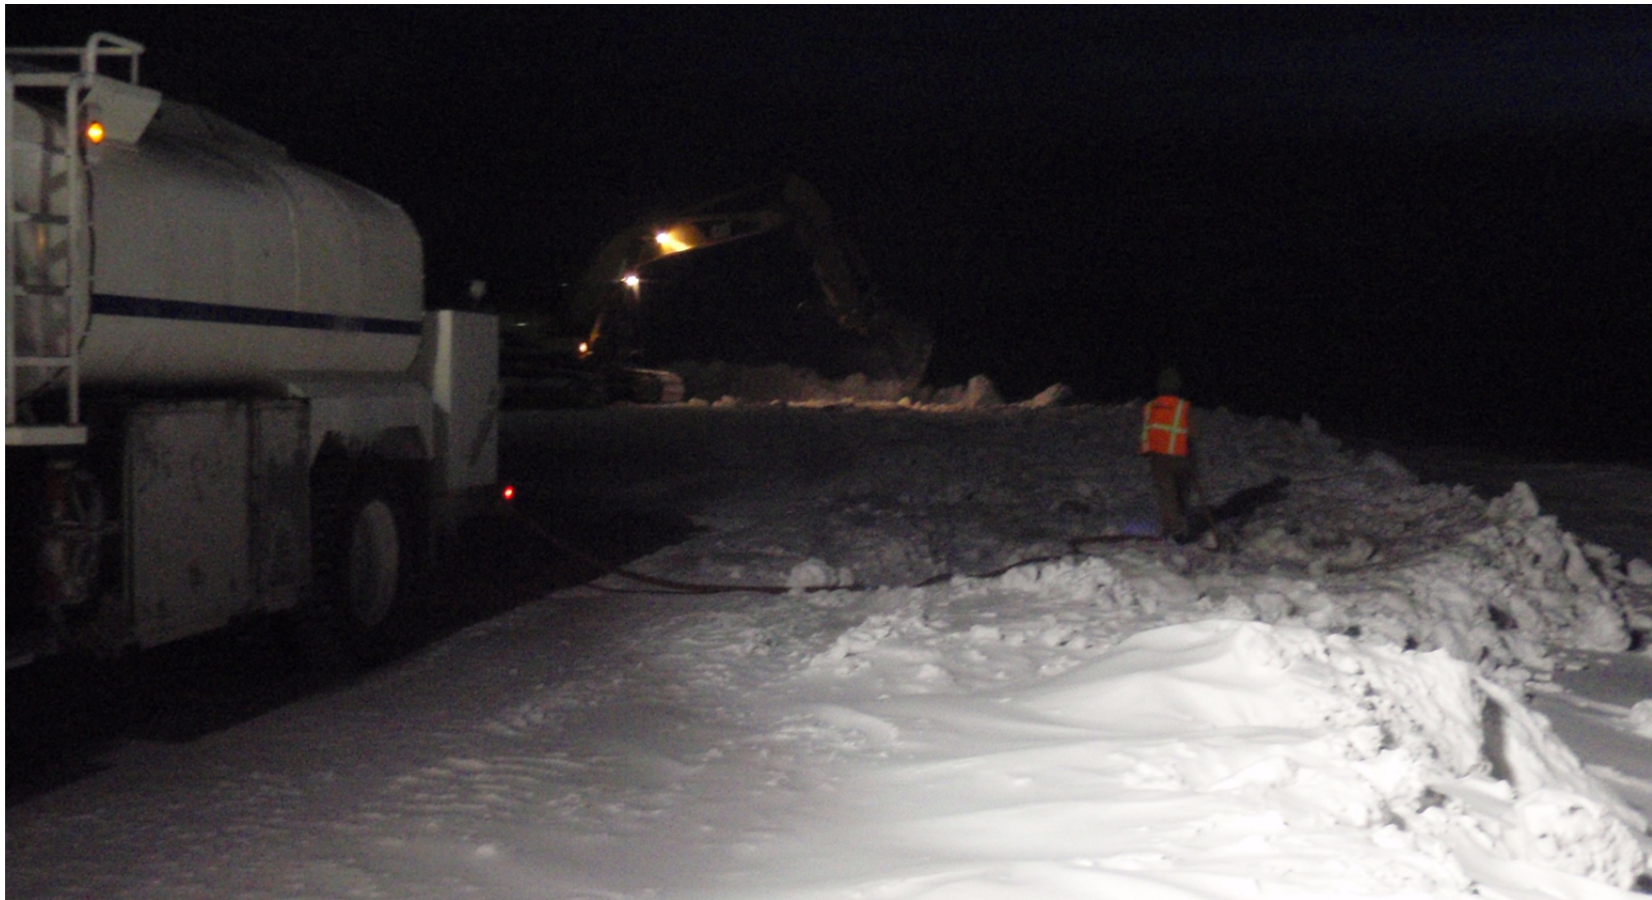
- Snow was placed by an excavator and watered near the WNW end of the FCP Pad. This snow placement is being completed to extend the W end of the FCP pad to allow for a wider turning radius for the haul trucks entering the FCP.

- See Photo 11
  - To minimize the amount of time that the FCP access doors are open, flow through the FCP plant is expected to go from the S end of the FCP plant to the N.

**Photo 11:** Snow being spread and watered near the west extents of the FCP Plant Pad.

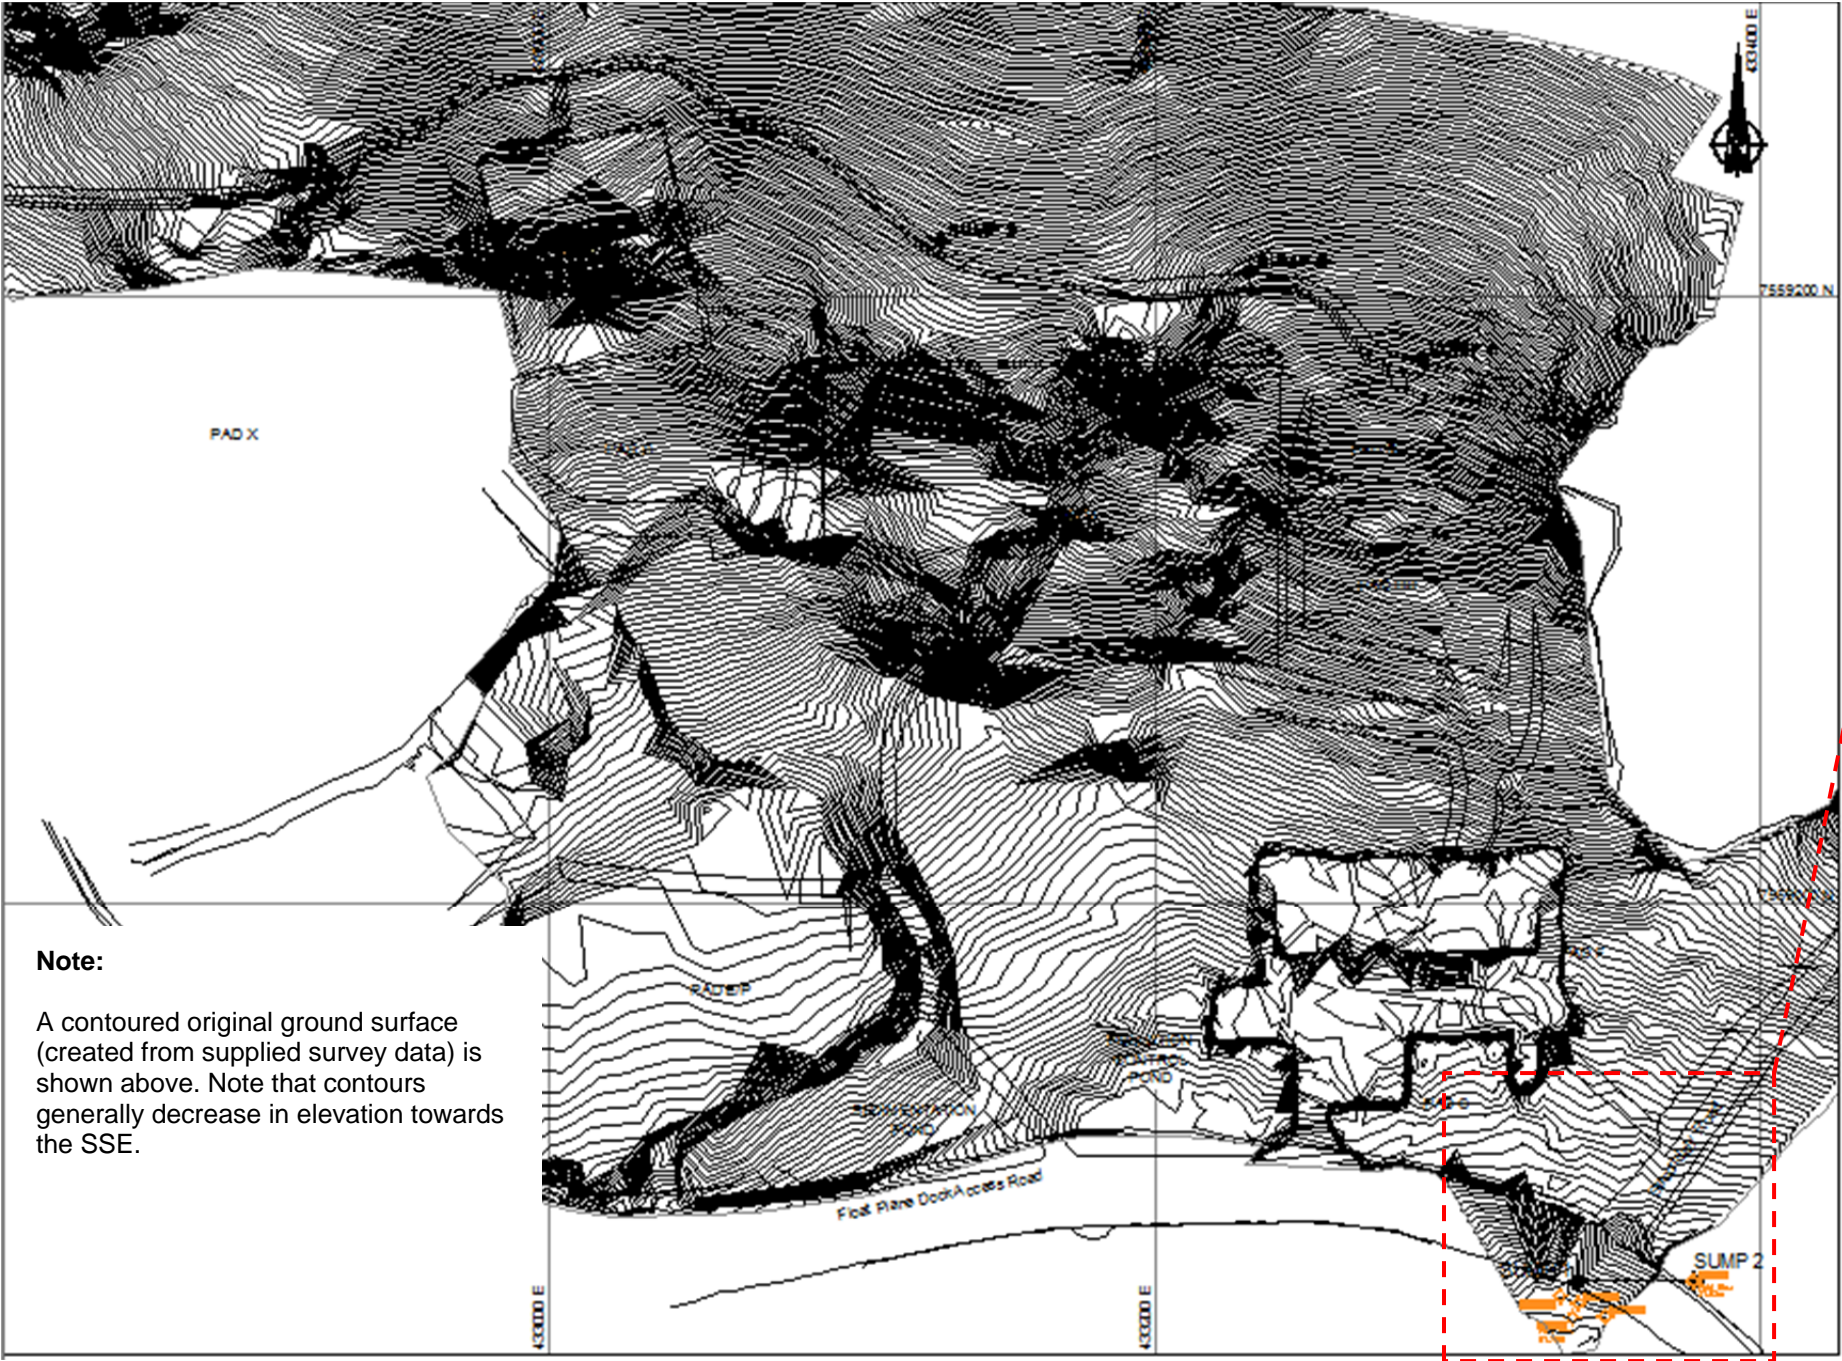
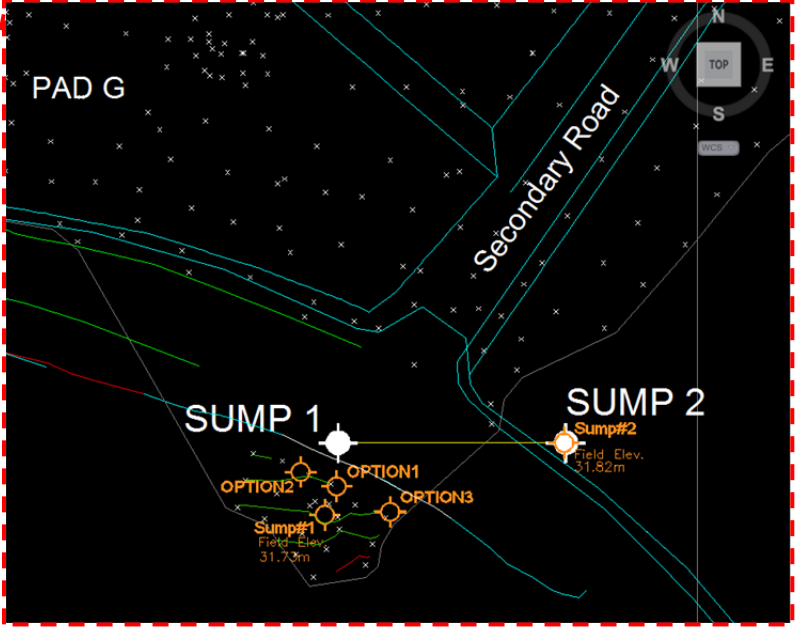
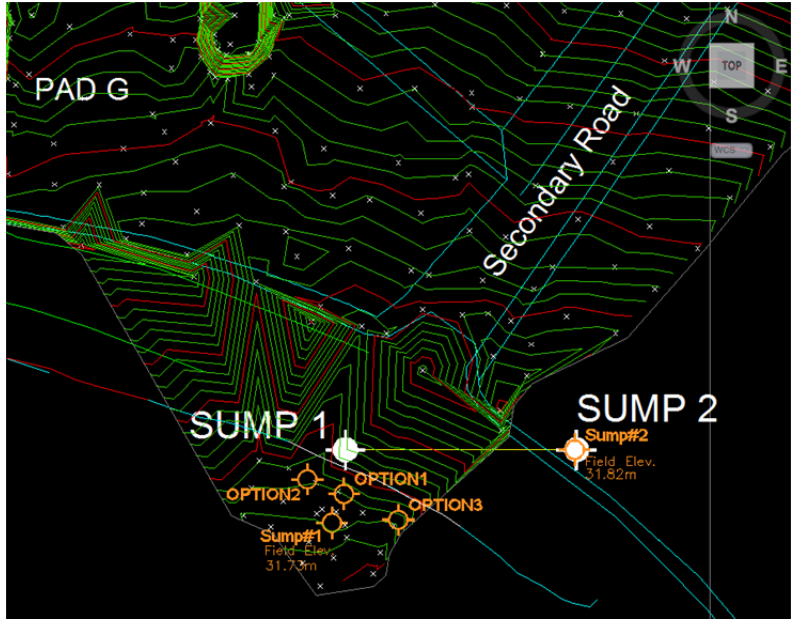
Preliminary notes for Sump #1 – Field Fit (In Progress) - 2011/01/14

- SRK completed a preliminary survey review around Sump #1 to assist in determining a new field fit location. Details on the preliminary survey review are provided at the end of this report after the Photos section.

- The final location of Sump 1 will be determined in the coming days. The current snow pad appears to be in a suitable location however, the final Sump 1 location is expected to move inwards towards the NNE of the proposed stake location noted in SRK daily #8.

COORDINATES FOR NEW SUMP #1 OPTIONS (~ 2.5m offset from outside of proposed sump to cables at S road toe):

- *OPTION 1* → N = 7558867.75, E = 433339.79, Elev ~31.80m
- *OPTION 2* → N = 7558870.16, E = 433333.76, Elev ~31.82m
- *OPTIONS 3* → N = 7558863.51, E = 433348.70, Elev ~31.74m

- IFC location for Sump 1 and 2 are shown in white.
- Previously proposed Sump 1 and 2 locations (see SRK daily #8) are shown in Orange and labeled as Sump 1 and Sump 2. The location of Sump 2 is expected to remain as outlined on dwg DN-DMC-045
- The location of Sump 1 is expected to move S, as the original location was located on the side slope of the Float Plane Dock Access Road.
- The final options for sump 1 are outlined in orange as 'Option' 1 to 3.
- Final field fit location for Sump 1 to be determined tomorrow.

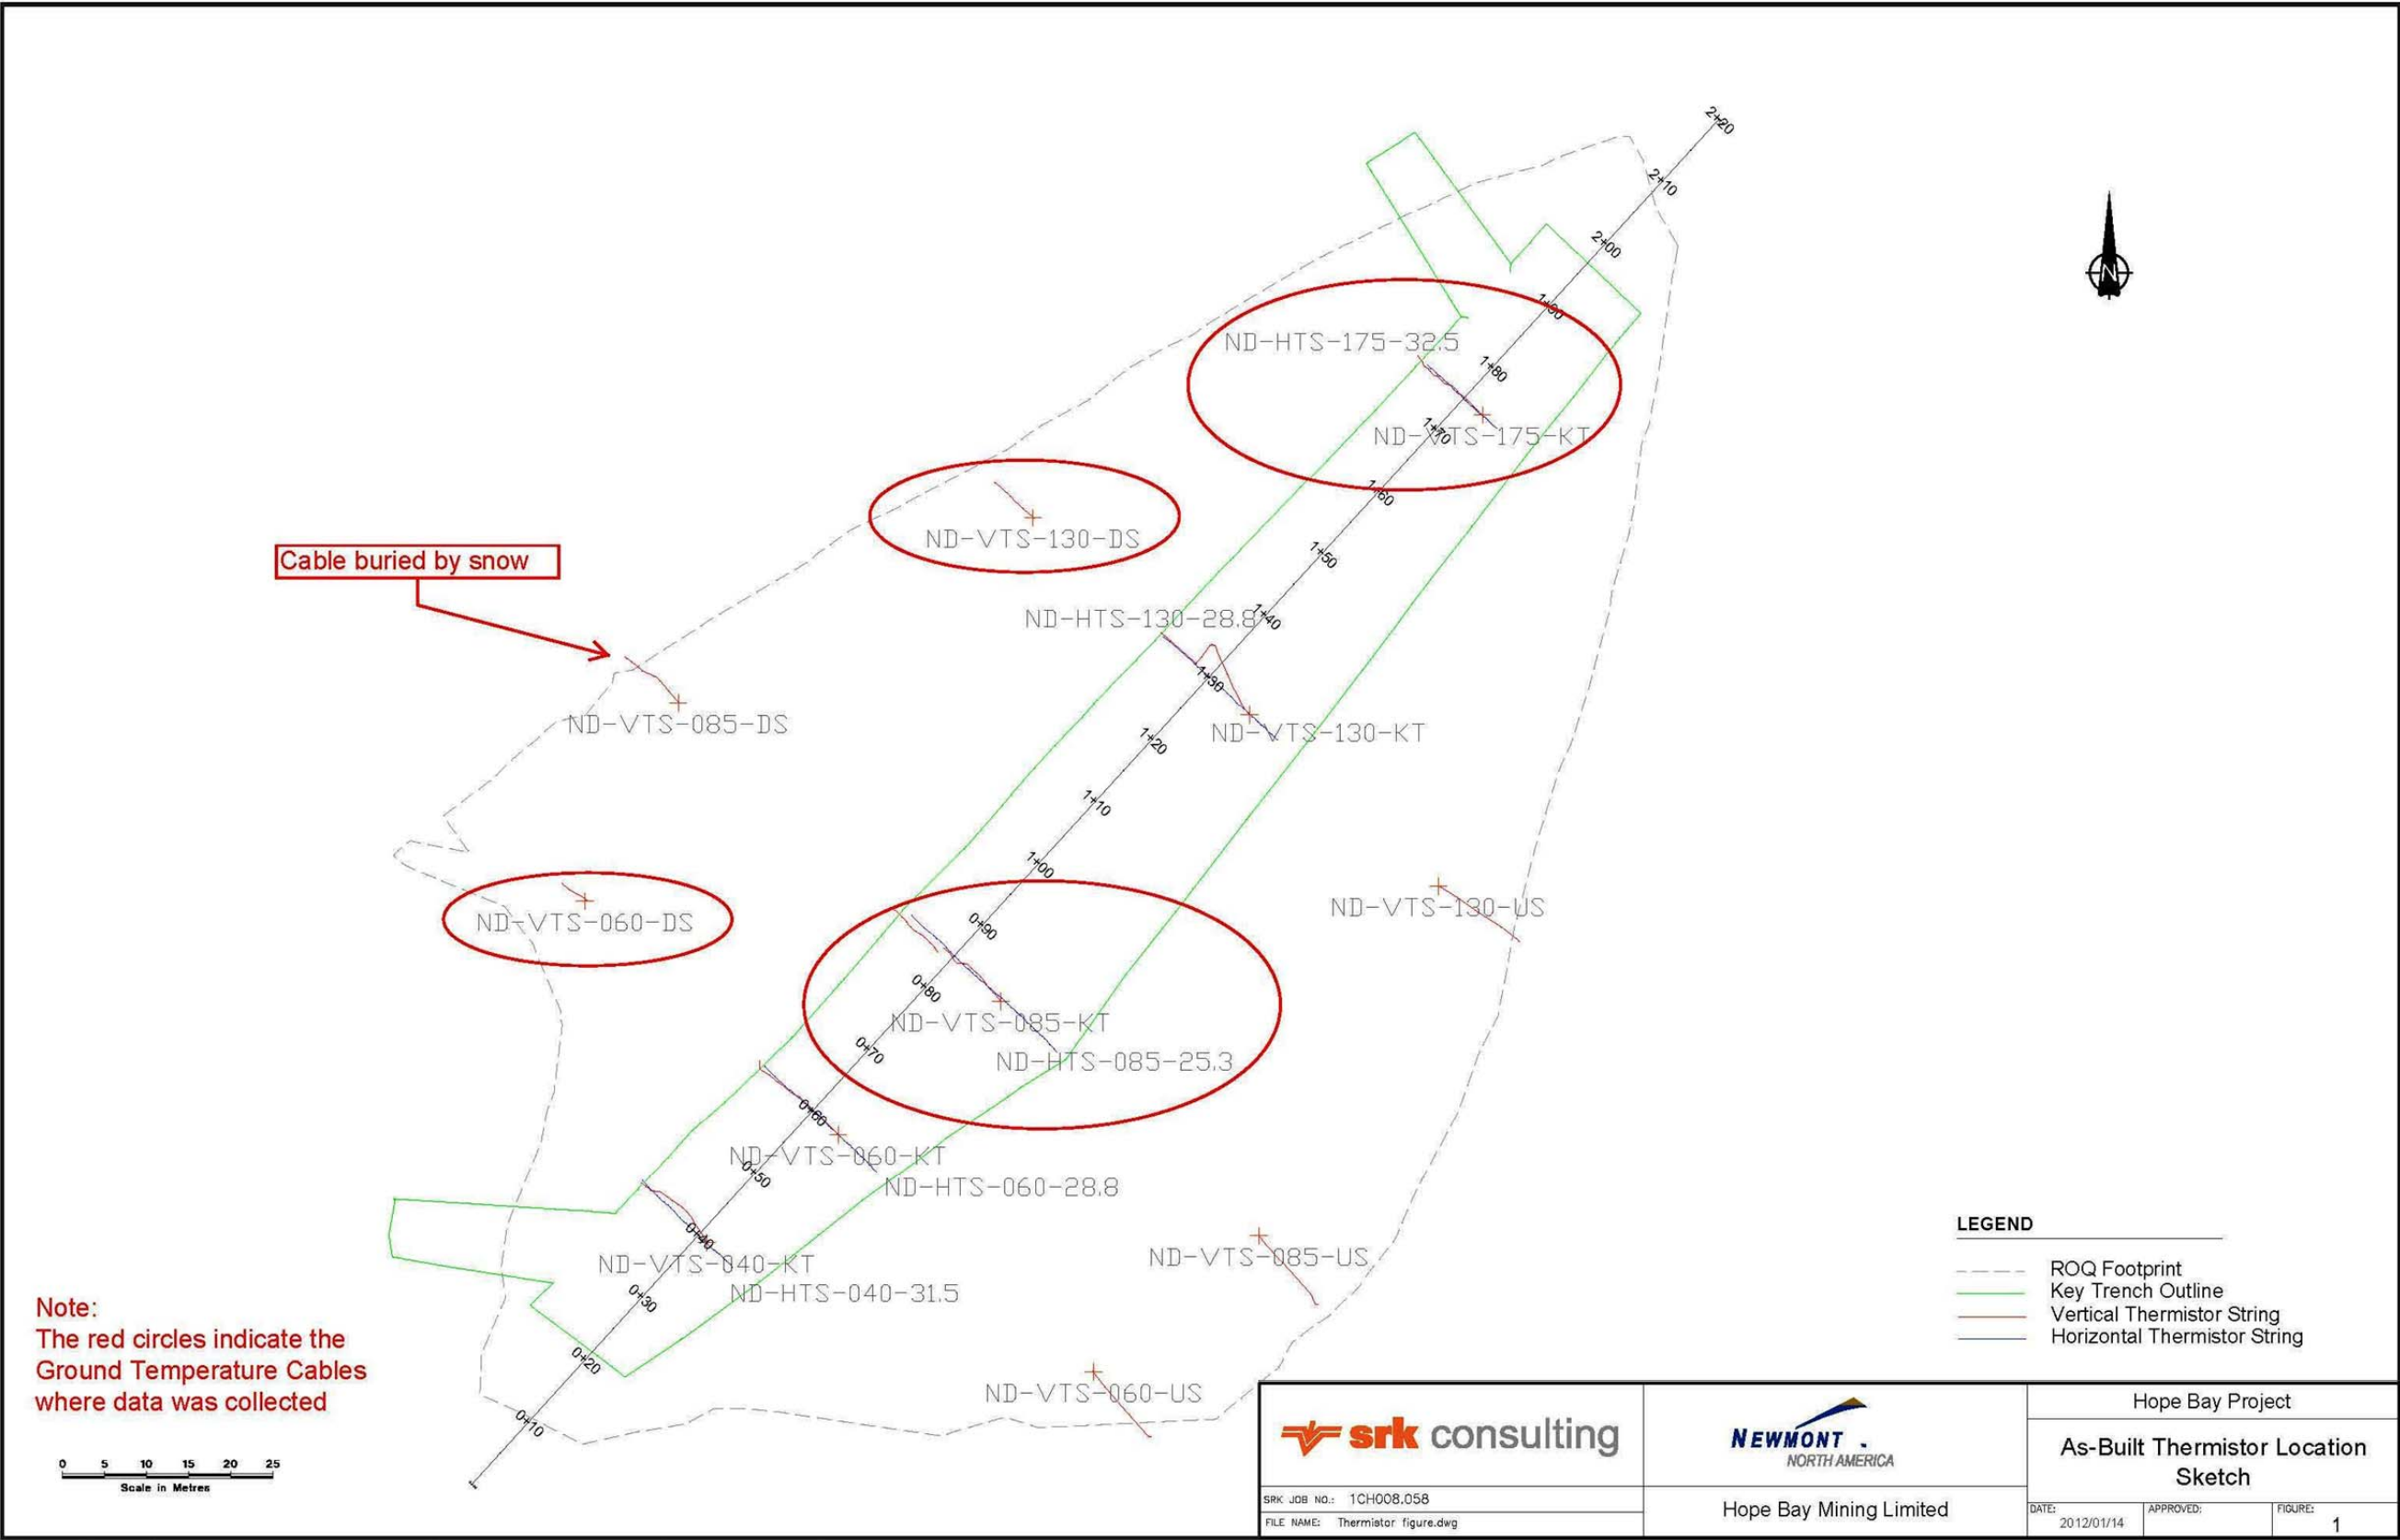
FIGURE:

- Some of the ground temperature cables, installed in the North Dam, were read. The current location of the ground temperature cables are shown in Figure 1 (found at the end of the report). Today's readings are provided below.
