7DAILY REPORT #103– DORIS NORTH INFRASTRUCTURE/ NORTH DAM

Prepared by:	Lawrence Borowski	Date:	2012.04.17
Reviewed by:		Project #:	1CH008.058.0320
Role	Company	Personnel – Position	On Site
Client	Hope Bay Mining Limited (HBML)	Angela Holzapfel – ESR Compliance Manager David Vokey – ESR Coordinator Dean Wold - Safety Jill Turk – ESR Coordinator Katsky Venter – ESR Manger Michelle Tanquay – ESR Site Manager Stirling Kelly – HSLP Advisor	No Yes Yes No No Yes No
	JDS	Doug Fielding – Construction Manager Ishan Fechter – Construction Coordinator Jerry Graham – Construction Manager Mark Valeriot – Construction Manager Calvin Goldschmidt – Construction Coordinator	Yes Yes No No No
Engineering Design Consultants	SRK Consulting (Canada) Inc.	Megan Miller – Site Engineer Lawrence Borowski – Site Engineer Iozsef Miskolczi – Site Engineer	No Yes No
Earthworks Contractor	Nuna Logistics	Doug Haverland - Area Superintendent Gary Sodhi – Field Engineer Georges Cornelissen – Survey Manager Jeff Roberts - Surveyor Jim Cardinal – Foreman Jordan Gunter – Foreman (Day Shift) Kyle Kuntz – Project Engineer Margaret Caley – Surveyor Mike MacMaster – Surveyor Mike Price – Field Engineer Rick Peter – Forema

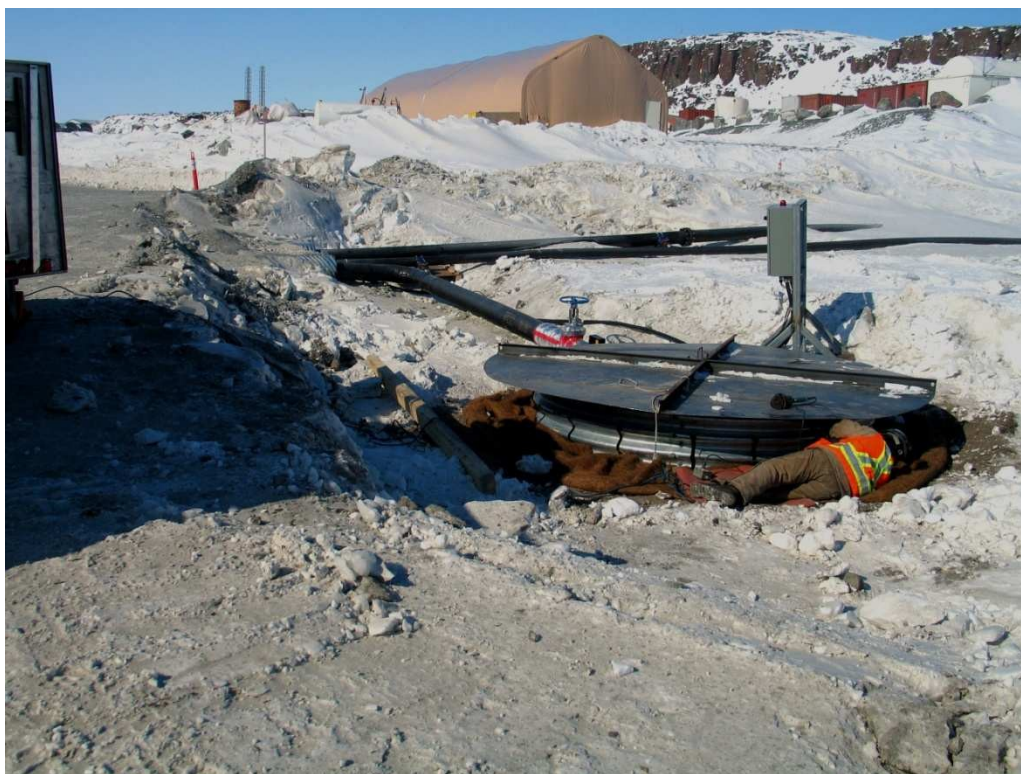
Photo 1: Welding tabs at Sump 2

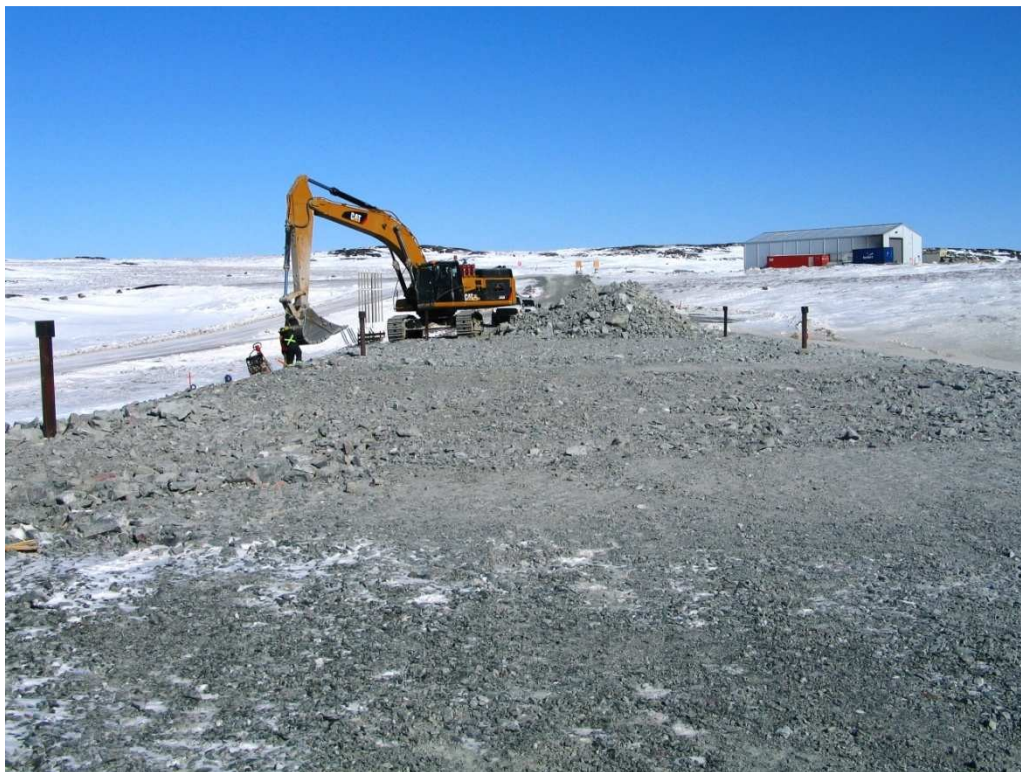
Photo 2: North dam facing north, showing progress on survey monuments.

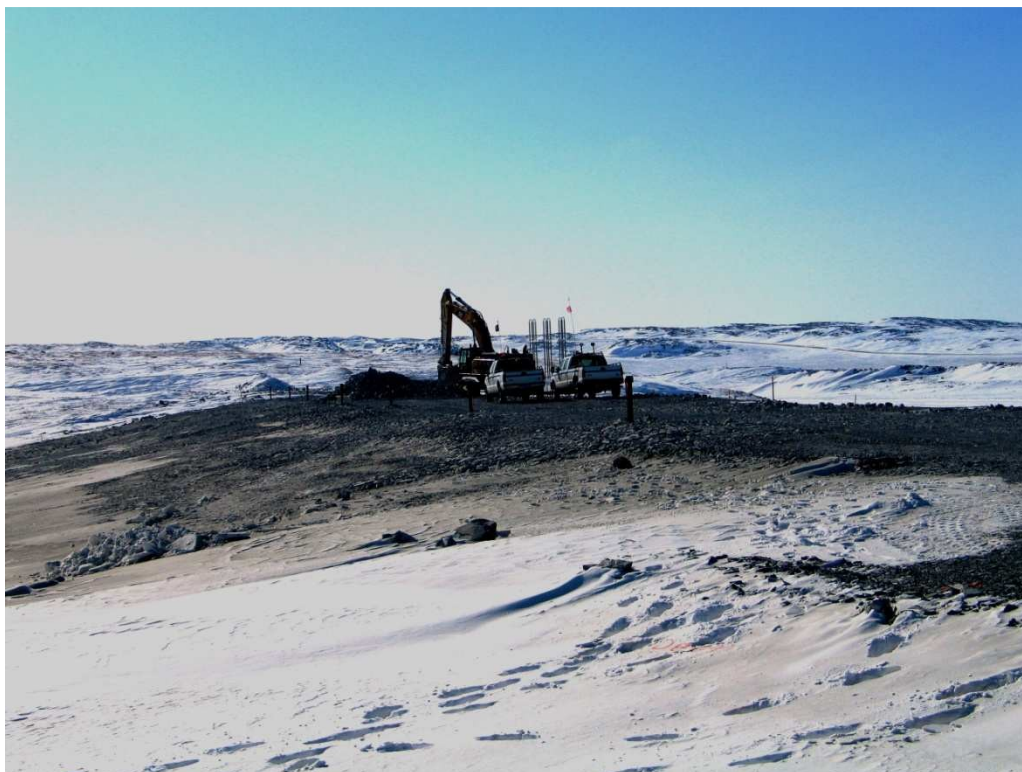
Photo 3 North dam facing SW showing the seven survey monuments on the upstream side of the dam.

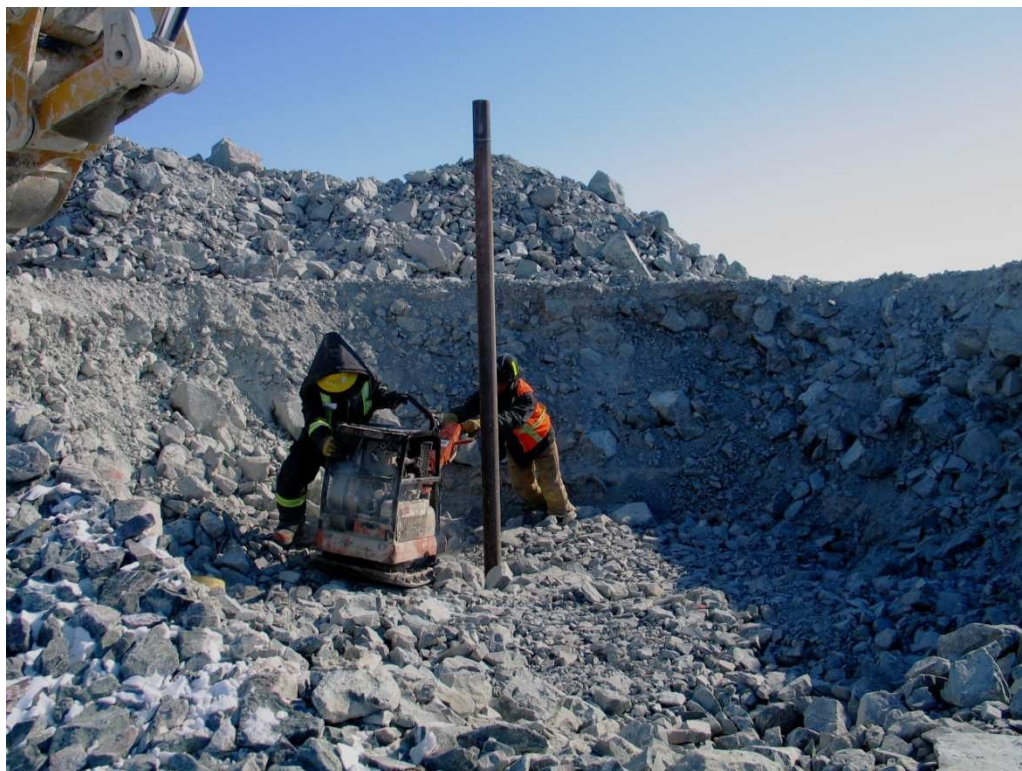
- Followed up on current plans for installing cables and instrumentation at the dam. Requirements are now understood, and communicated to Nuna.
- Nuna crew reported that they were hitting frozen core material in the survey monument excavations. On the second monument # ND-SMP-080-DS approximately .3 m was exposed. Excavation at #ND-SMP-100-DS revealed that ~ 1 m of frozen core material was exposed. Survey marked out the design location of the liner, which was at the limit of the excavation and ~ 1 m from the exposed edge. It is difficult to visualize that the frozen core was overbuilt by a meter. It was also noted that there was 6 in material under the exposed edge. ~.3 m was trimmed back to permit the packer to go around the survey monument.

Photo 4: Hand packing first lift of ROQ at ND-SMP-080-DS

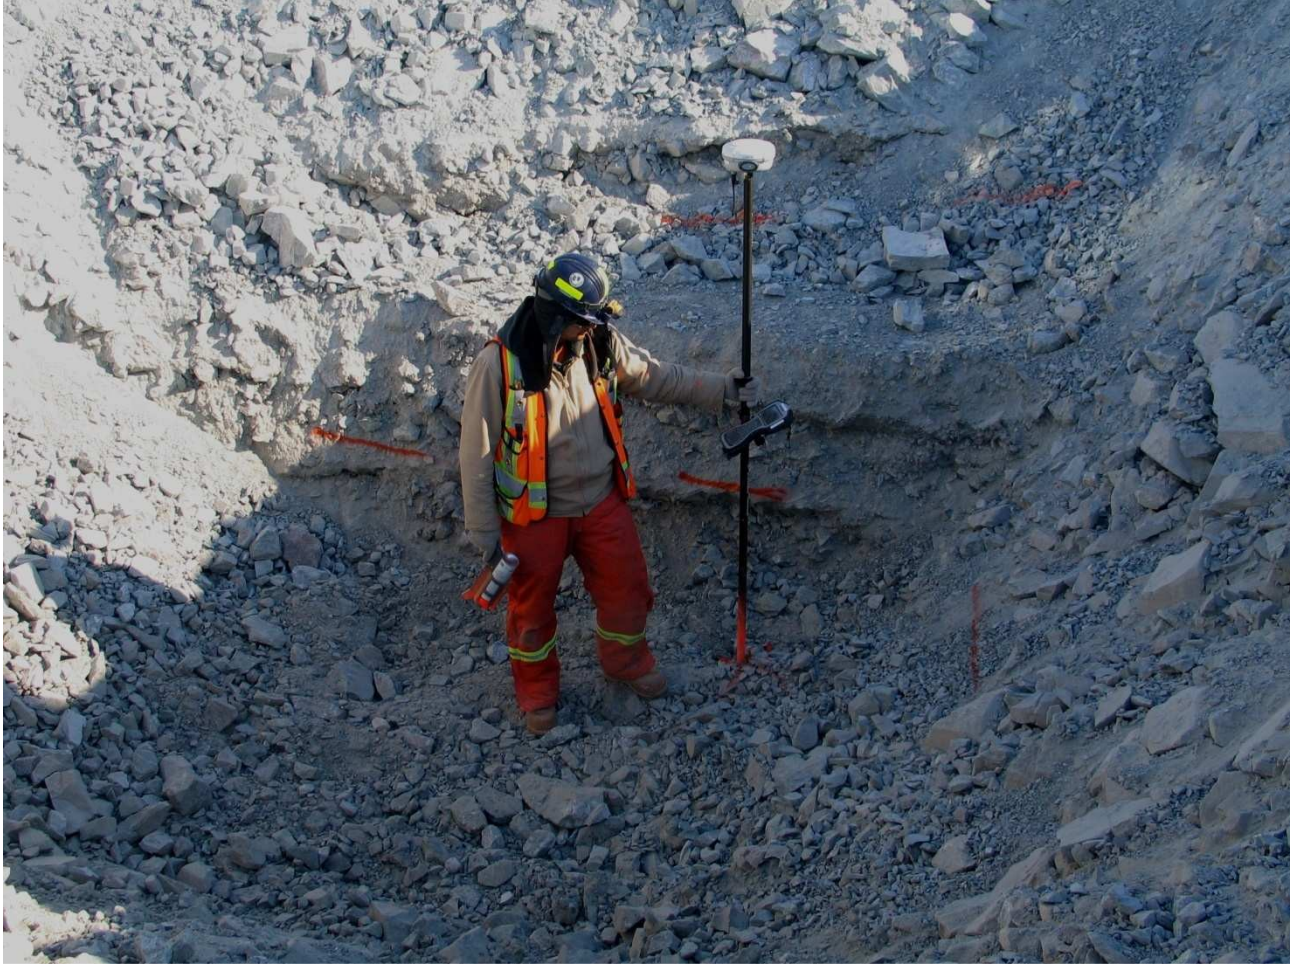
- In discussions with persons who were there at the time it is suspected that excess frozen core was wasted at that location as there was no where to place it at the time.

Photo 5: Excavation at ND-SMP-100-DS. Survey rod is being held at the plate center. The red line waist level of the surveyor is bottom of the plate elevation. The line above the surveyor's head is the location of the edge of the liner. The distance between the edge of the liner and the edge of the frozen core (brown in the picture) is ~ 1 meter. It is suspected that at this approximate location frozen core material was wasted as there was no where to place it. Approx..3 m of the core material was trimmed back to provide adequate width for the hand packer.
