DAILY REPORT #104– DORIS NORTH INFRASTRUCTURE/ NORTH DAM

Prepared by:	Lawrence Borowski	Date:	2012.04.18
Reviewed by:		Project #:	1CH008.058.0320
Role	Company	Personnel – Position	On Site
Client	Hope Bay Mining Limited (HBML)	Angela Holzapfel – ESR Compliance Manager David Vokey – ESR Coordinator Dean Wold - Safety Jill Turk – ESR Coordinator Katsky Venter – ESR Manger Michelle Tanquay – ESR Site Manager Stirling Kelly – HSLP Advisor	No Yes Yes No No Yes No
	JDS	Doug Fielding – Construction Manager Ishan Fechter – Construction Coordinator Jerry Graham – Construction Manager Mark Valeriote – Construction Manager Calvin Goldschmidt – Construction Coordinator	Yes Yes No No No
Engineering Design Consultants	SRK Consulting (Canada) Inc.	Megan Miller – Site Engineer Lawrence Borowski – Site Engineer Iozsef Miskolczi – Site Engineer	No Yes No
Earthworks Contractor	Nuna Logistics	Doug Haverland - Area Superintendent Gary Sodhi – Field Engineer Georges Cornelissen – Survey Manager Jeff Roberts - Surveyor Jim Cardinal – Foreman Jordan Gunter – Foreman (Day Shift) Kyle Kuntz – Project Engineer Margaret Caley – Surveyor Mike MacMaster – Surveyor Mike Price – Field Engineer Rick Peter – Forema

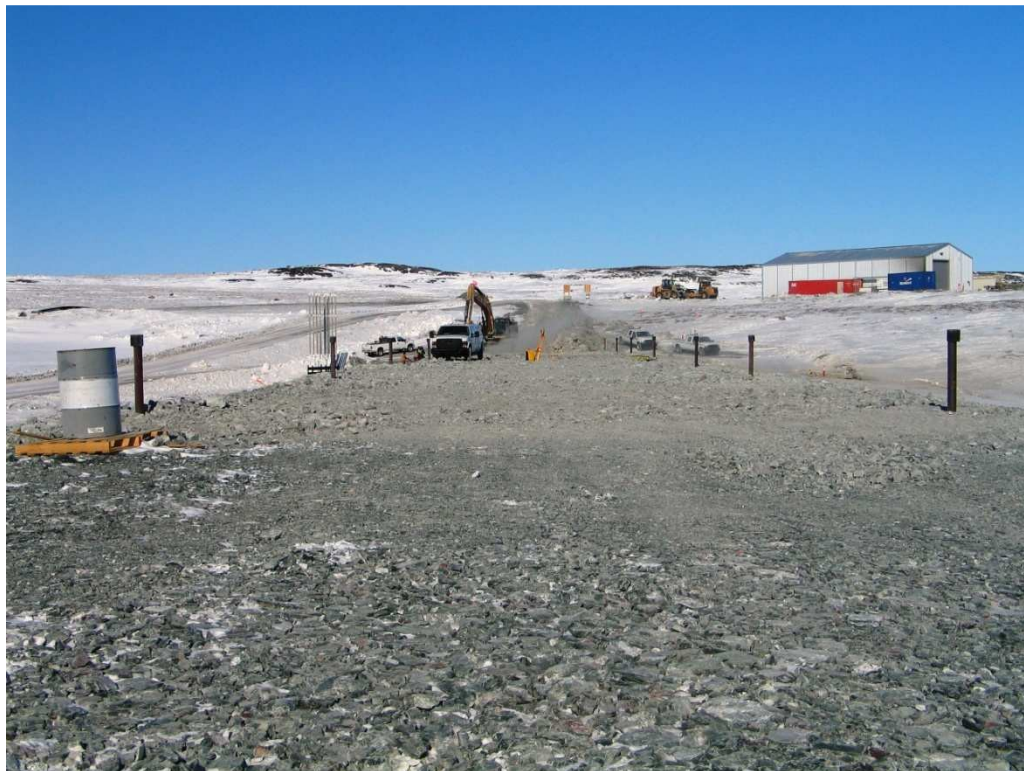
Photo 1: North dam facing north. Excavator is installing the last survey monument.

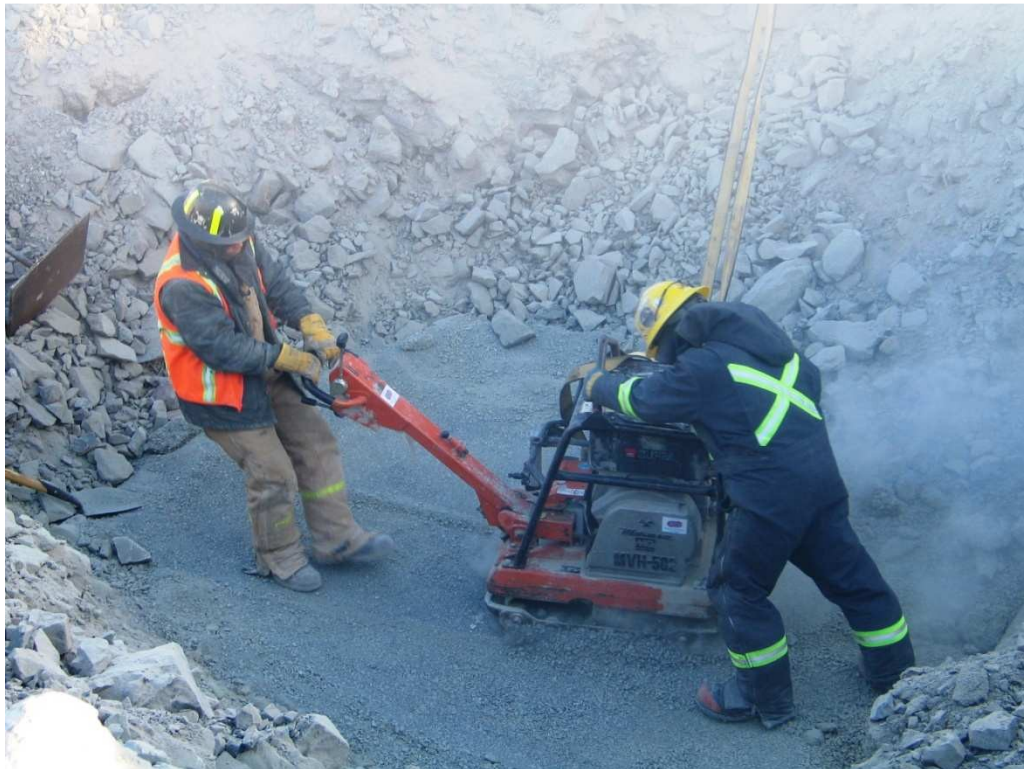
Photo 3: Packing base for monument plate .ND-SMP-120-DS

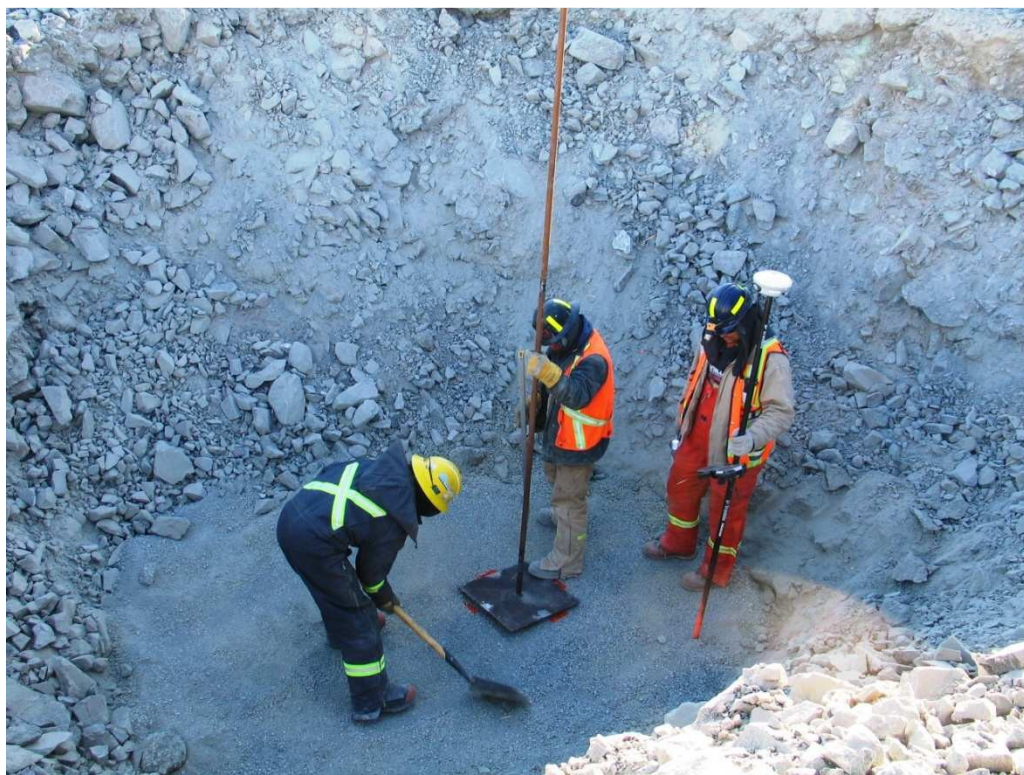
- Location of frozen core was monitored at the excavations. At ND-SMP-120-DS and at ND-SMP-160-DS frozen core was noted ~ 1 meter from the survey monument center point. On all three monuments installed today there was adequate room for the hand packer, thus no frozen core was excavated.
- All thermistors at the north dam were read today in preparation for stringing cables up the slopes tomorrow.
- A cat train was assembled and returned to Cambridge Bay
- A pad was constructed for JDS for their pump.
- JDS spent the day calibrating flow meters.

Photo 4: Setting monument base ND-SMP-120-DS. Frozen core material is barely visible behind the surveyor's right knee.

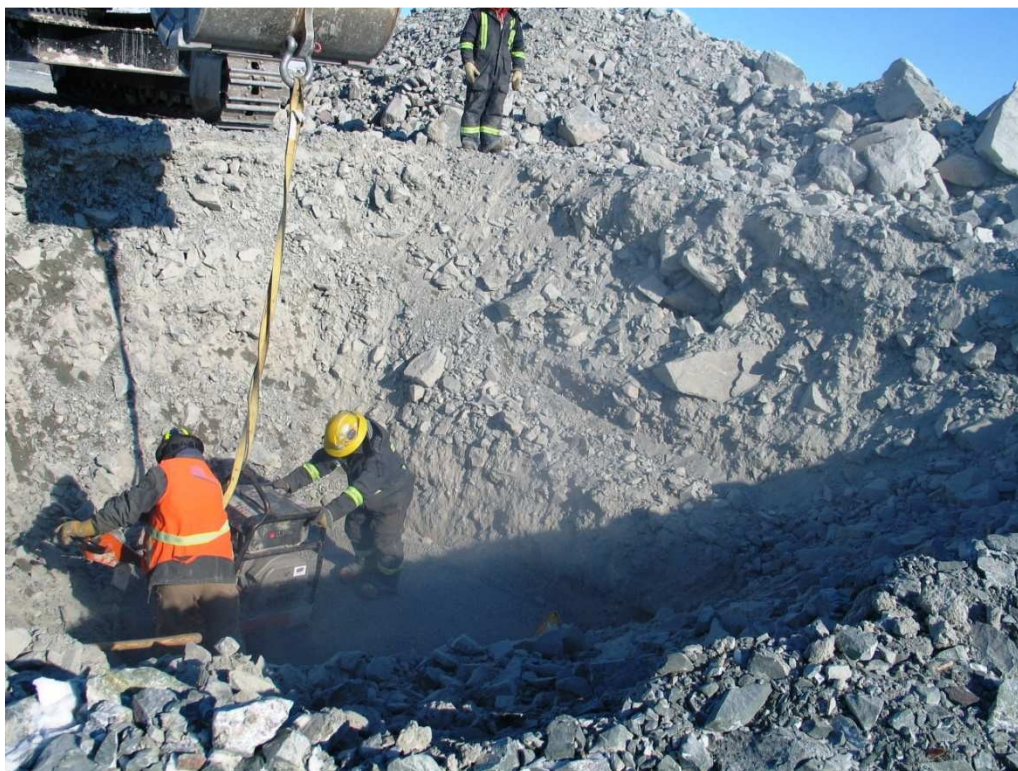
Photo 5: Packing base ND-SMP-160-DS

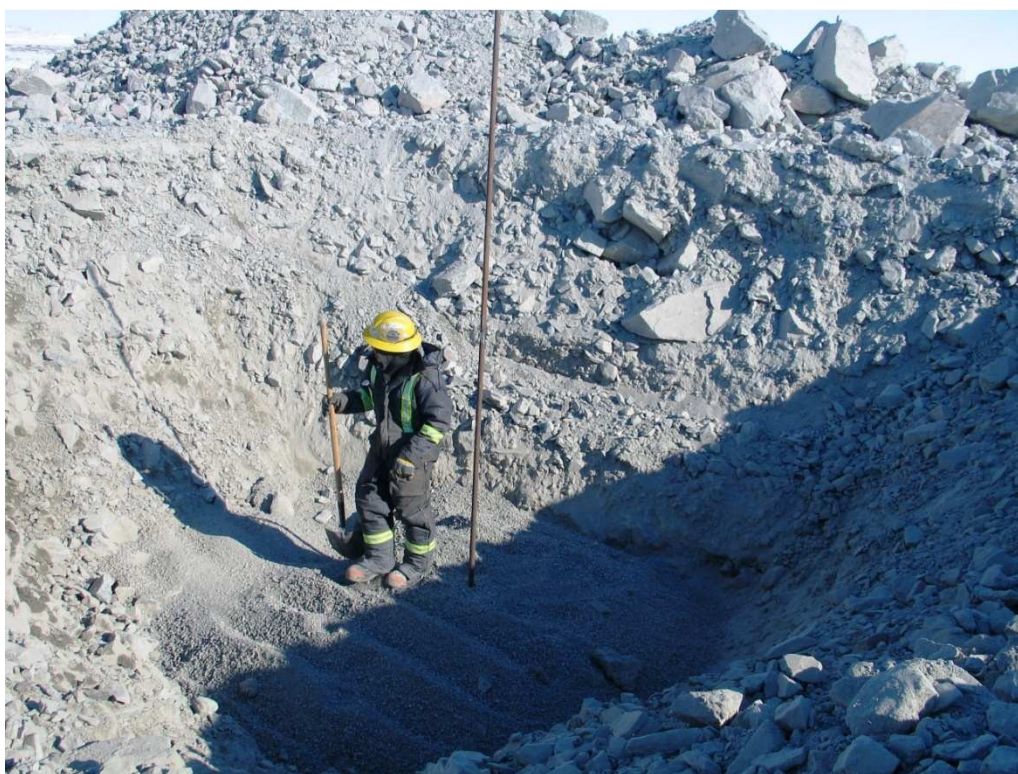
Photo 6: Setting base ND-SMP-160-DS. Frozen core material visible behind worker
