DAILY REPORT #105– DORIS NORTH INFRASTRUCTURE/ NORTH DAM

Prepared by:	Lawrence Borowski	Date:	2012.04.19
Reviewed by:		Project #:	1CH008.058.0320
Role	Company	Personnel – Position	On Site
Client	Hope Bay Mining Limited (HBML)	Angela Holzapfel – ESR Compliance Manager David Vokey – ESR Coordinator Dean Wold - Safety Jill Turk – ESR Coordinator Katsky Venter – ESR Manger Michelle Tanquay – ESR Site Manager Stirling Kelly – HSLP Advisor	In Yes Out No In Out In
	JDS	Doug Fielding – Construction Manager Ishan Fechter – Construction Coordinator Jerry Graham – Construction Manager Mark Valeriote – Construction Manager Calvin Goldschmidt – Construction Coordinator	Yes Out No No In
Engineering Design Consultants	SRK Consulting (Canada) Inc.	Megan Miller – Site Engineer Lawrence Borowski – Site Engineer Iozsef Miskolczi – Site Engineer	No Yes No
Earthworks Contractor	Nuna Logistics	Doug Haverland - Area Superintendent Gary Sodhi – Field Engineer Georges Cornelissen – Survey Manager Jeff Roberts - Surveyor Jim Cardinal – Foreman Jordan Gunter – Foreman (Day Shift) Kyle Kuntz – Project Engineer Margaret Caley – Surveyor Mike MacMaster – Surveyor Mike Price – Field Engineer Rick Peter – Forema

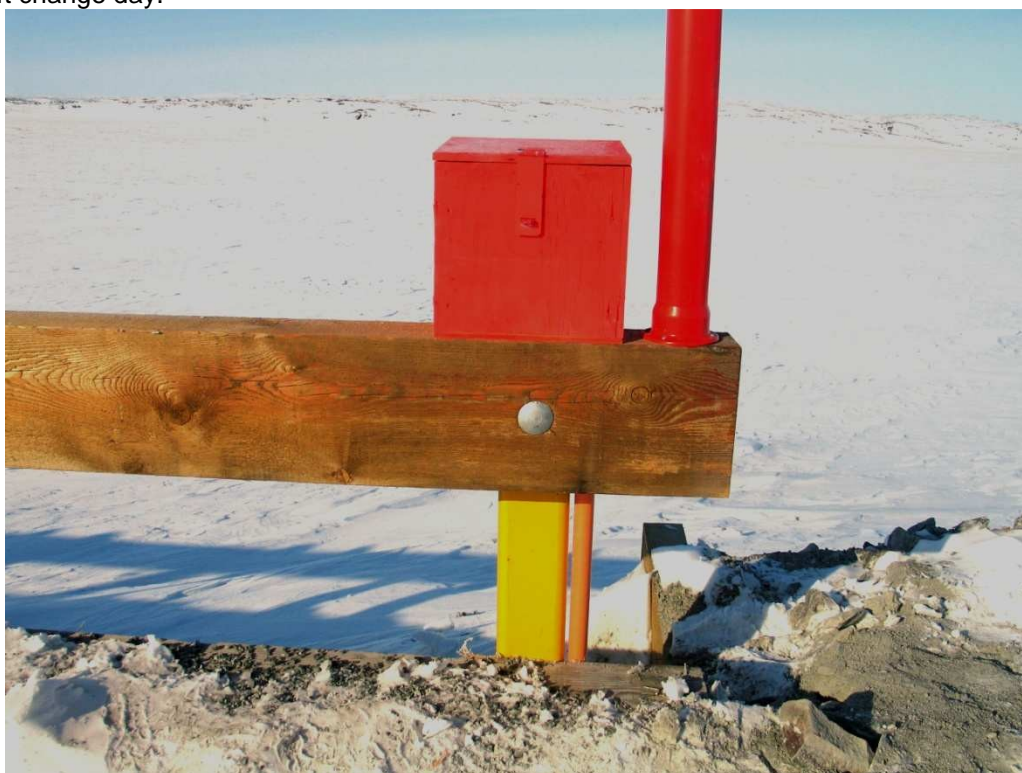
- Termination boxes for thermistors at bridges 2,3 and 4 have been installed.
- Still a question of whether or not Batt needs to return to site for some work at the RBTF.

Photo 2: Thermister termination boxes. Bridge 2 north end. Note part of exposed cable is in a conduit.

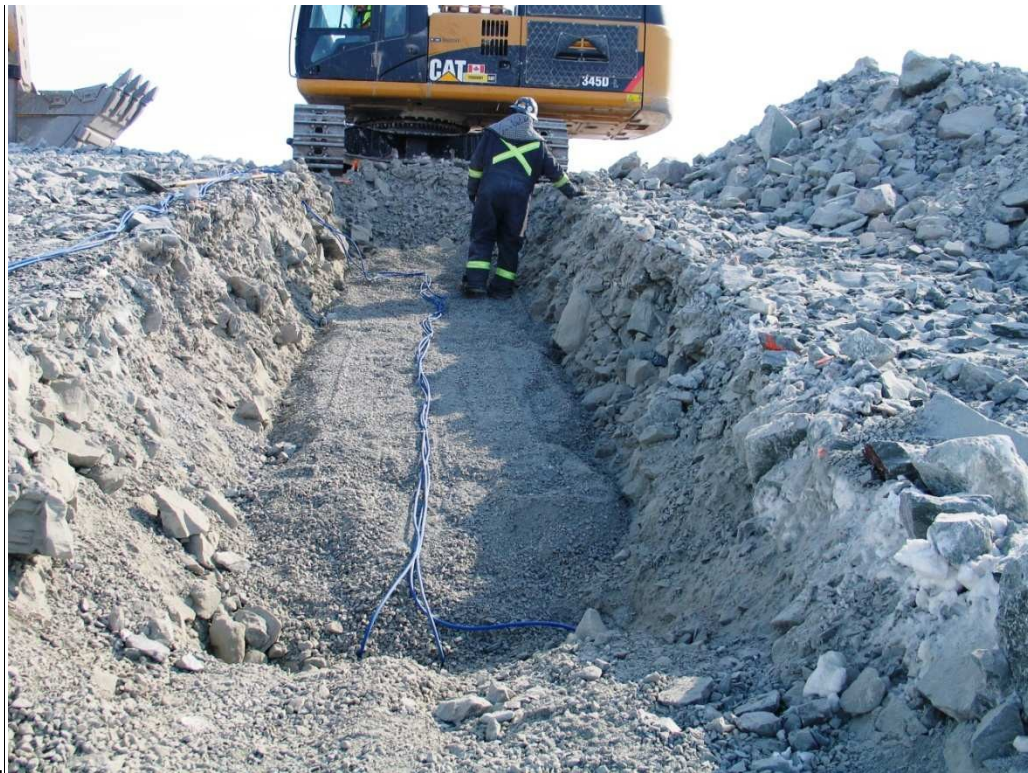
- Started excavating the trench for the cables at Sta 0+40. at noon. At the downstream location where the three cables were exposed crush over cables was hand excavated until the trench was ~ .6m. In so doing, the need for buttresses was eliminated.

- Trench was excavated to >1 meter depth. Width is a bucket width (1.2 m). Survey checked excavations and marked .3 m levels in the trench.
- Cables were bundled and tied together with ties.

Photo 3: Sta 0+40 cable cluster

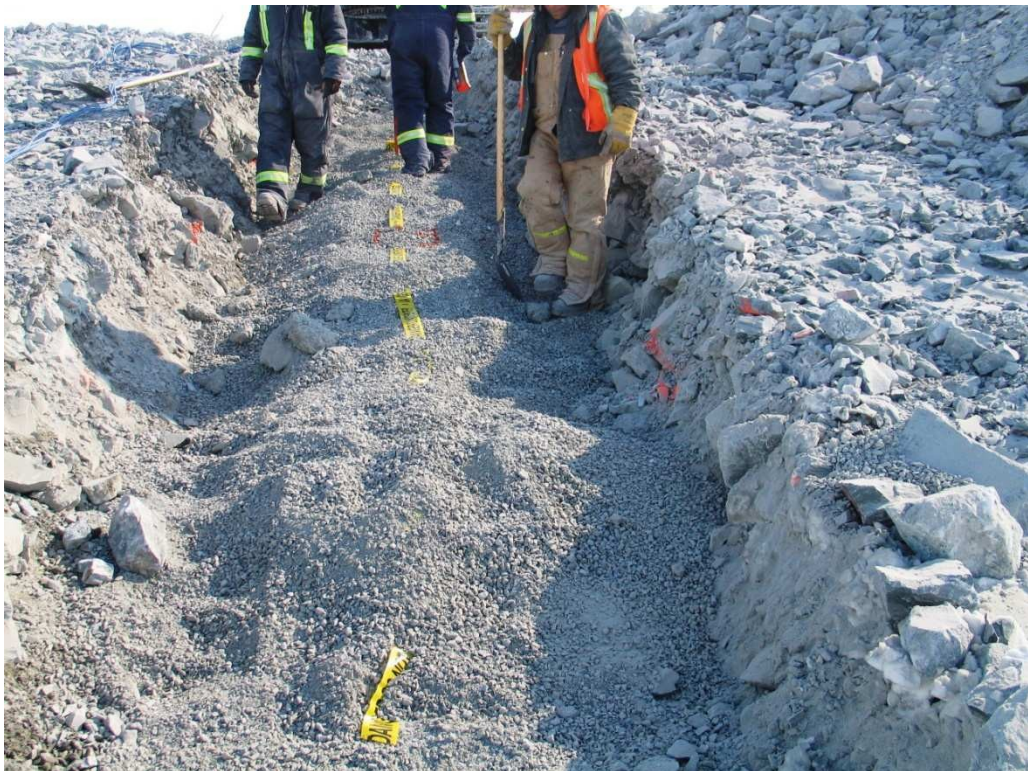
- Levelling the crush layer under the cables and over the cables was done by hand.
- A warning tape was placed over the second layer of tape.
- The trench was then backfilled.

Photo 4: Warning tape placed over final lift crush

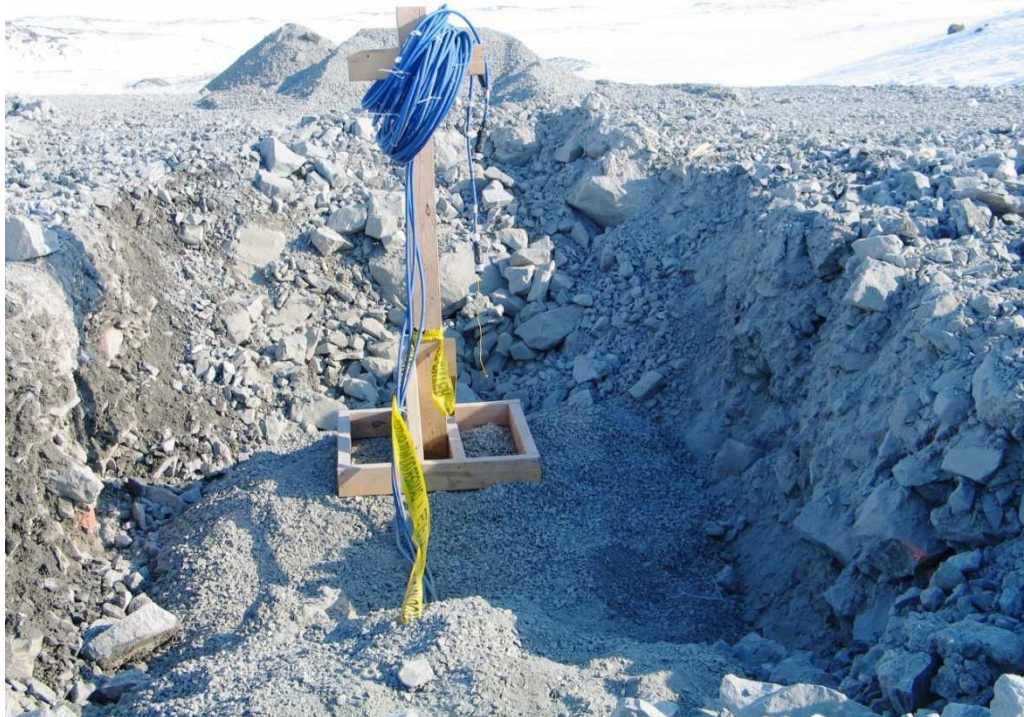
- At the termination point, crush has been placed to the elevation of the bottom of the plate. The excavation was left open and surplus cable was coiled up.

Photo 5: Termination of cables at Sta 0+40

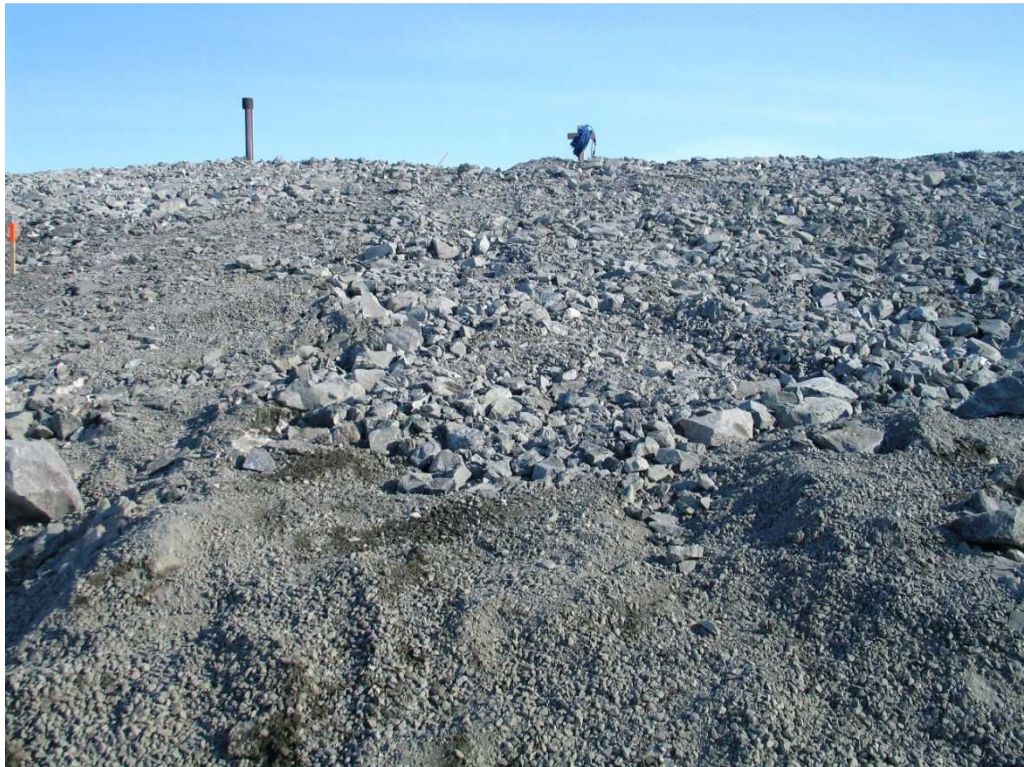
- Work at Sta 0+40 was complete by 3:00 pm except for compaction on the ROQ.
- Work at Sta 0+60 started with having survey check that the location of the cable was in fact where it came out of the ground. Accordingly, excavation did not start until 4:00 pm. The cable was hand excavated down to ~.6 m where it was discovered that for inexplicable reasons there was a loop in the cable. Fortunately, the cable was not cut, and was checked with the RST meter.

Photo 6: Finished product Sta 0+40. Still to be compacted with 10 ton packer

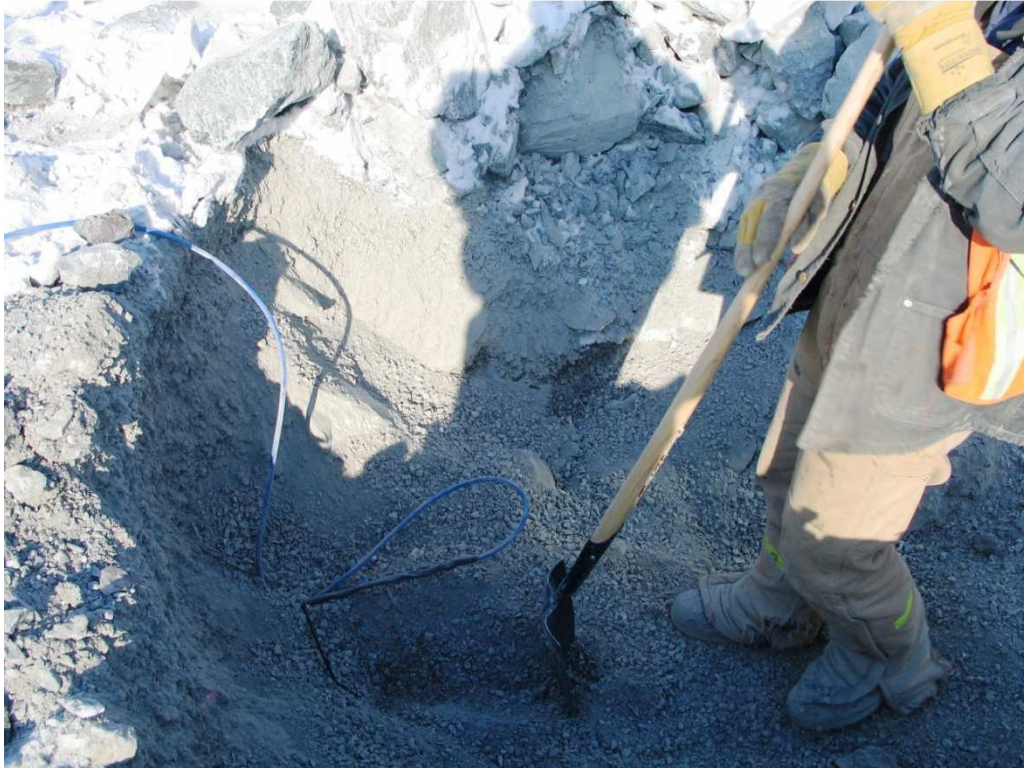
Photo 7: Sta 0+60 Coil in cable ~ 2 feet down.

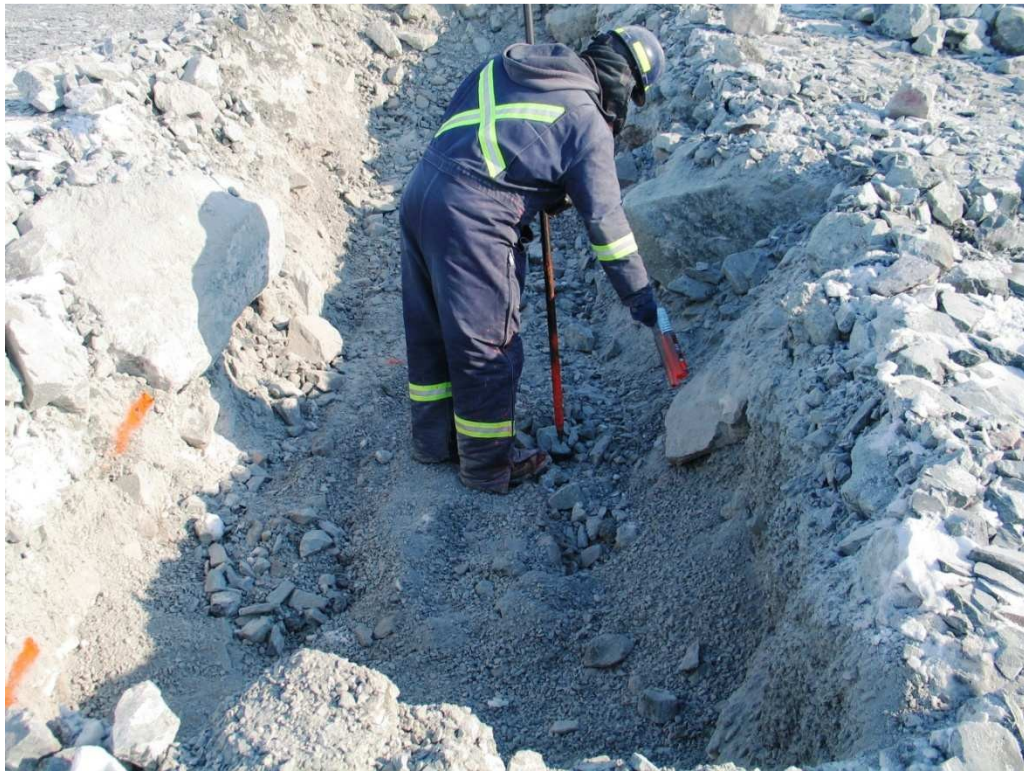
Photo 8: Surveyor marking crush fill levels.

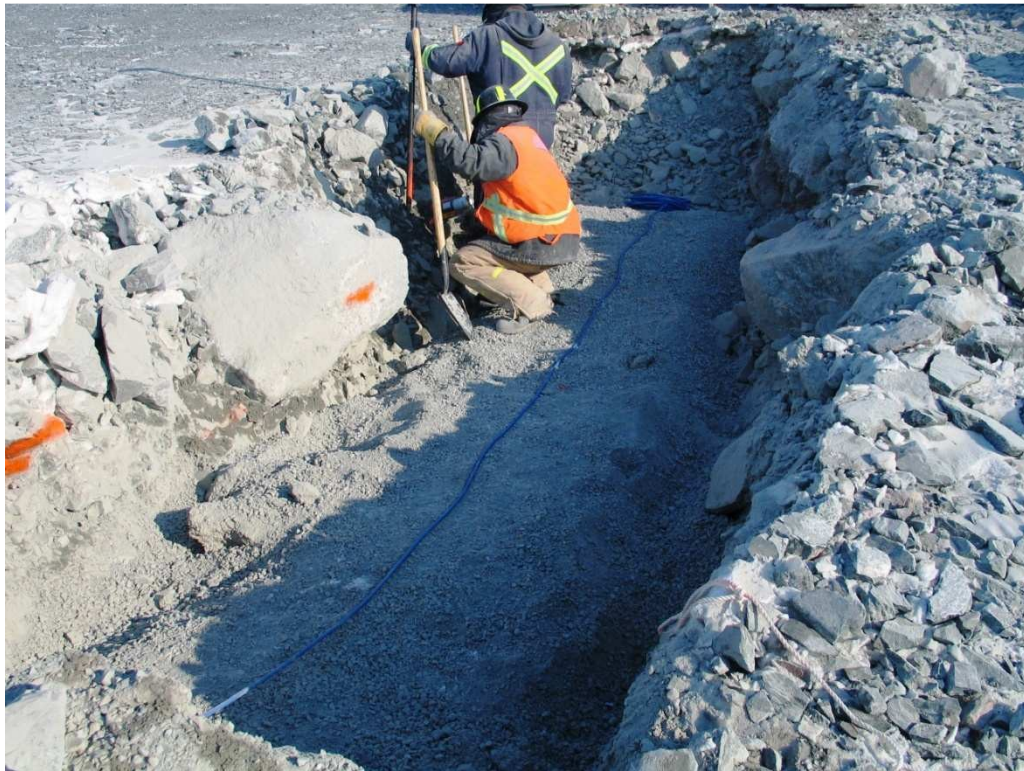
Photo 9: Sta 0+60 Single cable.

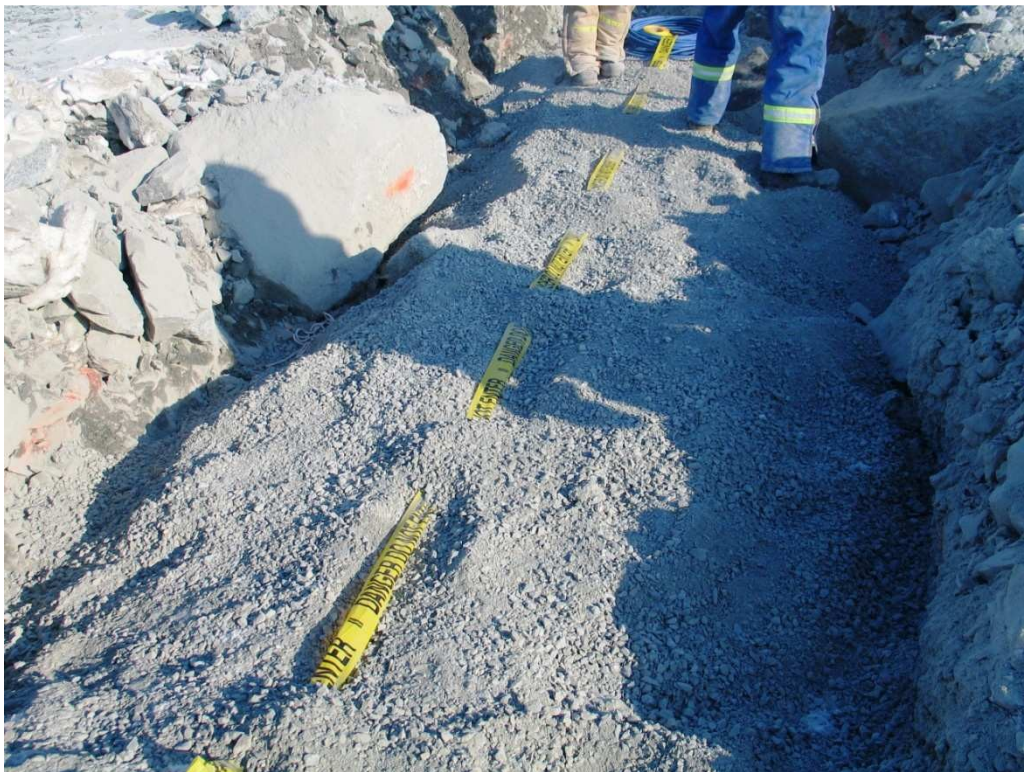
- The same procedure was followed as at Sta 0+40. By end of shift about 1/3 of the length was excavated and crush placed.
- Getting by the next set of cables protruding may be an issue. Nuna has decided that the best way would be to have the excavator straddle the cables up the slope. Tomorrow's issue.

Photo 10: Sta 0+60.Tape over crush
