## DAILY REPORT #10 – DORIS NORTH INFRASTRUCTURE/ NORTH DAM

Prepared by:	John Kurylo	Date:	2012.01.15
Reviewed by:		Project #:	1CH008.058.0320
Role	Company	Personnel – Position	On Site
Client	Hope Bay Mining Limited (HBML)	Angela Holzapfel – ESR Compliance Manager David Vokey – ESR Coordinator Don Ethelston – HSLP Advisor Dean Wold - Safety Jill Turk – ESR Coordinator Katsky Venter – ESR Manger Michelle Tanquay – ESR Site Manager Stirling Kelly – HSLP Advisor	No Yes No No No No Yes Yes
	JDS	Lloyd Jackson – Mechanical Superintendent Sven Archimowtiz – Electrical Superintendent Doug Fielding – Construction Manager Ishan Fechter – Construction Coordinator Jerry Graham – Construction Manager Kevin Whieldon – Project Coordinator Mark Valeriote – Construction Manager	Yes Yes No Yes Yes No No
Engineering Design Consultants	SRK Consulting (Canada) Inc.	John Kurylo – Site Engineer Megan Miller – Site Engineer Lawrence Borowski – Site Engineer Murry McGregor – Site Engineer Lowell Wade – Senior Engineer	Yes No No No No

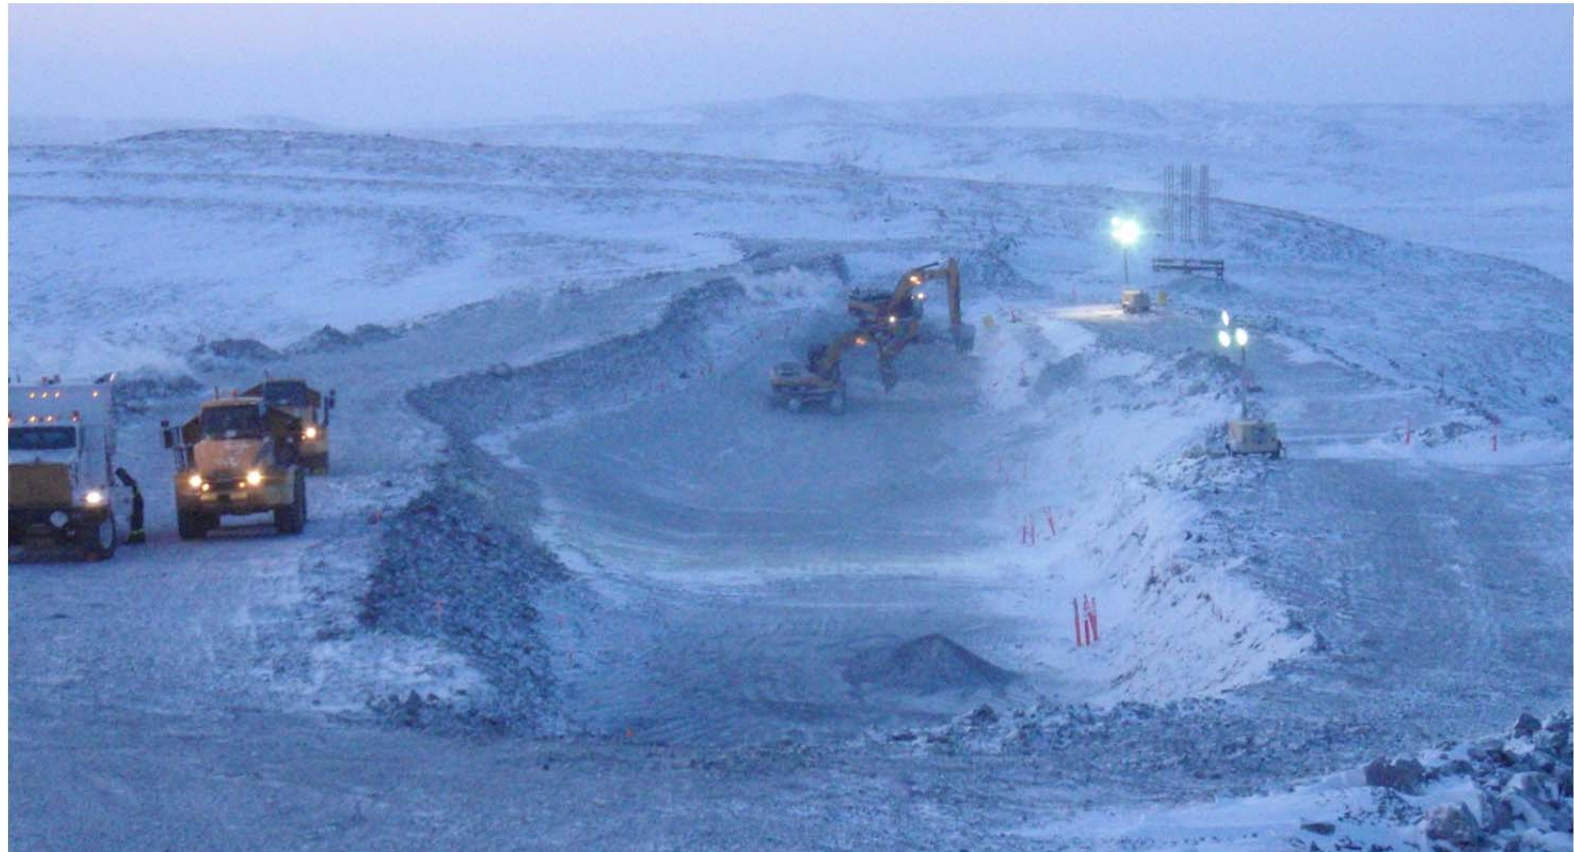
**Photo 1:** ~WSW view down key trench centerline. Note excavators in background removing/ scraping down 5/8" material.

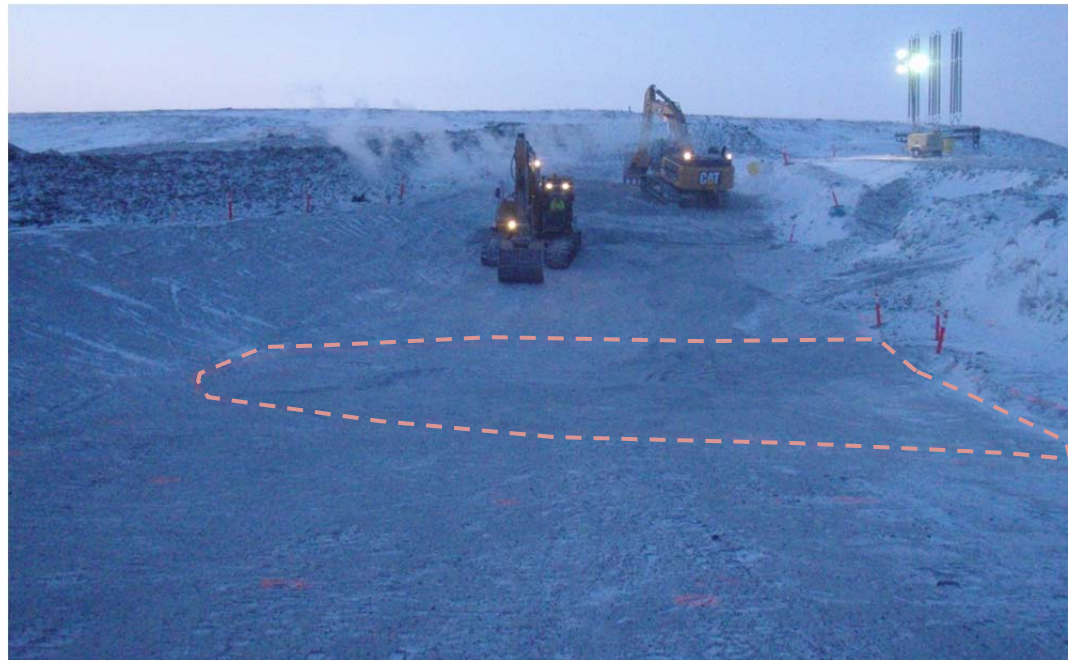
**Photo 3:** ~W view of cleaning activities around the central key trench area (i.e. WSW of station 0+85). Note that the area where placement occurred today is outlined by the light red dashed line.

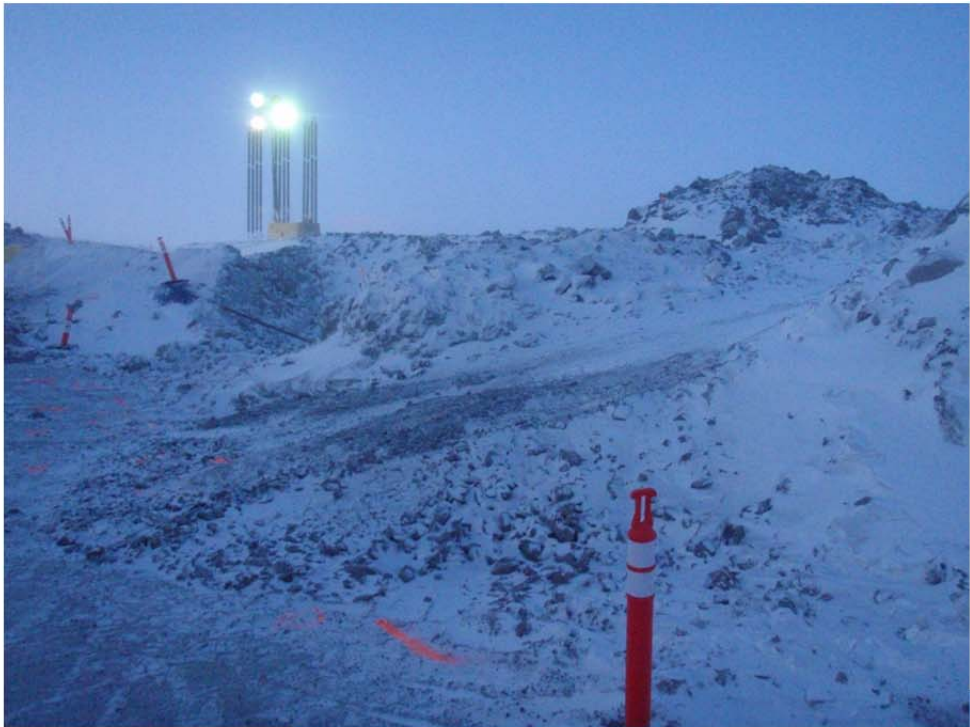
**Photo 2:** View of central access ramp into the North Dam key trench. Note that the base of the ramp will be required to be pulled back at a later date as it is within the core footprint. The base of the access ramp is construction with transition material (compaction is required on this ramp).

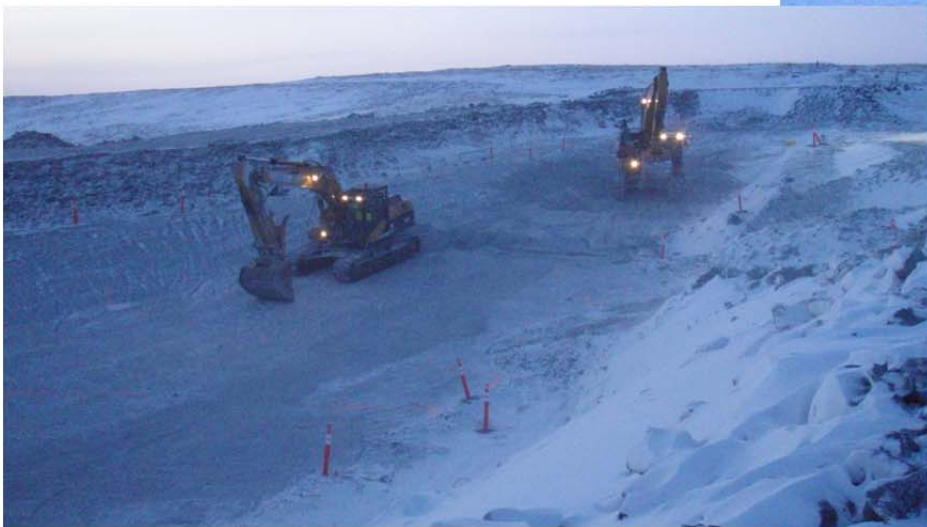
**Photo 4:** ~SW view of excavators scratching frozen 5/8" material from the key trench base. Note that the excavator in the forefront has a finishing bucket while the excavator in the back has a toothed bucket.

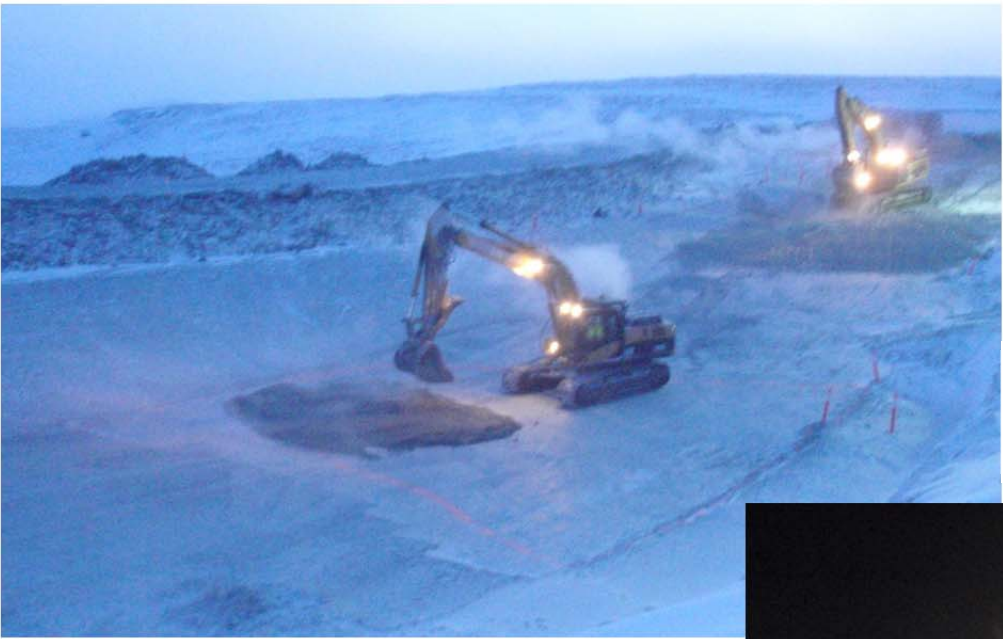
Photo 9 (above/ top center): Excavator spreading the first 2012 load of frozen core in the key trench, ~ SW view.

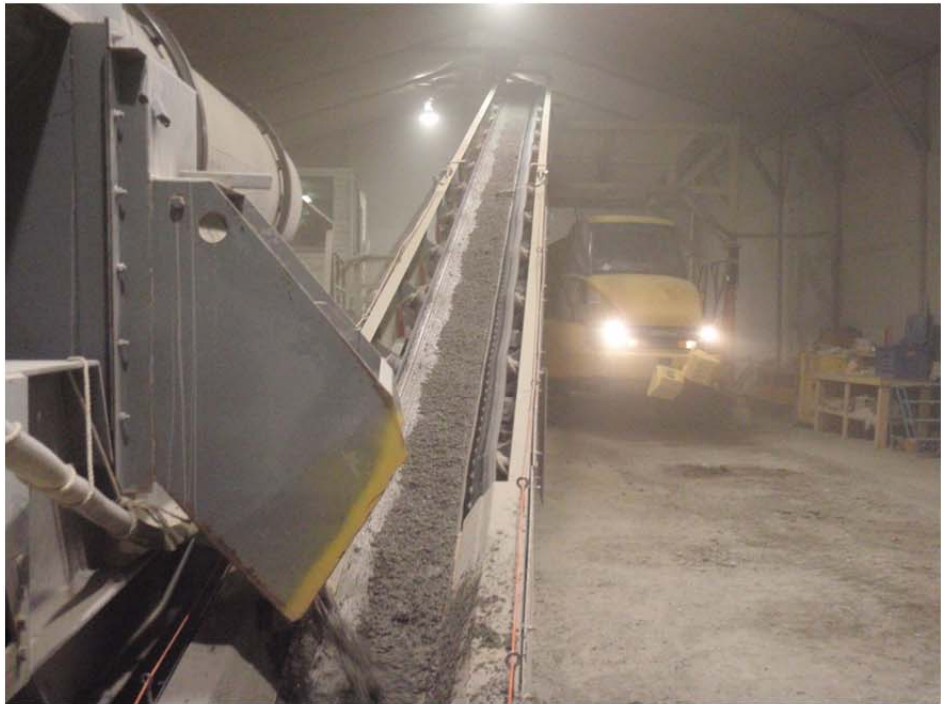
- After the first load of FCM was produced the 'grizzly bars' of the hopper became clogged with frozen clumps of FCM material and V-belt was noted to be having issues. These items were addressed and production resumed.

Photo 12: (above/ center): View after V-belt slipped and hopper became clogged with non saturated frozen core clumps from the frozen stockpile.

- Nuna to investigate methods to reduce the occurrence of frozen clumps being fed into the hopper.

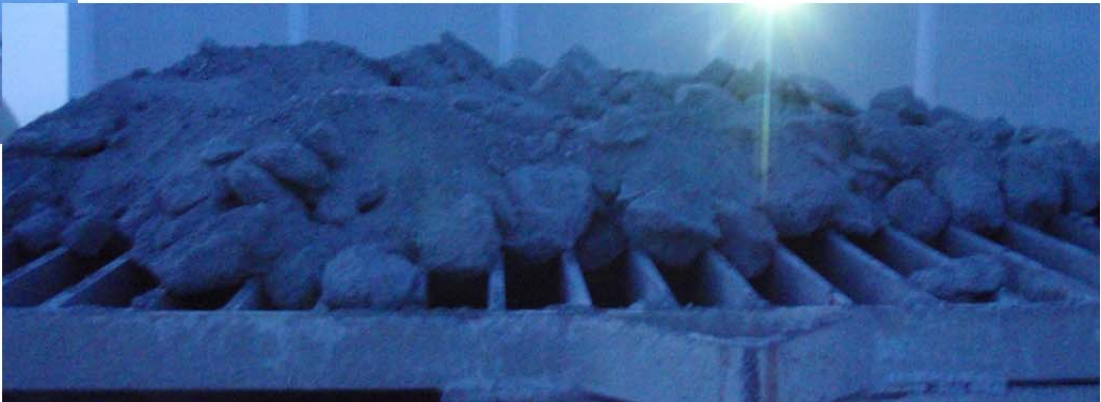
Photo 13 (above/ bottom right): Close up view of hopper after V-belt slipped and became clogged with clumps from the frozen stockpile.

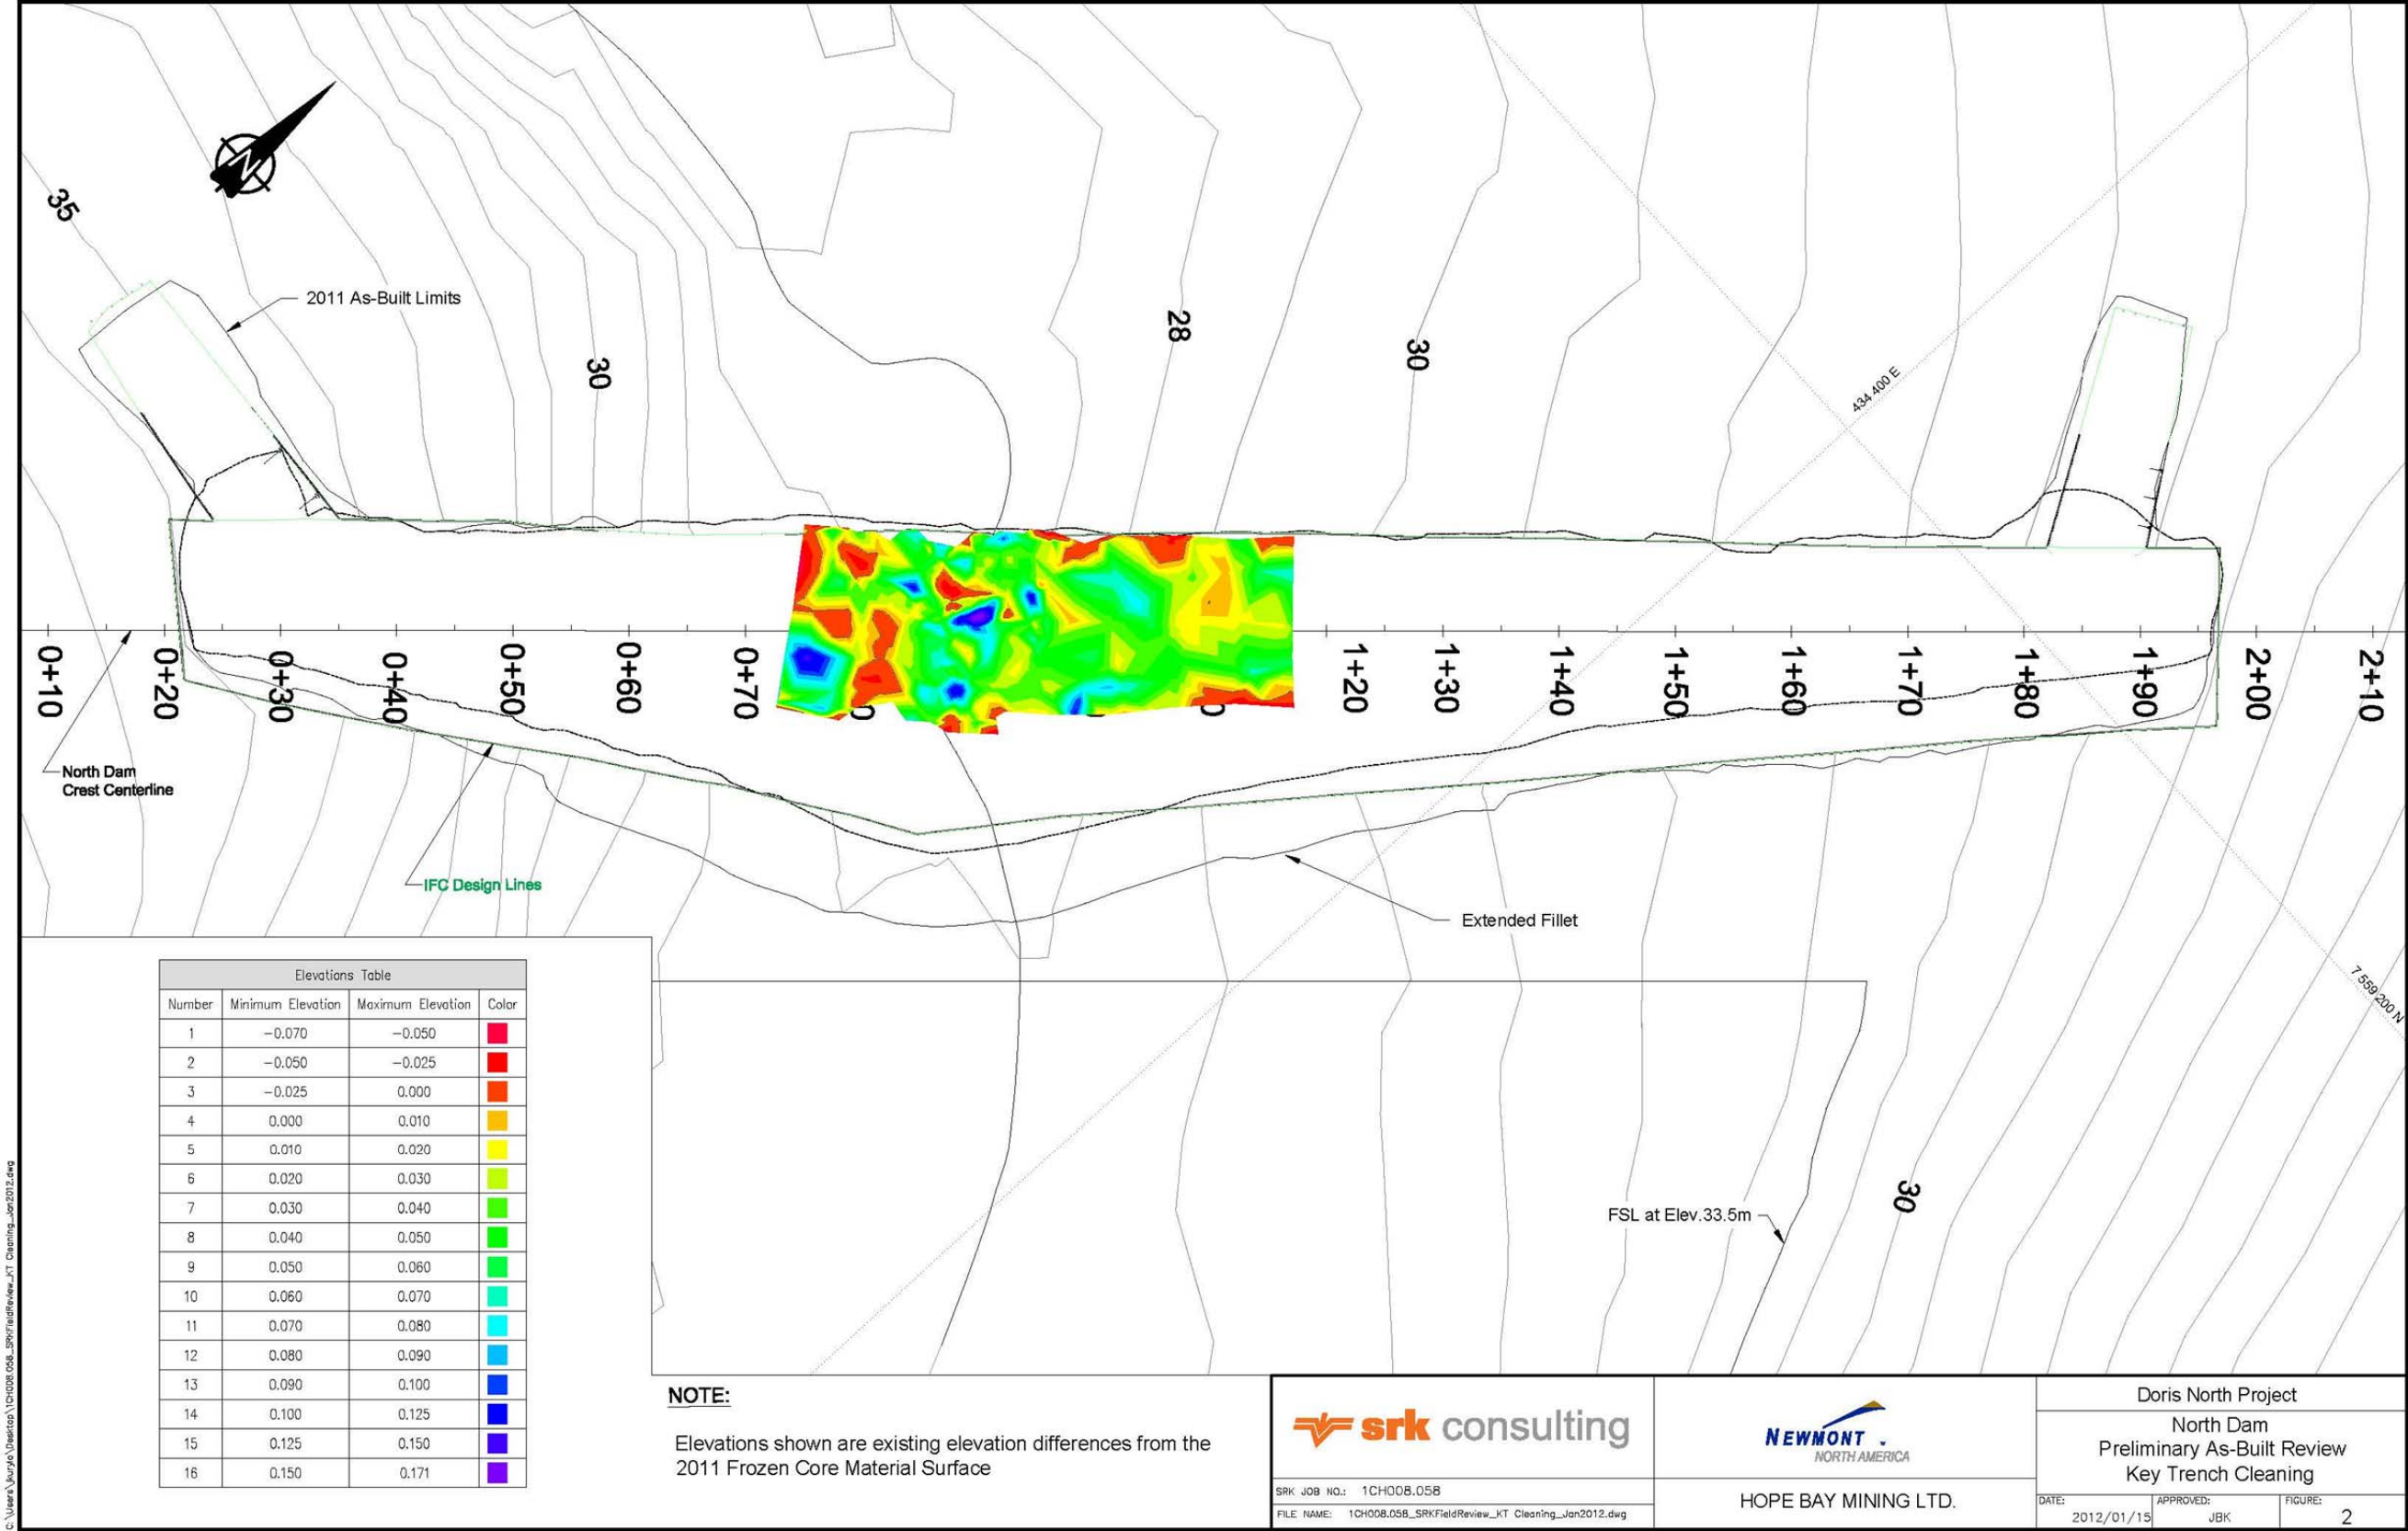
Figure - Nuna As-Built Review of Cover Material Excavation (i.e. Key Trench Cleaning)  
- Note that the isopach points show the elevation difference from the 2011 Frozen Core Elevation data (+ for above grade, - for cut /below)
