## DAILY REPORT #111– DORIS NORTH INFRASTRUCTURE/ NORTH DAM

Prepared by:	Lawrence Borowski	Date:	2012.04.25
Reviewed by:		Project #:	1CH008.058.0320
Role	Company	Personnel – Position	On Site
Client	Hope Bay Mining Limited (HBML)	Angela Holzapfel – ESR Compliance Manager David Vokey – ESR Coordinator Dean Wold - Safety Jill Turk – ESR Coordinator Katsky Venter – ESR Manger Michelle Tanquay – ESR Site Manager Stirling Kelly – HSLP Advisor	Yes Yes No No Yes No Yes
	JDS	Doug Fielding – Construction Manager Ishan Fechter – Construction Coordinator Jerry Graham – Construction Manager Mark Valeriote – Construction Manager Calvin Goldschmidt – Construction Coordinator	Yes No No No Yes
Engineering Design Consultants	SRK Consulting (Canada) Inc.	Lowell Wade-Site Engineer Lawrence Borowski – Site Engineer	No Yes
Earthworks Contractor	Nuna Logistics	Doug Haverland - Area Superintendent Gary Sodhi – Field Engineer Georges Cornelissen – Survey Manager Jeff Roberts - Surveyor Jim Cardinal – Foreman Jordan Gunter – Foreman (Day Shift) Mike MacMaster – Surveyor Mike Price – Field Engineer Rick Peter – Foreman (Night Shift) Trevor Sorken – Superintendent	No No No No Yes Yes Yes Yes No Yes

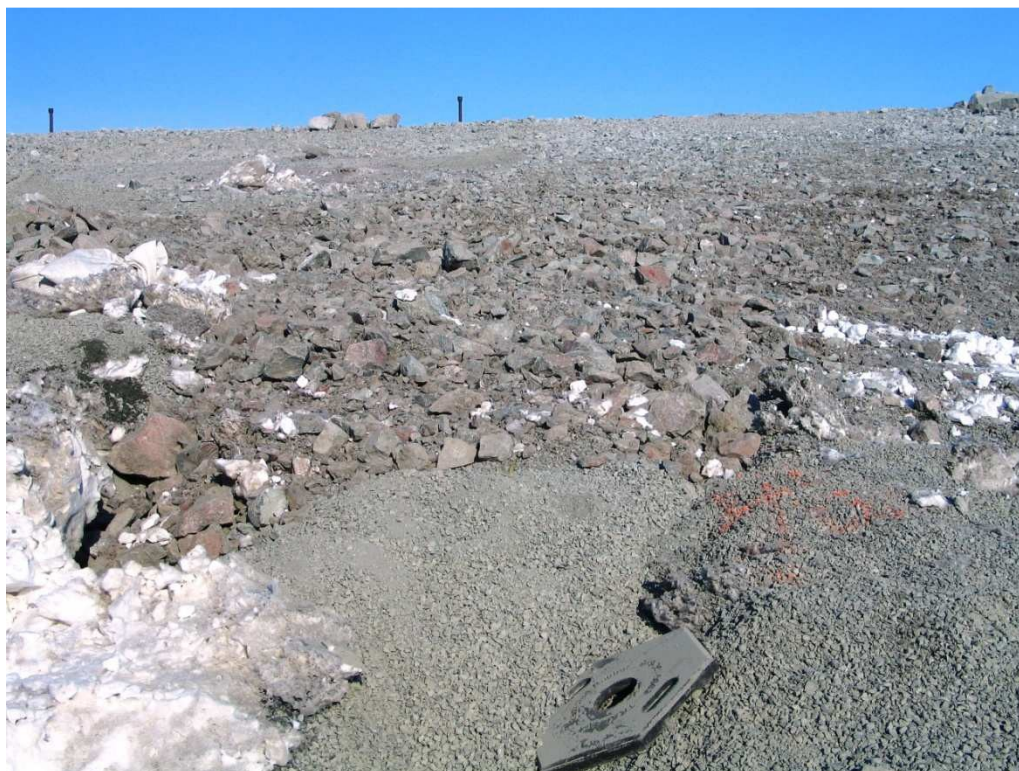
**Photo 1:** Final product Sta 0+85 US

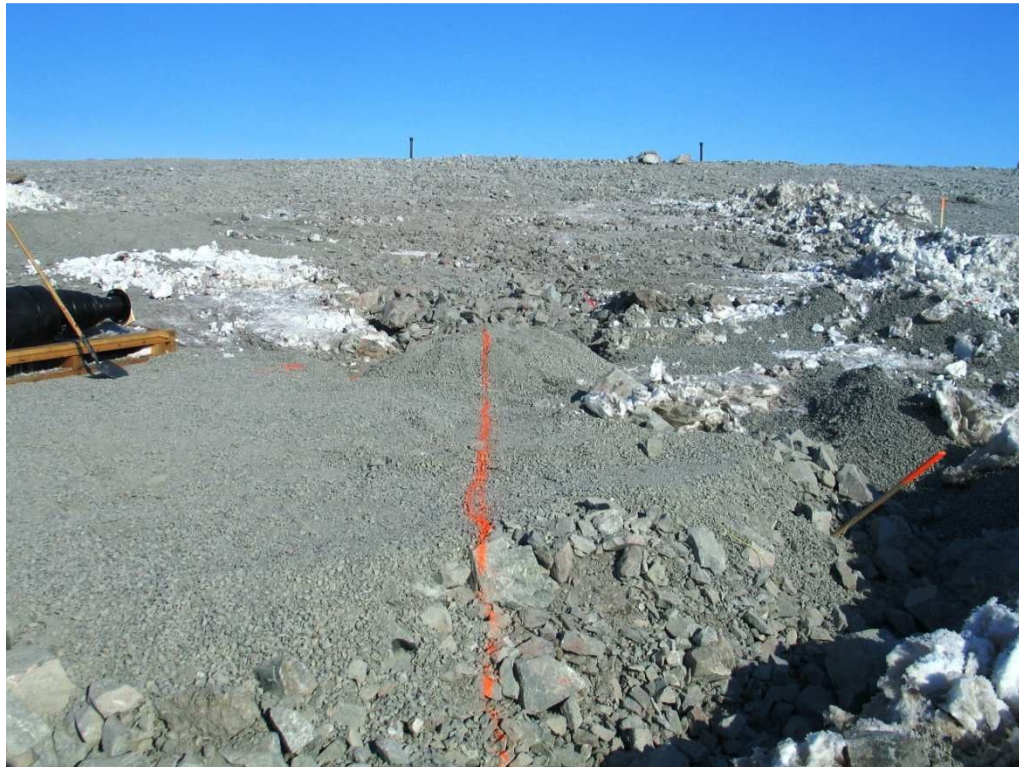
**Photo 2:** Final product Sta 0+60

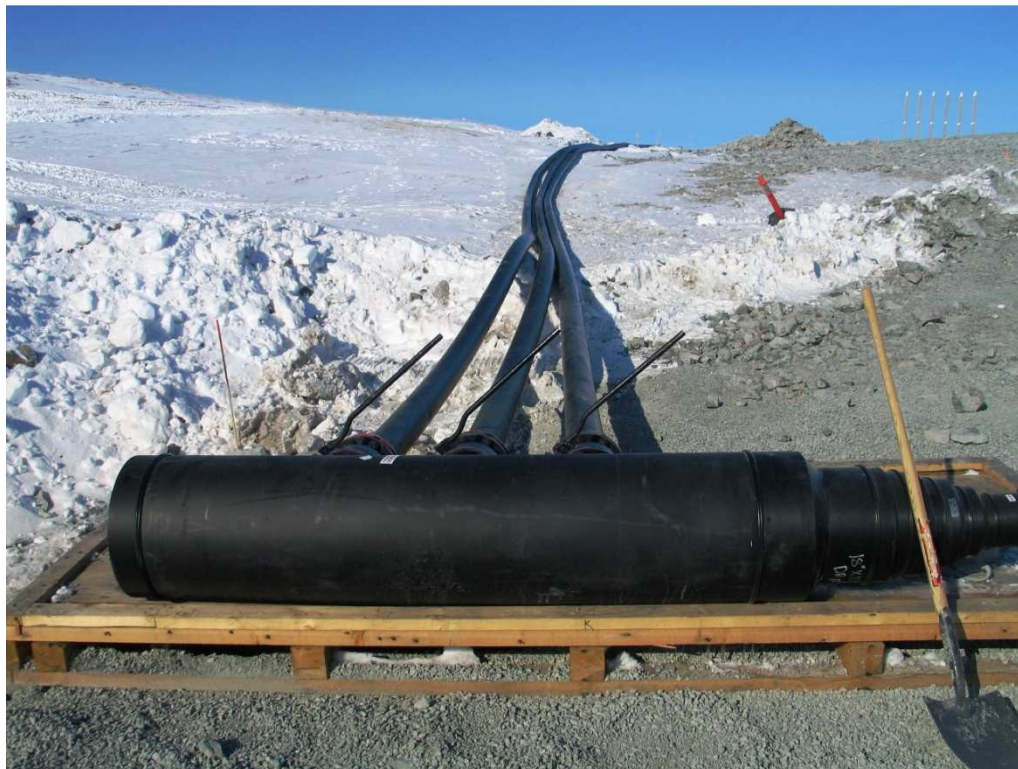
**Photo 3:** Termination of pipes on pad by Sta 0+60 thermister cable.

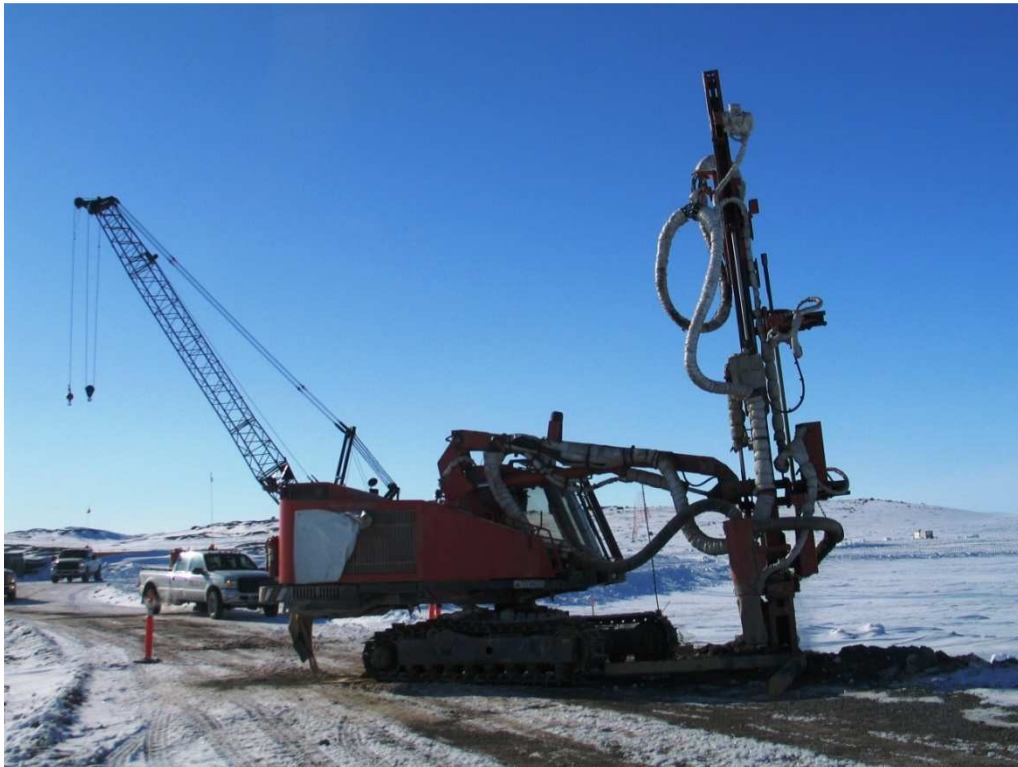
- Thermistor at the jetty installed. This was the second attempt.
- West Arc tooling in preparation for drilling deep holes tomorrow.

**Photo 4:** West Arc drilling thermister at jetty..

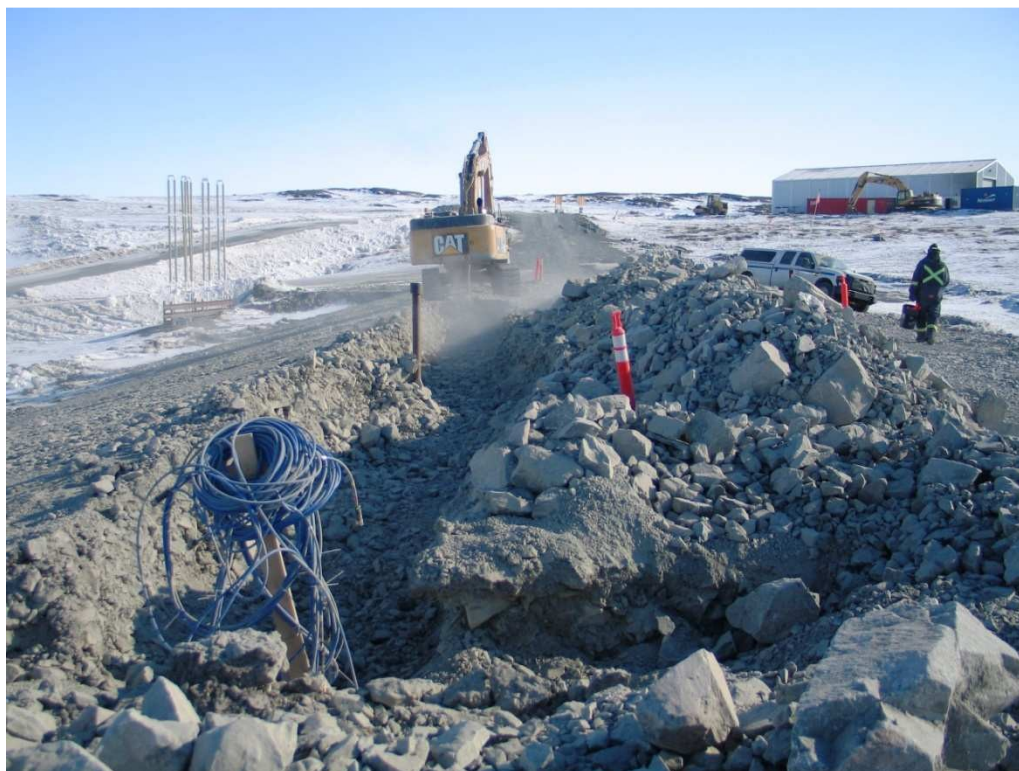
**Photo 5:** Excavation for connector cable, Sta 1+30 to Sta 1+75

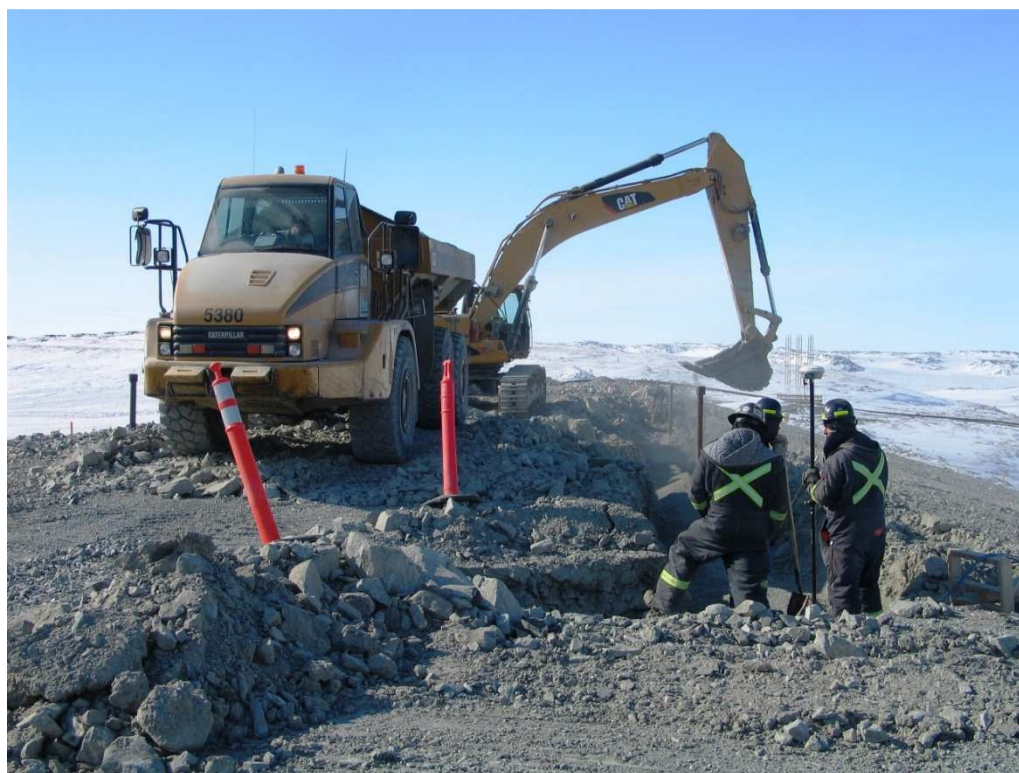
**Photo 6:** Placing crush Sta 1+75 to Sta 1+30

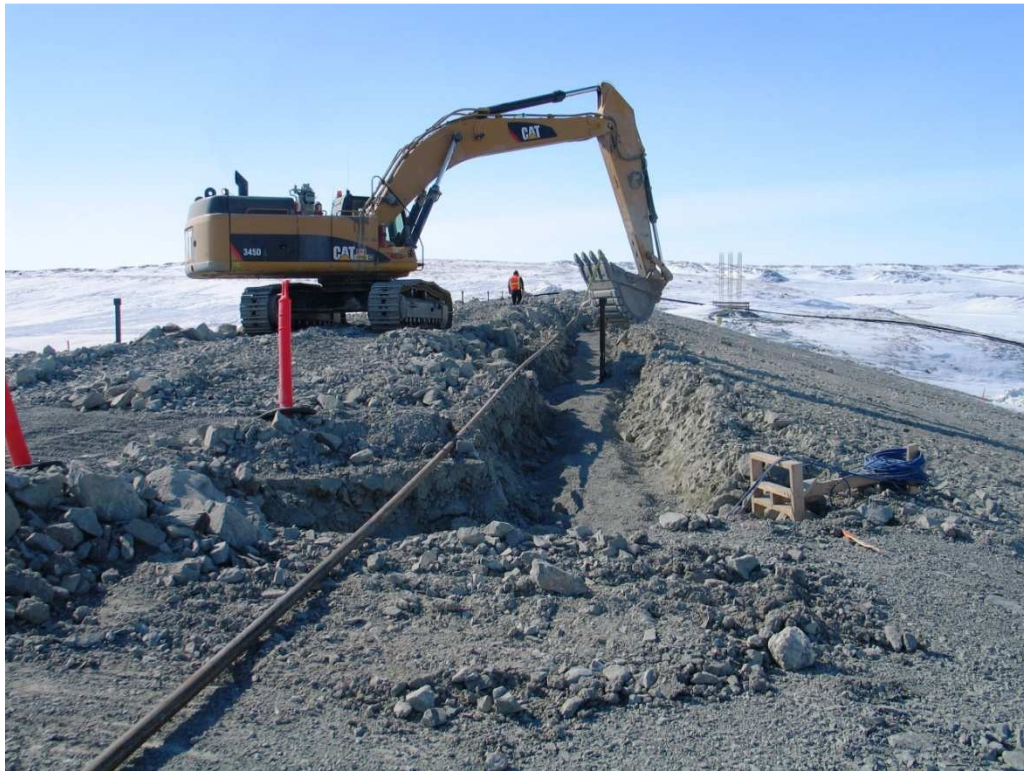
**Photo 7:** Positioning pipe in place .

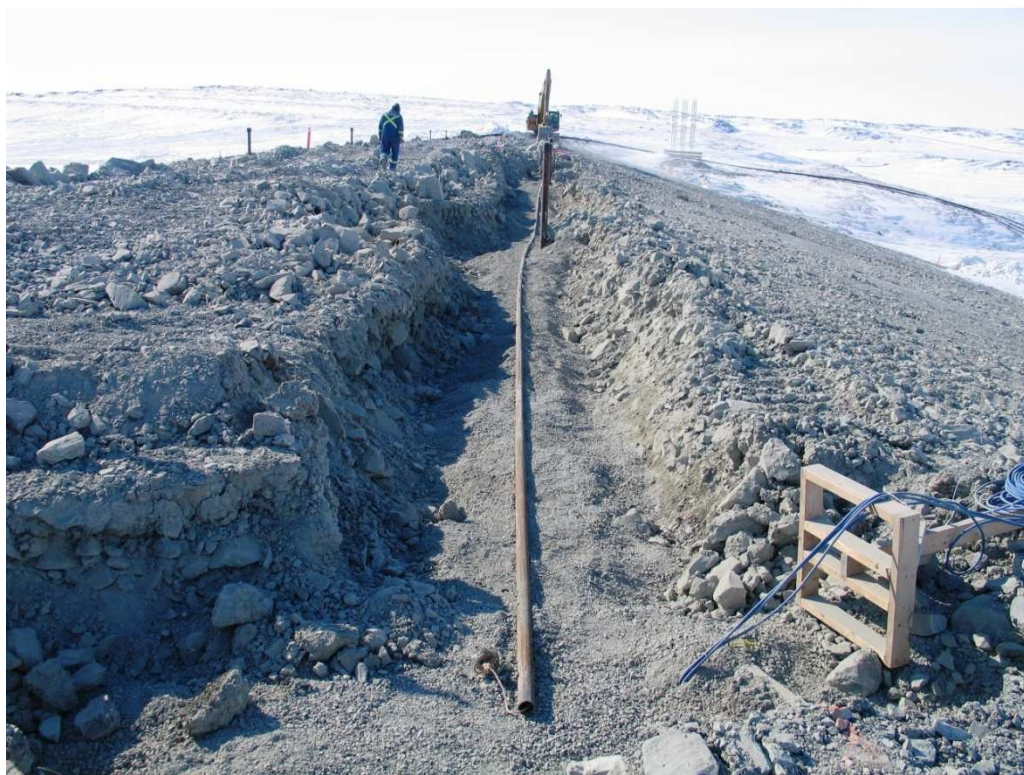
**Photo 8:** Pipe for connector cable in place, Sta 1+75 to Sta 1+30.

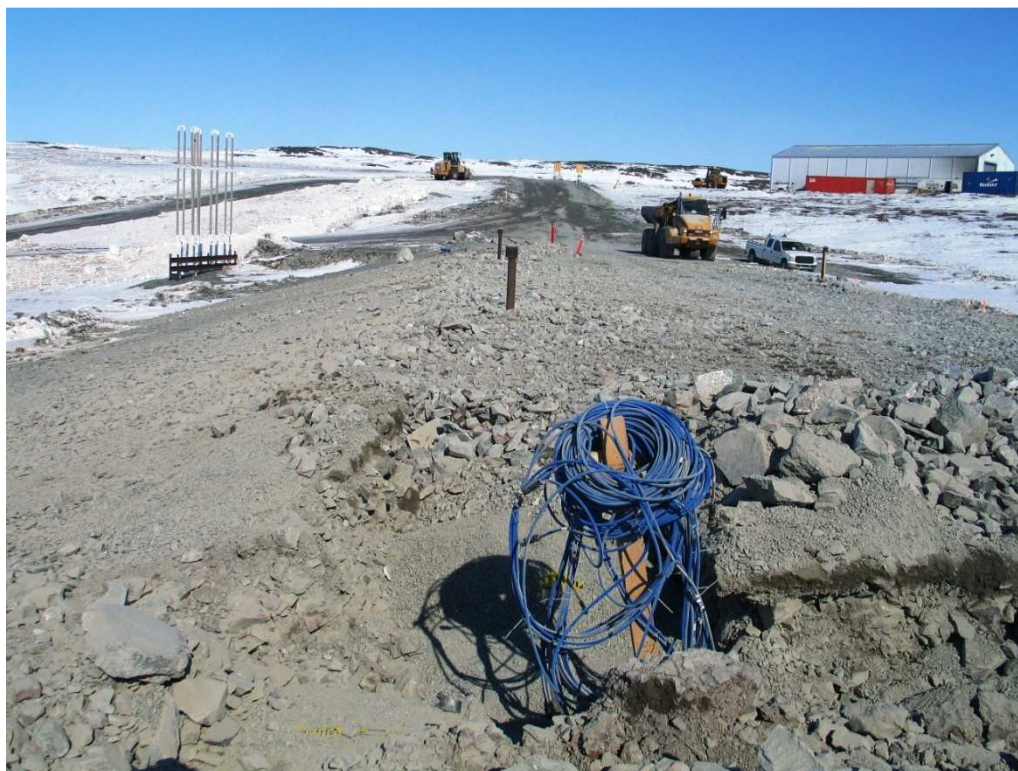
**Photo 9:** Final product Sta 1+30 to Sta 1+75

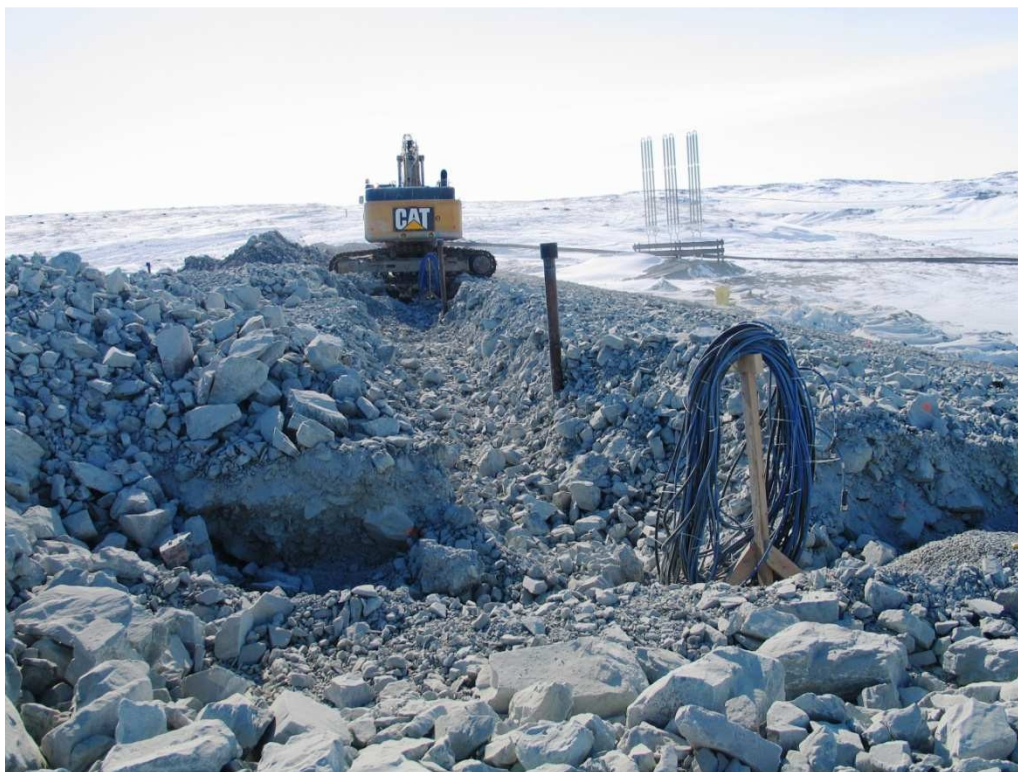
**Photo 10:** Excavation Sta 0+85 to Sta 0+60
