### DAILY REPORT #113 – DORIS NORTH INFRASTRUCTURE/ NORTH DAM

Prepared by:	Lowell Wade	Date:	2012.04.27
Reviewed by:		Project #:	1CH008.058.0320
Role	Company	Personnel – Position	On Site
Client	Hope Bay Mining Limited (HBML)	Angela Holzapfel – ESR Compliance Manager David Vokey – ESR Coordinator Dean Wold - Safety Jill Turk – ESR Coordinator Katsky Venter – ESR Manger Michelle Tanquay – ESR Site Manager Stirling Kelly – HSLP Advisor	No No No Yes Yes No Yes
	JDS	Doug Fielding – Construction Manager Ishan Fechter – Construction Coordinator Jerry Graham – Construction Manager Mark Valeriote – Construction Manager Calvin Goldschmidt – Construction Coordinator	No No Yes No Yes
Engineering Design Consultants	SRK Consulting (Canada) Inc.	Lowell Wade-Site Engineer Lawrence Borowski – Site Engineer	Yes No
Earthworks Contractor	Nuna Logistics	Doug Haverland - Area Superintendent Gary Sodhi – Field Engineer Georges Cornelissen – Survey Manager Jeff Roberts - Surveyor Jim Cardinal – Foreman Jordan Gunter – Foreman (Day Shift) Mike MacMaster – Surveyor Mike Price – Field Engineer Rick Peter – Foreman (Night Shift) Trevor Sorken – Superintendent	No No Yes No Yes No No Yes Yes Yes

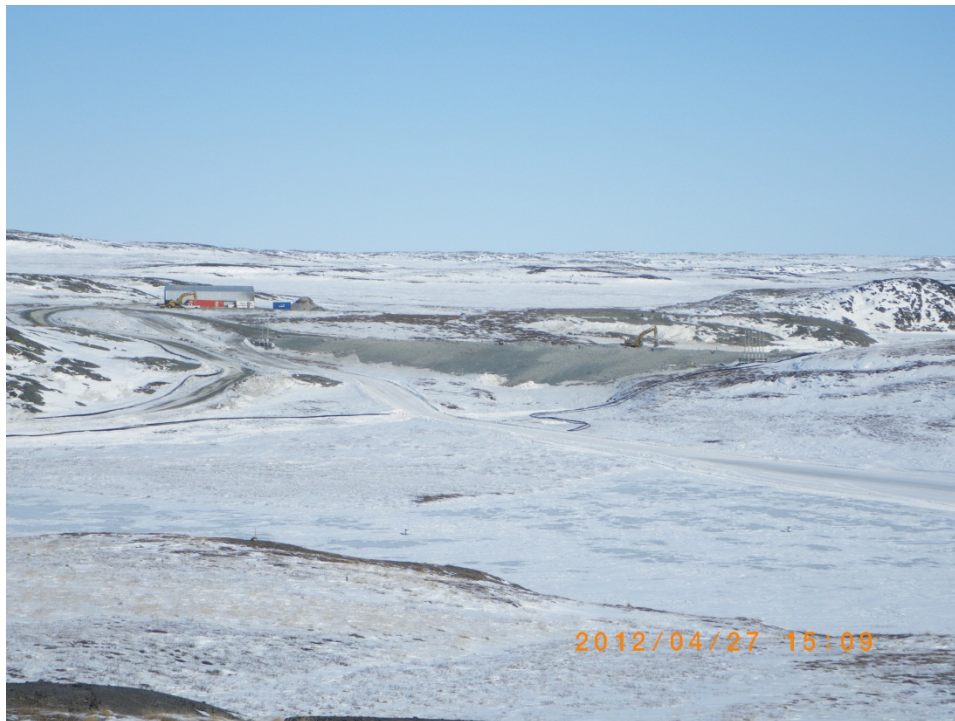
**Photo 1:** The downstream face of the North Dam. Looking east from the Primary Vent Raise.

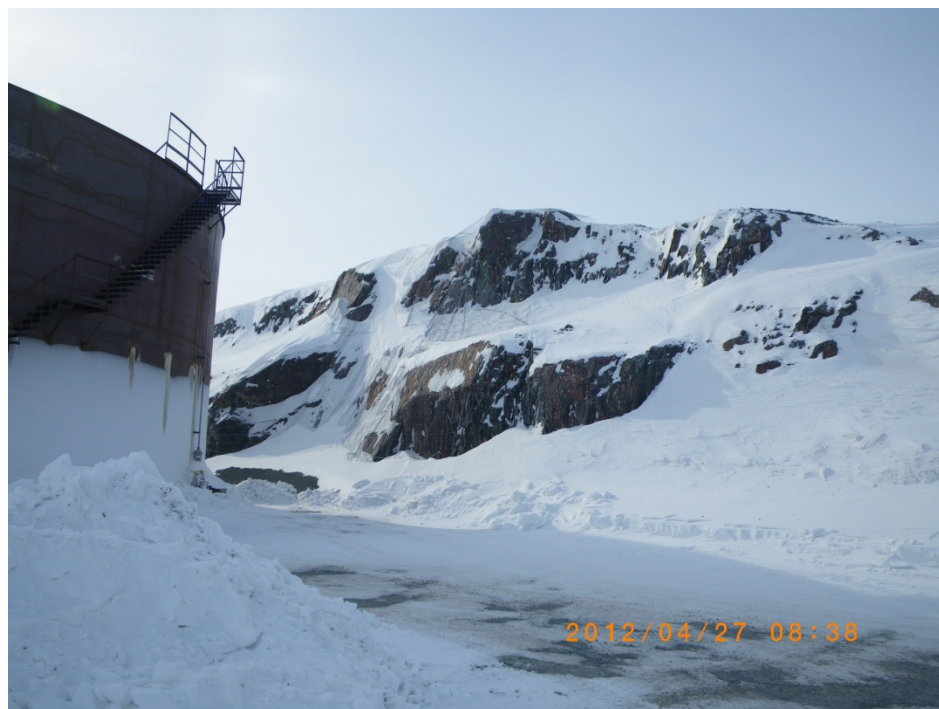
**Photo 2:** The Roberts Bay Fuel Tank Farm highwall. Still mostly covered in snow.

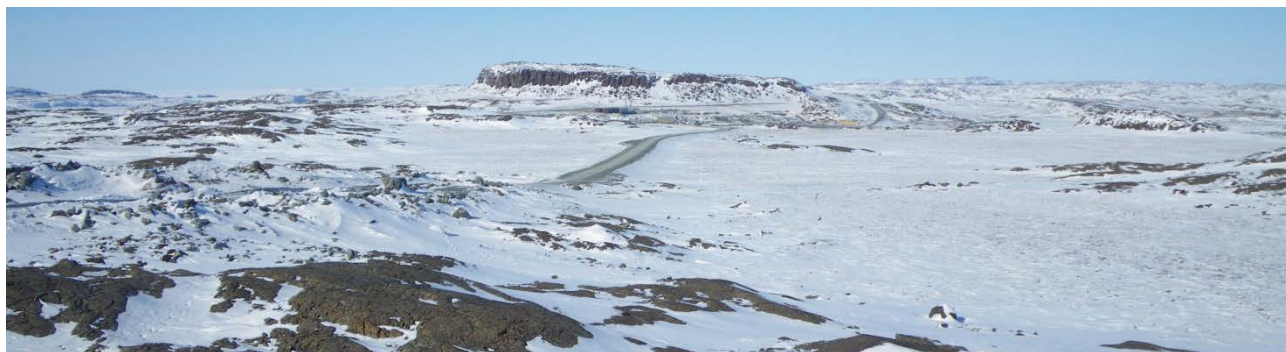
**Photo 3:** Panorama of Doris North from Quarry 2 on the left to the North Dam on the right.
