DAILY REPORT #113 – DORIS NORTH INFRASTRUCTURE/ NORTH DAM

Prepared by:	Lowell Wade	Date:	2012.04.28
Reviewed by:		Project #:	1CH008.058.0320
Role	Company	Personnel – Position	On Site
Client	Hope Bay Mining Limited (HBML)	Angela Holzapfel – ESR Compliance Manager David Vokey – ESR Coordinator Dean Wold - Safety Jill Turk – ESR Coordinator Katsky Venter – ESR Manger Michelle Tanquay – ESR Site Manager Stirling Kelly – HSLP Advisor	No No No Yes Yes No Yes
	JDS	Doug Fielding – Construction Manager Ishan Fechter – Construction Coordinator Jerry Graham – Construction Manager Mark Valeriote – Construction Manager Calvin Goldschmidt – Construction Coordinator	No No Yes No Yes
Engineering Design Consultants	SRK Consulting (Canada) Inc.	Lowell Wade-Site Engineer Lawrence Borowski – Site Engineer	Yes No
Earthworks Contractor	Nuna Logistics	Doug Haverland - Area Superintendent Gary Sodhi – Field Engineer Georges Cornelissen – Survey Manager Jeff Roberts - Surveyor Jim Cardinal – Foreman Jordan Gunter – Foreman (Day Shift) Mike MacMaster – Surveyor Mike Price – Field Engineer Rick Peter – Foreman (Night Shift) Trevor Sorken – Superintendent	No No Yes No Yes No No Yes Yes Yes

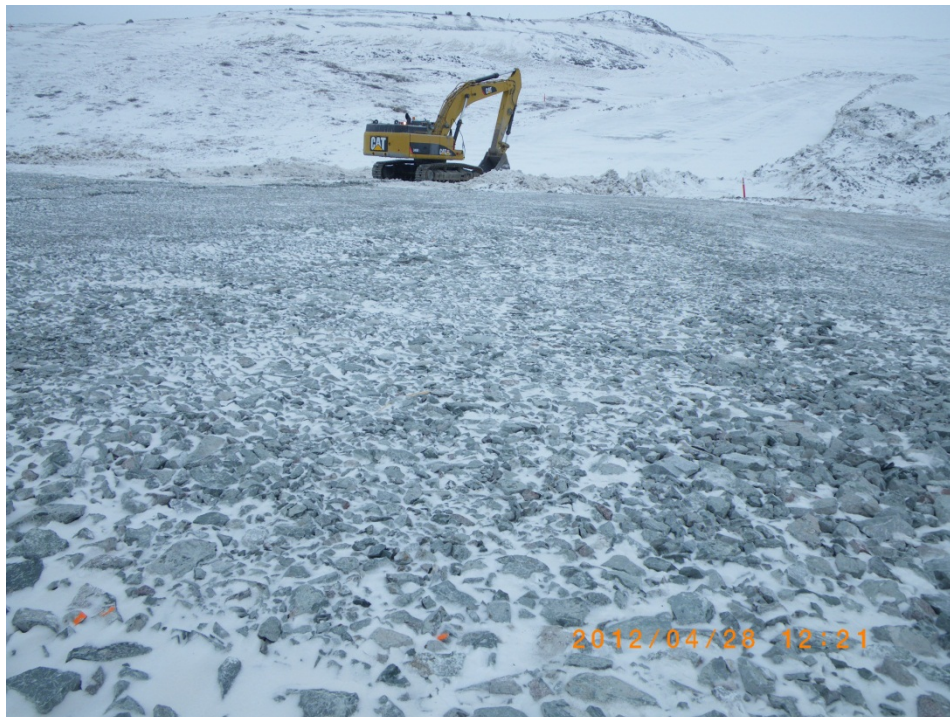
- Excavator conducting final clean-up and dressing the upstream slope of the dam.
- Vibratory compactor running over the upstream face of the dam.
- Survey of final upstream face of the dam will be conducted.
- Drilling of the additional instrumentation boreholes was not started.

Photo 1: The final surface of the upstream face of the North Dam.

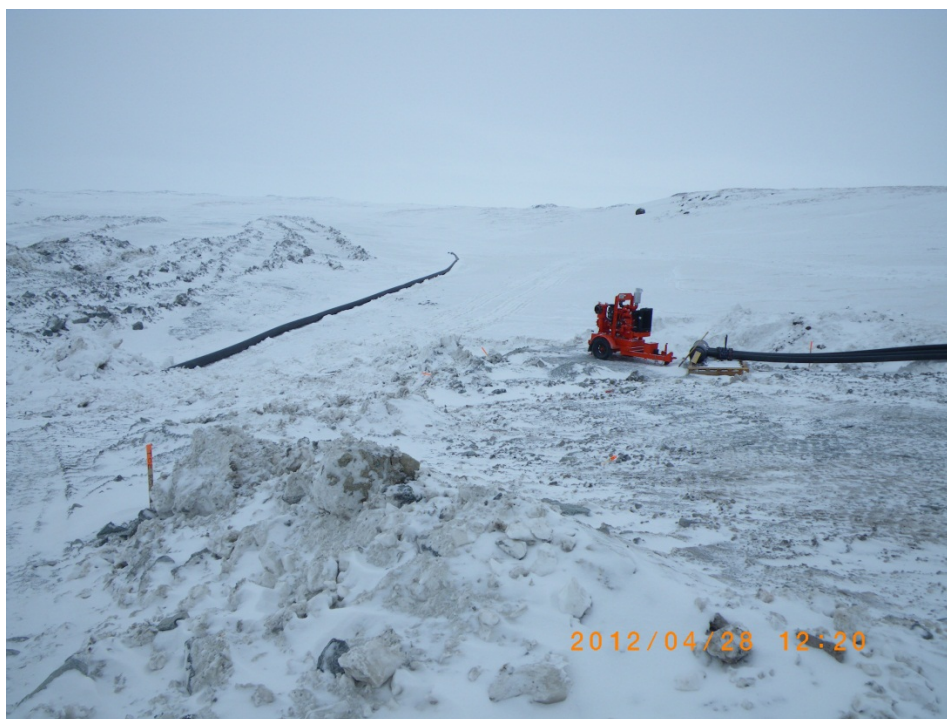
Photo 2: The water discharge pump in Tail Lake is being prepared.
