DAILY REPORT #115 – DORIS NORTH INFRASTRUCTURE/ NORTH DAM

Prepared by:	Lowell Wade	Date:	2012.04.29
Reviewed by:		Project #:	1CH008.058.0320
Role	Company	Personnel – Position	On Site
Client	Hope Bay Mining Limited (HBML)	Angela Holzapfel – ESR Compliance Manager David Vokey – ESR Coordinator Dean Wold - Safety Jill Turk – ESR Coordinator Katsky Venter – ESR Manger Michelle Tanquay – ESR Site Manager Stirling Kelly – HSLP Advisor	No No No Yes Yes No Yes
	JDS	Doug Fielding – Construction Manager Ishan Fechter – Construction Coordinator Jerry Graham – Construction Manager Mark Valeriot – Construction Manager Calvin Goldschmidt – Construction Coordinator	No No Yes No Yes
Engineering Design Consultants	SRK Consulting (Canada) Inc.	Lowell Wade-Site Engineer Lawrence Borowski – Site Engineer	Yes No
Earthworks Contractor	Nuna Logistics	Doug Haverland - Area Superintendent Gary Sodhi – Field Engineer Georges Cornelissen – Survey Manager Jeff Roberts - Surveyor Jim Cardinal – Foreman Jordan Gunter – Foreman (Day Shift) Mike MacMaster – Surveyor Mike Price – Field Engineer Rick Peter – Foreman (Night Shift) Trevor Sorken – Superintendent	No No Yes No Yes No No Yes Yes Yes

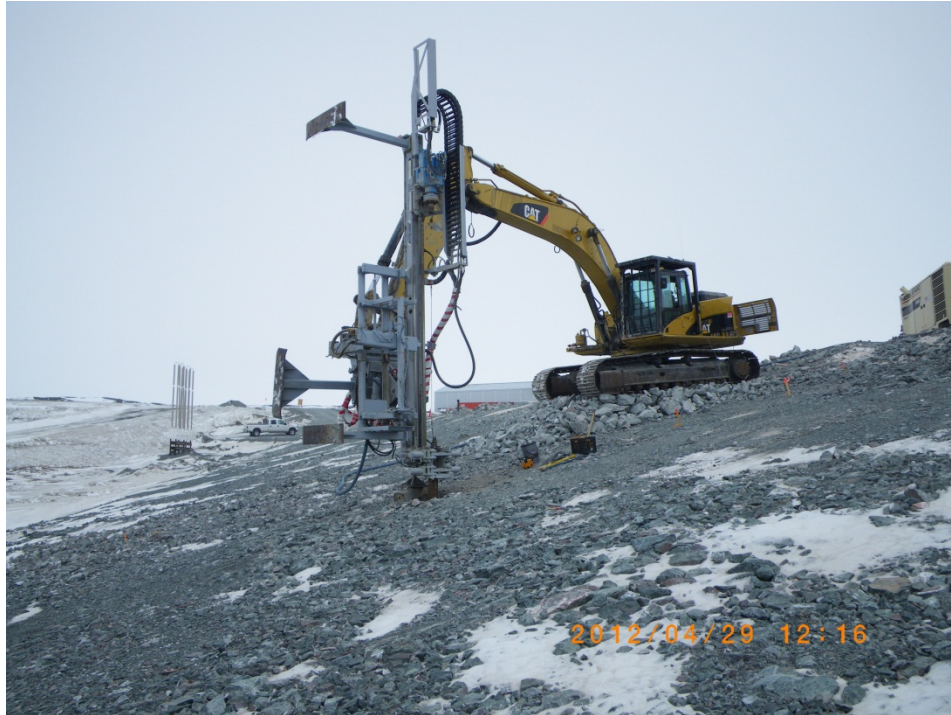
- Drilling of ND-IN-120-3 started:
 - Collar elevation = 33.719 m
 - Bottom of inclinometer casing elevation = 24.5 m [9.2 m]
 - Hoe drill had no problems drilling to 9.5 m depth. The down-hole hammer and the outer steel casing were inter-locked to allow for drilling and advancing the casing

Photo 1: Drilling ND-IN-120-3 using an 330 excavator with the hoe-drill.

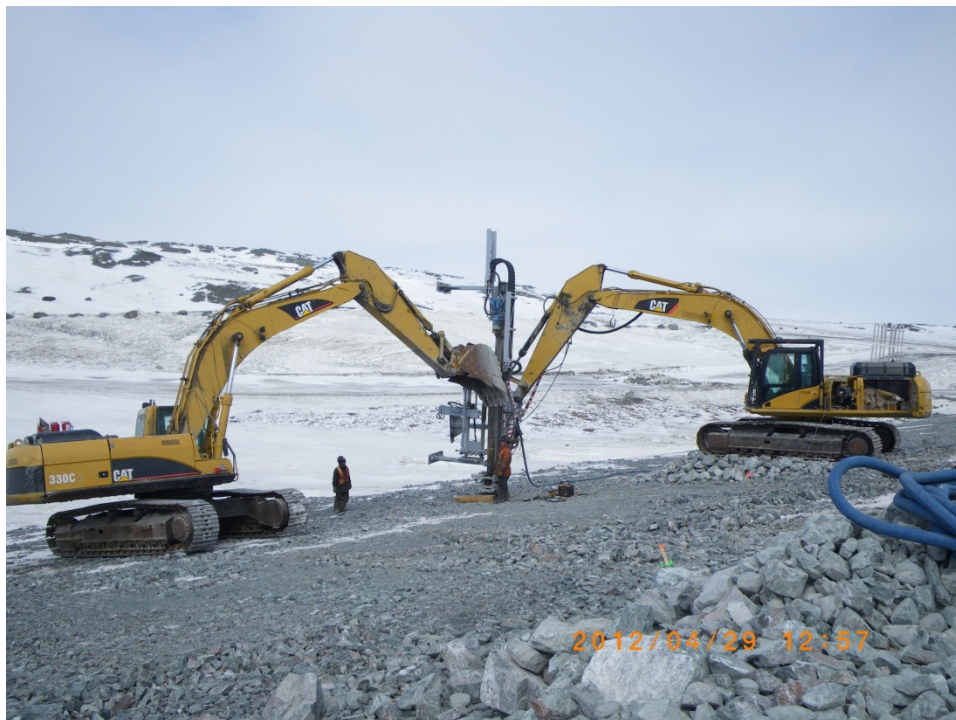
Photo 2: A sections of drill rod and outer steel casing being added to the drill stem.

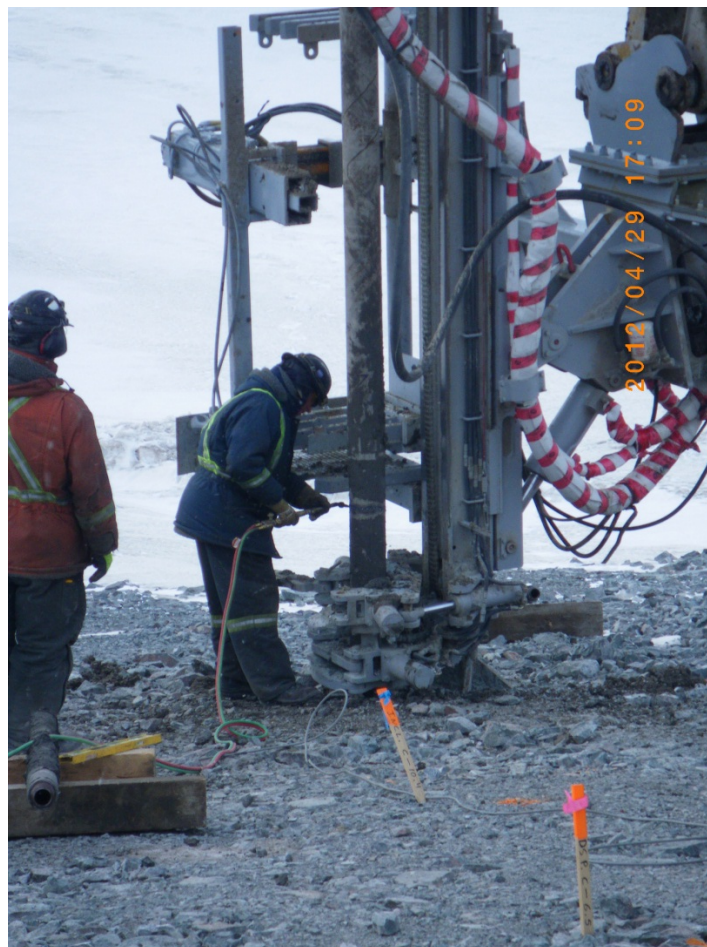
- Attempts to “break” the sections apart using the drill chuck crimped the steel casing close to the threads.
 - The decision was made to cut the steel casing into sections using an oxy-acetylene torch. Before the steel casing was removed from the borehole it was used to ream the hole in hopes the borehole

Photo 3: The outer steel casing being cut to permit removal.

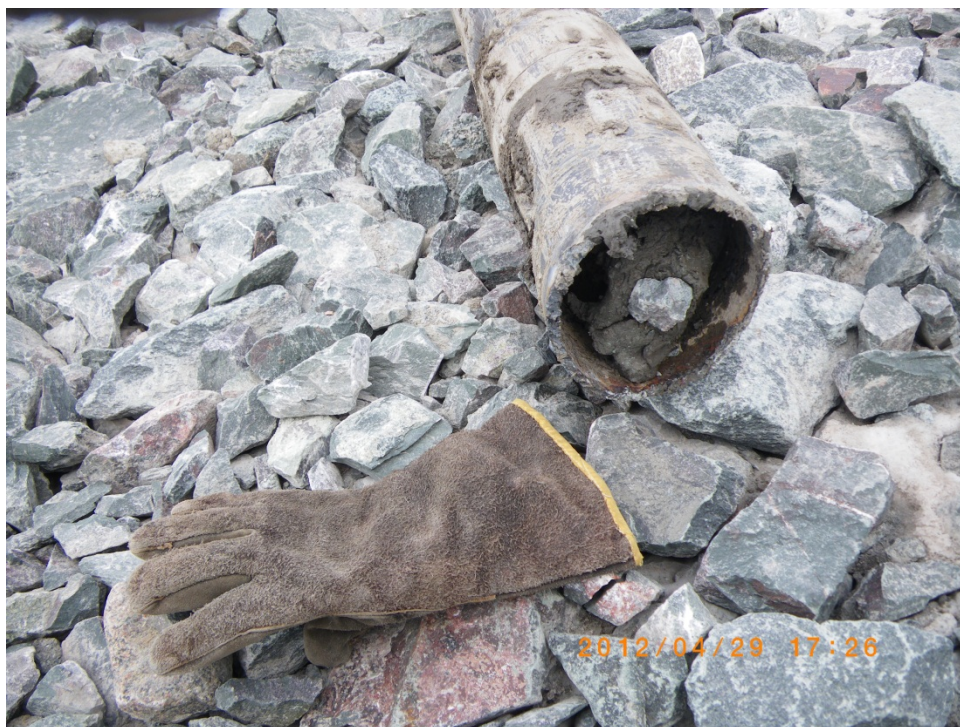
- Close to completion of the borehole the down-hole hammer broke free of the steel casing
 - The hoe-drill was able to remove the down-hole hammer but the sections of steel casing could not be removed.

- would stay open and allow for the Inclinator casing to be installed
- Once the casing had been removed it was discovered the lead section of the outer steel casing had been sheared off.
- A tape measure was used to sound the borehole and determined the top of the outer steel casing was 7 m [EL 26.7 m] below the surface of ROQ.

Photo 2: The crippled and cut steel casing. Overburden material was observed on the down-hole hammer rods and inside the steel casing.
