DAILY REPORT #116 – DORIS NORTH INFRASTRUCTURE/ NORTH DAM

Prepared by:	Lowell Wade	Date:	2012.04.30
Reviewed by:		Project #:	1CH008.058.0320
Role	Company	Personnel – Position	On Site
Client	Hope Bay Mining Limited (HBML)	Angela Holzapfel – ESR Compliance Manager David Vokey – ESR Coordinator Dean Wold - Safety Jill Turk – ESR Coordinator Katsky Venter – ESR Manger Michelle Tanquay – ESR Site Manager Stirling Kelly – HSLP Advisor	No No No Yes Out No Yes
	JDS	Doug Fielding – Construction Manager Ishan Fechter – Construction Coordinator Jerry Graham – Construction Manager Mark Valeriot – Construction Manager Calvin Goldschmidt – Construction Coordinator	No No Yes No Yes
Engineering Design Consultants	SRK Consulting (Canada) Inc.	Lowell Wade-Site Engineer Lawrence Borowski – Site Engineer	Yes No
Earthworks Contractor	Nuna Logistics	Doug Haverland – Area/Site Superintendent Gary Sodhi – Field Engineer Georges Cornelissen – Survey Manager Jeff Roberts - Surveyor Jim Cardinal – Site Services Foreman Mike MacMaster – Surveyor Mike Price – Field Engineer Rick Peter – Foreman Trevor Sorken – Area/Site Superintendent	No In Yes No Yes No Out Yes Yes

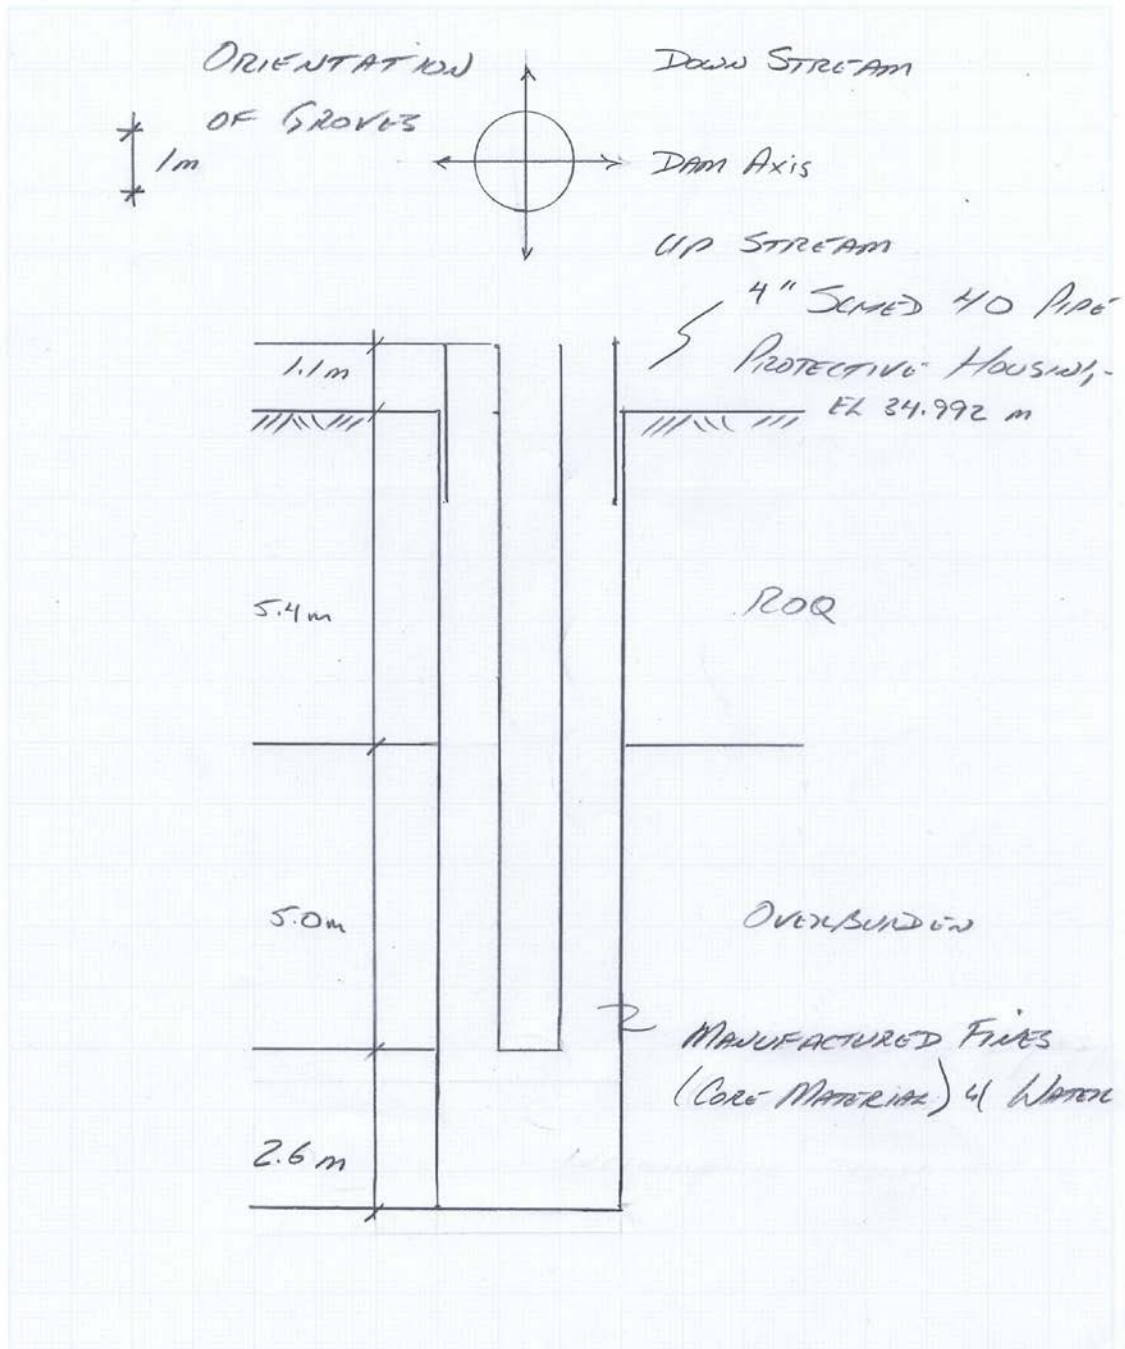
- Drilling of ND-IN-120-2 completed and inclinometer casing installed (Figure 2):
 - Collar elevation = 34.992 m
 - Bottom of inclinometer casing elevation = 24.6 m [10.4 m]
 - Hoe drill using a 6" drill bit and no casing had no problems drilling to 13.0 m depth.
 - Snow was added to the borehole and allowed to melt and re-freeze to make sure the ROQ did not collapse into the borehole. Once the drill passed through the ROQ into the overburden, the marine silts and clays were used to "smear" the sides of the borehole to keep it open
 - The drill steel was lost down the borehole twice but was eventually retrieved
 - The inclinometer casing was assembled and lowered to the correct bottom elevation in the borehole and held in-place by hand.

- Manufactured fines [i.e. core material] was slowly poured down the sides of the borehole while the inclinometer casing was gently lifted up and down until it firmly sat on the bottom of the borehole at the correct depth.
- Core material and water were slowly pored around the inclinometer casing to 1.5 m below the collar elevation. The inclinometer casing was gently tapped during the backfilling process to prevent any bridging of back-fill material.
- A 4" Schedule 40 protective housing was installed over the inclinometer casing. The protective house extends 1.5 m below the surface elevation and 1.1 m above grade.
- A protective cap has yet to be manufactured.
- Drilling of ND-IN-120-1 was started late in the day and was advanced to 6 m

Figure 2: As-built of slope indicator casing installation for ND-IN-120-2.

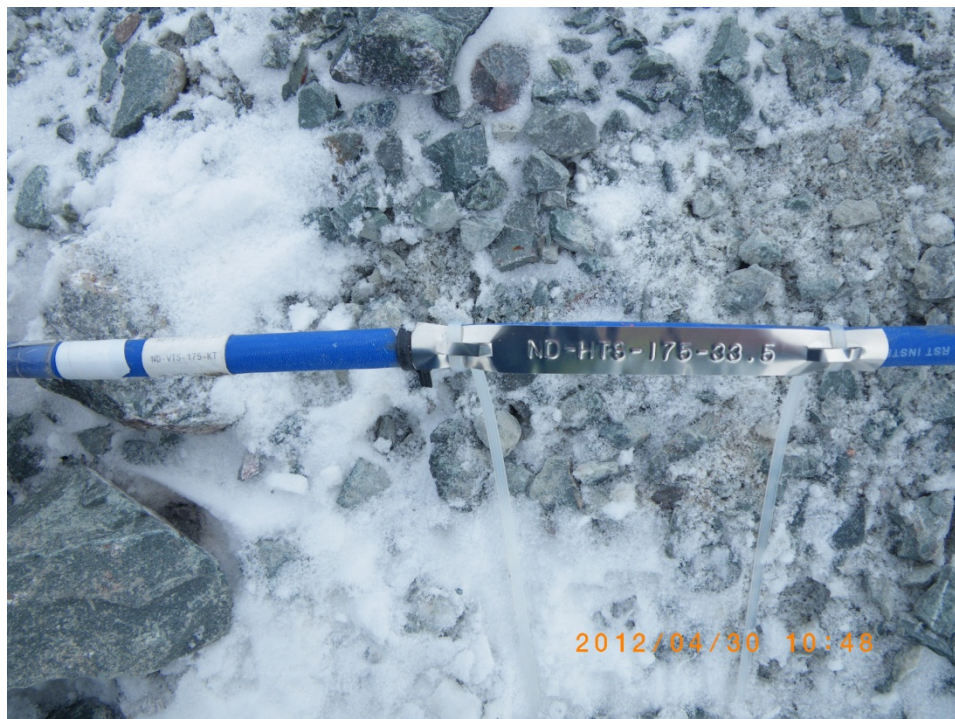
- As a reminder, the extensions for GTC's ND-VTS-175-KT and ND-HTS-175-33.5 were switched when these cables were repaired. The steel labels, secured by zap-straps, provide the correct GTC identification.
- The table below provides the as-built ground temperature cable [SRK-JT2-12] bead elevations

Photo 1: GTC ND-HTS-175-33.5 correctly labelled.

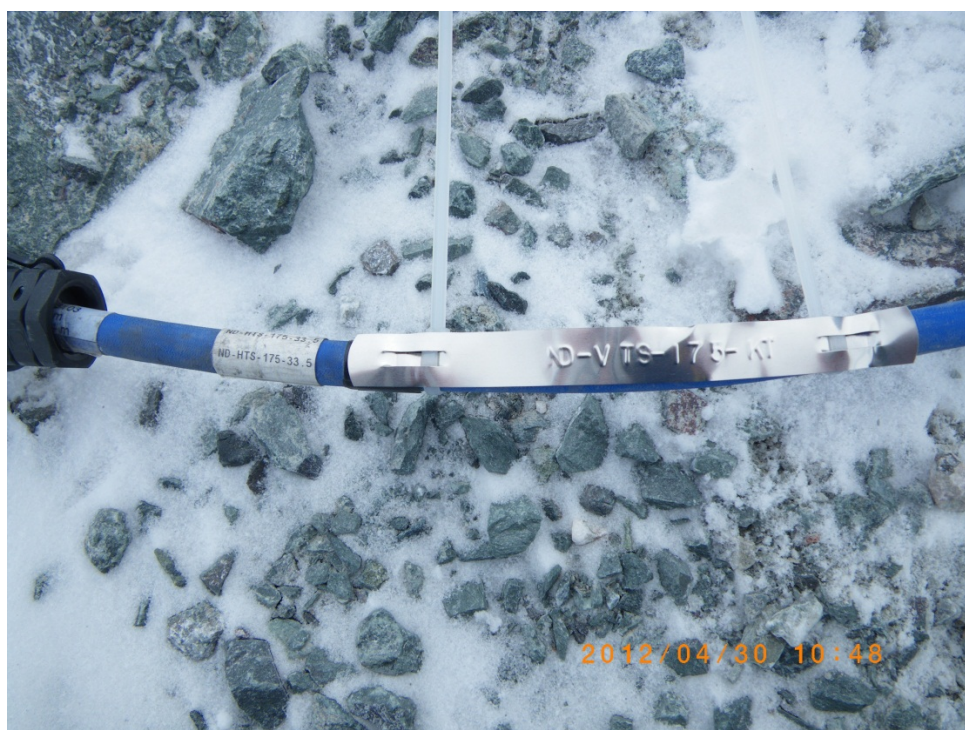
Photo 2: GTC ND-VTS-175-KT correctly labelled.

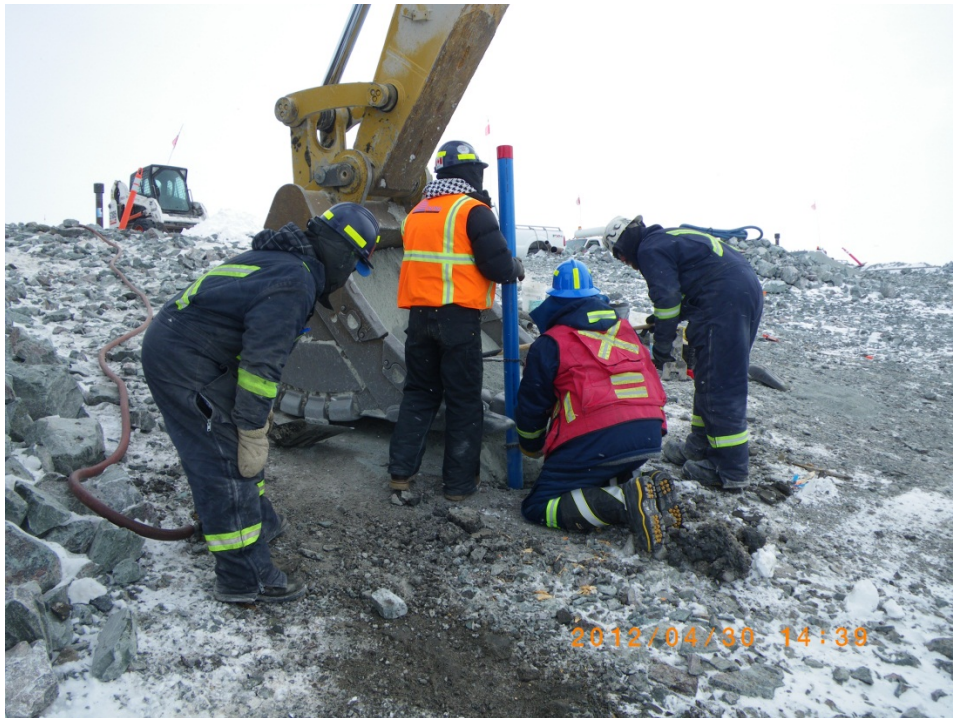
Photo 3: Inclinometer casing back-filling operations.

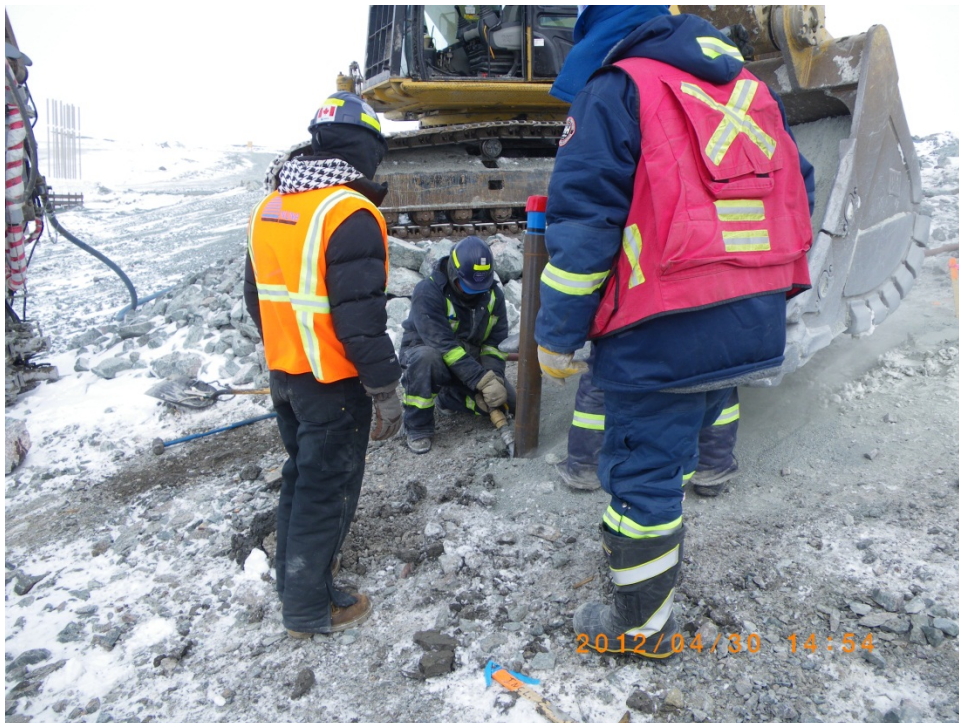
Photo 4: The 4" Sced 40 protective housing installed. The Inclinometer casing to be cut to final elevation and the protective steel cover yet to be manufactured.
