### DAILY REPORT #117 – DORIS NORTH INFRASTRUCTURE/ NORTH DAM

Prepared by:	Lowell Wade	Date:	2012.05.01
Reviewed by:		Project #:	1CH008.058.0320
Role	Company	Personnel – Position	On Site
Client	Hope Bay Mining Limited (HBML)	Angela Holzapfel – ESR Compliance Manager David Vokey – ESR Coordinator Dean Wold - Safety Jill Turk – ESR Coordinator Katsky Venter – ESR Manger Michelle Tanquay – ESR Site Manager Stirling Kelly – HSLP Advisor	No No No Yes No No Yes
	JDS	Doug Fielding – Construction Manager Ishan Fechter – Construction Coordinator Jerry Graham – Construction Manager Mark Valeriot – Construction Manager Calvin Goldschmidt – Construction Coordinator	No No Yes No Yes
Engineering Design Consultants	SRK Consulting (Canada) Inc.	Lowell Wade-Site Engineer Lawrence Borowski – Site Engineer	Yes No
Earthworks Contractor	Nuna Logistics	Doug Haverland – Area/Site Superintendent Gary Sodhi – Field Engineer Georges Cornelissen – Survey Manager Jeff Roberts - Surveyor Jim Cardinal – Site Services Foreman Mike MacMaster – Surveyor Mike Price – Field Engineer Rick Peter – Foreman Trevor Sorken – Area/Site Superintendent	No Yes Yes No Yes No No Yes Yes

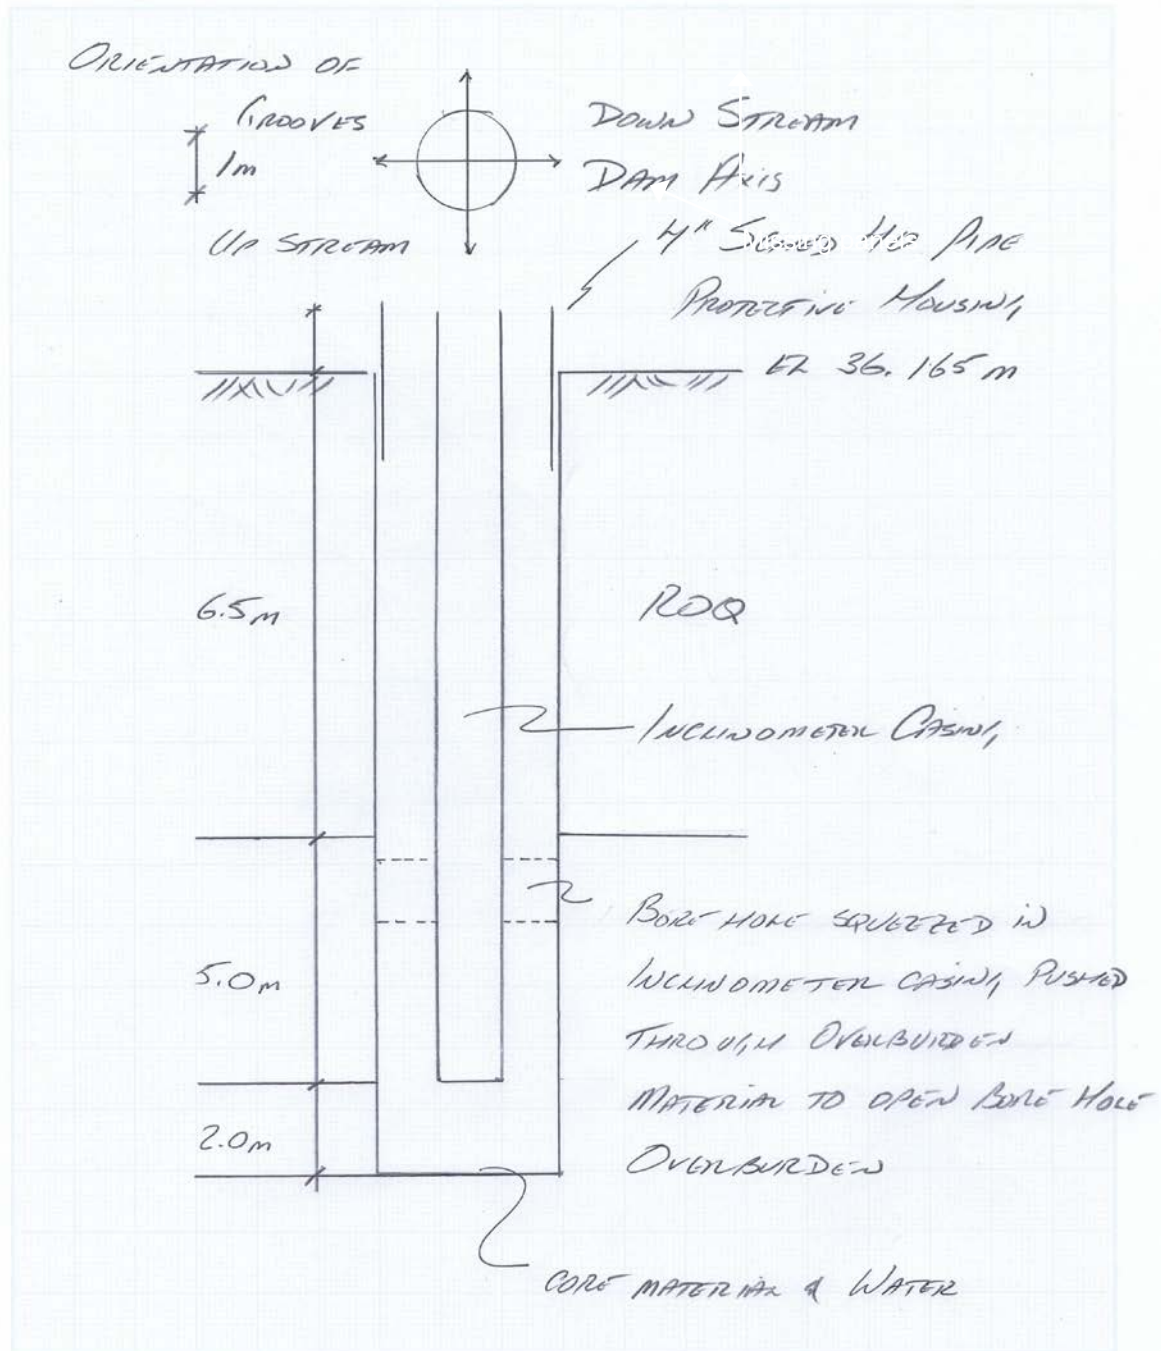
Subject ND-IN-120-1 Sheet 1 of 1

- Drilling of ND-IN-120-1 completed and inclinometer casing installed (Figure 1):
  - Collar elevation = 36.165 m
  - Bottom of inclinometer casing elevation = 29.7 m [6.5 m]

- Hoe drill using a 6" drill bit and no casing had no problems drilling to 13.5 m depth.
  - Drilling procedure the same as for ND-IN-120-2.
  - The inclinometer casing was assembled and lowered to the correct bottom elevation in the borehole and held in-place by hand.

- Manufactured fines [i.e. core material] was slowly poured down the sides of the borehole while the inclinometer casing was gently lifted up and down until it firmly sat on the bottom of the borehole at the correct depth.

- Core material and water were slowly pored around the inclinometer casing to 1.5 m below the collar elevation. The inclinometer casing was gently tapped during the backfilling process to prevent any bridging of back-fill material.

- A 4" Schedule 40 protective housing was installed over the inclinometer casing. The protective house extends 1.5 m below the surface elevation and 1.1 m above grade.

Figure 1: Borehole log for ND-IN-120-1.

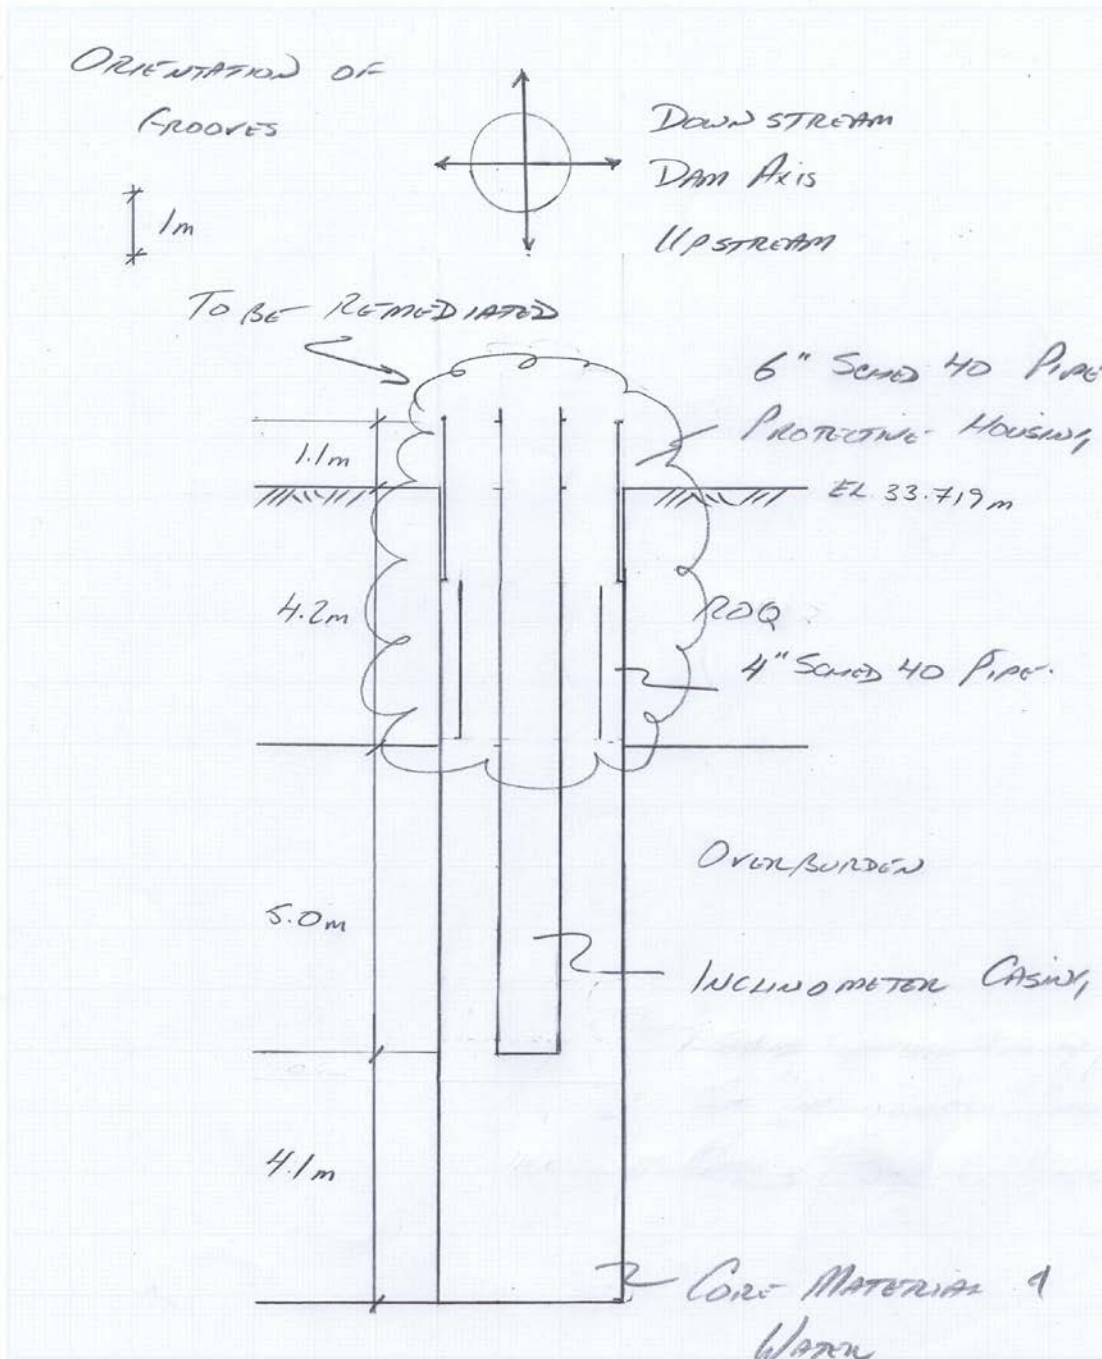
Subject ND-W-120-3 Sheet 1 of 1

- Borehole ND-IN-120-3 was reamed and inclinometer casing was installed and backfilled with core material and water slurry.
- Once the core material and water slurry reached 1.5 m below ROQ surface grade it was sounded with a length of rebar to confirm the depth below grade was 1.5 m.

- A 2.6 m length of 4" Schedule 40 pipe was installed over the inclinometer casing for the protective housing. As it was lowered into the borehole the steel pipe did not remain in-place and settled further down the borehole such that the top of the pipe was 1.6 m below ROQ surface grade. Core material and water was used to back-fill the borehole around the 4" Schedule 40 pipe and 2.6 m length of 6" Schedule 40 steel pipe was installed.

- As shown in Figure 2 the resulting installation does not allow for inclinometer readings within the ROQ dam shell as this length of borehole is completely cased.

**Figure 2:** As-built of slope indicator casing installation for ND-IN-120-3.

- An evening conference call with Trevor Sorken, Gary Sodhi, Rick Peter, Lowell Wade, and Maritz Rykaart developed a remediation plan to recover this borehole without delaying the drilling of the remaining boreholes.

- An excavator will be used to remove the material around the upper 6" steel pipe and the upper portion of the lower 4" steel pipe. The upper 6" steel pipe will be removed. The lower steel pipe will be lifted up to the correct elevation around the inclinometer casing and the excavation backfilled.

- The remaining 4" Schedule 40 steel pipe protective housings will have a 12" long ¼" thick flat bar welded to one side of the casing. This flat metal bar will act as a "stop" to hold the casing at the correct elevation as the steel pipe is lowered over the inclinometer casing. Only one "stop" will be welded onto the side of the protective housing so as not to interfere with back-filling of the borehole

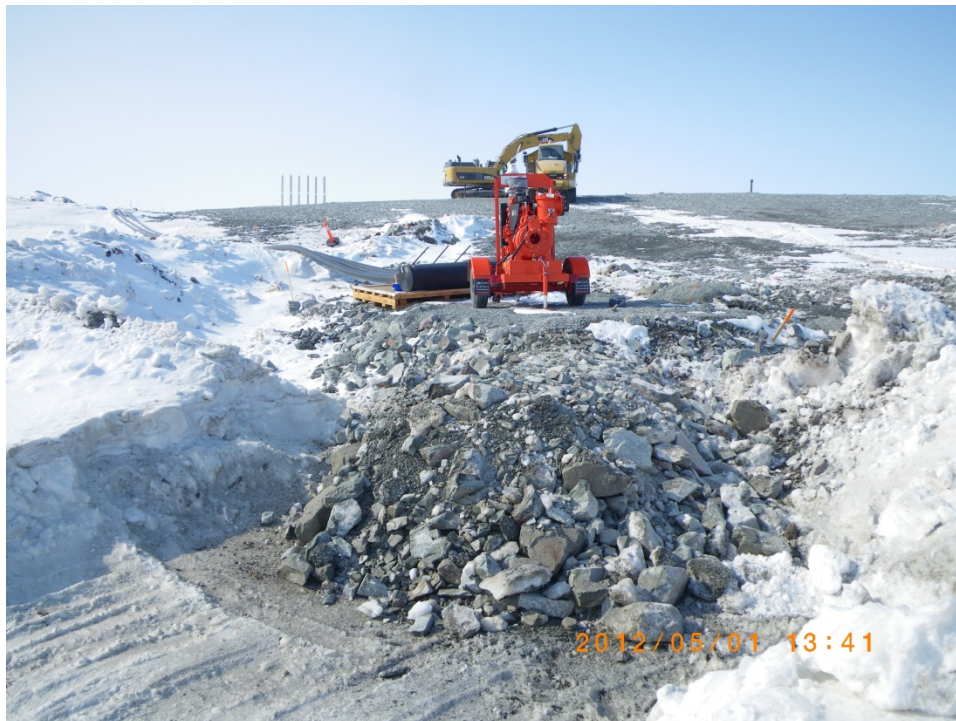
- The buttress at 0+60 was constructed.
- The buttress at 0+85 was constructed.
- The Slope Indicator Dummy Probe arrived on-site and was used to on the installed inclinometer casings ND-IN-120-1 to 3. No problems were encountered.

**Photo 1:** Butress at 0+60.

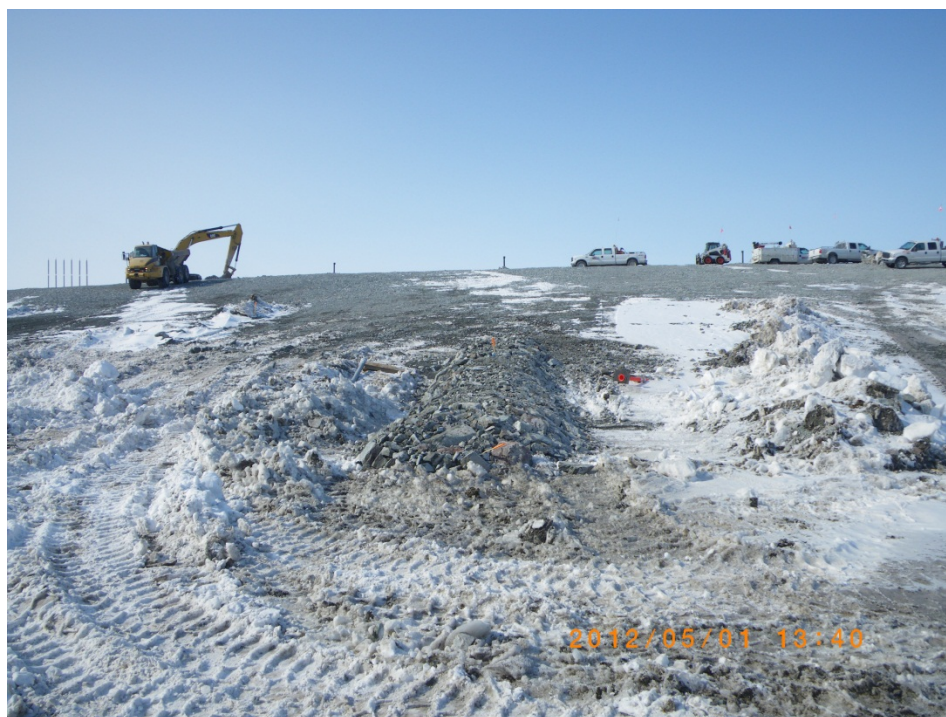
**Photo 2:** Butress at 0+85.

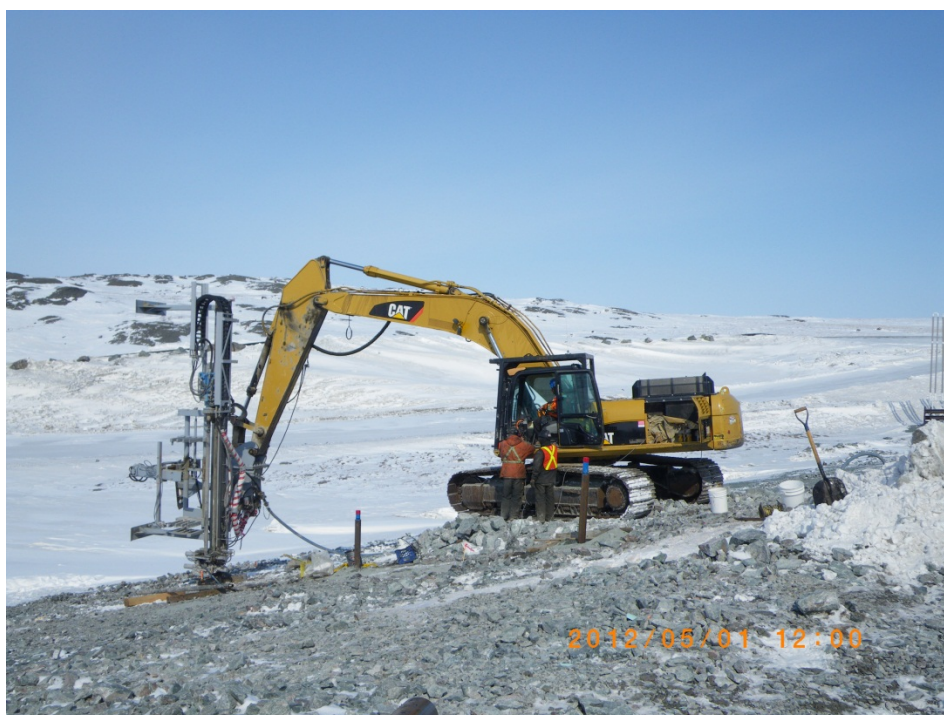
- A protective cap has yet to be manufactured.
- The lead outer steel casing lost in borehole ND-IN-120-3 was retrieved
- The weld at the top of the lead outer steel casing failed as it was being removed from the borehole. The bottom of the lead outer steel casing is undamaged.

**Photo 3:** Inclinator installation at ND-IN-120-1 complete. Retrieval of outer steel casing lost in borehole ND-IN-120-3 in progress.
