DAILY REPORT #11 – DORIS NORTH INFRASTRUCTURE/ NORTH DAM

Prepared by:	John Kurylo/ Jeff Orr	Date:	2012.01.16
Reviewed by:		Project #:	1CH008.058.0320
Role	Company	Personnel – Position	On Site
Client	Hope Bay Mining Limited (HBML)	Angela Holzapfel – ESR Compliance Manager David Vokey – ESR Coordinator Don Ethelston – HSLP Advisor Dean Wold - Safety Jill Turk – ESR Coordinator Katsky Venter – ESR Manger Michelle Tanquay – ESR Site Manager Stirling Kelly – HSLP Advisor	No Yes No No No No Yes Yes
	JDS	Lloyd Jackson – Mechanical Superintendent Sven Archimowtiz – Electrical Superintendent Doug Fielding – Construction Manager Ishan Fechter – Construction Coordinator Jerry Graham – Construction Manager Kevin Whieldon – Project Coordinator Mark Valeriote – Construction Manager	Yes Yes No Yes Yes No No
Engineering Design Consultants	SRK Consulting (Canada) Inc.	John Kurylo – Site Engineer Megan Miller – Site Engineer Lawrence Borowski – Site Engineer Murry McGregor – Site Engineer Lowell Wade – Senior Engineer	Yes No No No No

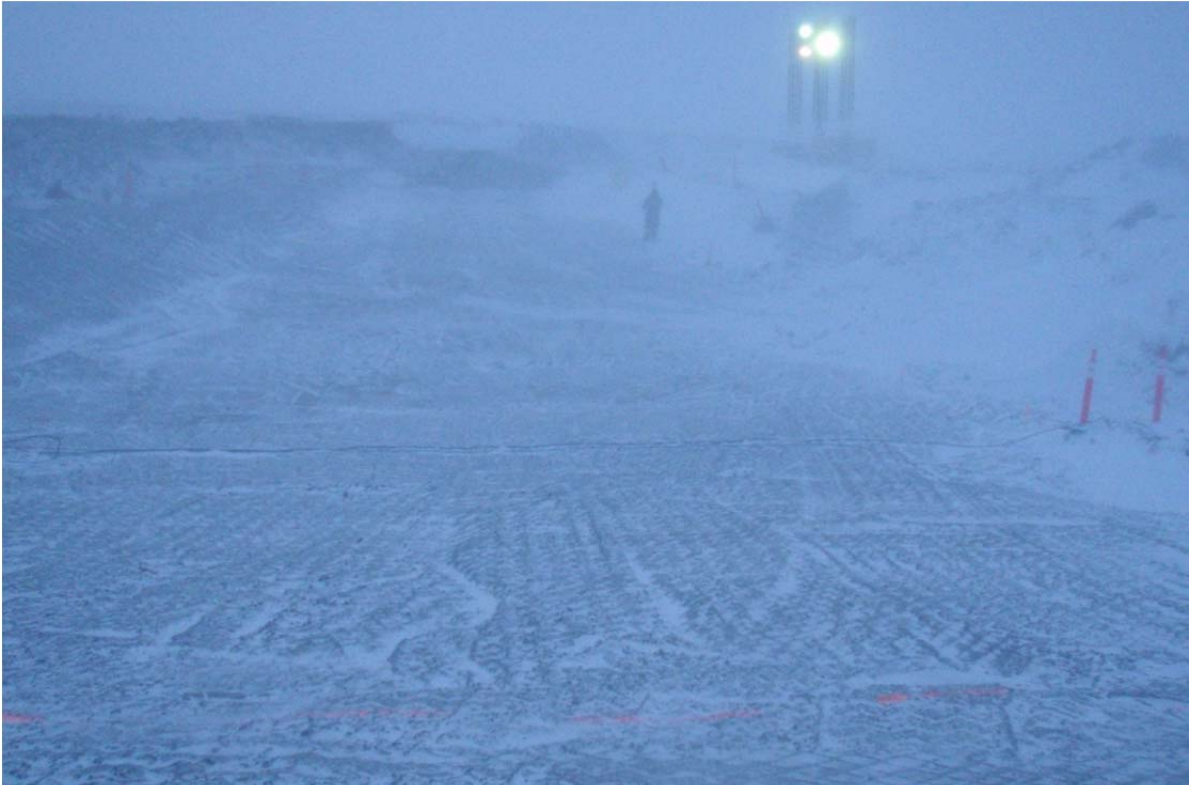
Photo 1: ~SW view of center of key trench. Material placed on 2012/01/15 is in the forefront.

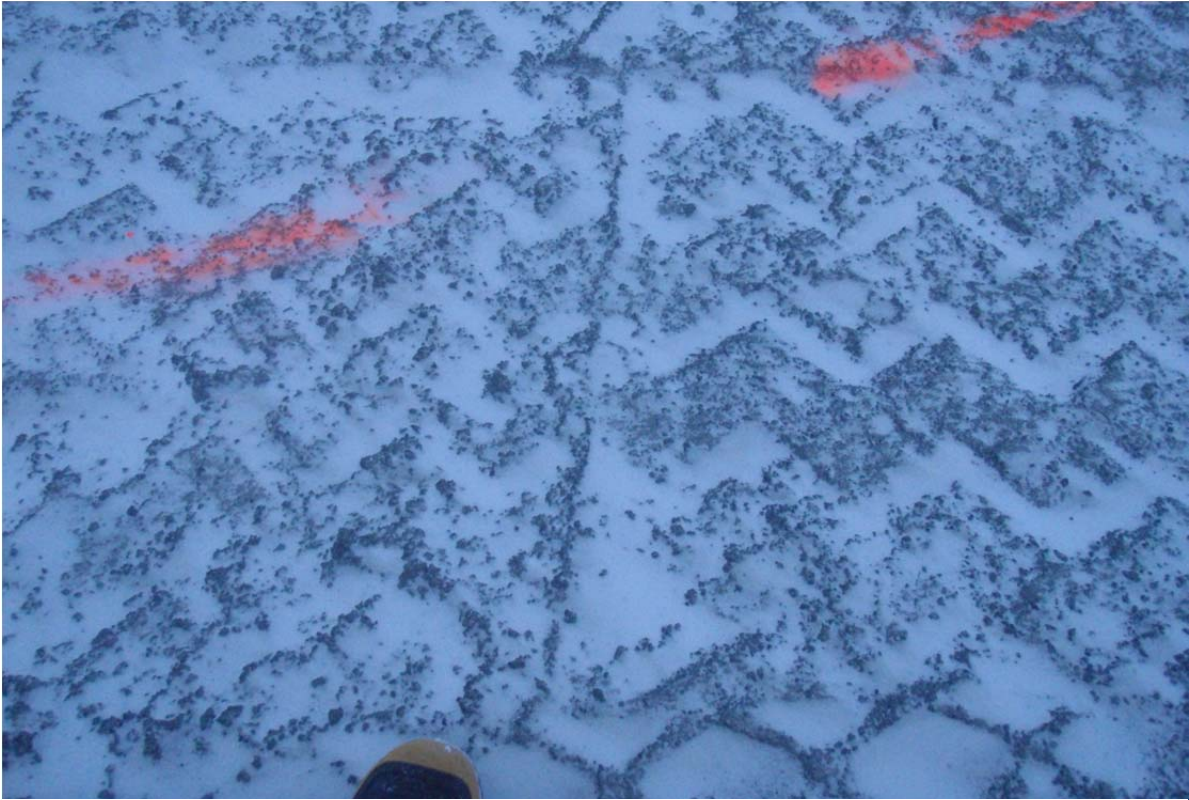
- Nuna's air compressor failed at the end of the day leaving them unable to clean the rough surface left by the hard ground 'zig zag' compactor used on the previous day.

Photo 2: Close up view of Frozen Core Material surface. Note that this material was placed on 2011/01/15. Note the 'zig zag' compactor drum marks on the freezing surface.

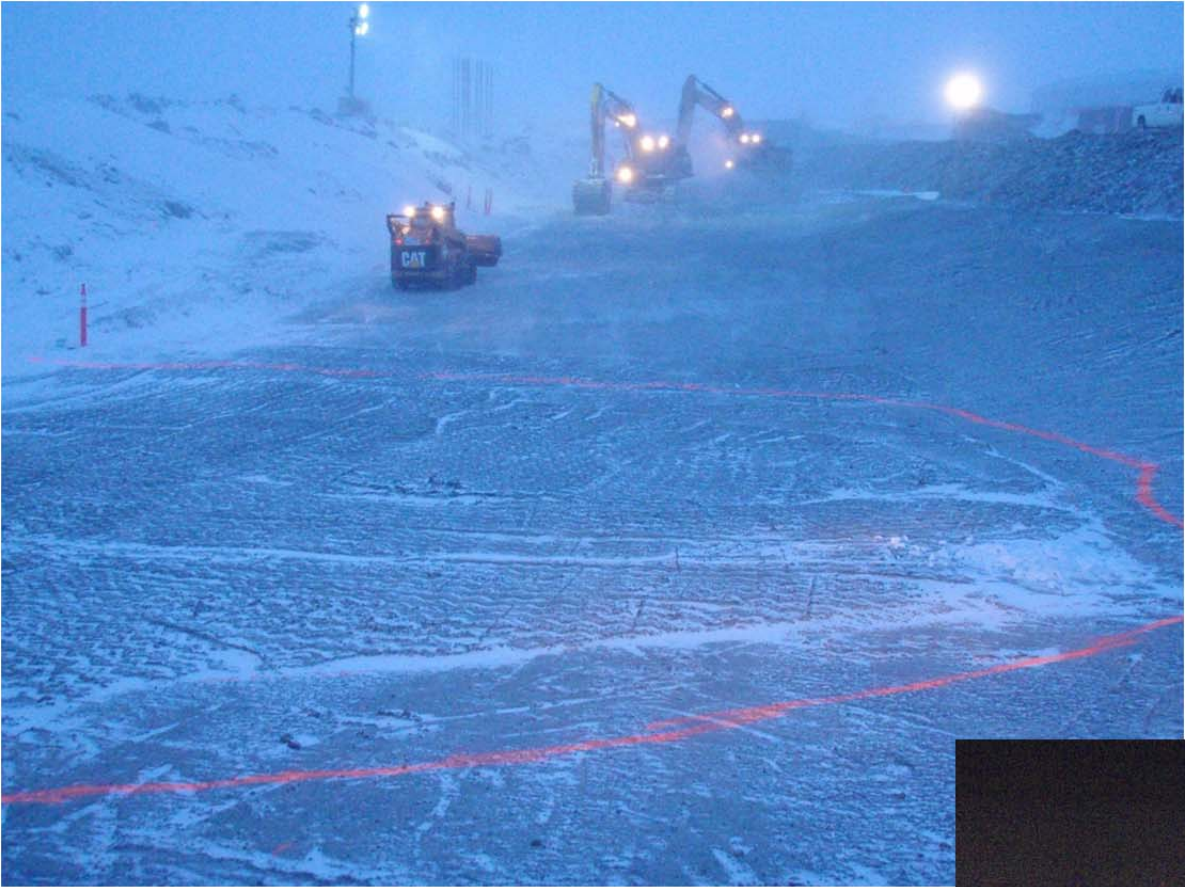
Photo 3: ~NE view of the area where the next center lift is planned to be placed. Note the excavators and bobcat cleaning/ scratching the key trench surface in the background.

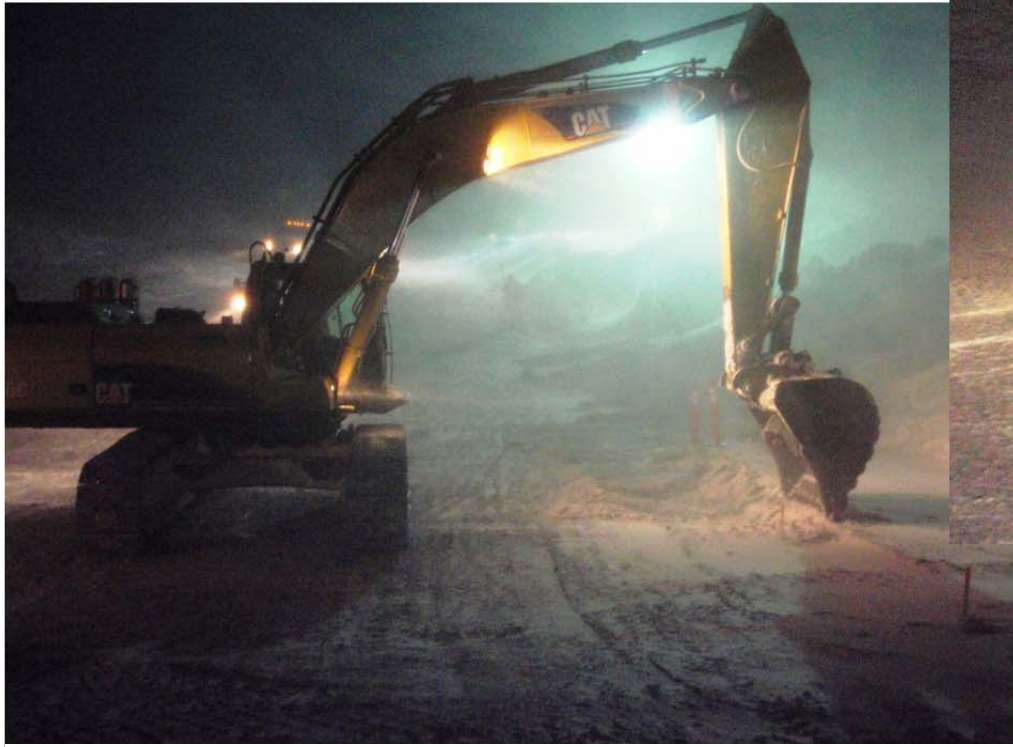
Photo 4: ~W view of the Excavator cleaning snow and 5/8" material in the key trench (around station 1+10)

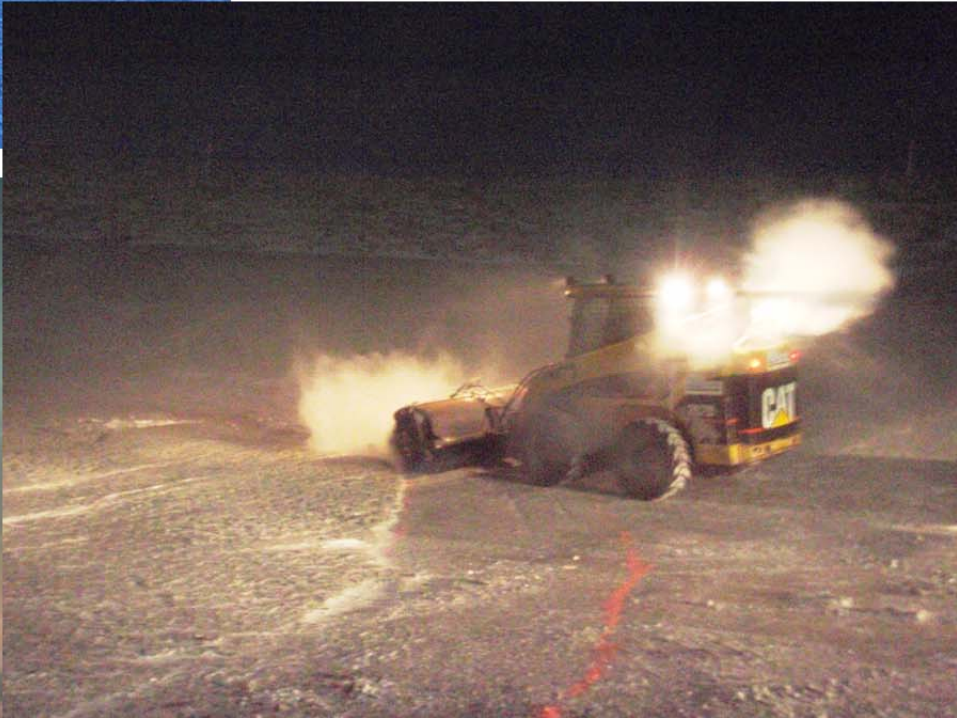
Photo 5: View of Bobcat (equipped with brush), cleaning central key trench area (around station 0+80).

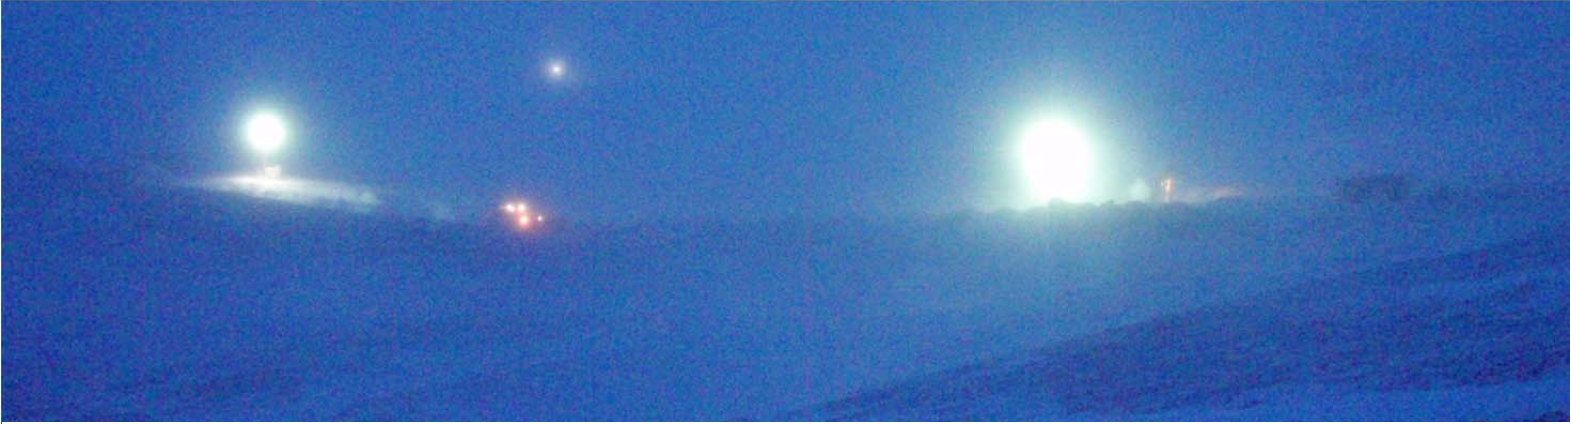
Photo 6: Progress photo of the North Dam construction. Photo taken from Photo Point 2, looking ~ north-west.
Note: Progress photo of the North Dam construction from Photo Point 1 was not taken today due to poor visibility.

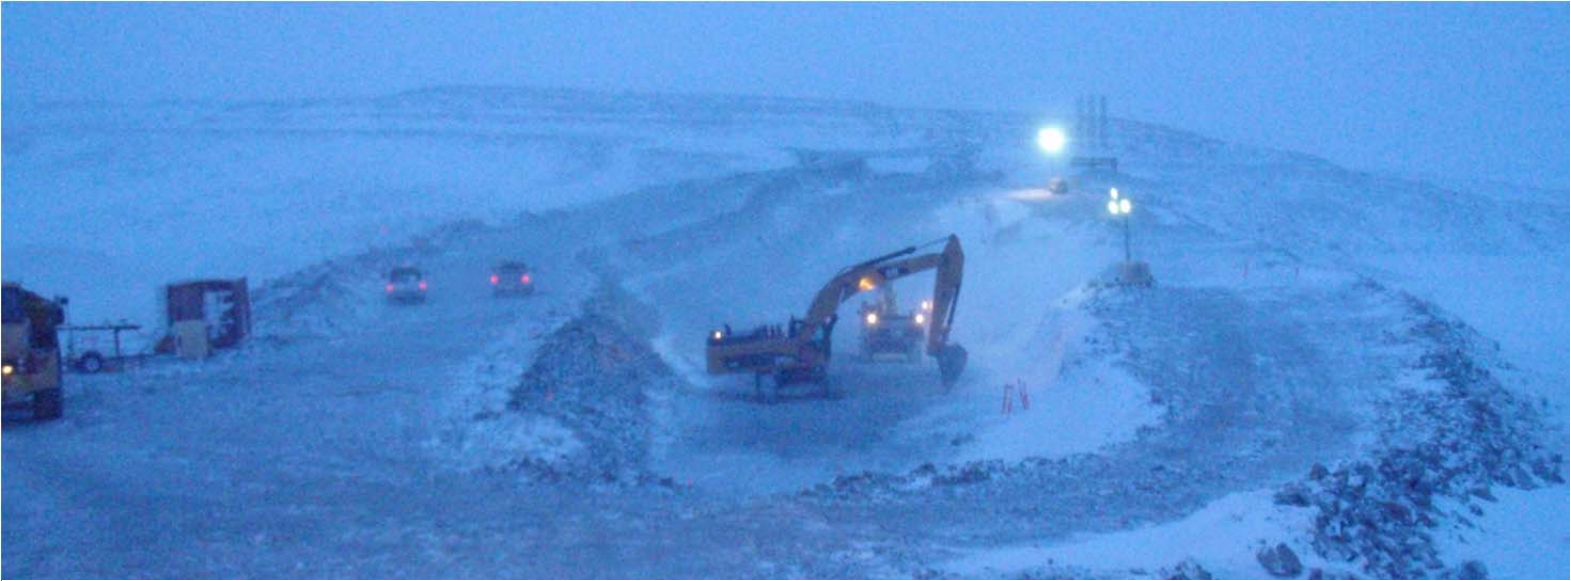
Photo 7: ~ WSW view of construction progress in the key trench.

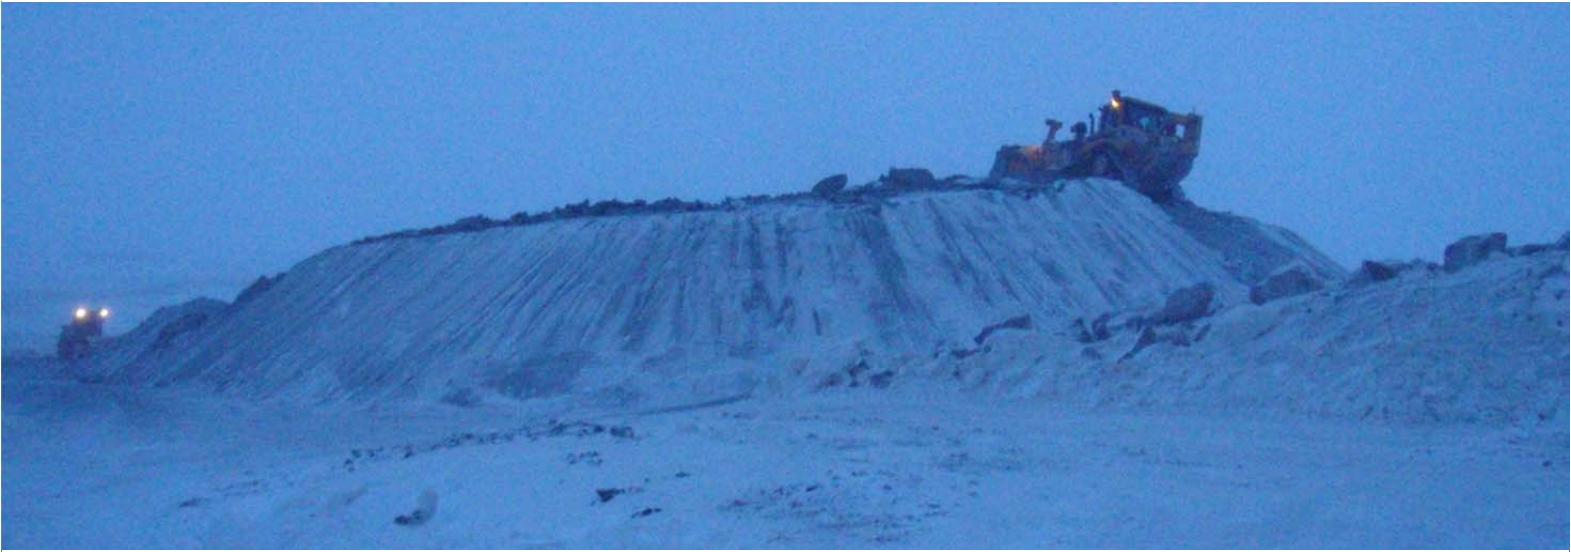
Photo 8: Dozer working on breaking up frozen clumps on top of FCM stockpile (at the FCP Pad).

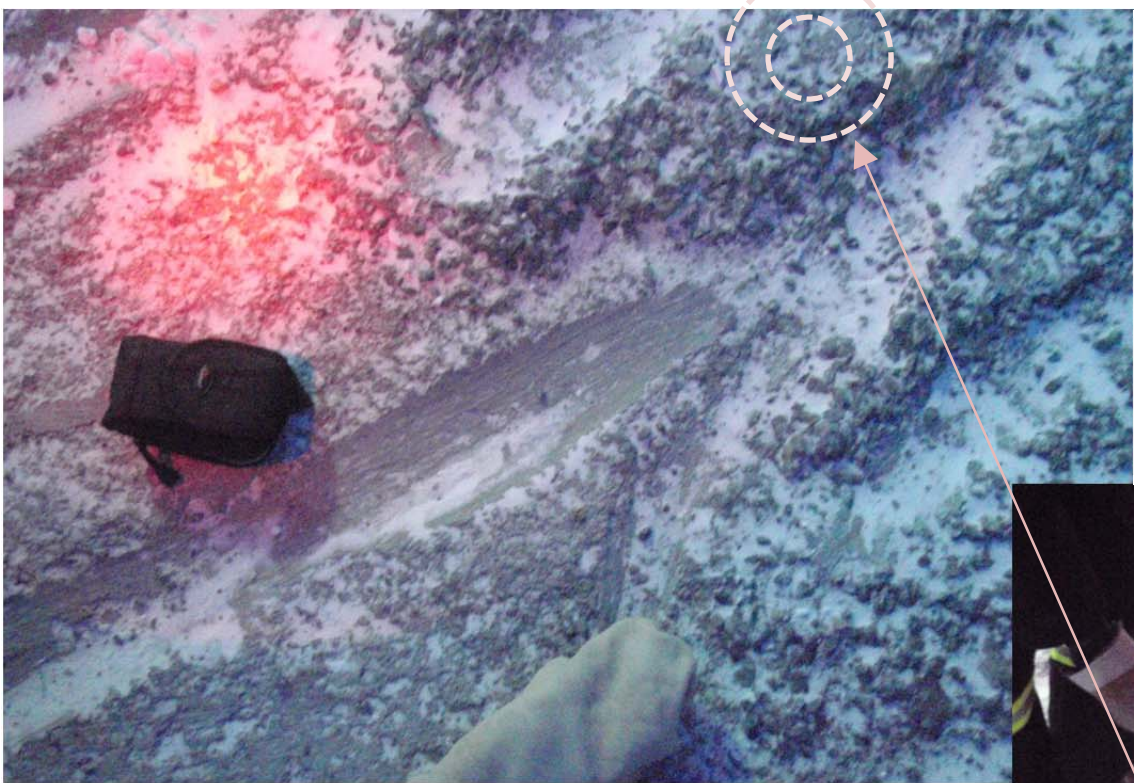
- Details and Photos taken of core taken today are presented as Photos 9 to 12.
 - 5/8" material on the E side was not as saturated and not as intermixed with the FCM (pushed into), as the central area was. An additional core is planned to be taken close to 0+80 in the coming days.

Photo 9: Close up view of cleaning in progress. Note the coarser 5/8" material in relation to the finer core material. The dashed circle shows approximately what the cored location looked like prior to coring.
Note: scraping/ cleaning activities were not fully completed around this area at the time of this picture.

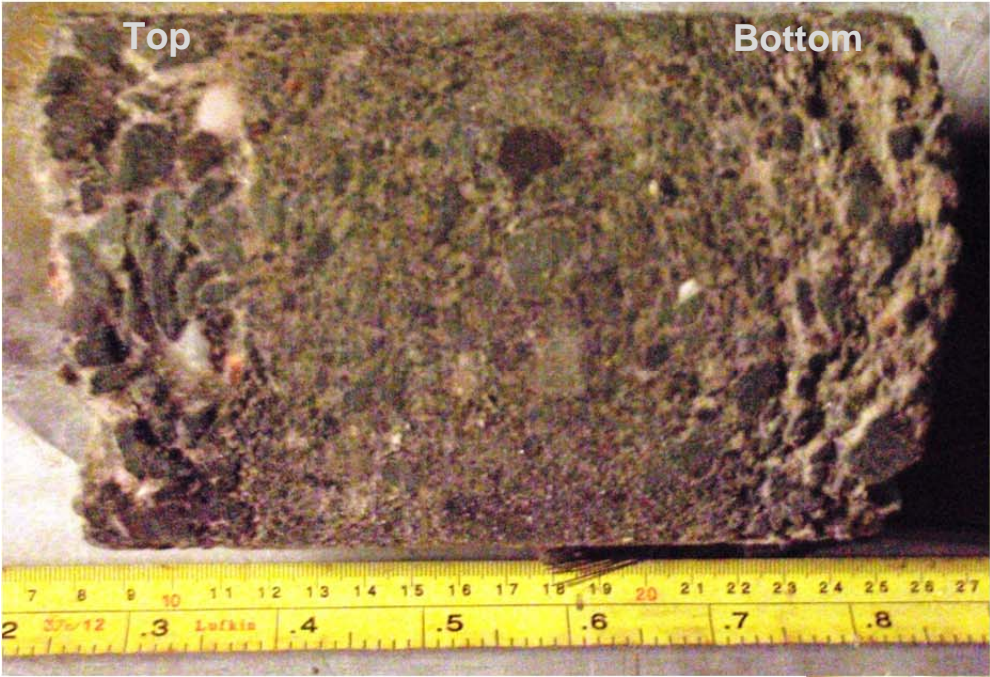
Photo 11: Drilled core collected today to investigate bonding of 5/8" material with underlying frozen core.
Note: the 5/8" material was noted to be more apparent around 1+30 compared to around the inflection point in the key trench. Cleaning activities were not fully completed around this location and a more 5/8" clear rich location was selected. Additional cores are planned to be taken closer to the inflection point in the key trench to further examine 5/8" and FCM interface (i.e. at an area that was softer at the time of closure and where more thorough cleaning has been completed.).

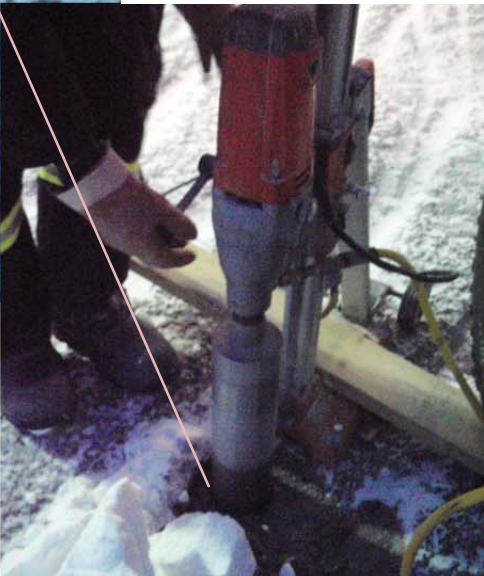
Photo 10: Coring around station 1+30, downstream.

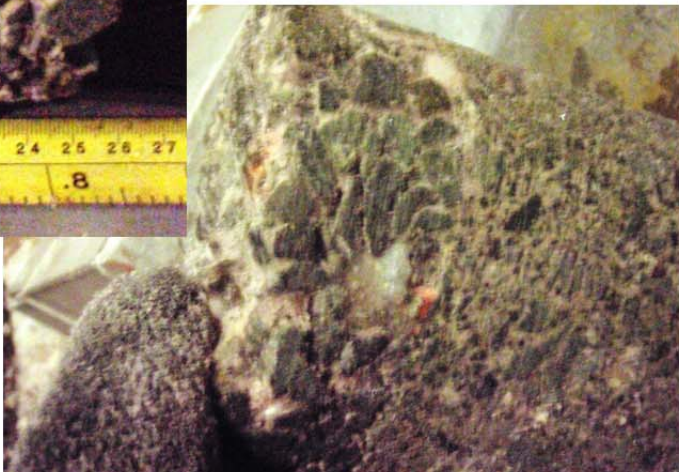
Photo 12: Close up of 5/8" material at start of drilled core (HB12-ND-CORE-DC1-20120116).

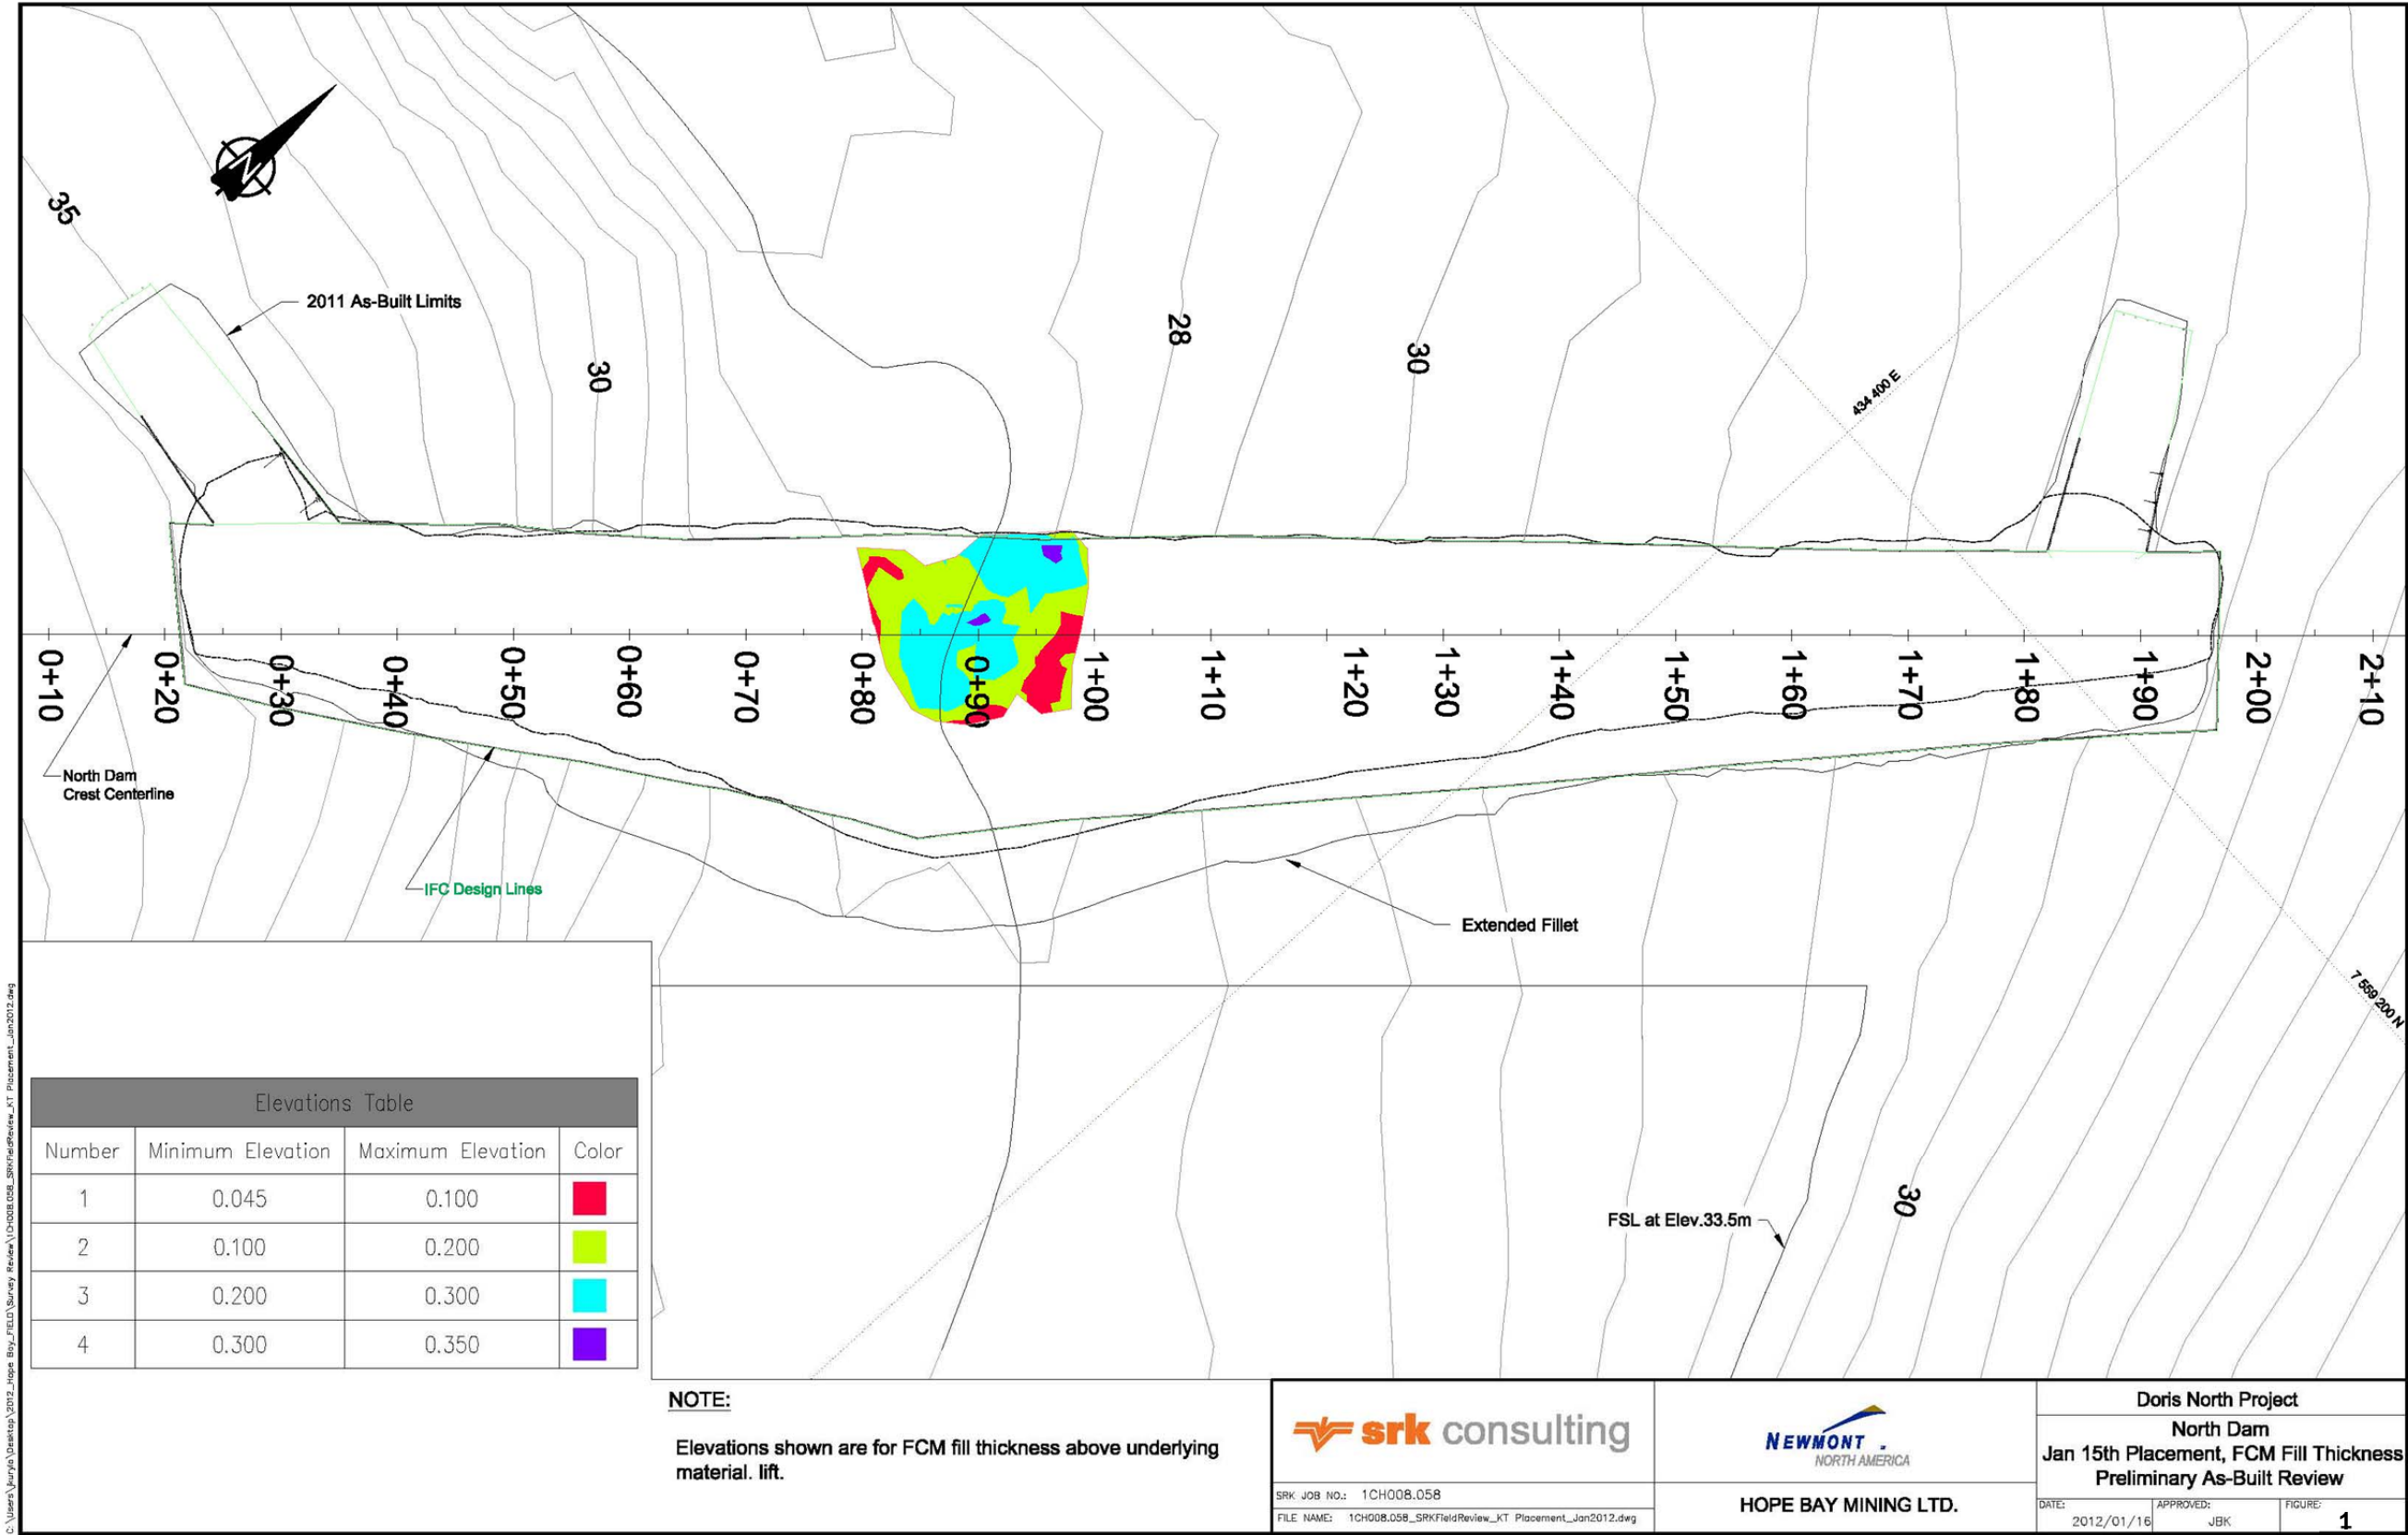
FIGURES: - SRK Preliminary As-Built Review for 2012/01/15 FCM Placement.
- Note that the thickness of the place lift is shown in the Isopach below.

Figure - Nuna As-Built Review. Figure shows area of dental cleaning on night shift and area where core was placed on 2012/01/15

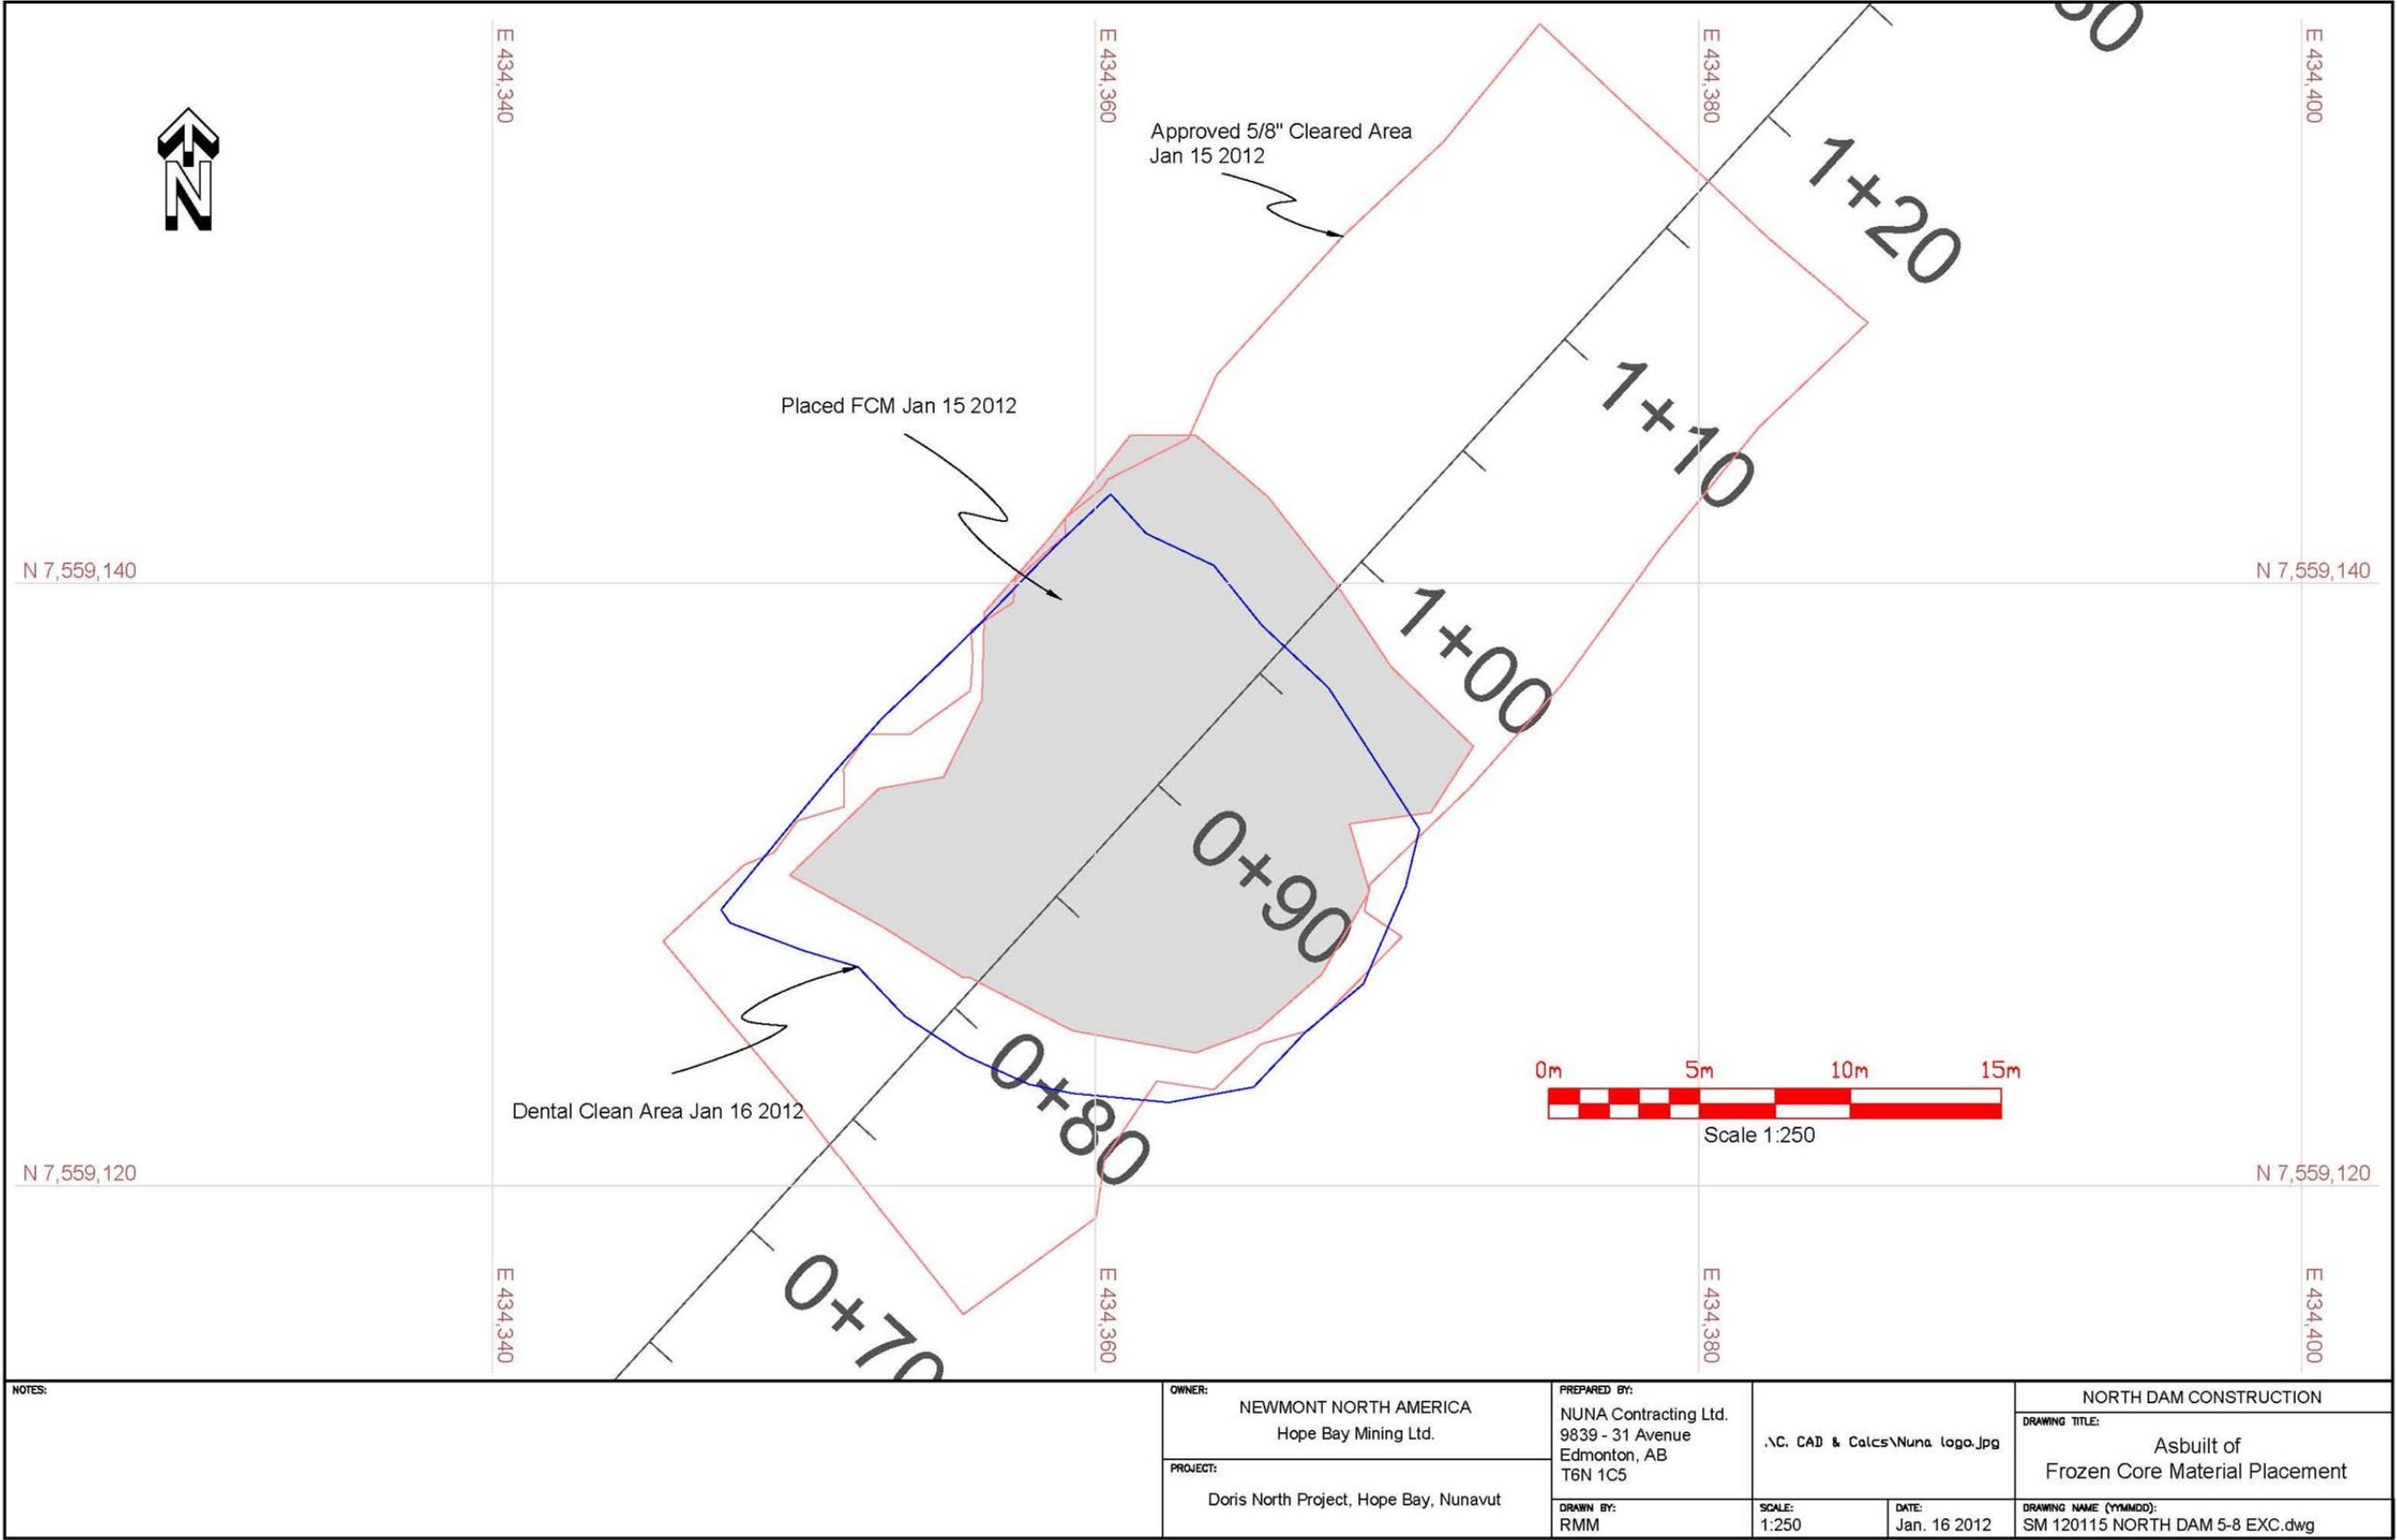
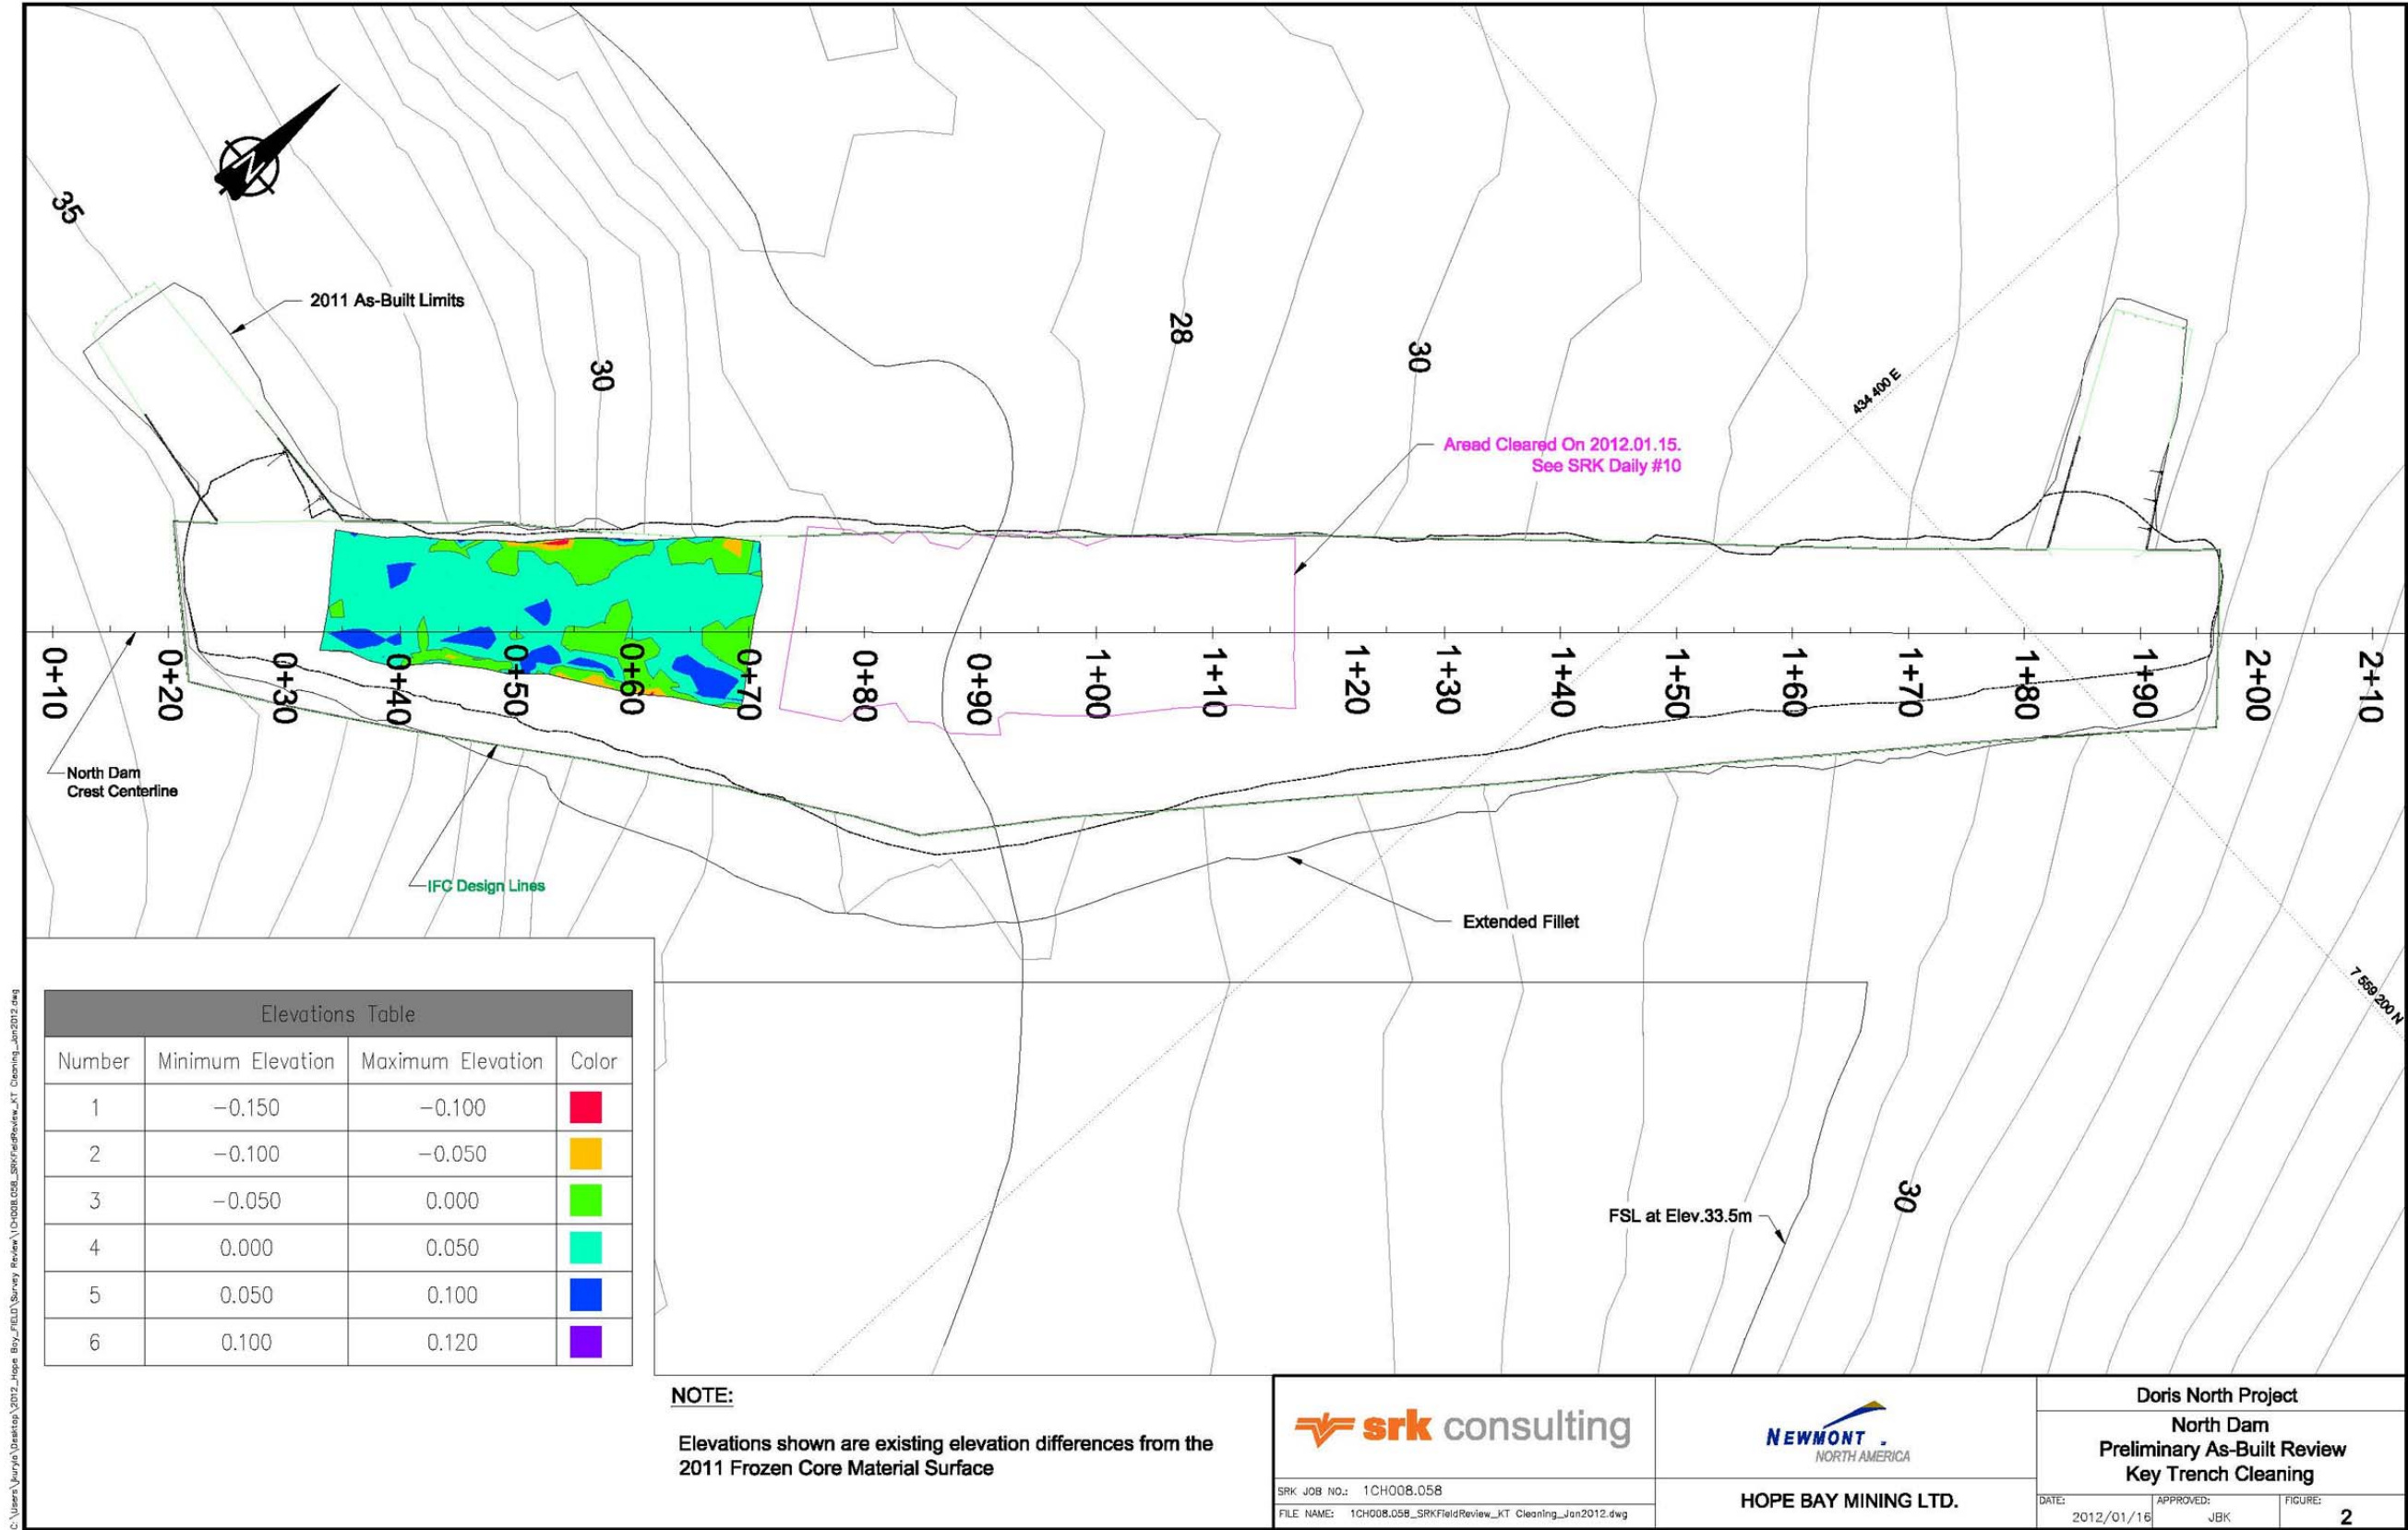
- Nuna survey completed a preliminary isopach for the key trench clearing around station 0+25 to 0+70 (see Figure section of this report).
 - SRK completed a preliminary isopach review to compare the existing key trench elevation to the 2011 FCM surface from ~ station 0+35 to 0+70. In general the existing surface was noted to be typically 0 to 0.05m (0.3m avg) above the 2011 FCM grade in this section. Details of this review are provided in the Figure section of this report.

Figure - SRK Preliminary As-Built Review of Key Trench cleaning/ 5/8” material removal completed on 2012/01/16.
- Note that the existing elevation in relation to the 2011 FCM surface is shown in the isopach below/
