DAILY REPORT #11 – DORIS NORTH INFRASTRUCTURE/ NORTH DAM

Prepared by:	John Kurylo/ Jeff Orr	Date:	2012.01.16
Reviewed by:		Project #:	1CH008.058.0320
Role	Company	Personnel – Position	On Site
Client	Hope Bay Mining Limited (HBML)	Angela Holzapfel – ESR Compliance Manager David Vokey – ESR Coordinator Don Ethelston – HSLP Advisor Dean Wold - Safety Jill Turk – ESR Coordinator Katsky Venter – ESR Manger Michelle Tanquay – ESR Site Manager Stirling Kelly – HSLP Advisor	No Yes No No No No Yes Yes
	JDS	Lloyd Jackson – Mechanical Superintendent Sven Archimowtiz – Electrical Superintendent Doug Fielding – Construction Manager Ishan Fechter – Construction Coordinator Jerry Graham – Construction Manager Kevin Whieldon – Project Coordinator Mark Valeriote – Construction Manager	Yes Yes No Yes Yes No No
Engineering Design Consultants	SRK Consulting (Canada) Inc.	John Kurylo – Site Engineer Megan Miller – Site Engineer Lawrence Borowski – Site Engineer Murry McGregor – Site Engineer Lowell Wade – Senior Engineer	Yes No No No No

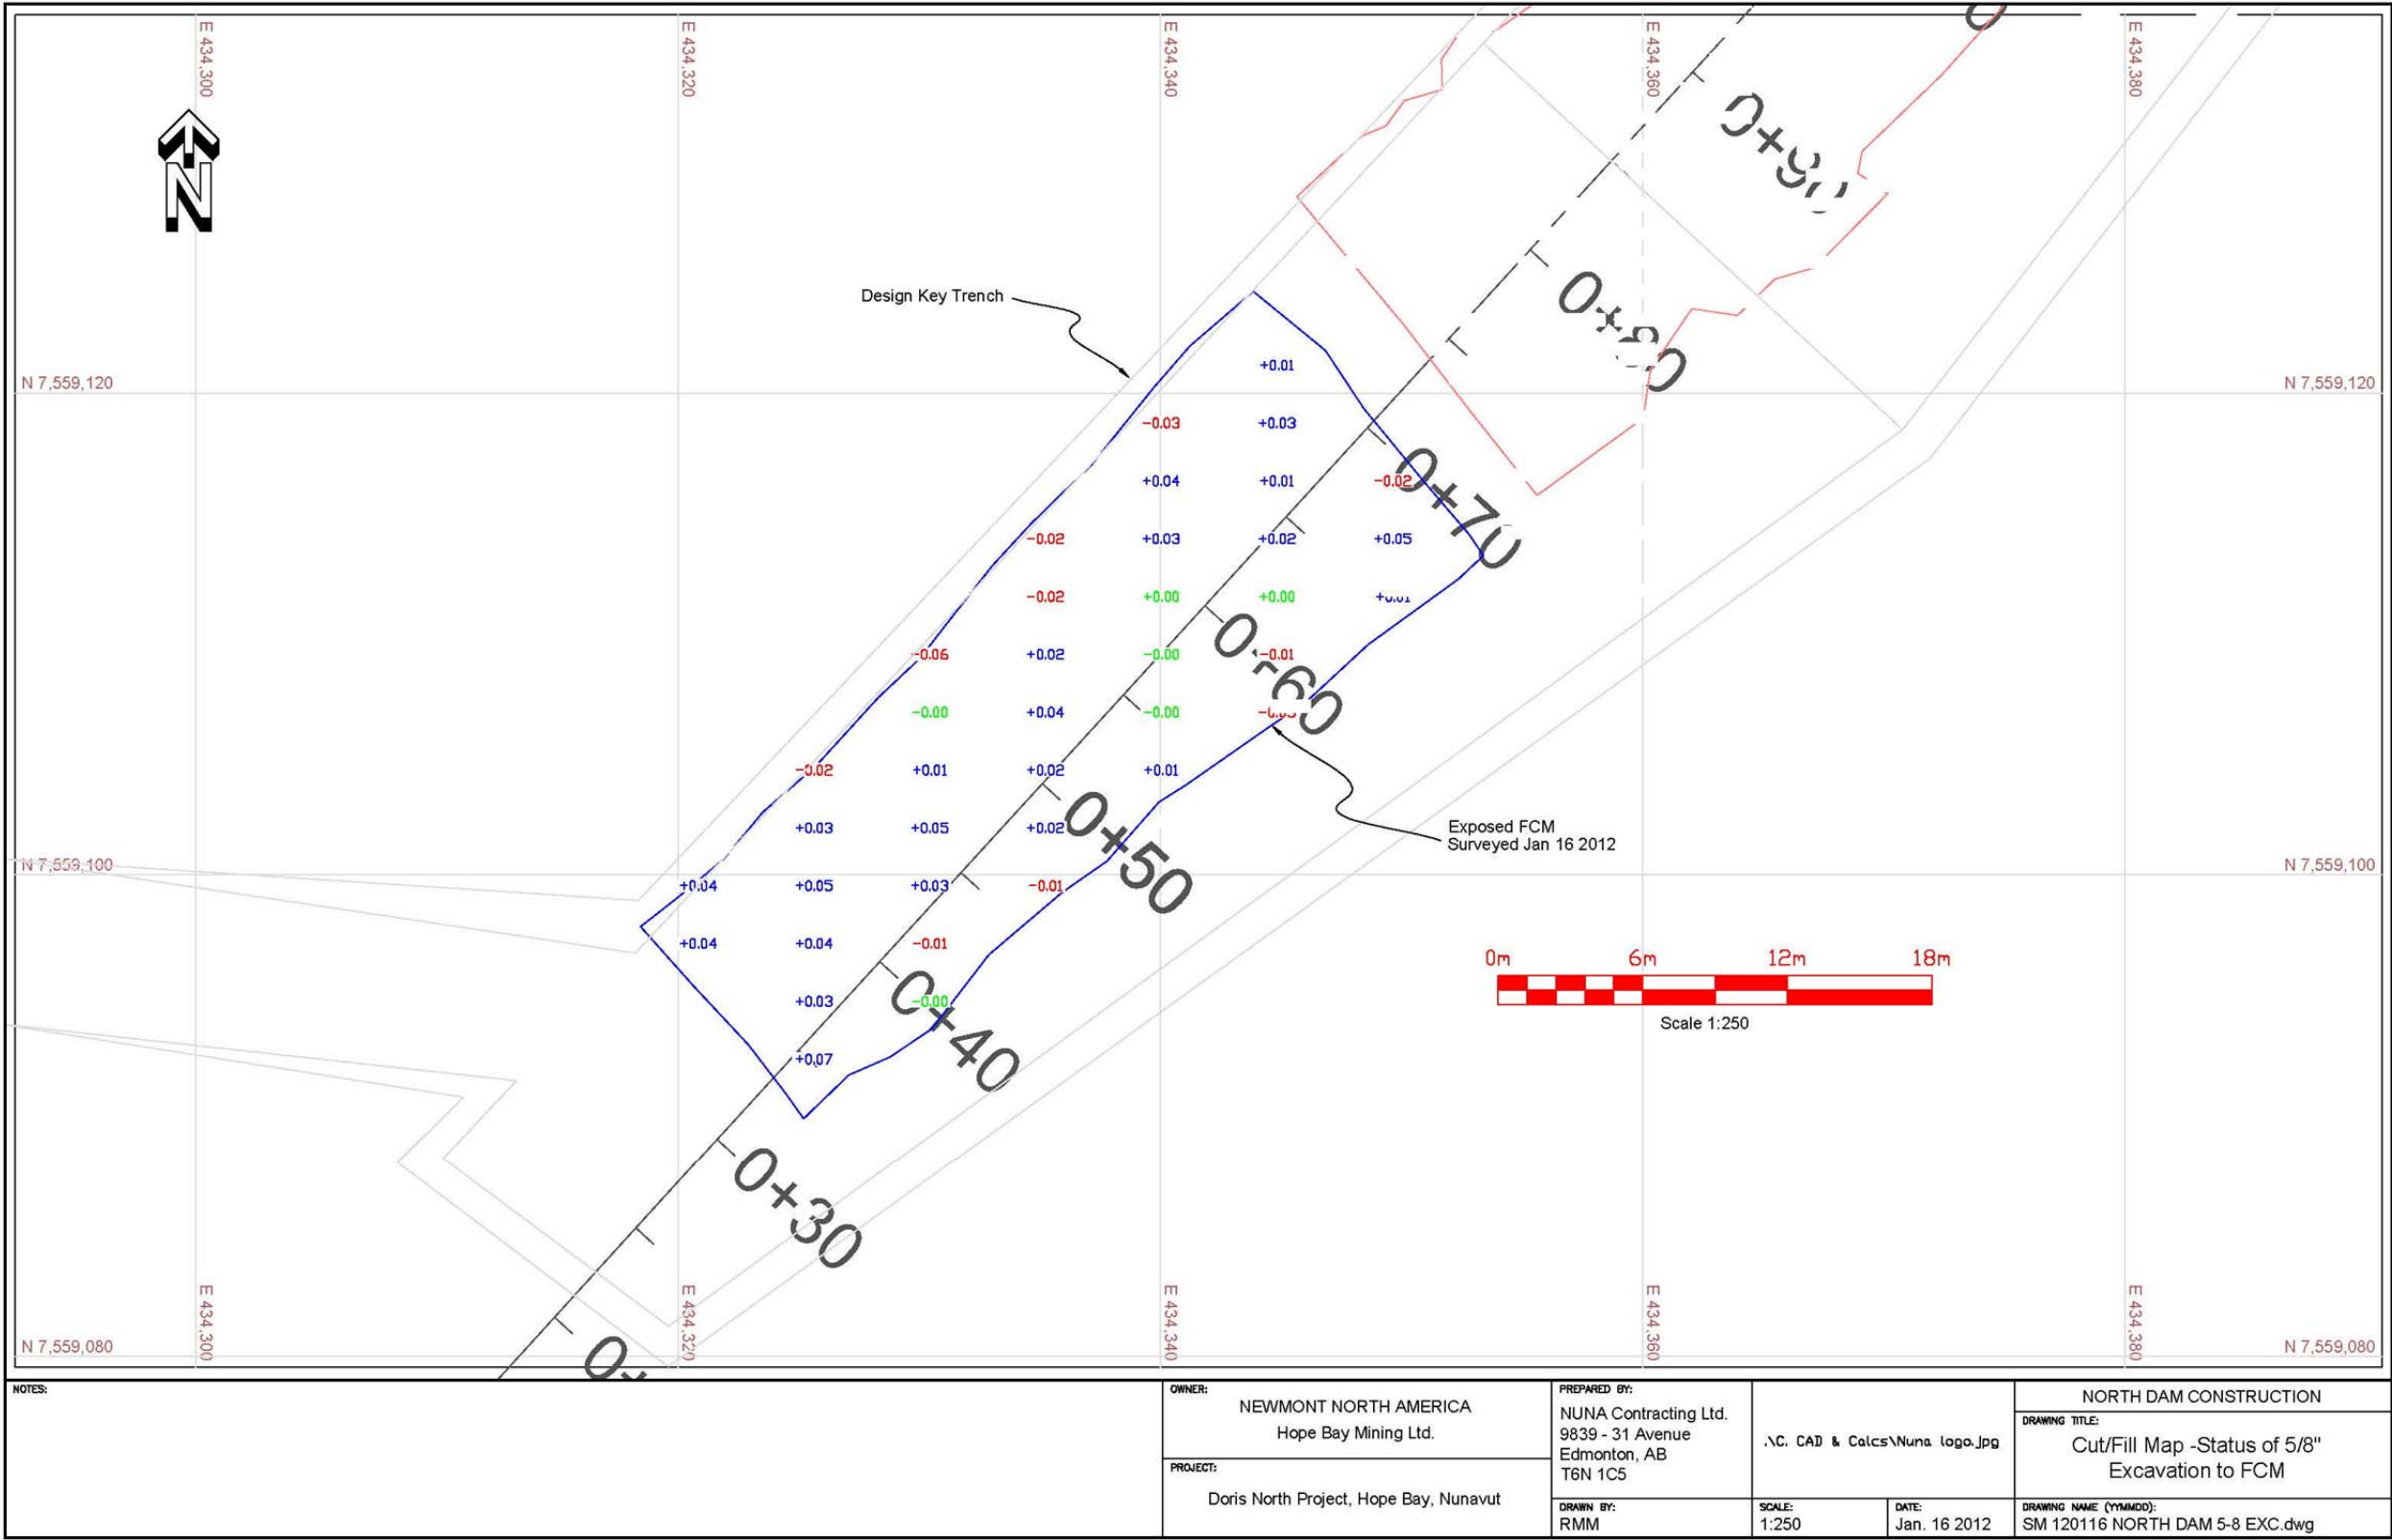
Figure - Nuna As-Built Review of Cover Material Excavation (i.e. Key Trench Cleaning) for 2012/01/16

- Note that the isopach points show the elevation difference from the 2011 Frozen Core elevation data (+ for above grade, - for cut /below)
