DAILY REPORT #122 – DORIS NORTH INFRASTRUCTURE/ NORTH DAM

Prepared by:	Lowell Wade	Date:	2012.05.06
Reviewed by:		Project #:	1CH008.058.0320
Role	Company	Personnel – Position	On Site
Client	Hope Bay Mining Limited (HBML)	Angela Holzapfel – ESR Compliance Manager David Vokey – ESR Coordinator Dean Wold - Safety Jill Turk – ESR Coordinator Katsky Venter – ESR Manger Michelle Tanquay – ESR Site Manager Stirling Kelly – HSLP Advisor	No No Yes Yes No No No
	JDS	Doug Fielding – Construction Manager Ishan Fechter – Construction Coordinator Jerry Graham – Construction Manager Mark Valeriot – Construction Manager Calvin Goldschmidt – Construction Coordinator	No Yes Yes No No
Engineering Design Consultants	SRK Consulting (Canada) Inc.	Lowell Wade-Site Engineer Lawrence Borowski – Site Engineer	Yes No
Earthworks Contractor	Nuna Logistics	Doug Haverland – Area/Site Superintendent Gary Sodhi – Field Engineer Georges Cornelissen – Survey Manager Jeff Roberts - Surveyor Jim Cardinal – Site Services Foreman Mike MacMaster – Surveyor Mike Price – Field Engineer Rick Peter – Foreman Trevor Sorken – Area/Site Superintendent	Yes Yes Yes No Yes No No Yes No

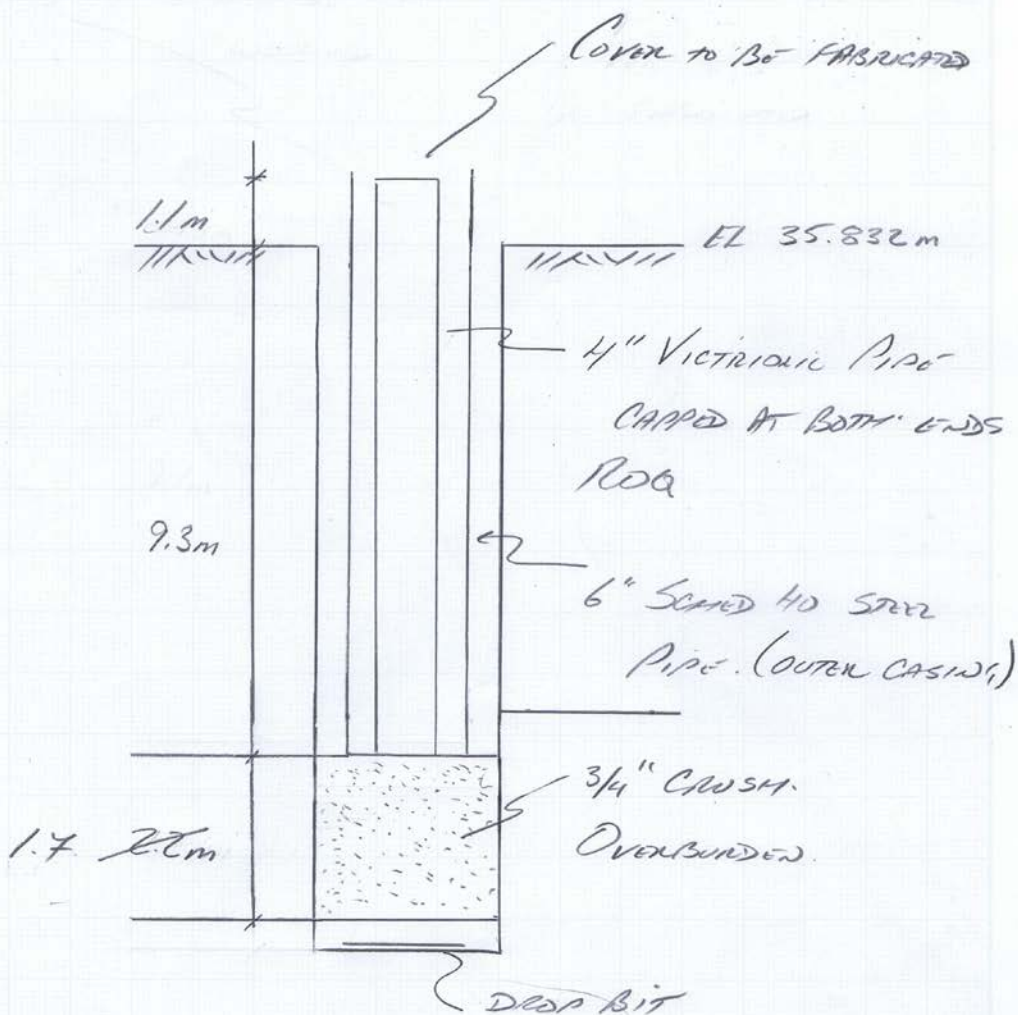
Subject ND-DSP-070 Sheet 1 of 1

OVERDRILLED BOREHOLE BACKFILLED WITH $\frac{3}{4}$ " CRUSH TO 0.5m BELOW
 BOTTOM OF CASING. QUANTITY OF CRUSH BASED ON SOUNDING = 0.0218 m^3
 ACTUAL QUANTITY OF CRUSH USED = 0.276 m^3 0.33 m^3

Figure 1: Borehole log for ND-DSP-070.

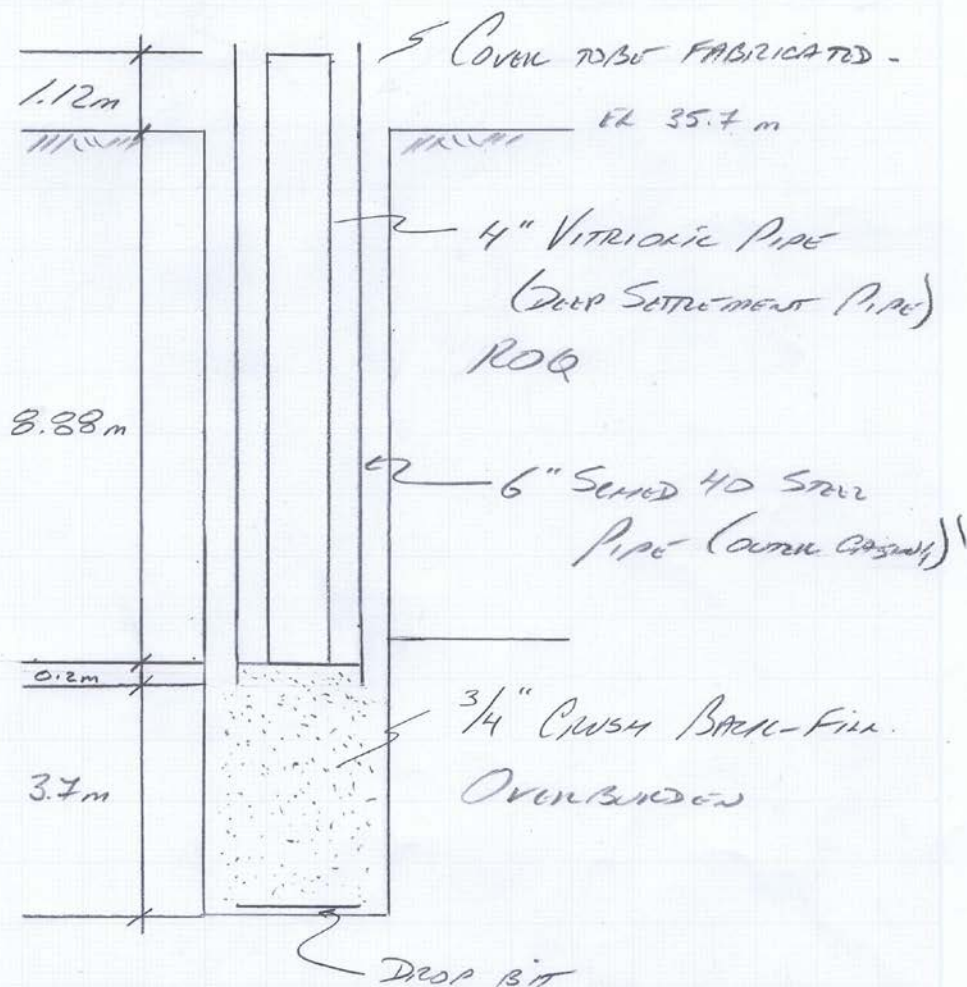
Subject ND-DSP-100

OVERDRILLED BOREHOLE BACKFILLED WITH $\frac{3}{4}$ " CRUSH
 QUANTITY OF CRUSH BASED ON SOUNDING = 0.049 m^3
 ACTUAL QUANTITY OF CRUSH USED = 0.091 m^3

Figure 2: Borehole log for ND-DSP-100.

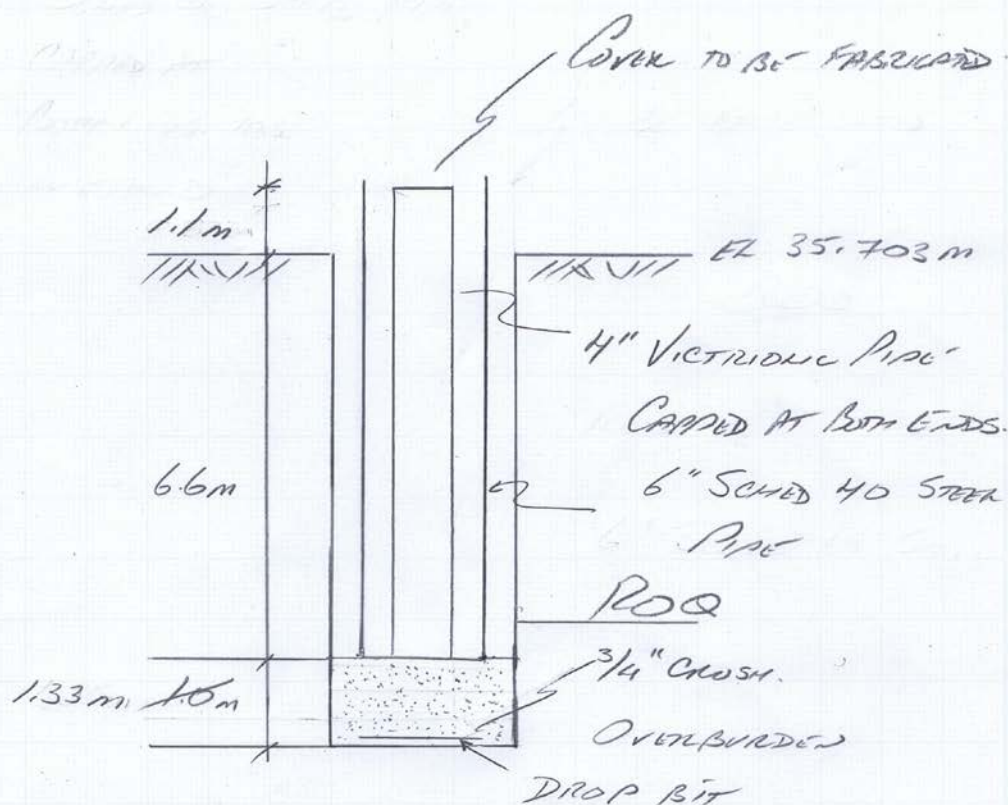
Subject ND-DSP-120 Sheet 1 of 1

OVER DRILLED BOREHOLE BACK FILLED WITH $\frac{3}{4}$ " CRUSH
 TO 0.5m BELOW BOTTOM OF CASING,
 QUANTITY OF $\frac{3}{4}$ " CRUSH MATERIAL BASED ON SOUNDING,
 BOREHOLE = $0.015 \text{ m}^3 = 4 \text{ U.S. GALLONS}$
 ACTUAL QUANTITY OF $\frac{3}{4}$ " CRUSH USED = 0.087 m^3
 0.104 m^3

Figure 3: Borehole log for ND-DSP-120.

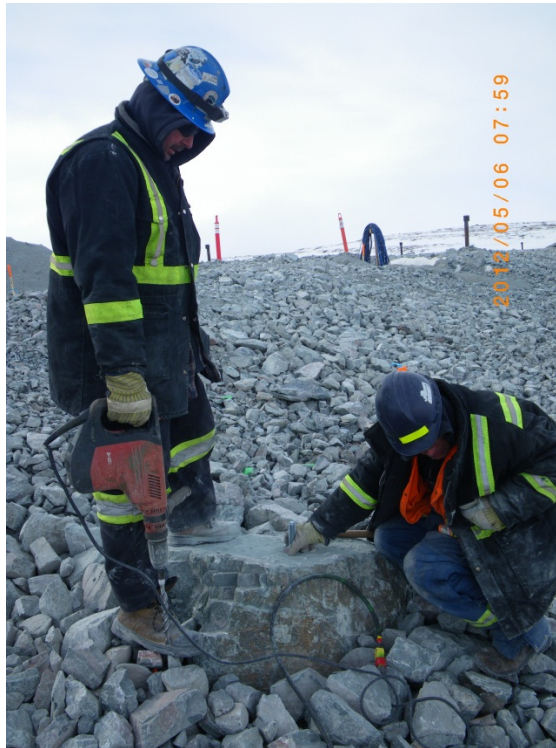
Photo 1: Installation of survey pins in the surface survey points.

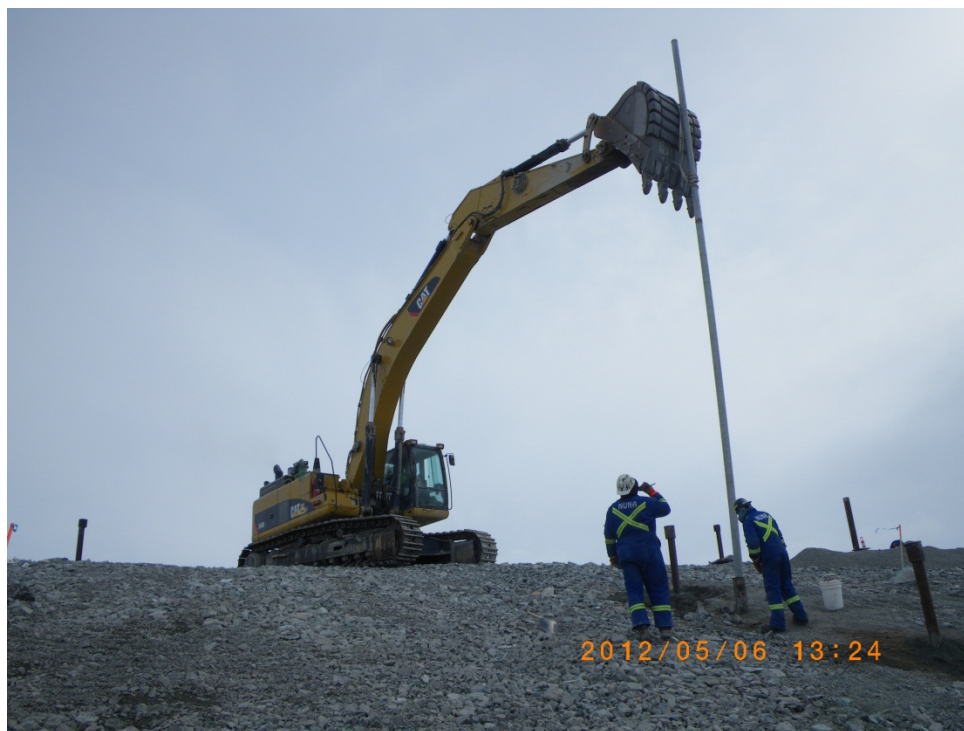
Photo 2: Installation of the last Deep Settlement Pipe into ND-DSP-070.

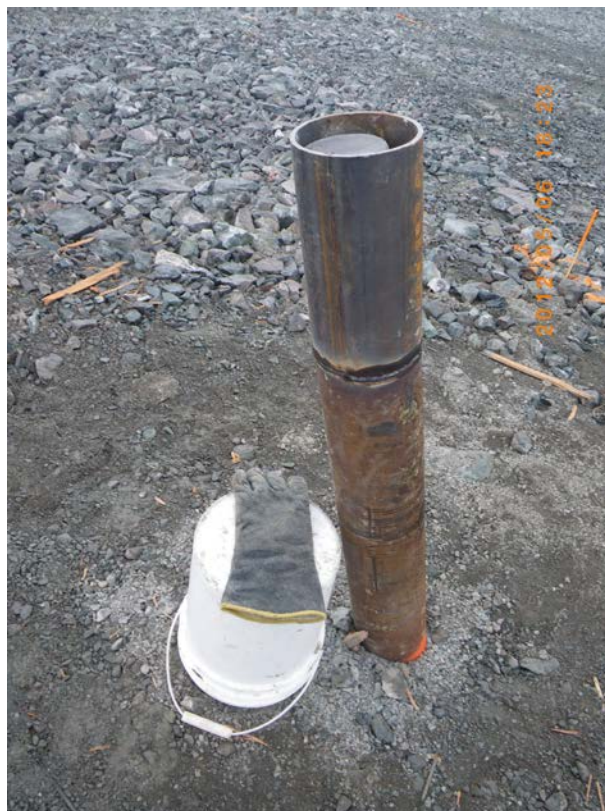
Photo 3: Final inspection of ND-DSP-120.

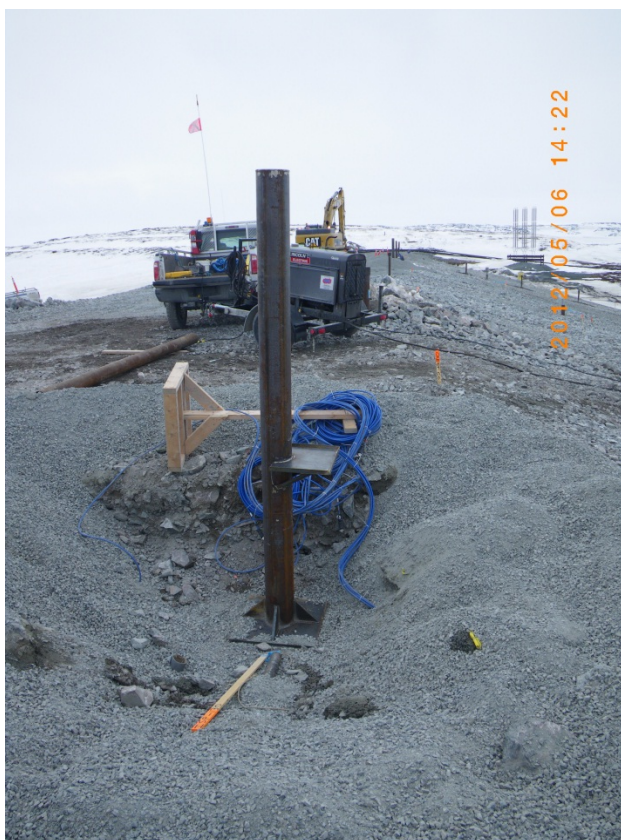
Photo 4: Installation of the ND-ISP monuments.

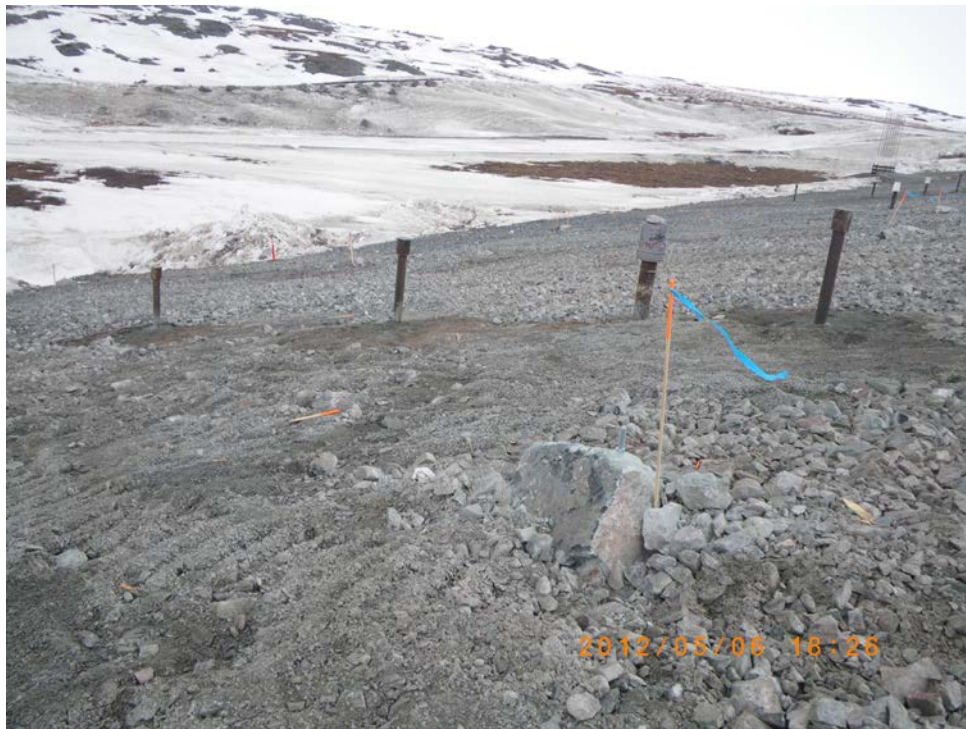
Photo 4: All the instrumentation on the downstream face of the dam has been installed.

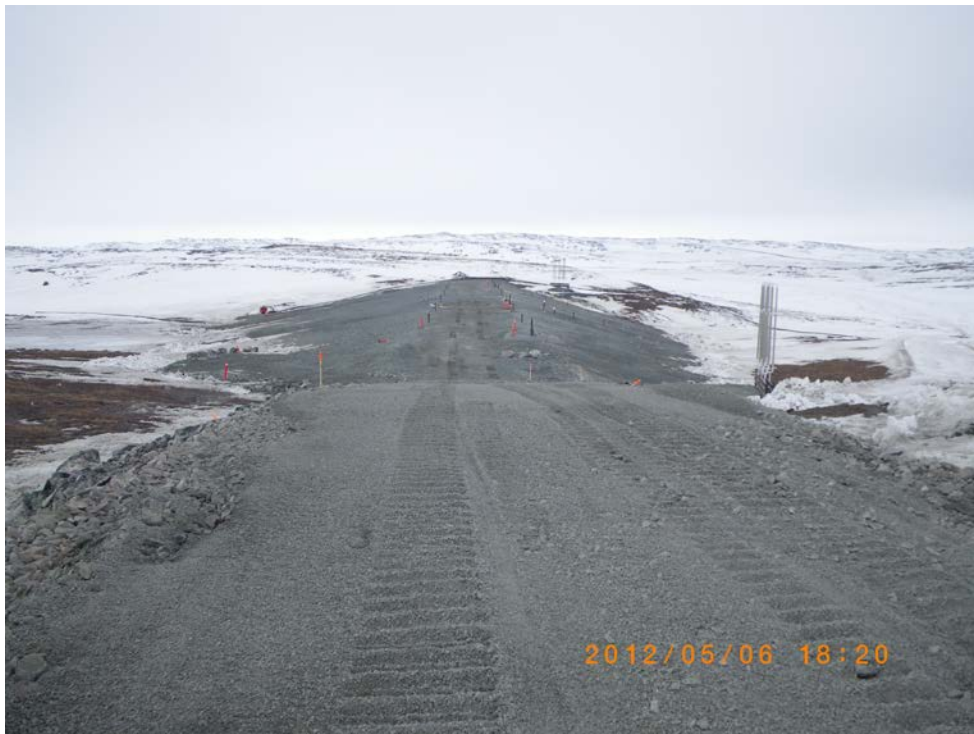
Photo 5: Looking down on the North Dam from the Access Road. The Access Road is being brought up to grade.
