DAILY REPORT #12 – DORIS NORTH INFRASTRUCTURE/ NORTH DAM

Prepared by:	John Kurylo/ Jeff Orr	Date:	2012.01.17
Reviewed by:		Project #:	1CH008.058.0320
Role	Company	Personnel – Position	On Site
Client	Hope Bay Mining Limited (HBML)	Angela Holzapfel – ESR Compliance Manager David Vokey – ESR Coordinator Don Ethelston – HSLP Advisor Dean Wold - Safety Jill Turk – ESR Coordinator Katsky Venter – ESR Manger Michelle Tanquay – ESR Site Manager Stirling Kelly – HSLP Advisor	No Yes No No No No Yes Yes
	JDS	Lloyd Jackson – Mechanical Superintendent Sven Archimowtiz – Electrical Superintendent Doug Fielding – Construction Manager Ishan Fechter – Construction Coordinator Jerry Graham – Construction Manager Kevin Whieldon – Project Coordinator Mark Valeriote – Construction Manager	Yes Yes No Yes Yes No No
Engineering Design Consultants	SRK Consulting (Canada) Inc.	John Kurylo – Site Engineer Megan Miller – Site Engineer Lawrence Borowski – Site Engineer Murry McGregor – Site Engineer Lowell Wade – Senior Engineer	Yes No No No No

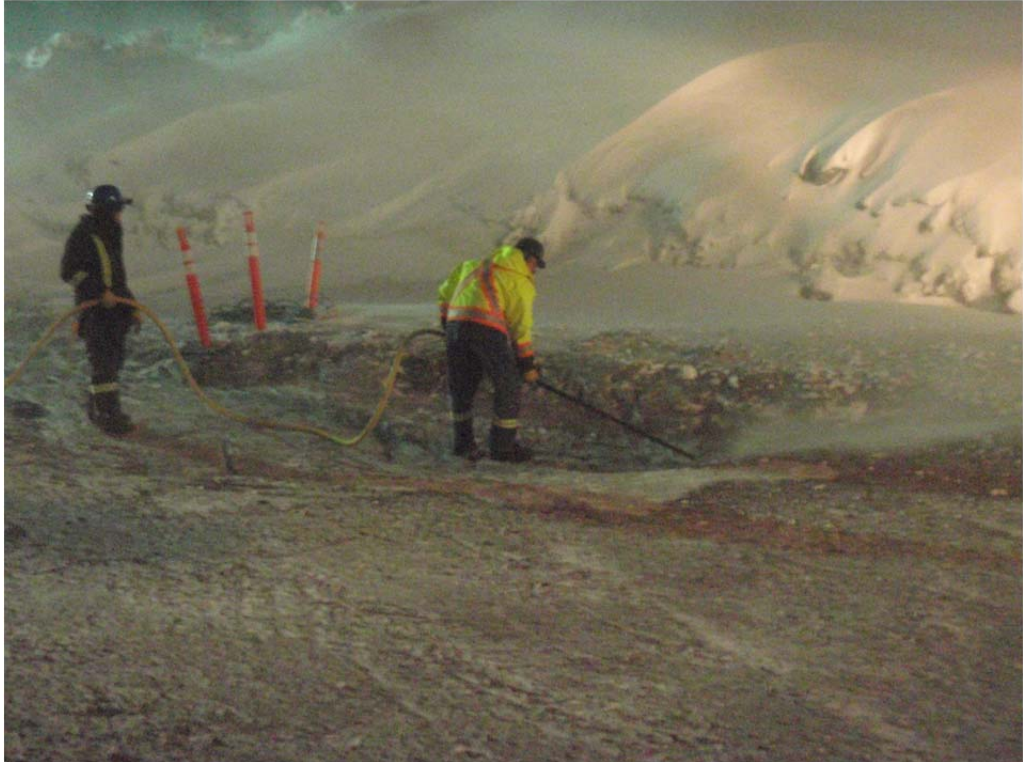
- The remaining metal fragments, from the location where the culvert sump was previously located (around station 0+85), were ripped out. This area was approved for placement after cleaning.

Photo 1: Compressed air blow hose being used to clean around the removed sump location (around station 0+85).

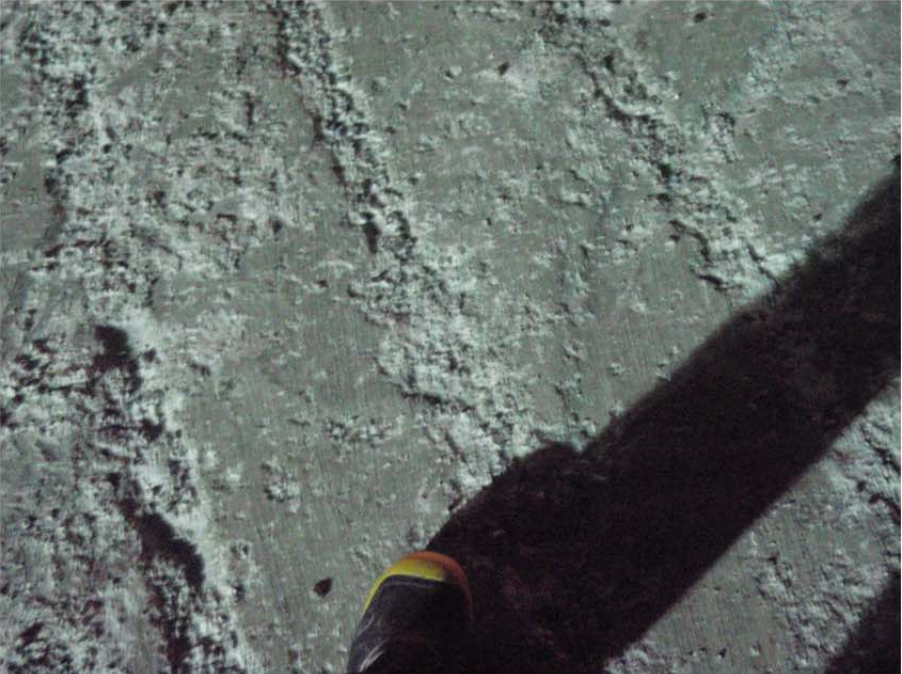
- 5/8" clearing from ~ 0+35 to 0+70 (see isopachs in SRK Daily #11) was inspected today.
 - Some 5/8" material, that could still be readily scraped from the surface (could be kicked up by boot) remains in this area. Additional clearing (likely with excavator with finishing bucket) is still required.

Photo 2: Close up view of surface cleaning around station 0+60. Note that this 2011 frozen core can be observed at this surface. This area is near a grade acceptable for placement.

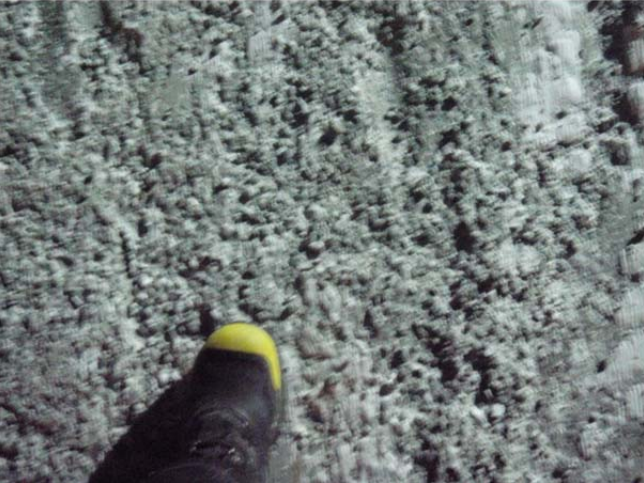
- The 5/8" material on the higher elevation key trench sides is not fully saturated and is not combined in with the core, like portions of the 5/8" material in the central area was.

Photo 3: Close up view of surface cleaning around station 0+50. Note that frozen and loose 5/8" material is observed at this surface. This area required further scraping (likely with an excavator with a finishing bucket) before approval for placement. Note that the 5/8" material higher on the slope is less saturated and not incorporated into the FCM like it was observed to be in the central area.

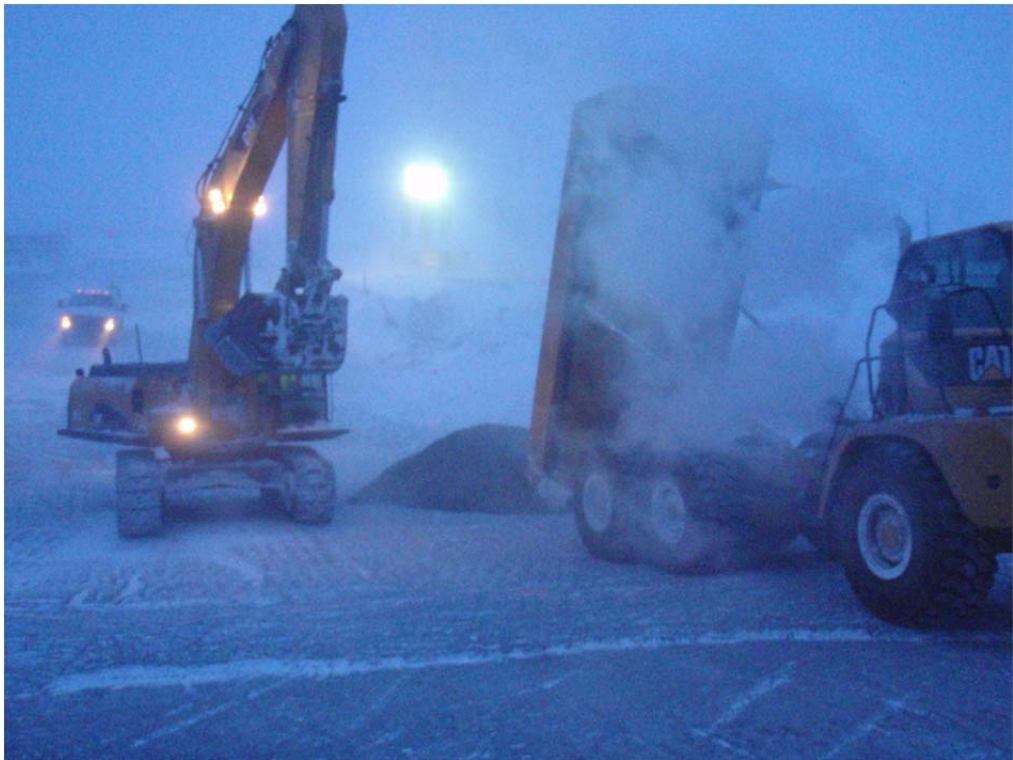
Photo 5: ~ E view of FCM starting to be placed around, 0+85 over frozen lift placed on 2012/01/15.

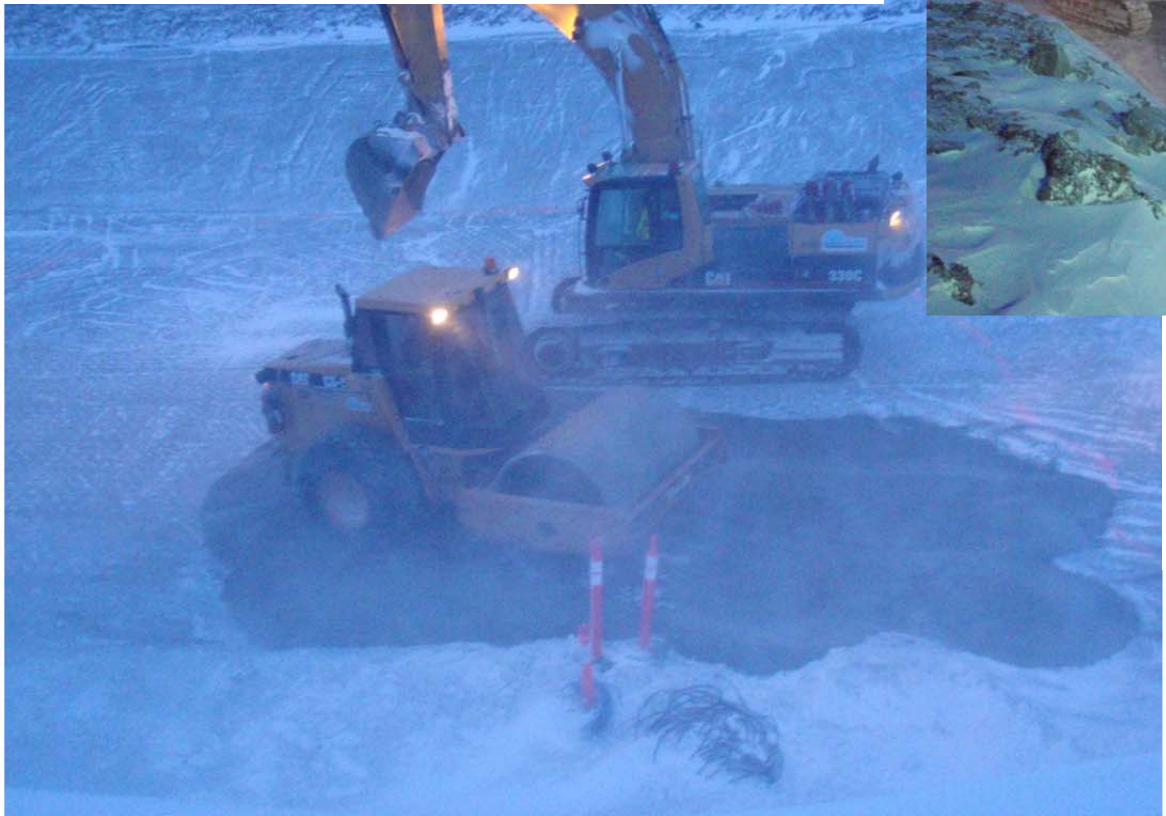
Photo 6: Smooth drum compacting FCM, placed by the 330C excavator around station 0+80 to 0+90, ~ ESE view.

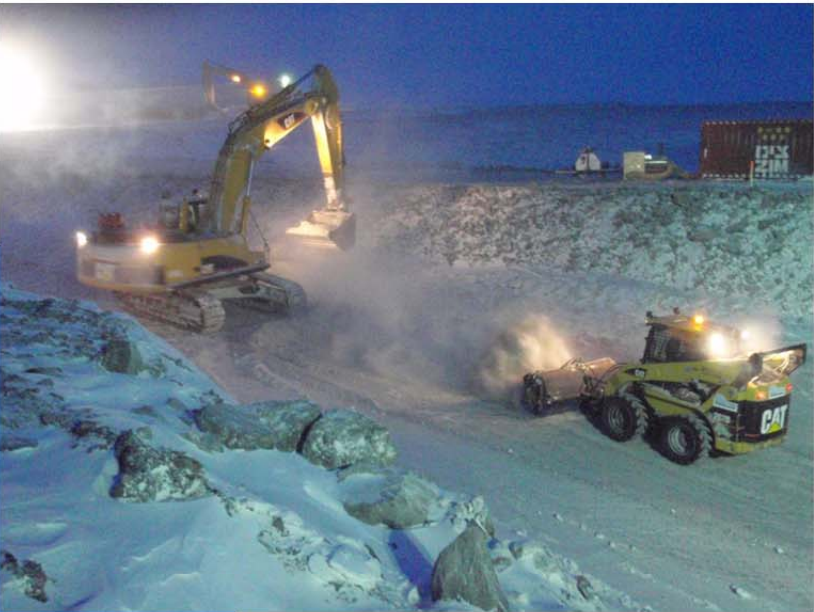
- An additional area from ~1+00 to 1+17 was cleaned for placement. No placement resulted on this section and additional snow clearing will now be required.

Photo 4: Bobcat with brush and excavator cleaning key trench from ~ 1+00 to 1+17, ~ E view.

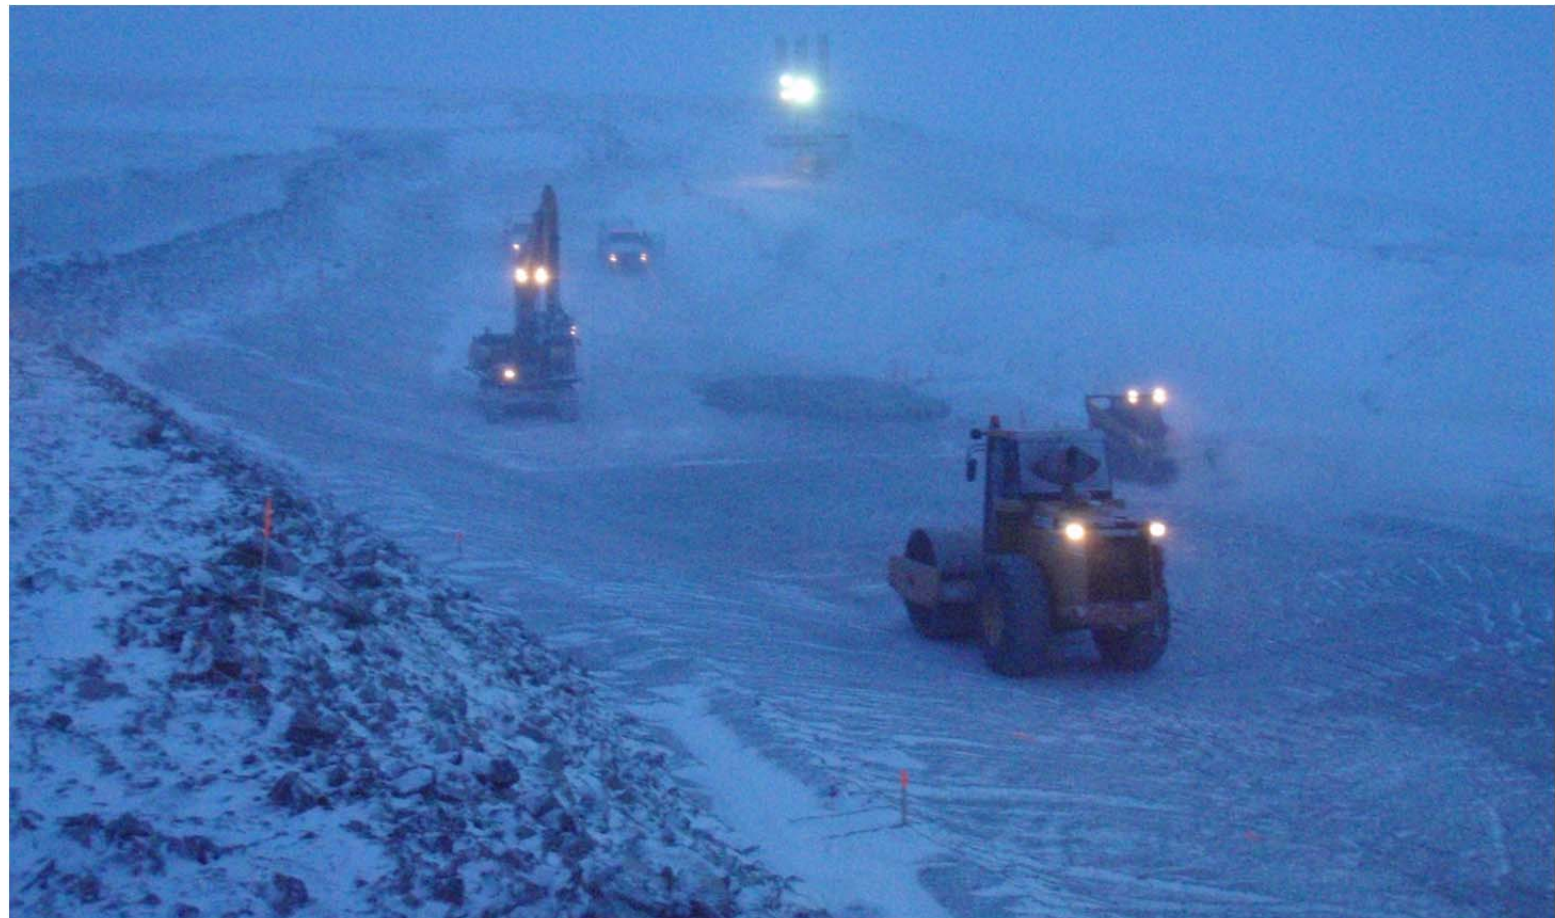
Photo 7: ~W view of construction progress in the key trench. Note that this picture was taken after the first two loads of FCM were placed today.

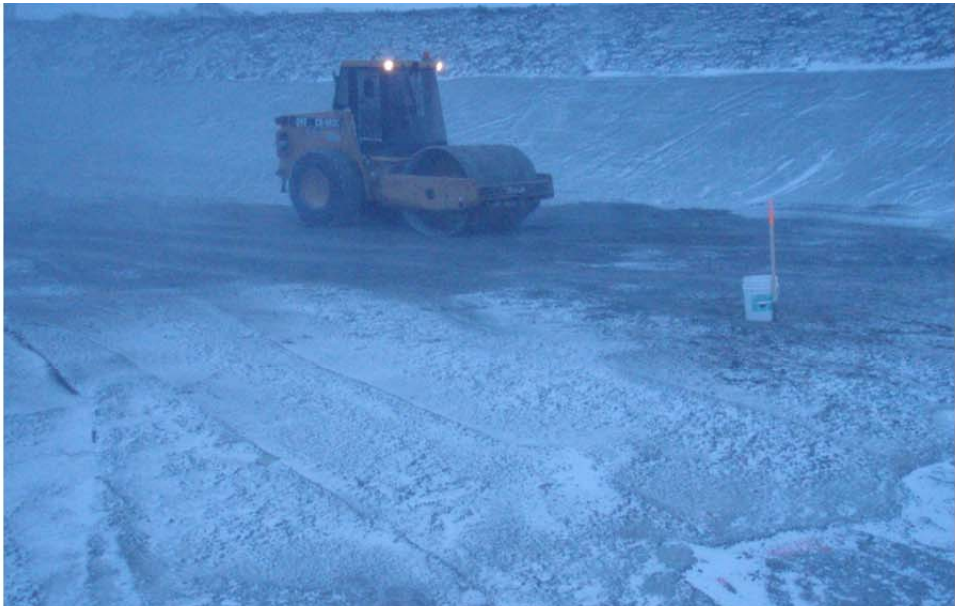
Photo 9: Smooth drum vibratory compactor packing FCM around the inflection point of the key trench. Note the installed single bead thermistor in the white bucket.

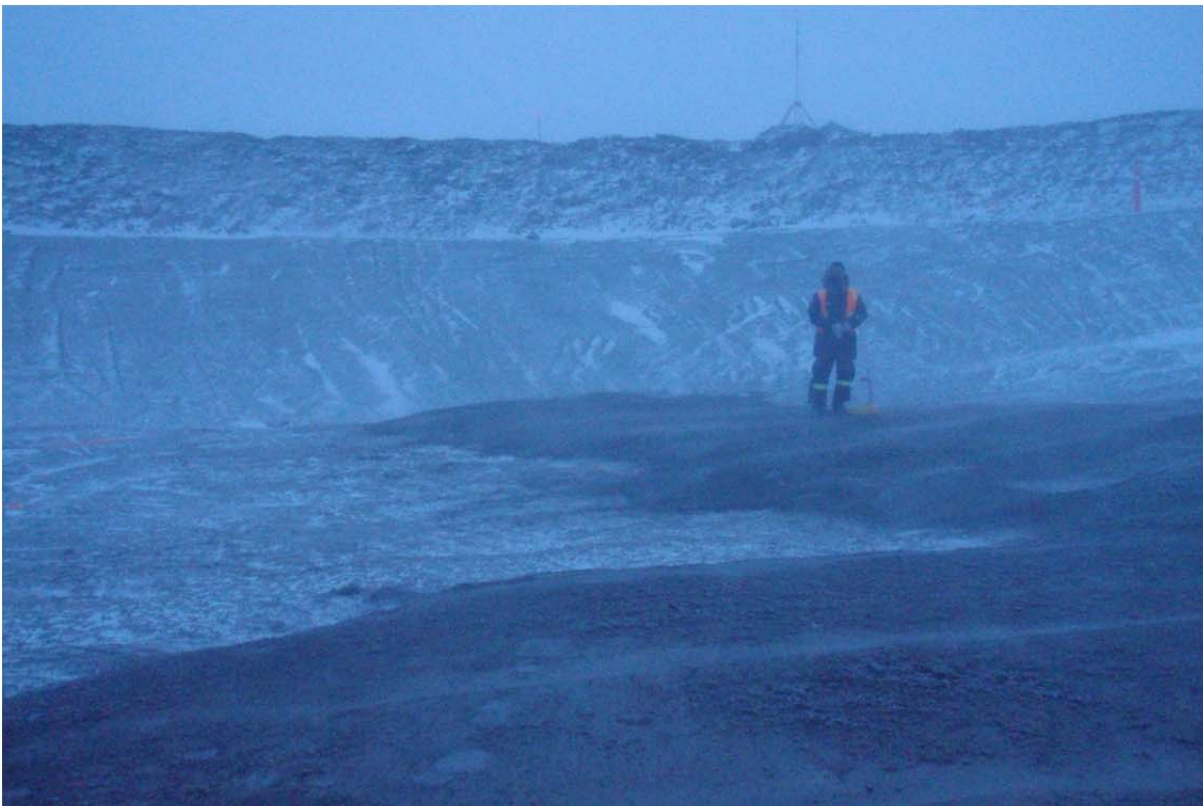
Number of Tests	Material	Tested By	Shift	Notes
4	2:3 FCM	JO	Day	All Passed

Photo 8: Compaction testing around station 0+80 in the key trench.

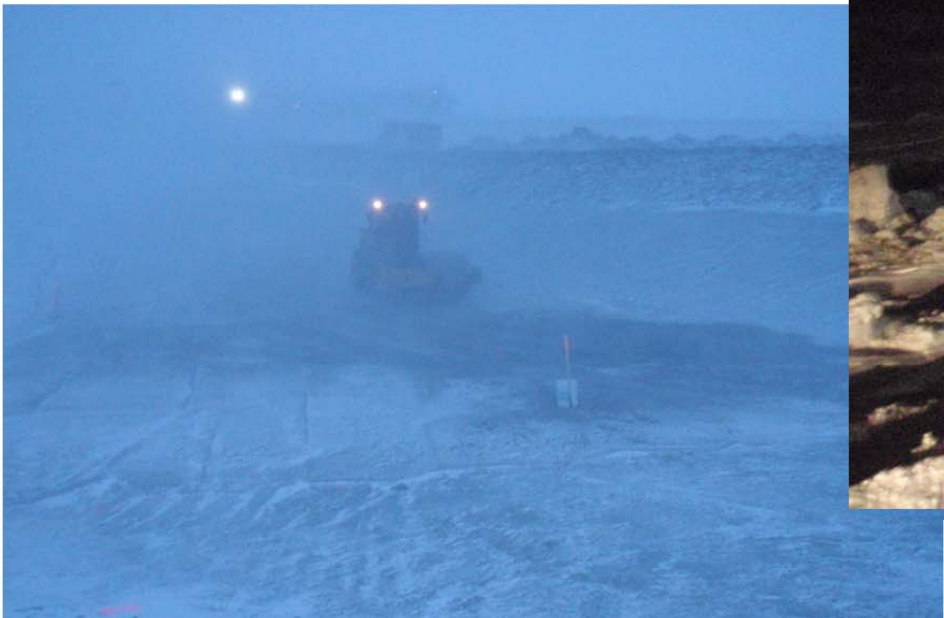
Photo 10: View of FCM placed today around the central portion of the key trench ~ 0+80 to 1+00. Note that conditions are progressing towards 'white out'.

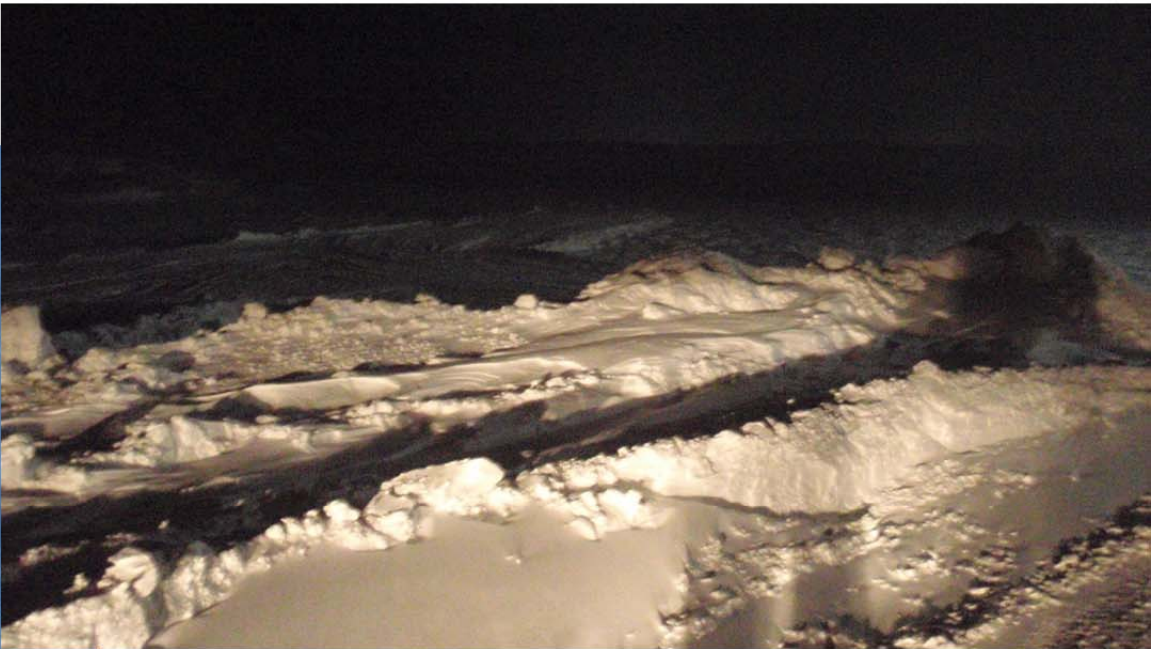
Photo 11: ~NE view towards the snow road construction around the Doris North Diversion Berm footprint.

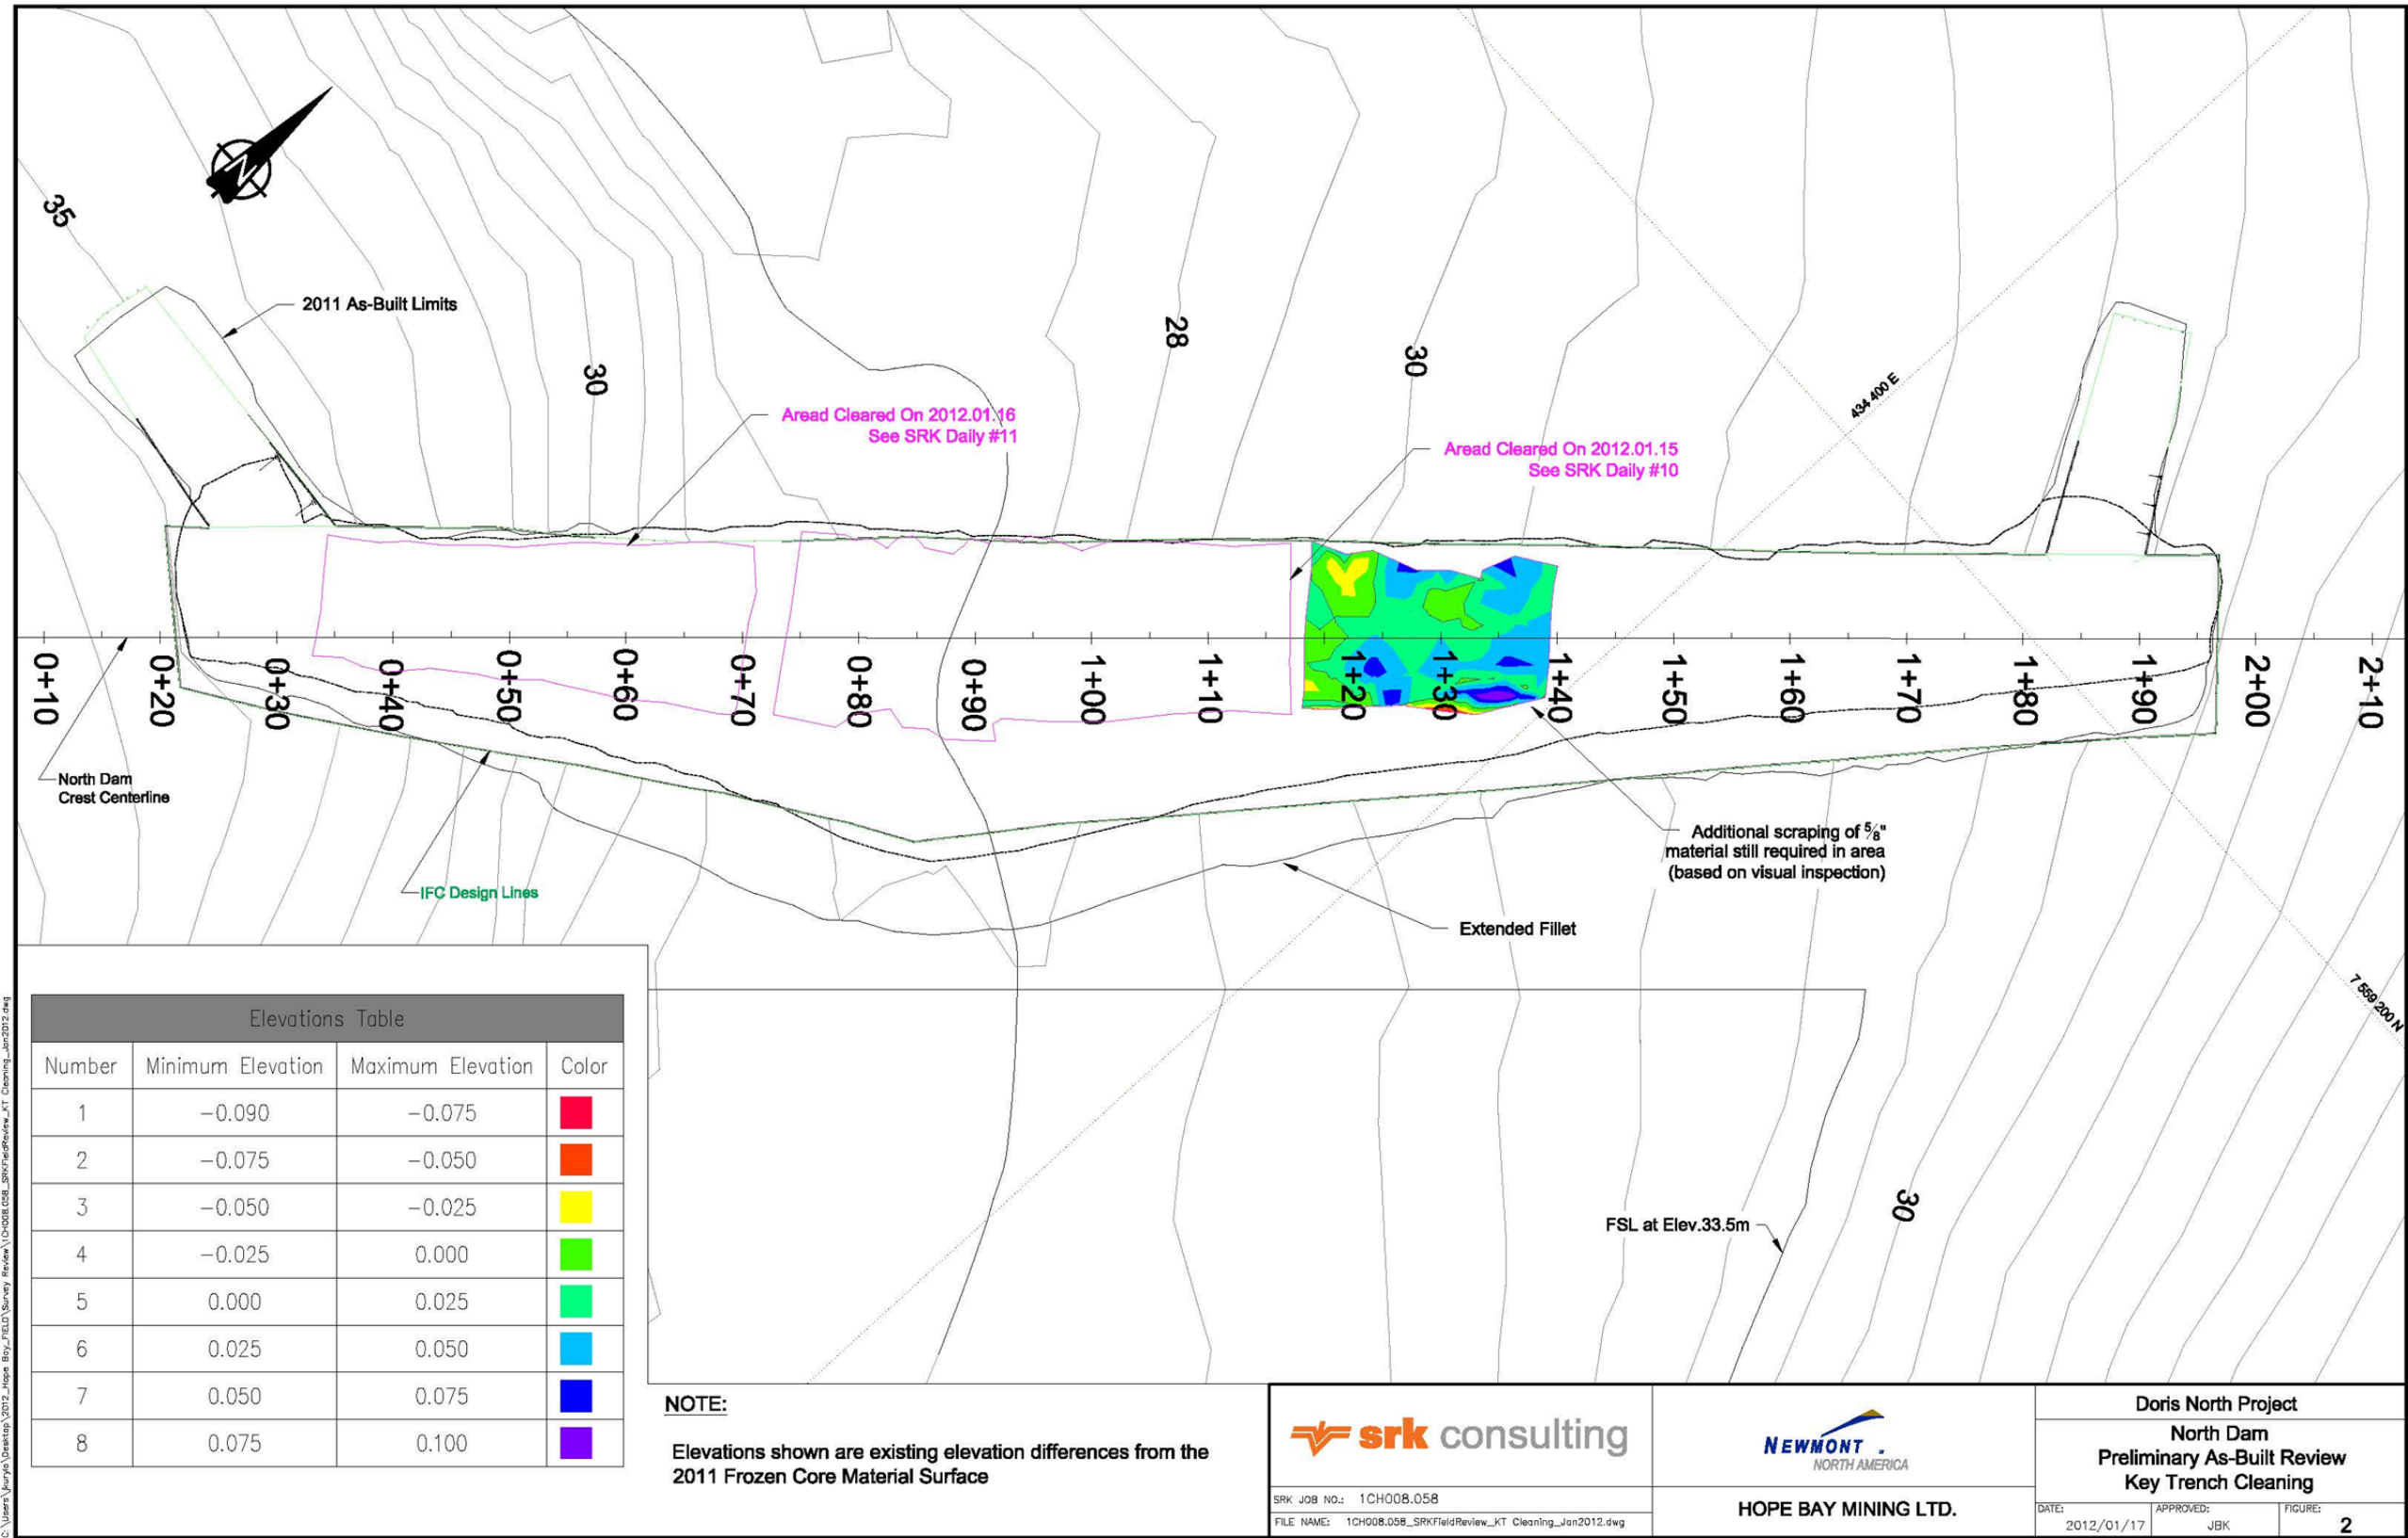
- SRK completed a preliminary isopach review to compare the existing key trench elevation to the 2011 FCM surface from ~ station 1+17 to 1+38. In general the existing surface was noted to be typically 0 to 0.05m (0.2m avg) above the 2011 FCM grade in this section. Details of this review are provided in the Figure section of this report.

Figure - SRK Preliminary As-built review of Key Trench cleaning (5/8" material removal) completed on 2012/01/17, ~ between 1+17 and 1+38.
- Note that the existing elevation, in relation to the 2011 FCM surface, is shown in the isopach below.

- Additional clearing (likely with the excavator and finishing bucket) is required on section 1+17 to 1+38 to remove some unsaturated 5/8" clear material.

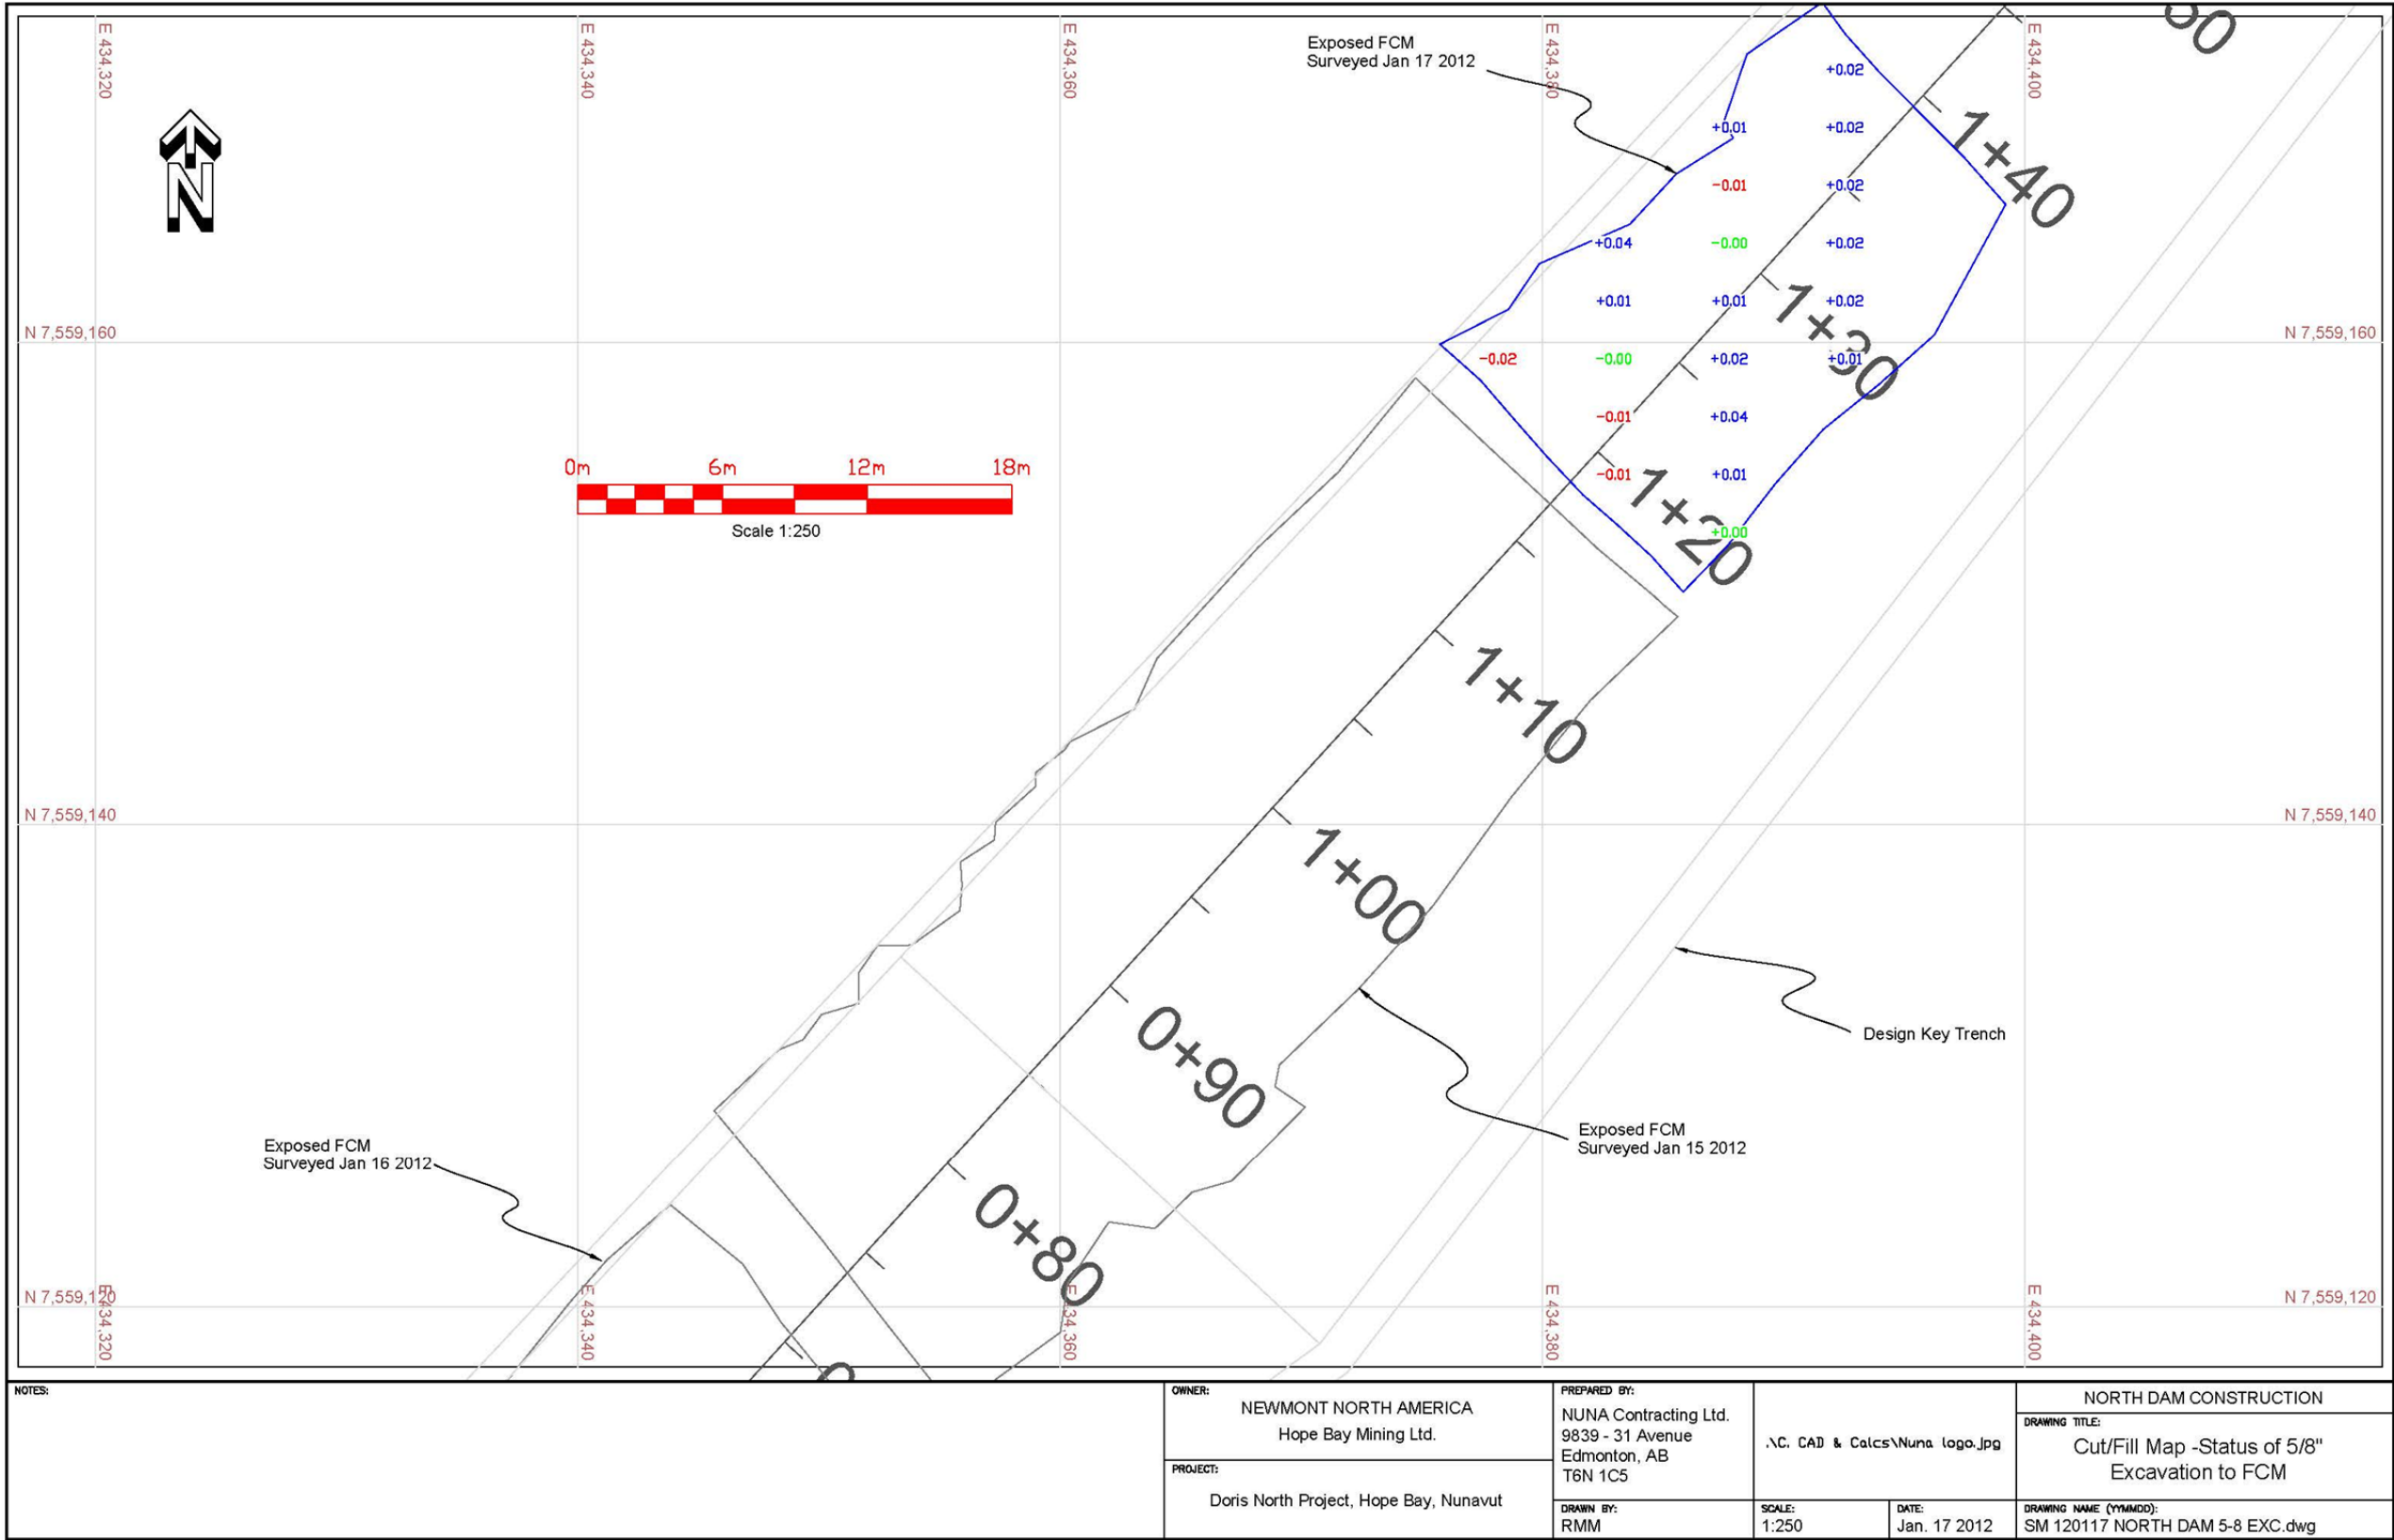
- Nuna survey picked up and as-built of the existing key trench excavation/ clearing progress (from ~ chainage 1+17 to 1+38).
 - Nuna survey completed a preliminary isopach for the key trench clearing around 1+17 to 1+38 (see Figure section of this report).

Figure - Nuna As-built review of Cover Material excavation (i.e. Key Trench Cleaning) for 2012/01/17, ~ between stations 1+17 and 1+38.
- Note that the isopach points show the elevation variances from the 2011 Frozen Core surface (+ for above grade, - for cut /below)
