## DAILY REPORT #13 – DORIS NORTH INFRASTRUCTURE/ NORTH DAM

Prepared by:	John Kurylo/ Jeff Orr	Date:	2012.01.18
Reviewed by:		Project #:	1CH008.058.0320
Role	Company	Personnel – Position	On Site
Client	Hope Bay Mining Limited (HBML)	Angela Holzapfel – ESR Compliance Manager David Vokey – ESR Coordinator Don Ethelston – HSLP Advisor Dean Wold - Safety Jill Turk – ESR Coordinator Katsky Venter – ESR Manger Michelle Tanquay – ESR Site Manager Stirling Kelly – HSLP Advisor	No Yes No No No No Yes Yes
	JDS	Lloyd Jackson – Mechanical Superintendent Sven Archimowtiz – Electrical Superintendent Doug Fielding – Construction Manager Ishan Fechter – Construction Coordinator Jerry Graham – Construction Manager Kevin Whieldon – Project Coordinator Mark Valeriote – Construction Manager	Yes Yes No Yes Yes No No
Engineering Design Consultants	SRK Consulting (Canada) Inc.	John Kurylo – Site Engineer Megan Miller – Site Engineer Lawrence Borowski – Site Engineer Murry McGregor – Site Engineer Lowell Wade – Senior Engineer	Yes No No No No

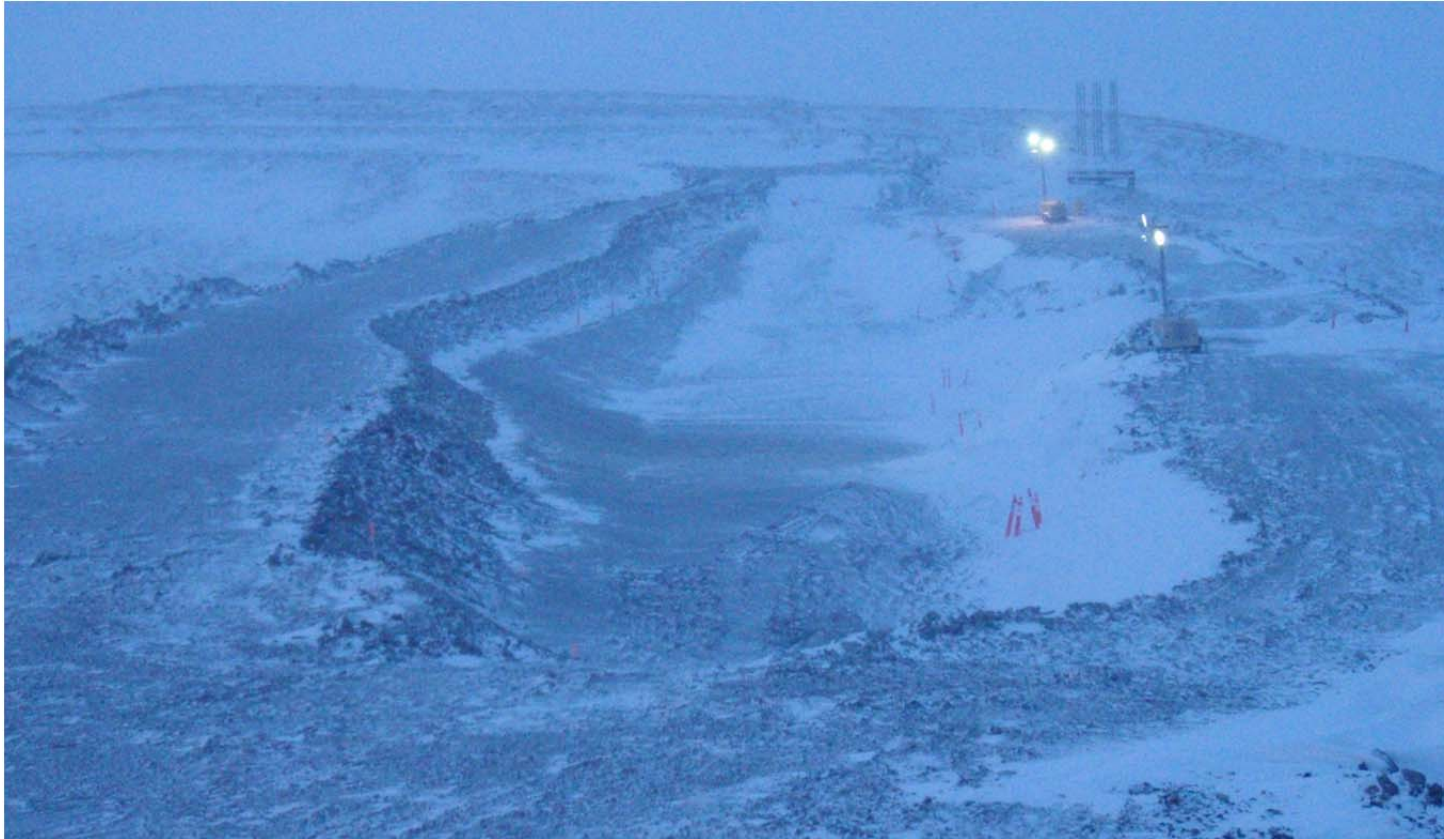
**Photo 1:** ~SWW view down key trench after ‘white out’ conditions were changed to Level 1 conditions in the am. Note the snow that has built up against the downstream bank of the key trench.

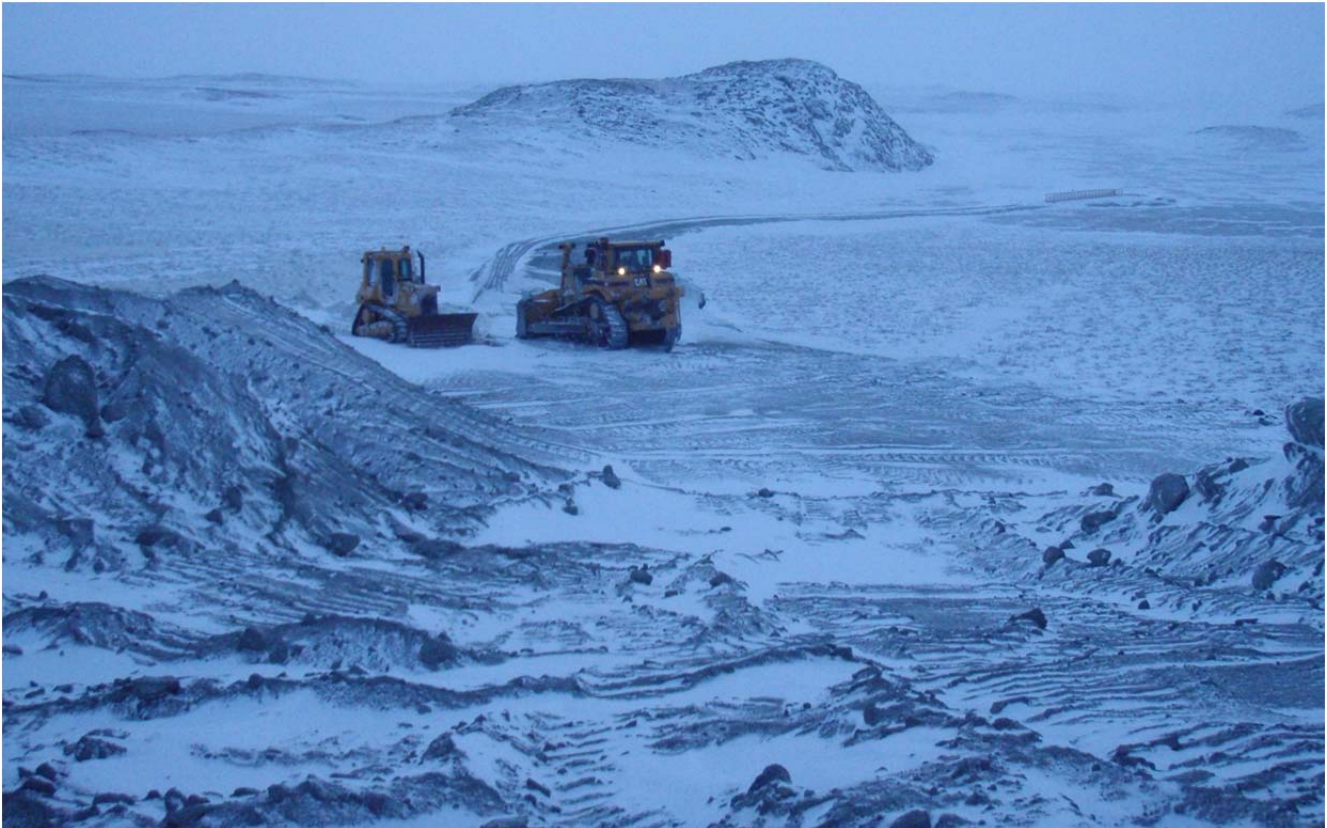
**Photo 3:** ~SE view from the FCM stockpile on the FCP Pad. Looking towards the Tail Lake Access Road (in the background). Note that this is the area that the Dozer was working on and the area where the loader has been loading the hopper from.

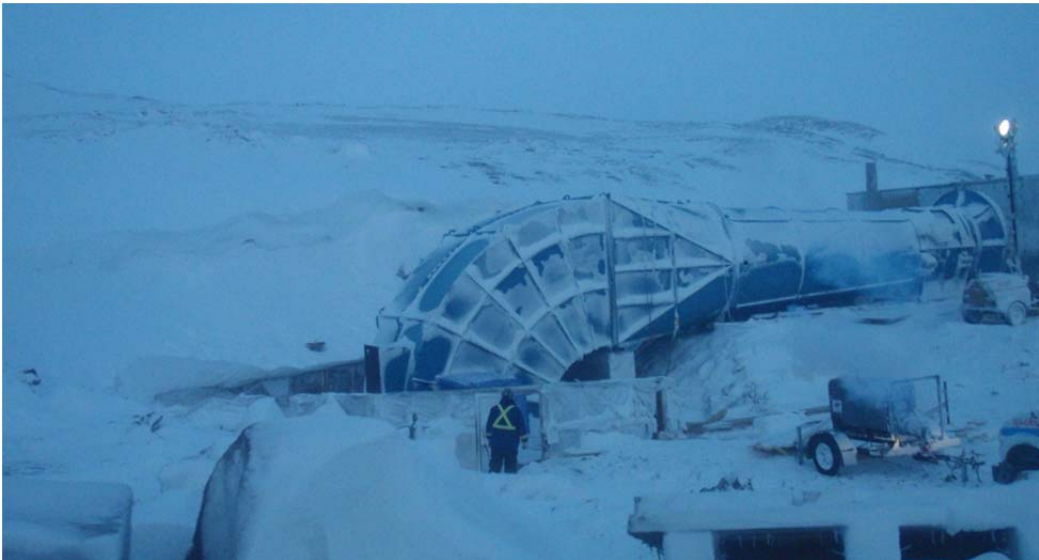
**Photo 2:** ~ ENE view of the Doris North Vent Raise.

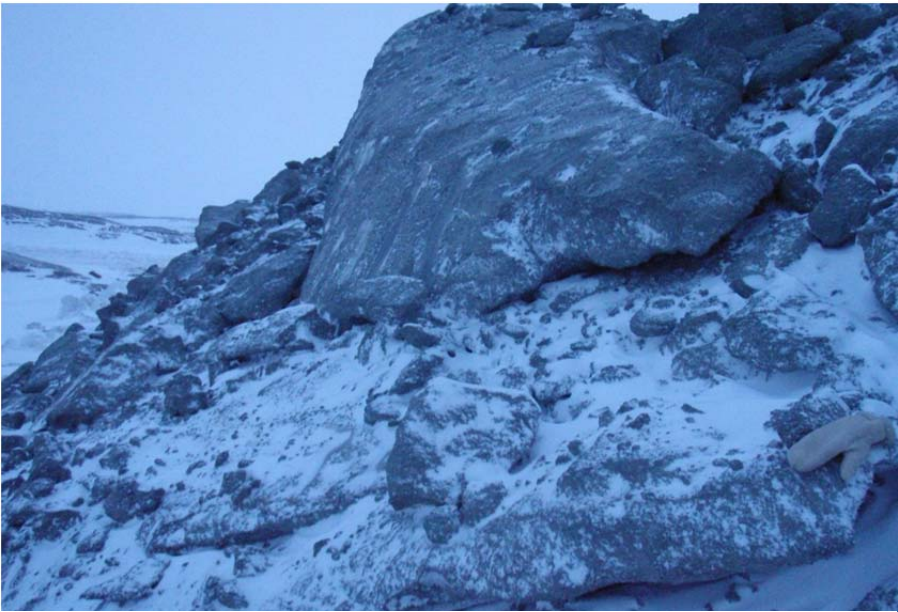
- Material production at the frozen core plant was started around 16:30. Consistency of material was posing problems due to frozen lumps in the feed stock at the plant. Moisture contents were variable due to the inconsistent feed.
  - Had to stop around 17:30 due to belt from hopper getting clogged up. When belt clogged feed became to wet. Some partial trucks sent to reject pile by plant operators at each stop/ start.
  - At 18:05 the plant stopped again due to issues with getting power to outside feed belt. An electrician is planned to visit the FCP plant to investigate this issue.
- The 345 DL excavator with toothed buckets worked on breaking up frozen clumps at the FCM stockpile, on the FCP Pad.
- In total 39 loader buckets were loaded into the FCP hopper during today's production.

**Photo 4:** View of large chunks of frozen material that have been dozed off the top of the FCM stockpile, on the FCP Pad. This picture was taken of the N side of the stockpile.

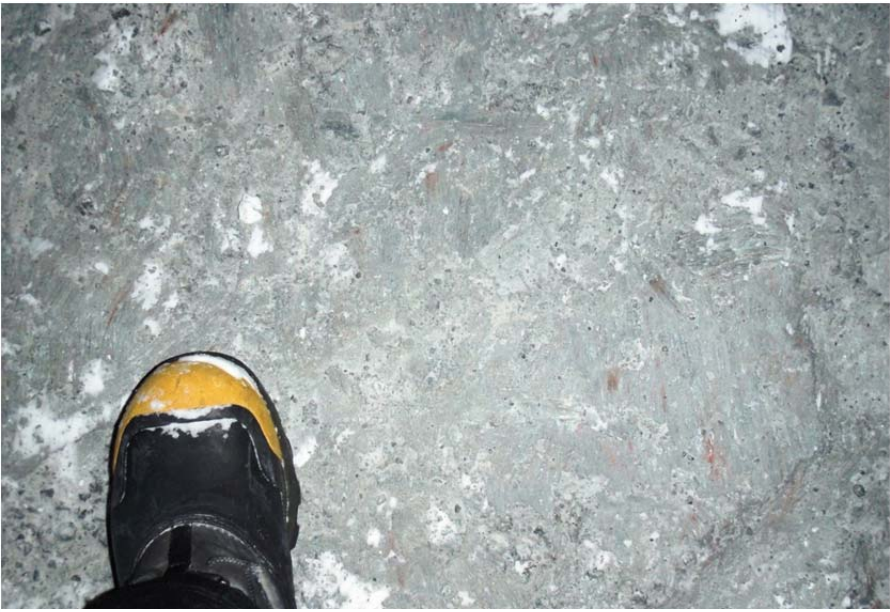
**Photo 5:** Close-up view of appearance of typical key trench base after most of 5/8" clear material has been removed, taken around station 1+00 before dental cleaning.

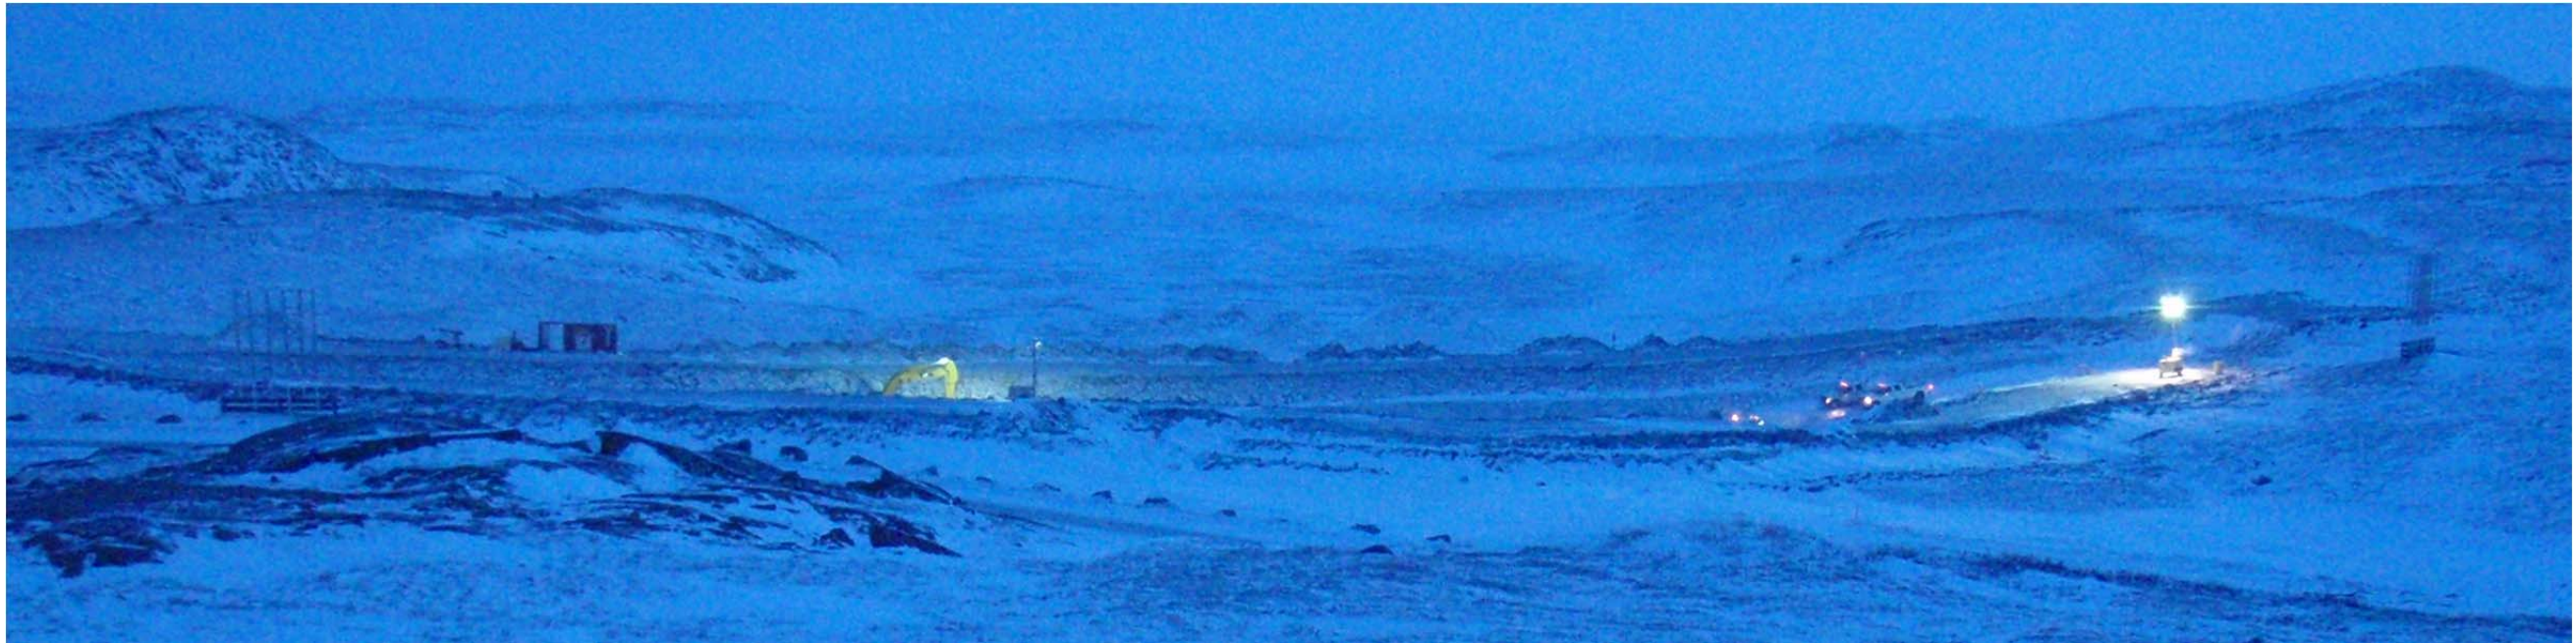
**Figure 6:** Progress photo of the North Dam construction from Photo Point 1; taken in the pm, ~ SE view.

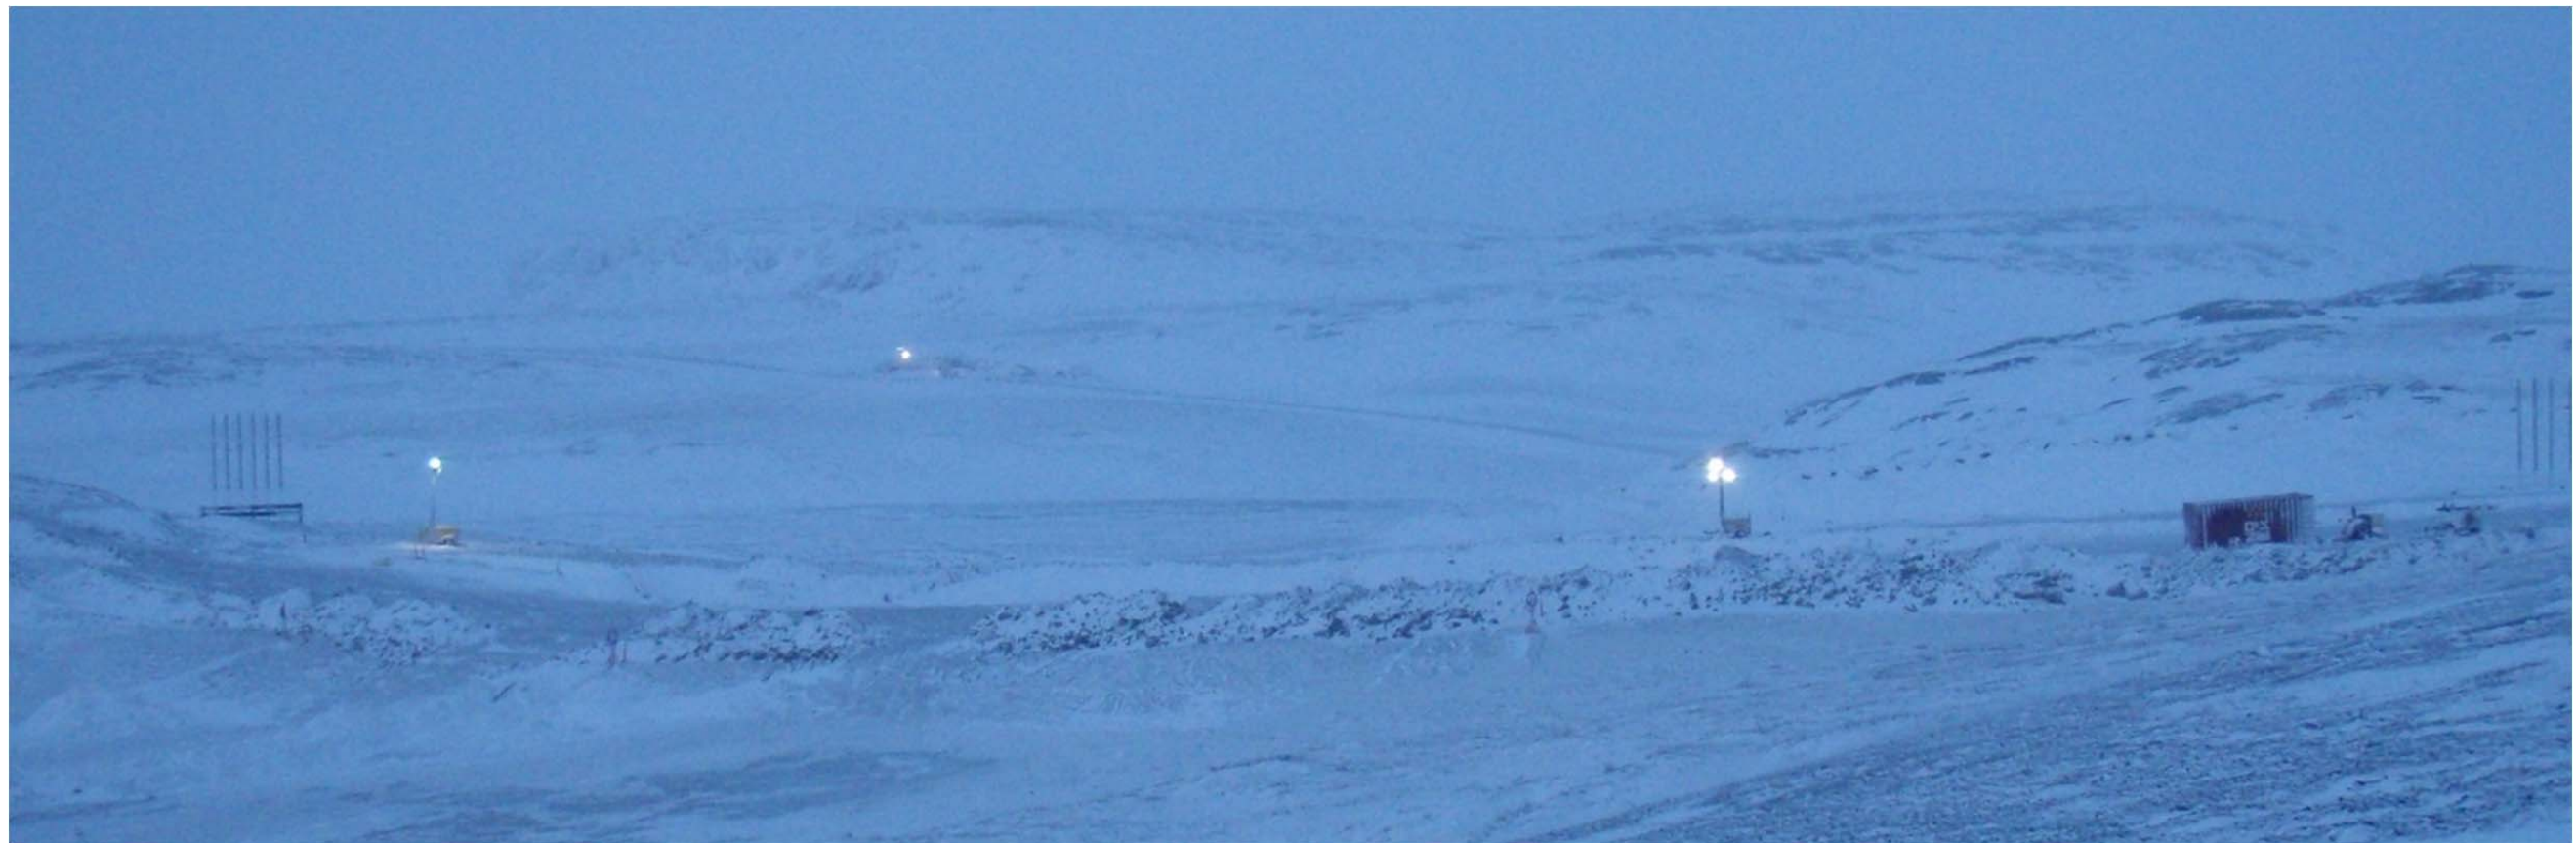
**Figure 7:** Progress photo of the North Dam construction from Photo Point 2; taken in the am, ~ WNW view.

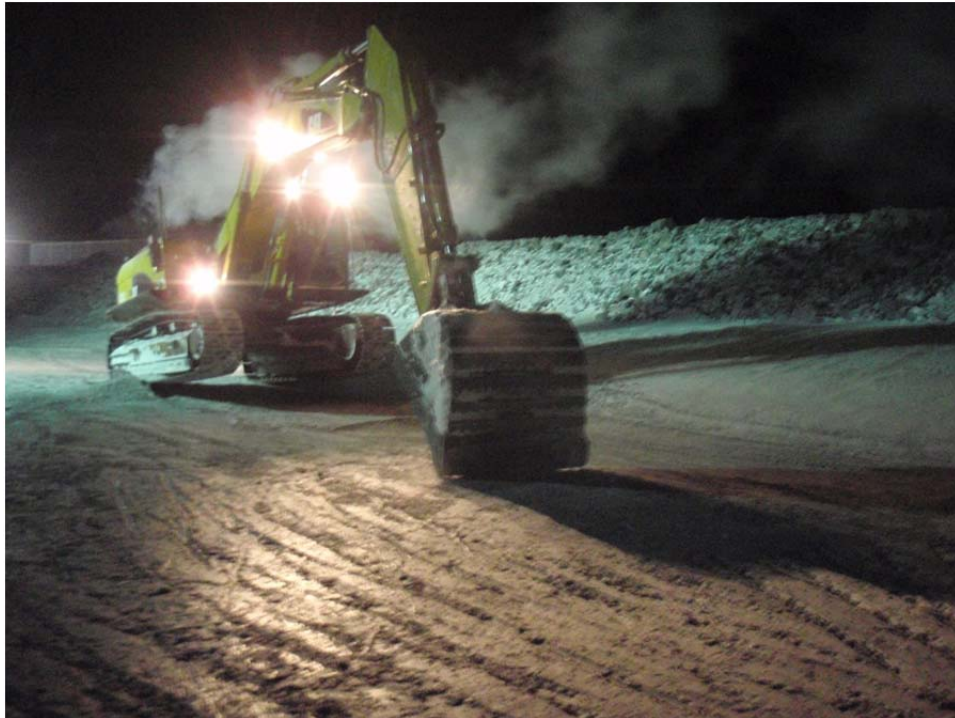
**Photo 8:** CAT 33 CL Excavator (equipped with finishing bucket) scraping down 5/8" material in the key trench. Note that the excavator is working around station 1+20 at the time this picture was taken.

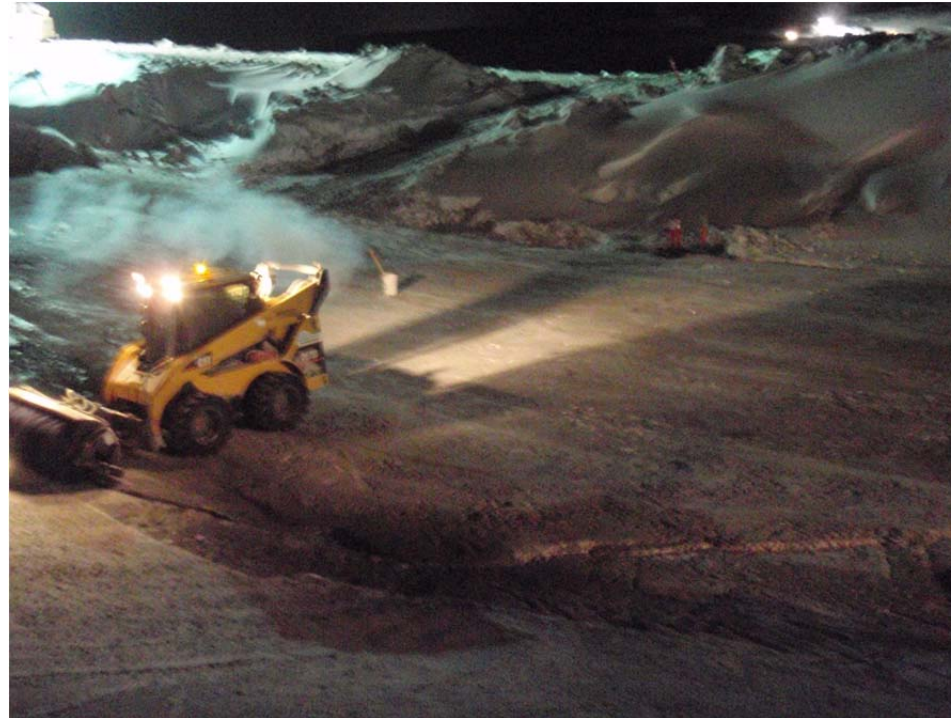
**Photo 9:** Bobcat (equipped with brush) cleaning the central key trench area before placement, ~ NW view.

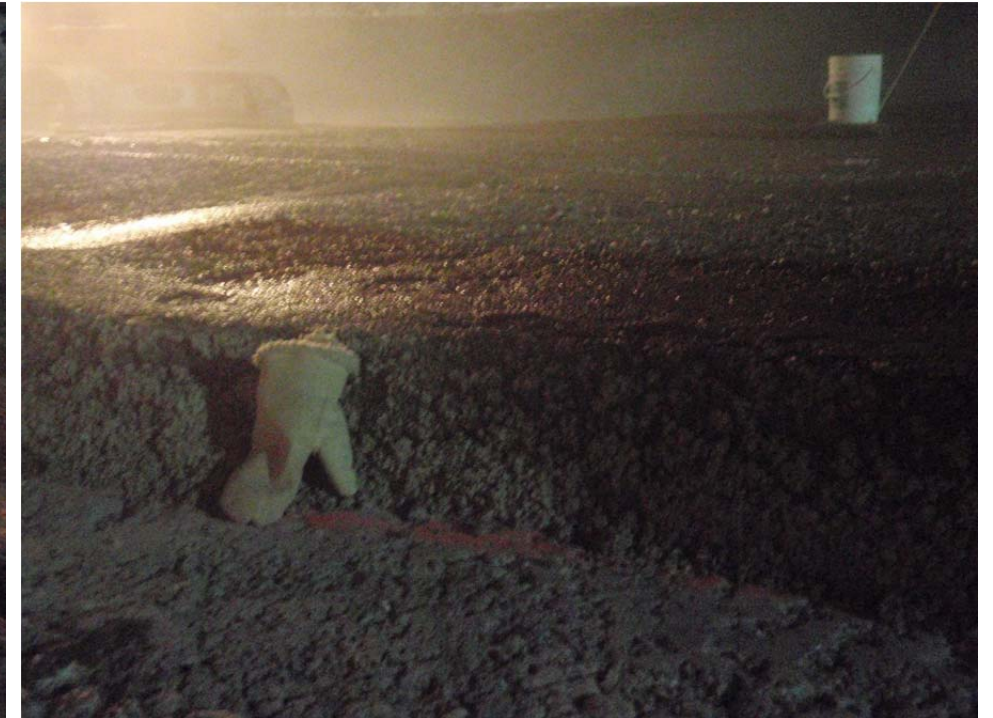
**Photo 10:** View of lift thickness placed today. Photo taken around station 0+85.

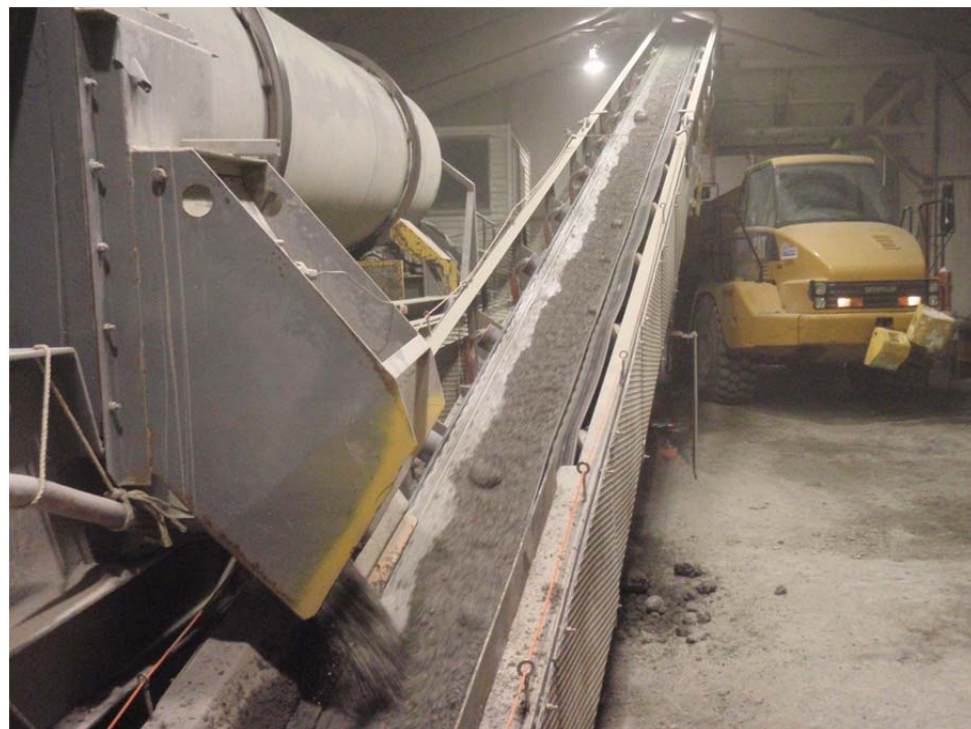
- FCM placement resulted at the North Dam in the afternoon from station ~ 0+80 to 1+00.
  - Only 4 loads were placed at the dam (Sta. 0+80 to 0+100) due to problems with the feed belt from the hopper plugging up with frozen lumps and over loading.

**Photo 11:** View of FCM exiting the chute at the FCP. Note that at the time this picture was taken a higher frequency of frozen clumps were being noted in the FCM. Shortly after this picture the FCP was temporary stopped while an overloaded belt, from the hopper, was fixed.

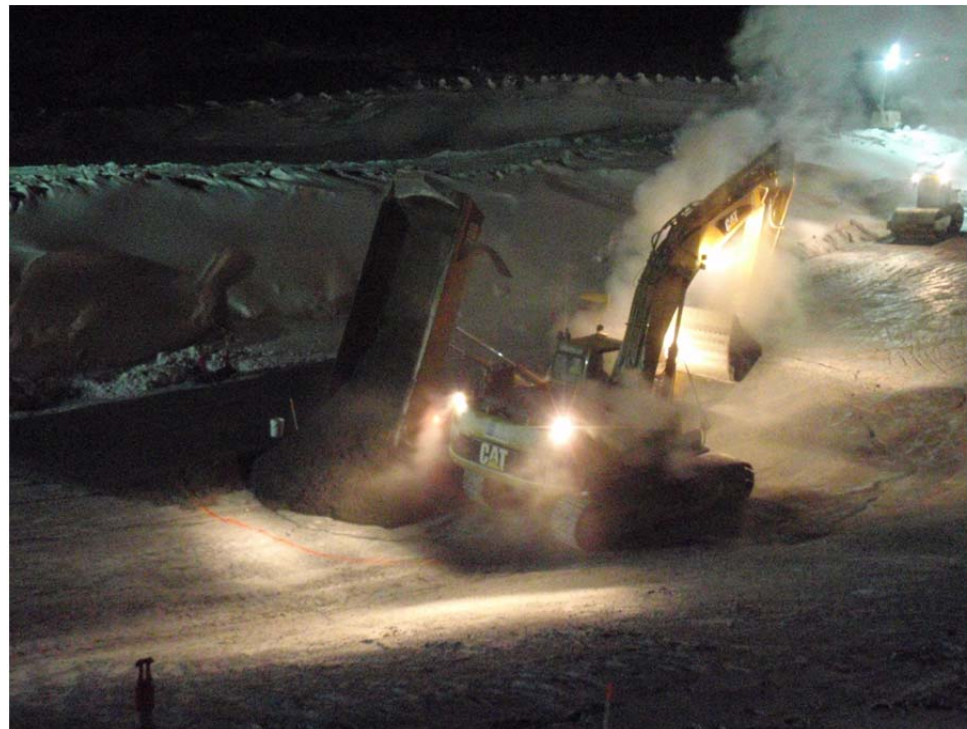
**Photo 12:** ~N view of FCM placement in the central key trench area.

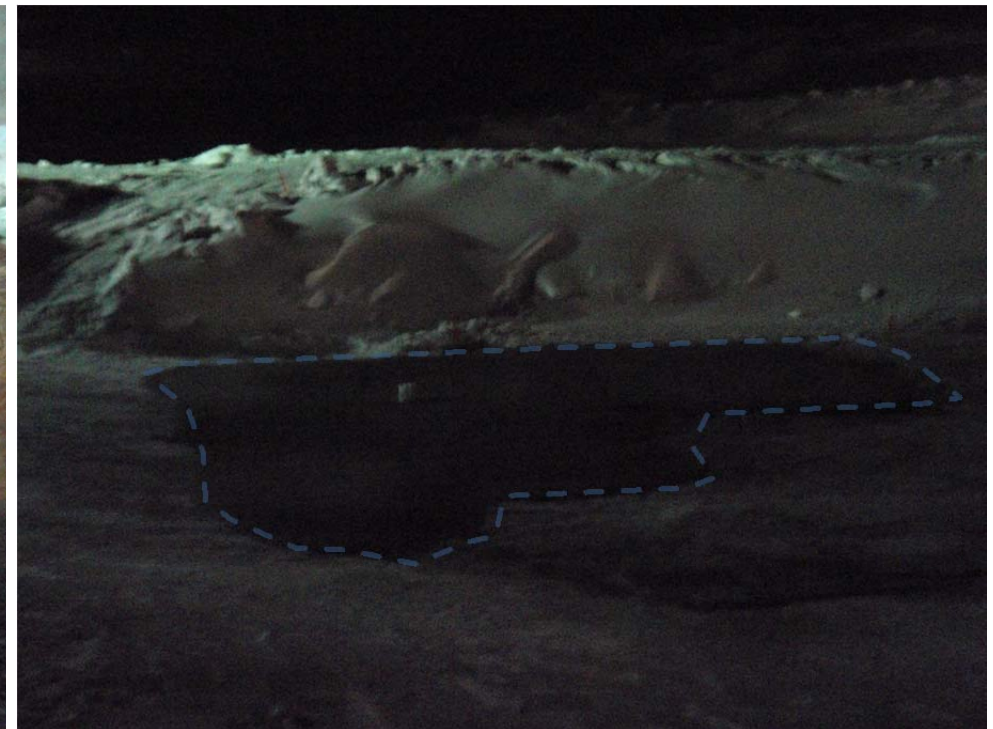
**Photo 13:** Area where FCM was placed today, ~ NNW view. Note that the material placed today has been highlighted with the light blue dashed line.

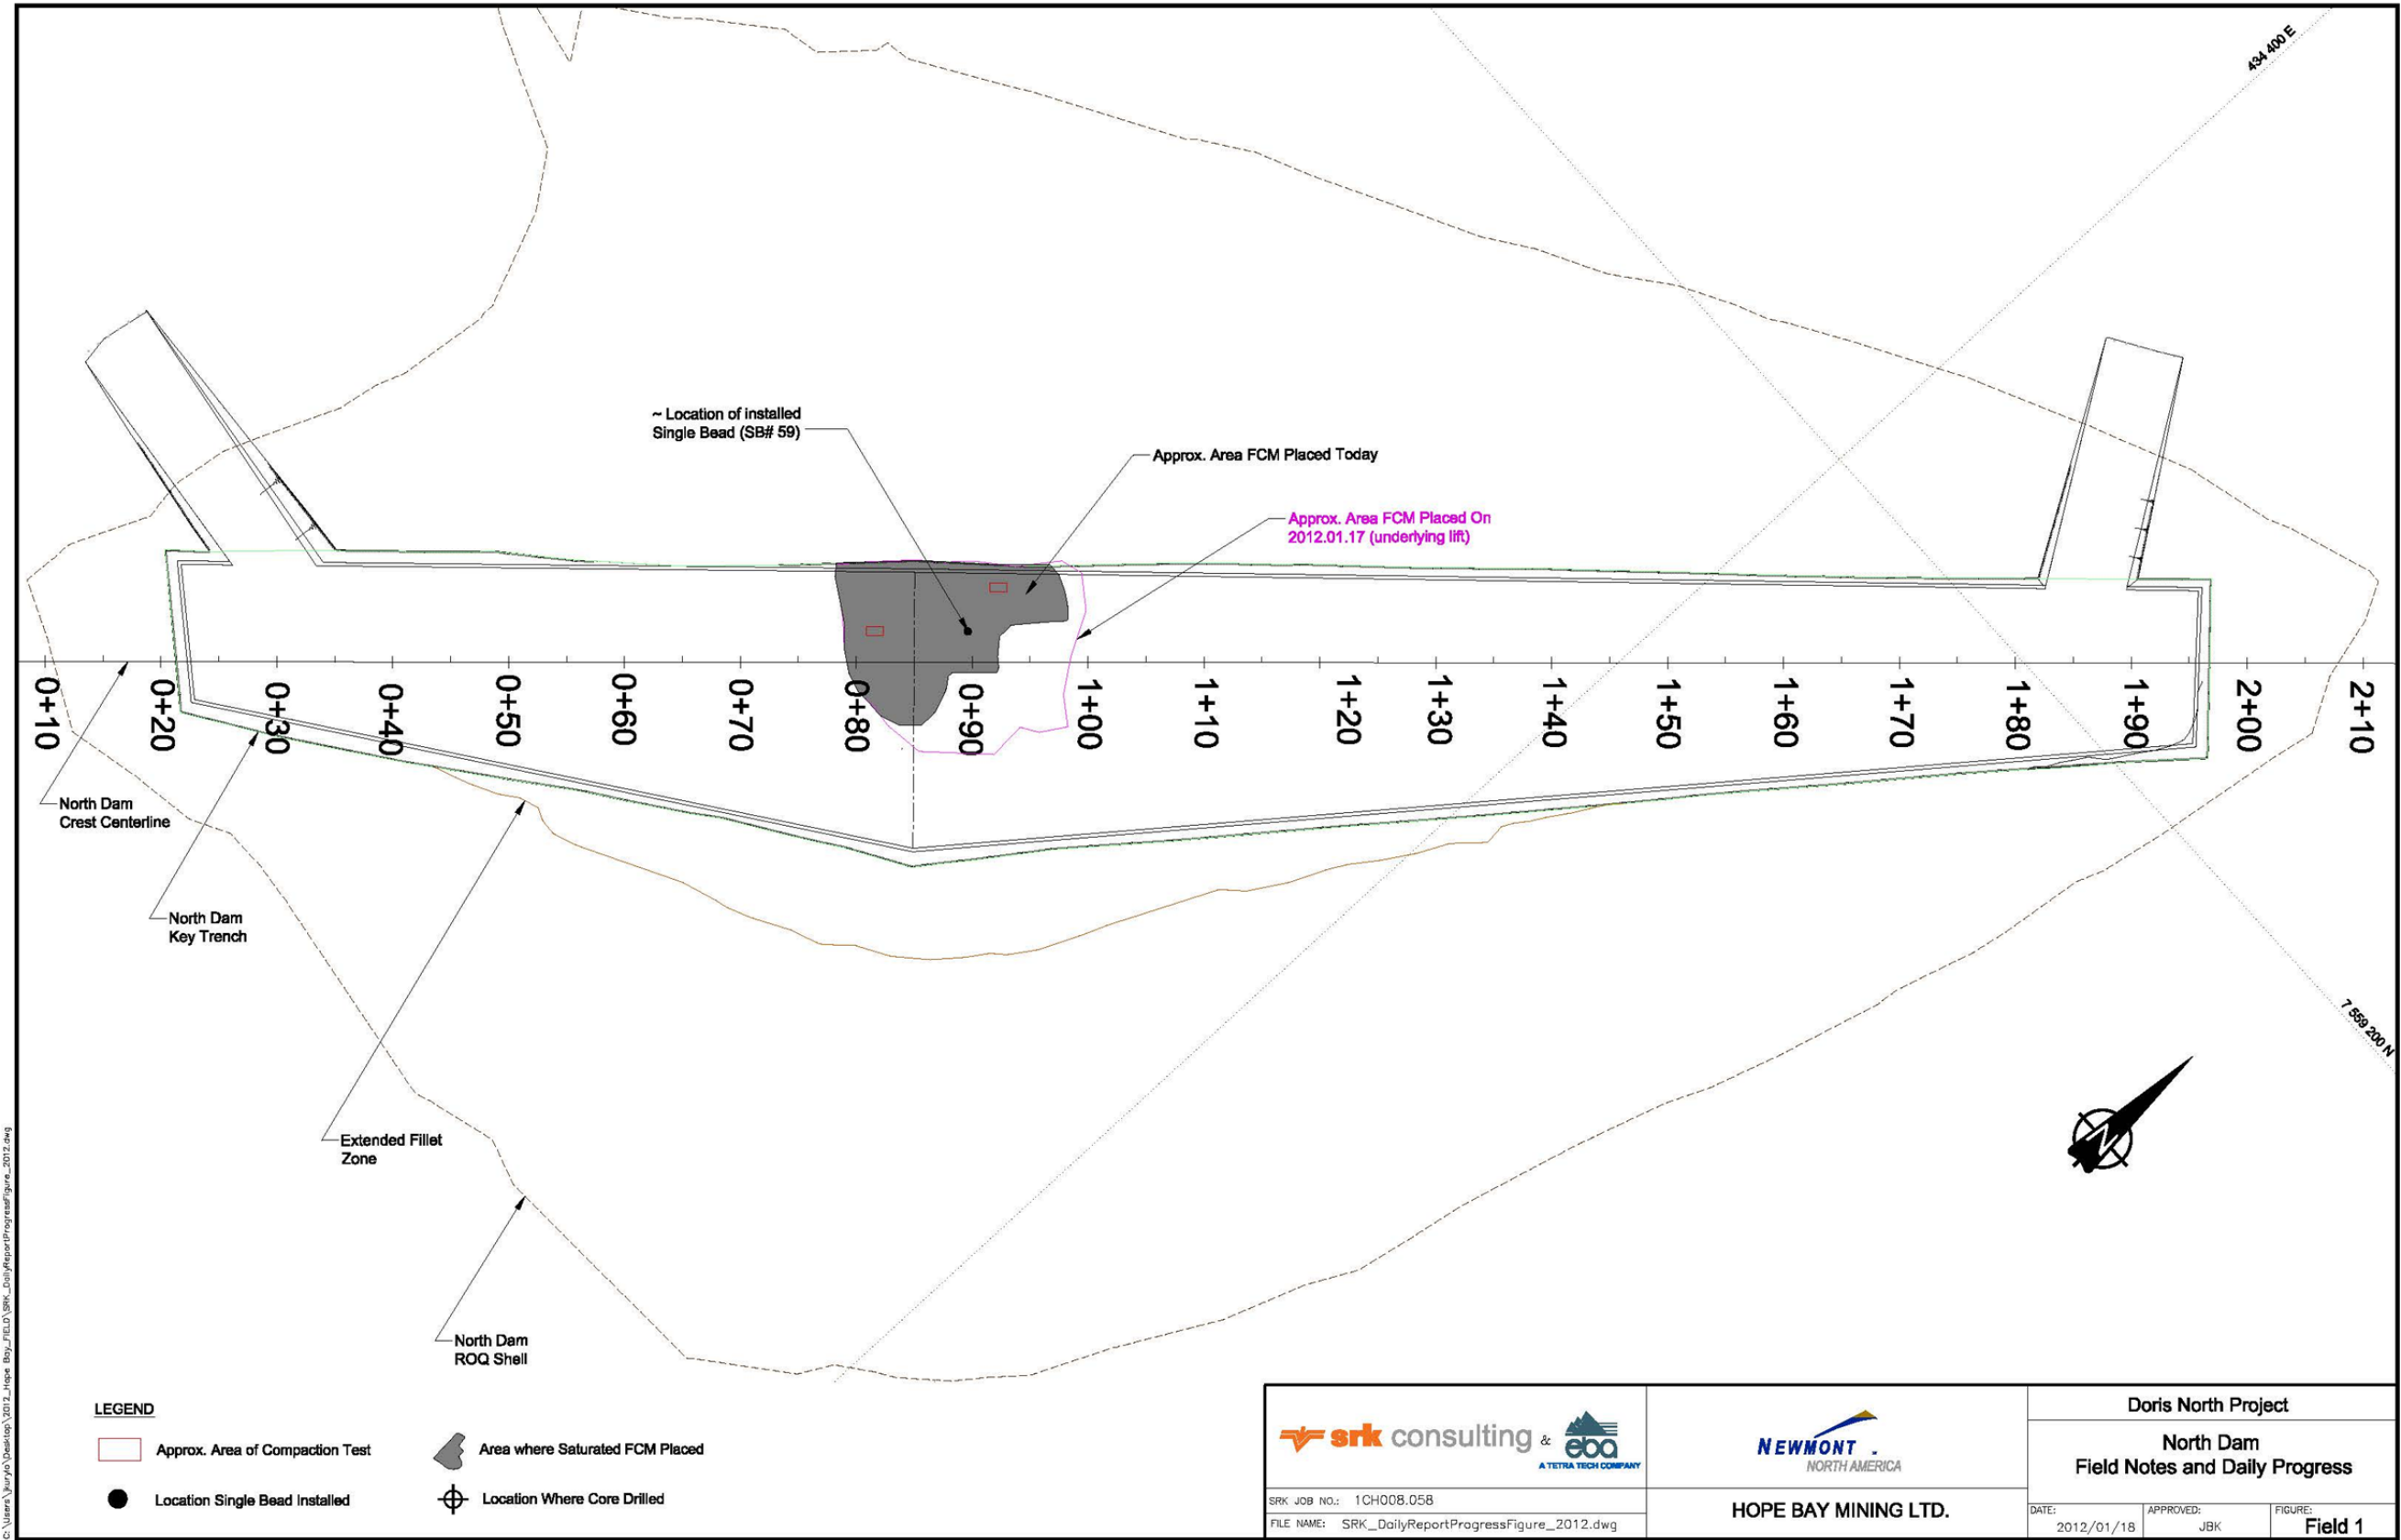
Figure 1 - Field notes/ progress figure for today's FCM placement (based on visual observation, i.e. as-built survey still to be picked up)

- A smooth drum compactor was used today. Note that the drum on the other vibratory compactor has now also been changed to a smooth drum.
- Figure 1 presents a progress figure and field notes for today's placement.

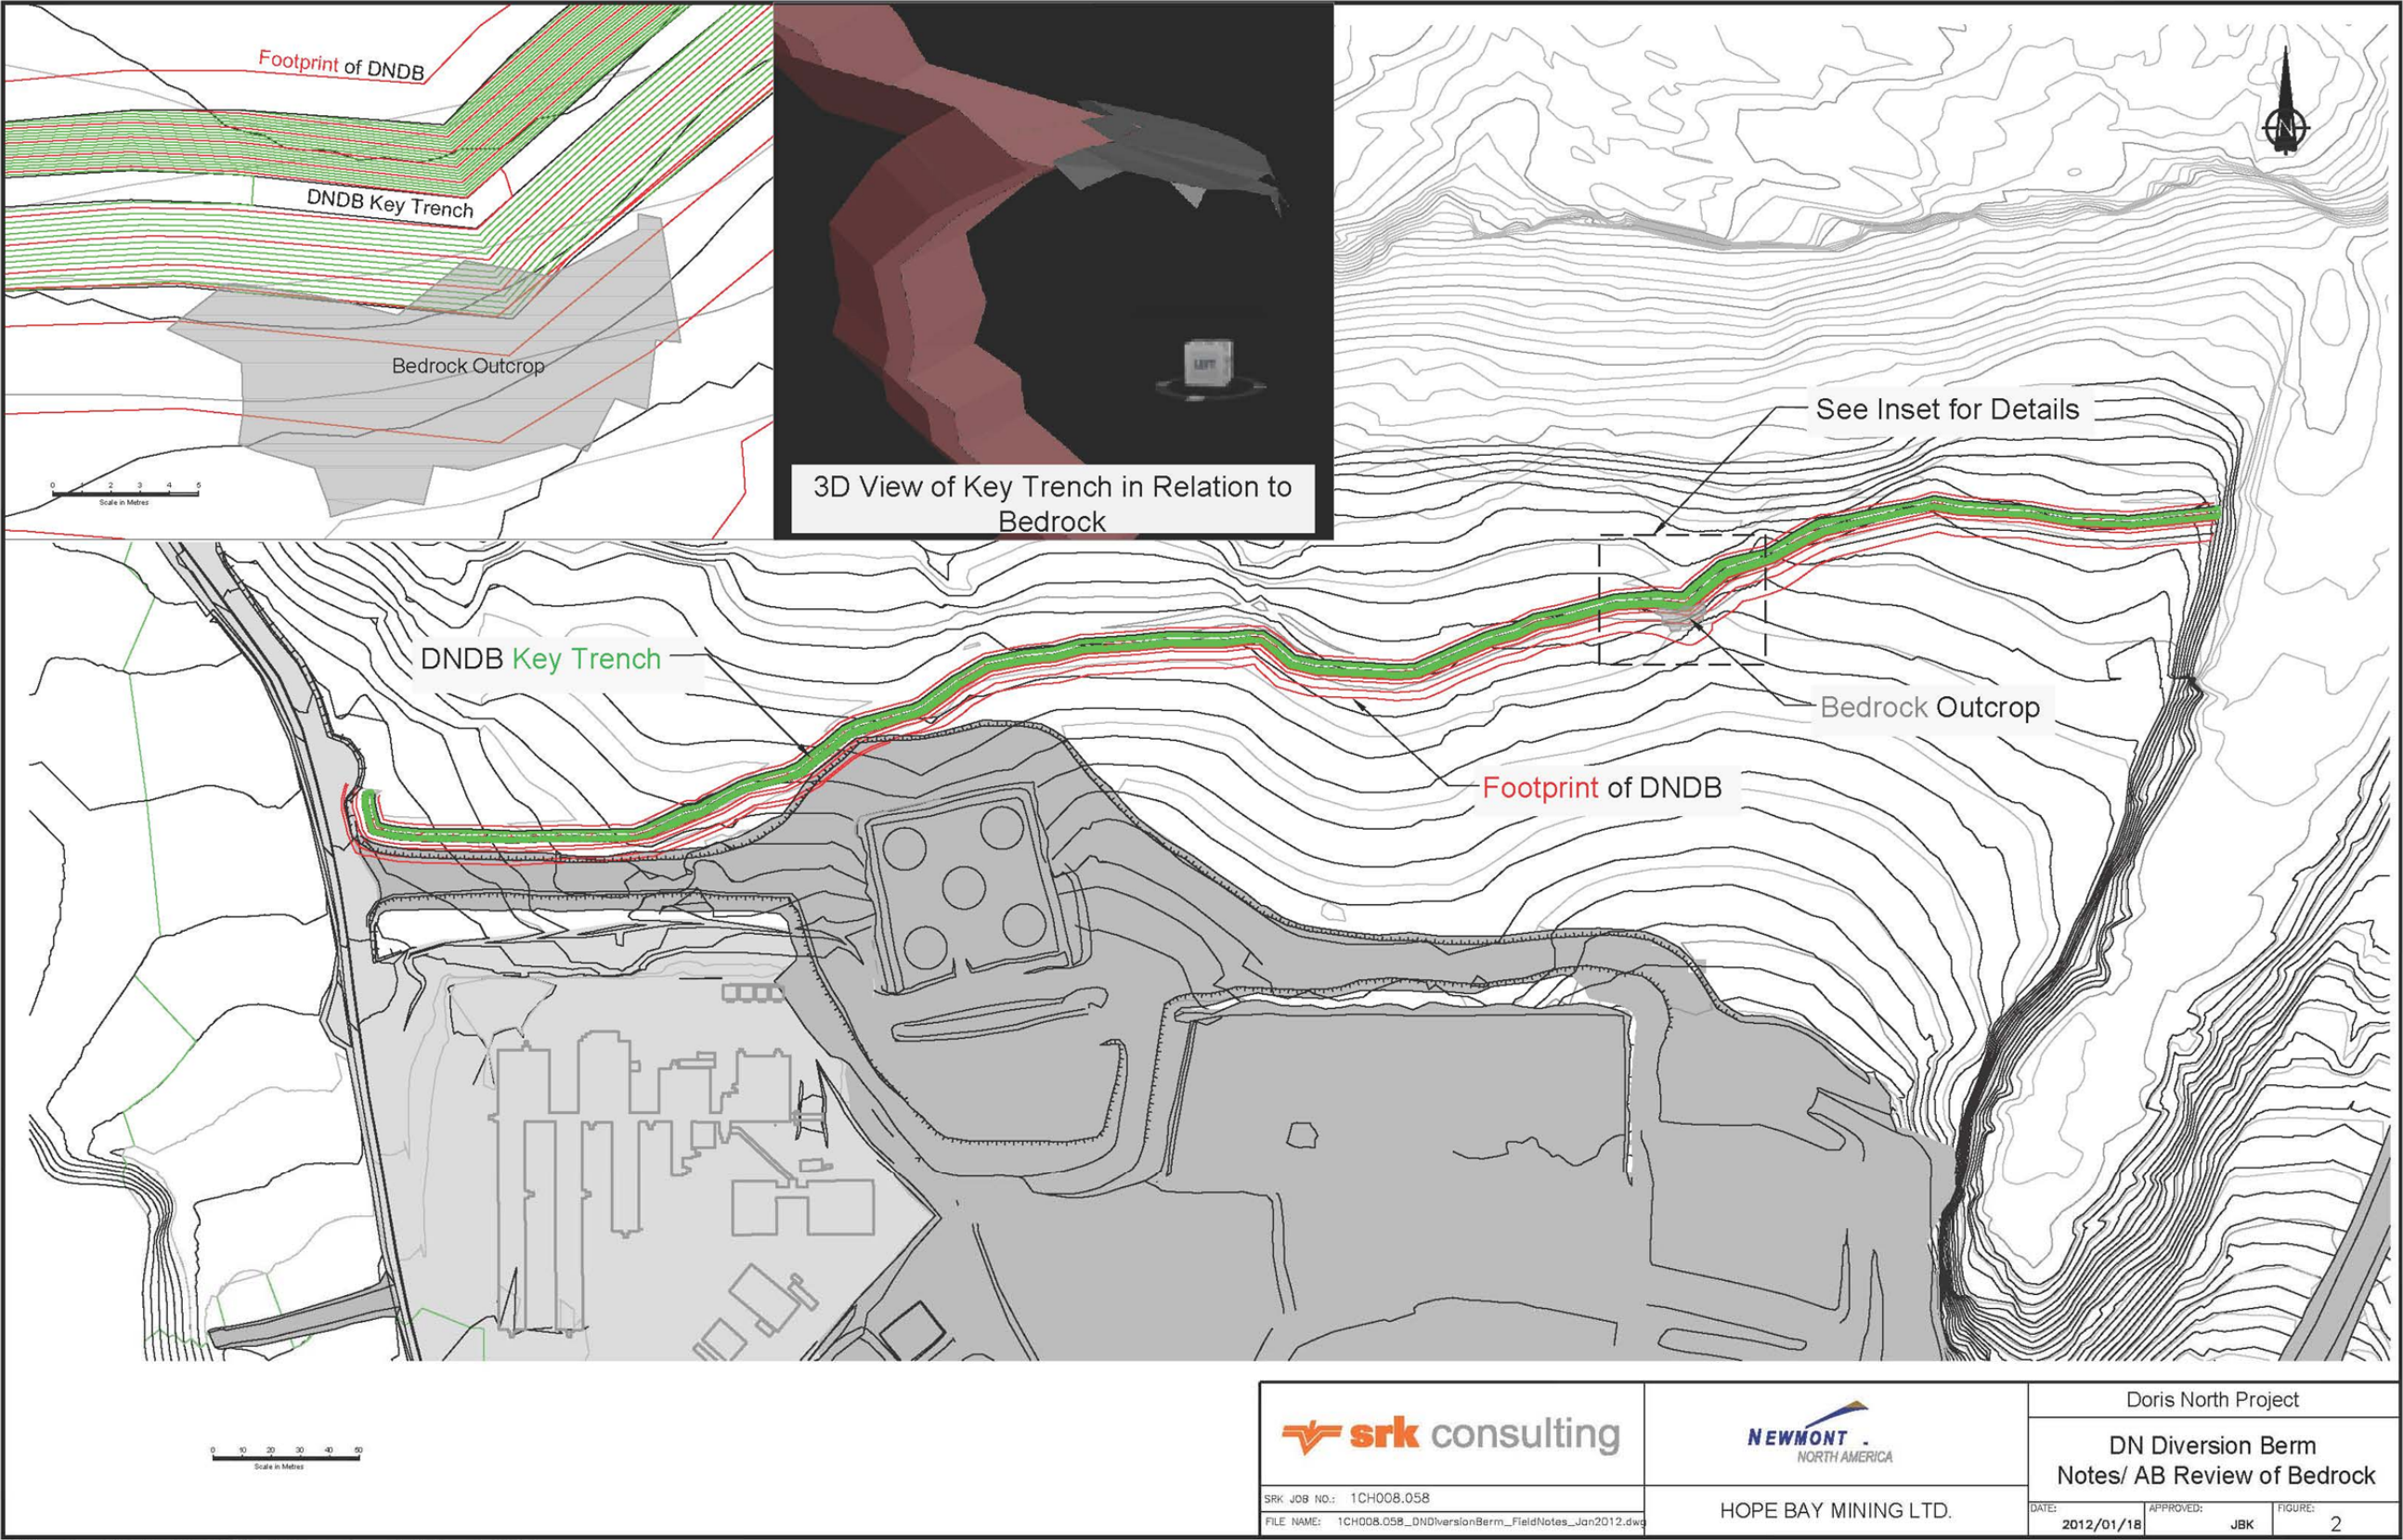
Figure 2 - SRK field notes on the location of the bedrock outcrop observed in the DN Diversion Berm footprint, based on as-built data.

- The snow road around the Doris North Diversion Berm continues. Minor additional work was completed on the snow road.
- The alignment of the Doris North Diversion Berm was staked out.
- SRK did a preliminary as-built survey review to better assess the area where the bedrock outcrop was observed. This was done to get a handle of the extent and exact location where bedrock may be expected to be blasted. This preliminary field review/ notes are provided as Figure 2.
