DAILY REPORT #14 – DORIS NORTH INFRASTRUCTURE/ NORTH DAM

Prepared by:	John Kurylo/ Jeff Orr / Megan Miller	Date:	2012.01.19
Reviewed by:		Project #:	1CH008.058.0320
Role	Company	Personnel – Position	On Site
Client	Hope Bay Mining Limited (HBML)	Angela Holzapfel – ESR Compliance Manager David Vokey – ESR Coordinator Don Ethelston – HSLP Advisor Dean Wold - Safety Jill Turk – ESR Coordinator Katsky Venter – ESR Manger Michelle Tanquay – ESR Site Manager Stirling Kelly – HSLP Advisor	No Yes In No No No Yes Out
	JDS	Lloyd Jackson – Mechanical Superintendent Sven Archimowtiz – Electrical Superintendent Doug Fielding – Construction Manager Ishan Fechter – Construction Coordinator Jerry Graham – Construction Manager Kevin Whieldon – Project Coordinator Mark Valeriote – Construction Manager	Out Yes In Yes Out No Yes
Engineering Design Consultants	SRK Consulting (Canada) Inc.	John Kurylo – Site Engineer Megan Miller – Site Engineer Lawrence Borowski – Site Engineer Murry McGregor – Site Engineer Lowell Wade – Senior Engineer	Yes In No No No

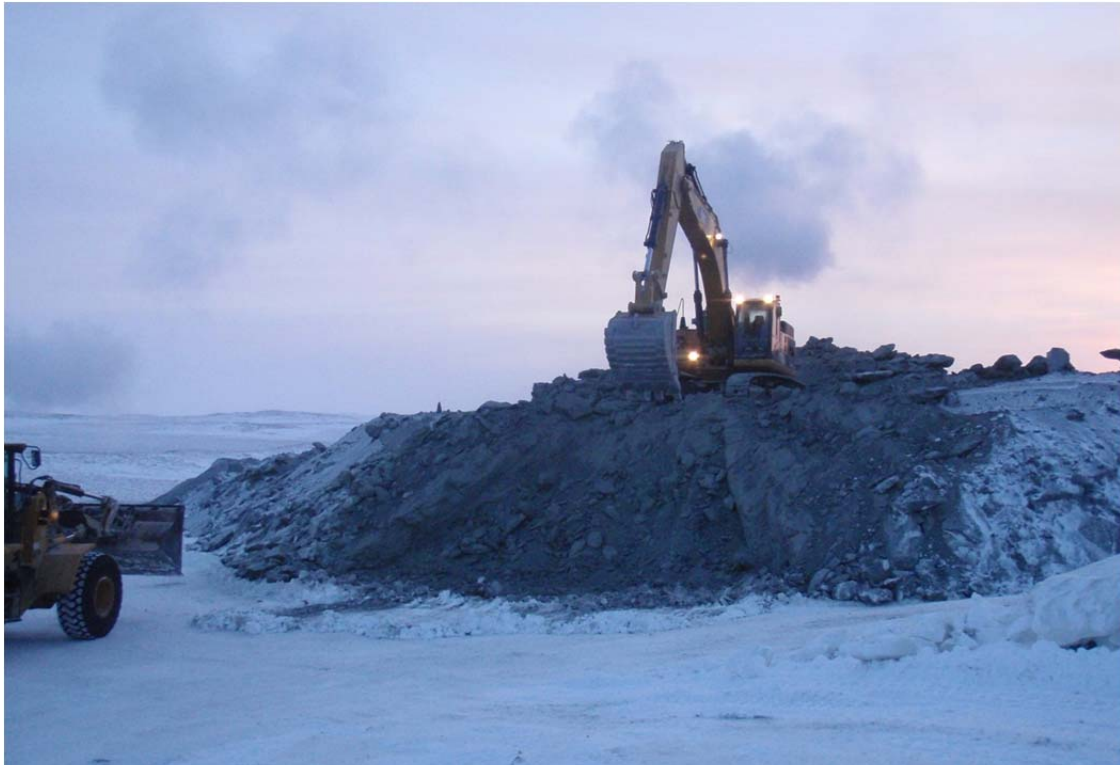
- Maintenance resulted at the FCP today. The electricians visited the FCP plant to investigate recent power issues.
- Once an error code is gathered from the FCP then the electricians plan to revisit the
- A 345 excavator was used to try and dig into the stockpile of FCM on the FCP pad. The unsaturated frozen clumps of FCM were noted to go deep into the pile.
 - After discussions with the crusher/ FCP operator it became apparent that, last summer, while crushing water was used to assist with dust control.
 - Further it was noted that when material was hauled to the FCP plant pad that there was some rain. Precipitation.
 - The majority of the FCM stockpile appears to have large clumps of unsaturated FCM intermixed throughout the pile.

Photo 1: 345 excavator digging into frozen stockpile of FCM at FCP Plant Pad.

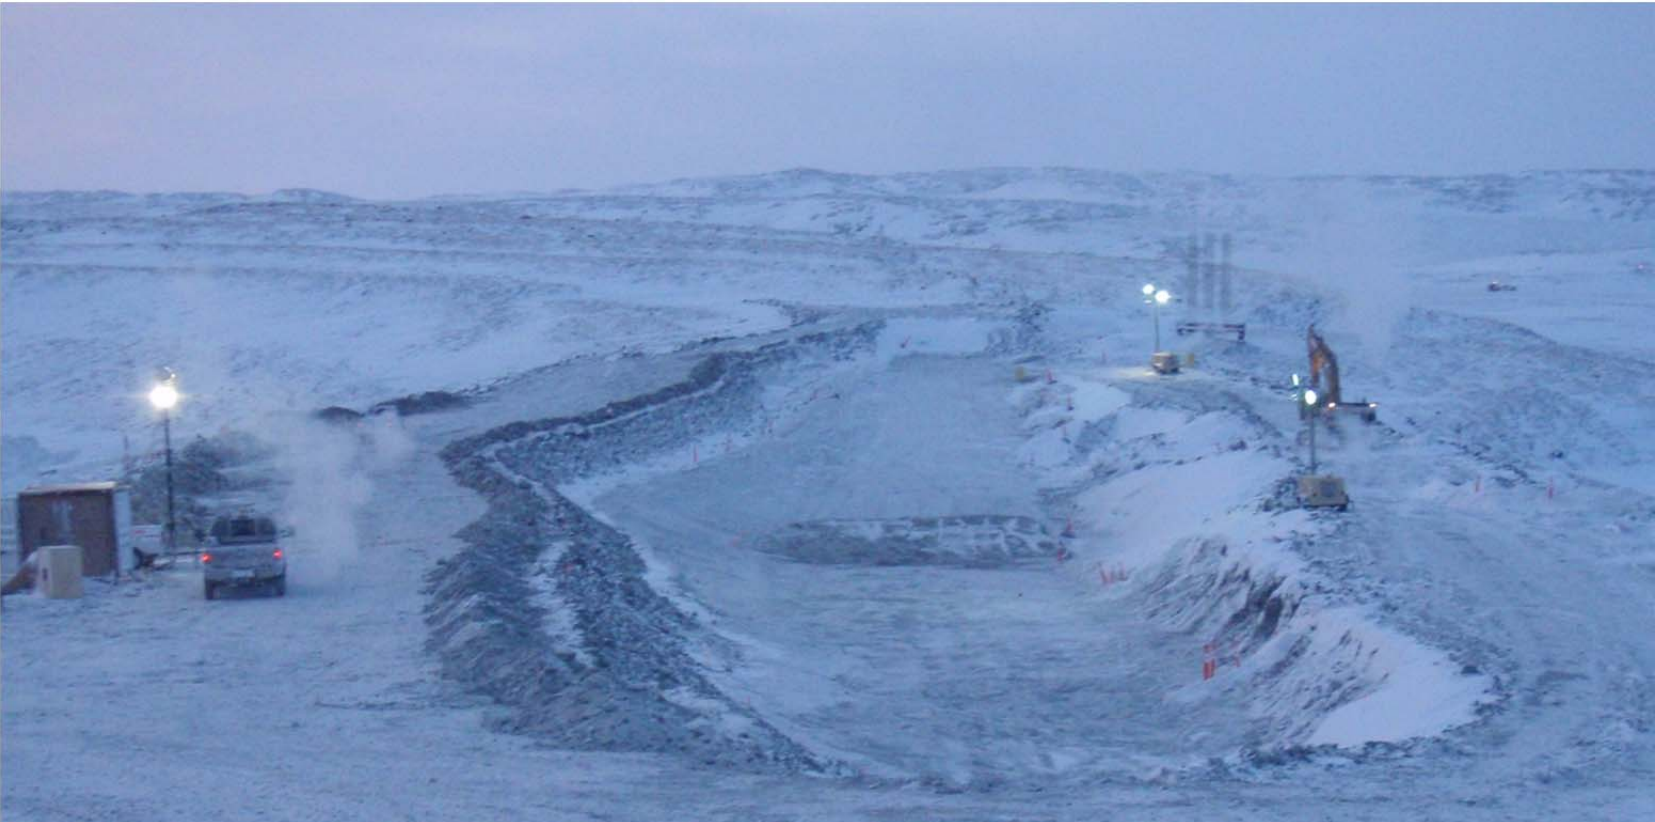
Photo 2: ~SWW view down key trech. Note the darker material in the central key trench area is the material that was placed on 2012/01/17 and 2012/01/18.

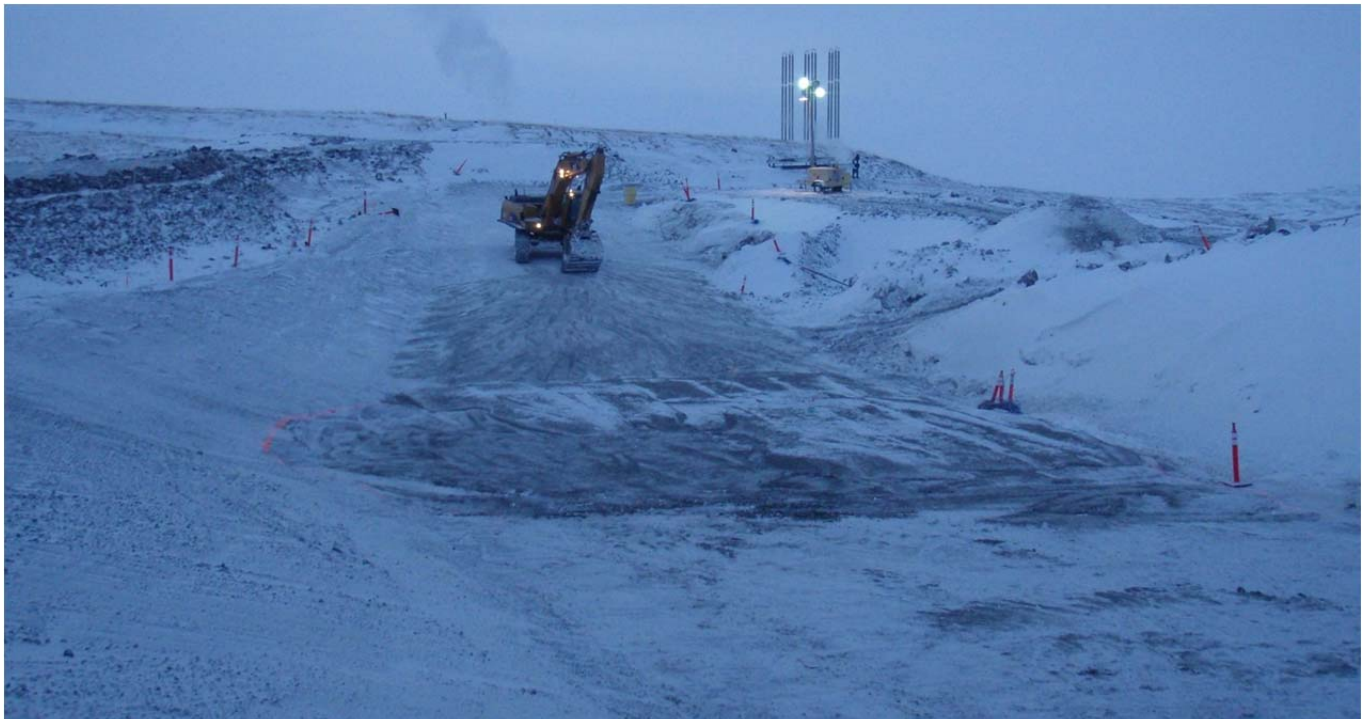
Photo 3: ~W view of 330 excavator scraping down 5/8" material in the key trench. Note the excavator is cleaning around station 0+50 in this photo.

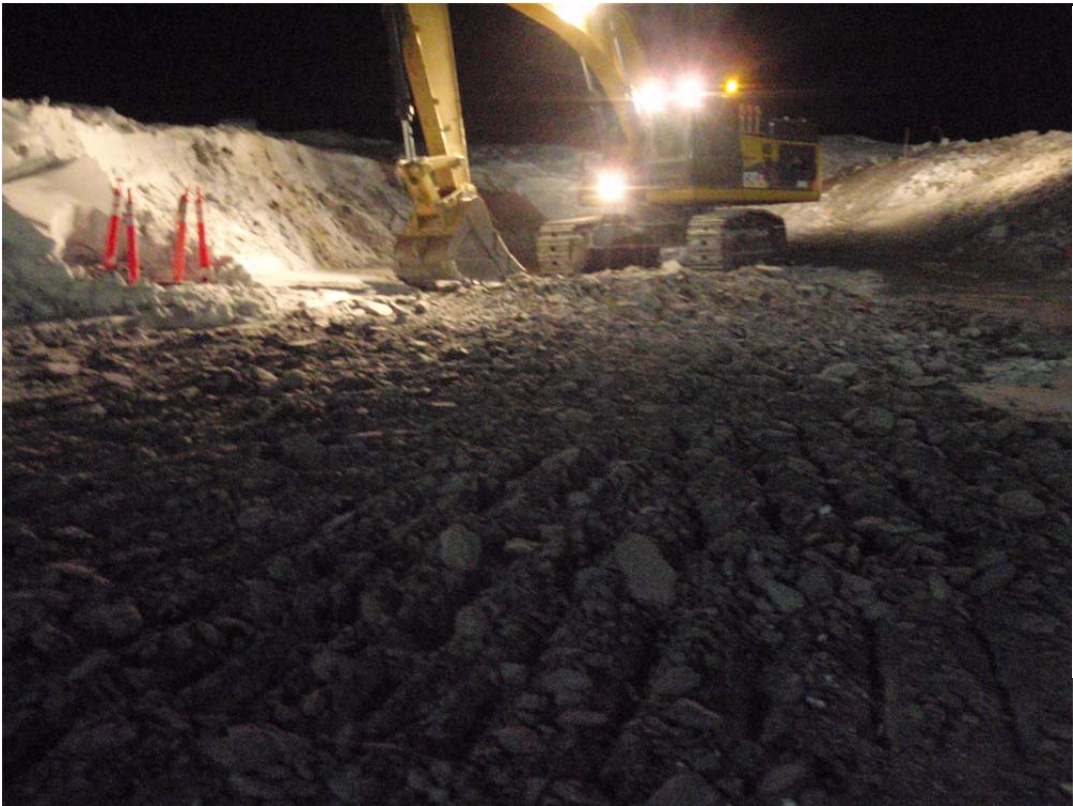
Photo 4: 345 excavator (with toothed bucket) ripping up frozen 5/8" material near station 1+70.

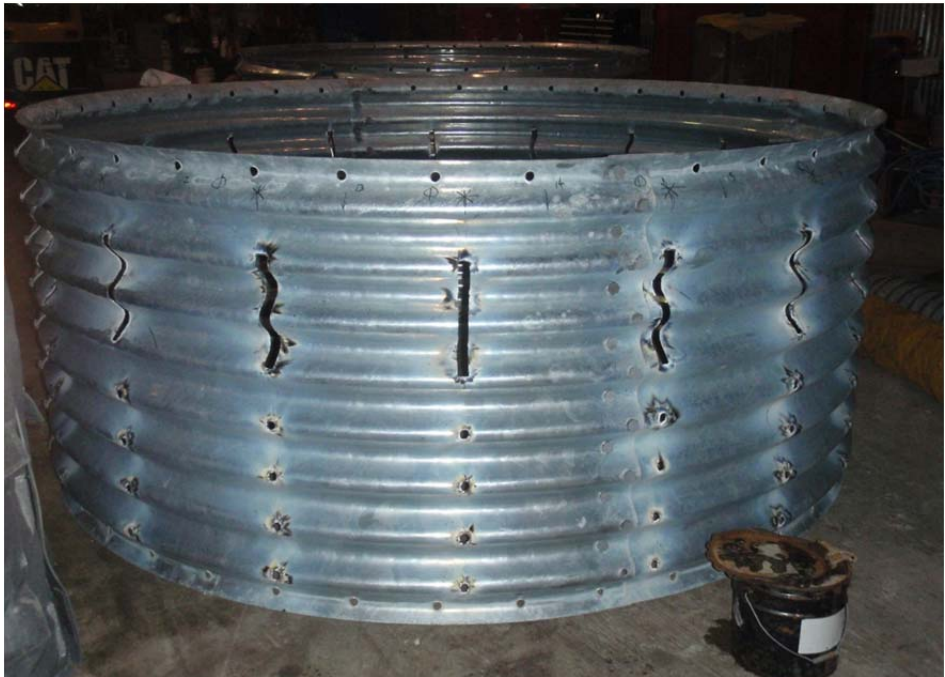
- The snow road around the Doris North Diversion Berm continues. Minor additional work was completed on the snow road.
- SRK inspected the sumps that are in the process of being fabricated. Photos 8 and 9 show progress of the sump fabrication. Hole/ slots in sumps were cut in the corrugated steel today.

Photo 8: View of the Doris North Camp Sump fabrication progress.

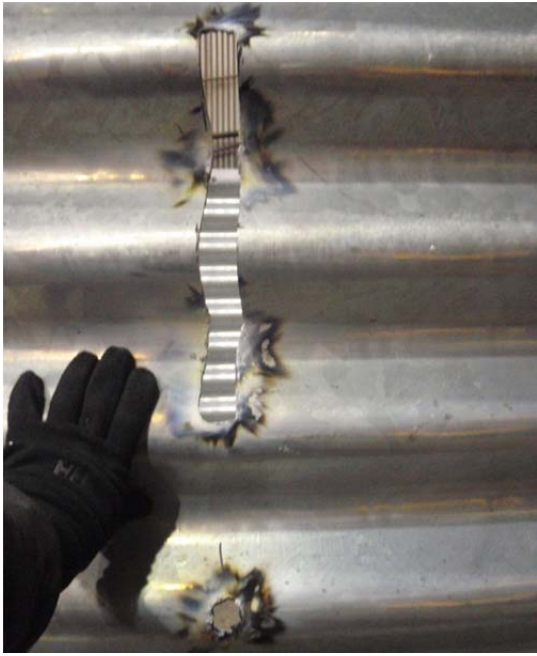
Photo 9: Close up view of slots being cut in the DN Camp Sumps.

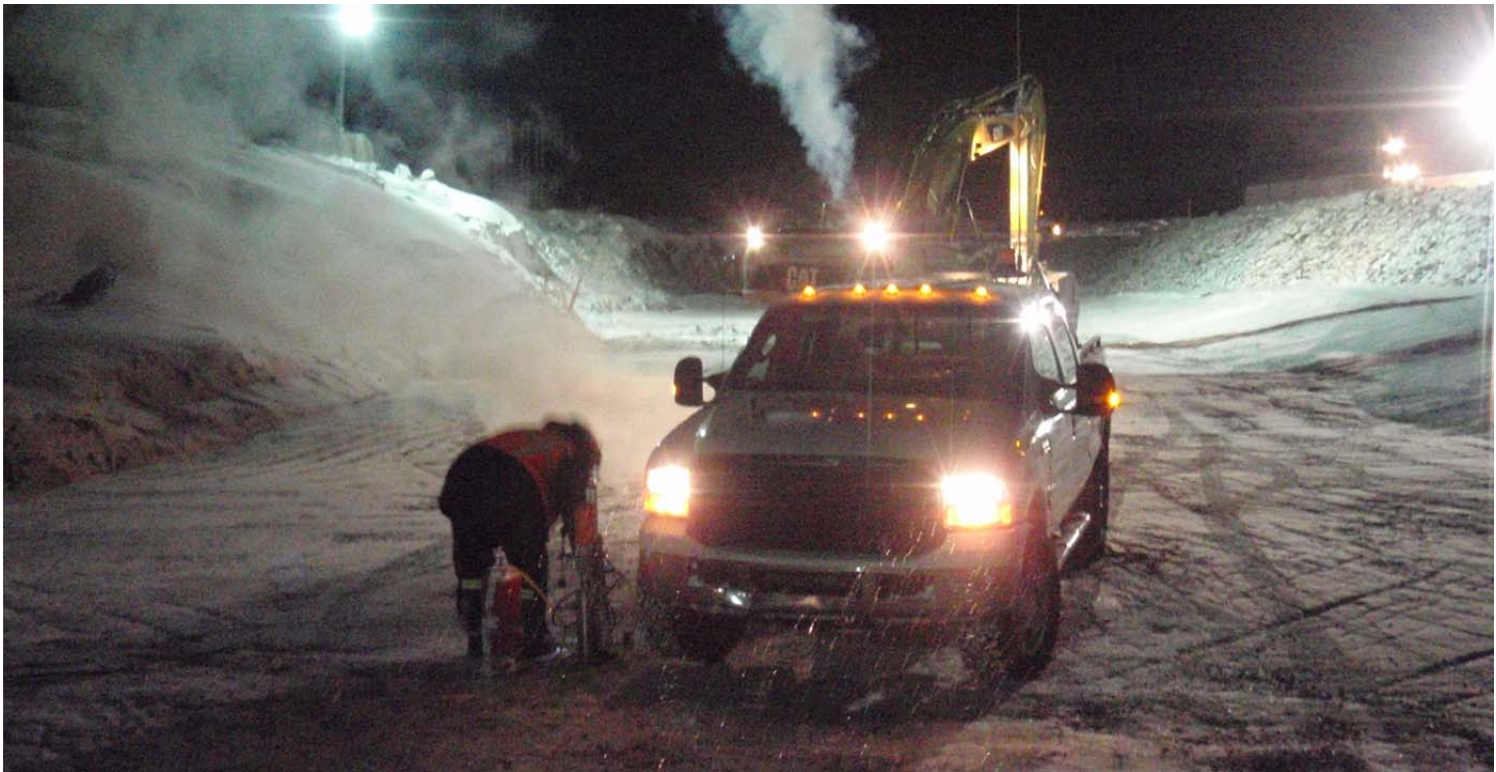
Photo 10: Setting up to take cores in the key trench, ~ NE view.

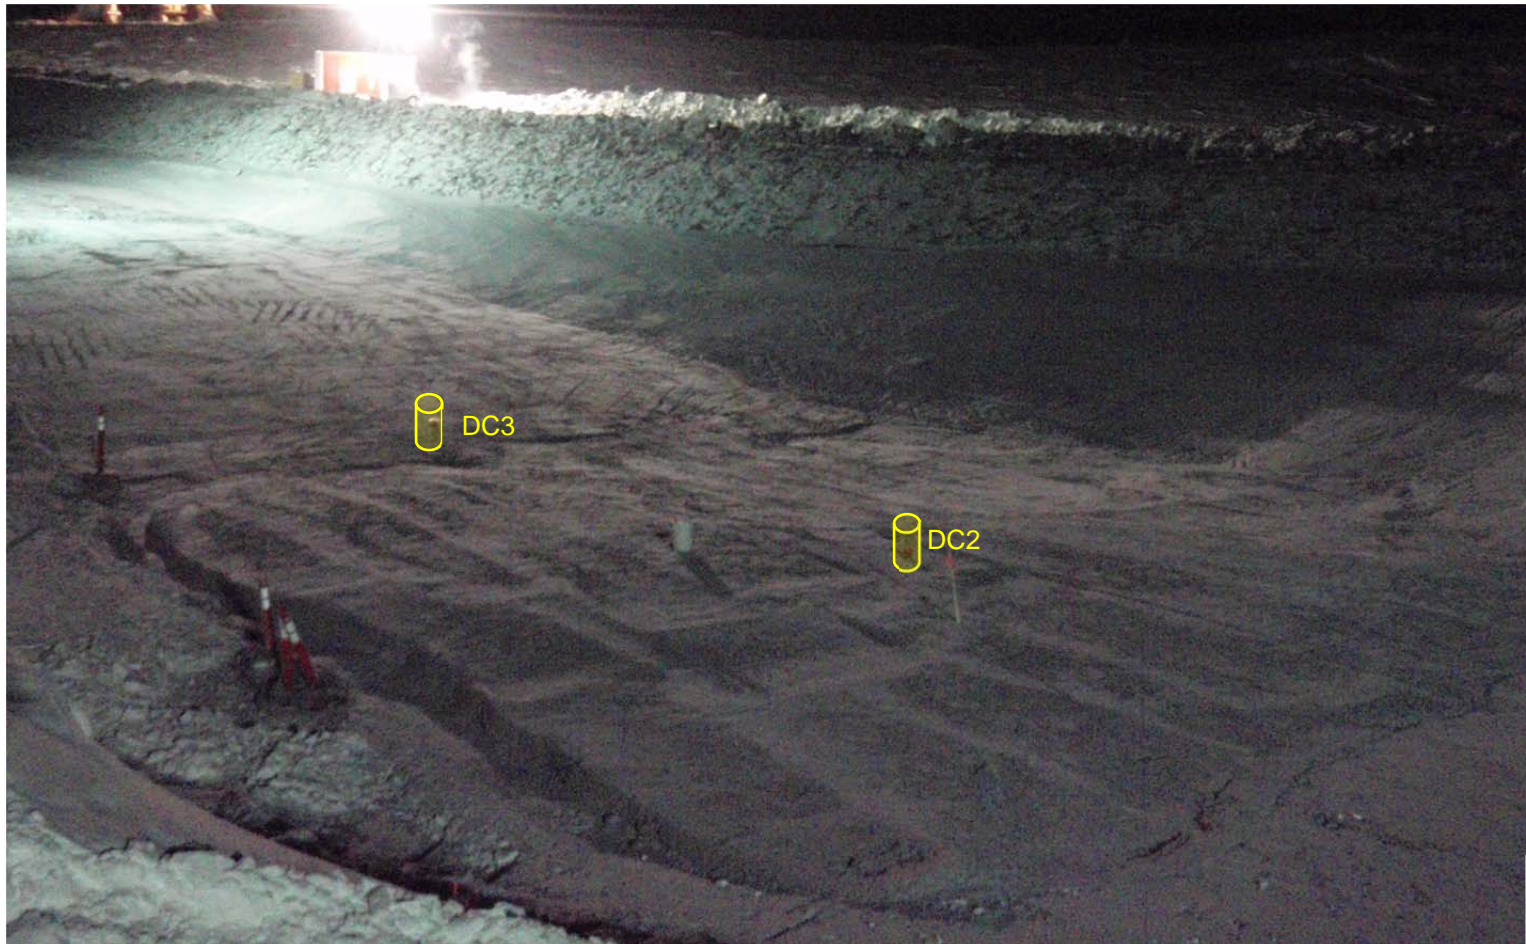
Photo 11: ~SEE view of key trench locations what were cored today. Note that the yellow cylinders mark the ~ locations that cores were drilled from.

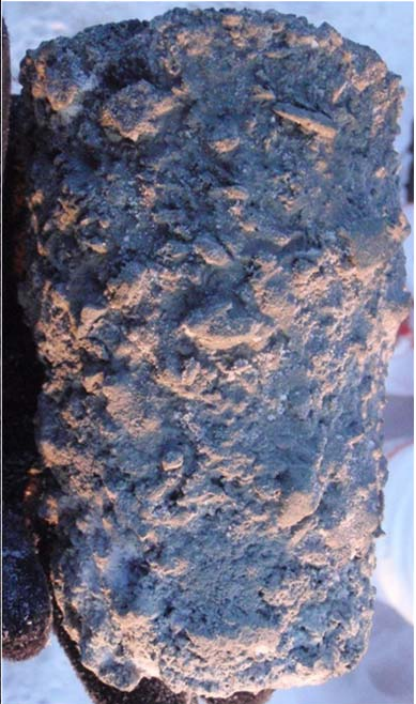
Photo 12 (center left): DC2 taken at 0+86, near centerline. The use of additional glycol was used in DC3 in increase recovered

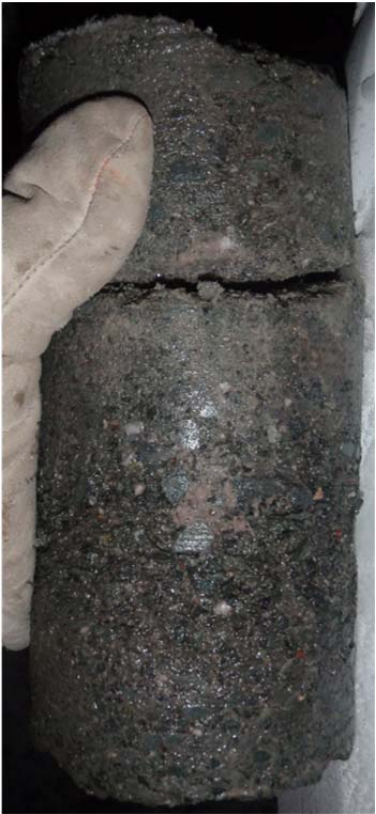
Photo 13 (center right): DC3 taken at 0+97 on the downstream. Taken at the edge of the lift placed on 2012/01/17.

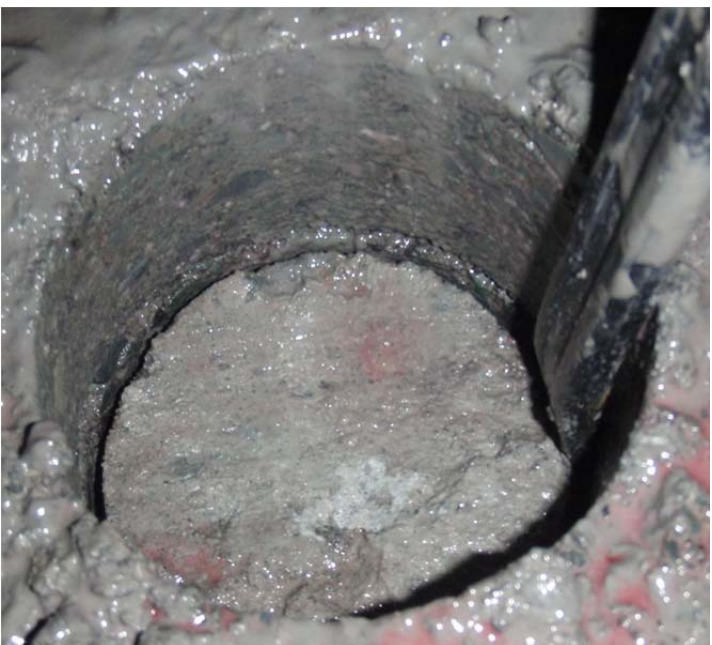
Photo 14: View at the location of drilled core 2. Note the interface connection noted between the recent lift and 2011 FCM at this location. Note that this area is near the edge of the lift placed on 2012/01/17. Bonding between layers is expected to be better in the areas where a larger mass/ volume of core material were placed. Additional cores to be taken in the coming days to better investigate bonding between lifts.

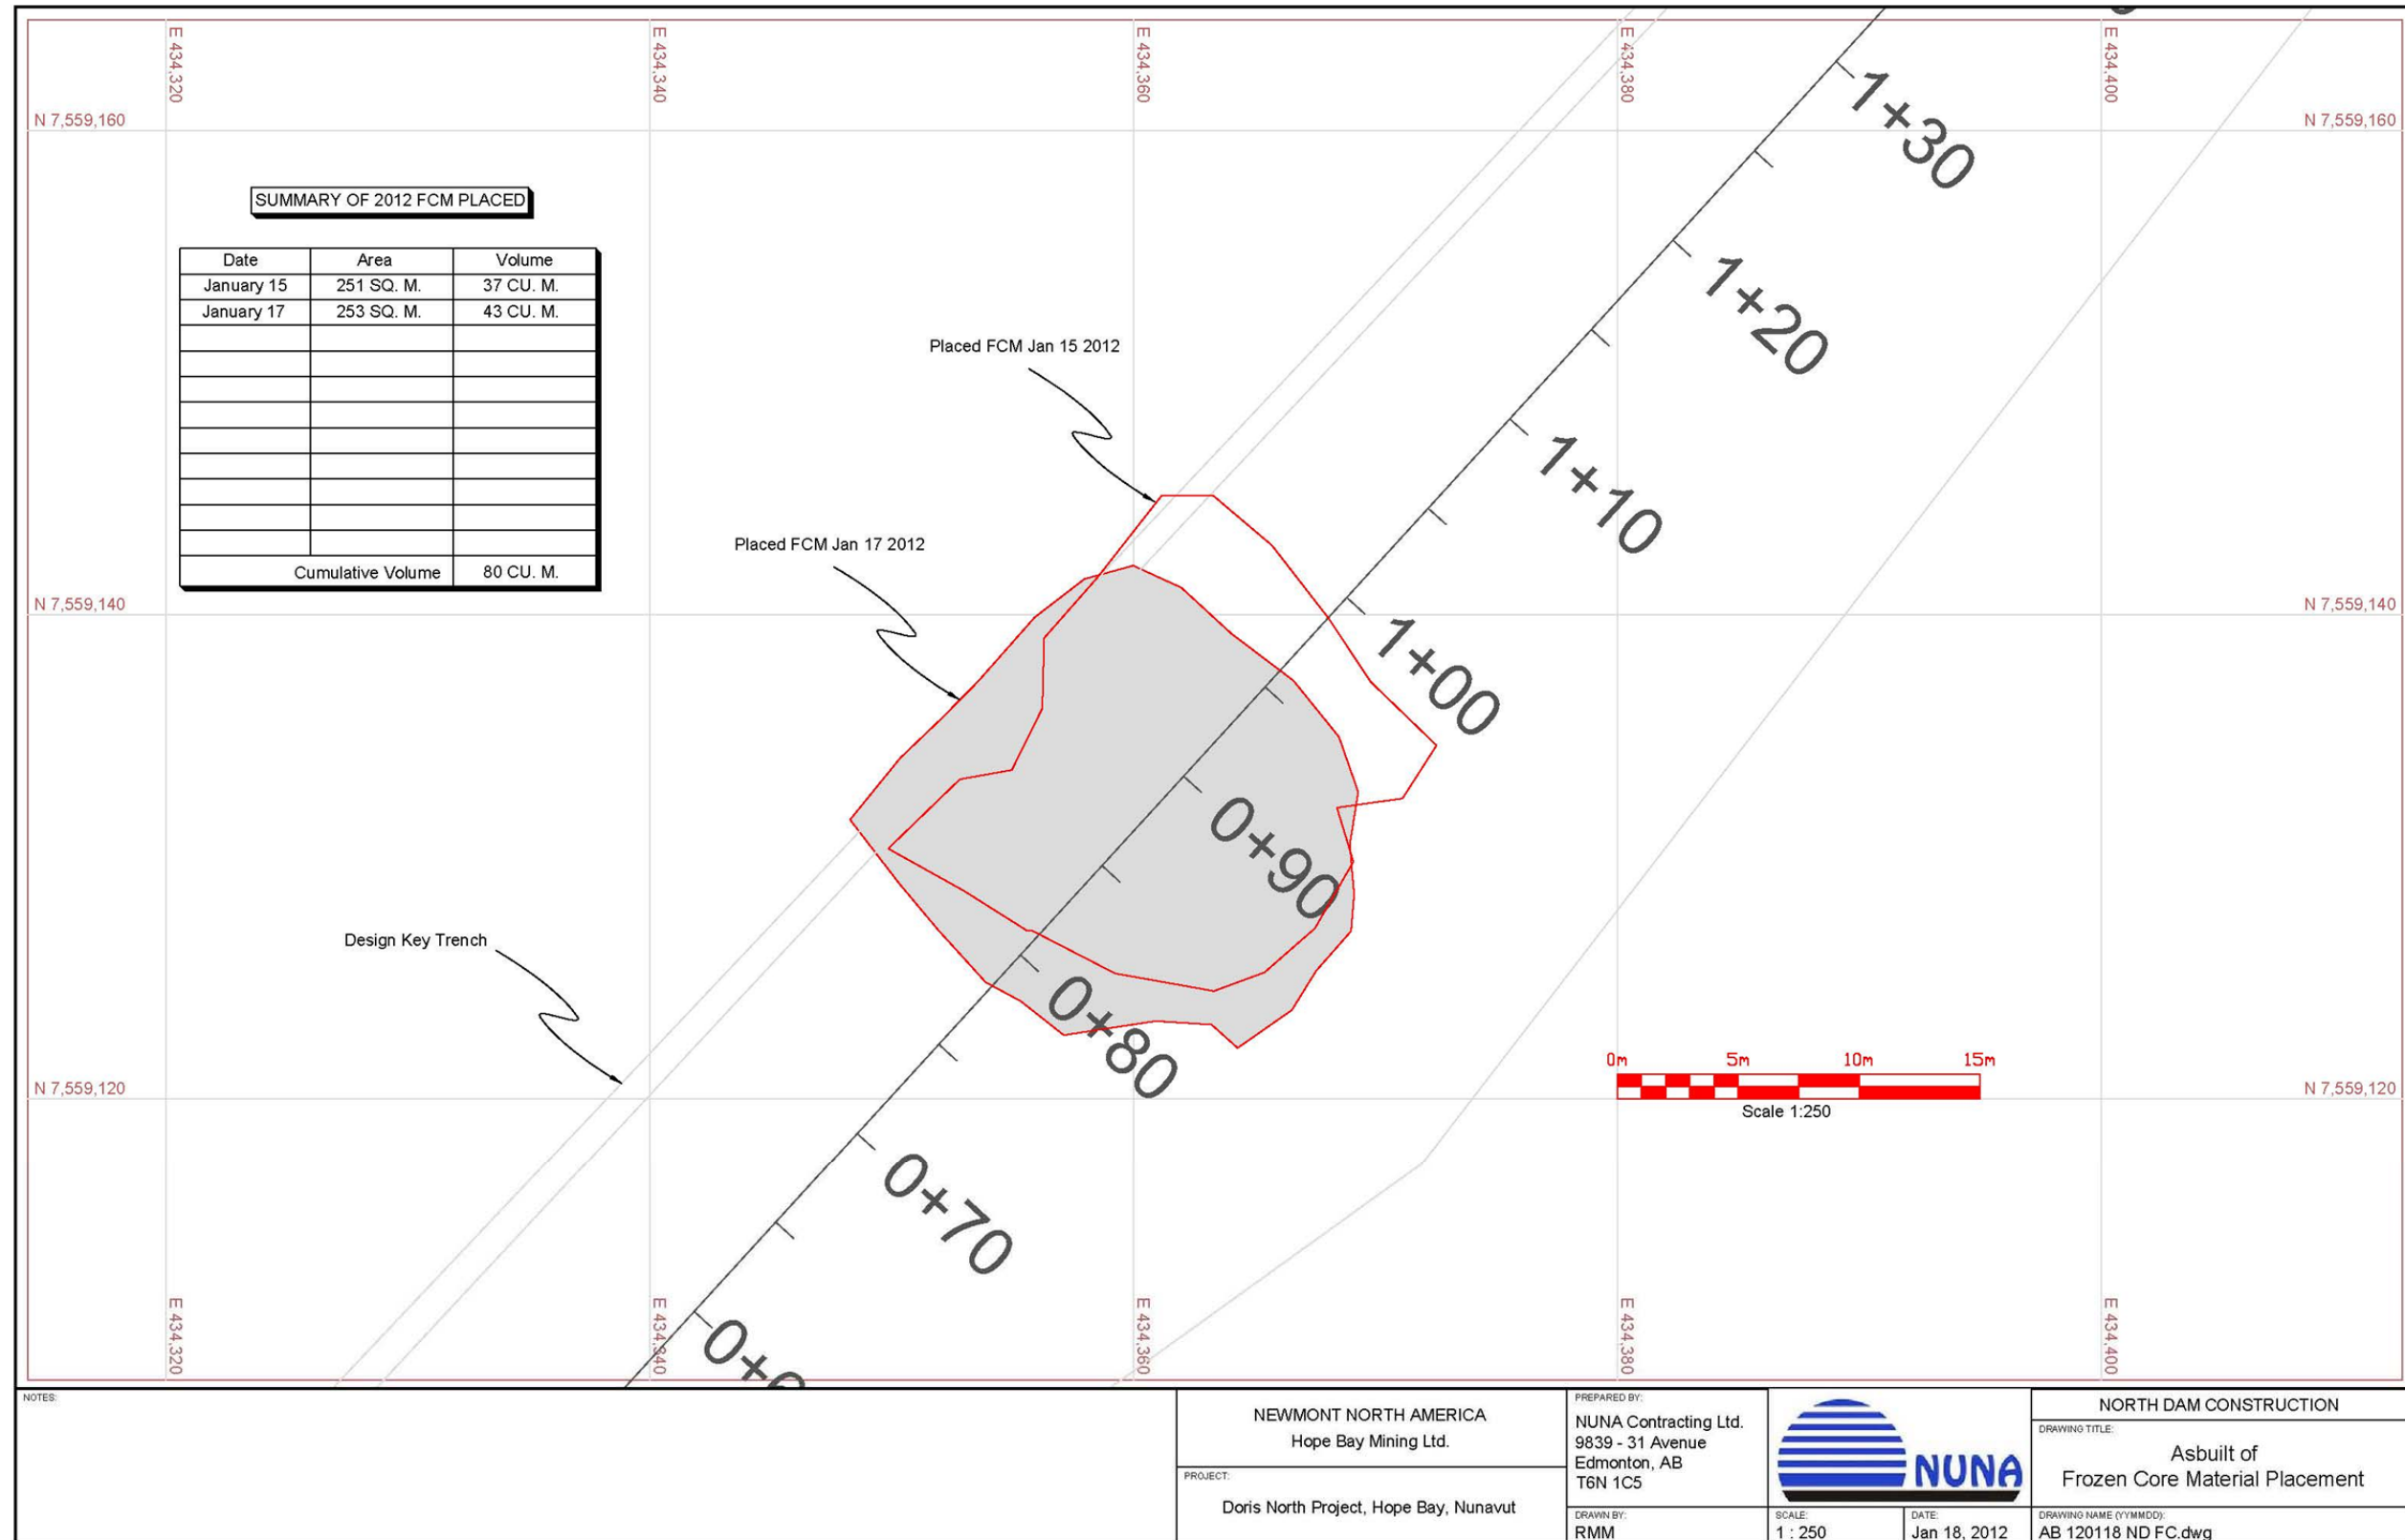
- An as-built figure showing the areas of placement for 2012/01/15 and 2012/01/17 is provided at the end of this report.
