## DAILY REPORT #15 – DORIS NORTH INFRASTRUCTURE/ NORTH DAM

Prepared by:	John Kurylo/ Jeff Orr / Megan Miller	Date:	2012.01.20
Reviewed by:		Project #:	1CH008.058.0320
Role	Company	Personnel – Position	On Site
Client	Hope Bay Mining Limited (HBML)	Angela Holzapfel – ESR Compliance Manager David Vokey – ESR Coordinator Don Ethelston – HSLP Advisor Dean Wold - Safety Jill Turk – ESR Coordinator Katsky Venter – ESR Manger Michelle Tanquay – ESR Site Manager Stirling Kelly – HSLP Advisor	No Yes Yes No No No Yes No
	JDS	Lloyd Jackson – Mechanical Superintendent Sven Archimowtiz – Electrical Superintendent Doug Fielding – Construction Manager Ishan Fechter – Construction Coordinator Jerry Graham – Construction Manager Kevin Whieldon – Project Coordinator Mark Valeriote – Construction Manager	No Yes Yes Yes No No Yes
Engineering Design Consultants	SRK Consulting (Canada) Inc.	John Kurylo – Site Engineer Megan Miller – Site Engineer Lawrence Borowski – Site Engineer Murry McGregor – Site Engineer Iozsef Miskolczi – Site Engineer	Yes Yes No No No

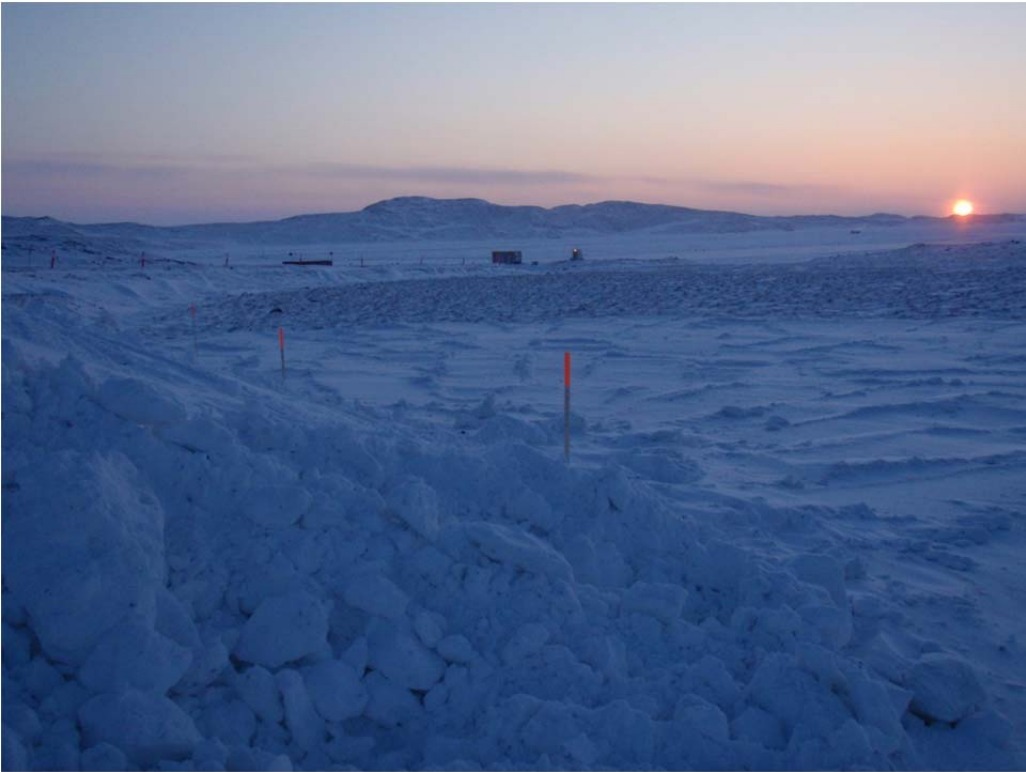
**Photo 1 (top left):** ~SEE view of snow pad near DN Camp Sump 1 location. Looking towards Doris Lake.

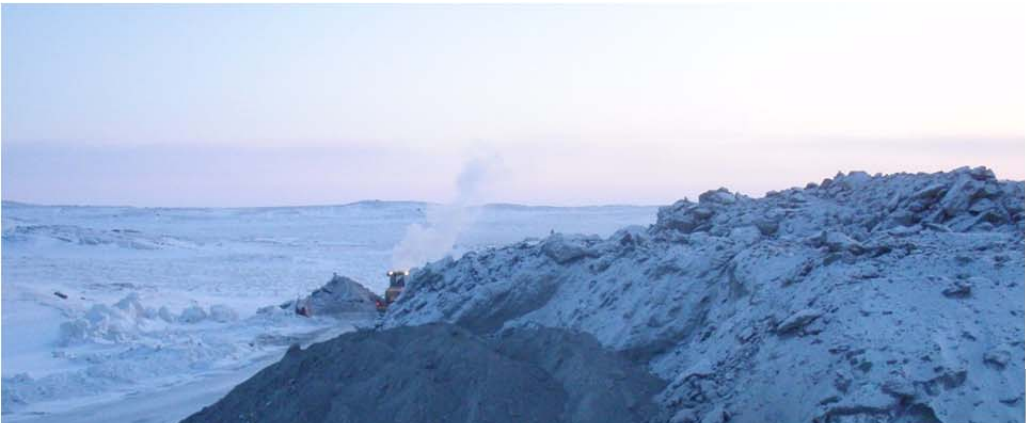
**Photo 2 (top center):** ~E view of FCM stockpile at the FCP Pad. Note that the frozen material is trying to be seperrated out and the better quality material stockpiled (i.e. small stockpile starting at the forefront of this picture).

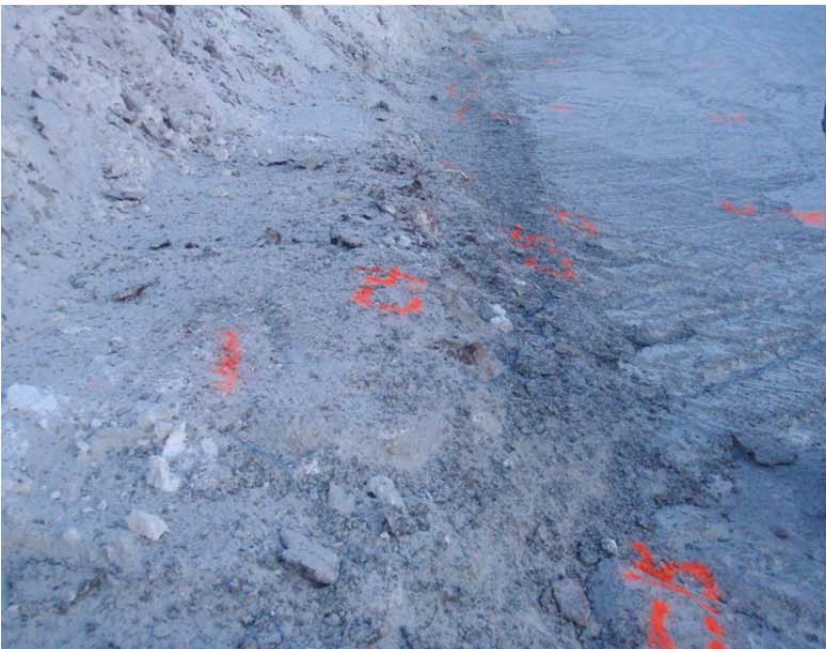
- Additional 5/8" clearing is required on the side slopes of the key trench FCM.
  - There was one area of the key trench, around the downstream edge of 1+40 where the key trench was protruding inwards of the SRK design lines. The material in this area was ripped out to the SRK design limits with the toothed excavator bucket. Photo 3 shows this area before the aforementioned material was removed.

**Photo 3 (center):** View of downstream slope around 1+40. Note that the ‘knob’ of frozen original ground was ripped out today as it was slightly inwards of the IFC design lines.

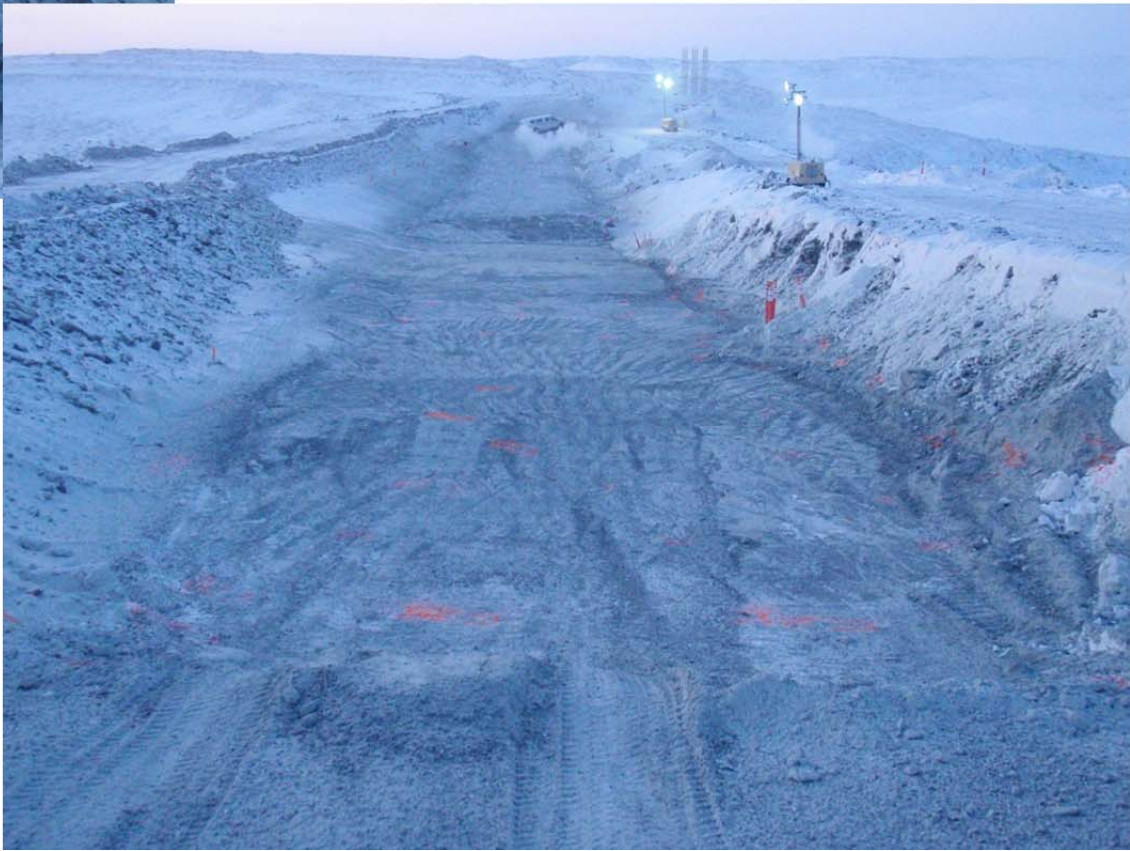
**Photo 4 (mid right):** ~W view, looking down the key trench, at cleaning progress.

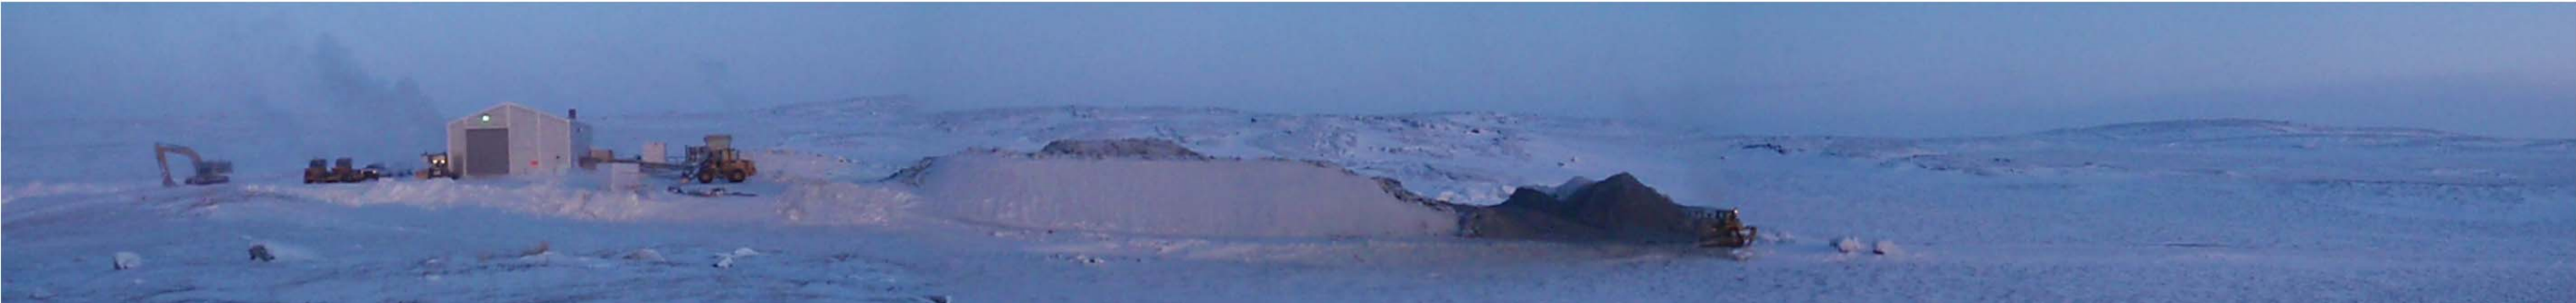
**Photo 5 (bottom):** ~ N view of the FCP Pad.

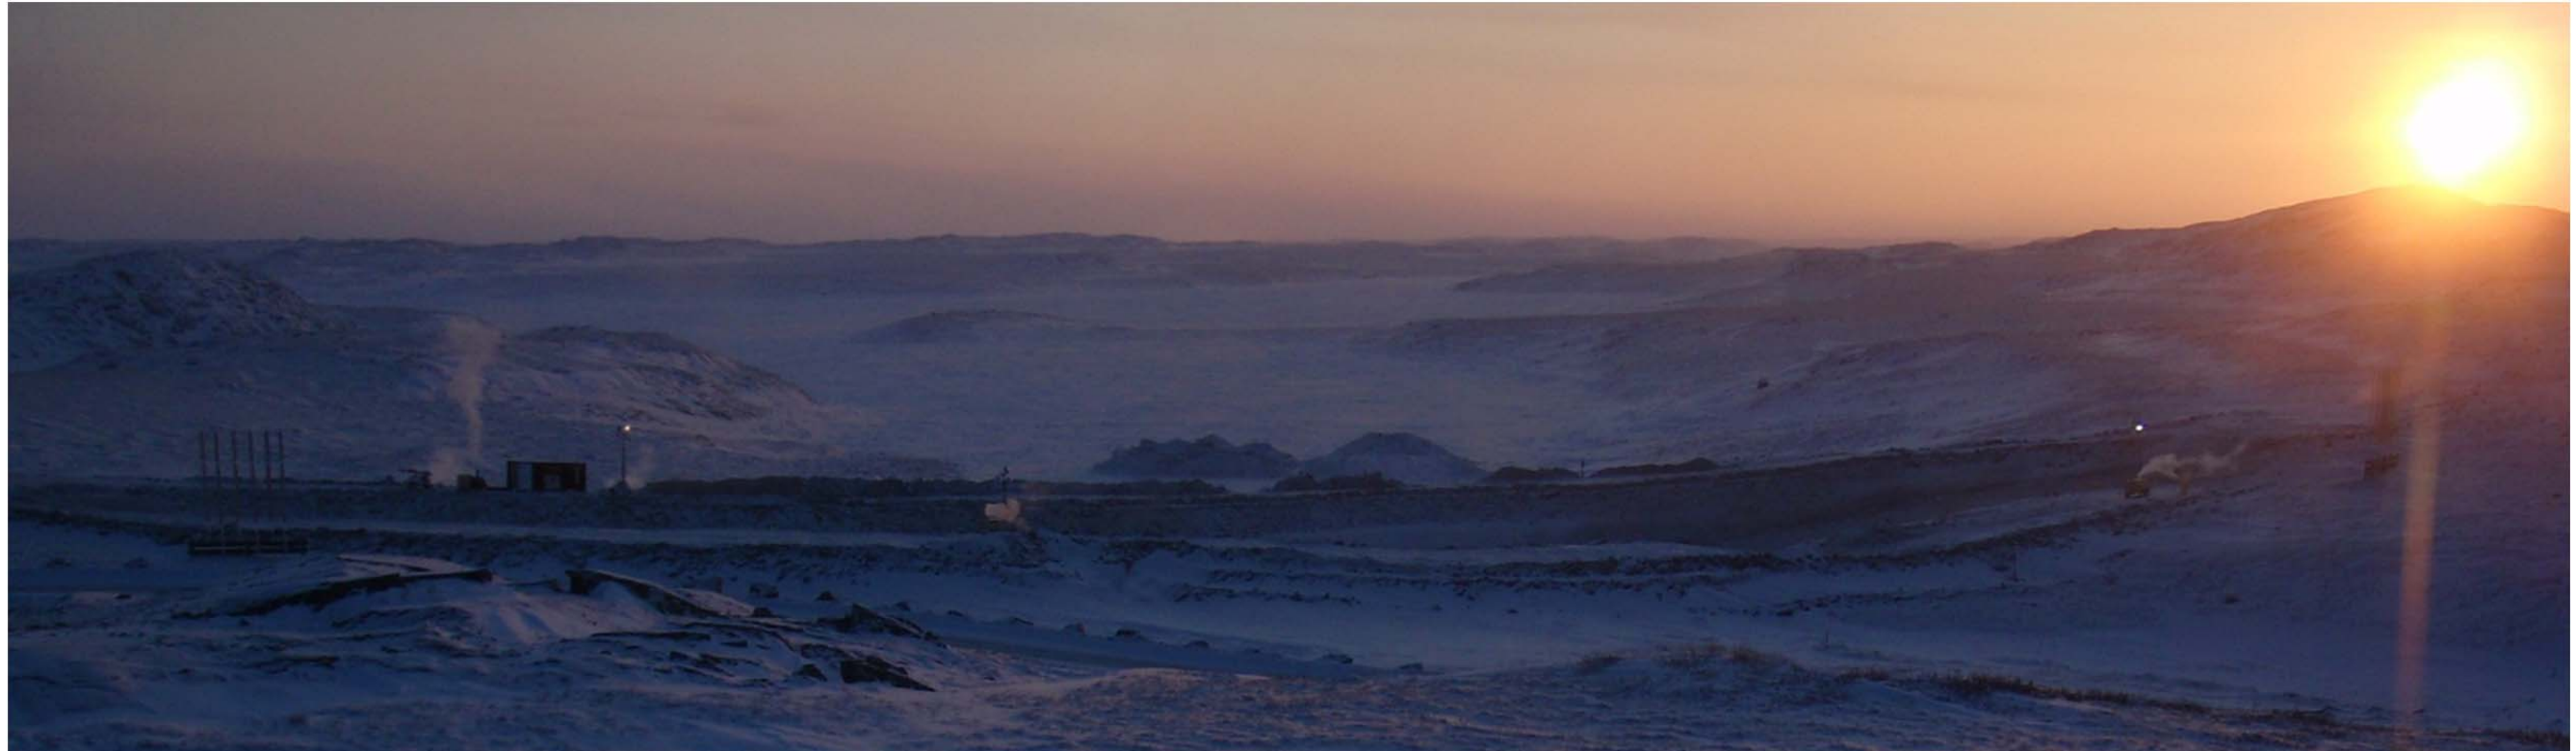
**Photo 6:** Progress photo of the North Dam construction from Photo Point 1; taken in the pm, ~ SE view.

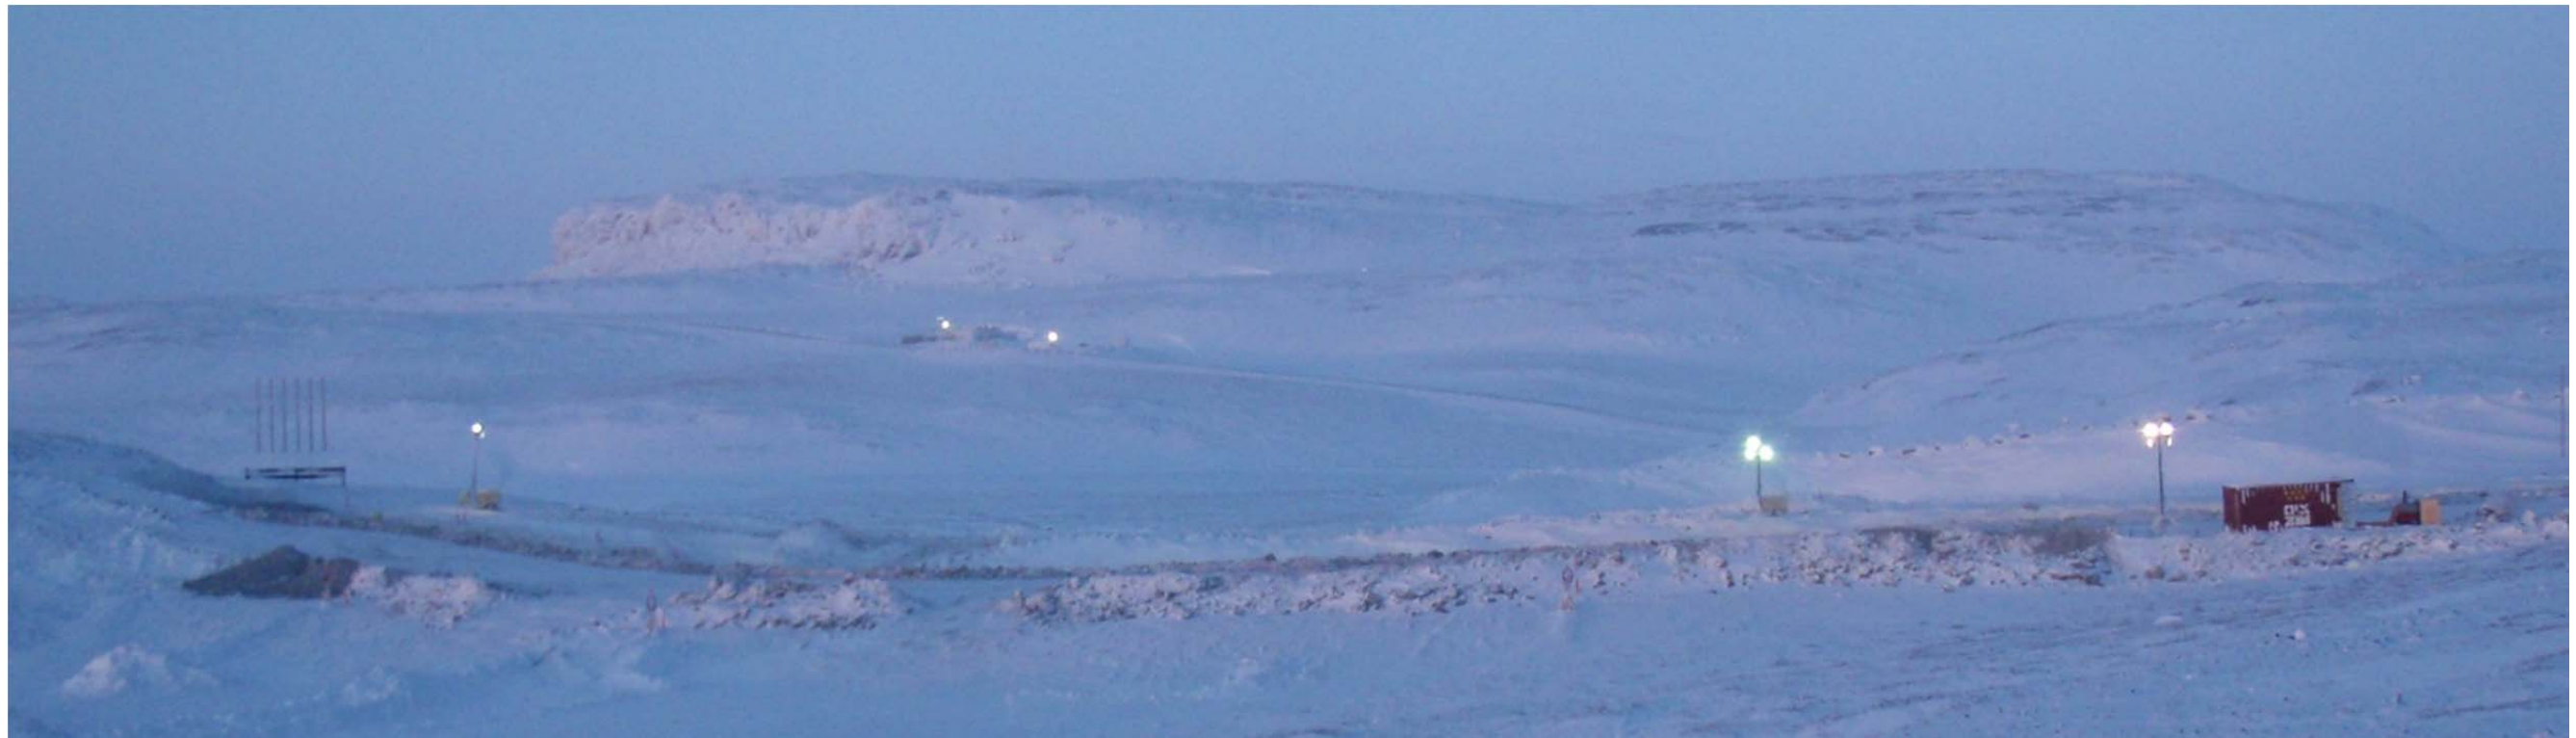
**Photo 7:** Progress photo of the North Dam construction from Photo Point 2; taken in the am, ~ WNW view.

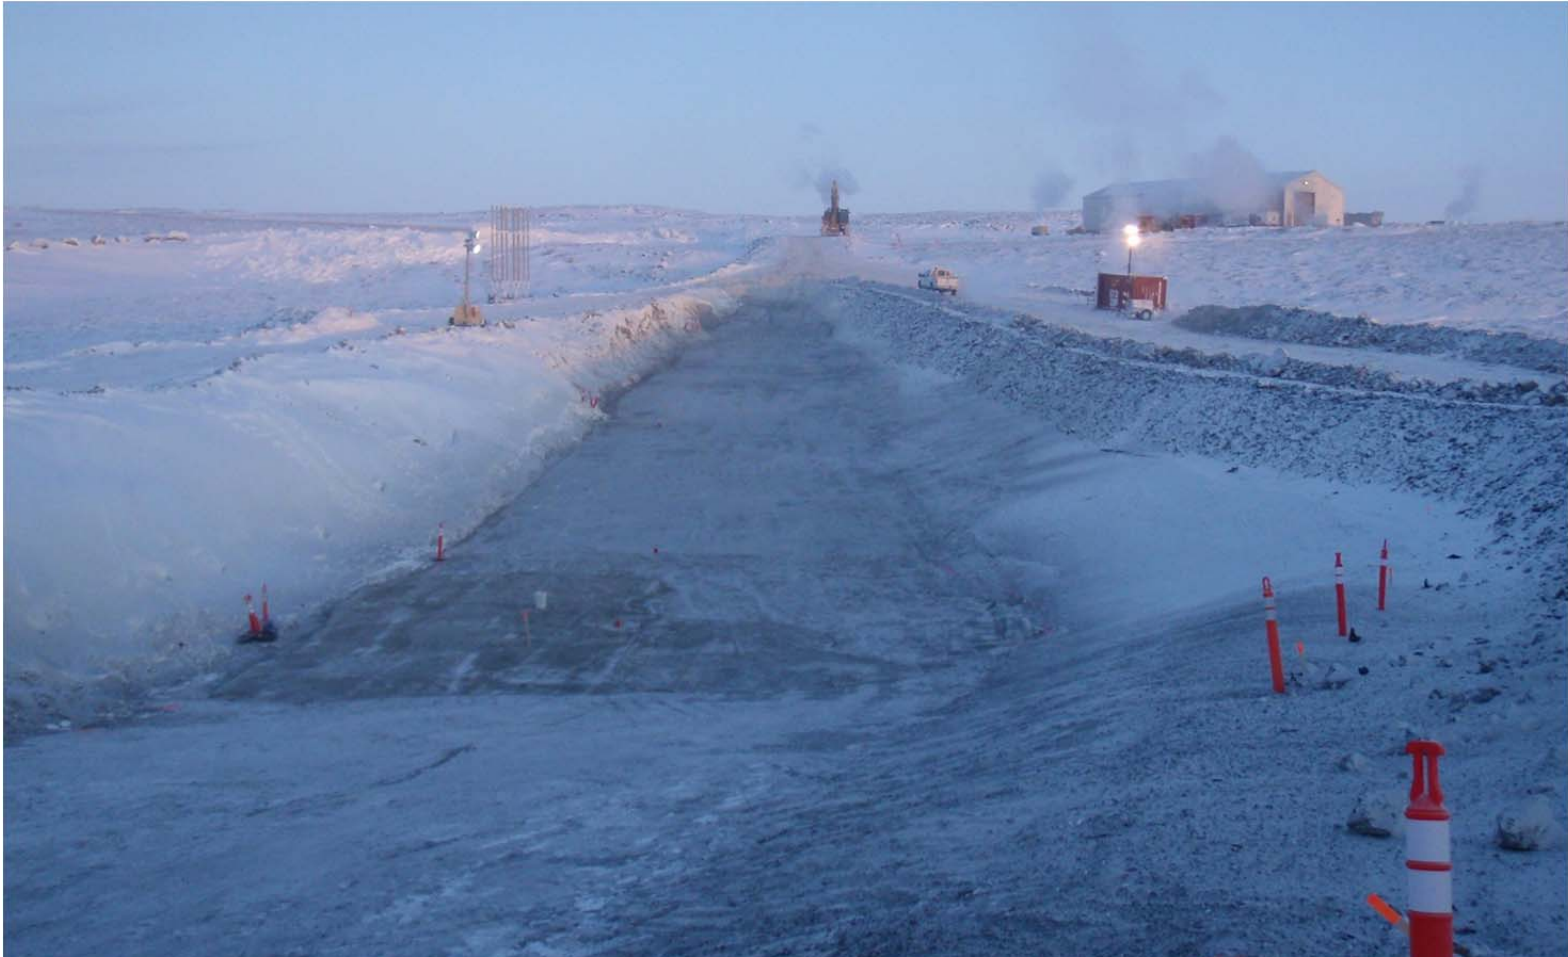
**Photo 8:** ~ NEE view down key trench. Note recent January 19<sup>th</sup> placement is the darker coloured material in the central area.

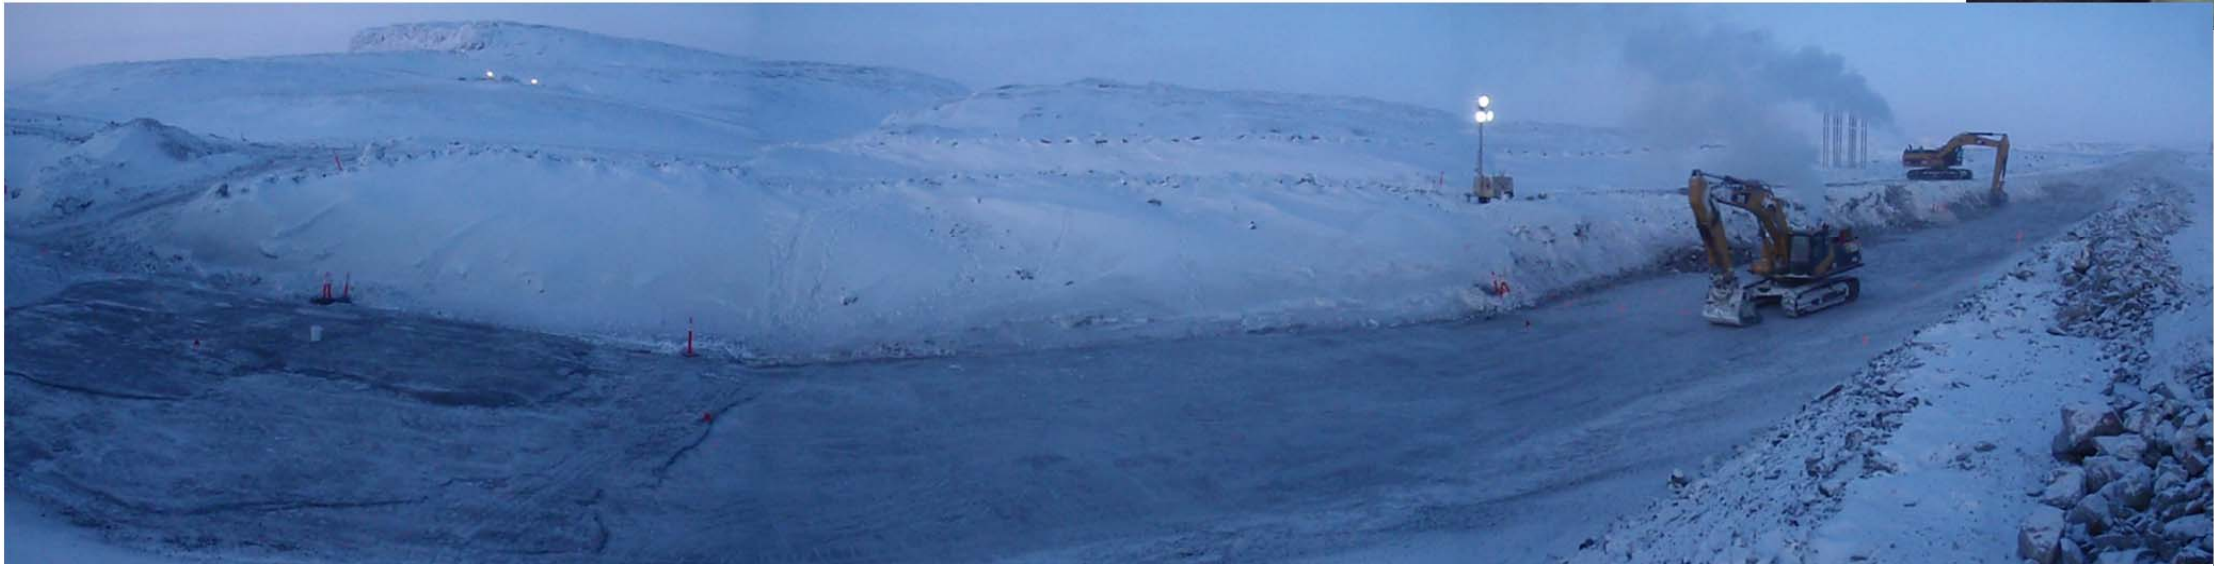
**Photo 9:** ~ N view of excavators working on cleaning eastern portion of key trench (stitched Panoramic view)

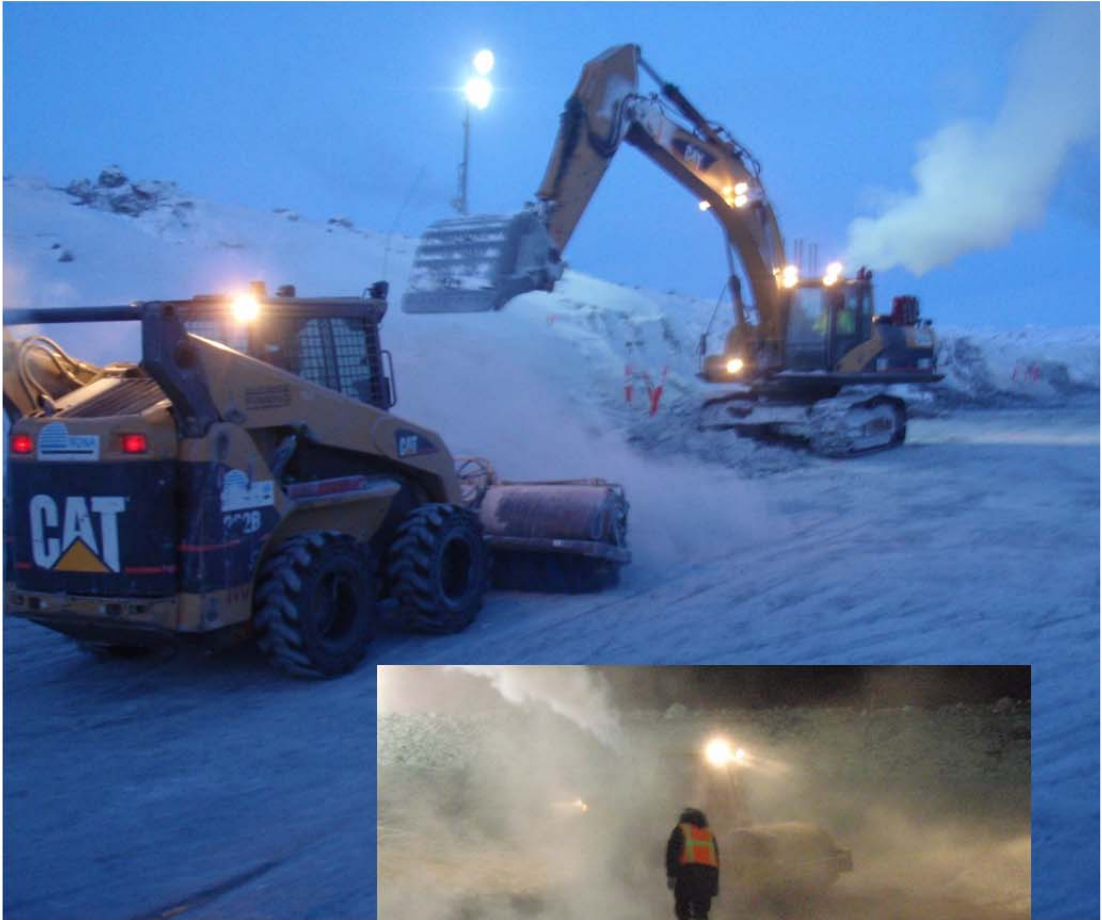
**Photo 10 (top right):** Bobcat and 330 excavator working cleaning snow and 5/8" material from downstream of key trench.

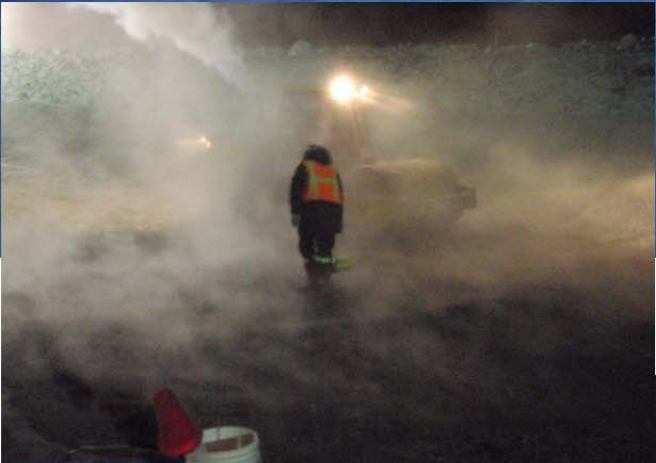
**Photo 11 (right center):** Compaction testing being completed around station 0+90 in the central key trench area.

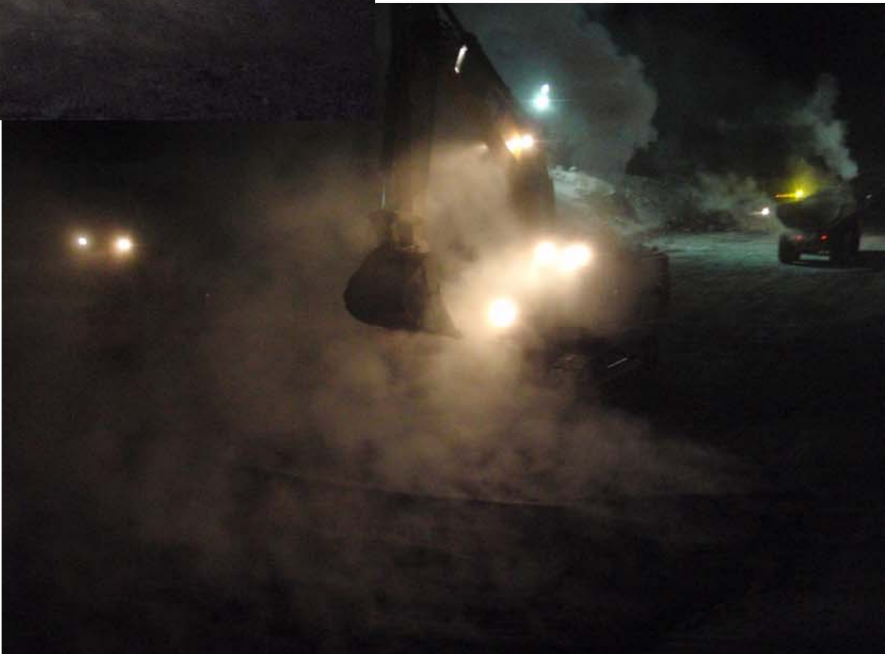
**Photo 12:** ~NNE view of 345 excavator spreading/ placing FCM.

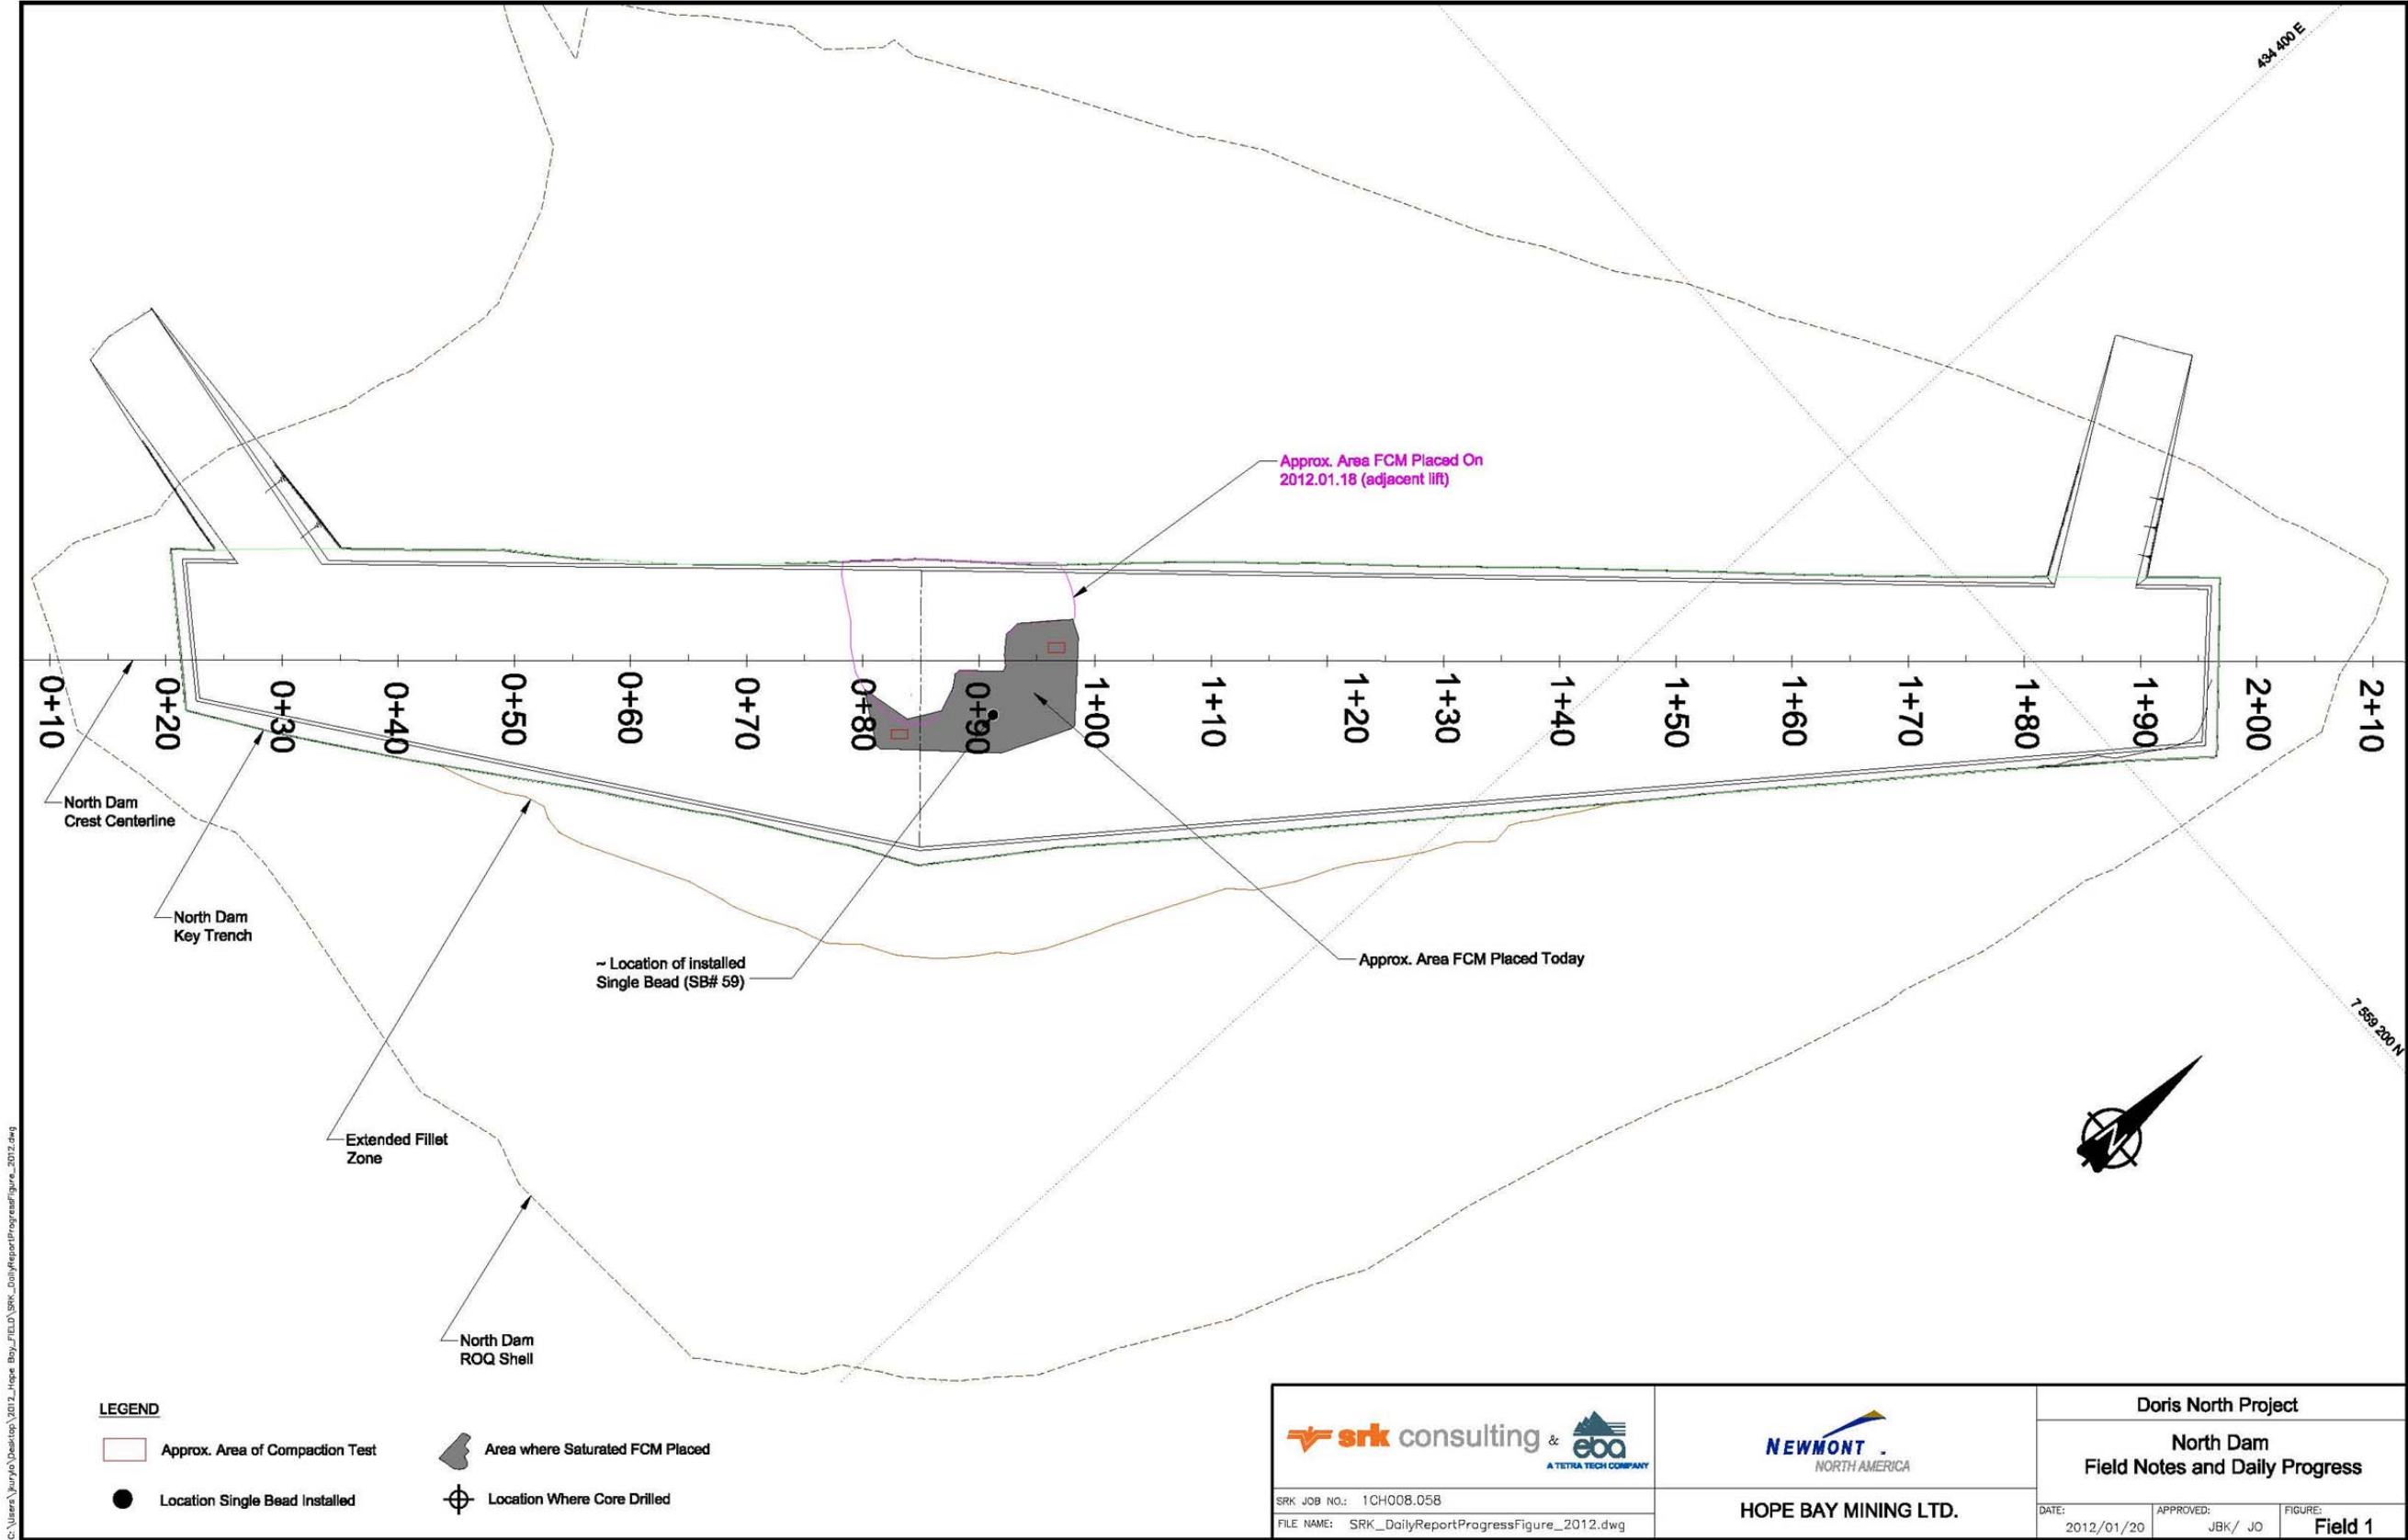
FIGURE:  
• FCM Progress/ Placement

- Thermistor ND-HTS-060-28.8 remains broken.
- A loader scraped snow of the edges and floor of the key trench for part of the night.
- A progress figure showing today's the approximate extent of today's placement is provided as Figure 1.
