DAILY REPORT #16 – DORIS NORTH INFRASTRUCTURE/ NORTH DAM

Prepared by:	John Kurylo/ Jeff Orr / Megan Miller	Date:	2012.01.21
Reviewed by:		Project #:	1CH008.058.0320
Role	Company	Personnel – Position	On Site
Client	Hope Bay Mining Limited (HBML)	Angela Holzapfel – ESR Compliance Manager David Vokey – ESR Coordinator Don Ethelston – HSLP Advisor Dean Wold - Safety Jill Turk – ESR Coordinator Katsky Venter – ESR Manger Michelle Tanquay – ESR Site Manager Stirling Kelly – HSLP Advisor	No Yes Yes No No No Yes No
	JDS	Lloyd Jackson – Mechanical Superintendent Sven Archimowtiz – Electrical Superintendent Doug Fielding – Construction Manager Ishan Fechter – Construction Coordinator Jerry Graham – Construction Manager Kevin Whieldon – Project Coordinator Mark Valeriote – Construction Manager	No Yes Yes Yes No No Yes
Engineering Design Consultants	SRK Consulting (Canada) Inc.	John Kurylo – Site Engineer Megan Miller – Site Engineer Lawrence Borowski – Site Engineer Murry McGregor – Site Engineer Iozsef Miskolczi – Site Engineer	Yes Yes No No No

NORTH DAM/FROZEN CORE PLANT PAD:

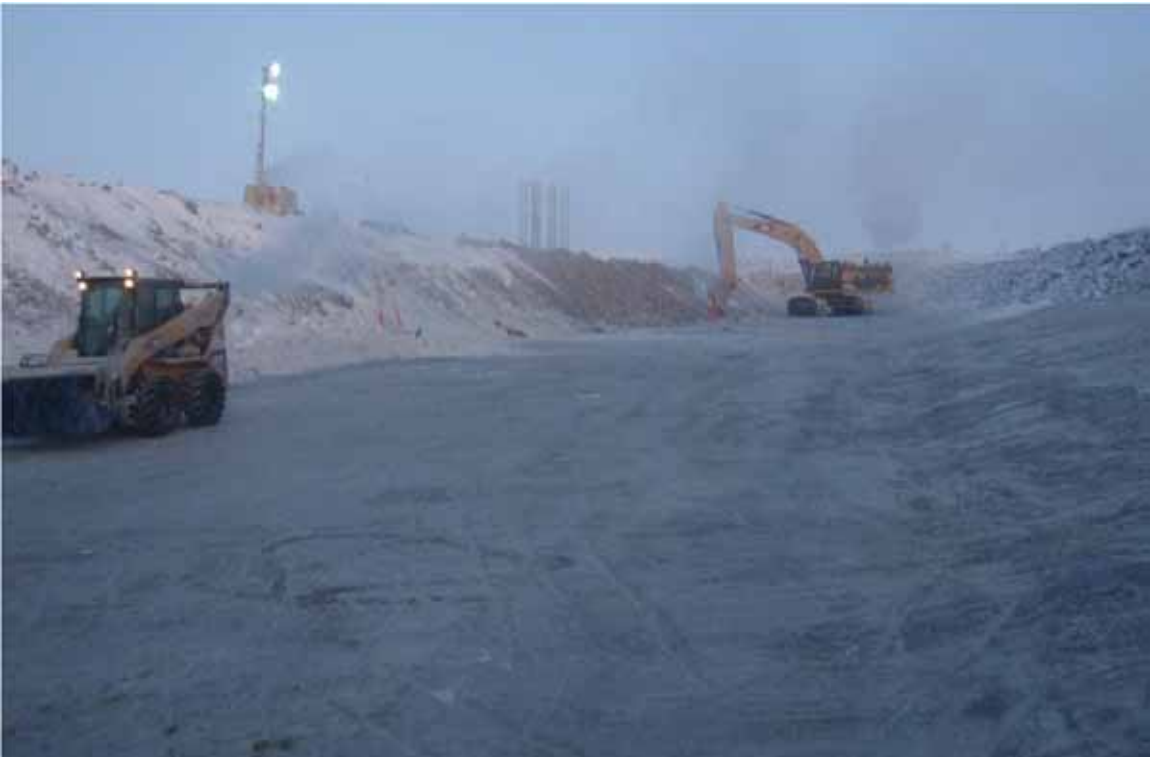
Photo 1: ~ NE view down key trench of cleaning activities. Note the excavation cleaning the DS slope around station 1+50.

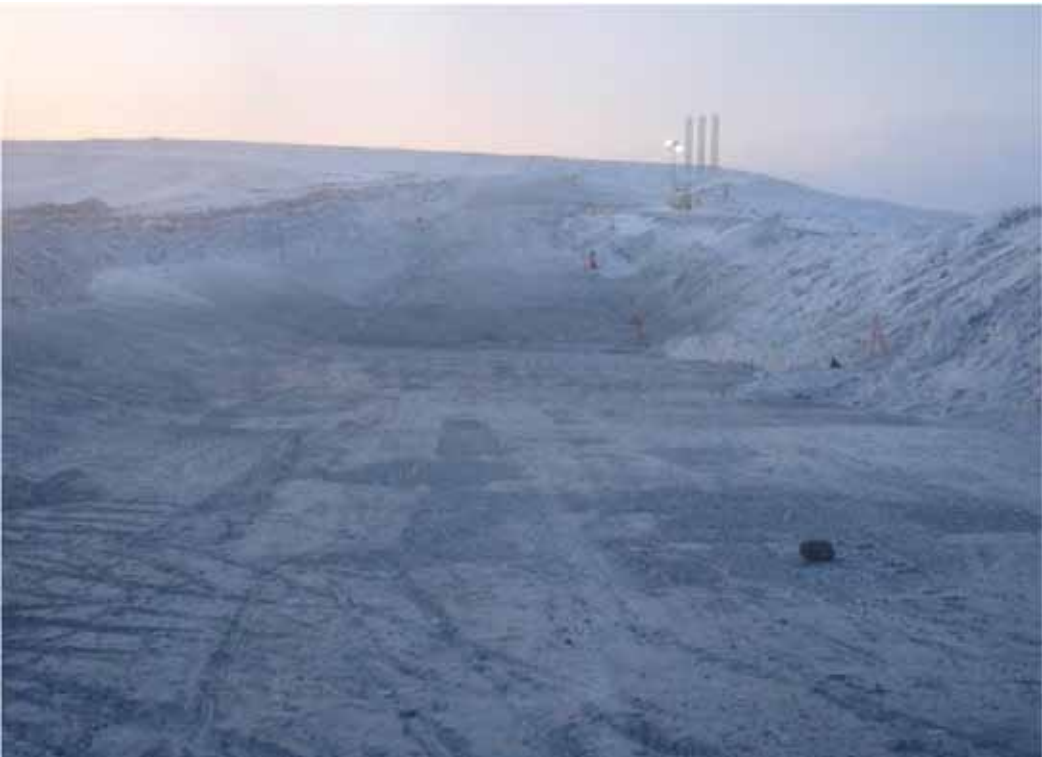
Photo 2: ~ WSW view down key trench towards Jan 21st placement. Photo taken from ~ station 1+50.

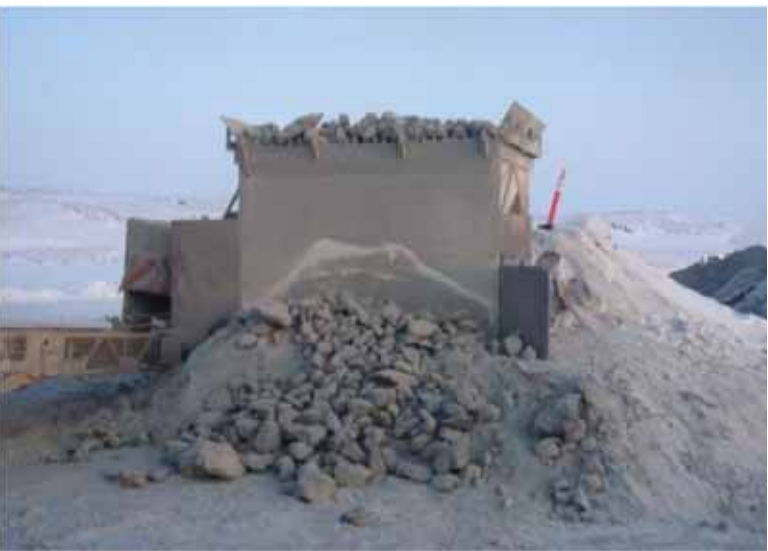
- After the first ~ ½ load of saturated frozen core material was sent down to the dam the plant had to be shut down to readdress issues. Frozen core material which had piled up on the grizzly bard of the hopper were removed.

Photo 3: ~ View of frozen lumps that have been pushed of grizzly bars as FCP hopper.

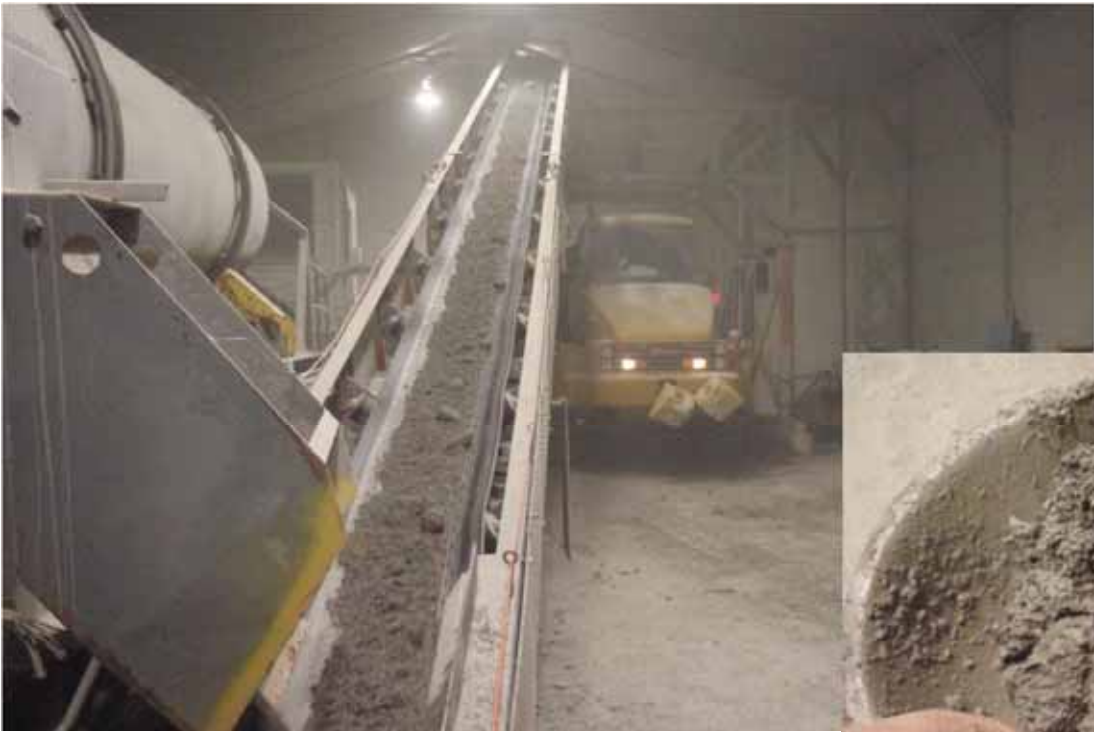
Photo 4: ~ View of FCM at FCP chute. Note this photo was taken at a time when a higher frequency of frozen lumps was being noted in the FCM. Less lumps were noted in later loads and on night shift.

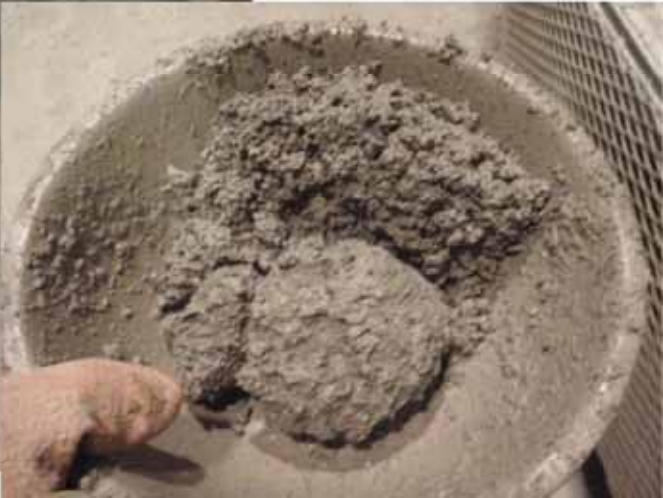
Photo 5 (bottom center): ~ Close up example of unsaturated frozen lumps observed in the FCM. A higher frequency of lumps was noted on dayshift placement however, night shift appears to have minimal lump frequency. Typically a slightly lower lump frequency was observed at the dam as FCM sits warm and heaped in the trucks before being dumped.

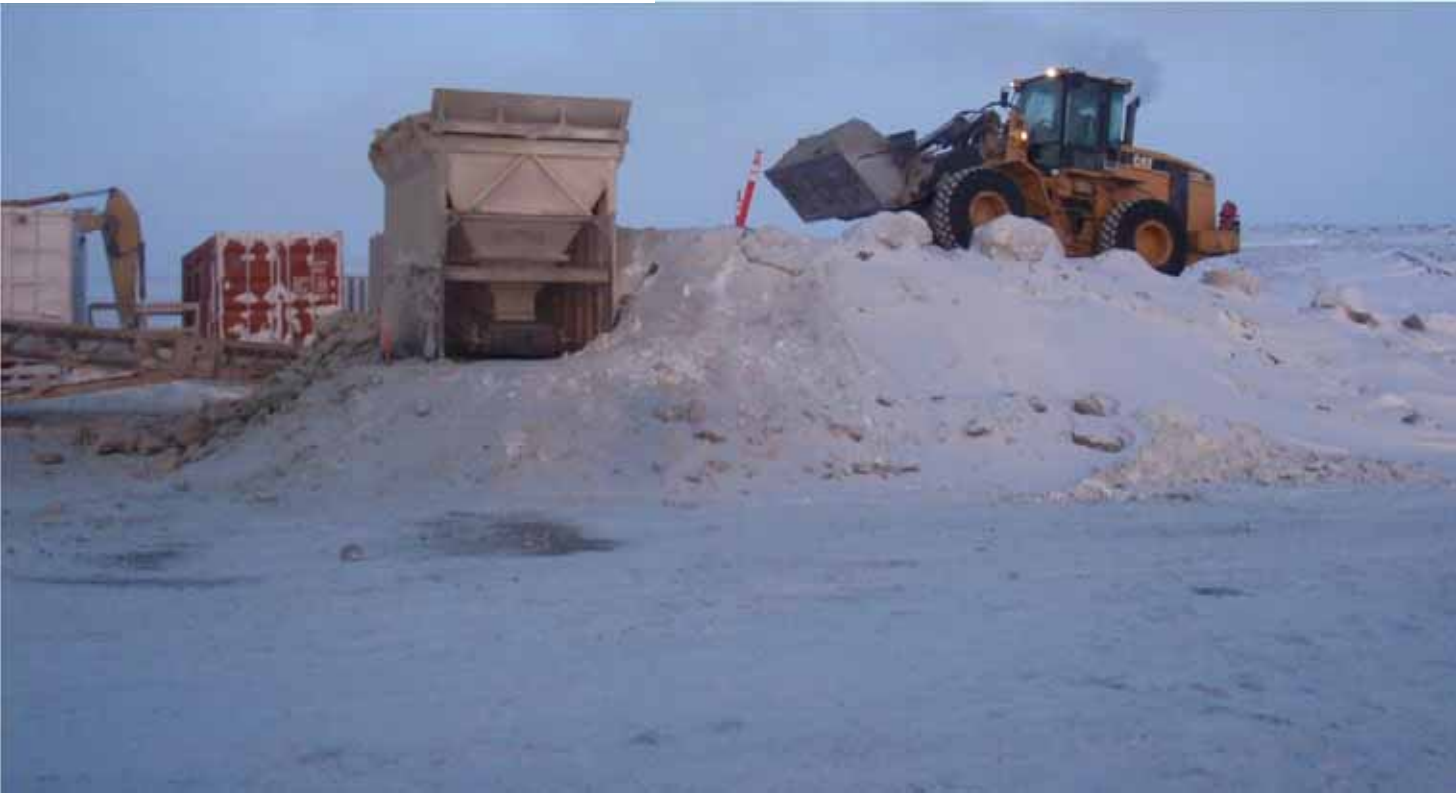
Photo 6: ~IT loader placing FCM into hopper at FCP.

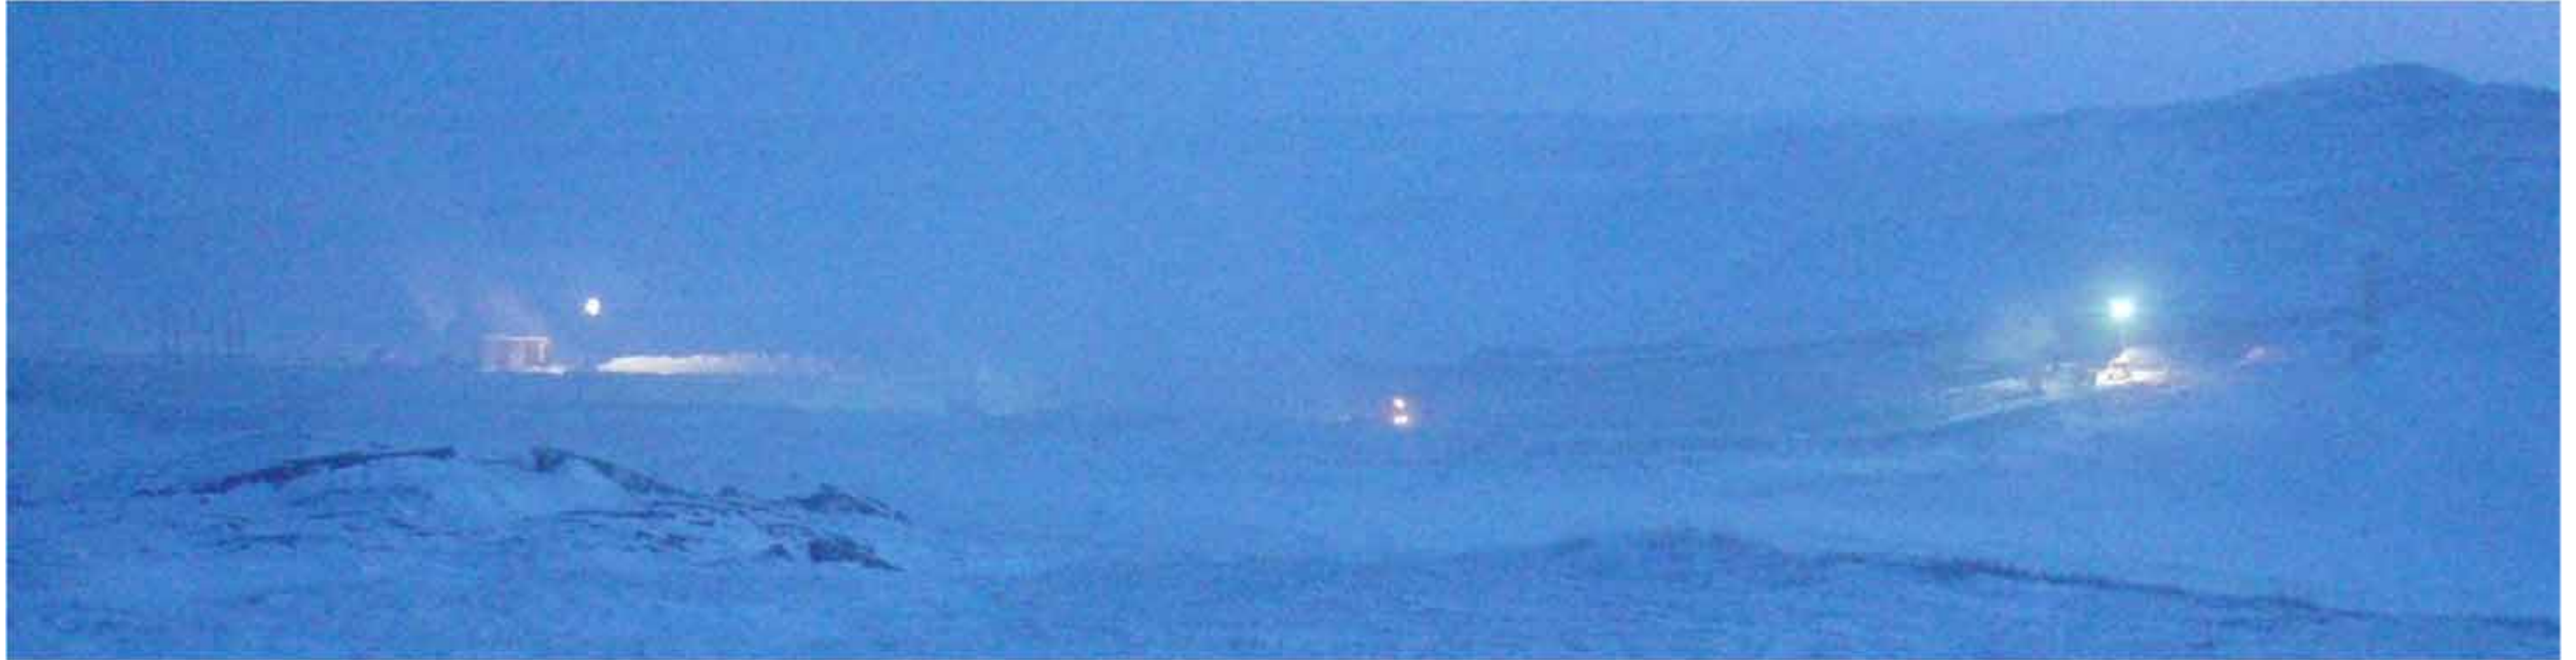
Photo 7: Progress photo of the North Dam construction from Photo Point 1; taken in the pm, ~ SE view.

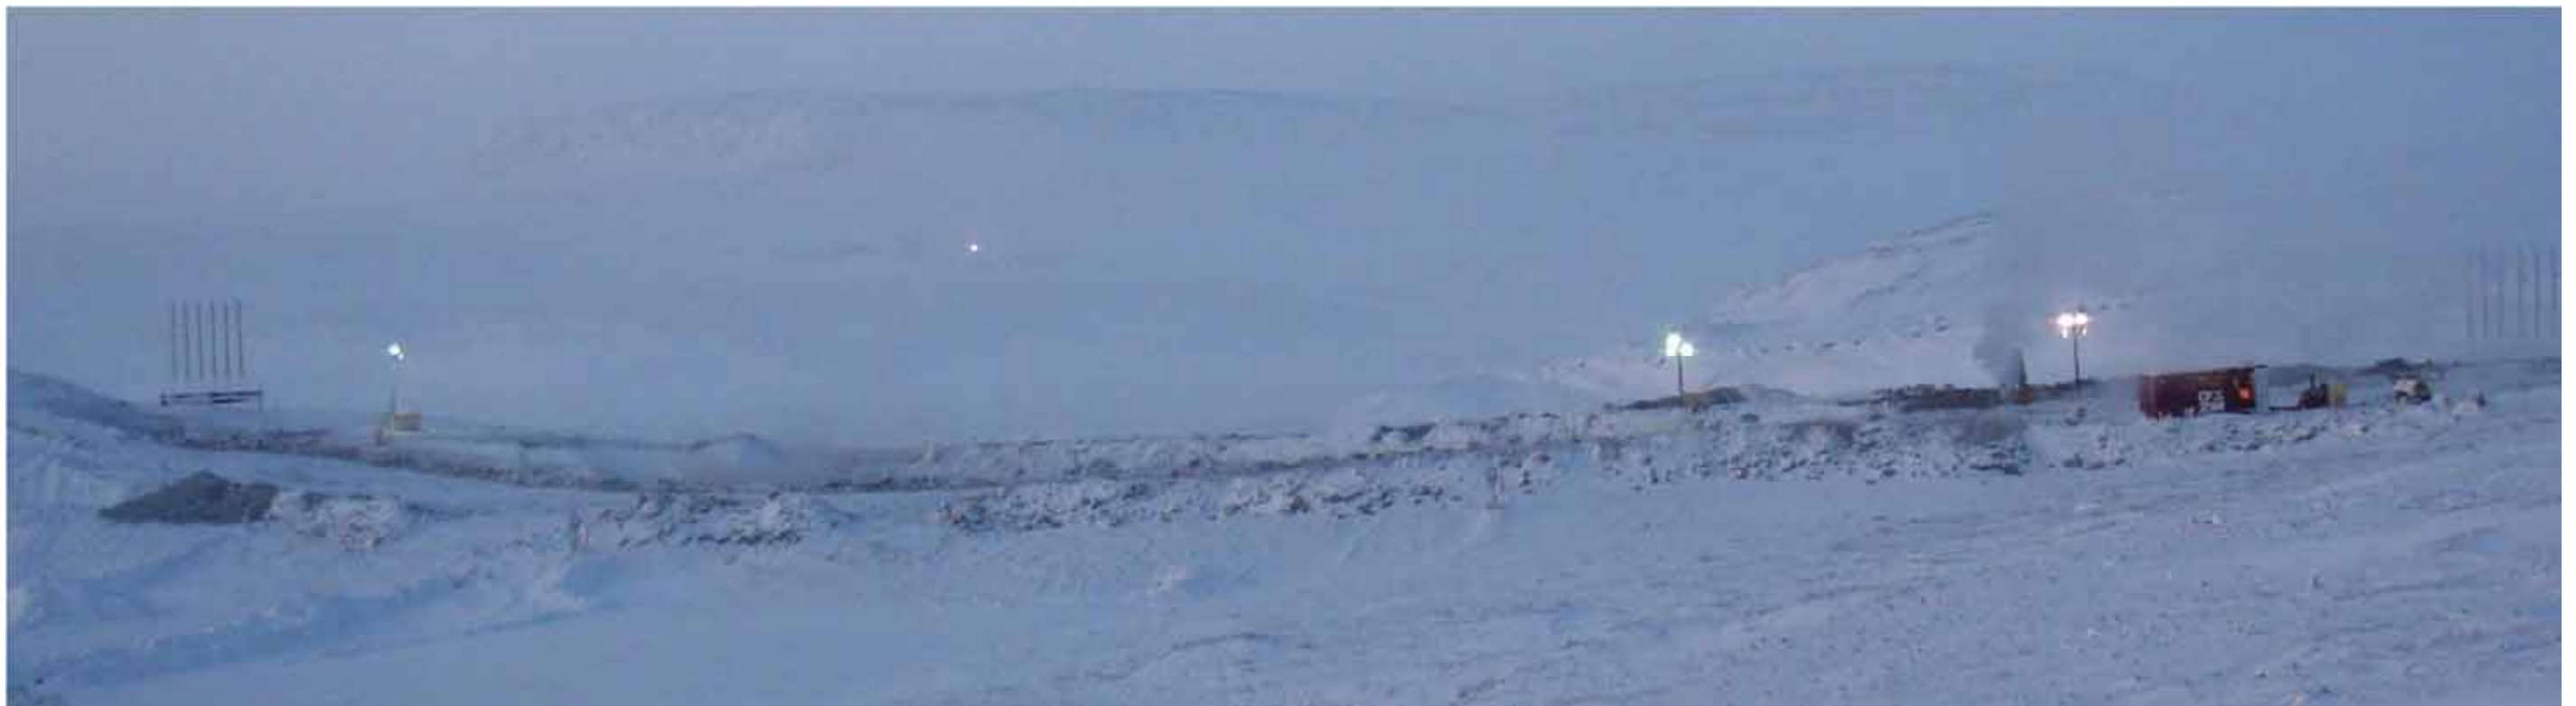
Photo 8: Progress photo of the North Dam construction from Photo Point 2; taken in the am, ~ WNW view.

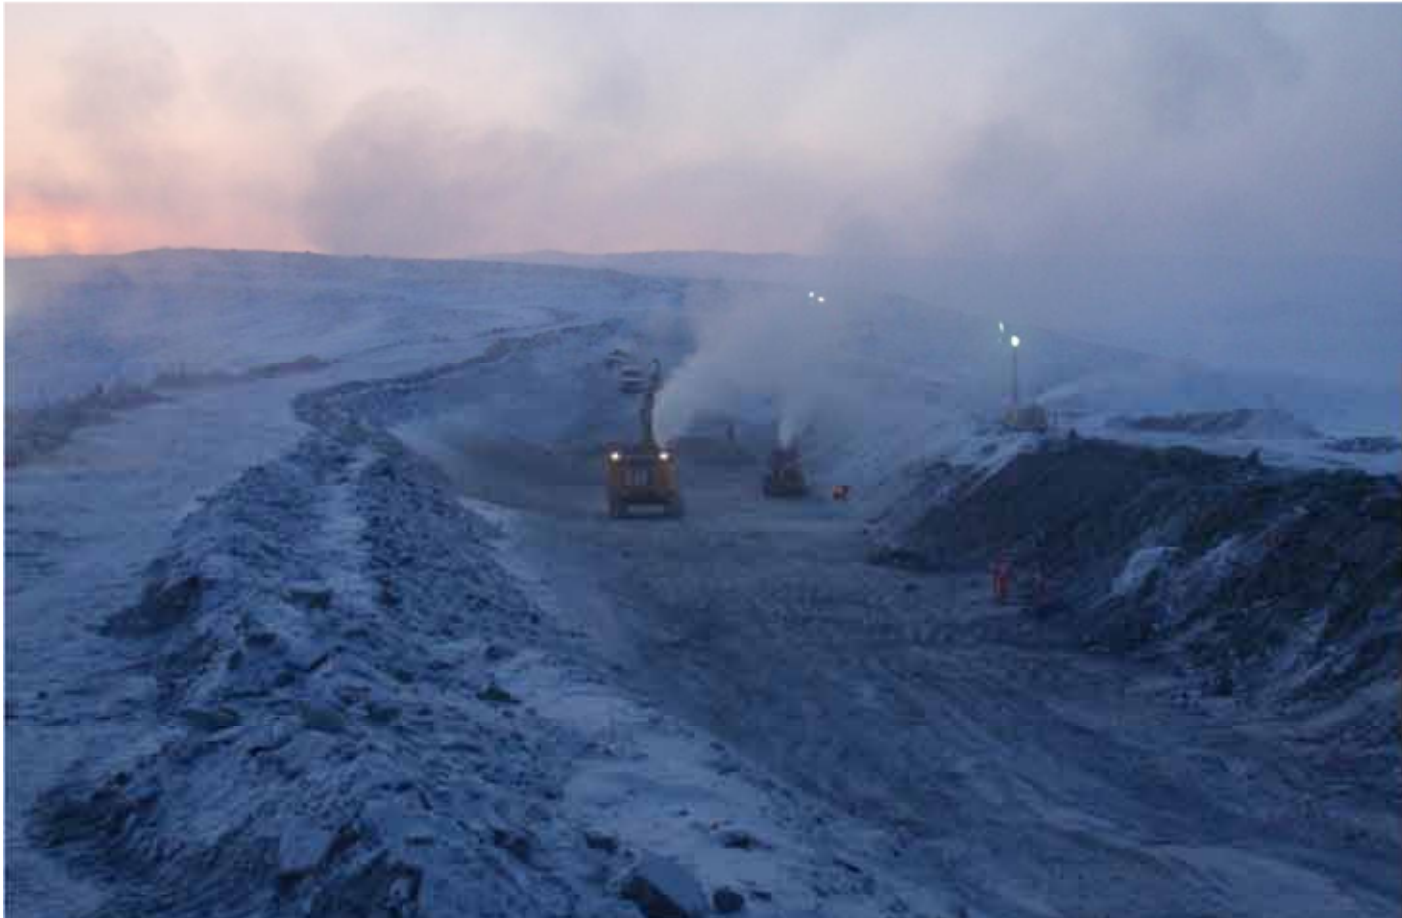
Photo 9: ~ ESE view down key trench. Note the 345 excavator and bobcat cleaning the central key trench area in preparation for the afternoon placement.

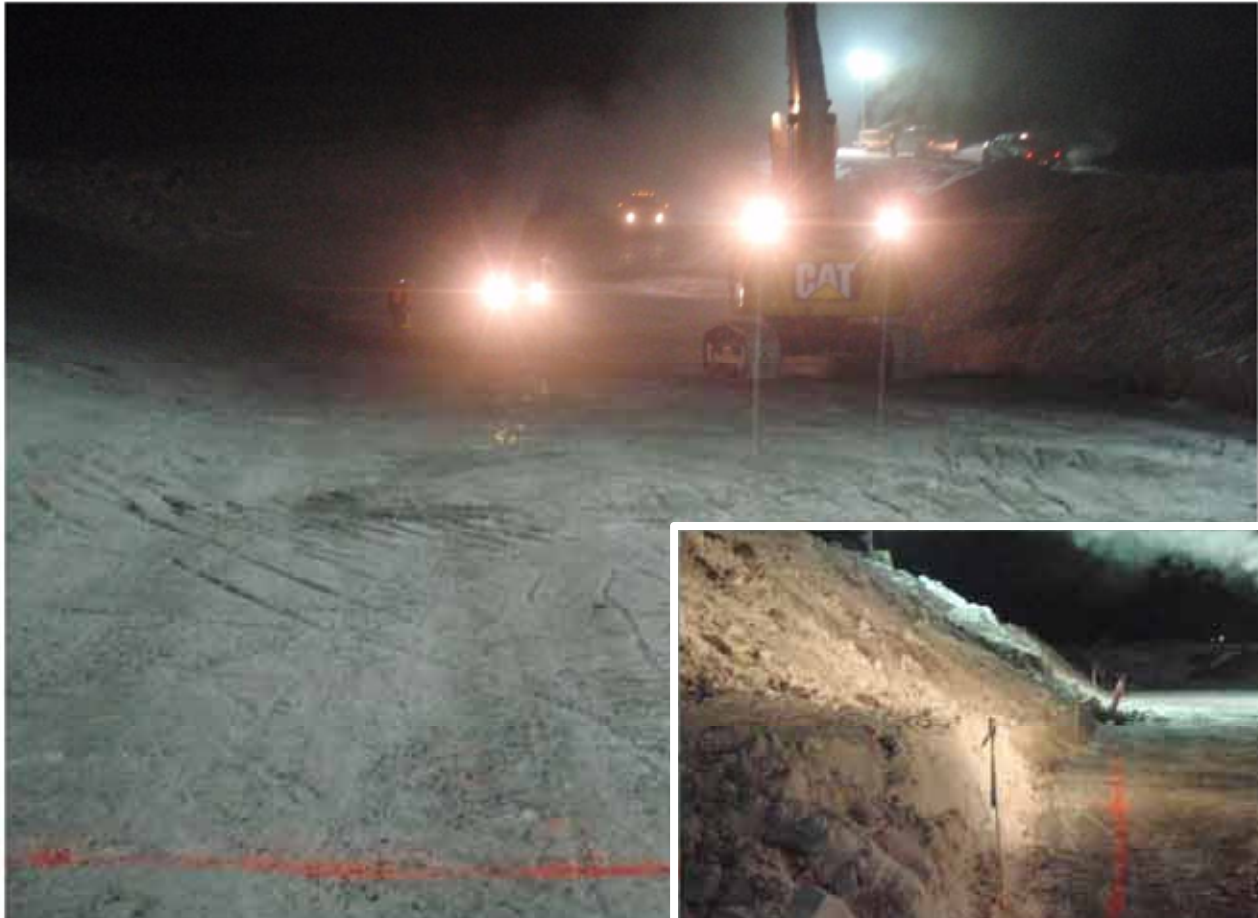
- 5/8" removal/ cleaning on the base of the key trench from ~ 0+40 to 1+70 were inspected. The key trench from 0+60 to 1+40 had 5/8" adequately removed from it before placement. The slopes on the upstream still require additional 5/8" material clearing before placement progresses to these areas.

Photo 12: View from ~Sta 1+40 towards the central area of the key trench. Note that 5/8” material removal from 0+60 to 1+40 was approved today for placement

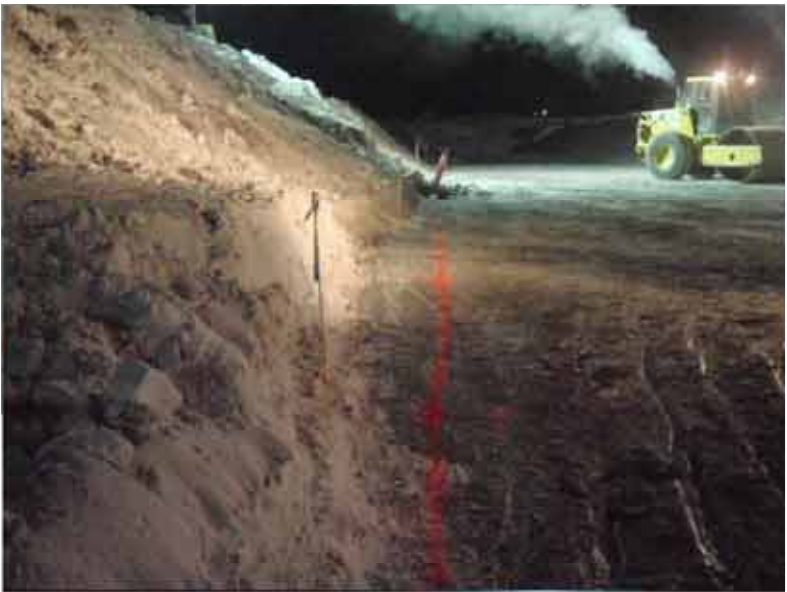
Photo 13 (center right): ~ ~NE view of downstream edge of key trench around Sta 1+10. Note that the stakes denote the surveyed IFC design crest and the line marks the required limits of the downstream key trench slope below original ground (i.e. downstream 0.5H:1V slope.

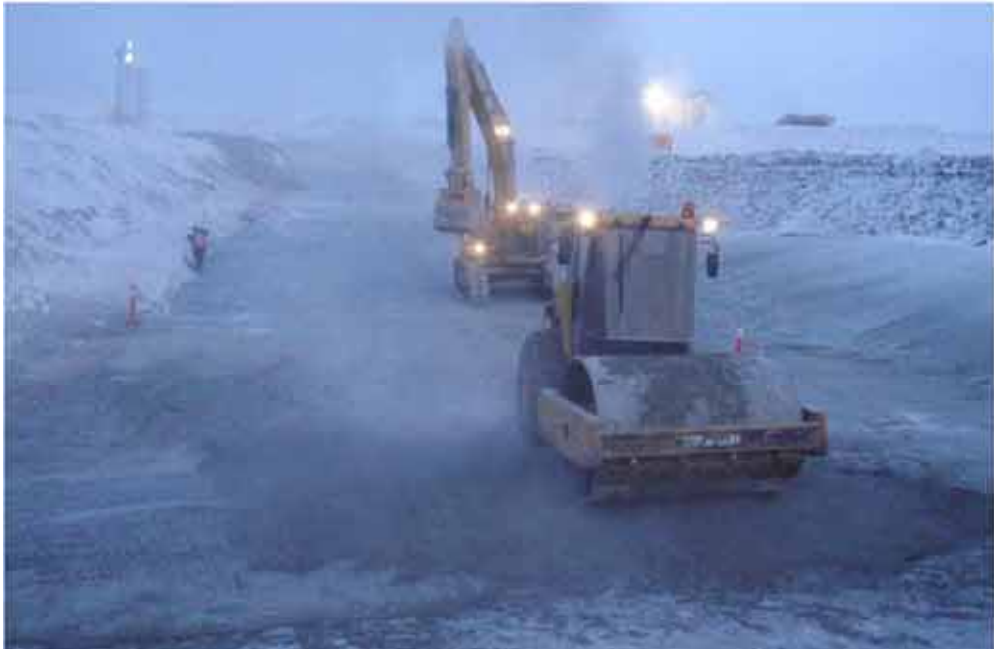
Photo 10: ~E view of vibrator compactor static rolling saturated FCM around station 0+85.

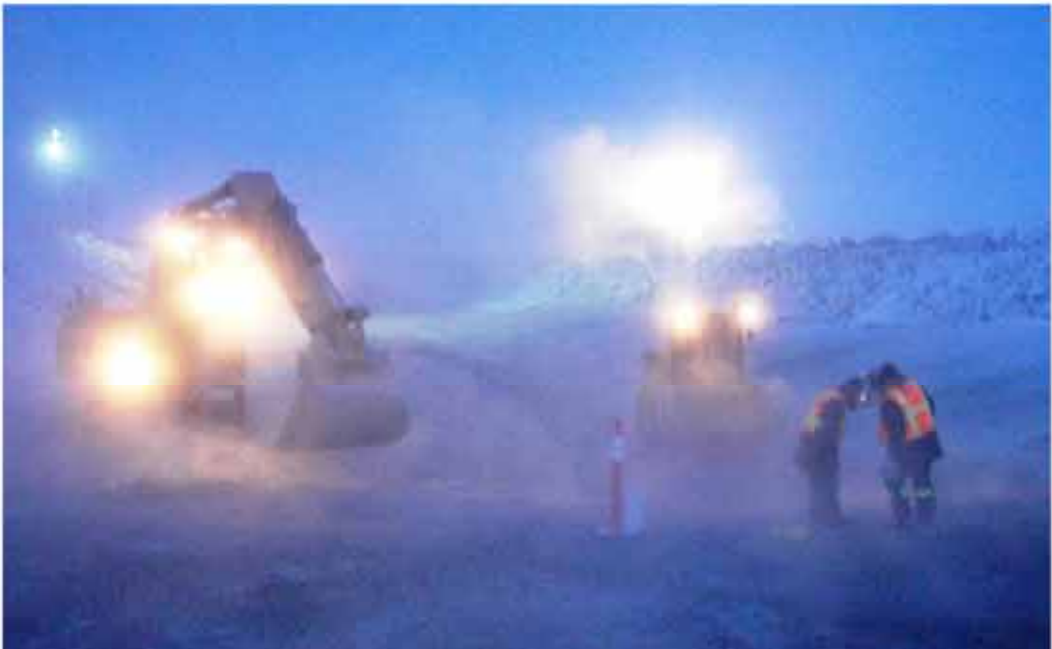
Photo 11: ~ENE view of FCM placement and inspection at the at central key trench area.

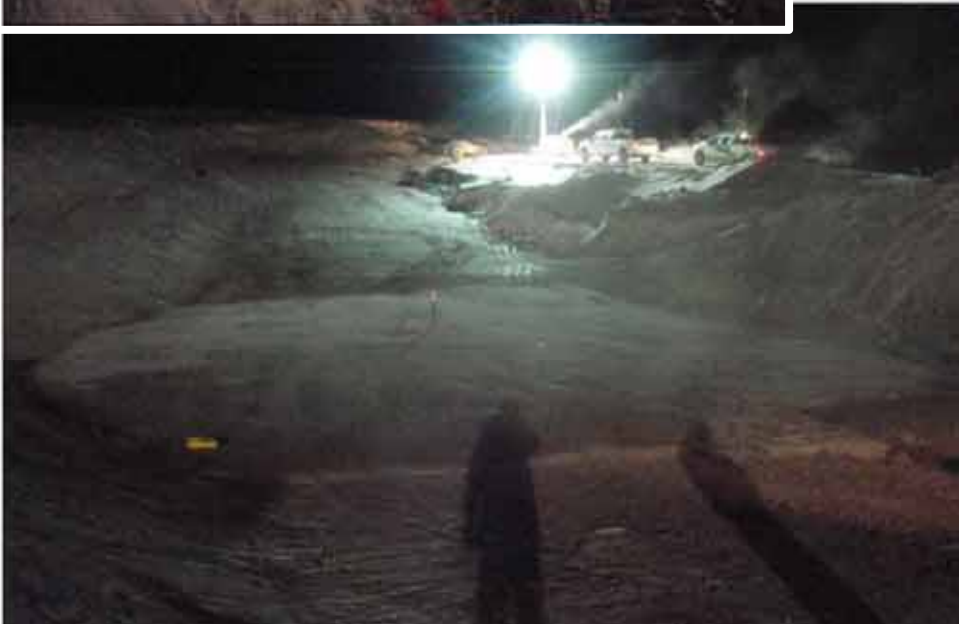
Photo 14: ~ WNW view of FCM placement at the end of dayshift.

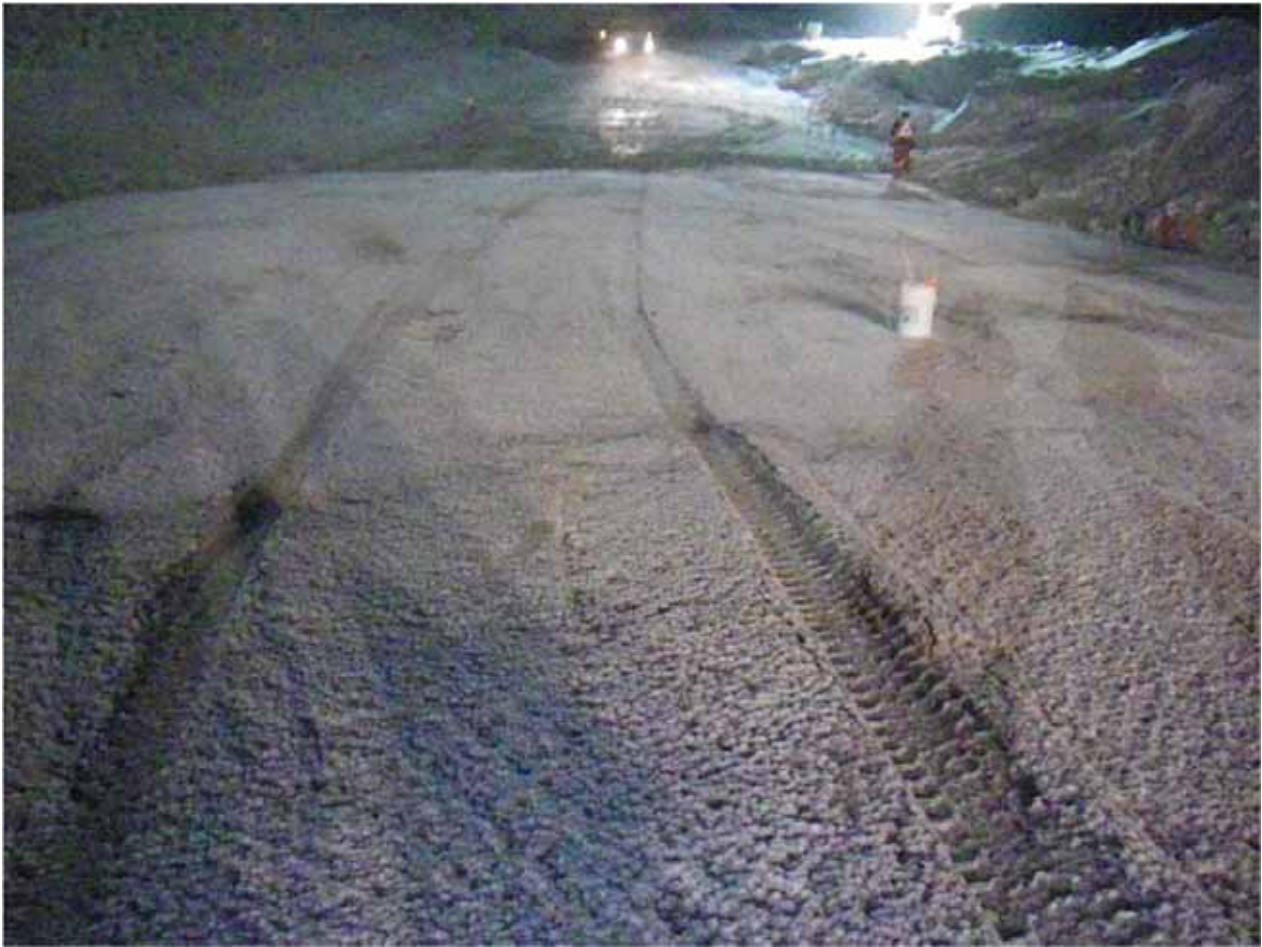
- At the beginning of the night shift pickup tracks were noted across the fresh FCM placed on the dayshift, prior to freeze back (FCM temp 9.3°C). Cracks along the edges of the tracks and ruts were apparent. The FCM affected by the tracks was removed with the CAT 345 excavator using a toothed bucket. A small portion of the material did not appear damaged by the tracks and was not removed. Photos are included below.

Photo 15: Pickup tracks across the fresh (not frozen back) FCM placed during the dayshift.

- Delineators were placed on the edges of the unfrozen back FCM to clearly identify where driving is not allowed.
- The key trench floor was cleaned and approved for placement from Sta. ~1+10 to 1+40. The bobcat with the brush was used to clean the trench.

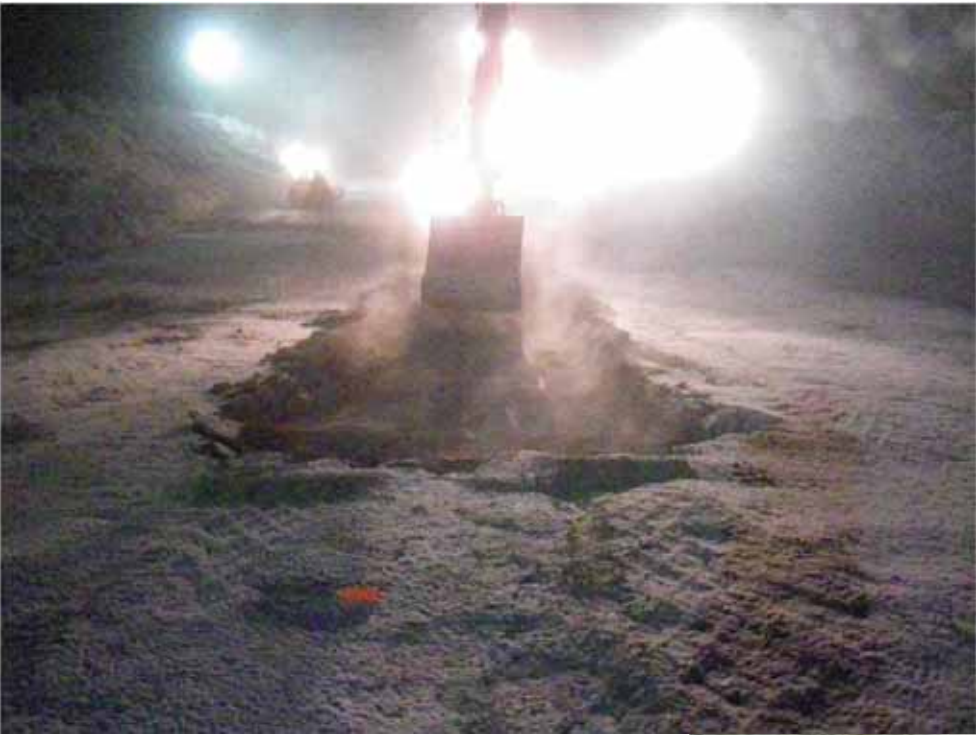
Photo 16: CAT 345 excavator removing damaged frozen core from pickup truck tracks.

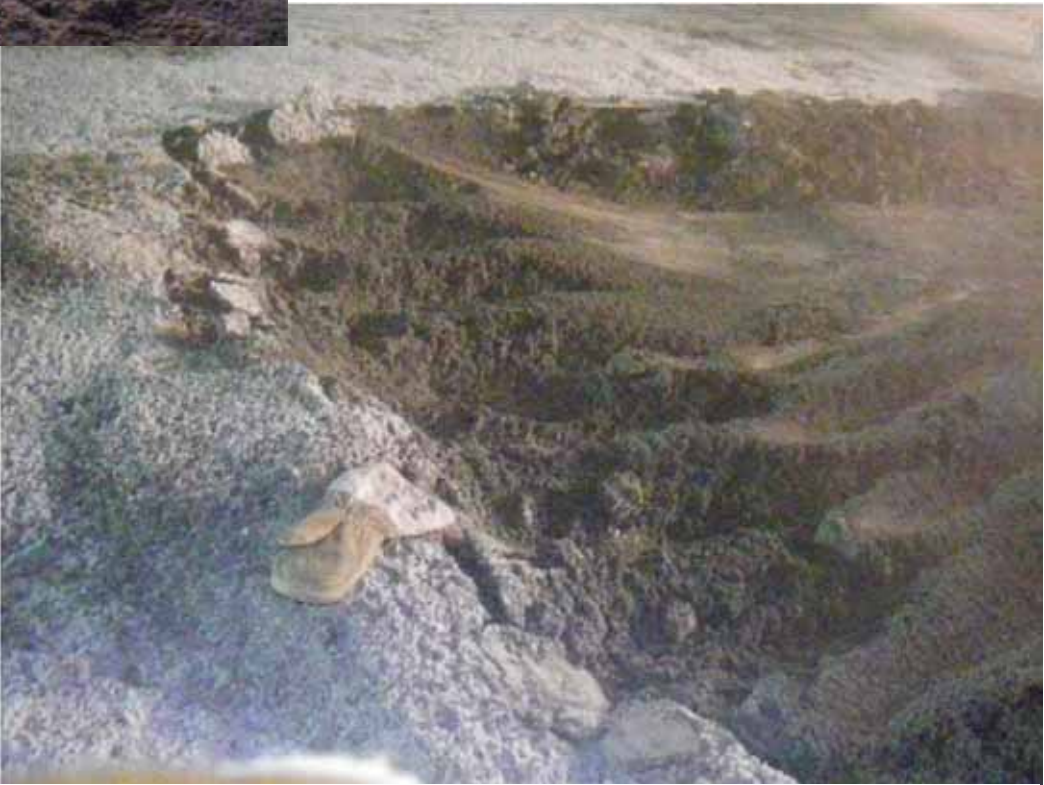
Photo 17: Edge of material being removed by CAT 345 excavator, as only the toothed bucket was available some ridges of material remain.

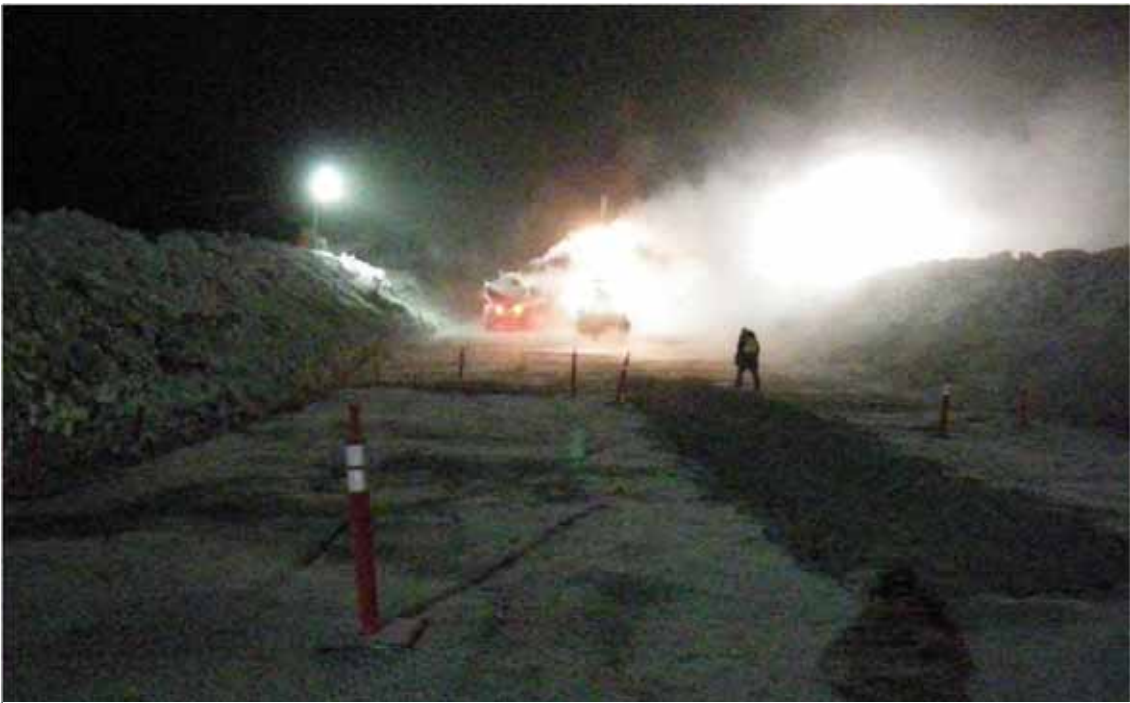
Photo 18: Material placement during the night shift. Looking north along the key trench. The delineators near the person mark the edge of the FCM placed during the day shift and the start of the material placed during the night shift.

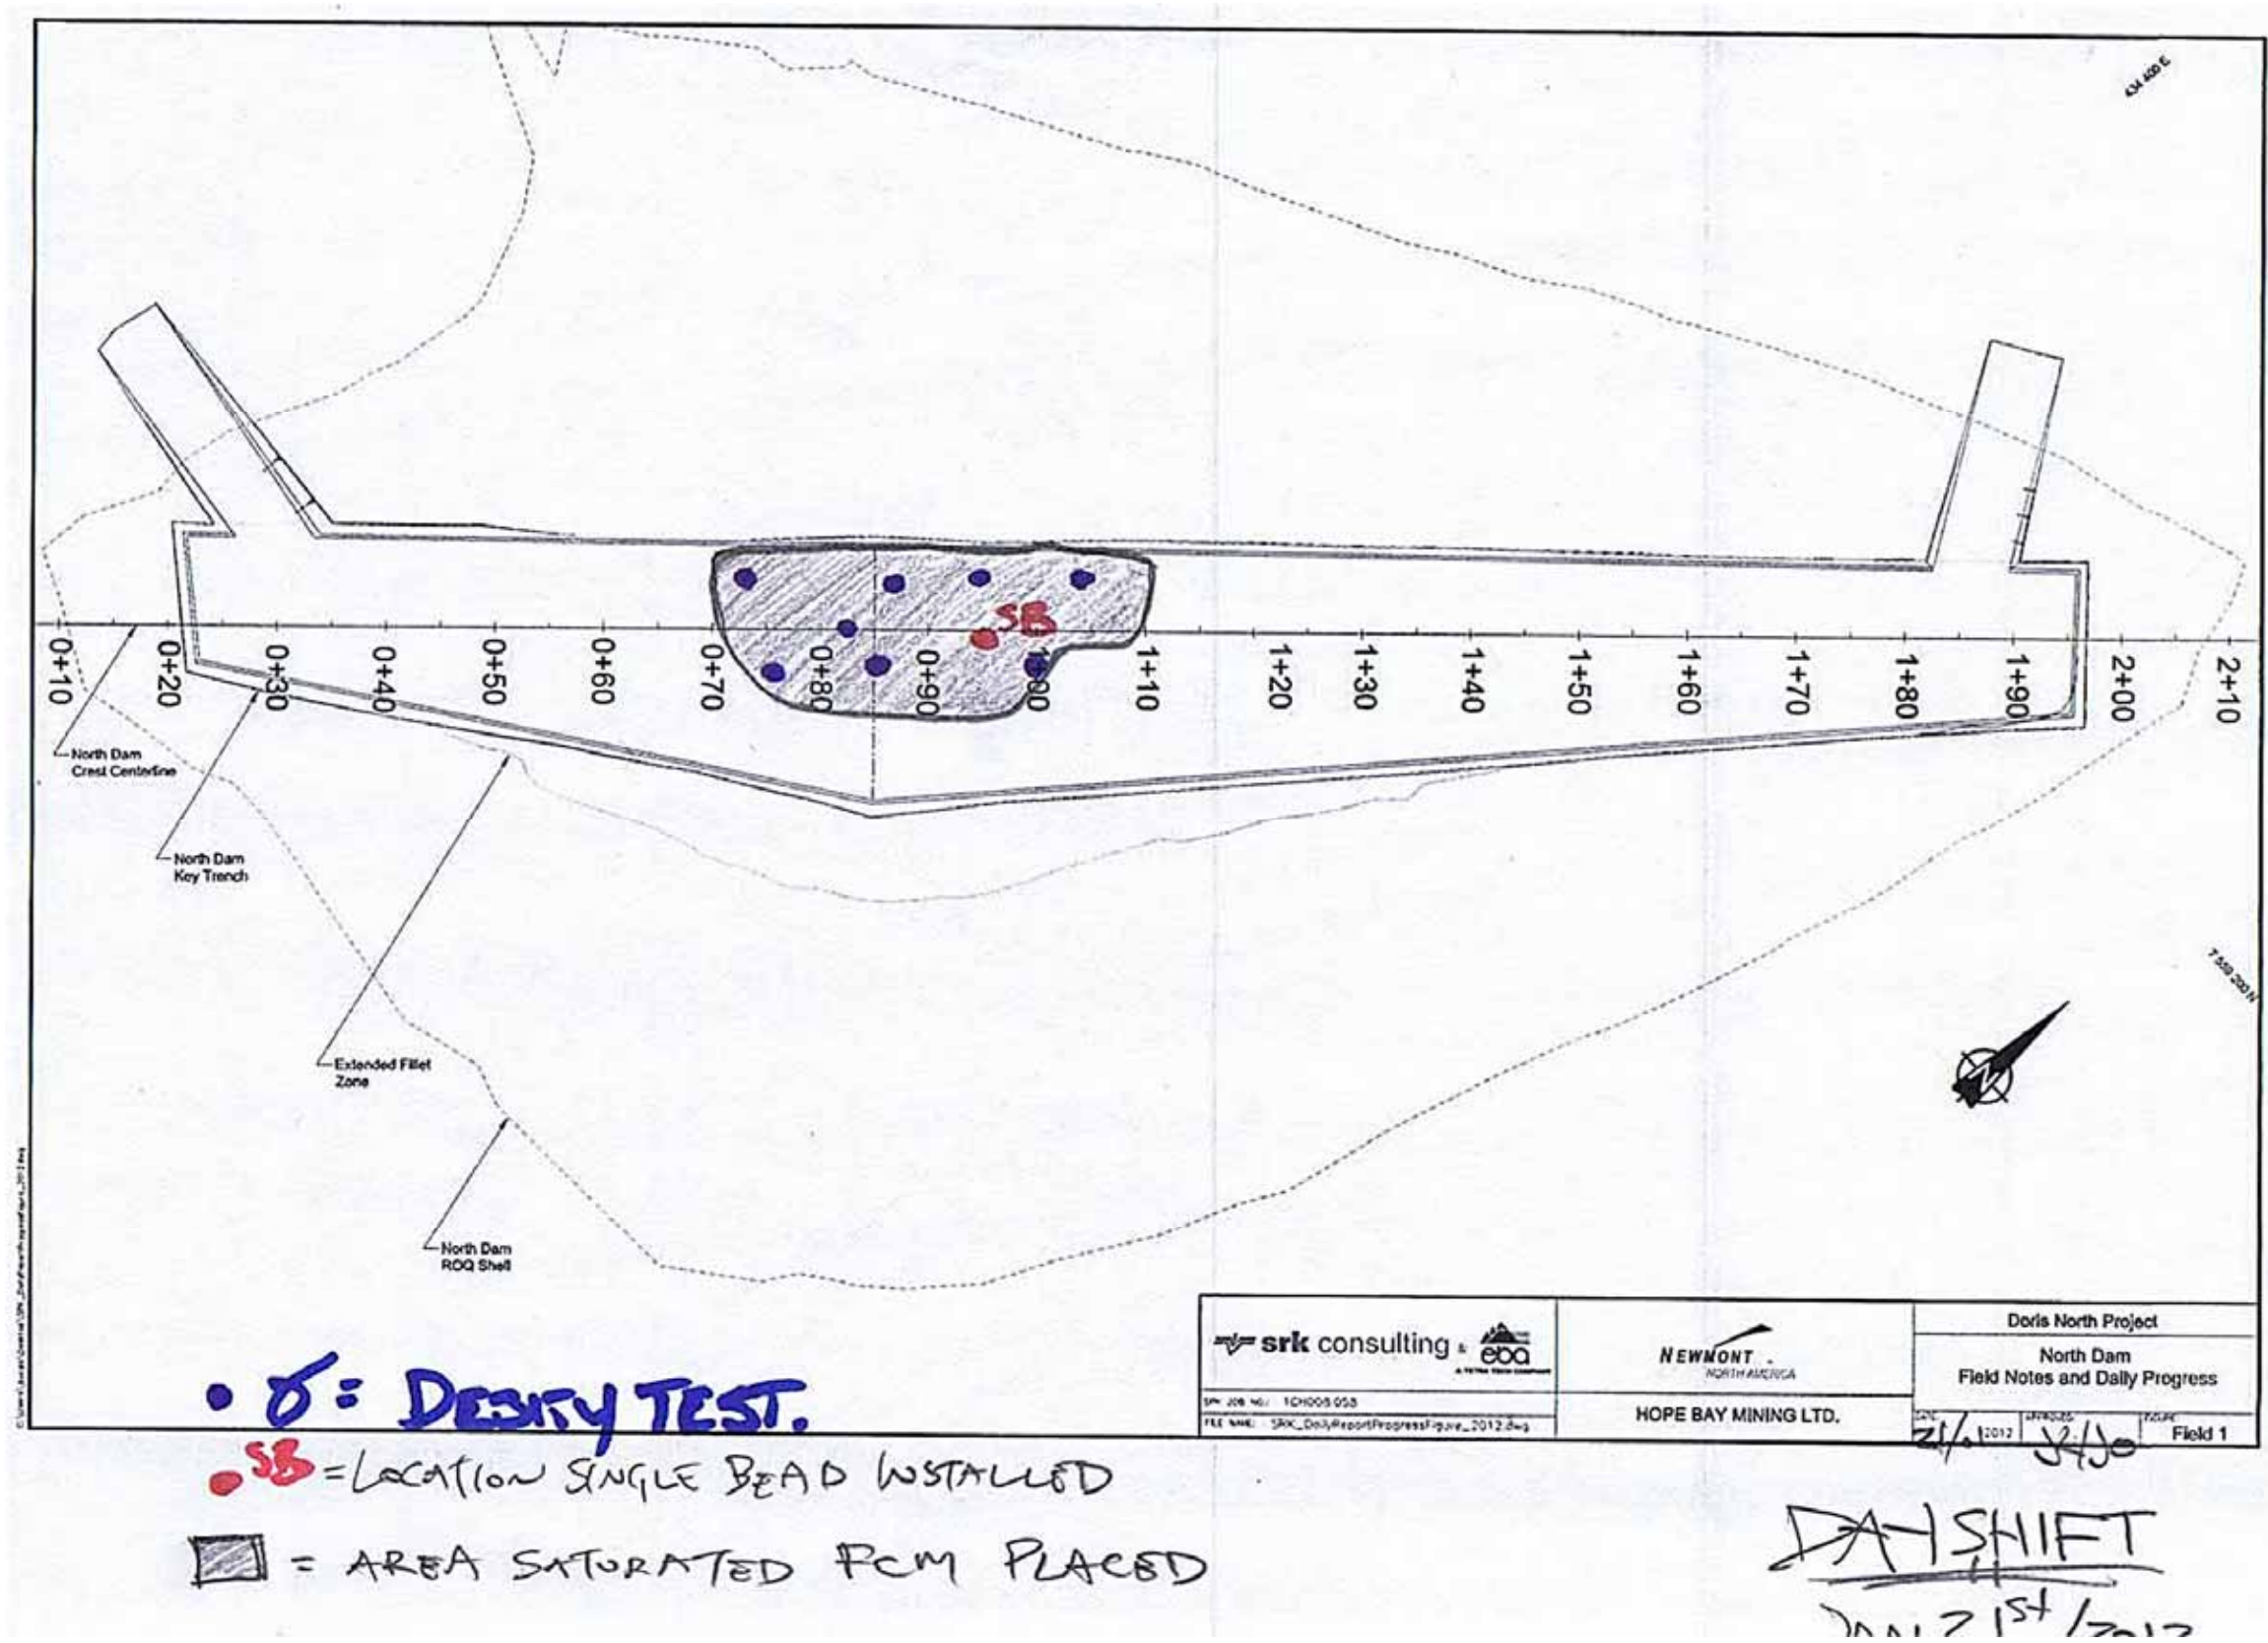
• Figure 1 - FCM Progress/ Placement – DAYSHIFT Jan 21st

- A progress figure showing today's the approximate extent of today's placement is provided as Figure 1 and 2.
