DAILY REPORT #16 – DORIS NORTH INFRASTRUCTURE/ NORTH DAM

Prepared by:	John Kurylo/ Jeff Orr / Megan Miller	Date:	2012.01.21
Reviewed by:		Project #:	1CH008.058.0320
Role	Company	Personnel – Position	On Site
Client	Hope Bay Mining Limited (HBML)	Angela Holzapfel – ESR Compliance Manager David Vokey – ESR Coordinator Don Ethelston – HSLP Advisor Dean Wold - Safety Jill Turk – ESR Coordinator Katsky Venter – ESR Manger Michelle Tanquay – ESR Site Manager Stirling Kelly – HSLP Advisor	No Yes Yes No No No Yes No
	JDS	Lloyd Jackson – Mechanical Superintendent Sven Archimowtiz – Electrical Superintendent Doug Fielding – Construction Manager Ishan Fechter – Construction Coordinator Jerry Graham – Construction Manager Kevin Whieldon – Project Coordinator Mark Valeriote – Construction Manager	No Yes Yes Yes No No Yes
Engineering Design Consultants	SRK Consulting (Canada) Inc.	John Kurylo – Site Engineer Megan Miller – Site Engineer Lawrence Borowski – Site Engineer Murry McGregor – Site Engineer Iozsef Miskolczi – Site Engineer	Yes Yes No No No

NORTH DAM/FROZEN CORE PLANT PAD:

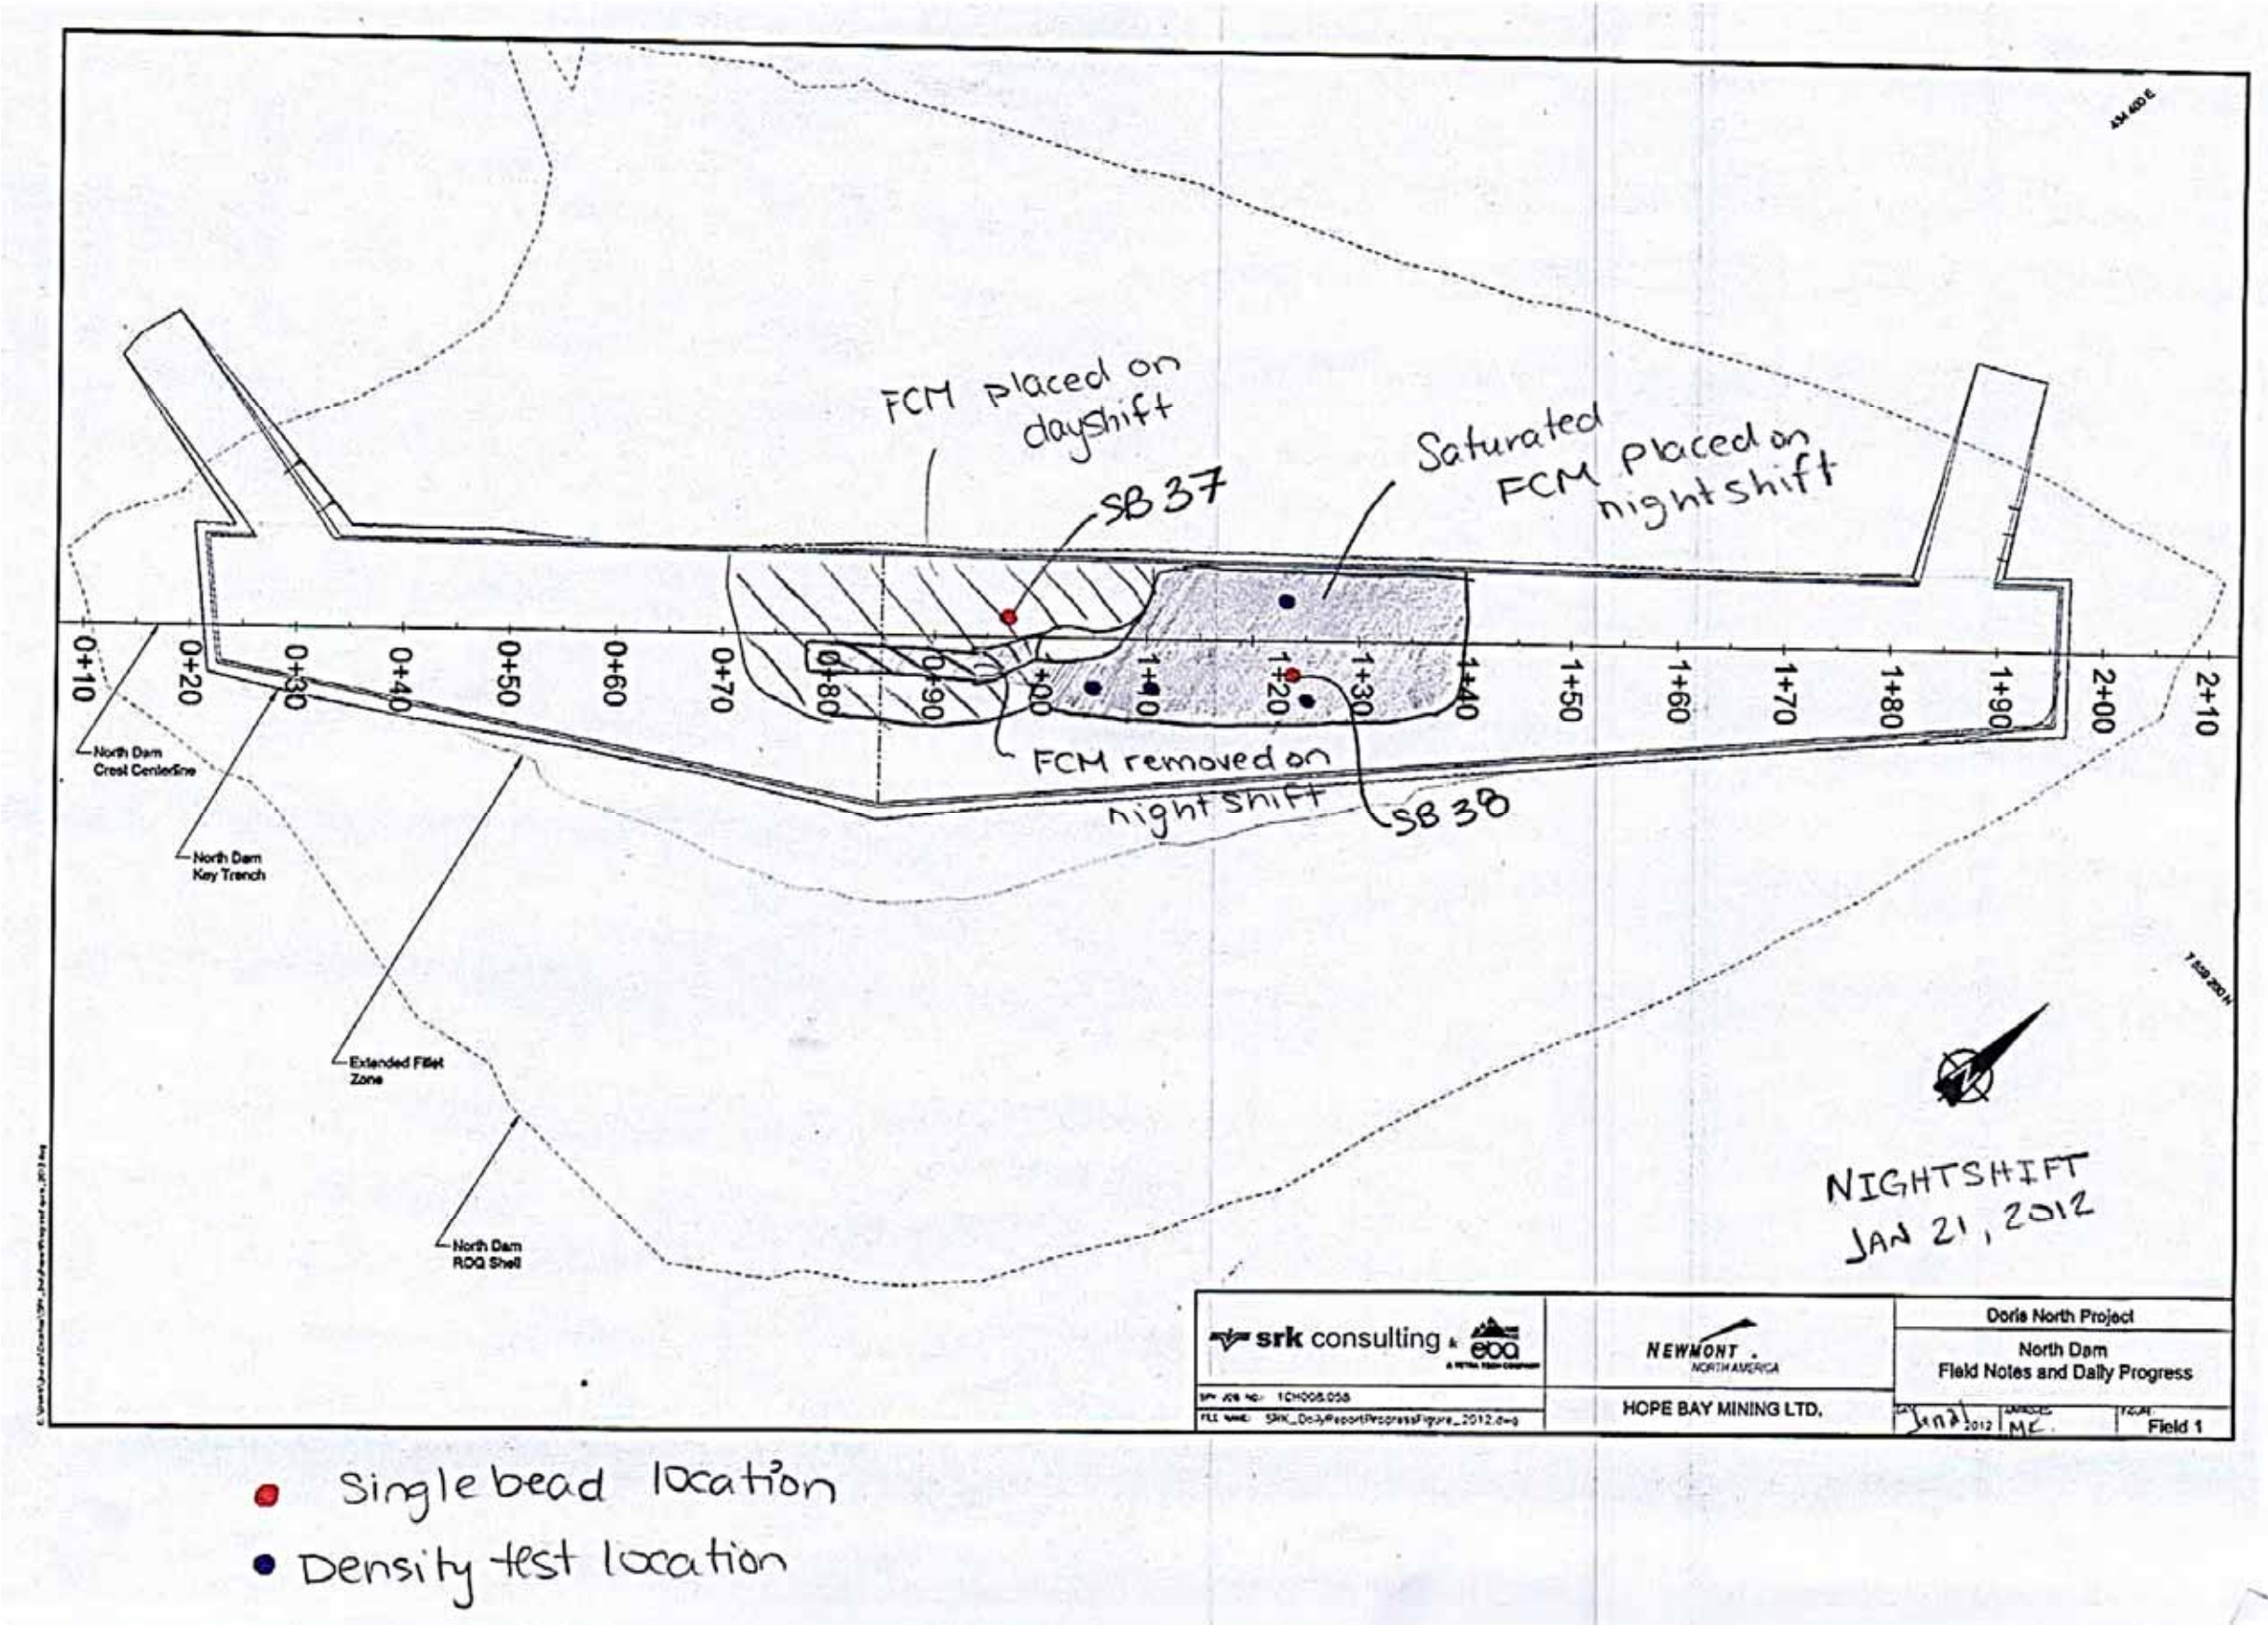
• Figure 2 - FCM Progress/ Placement – NIGHTSHIFT Jan 21st

- A progress figure showing today's the approximate extent of today's placement is provided as Figure 1 and 2.

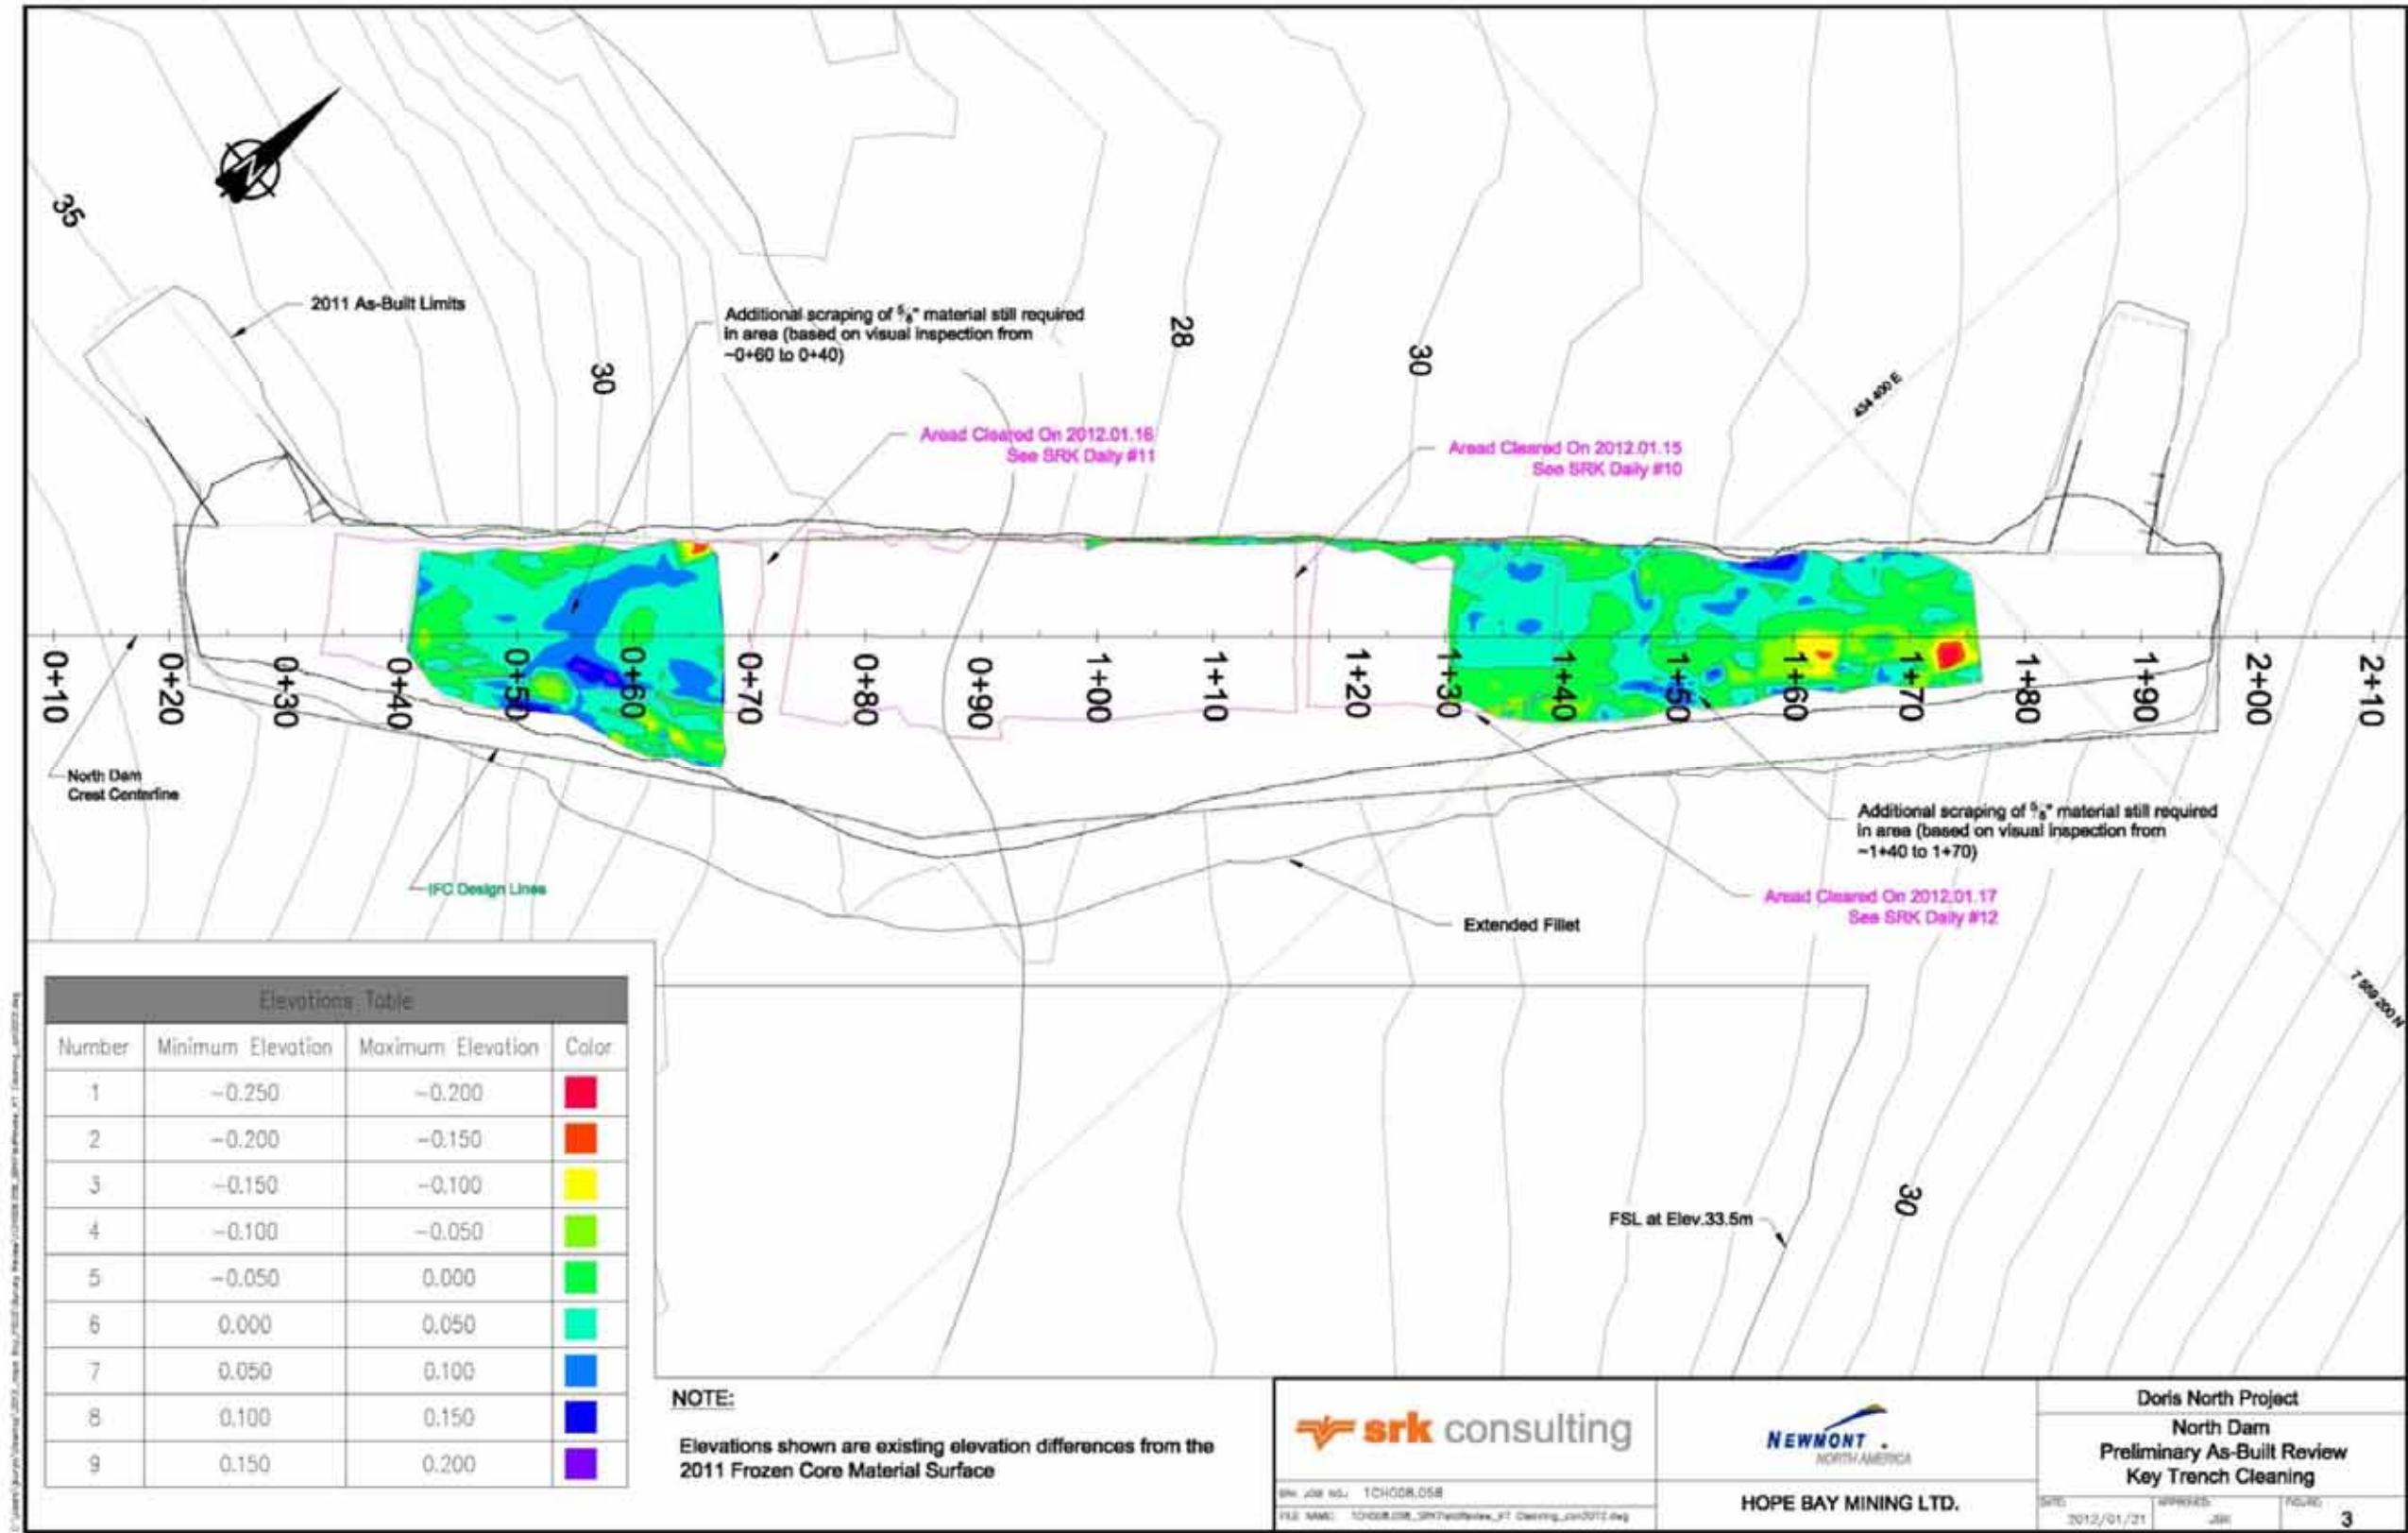
- The 330 excavator remains down.
- Figure 3 presents a preliminary as-built review completed to better assess the progress of the key trench cover material removal from +30 to 1+75 and 0+68 to 0+40.

- Figure 3 - SRK Preliminary As-built review of Key Trench cleaning (5/8" material removal) completed on 2012/01/17, ~ between 1+30 to 1+75 and 0+68 to 0+40.
 - Note that the existing elevation, in relation to the 2011 FCM surface, is shown in the isopach below.

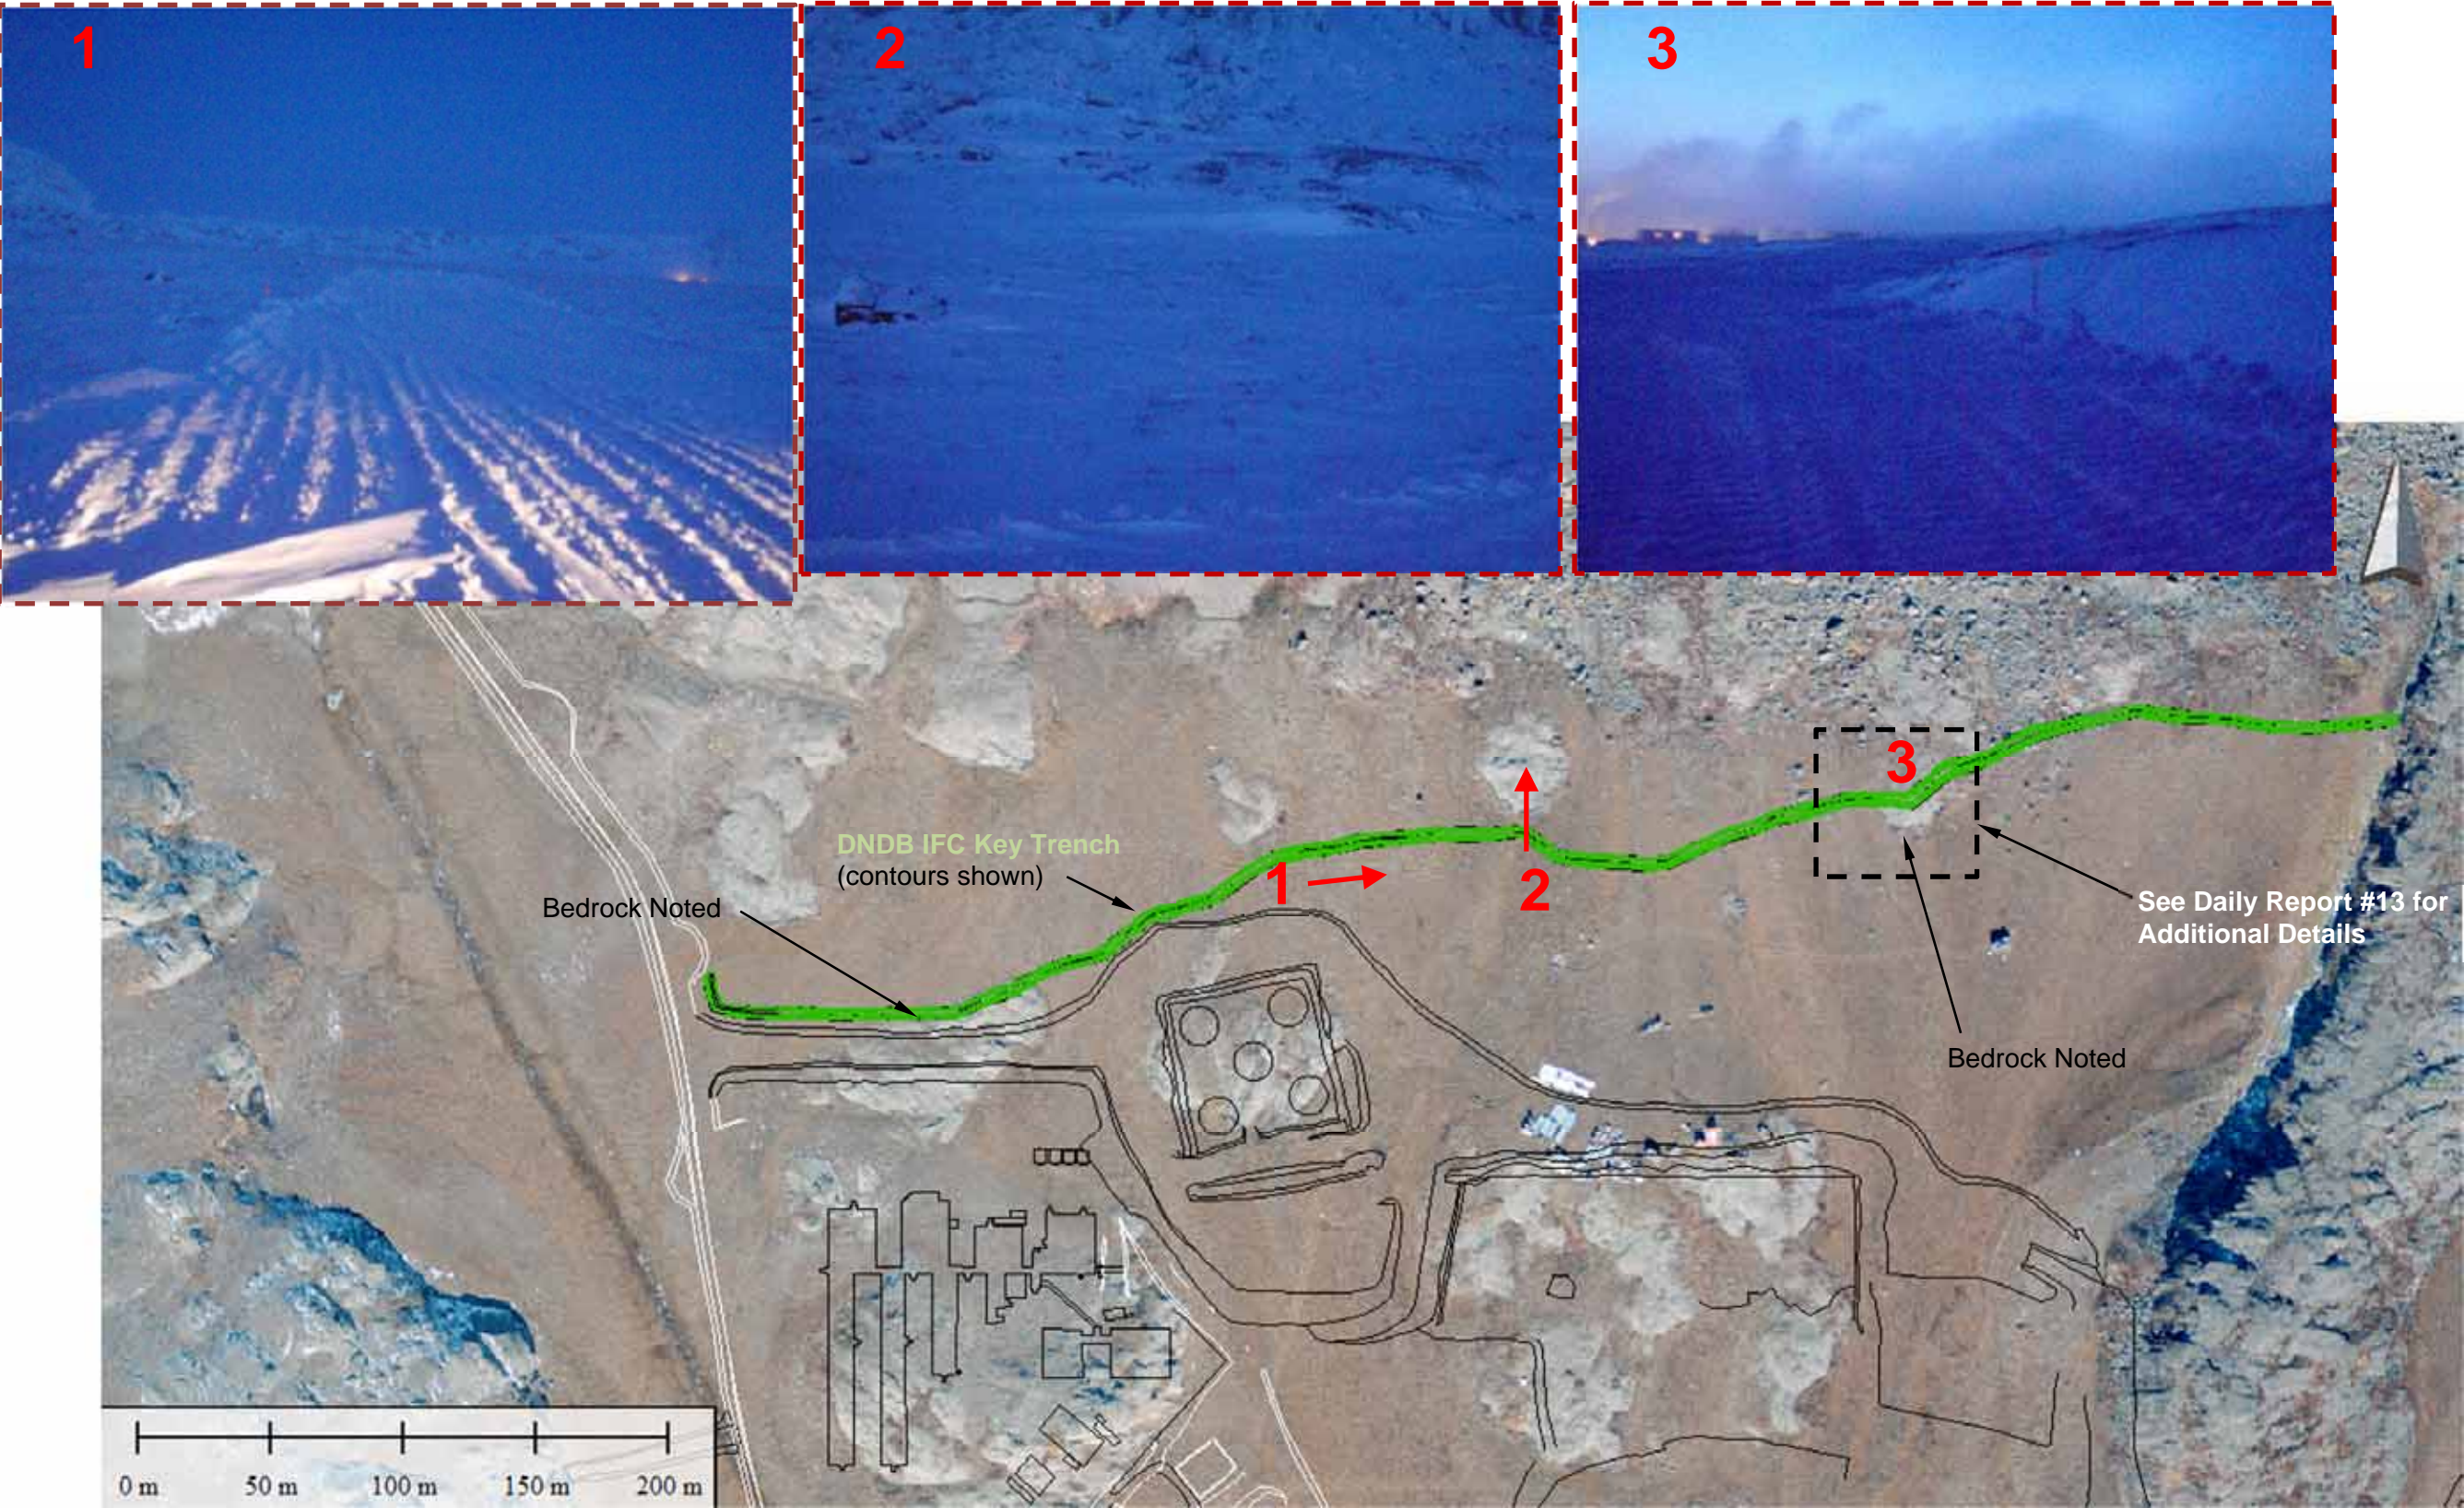
recon was to investigate the areas where bedrock intersected the DN Diversion Berm key trench alignment. Bedrock was only observed in two locations.

- **Figure 4 – Preliminary field notes on bedrock noted along DN Diversion Berm**
 - Note that a field traverse of the alignment was completed today to better assess the areas where bedrock outcrops can be observed.
 - Bedrock was only noted to outcrop directly in the DN Diversion Berm key trench footprint in two location. Note that a couple bedrock outcrops were observed outside but upslope of the DN Diversion Berm Alignment.
