## DAILY REPORT #18 – DORIS NORTH INFRASTRUCTURE/ NORTH DAM

Prepared by:	John Kurylo/ Jeff Orr / Megan Miller	Date:	2012.01.23
Reviewed by:		Project #:	1CH008.058.0320
Role	Company	Personnel – Position	On Site
Client	Hope Bay Mining Limited (HBML)	Angela Holzapfel – ESR Compliance Manager David Vokey – ESR Coordinator Don Ethelston – HSLP Advisor Dean Wold - Safety Jill Turk – ESR Coordinator Katsky Venter – ESR Manger Michelle Tanquay – ESR Site Manager Stirling Kelly – HSLP Advisor	No Yes Yes No No No Yes No
	JDS	Lloyd Jackson – Mechanical Superintendent Sven Archimowtiz – Electrical Superintendent Doug Fielding – Construction Manager Ishan Fechter – Construction Coordinator Jerry Graham – Construction Manager Kevin Whieldon – Project Coordinator Mark Valeriote – Construction Manager	No Yes Yes Yes No No Out
Engineering Design Consultants	SRK Consulting (Canada) Inc.	John Kurylo – Site Engineer Megan Miller – Site Engineer Lawrence Borowski – Site Engineer Murry McGregor – Site Engineer Iozsef Miskolczi – Site Engineer	Yes Yes No No No

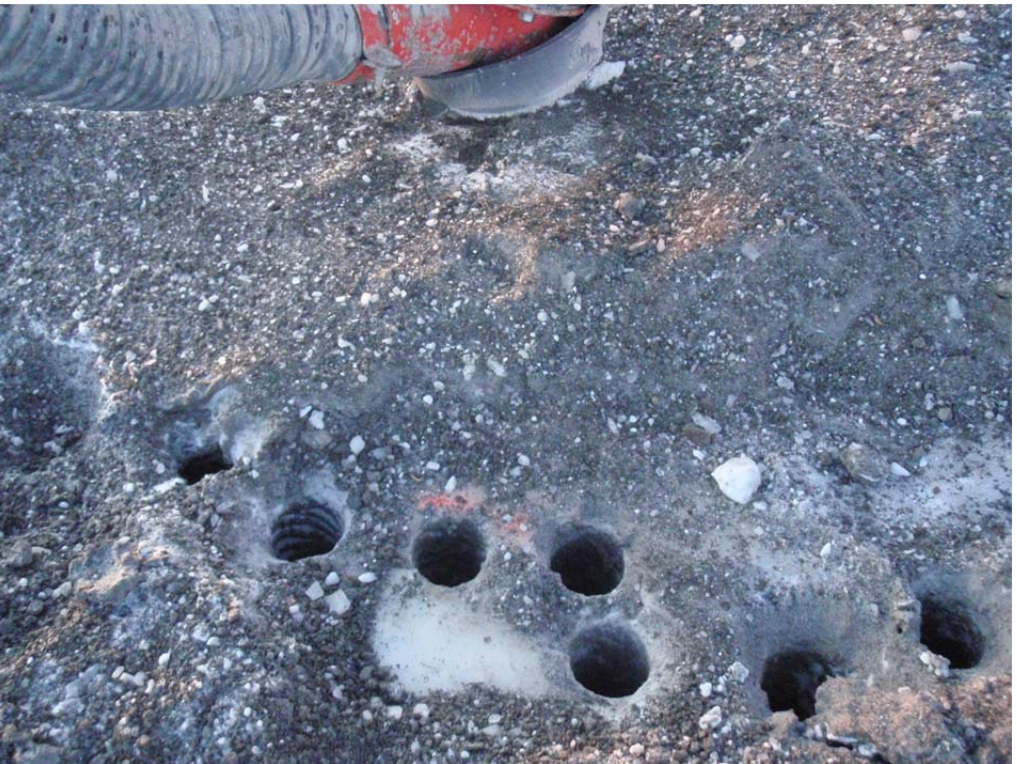
**Photo 3:** Close up view of drill hole spacing at Sump #2 (note ~ 3 to 4" spacing between holes).

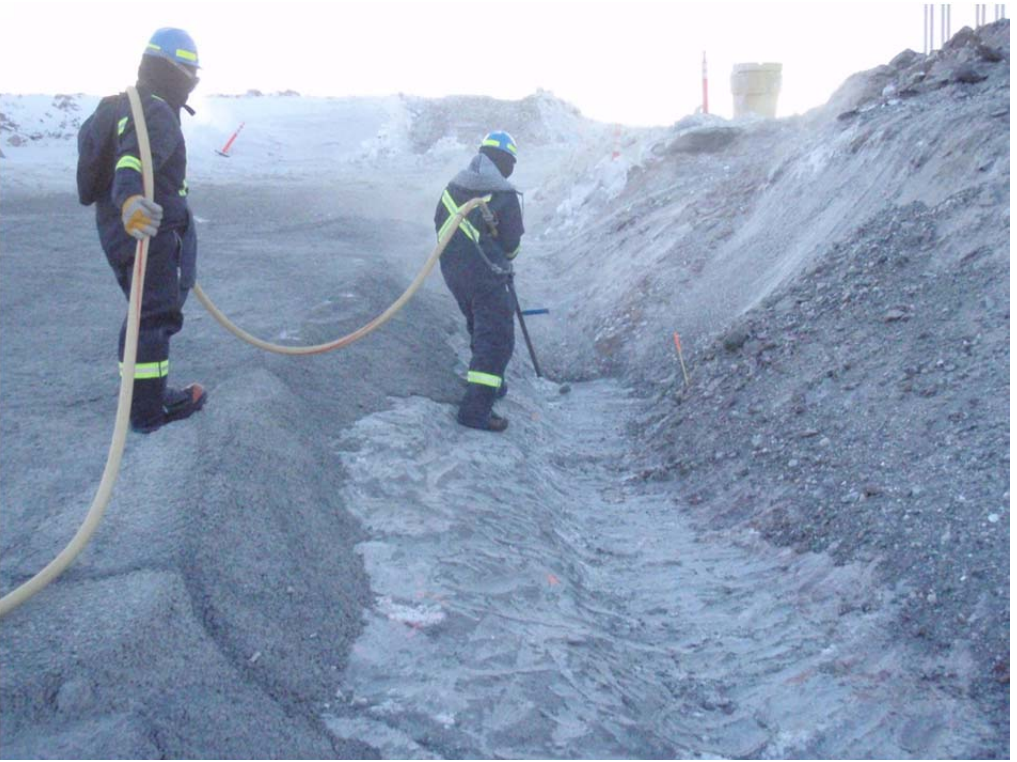
- 5/8" material was removed from the downstream edge and dental cleaned from ~ 0+62 to 0+45.
  - The bottom (flat) area cleaning from ~0+70 to 0+42 was approved for placement. The upstream fillet slope still requires additional cleaning.

**Photo 6:** Labourers dental cleaning downstream edge of key trench around station 0+60 to 0+40, ~ WNW view.

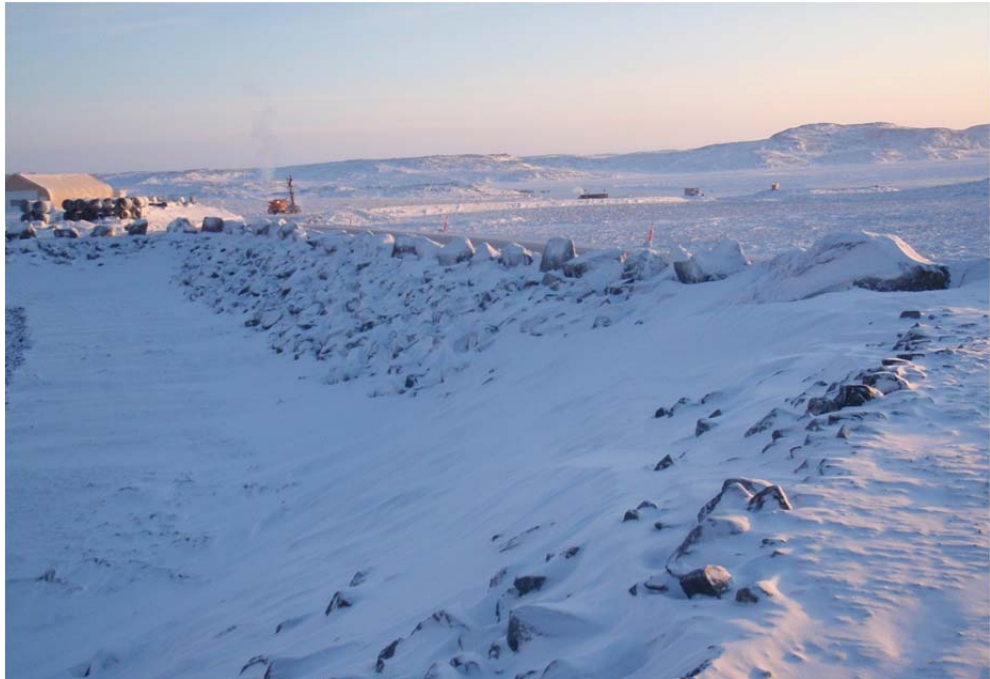
**Photo 15:** ~ E view of SW corner of Pollution Pond, where spillway culverts are currently buried in snow.

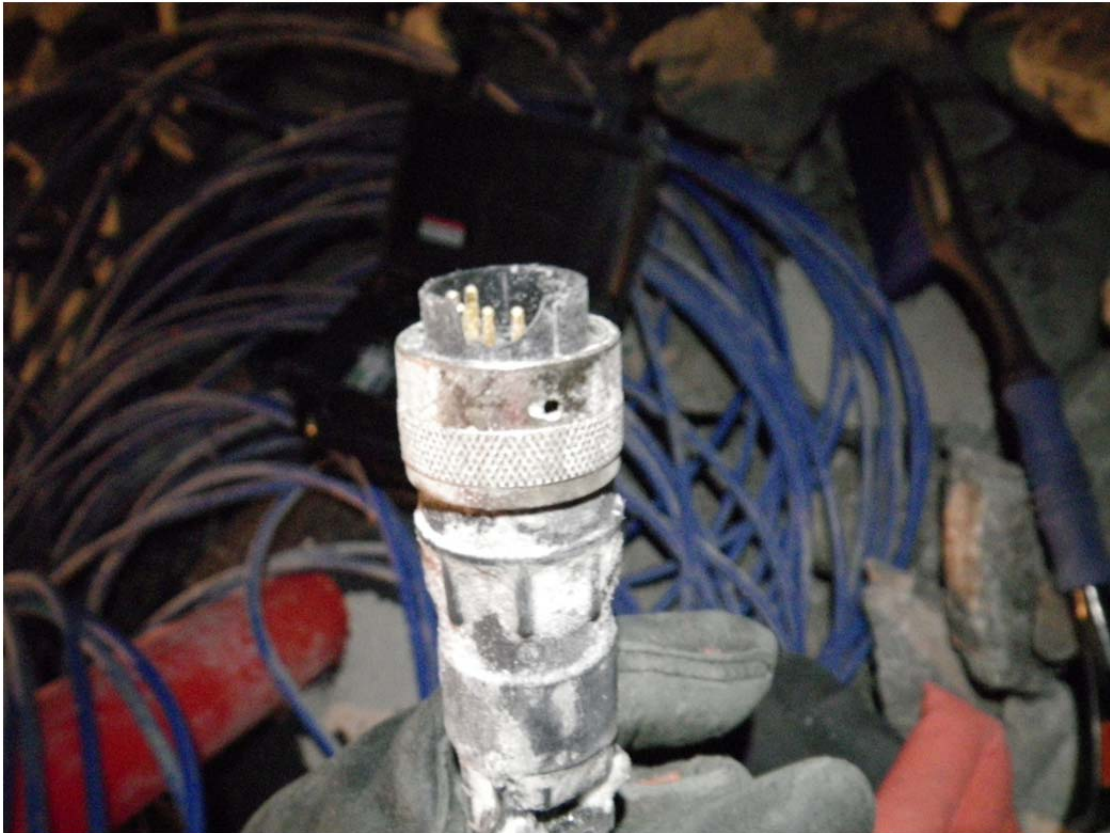
- A single, single bead thermistor (#56) was placed in the material in this area.
- All multi bead thermistors with the exception of ND-VTS-085-DS, ND-HTS-060-28.8, ND-VTS-085-KT and ND-HTS-085-25.3 were read and found in working order. Several of the protective caps from the thermistor connectors are missing, some plastic on one of the thermistor connectors is broken (see photo below) however the thermistor still works fine.
- Multi-bead thermistor ND-HTS-060-28.8 remains broken/ severed.

**Photo 21:** Thermistor connector with damaged plastic. This thermistor still works fine.

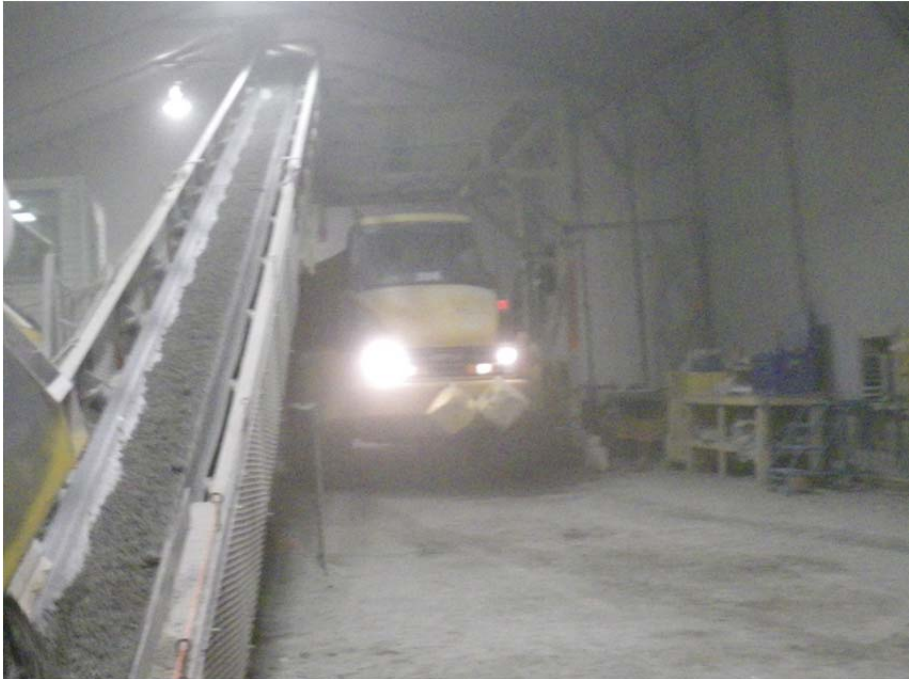
- The plant was started at ~1:15 am and ran until ~5:00 am. Ninety-nine loader buckets of material were fed through the frozen core plant on this shift.
- Some lumps of frozen material were noted exiting the mixing-heating drum at start up; however no frozen clumps were noted in the placed material.

**Photo 22:** A few clumps of frozen material were noticed in the plant at start up. No lumps of frozen material were noticed in placed core.

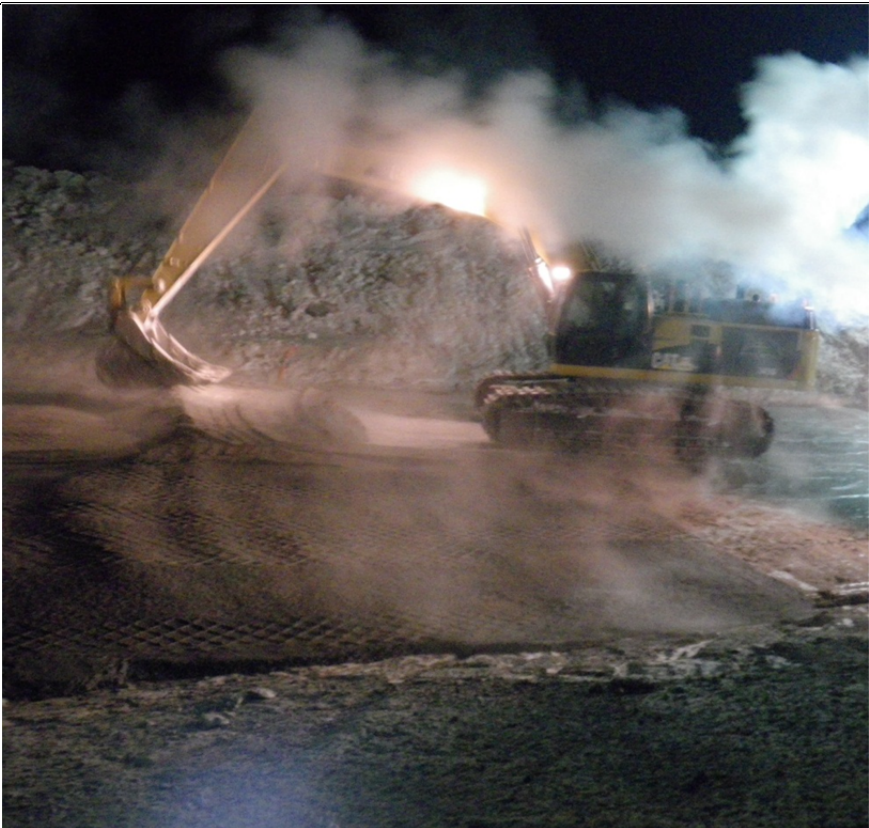
with the CAT 345 excavator. Everything went well. The surface of the placed material appears to be slightly undulating.

**Photo 23:** CAT 345 excavator placing saturated frozen core material in the key trench during the night shift.

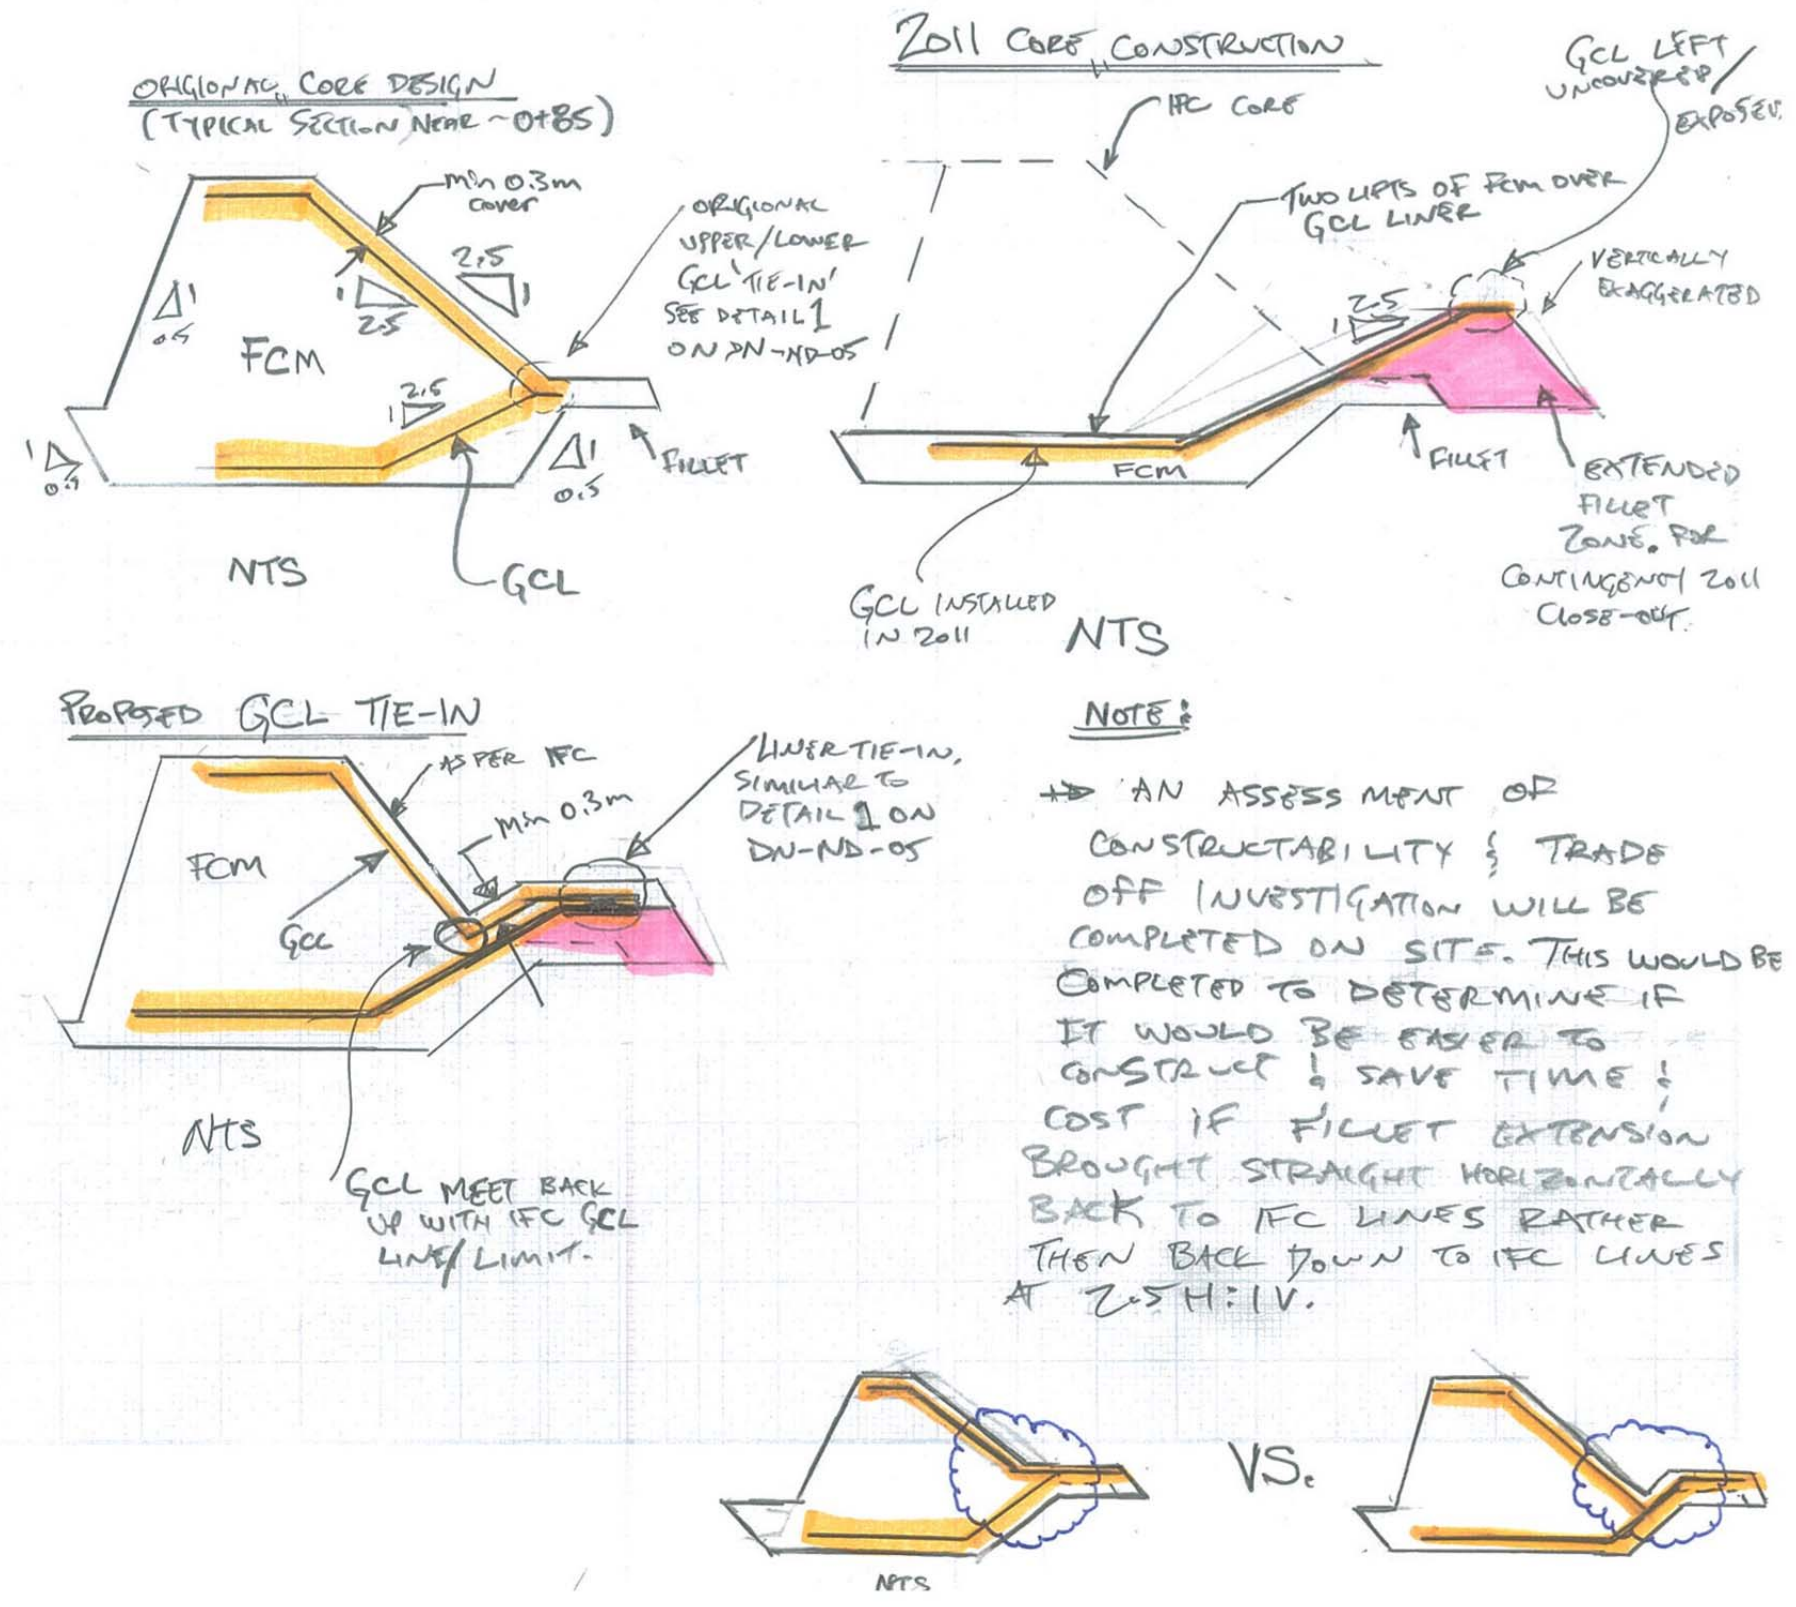
• Figure 3 – Notes from onsite discussions about North Dam GCL liner tie-in (tie in details to be further discussed in the coming weeks).

- SRK held discussions with JDS about the North Dam construction:
  - SRK and JDS discussed plans for the upper and lower GCL liner tie-in. Details of these discussions are presented as Figure 3.

- JDS is proposing to place granular material, processed as frozen core material prior to March 2011, over the GCL as cover (cover as outlined on the IFC). This is acceptable. The lines and grades shown on the IFC drawings and the appropriate section of Technical Specifications Rev. G are/ to be maintained.

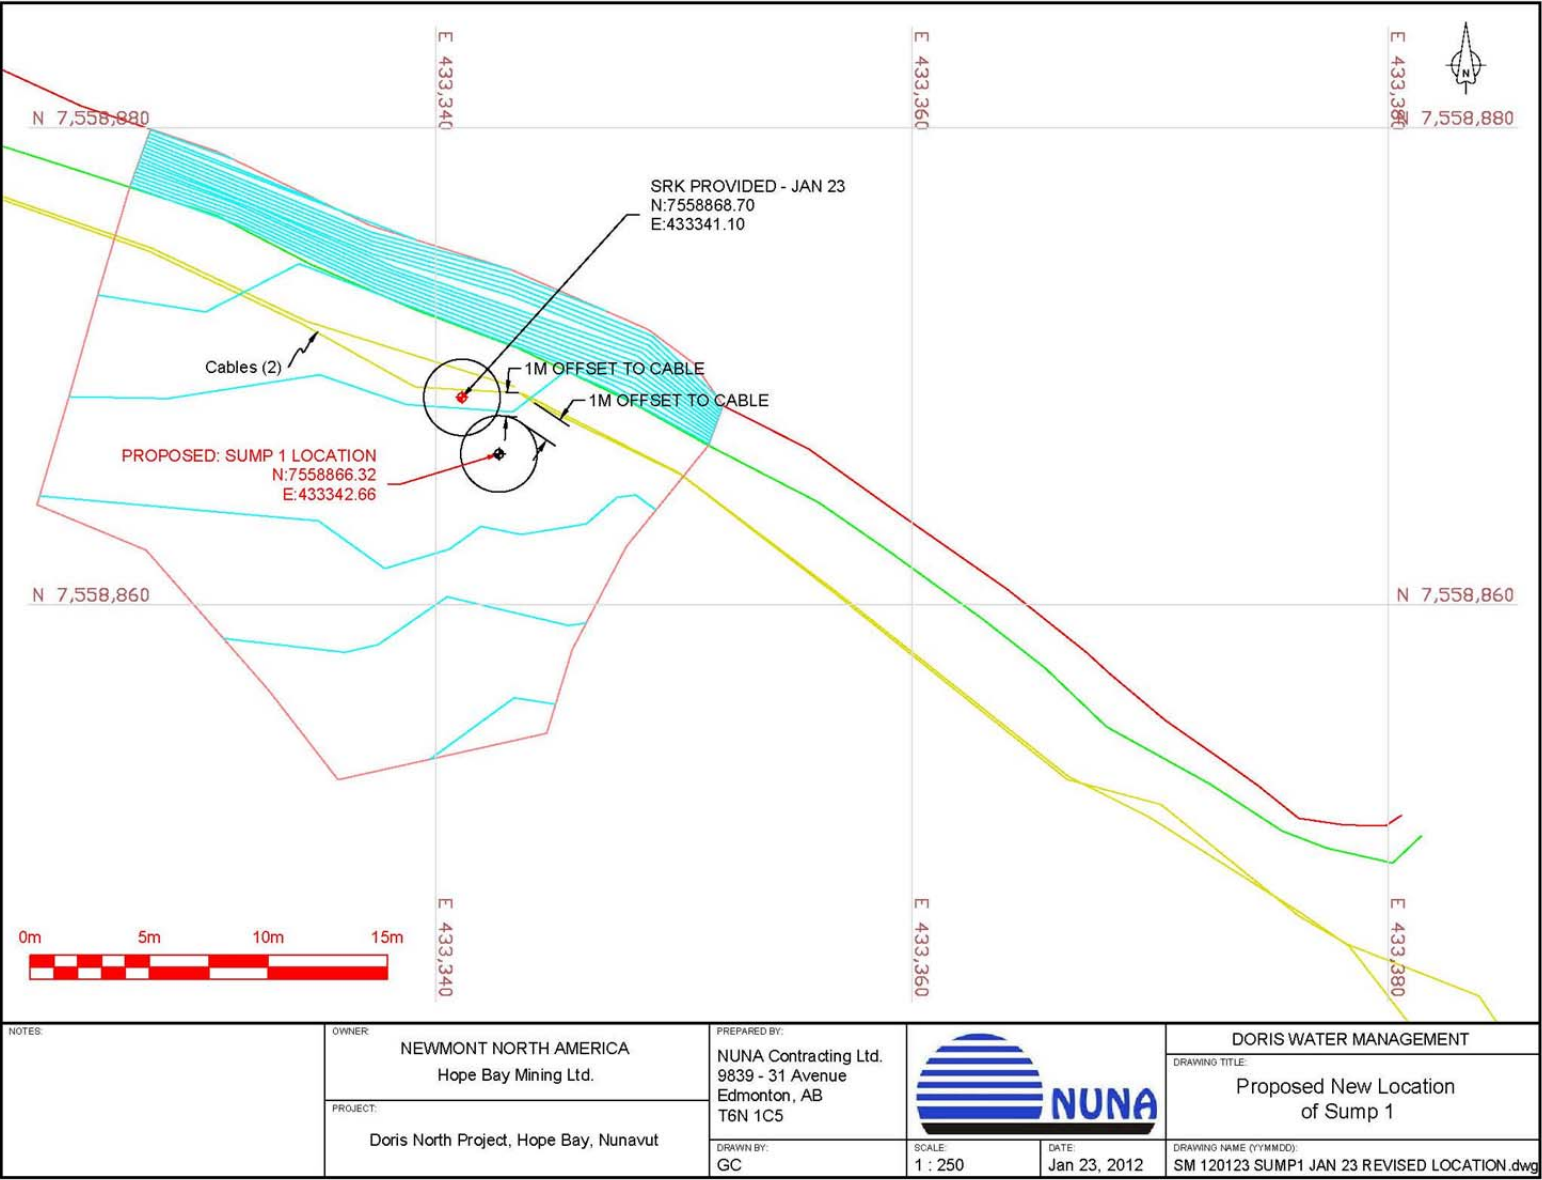
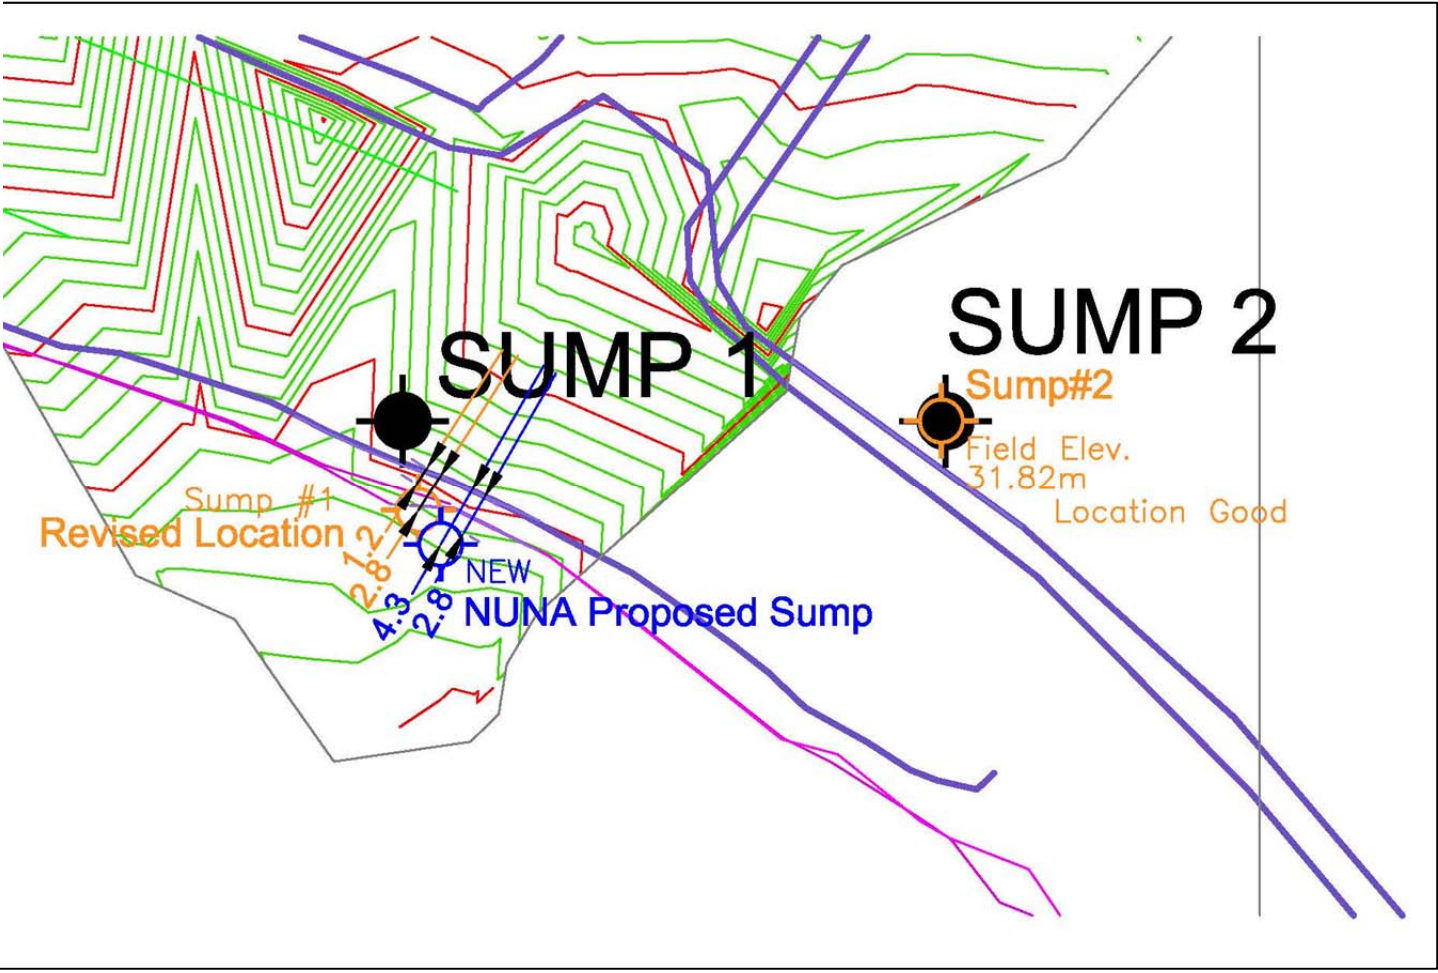
• **Figure 4 – Field Fit Notes on Revised Sump #1 Location.**

- The original location of Sump 1 was selected to intercept the surface and subsurface flow of water that has come into contact with Mine Waste. When the location of Sump 1 was originally laid out (see SRK Daily Report #) it was found that the Sump was on the pipe bench of the extended Float Plane Dock Access Road. A field fit with Nuna survey was worked out/ determined. Observed seeps have previously (in Summer 2011) been observed to exit near the toe of the road. To best capture flows the sump was/ is required to be as close to the road shoulder as possible. Further, future expected work will require that these sumps be in place to collect seepage. Today SRK provided Nuna and JDS with the revised Sump #1 location. The update location for Sump #1 is N = 7558868.7, E = 433341.1

- The revised location of the sump it near the toe of the road and does currently intersect two cables that are frozen on the tundra. JDS and Nuna expressed concerns about moving the cables.

- Nuna survey has proposed a new location from the outlined sump that will be ~ 1m from the cable. This move requires the sump to be shifted slightly downstream and outwards on the order of ~1.5 to 1.6m. As the sump location is further from the toe of the road it is seen as less favourable for seepage collection. Final discussions on Sump 1 to result on Jan 23<sup>rd</sup>.
