## DAILY REPORT #19 – DORIS NORTH INFRASTRUCTURE/ NORTH DAM

Prepared by:	John Kurylo/ Jeff Orr / Megan Miller	Date:	2012.01.24
Reviewed by:		Project #:	1CH008.058.0320
Role	Company	Personnel – Position	On Site
Client	Hope Bay Mining Limited (HBML)	Angela Holzapfel – ESR Compliance Manager David Vokey – ESR Coordinator Don Ethelston – HSLP Advisor Dean Wold - Safety Jill Turk – ESR Coordinator Katsky Venter – ESR Manger Michelle Tanquay – ESR Site Manager Stirling Kelly – HSLP Advisor	No Yes Yes No No No Yes No
	JDS	Lloyd Jackson – Mechanical Superintendent Sven Archimowtiz – Electrical Superintendent Doug Fielding – Construction Manager Ishan Fechter – Construction Coordinator Jerry Graham – Construction Manager Kevin Whieldon – Project Coordinator Mark Valeriote – Construction Manager	No Yes Yes Yes No No Out
Engineering Design Consultants	SRK Consulting (Canada) Inc.	John Kurylo – Site Engineer Megan Miller – Site Engineer Lawrence Borowski – Site Engineer Murry McGregor – Site Engineer Iozsef Miskolczi – Site Engineer	Yes Yes No No No

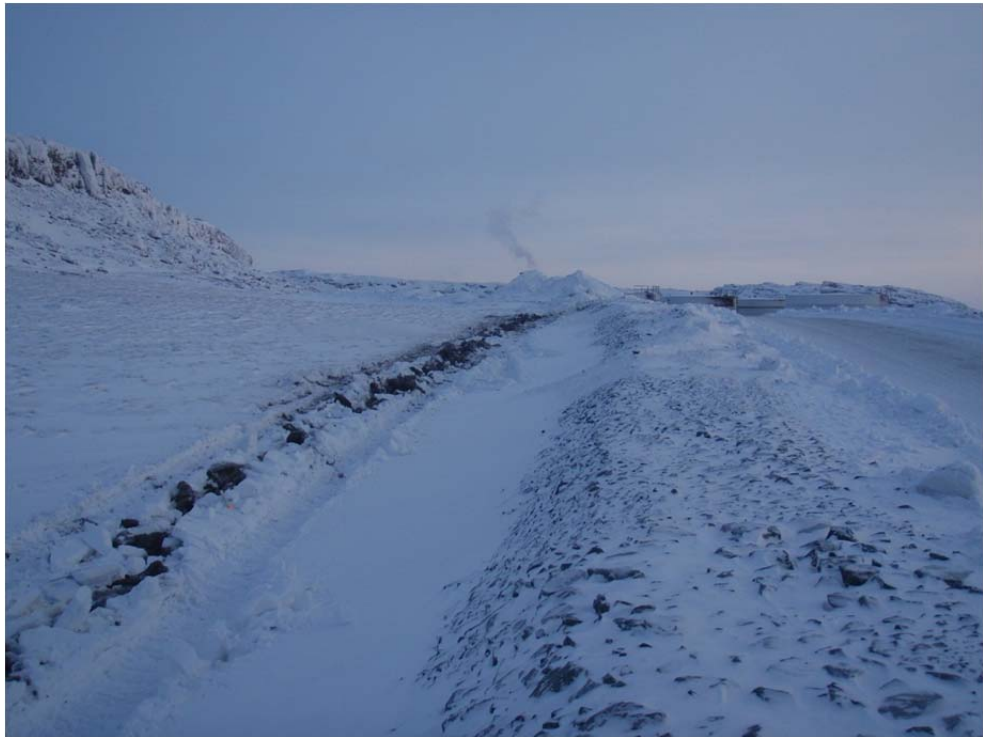
**Photo 1:** ~E view of test stripped ripped by D9 at the DN Diversion Berm alignment.

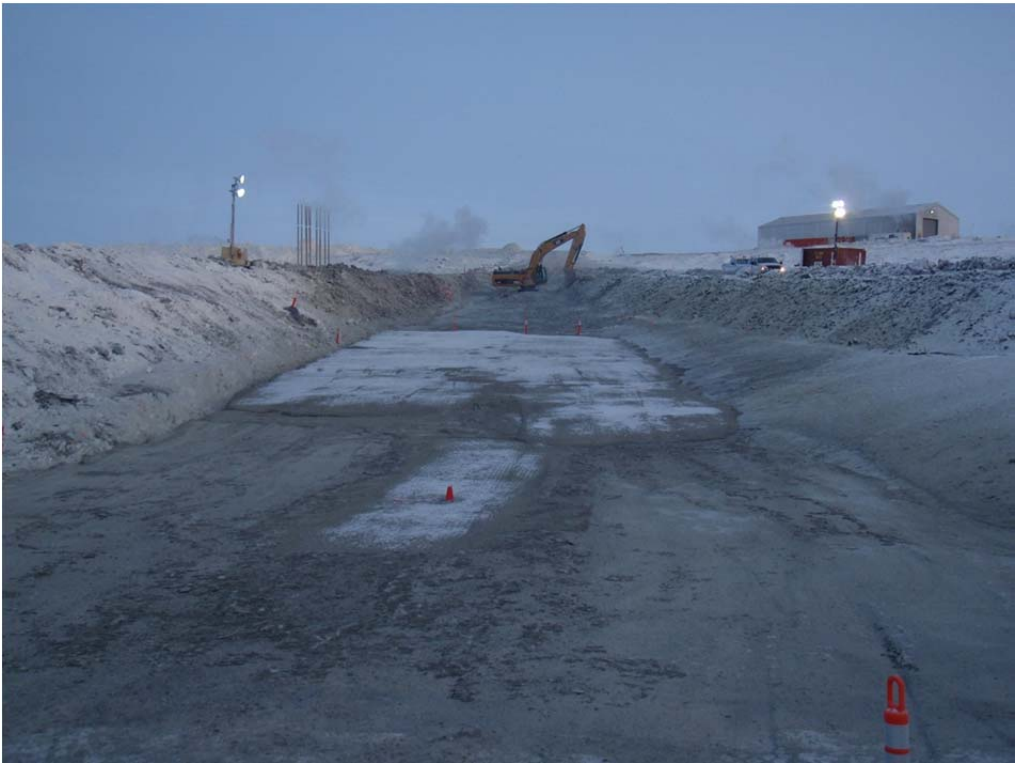
**Photo 2:** ~NNE view up key trench from ~ 0+70,

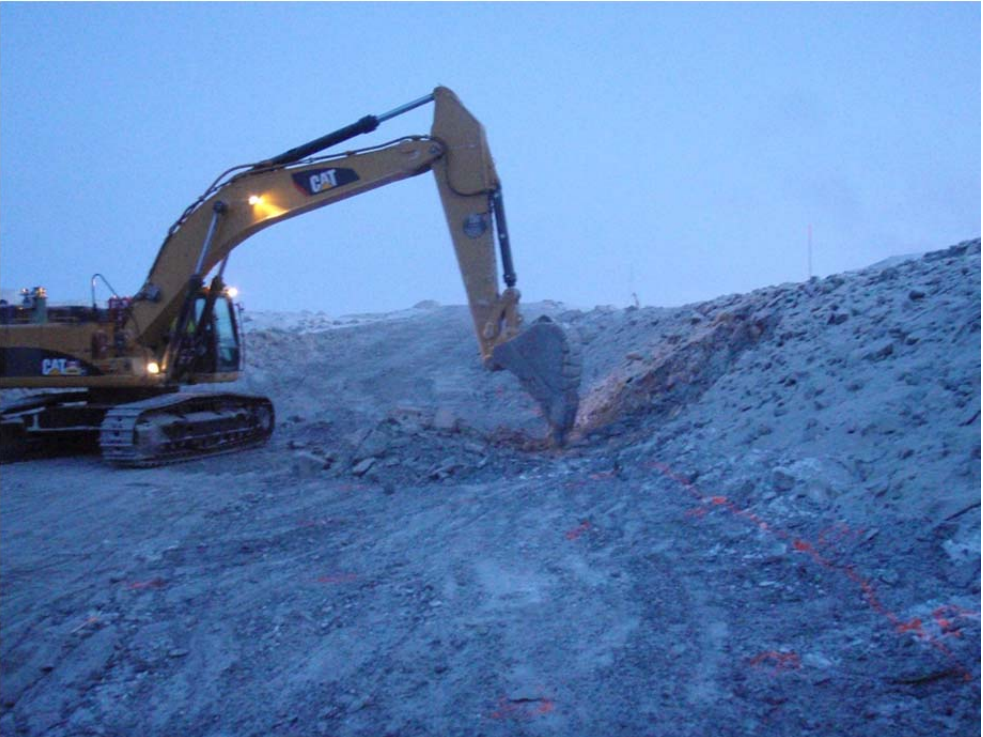
**Photo 3:** 345 excavator scraping 5/8" material cover from key trench around station 1+85

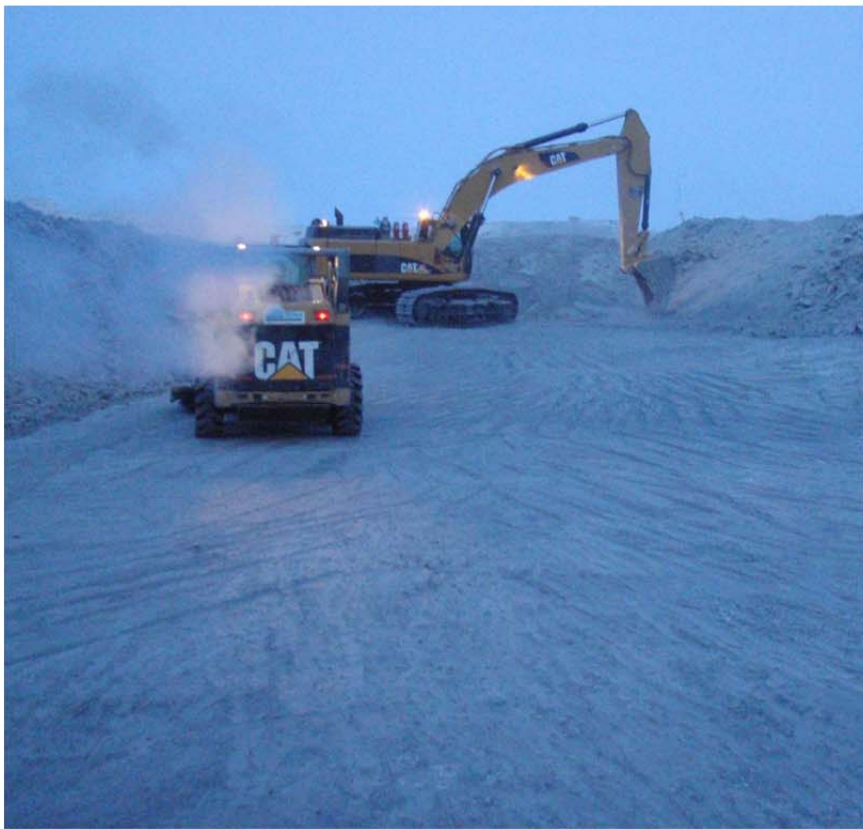
**Photo 4:** Bobcat with brush and 345 excavator cleaning key trench from ~ 1+40 to 1+85, ~NE view.

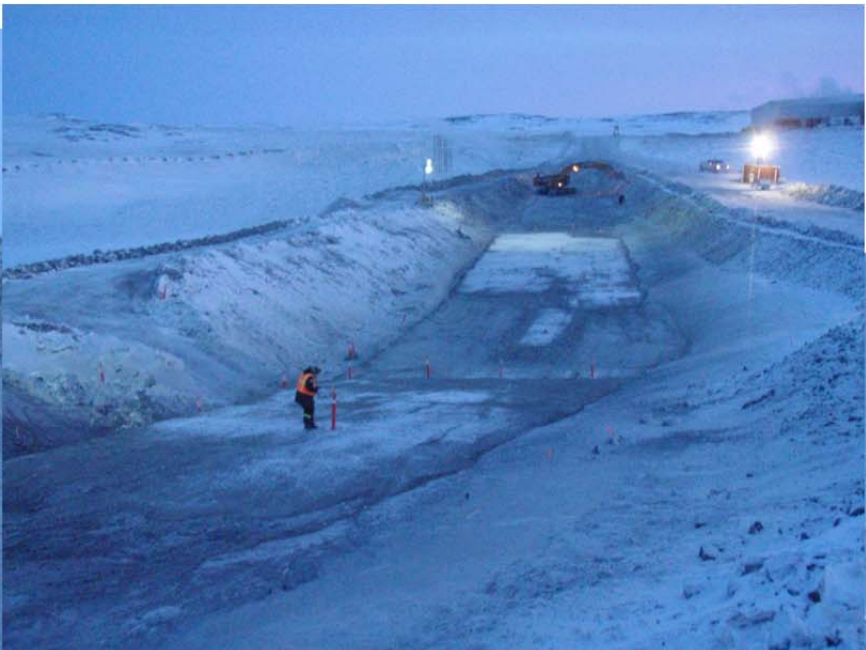
**Photo 5:** ~NE view down key trench. Note the whiter, frost covered, area in the center to eastern side of the picture shows the area where material on 2012/01/24 was placed.

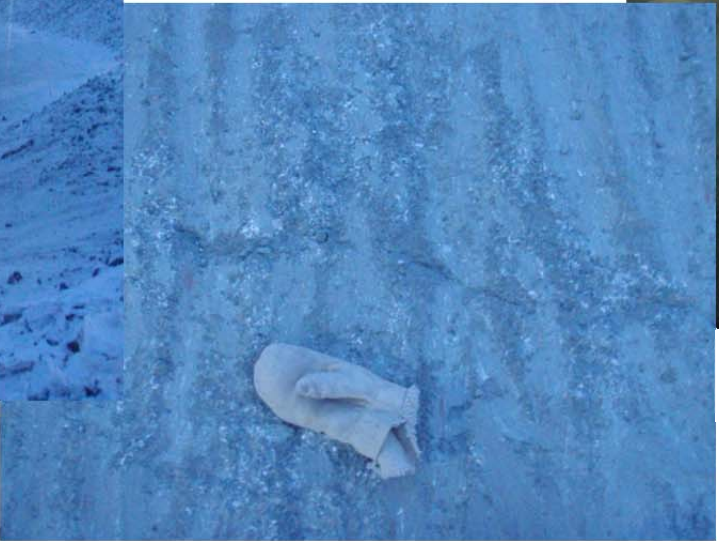
**Photo 6:** Close up view of surface around 1+50 where 5/8" removal is nearly complete. Note the faint line showing the approx.. location where overlying lift tapered out.

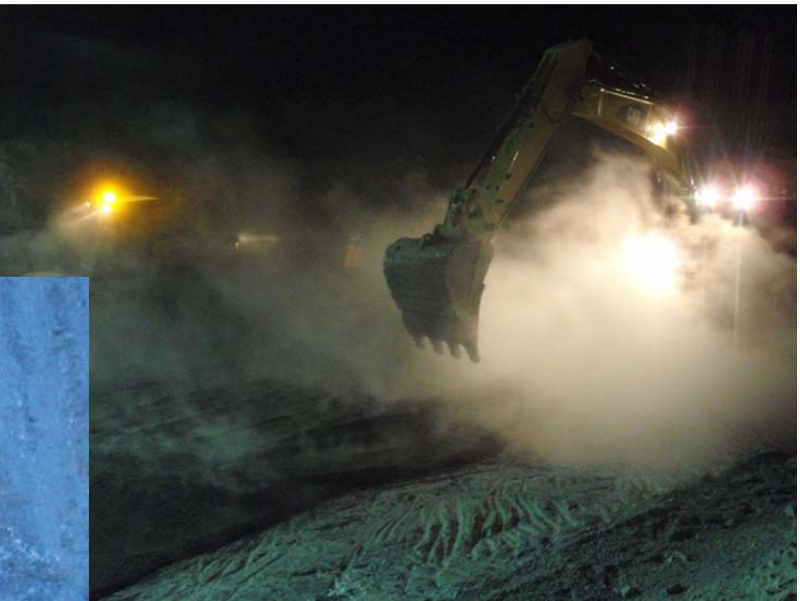
**Photo 7:** ~ N view towards FCM placement. Placement progressing around station 1+60 in this picture.

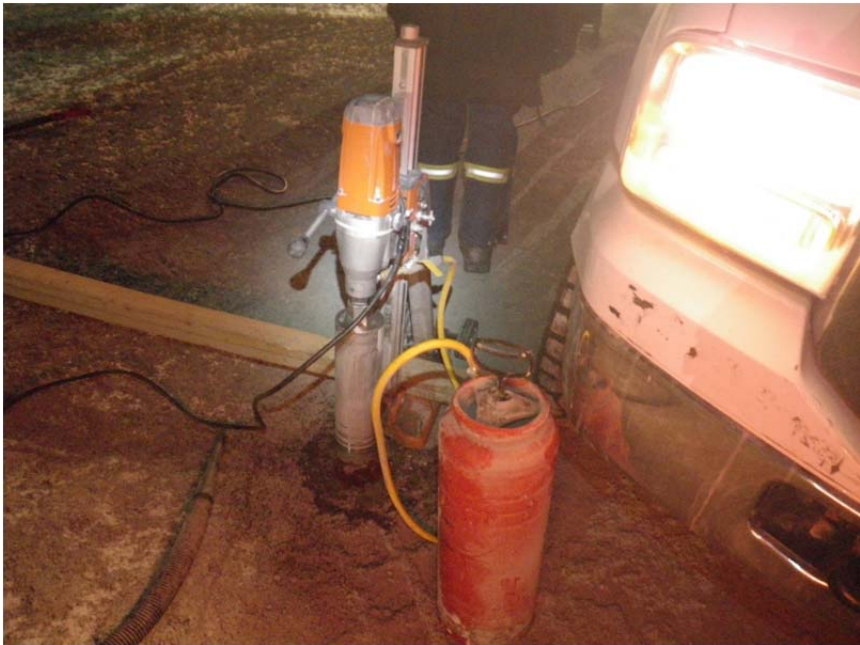
**Photo 7:** Coring on night shift!

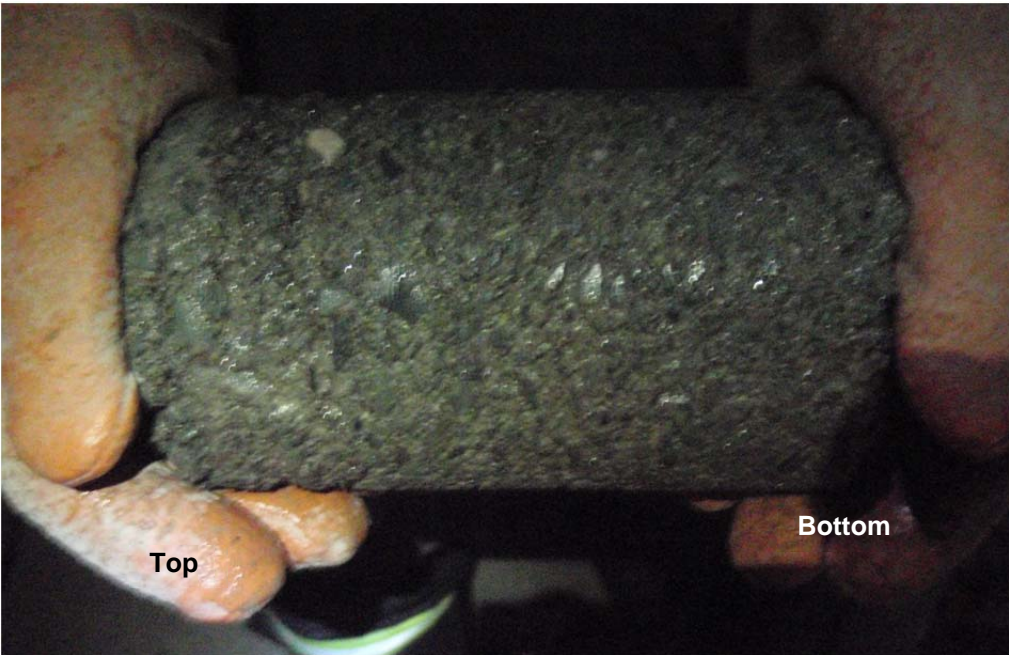
**Photo 8:** HB12-ND-CORE-DC5-20120123 collected from Sta. 0+50 center of the key trench. This core is typical of what you would expect to find when coring this material.

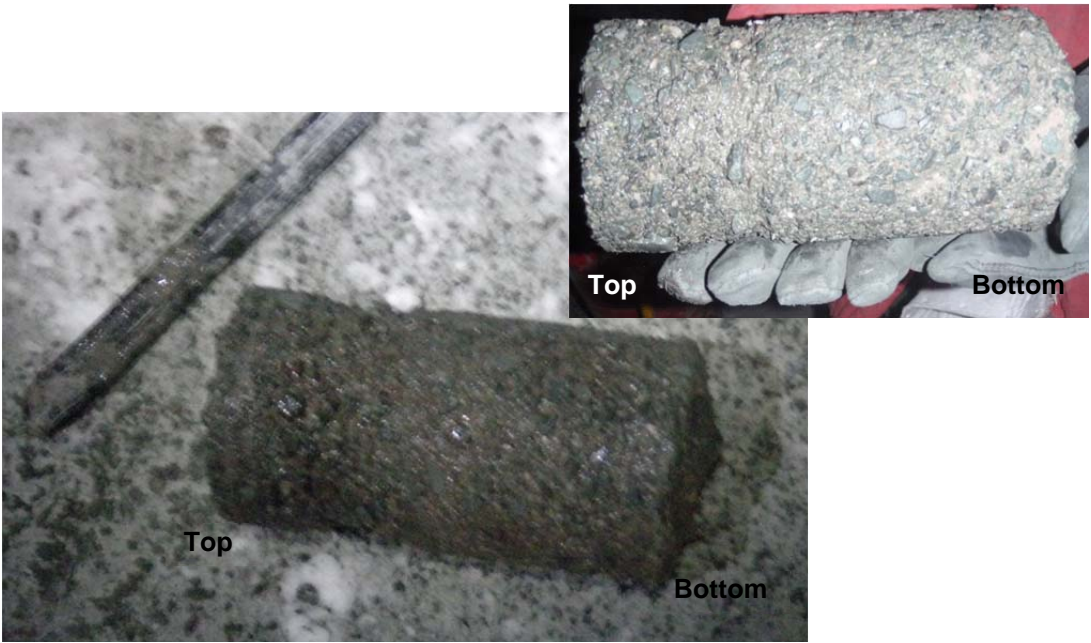
**Photo 9 and 10:** HB12-ND-CORE-DC6-20120123 collected from Sta. 0+95 center of key trench. Thinning near top of this core is due primarily to drill chatter.

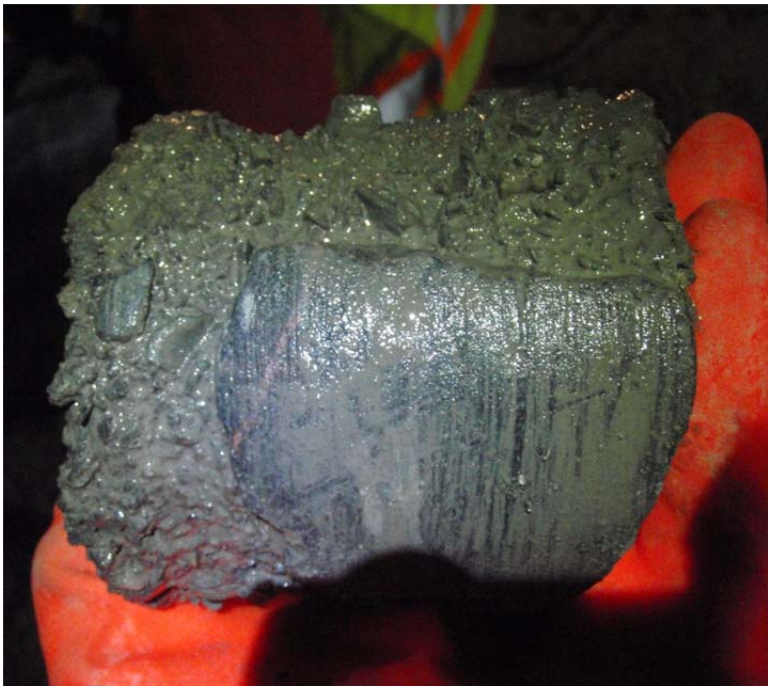
**Photo 10:** A large piece of rock was hit when coring the lift placed 2012/01/22 near station 1+20 downstream side. A second core was taken a few feet from the first, as the first core was stopped short and of very poor quality (due to drilling). Core HB12-ND-CORE-DC7-20120123 was taken immediately adjacent to this location.

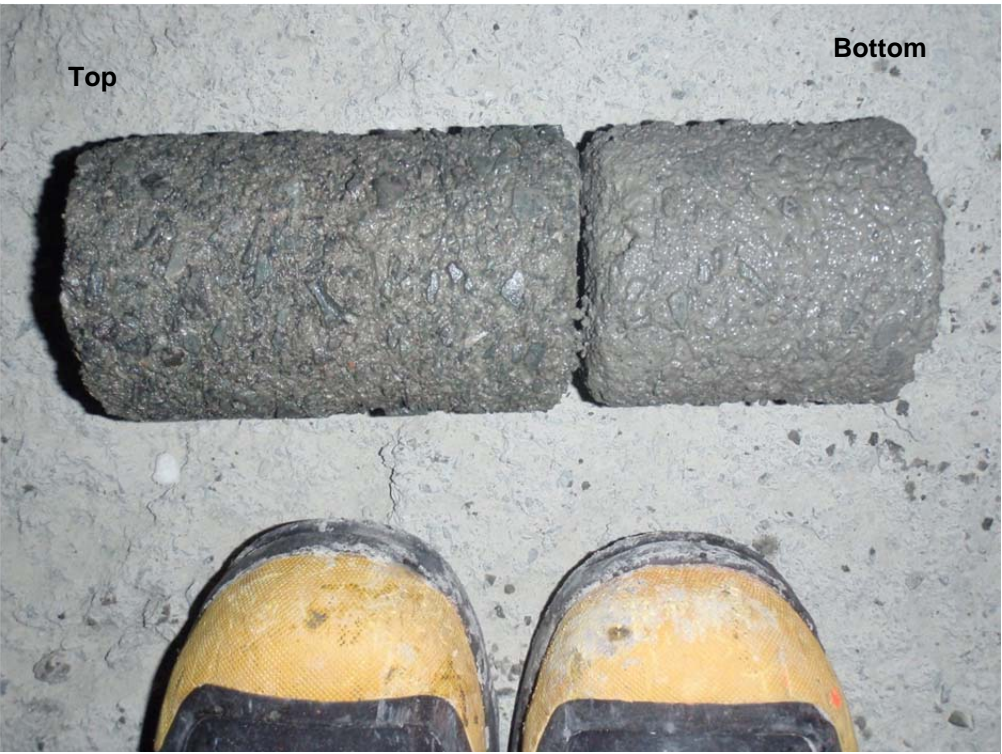
- One of the drilled cores broke in two (spun off) during sampling due poor bonding at the joint between lifts. This is a cause of concern. Higher placement temperatures are expected/ planned to be used in for future lifts to achieve better bonding between lifts. This will be discussed in more detail tomorrow with Nuna and JDS site staff.

- Based on field observations FCM is expected to be required to be leaving the FCP chute at temperatures in excess of 30°C. This is due to visual observations during coring. The lifts did not appear to be bonded or melted together as well as observed last year. The interface between to separate lifts was separating during coring. This was not a problem last year and is most likely a product of extreme low air temperature while placing.

**Photo 11** Drilled core HB12-ND-CORE-DC7-20120123 taken at Sta. 1+20 downstream. Note that this core separated (spun off) at the joint between lifts.

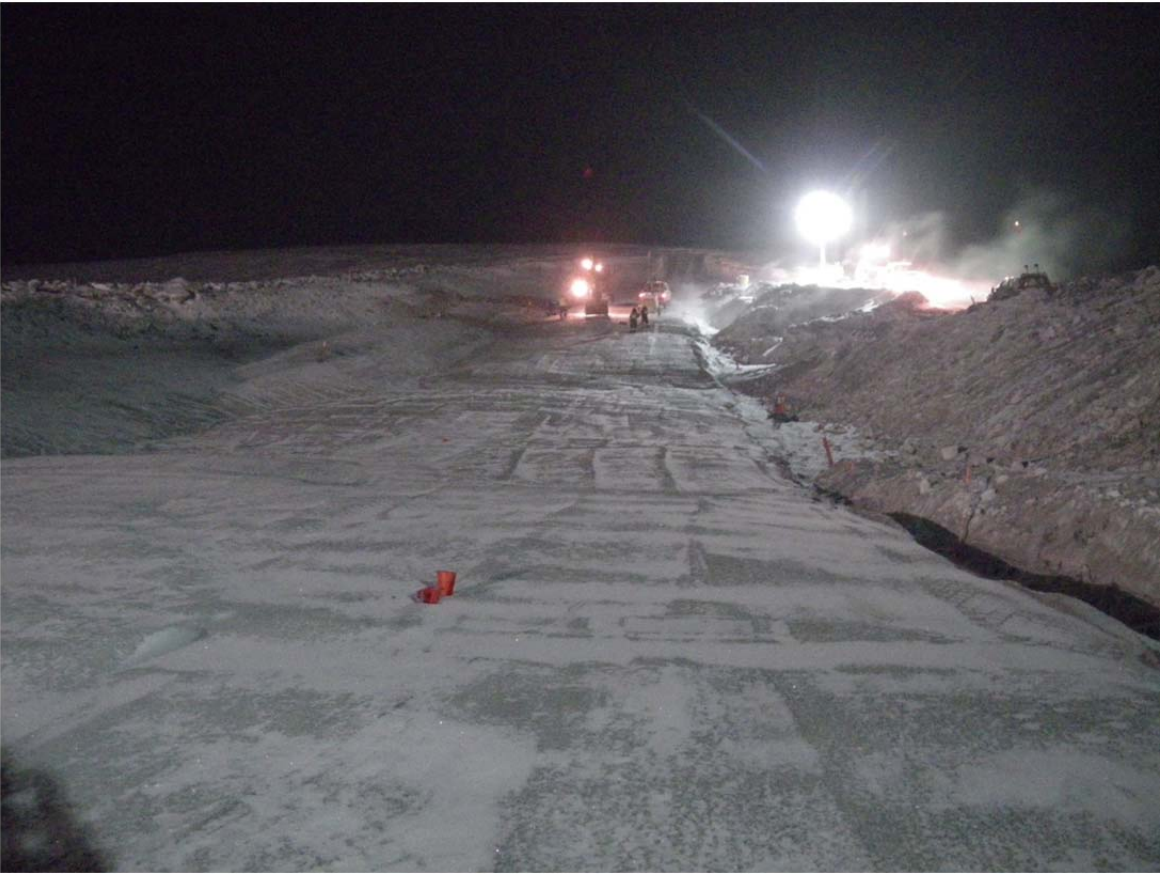
**Photo 12** Cleaning of key trench looking SW along trench. Note snow starting to fall on nightshift.

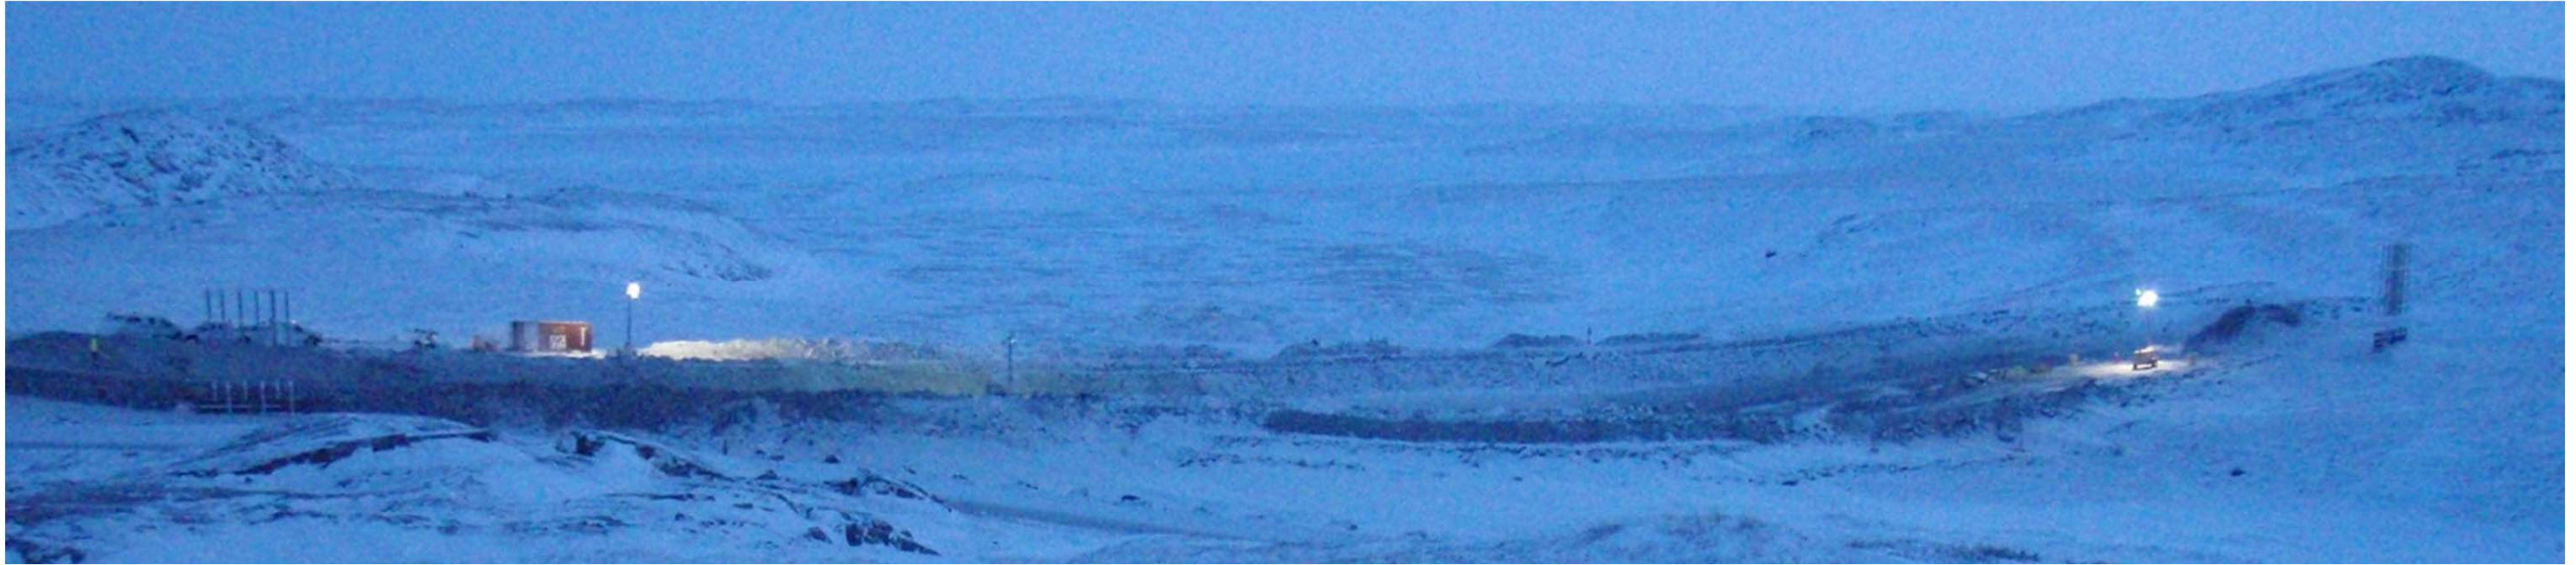
**Photo 13:** Progress photo of North Dam from photo point 1. ~SW view.

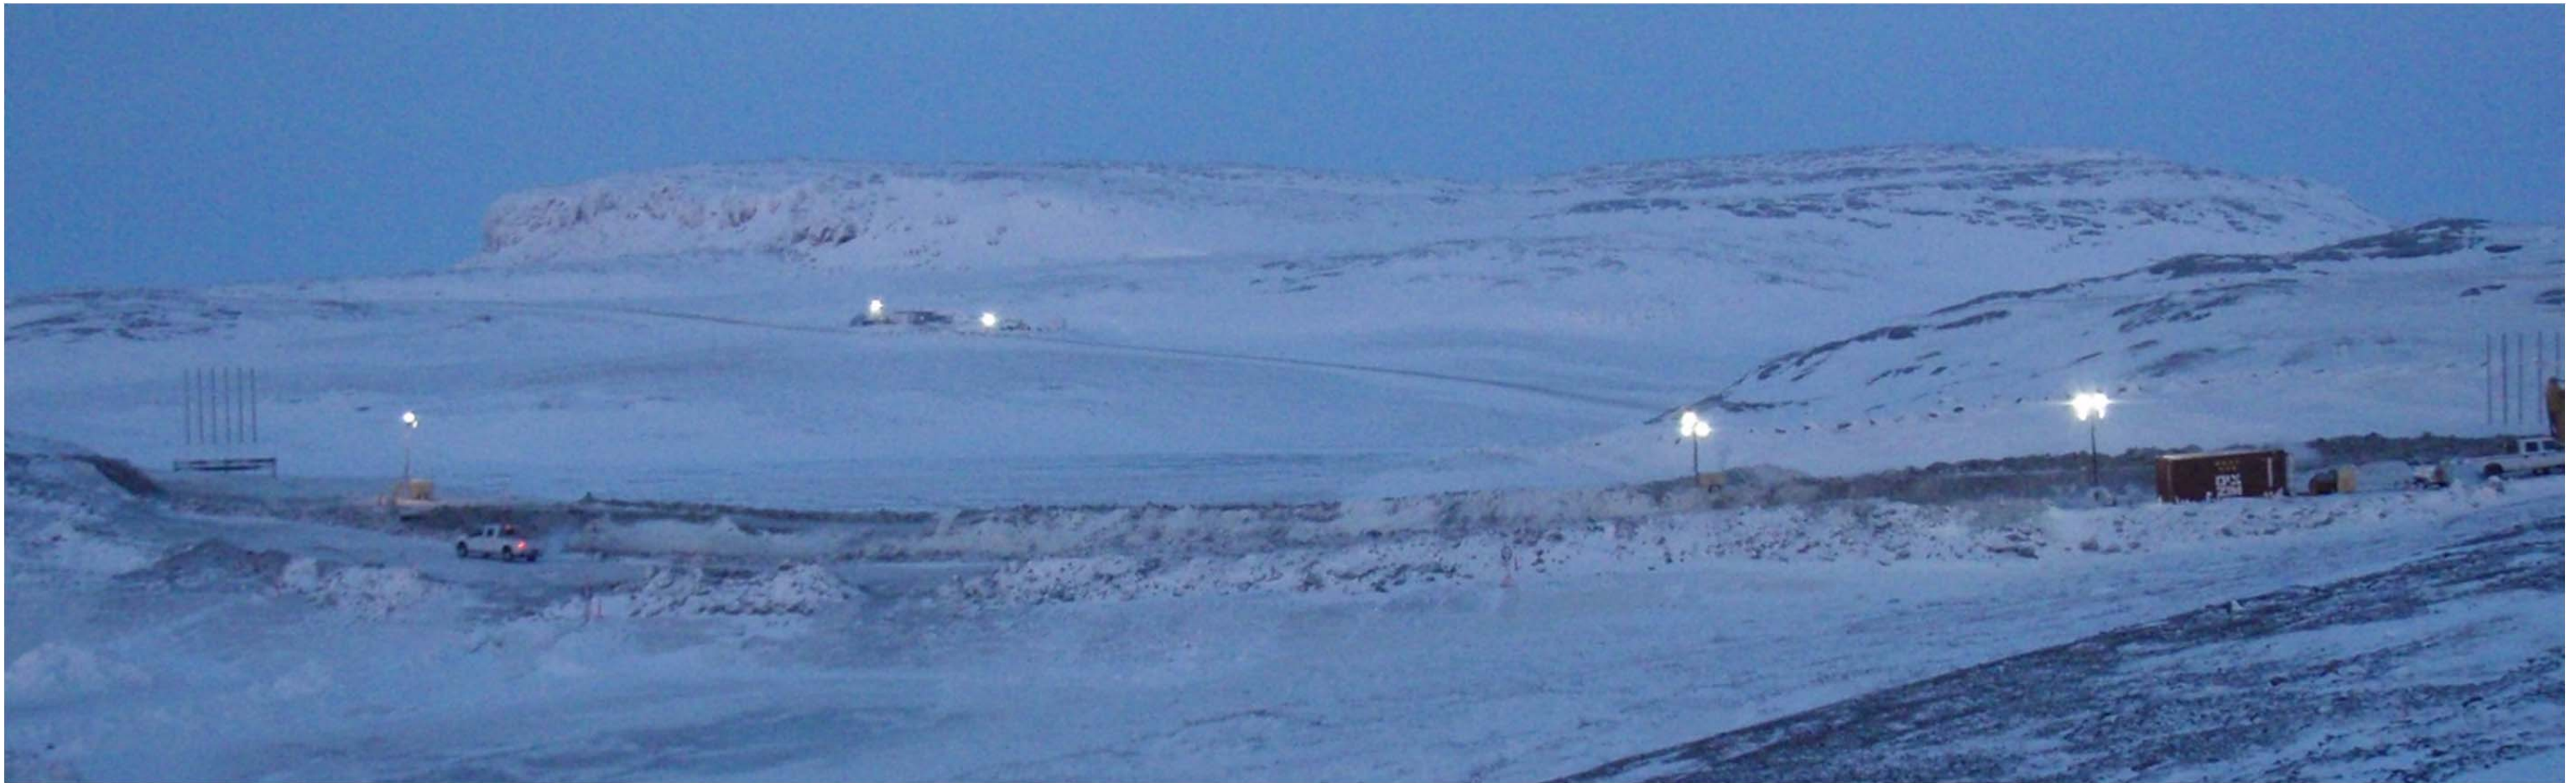
**Photo 14:** Progress photo of North Dam from photo point 2. ~WNW view.

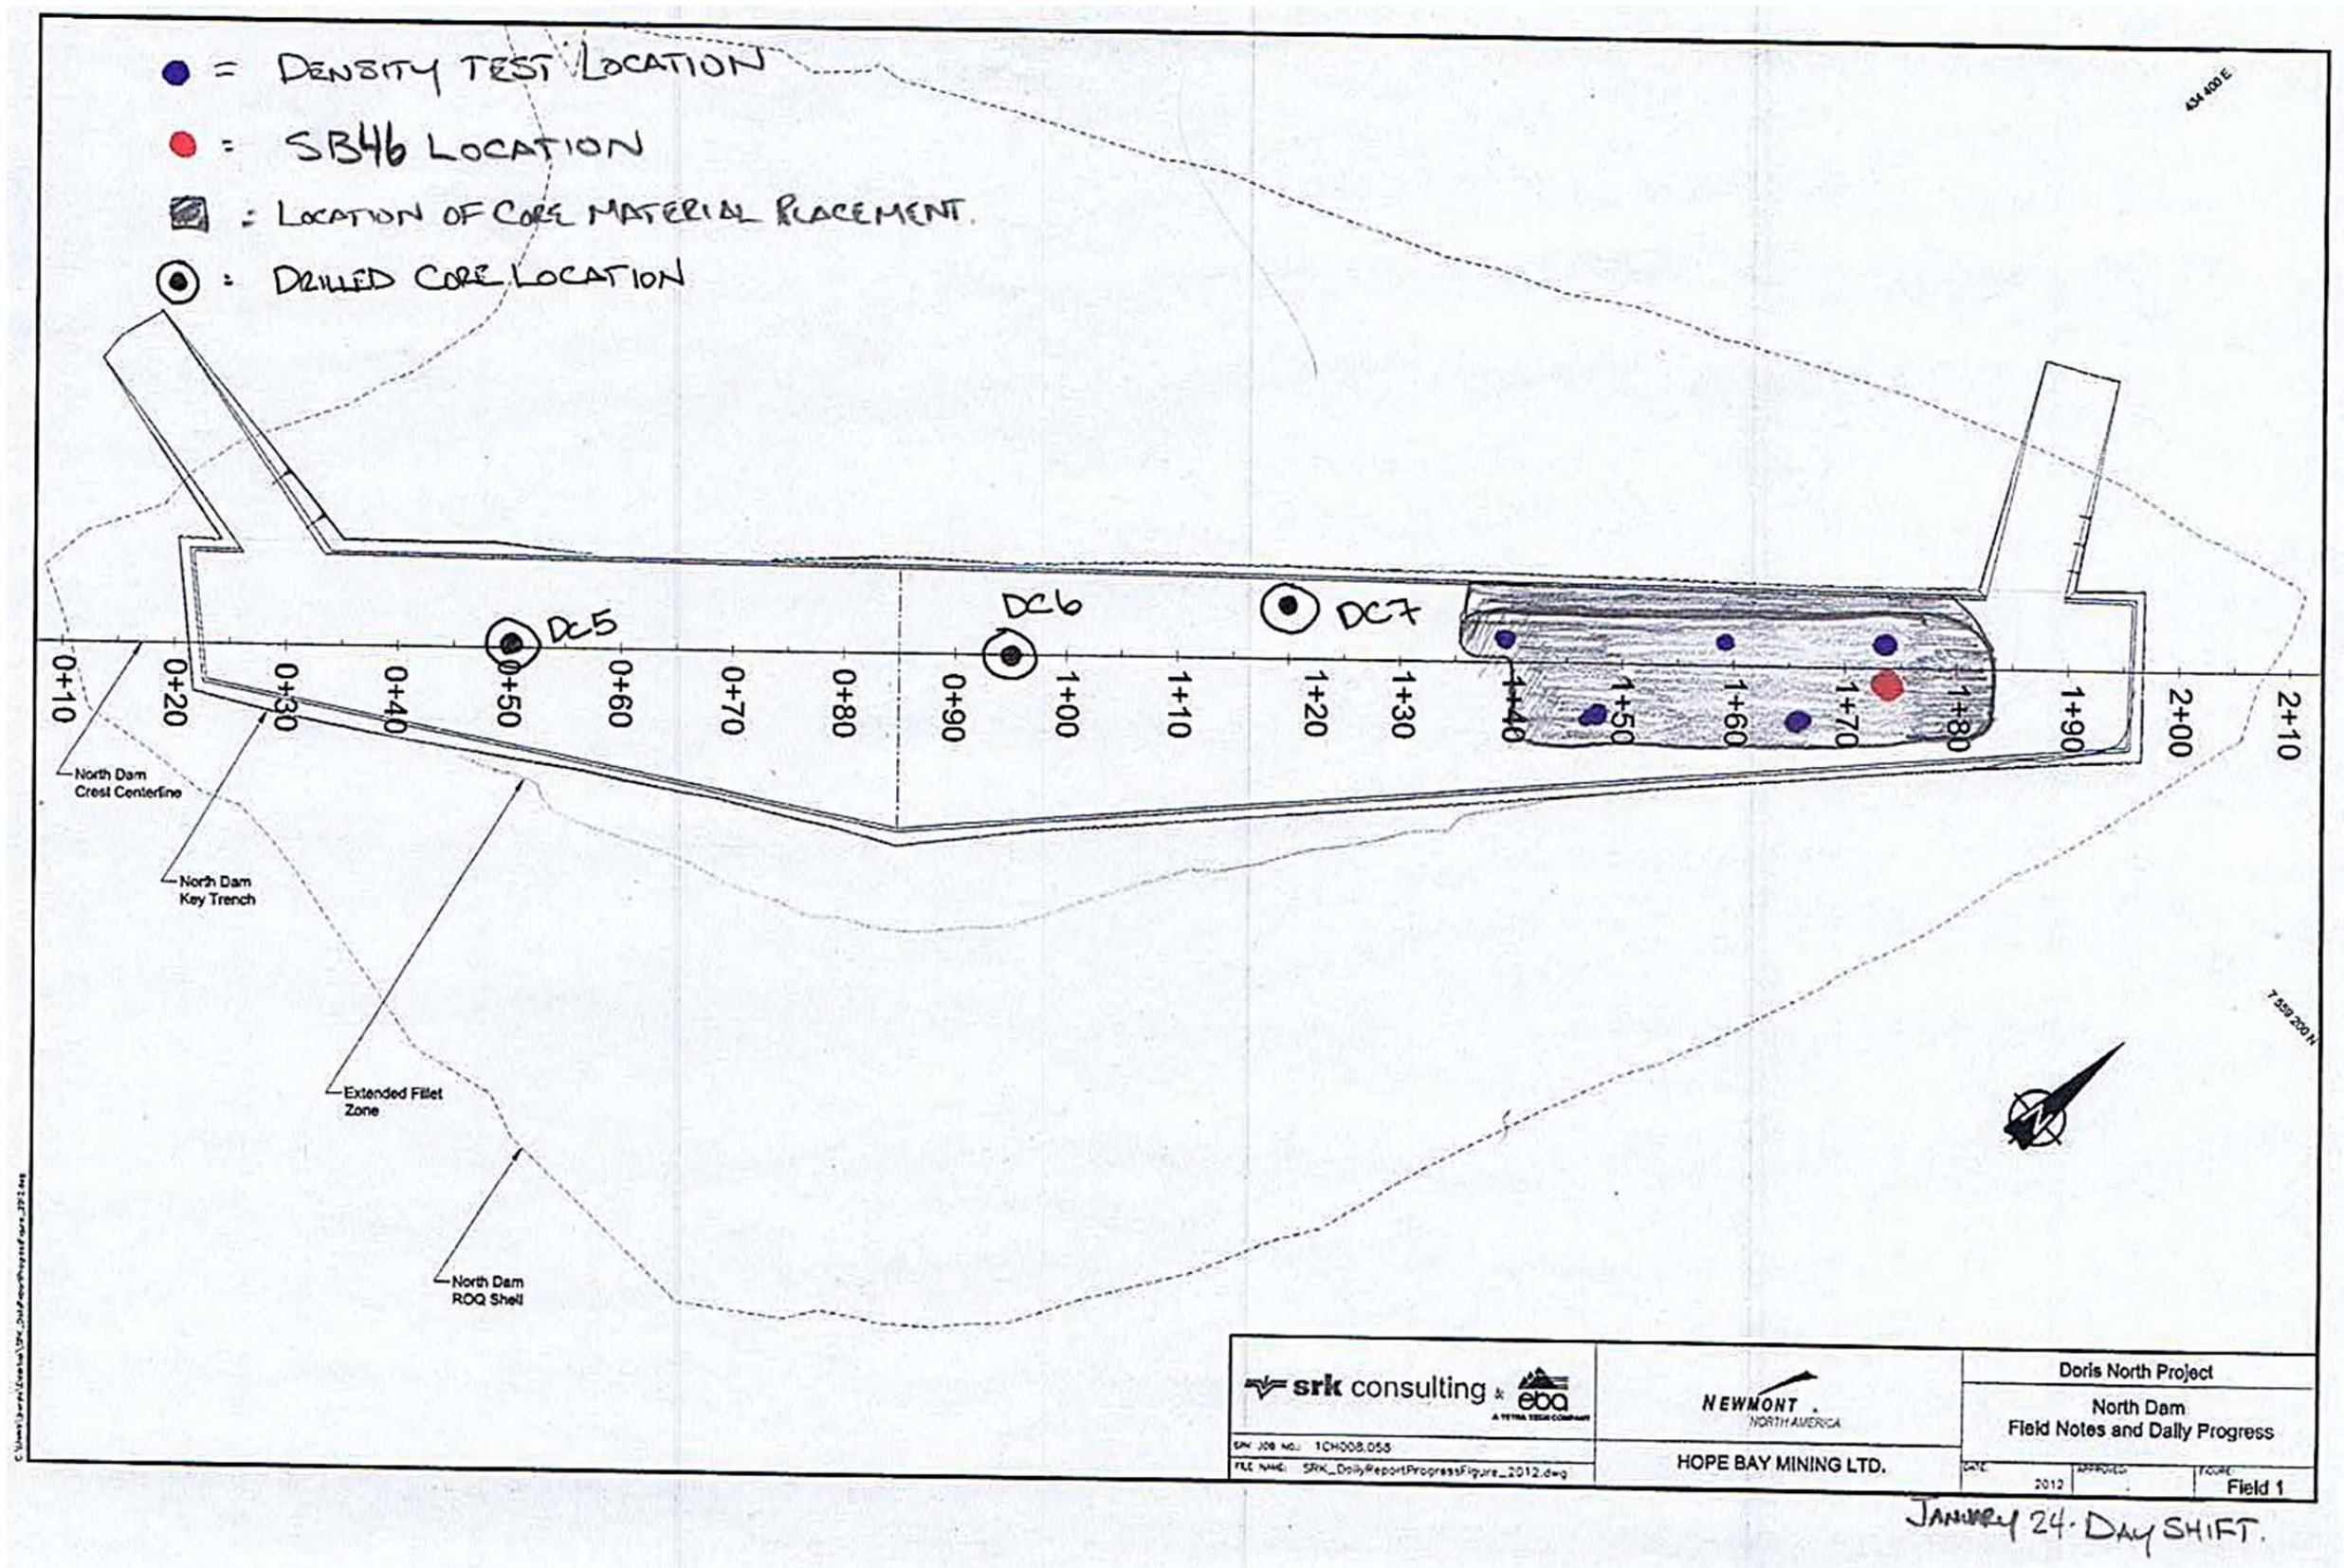
FIGURES:  
Figure 1 - FCM Progress/ Placement – Jan 24<sup>th</sup>

- A progress figure showing the approximate extent of today's placement is provided as Figure 1.
