DAILY REPORT #21 – DORIS NORTH INFRASTRUCTURE/ NORTH DAM

Prepared by:	John Kurylo/ Jeff Orr / Megan Miller	Date:	2012.01.26
Reviewed by:		Project #:	1CH008.058.0320
Role	Company	Personnel – Position	On Site
Client	Hope Bay Mining Limited (HBML)	Angela Holzapfel – ESR Compliance Manager David Vokey – ESR Coordinator Don Ethelston – HSLP Advisor Dean Wold - Safety Jill Turk – ESR Coordinator Katsky Venter – ESR Manger – ESR Site Manager Stirling Kelly – HSLP Advisor	No Yes Yes No No In Out No
	JDS	Lloyd Jackson – Mechanical Superintendent Sven Archimowitz – Electrical Superintendent Doug Fielding – Construction Manager Ishan Fechter – Construction Coordinator Jerry Graham – Construction Manager Kevin Whieldon – Project Coordinator Michelle Tanquay Mark Valeriote – Construction Manager	In Yes Yes Out No In In
Engineering Design Consultants	SRK Consulting (Canada) Inc.	John Kurylo – Site Engineer Megan Miller – Site Engineer Lawrence Borowski – Site Engineer Murry McGregor – Site Engineer Iozsef Miskolczi – Site Engineer	Yes Yes No No No

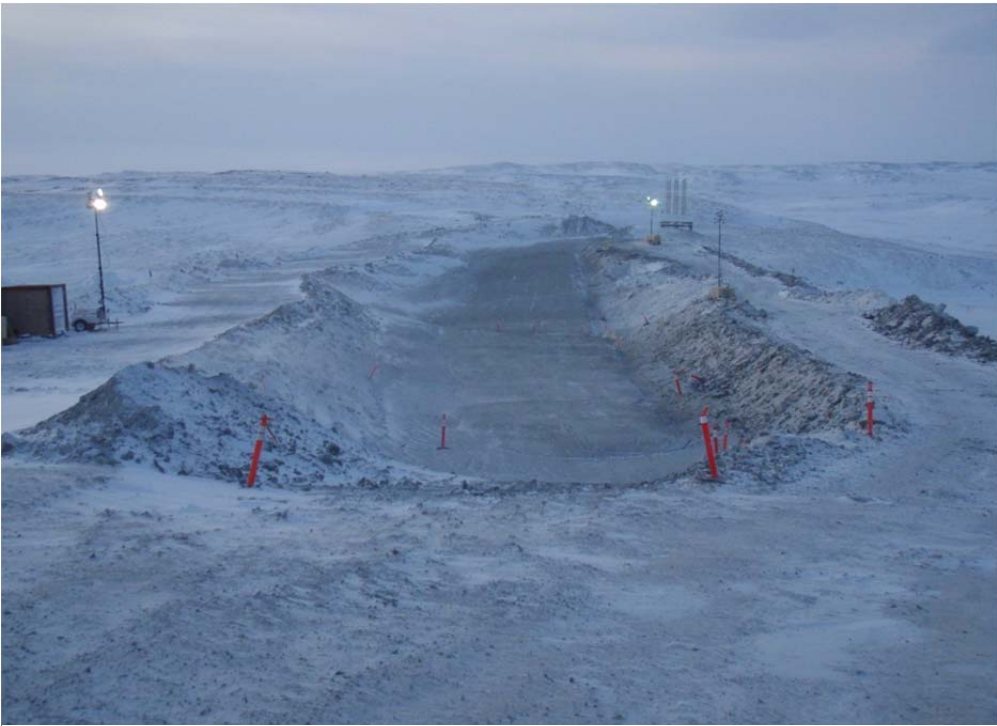
Photo 1: ~WSW view down key trench, photo taken in the am.

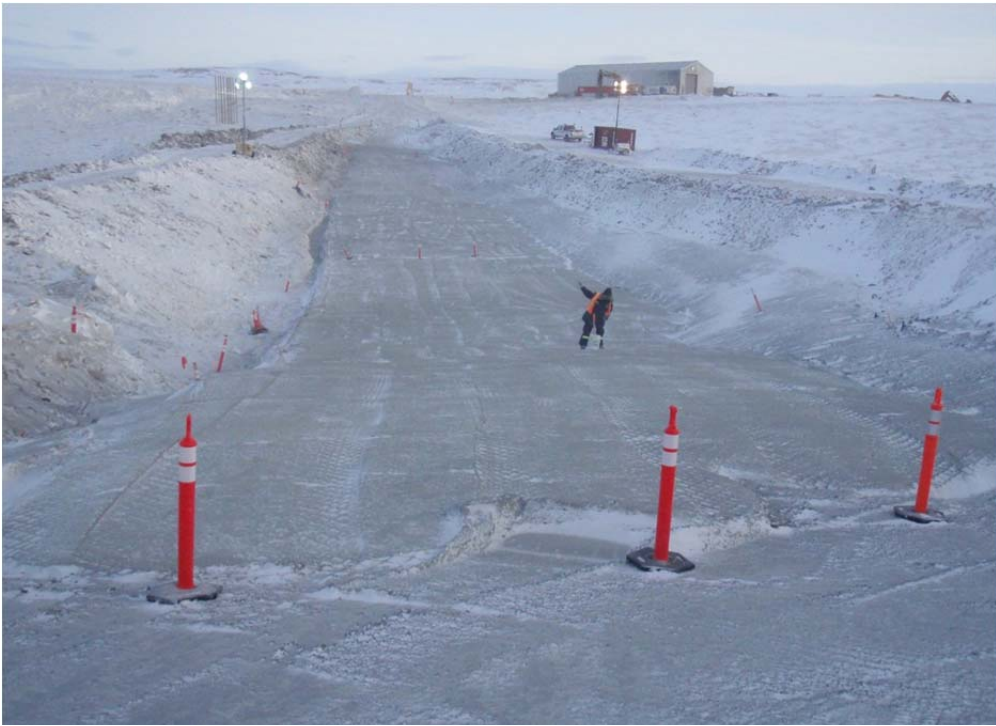
Photo 2: ~ENE view down key trench, EBA taking single bead reading at time of photo.

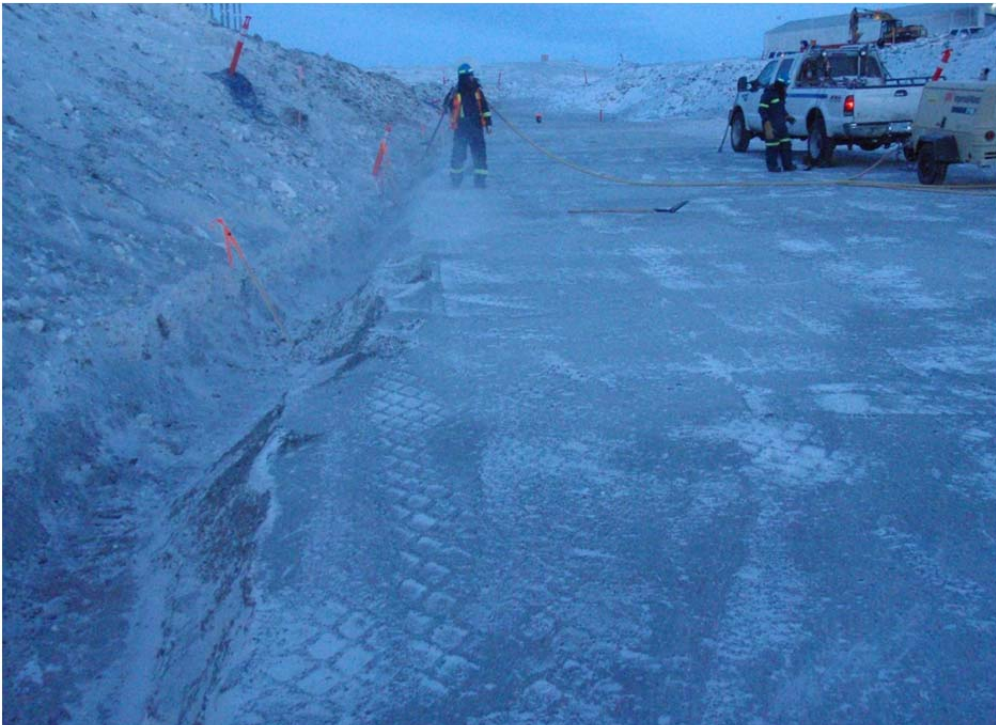
- SRK, Nuna and JDS held discussions about the current downstream core edge.
 - When inspecting cleaning it was found that the existing FCM placement has resulted inside of the SRK IFC design limits. The downstream area from ~ 0+95 to 1+80 was noted to be slightly underbuilt.

Photo 3: ~ NE view of labourer cleaning slightly underbuilt downstream slope area. See photo 10 for additional details.

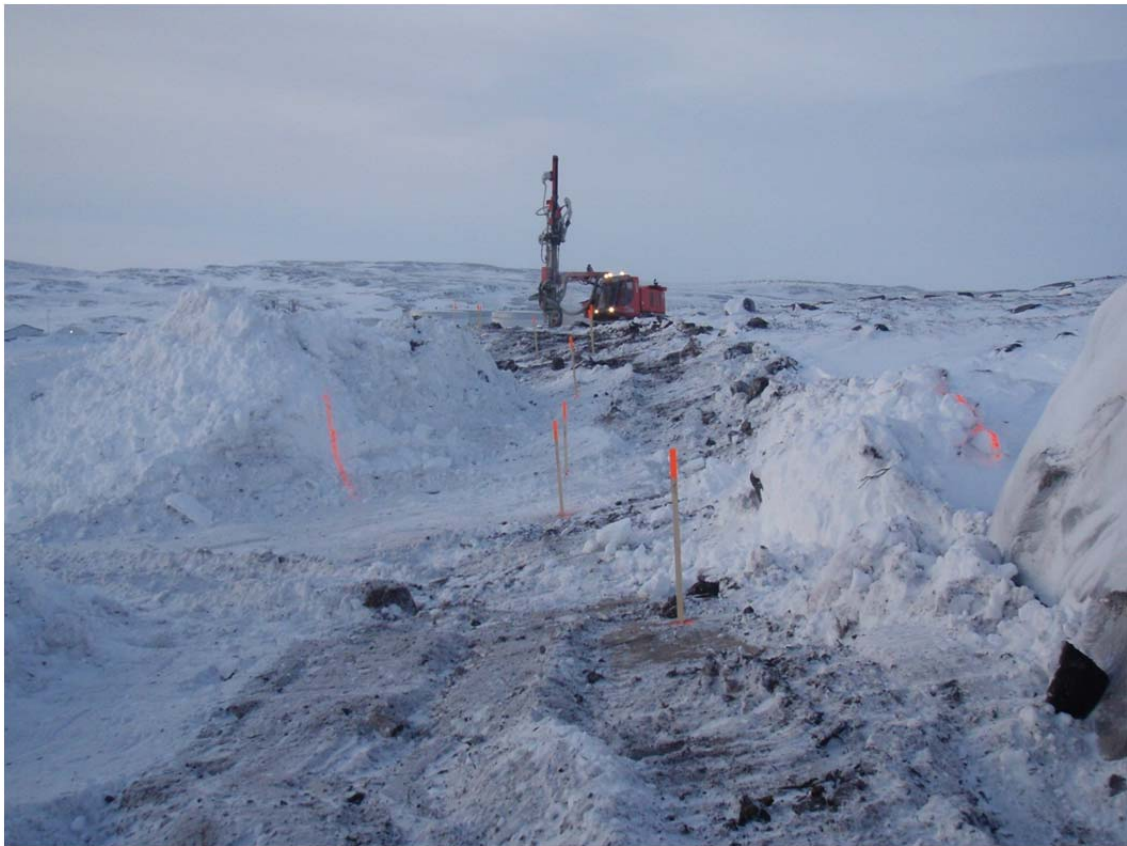
Photo 4: ~W view towards WestArc drill drilling bedrock outcrop noted near central east portion of the DN Diversion berm alignment.

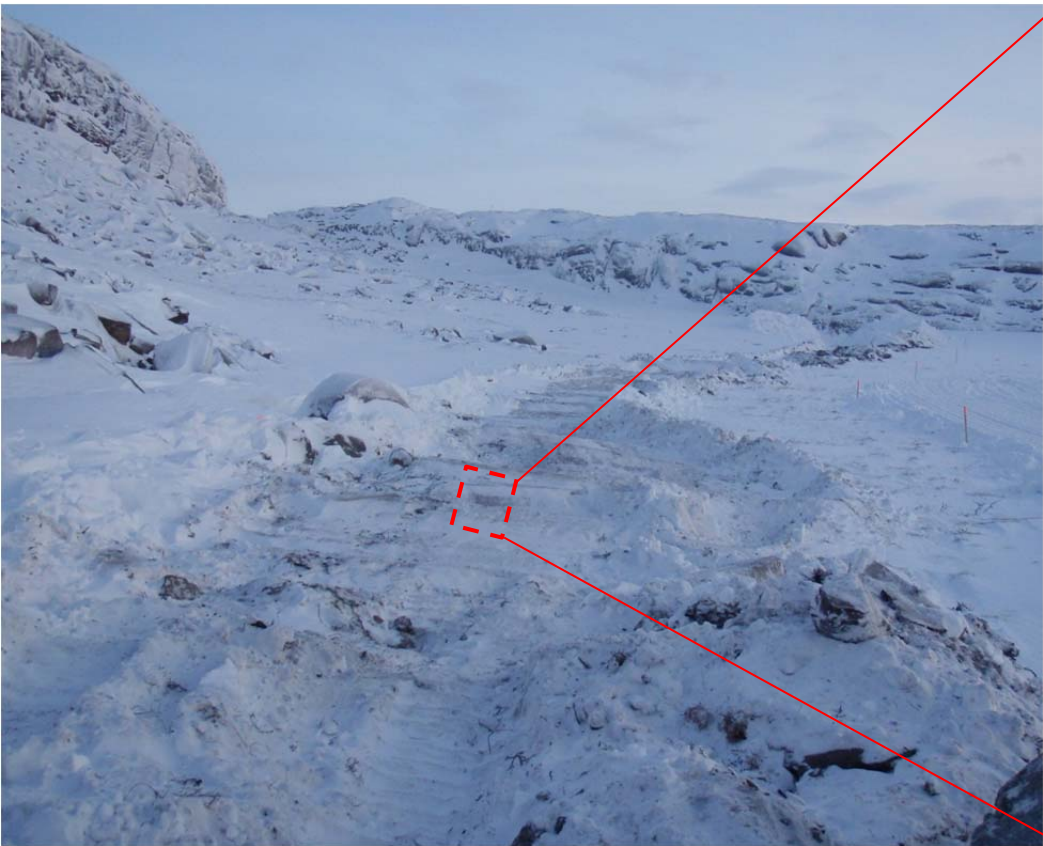
- Snow road construction around the DN Diversion Berm slowly continues.
- Westarc has started drilling at the main bedrock outcrop noted towards the east central area of the DN Diversion Berm. See Photo 4.
- SRK completed a field inspection along the eastern extents of the DN Diversion berm where snow had been removed. Besides the one previously noted bedrock outcrop the remainder of the alignment appeared to be in Tundra/ overburden at the surface of the diversion footprint. See Photos 4 to 6.

Photo 5: ~~E view down snow clearing completed along DN Diversion Berm footprint. Looking towards E bedrock slope tie-in.

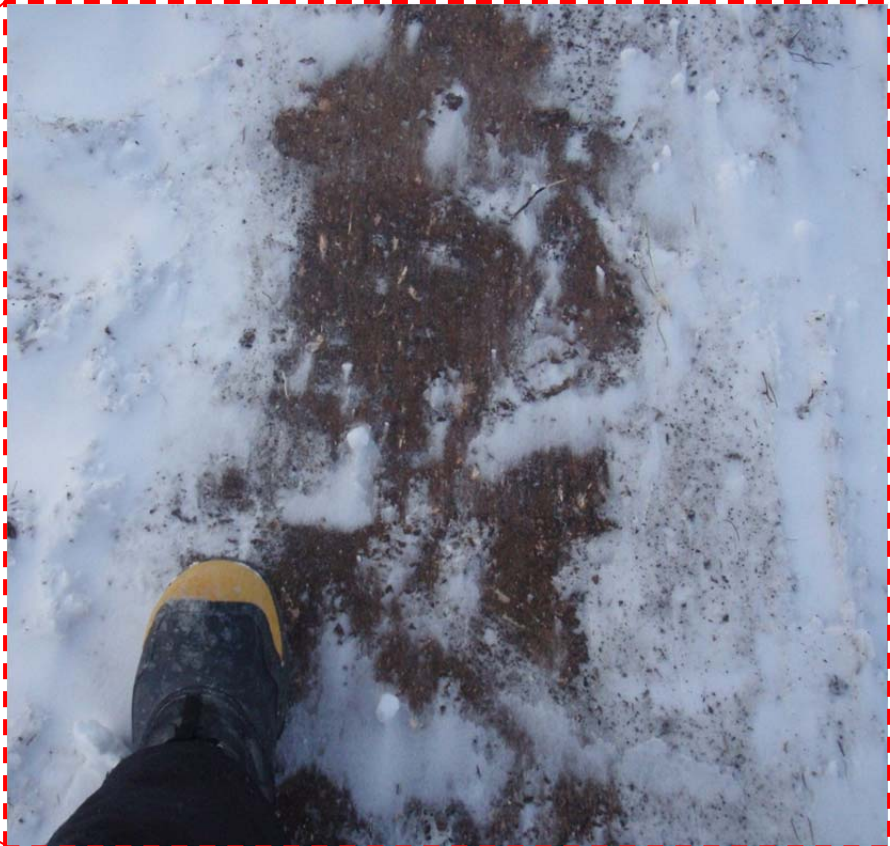
Photo 6: Close-up view of frozen tundra observable after snow clearing along the eastern portion of the DN Diversion Berm footprint.

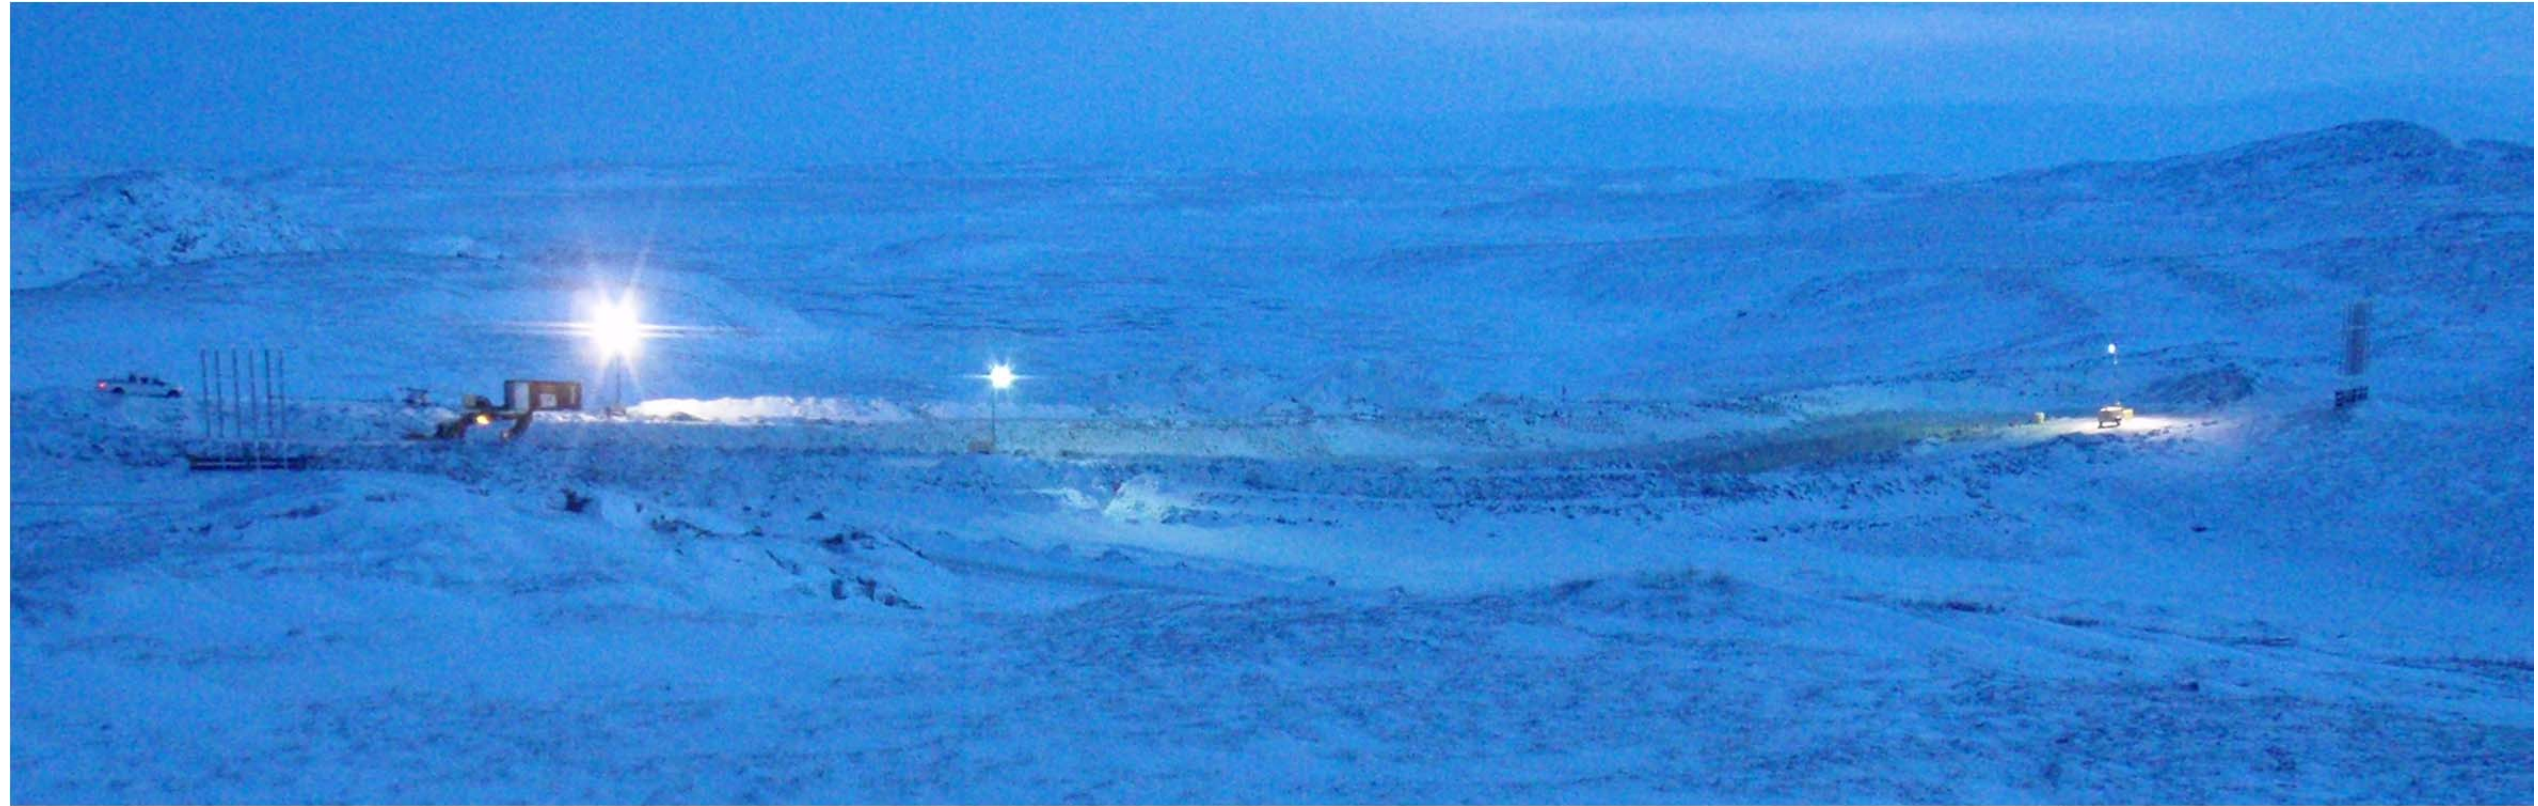
Photo 7: Progress photo of North Dam from photo point 1. ~SW view.

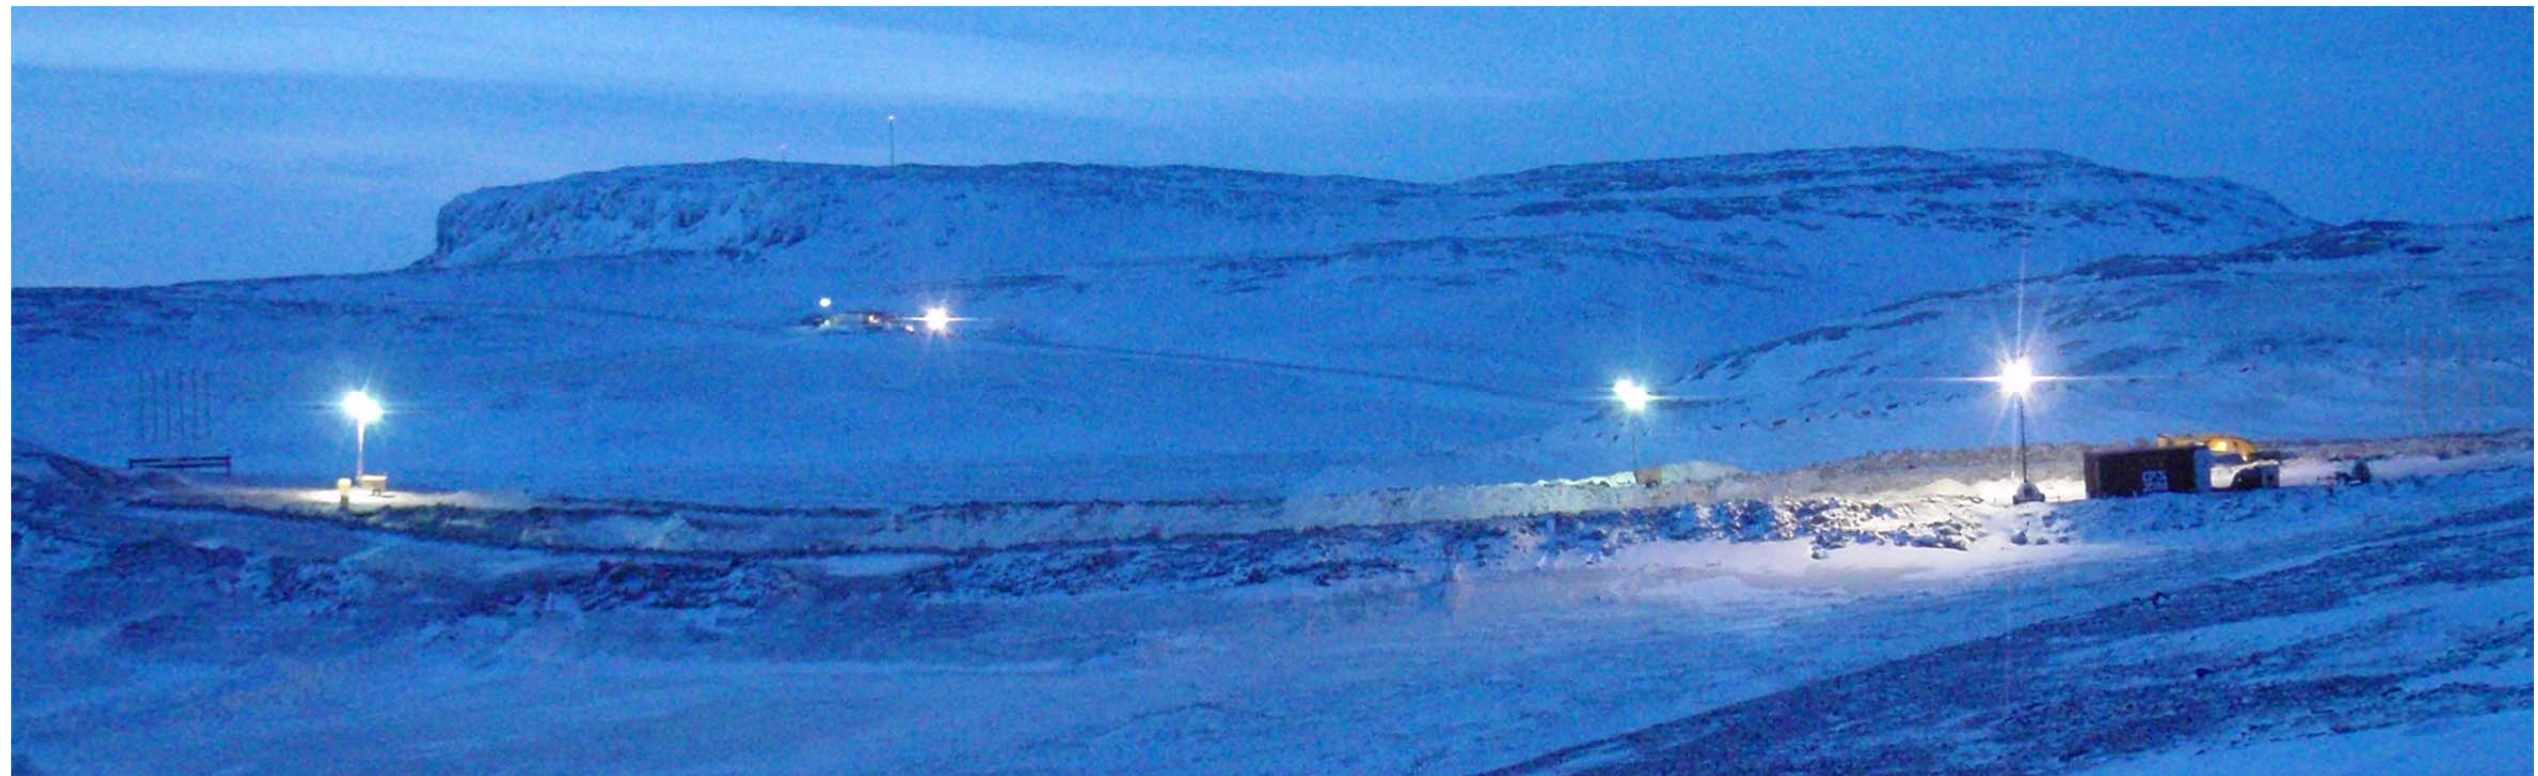
Photo 8: Progress photo of North Dam from photo point 2. ~WNW view.

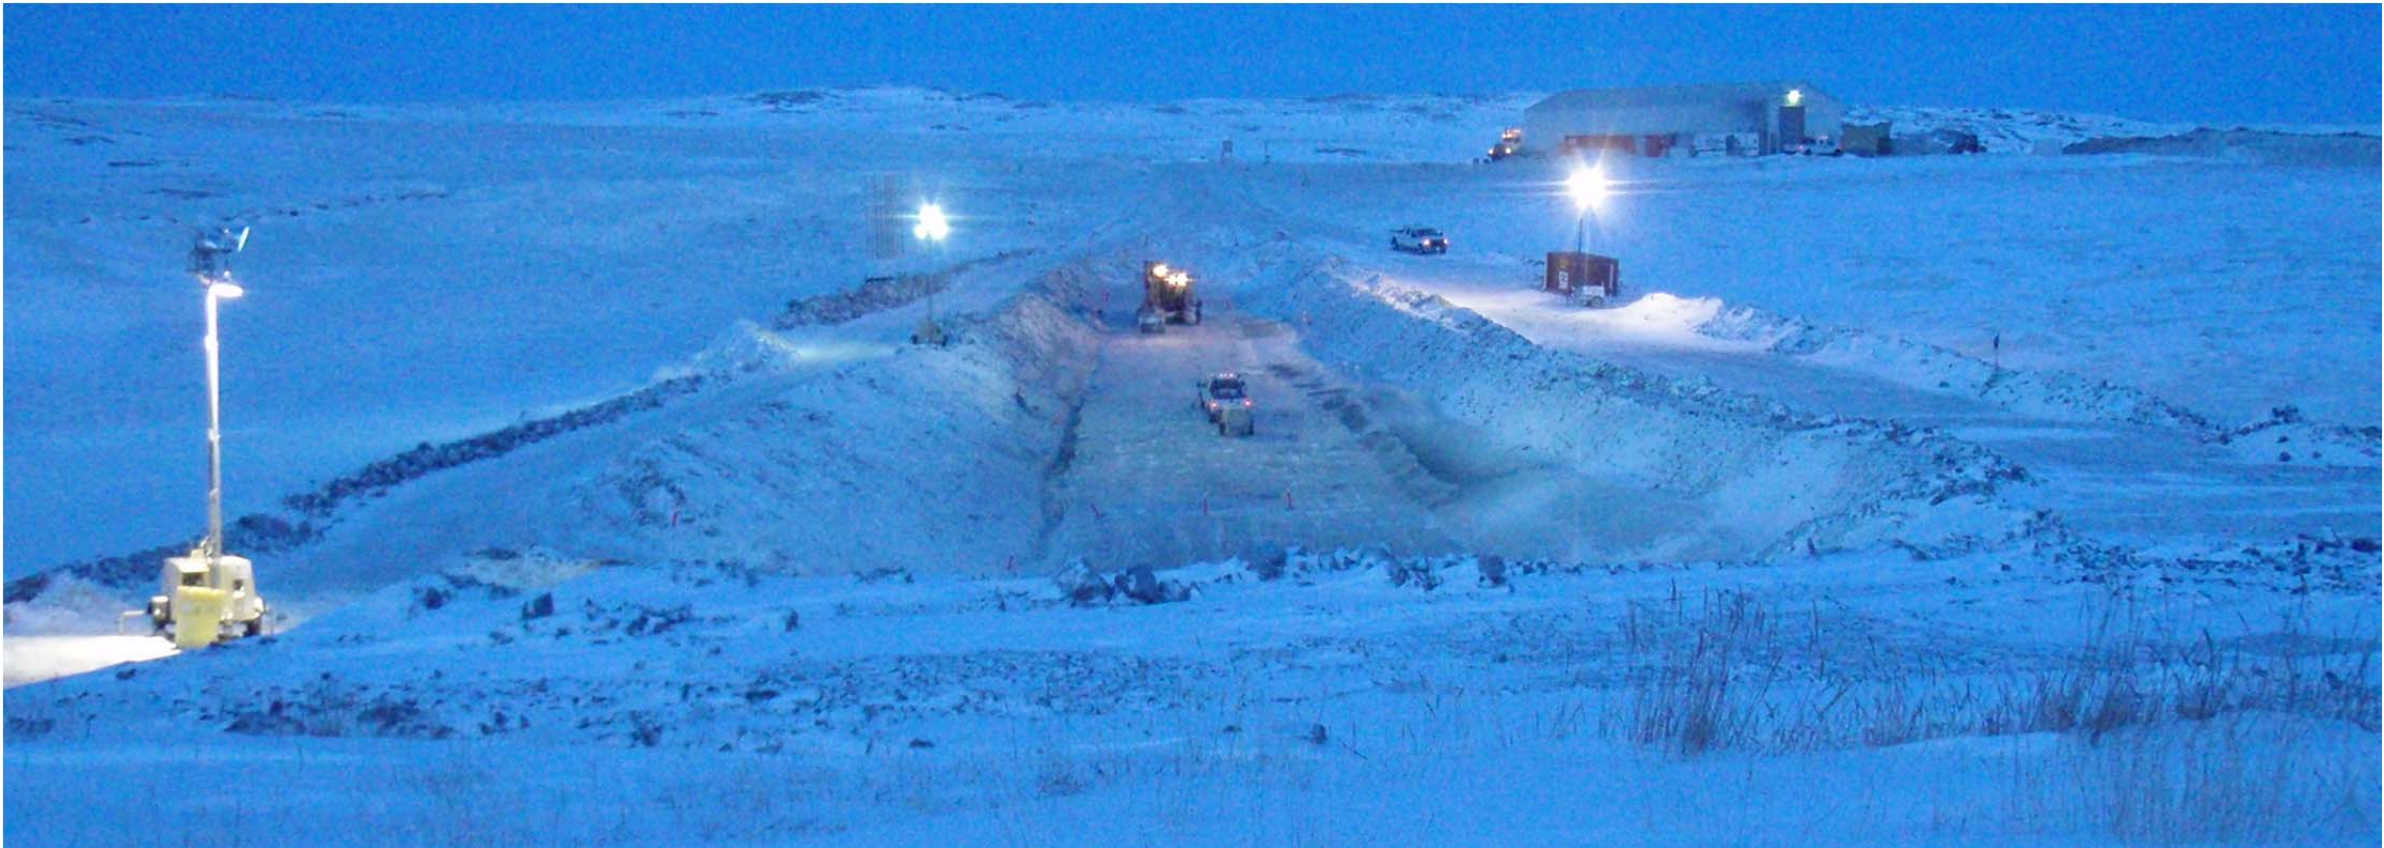
Photo 9: Progress photo of North Dam from photo point 3. ~ENE view.

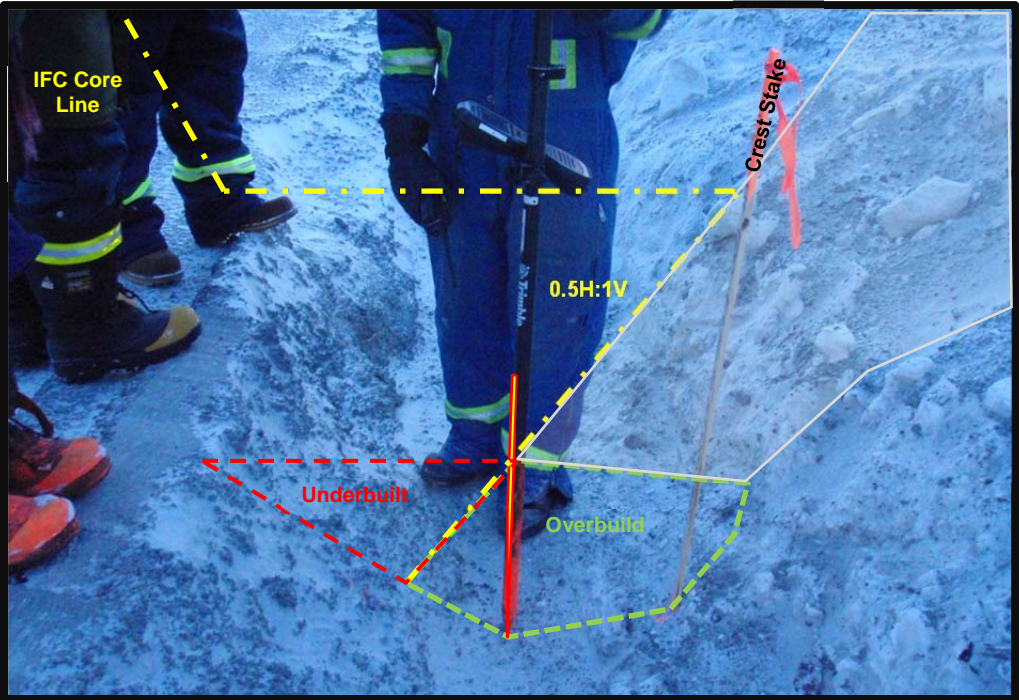
- Survey has been providing the line for the intersection of each lift with the downstream 0.5H:1 IFC key trench line. However, as the key trench has been overblasted in this area, there is empty space on the downstream, between the overblasted key and placed FCM. With each increasing lift the design slope lines have been going further towards the N however, due to the nature of the FCM, the placed lifts have been progressing at a slope transverse to the IFC slope.

Photo 10: Close up view of existing downstream FCM slope around ~ chainage 1+20. Note that the section below the photo highlights the approximate area of this photograph.

Note: the current FCM placement is slightly inside of the IFC design line (yellow lines). The underbuilt area is highlighted with red. It is planned that from ~station 0+95 to 1+40 that the downstream area will be slightly overbuilt (green lines) to fill in this 'gap/trench' area between the FCM and the overblasted key trench. After the next FCM lift is completed then the 0.5H:1V IFC slope line will be constructed on the downstream with Transition material (grey transparent hatch). This will provide a slope to build into for subsequent lifts.

- To correct the downstream slope it is required that the core in this section be overbuilt or that Transition material be placed and shaped so that the construction crew has a slope to build into.

- Transition material was planned to be placed on nightshift. Due to the limits amount of space between the overblasted key and the existing FCM it was decided that the area from ~ 0+95 to 1+40 would be slightly overbuilt and then transition would be placed; so that future lifts would be built to, but not exceeding the design limits.

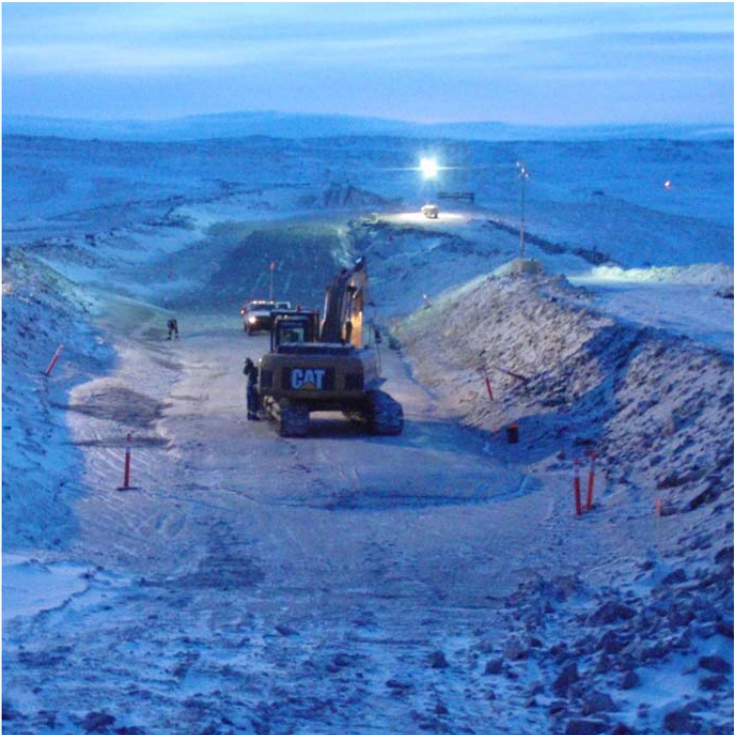
Photo 11: Excavator working on clearing 5/8" clear, and cleaning along the upstream and downstream slopes. ~ WSW view.

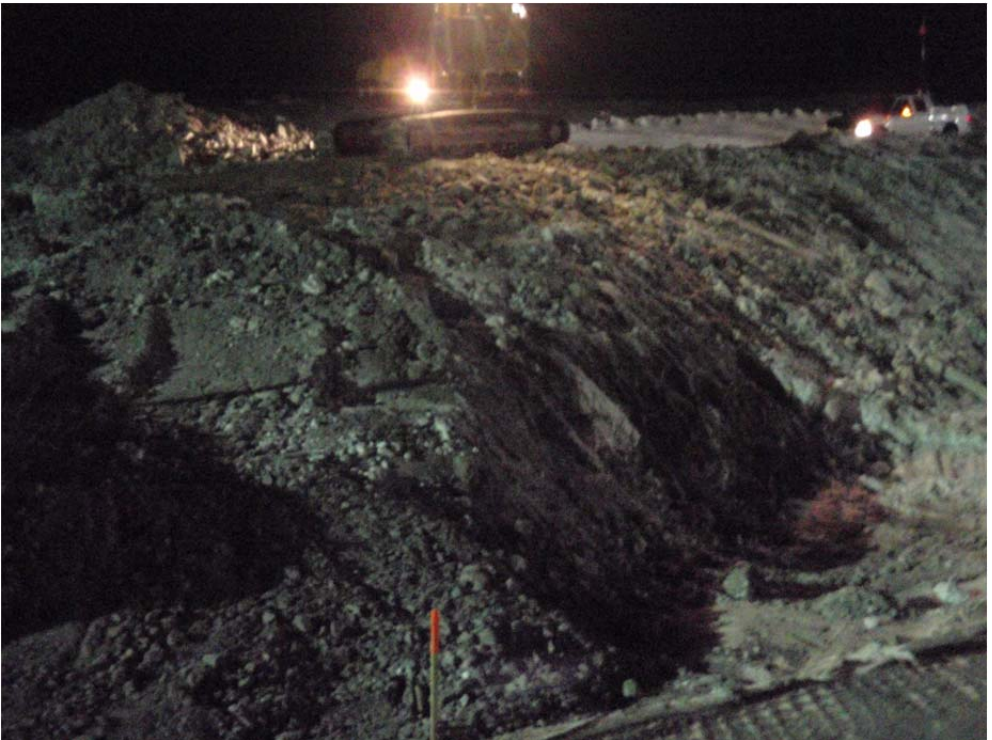
Photo 12: ~N view of excavator removing snow and debris from within the transition zone boundary, around station 0+85.

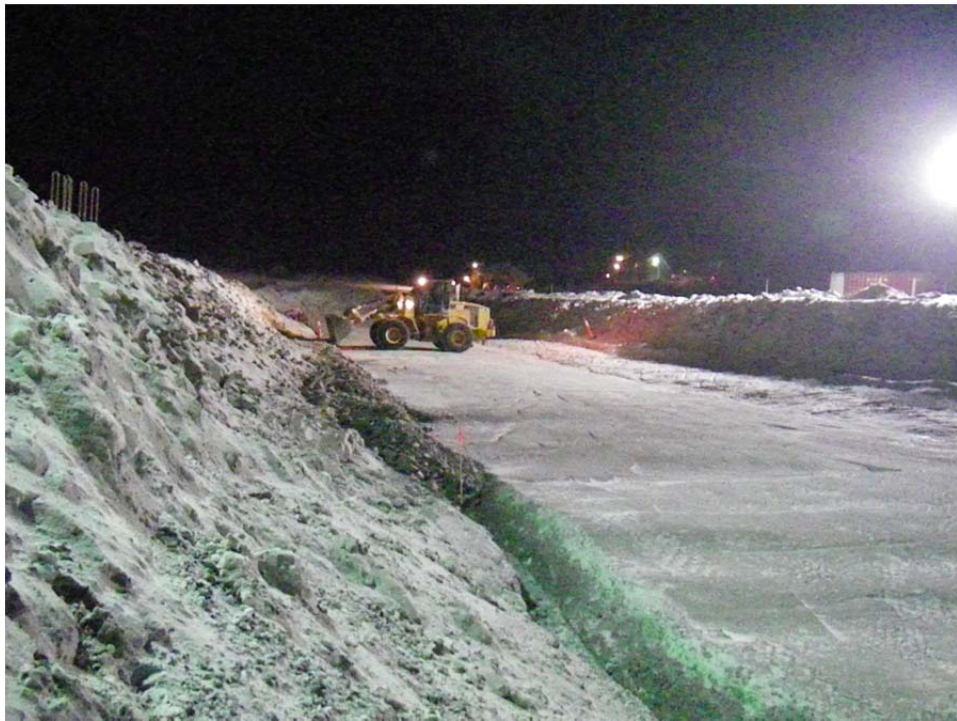
Photo 13: Loader placing transition material along the edge of the key trench. The trough in the forefront of the photo was cleaned and it is planned to be filled with core material.

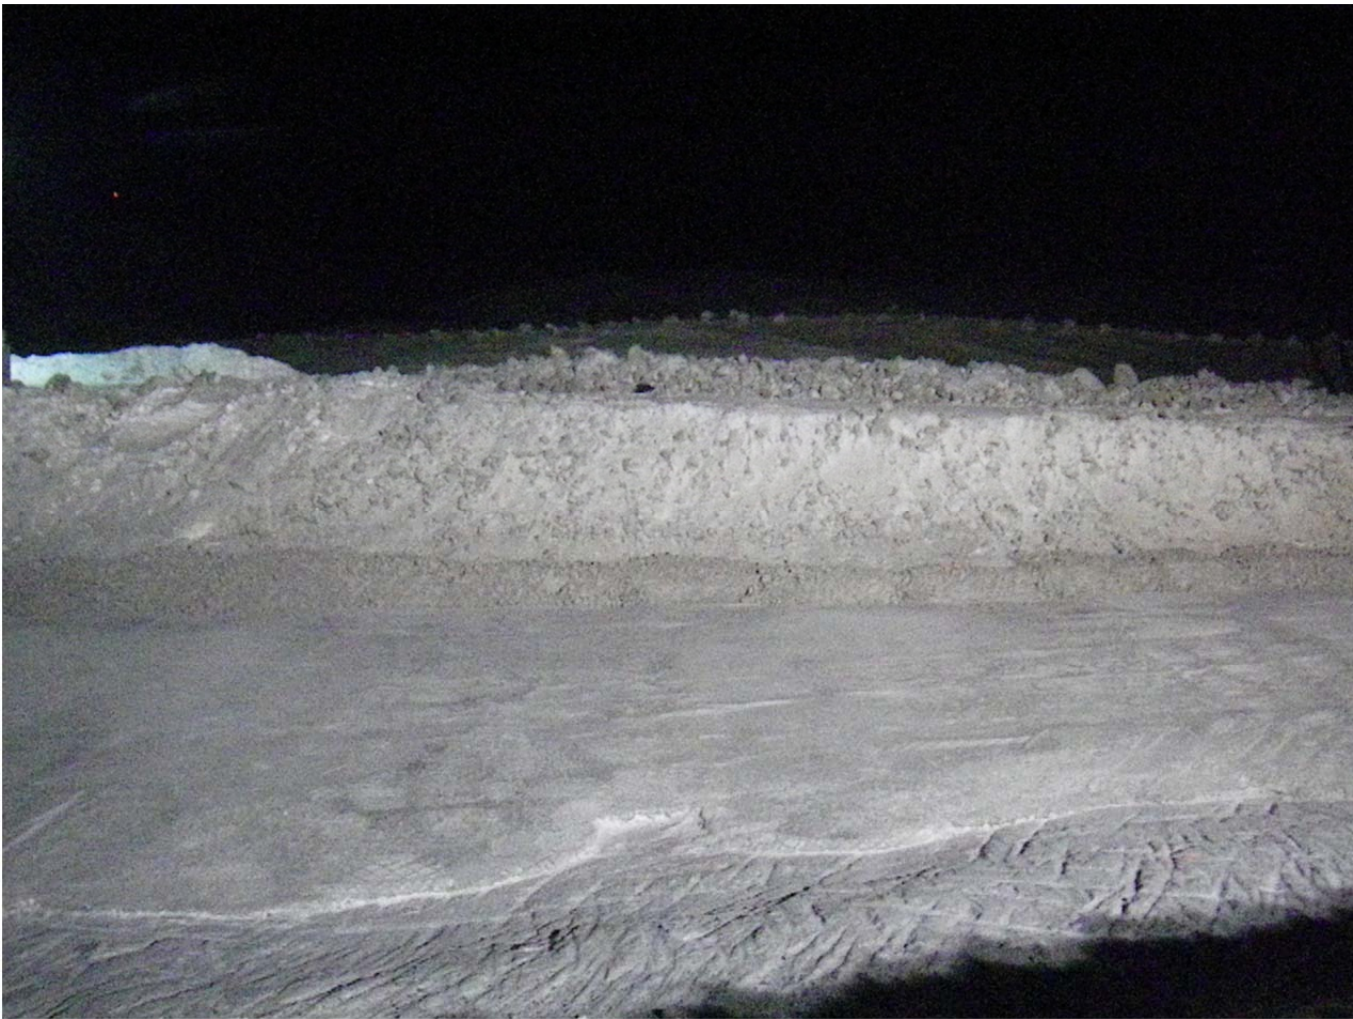
Photo 14: Transition material placed along edge of key trench.

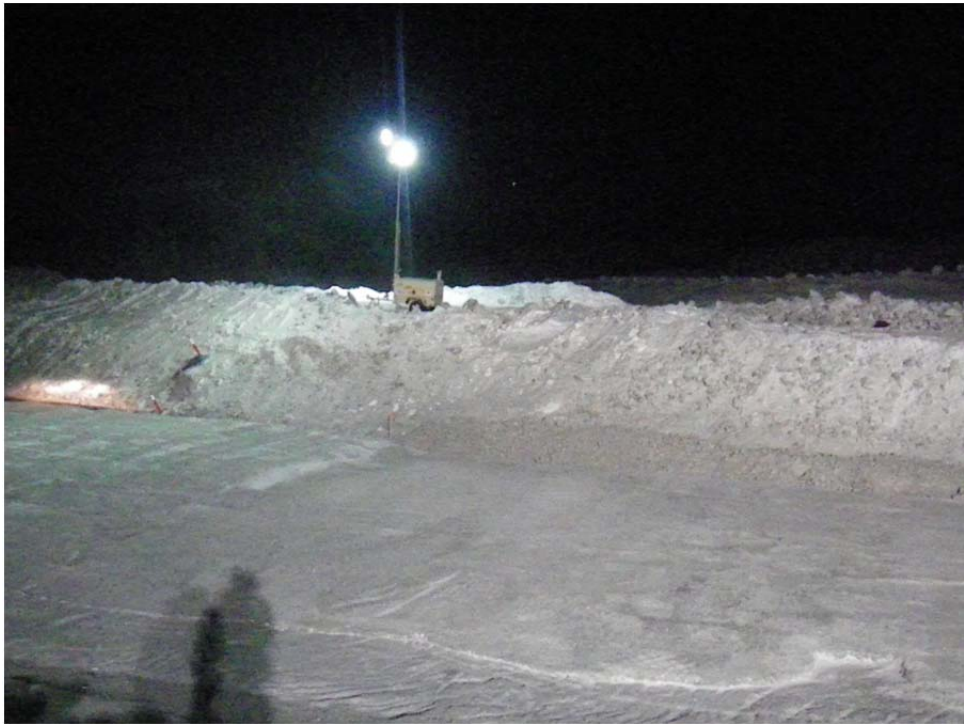
Photo 15: View of transition material placed along edge of trench

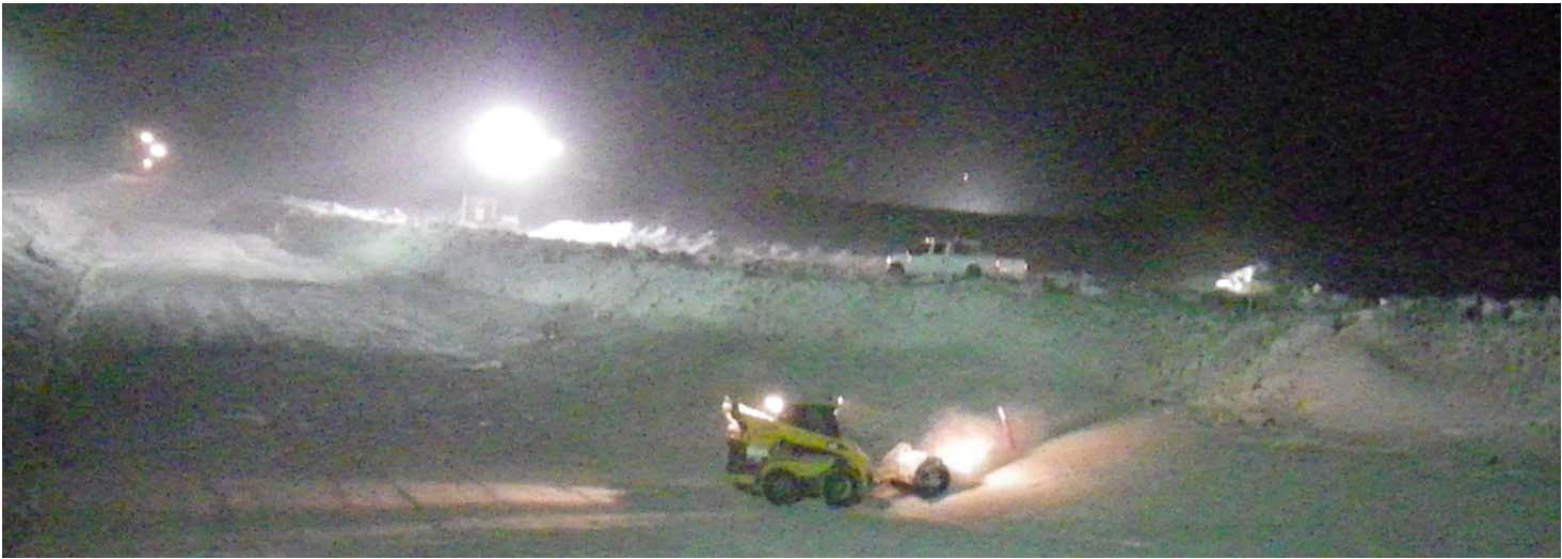
Photo 16: Skid steer with brush sweeping key trench near the end of nightshift.

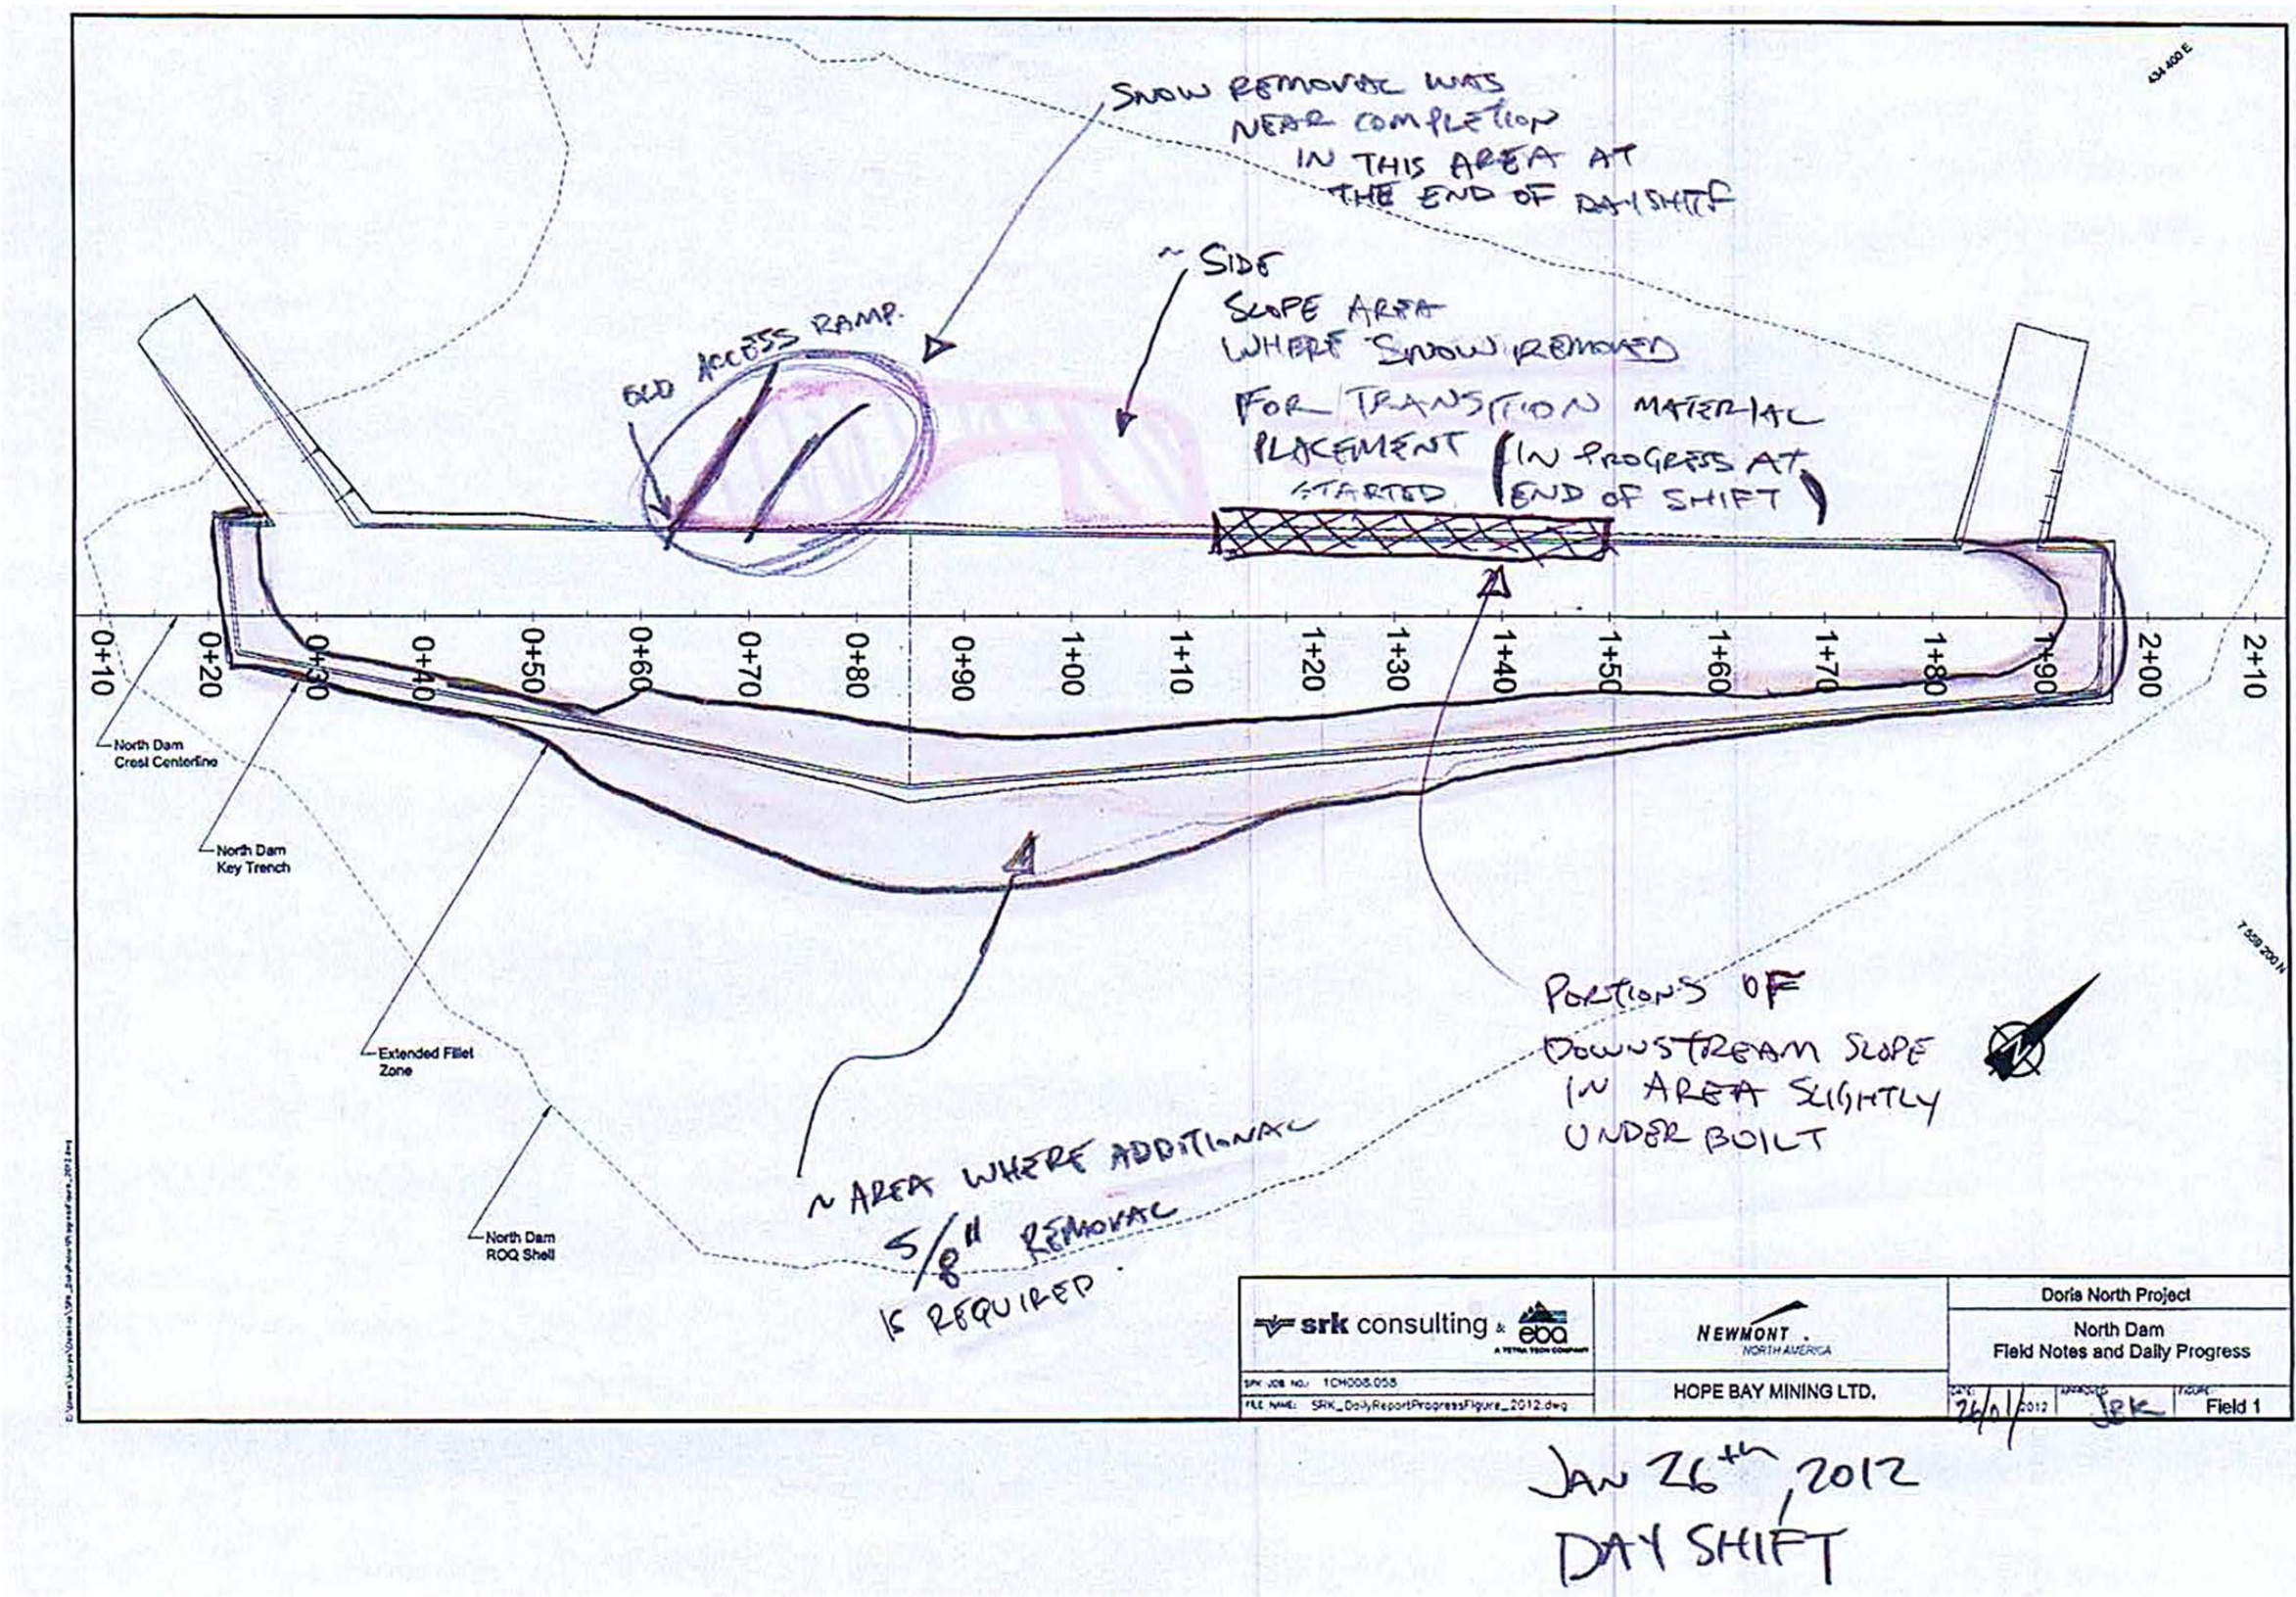
Figure 1 – North Dam Progress – Jan 26th DAYSHIFT

- Some snow removal resulted from the inside slopes neighbouring the dam core in the transition and ROQ zones. See Figure 1 and 2 for additional details.
