DAILY REPORT #21 – DORIS NORTH INFRASTRUCTURE/ NORTH DAM

Prepared by:	John Kurylo/ Jeff Orr / Megan Miller	Date:	2012.01.26
Reviewed by:		Project #:	1CH008.058.0320
Role	Company	Personnel – Position	On Site
Client	Hope Bay Mining Limited (HBML)	Angela Holzapfel – ESR Compliance Manager David Vokey – ESR Coordinator Don Ethelston – HSLP Advisor Dean Wold - Safety Jill Turk – ESR Coordinator Katsky Venter – ESR Manger – ESR Site Manager Stirling Kelly – HSLP Advisor	No Yes Yes No No In Out No
	JDS	Lloyd Jackson – Mechanical Superintendent Sven Archimowitz – Electrical Superintendent Doug Fielding – Construction Manager Ishan Fechter – Construction Coordinator Jerry Graham – Construction Manager Kevin Whieldon – Project Coordinator Michelle Tanquay Mark Valeriote – Construction Manager	In Yes Yes Out No In In
Engineering Design Consultants	SRK Consulting (Canada) Inc.	John Kurylo – Site Engineer Megan Miller – Site Engineer Lawrence Borowski – Site Engineer Murry McGregor – Site Engineer Iozsef Miskolczi – Site Engineer	Yes Yes No No No

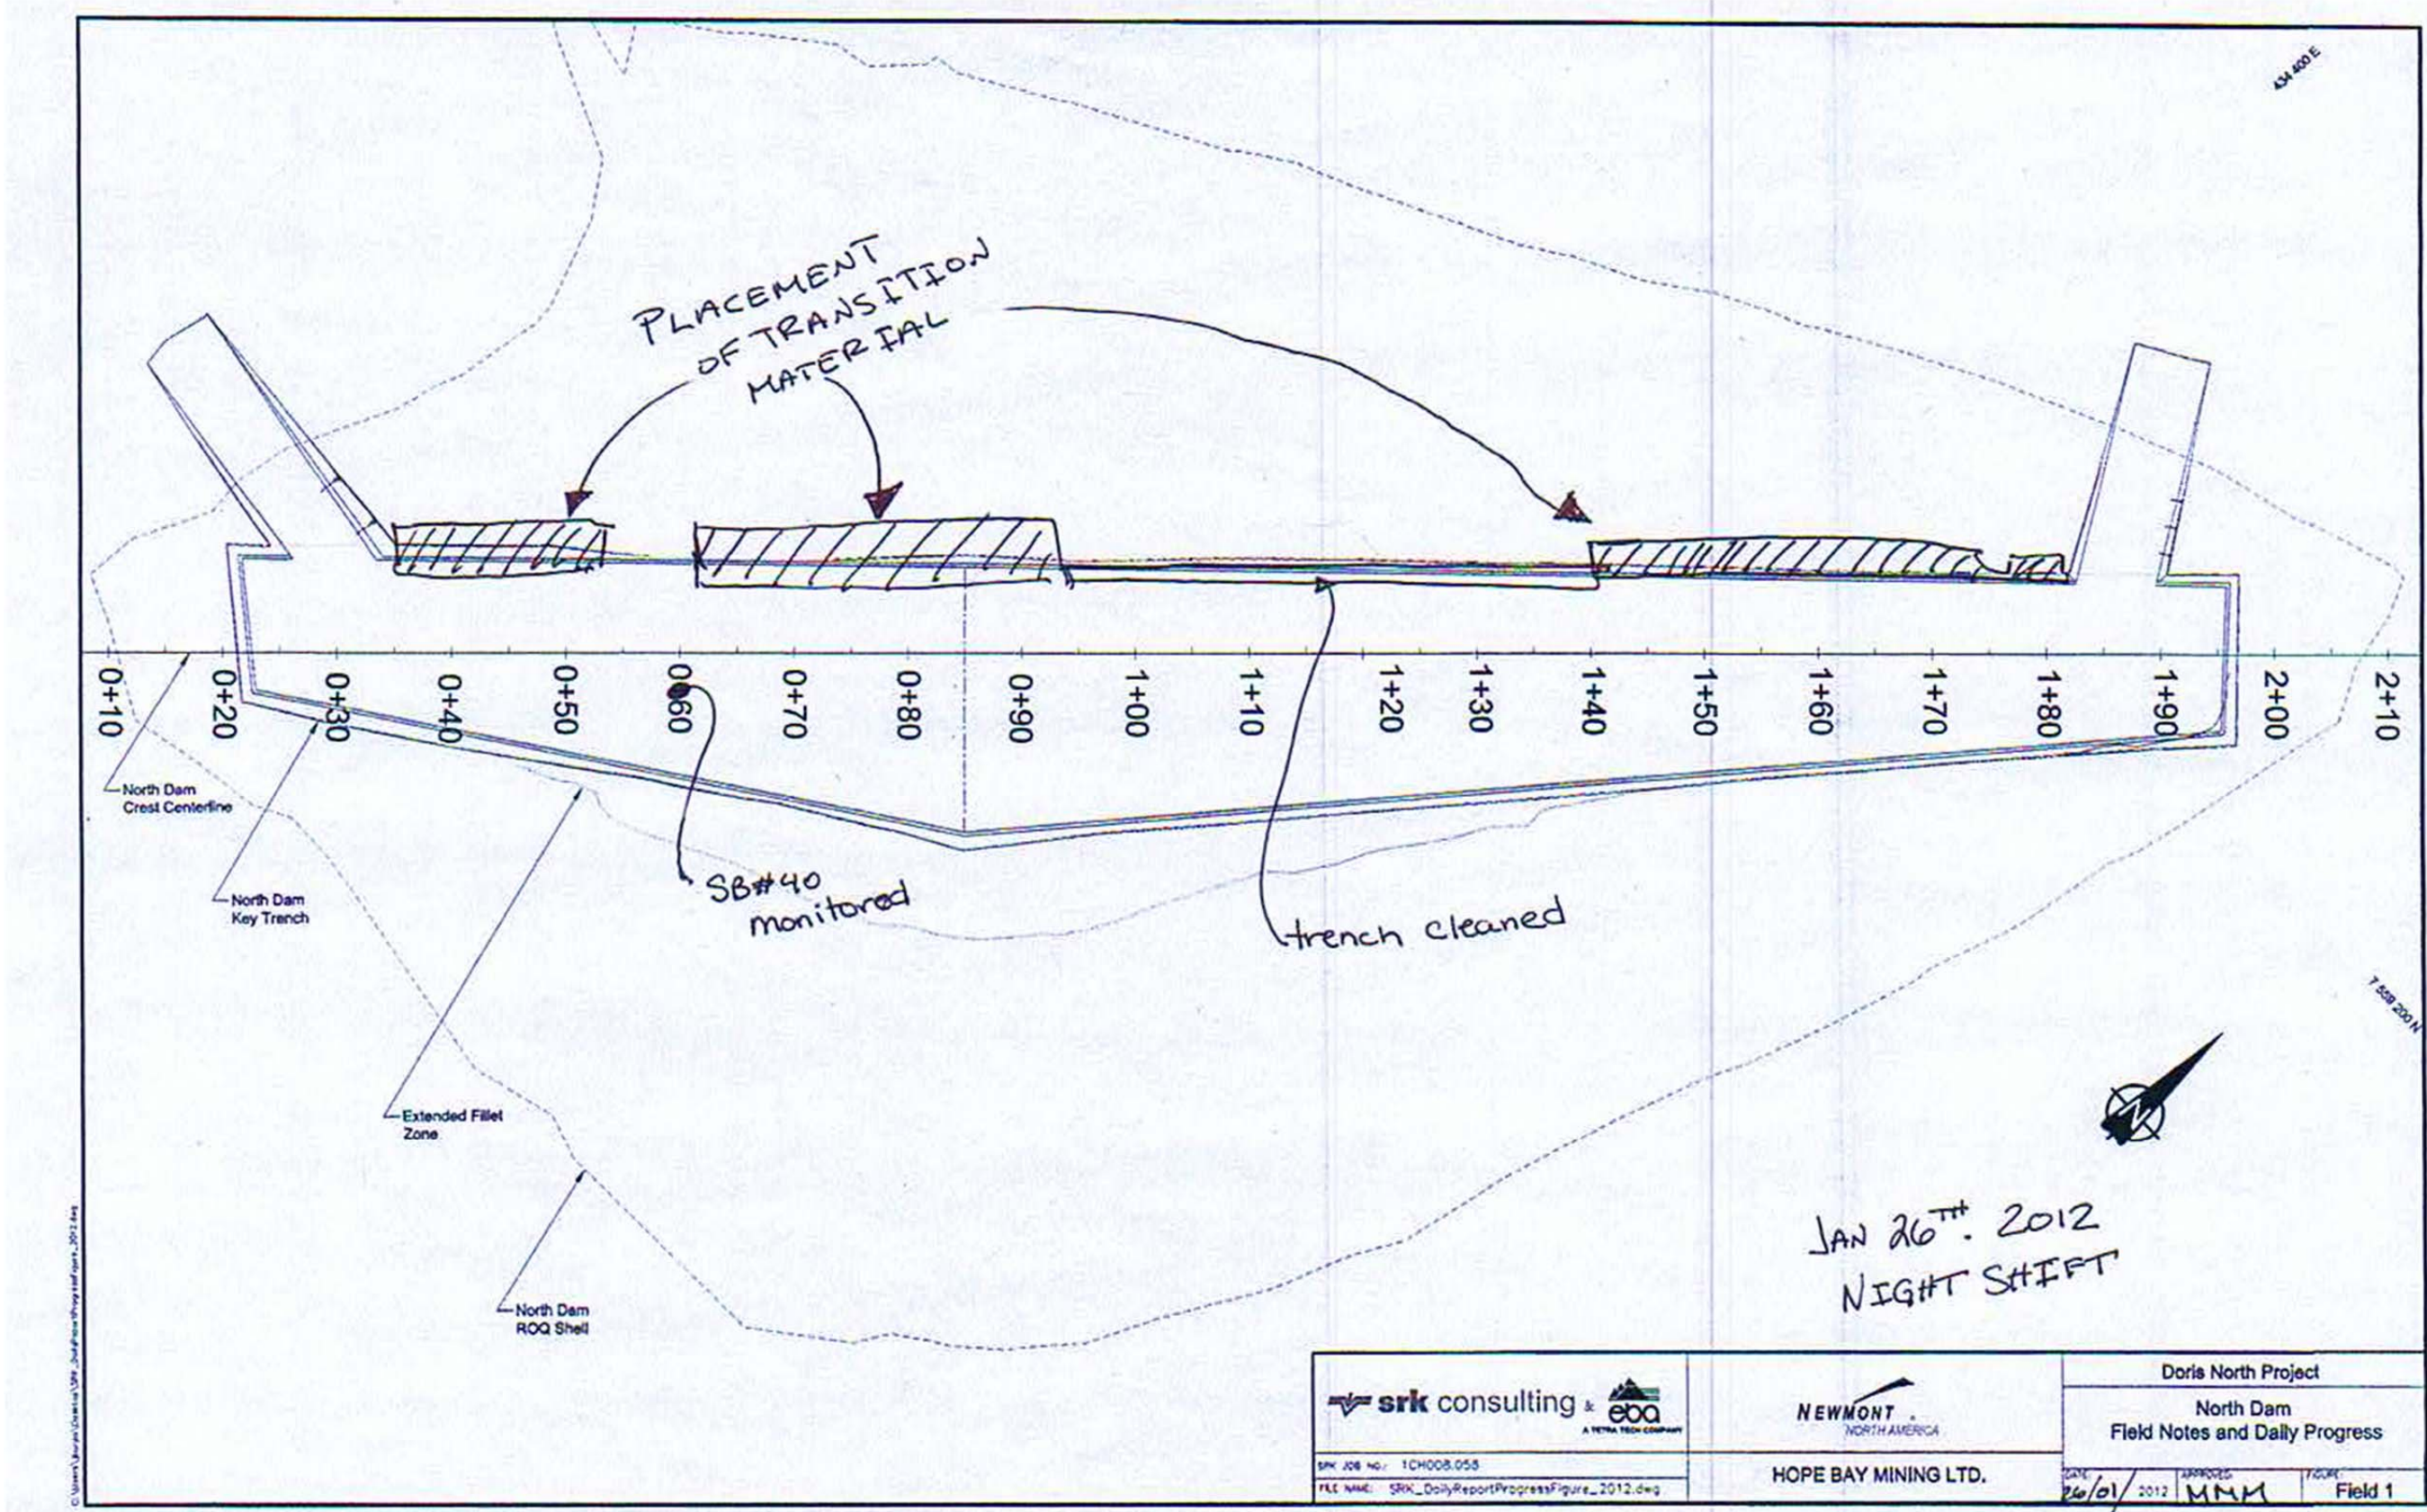
Figure 2 – North Dam Progress – Jan 26th NIGHTSHIFT

- No core material was placed on nightshift.
- Transition material was placed and compacted along the edge of the trench from approximately Sta. 1+40 to 1+75, 0+60 to 0+95 and 0+50 to 0+40.
