DAILY REPORT #22 – DORIS NORTH INFRASTRUCTURE/ NORTH DAM

Prepared by:	John Kurylo/ Jeff Orr / Megan Miller	Date:	2012.01.27
Reviewed by:		Project #:	1CH008.058.0320
Role	Company	Personnel – Position	On Site
Client	Hope Bay Mining Limited (HBML)	Angela Holzapfel – ESR Compliance Manager David Vokey – ESR Coordinator Don Ethelston – HSLP Advisor Dean Wold - Safety Jill Turk – ESR Coordinator Katsky Venter – ESR Manger Michelle Tanquay – ESR Site Manager Stirling Kelly – HSLP Advisor	No Yes Yes No No Yes No No
	JDS	Lloyd Jackson – Mechanical Superintendent Sven Archimowtiz – Electrical Superintendent Doug Fielding – Construction Manager Ishan Fechter – Construction Coordinator Jerry Graham – Construction Manager Kevin Whieldon – Project Coordinator Mark Valeriote – Construction Manager	Yes Yes Yes No No Yes Yes
Engineering Design Consultants	SRK Consulting (Canada) Inc.	John Kurylo – Site Engineer Megan Miller – Site Engineer Lawrence Borowski – Site Engineer Murry McGregor – Site Engineer Iozsef Miskolczi – Site Engineer	Yes Yes No No No

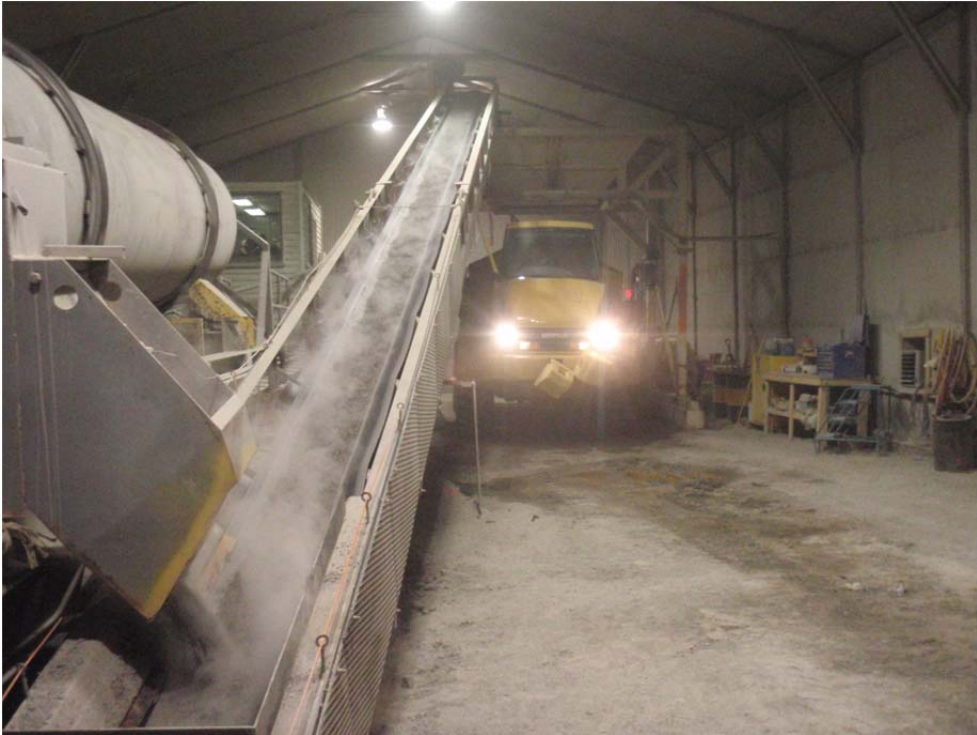
- The FCP started up at~ 9:00am today.
 - FCM temperatures leaving the FCP chute ranged from ~ 34 to 42°C today.
 - Around 16:30 the loader when down and the plant was run out. The last load was sent down to the dam around 17:15.

Photo 1: View of FCM exiting the FCP chute on dayshift. Note the steam coming off the now hotter (30+°C) material.

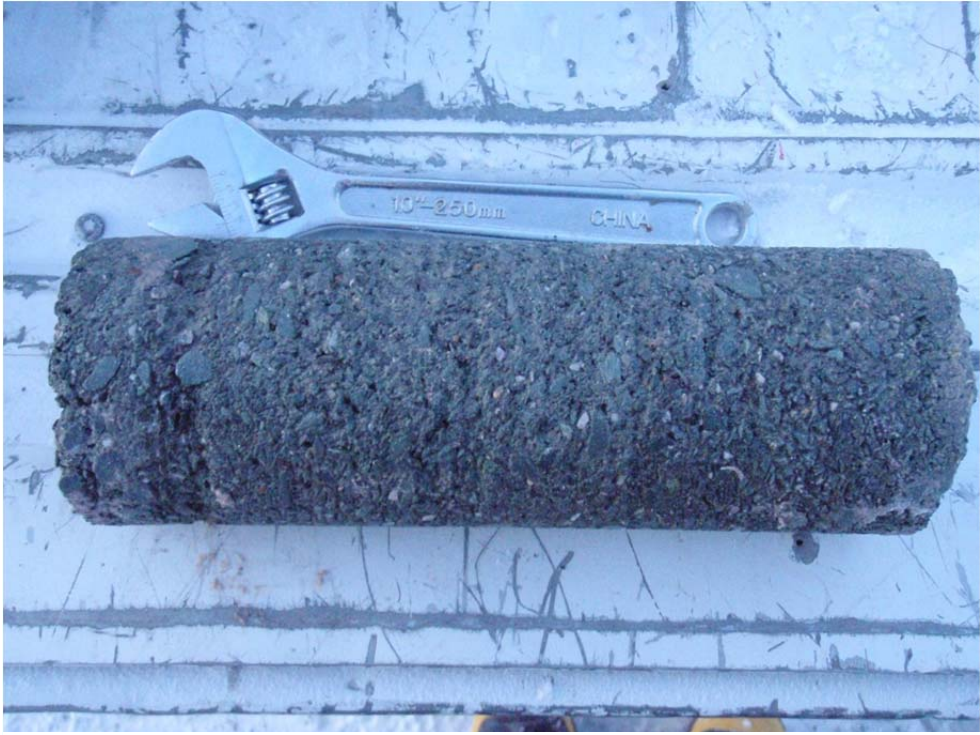
- Two cores were taken/ drilled on dayshift. Both cores exhibited good drill recovery/ quality.

- Drilled Core 8 (HB12-ND-CORE-DC8-QA-20120127) was taken from 1+60 on the downstream of the key
- Drilled Core 9 (HB12-ND-CORE-DC9-QA-20120127) was taken from 0+55 on the upstream of the key trench.

Photo 2: Drilled Core 8 (HB12-ND-CORE-DC8-QA-20120127) taken from 1+60 DS in the key trench.

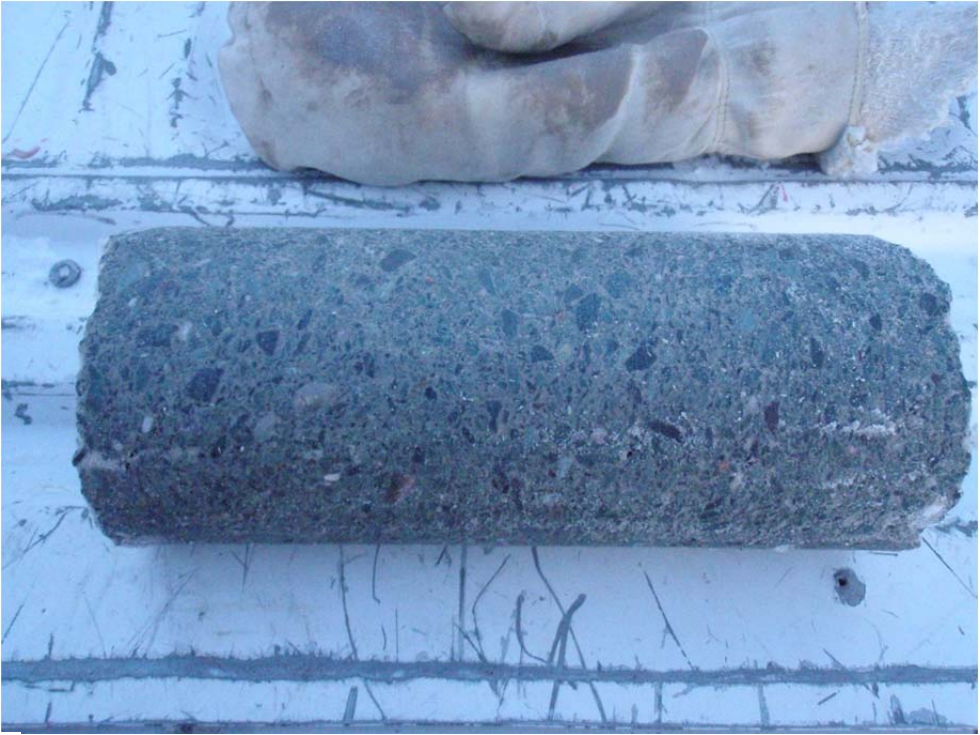
Photo 3: Drilled Core 9 (HB12-ND-CORE-DC9-QA-20120127) taken from 0+55 US in the key trench.

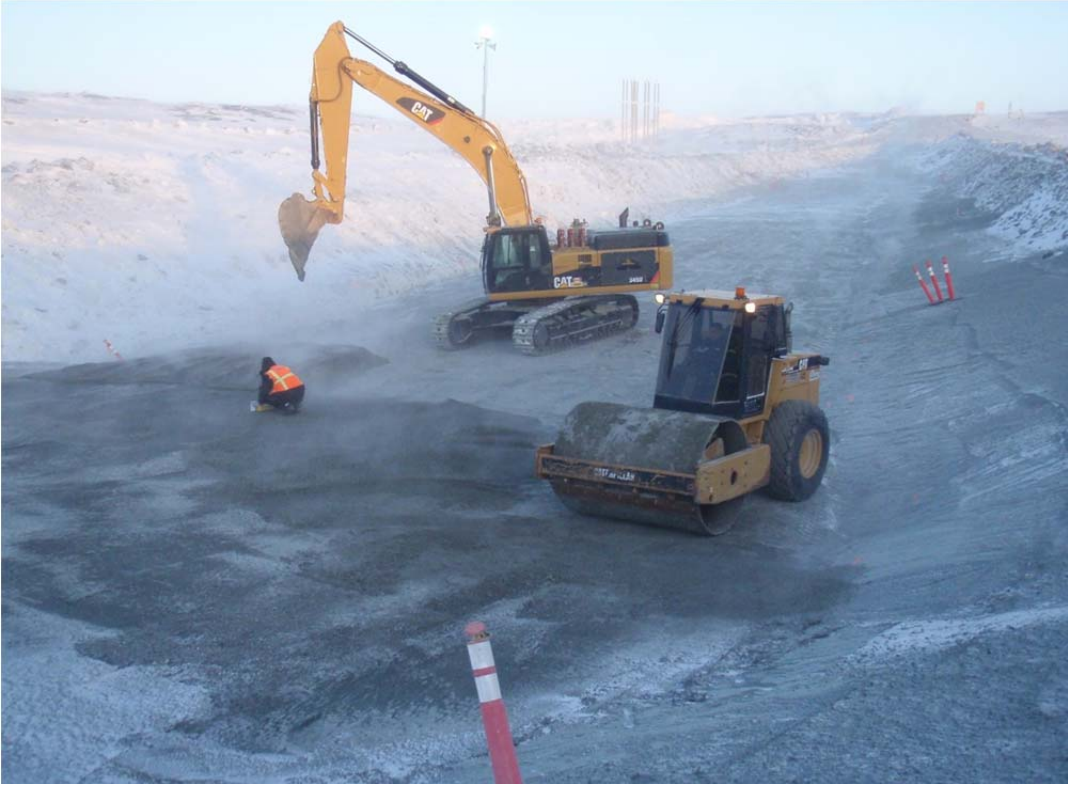
Photo 4: ~NNE view of FCM placement progress around station 0+90.

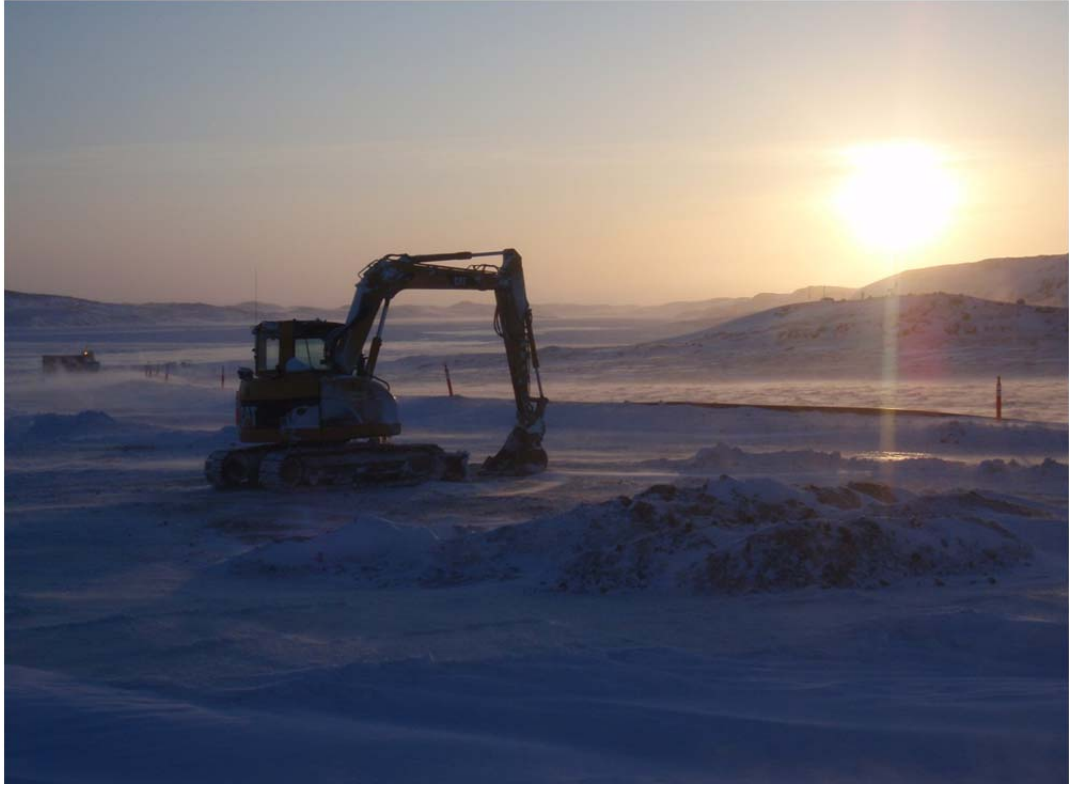
Photo 5: ~ESE view of 308 excavator mobilized to the Sump 2 location.

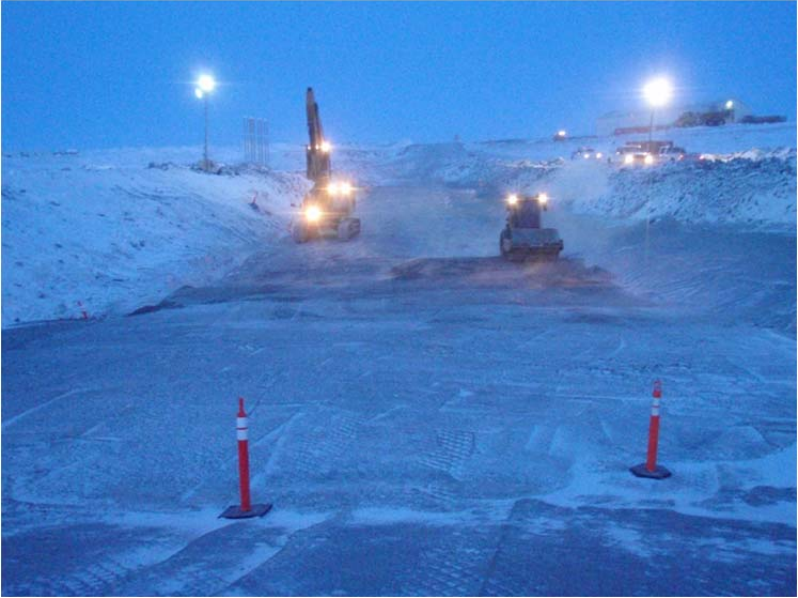
Photo 6: ~ENE view of FCM placement around station 1+10. The delineators in the forefront of the photo mark the area where FCM placement started on dayshift.

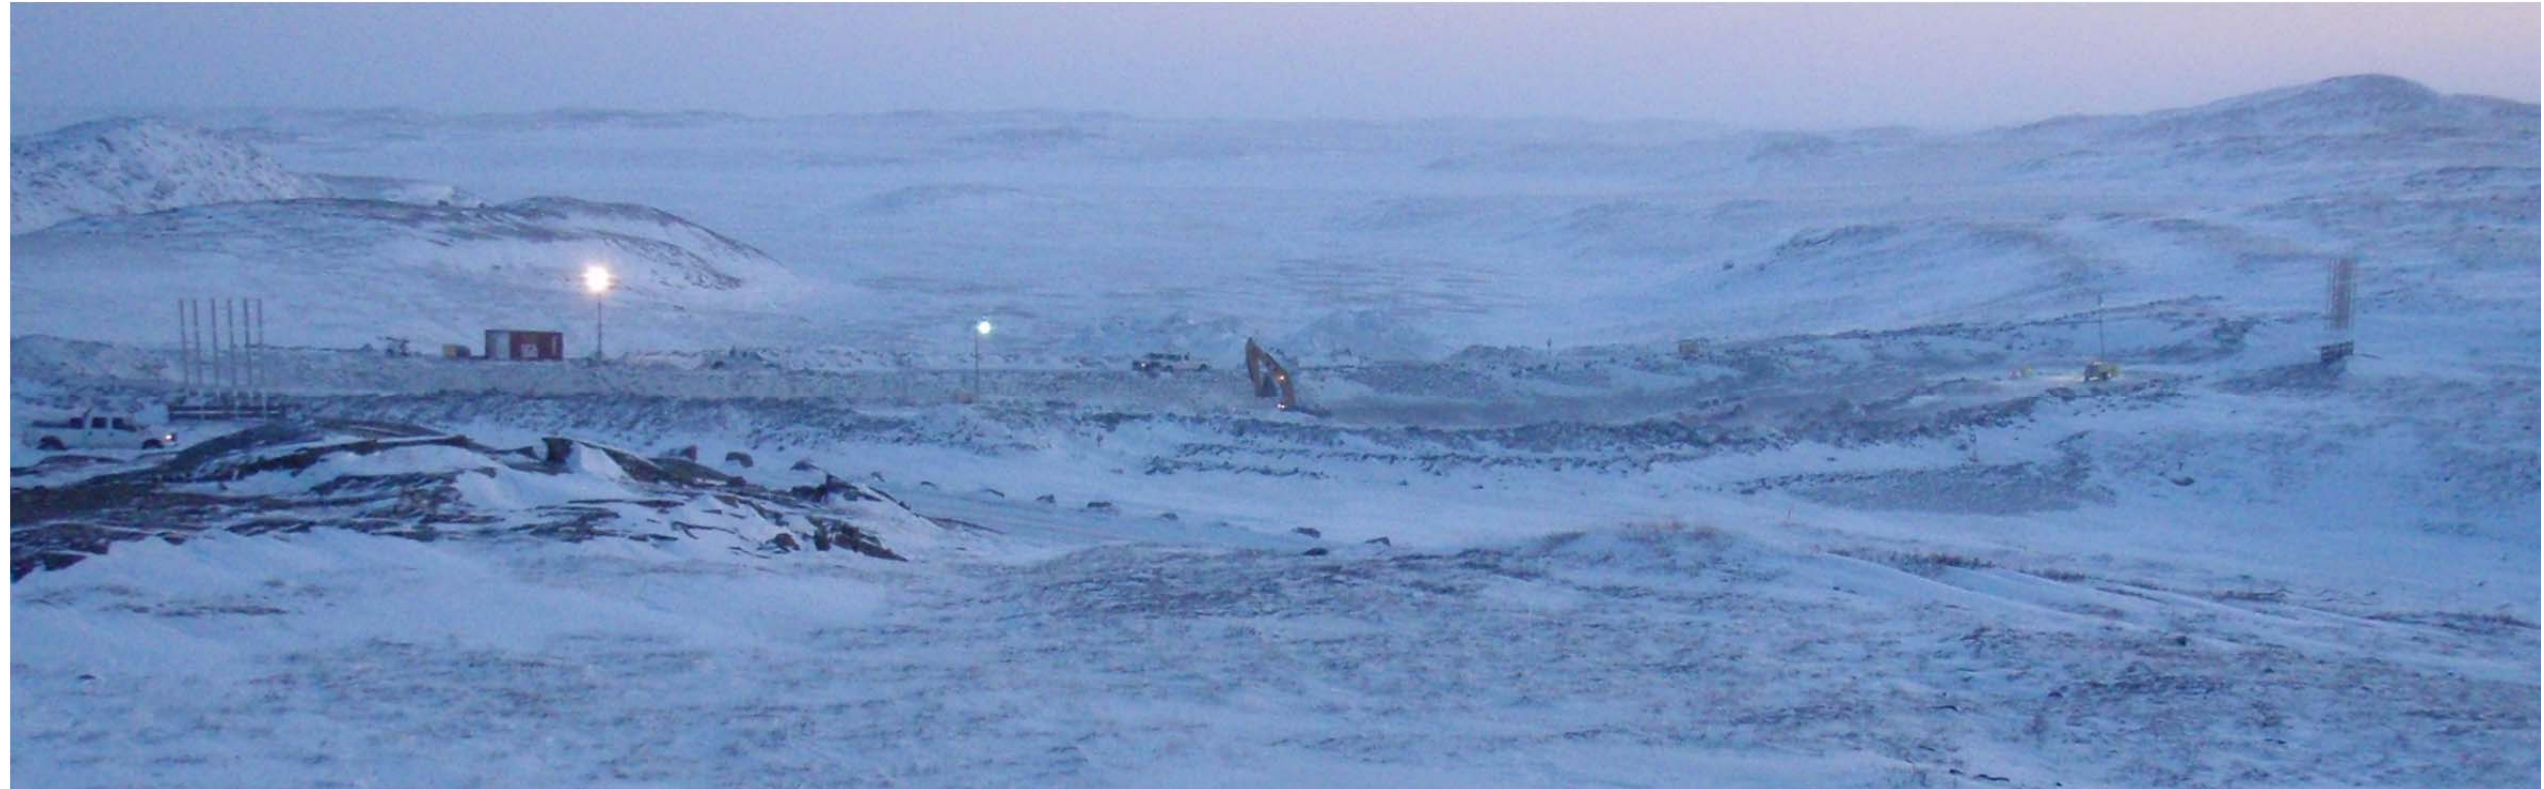
Photo 7: Progress photo of North Dam from photo point 1. ~SW view.

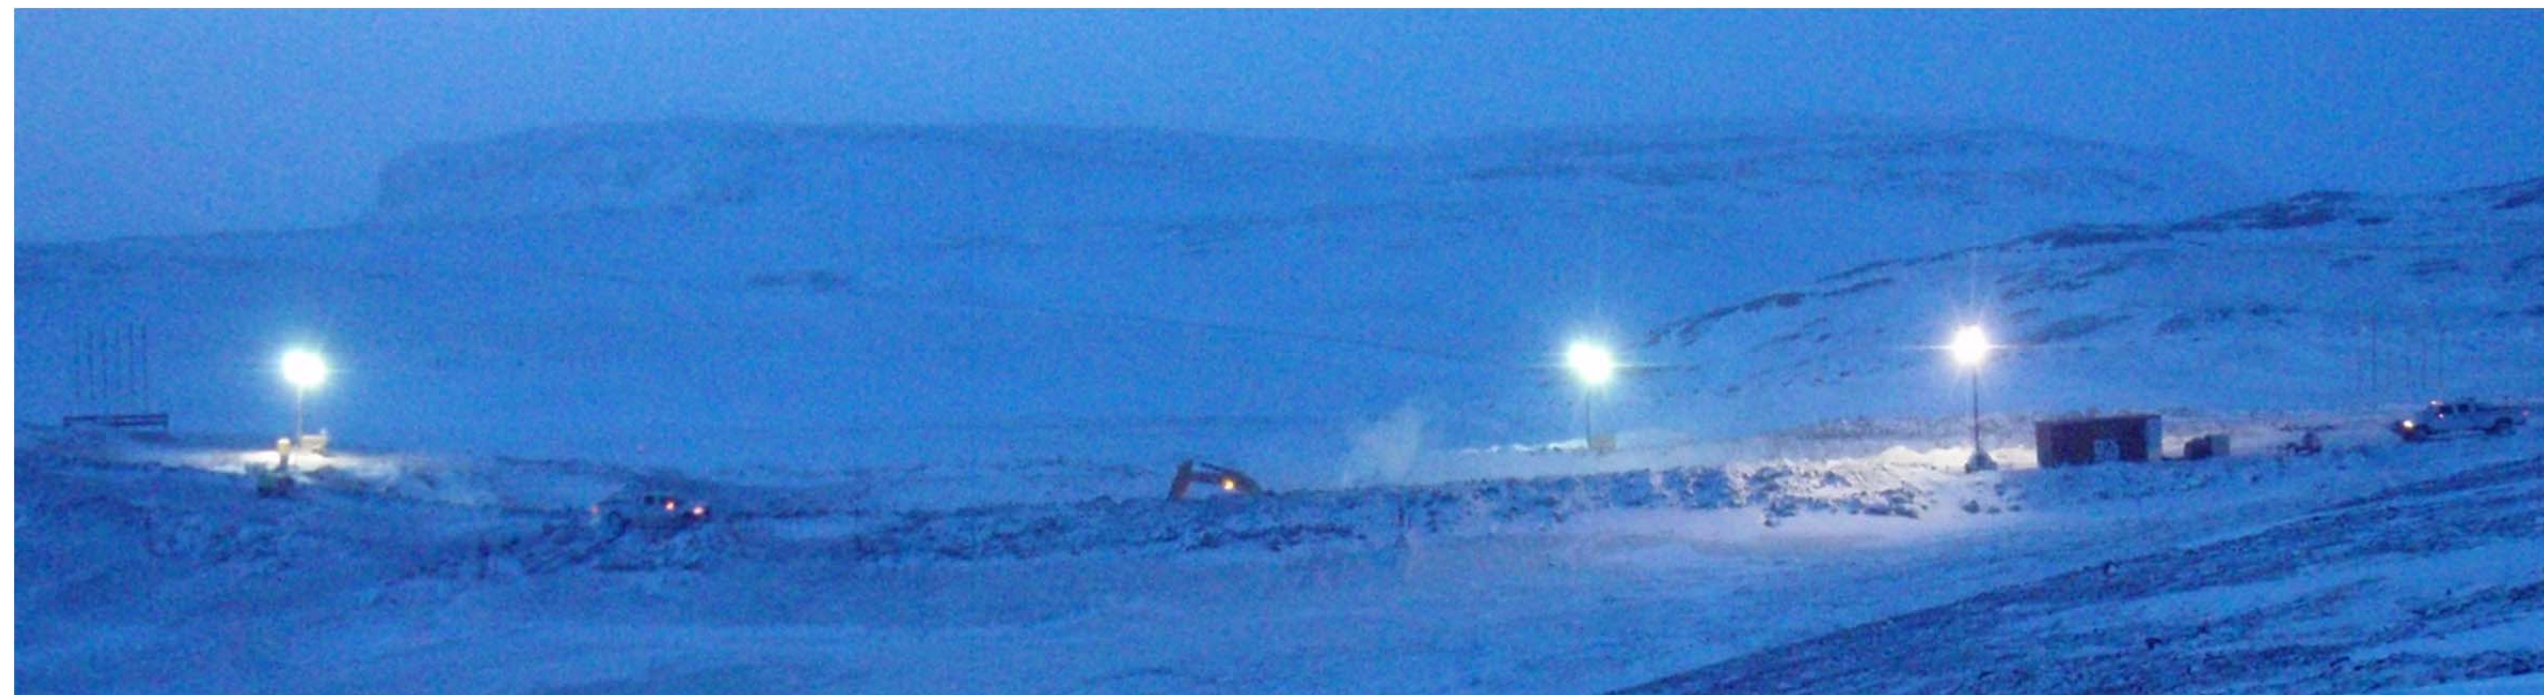
Photo 8: Progress photo of North Dam from photo point 2. ~WNW view.

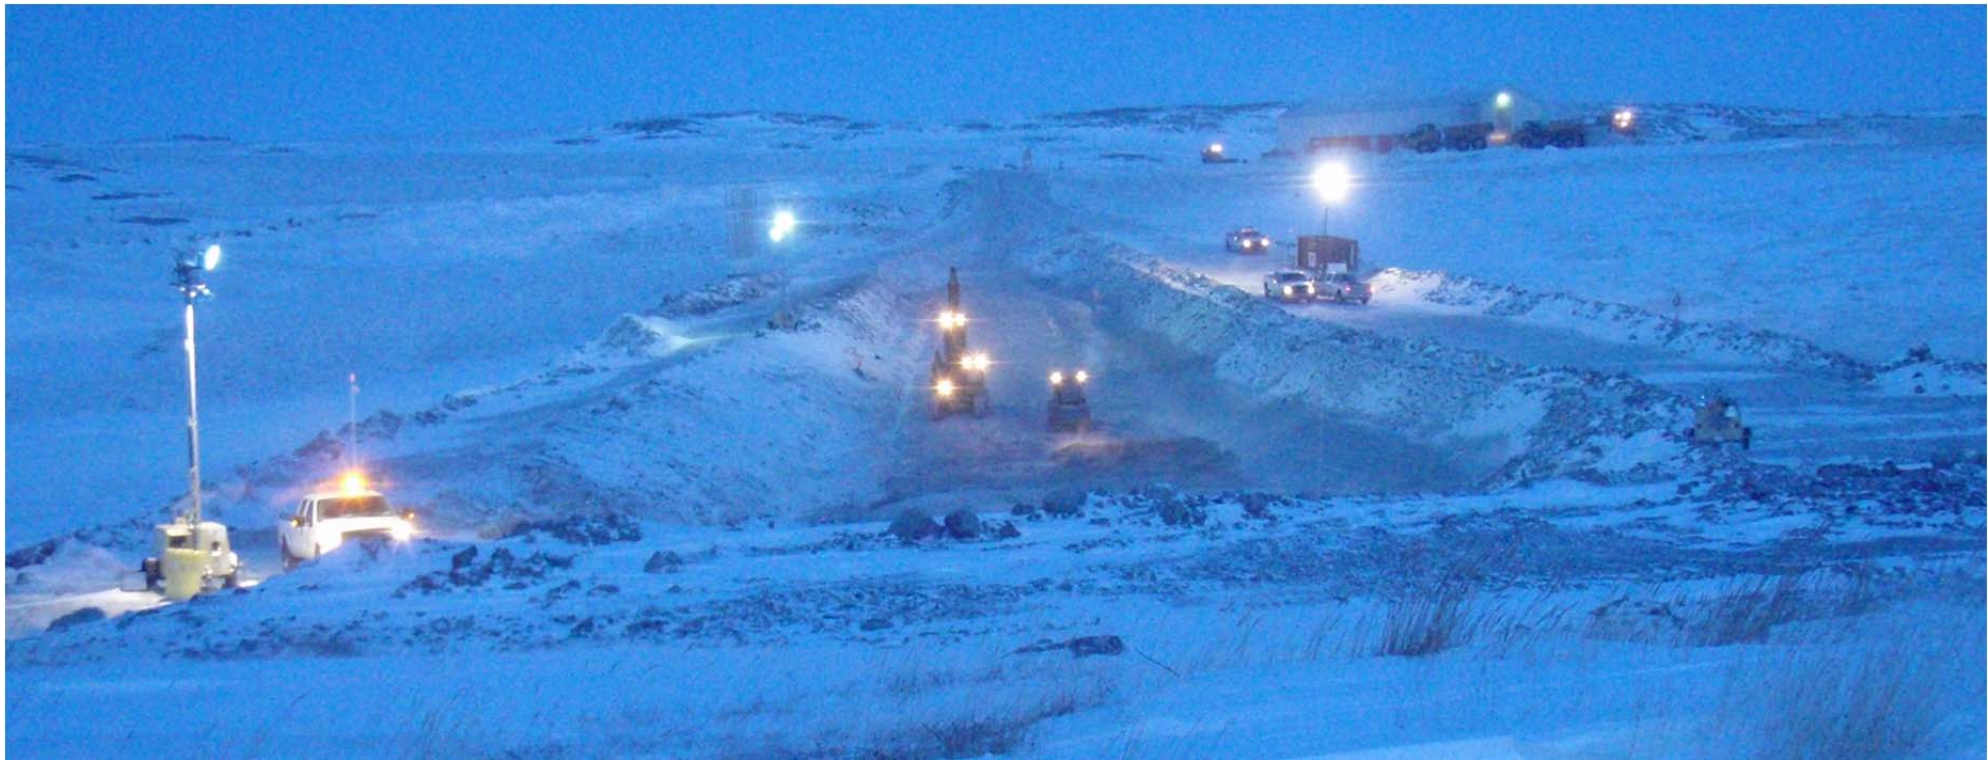
Photo 9: Progress photo of North Dam from photo point 3. ~ENE view.

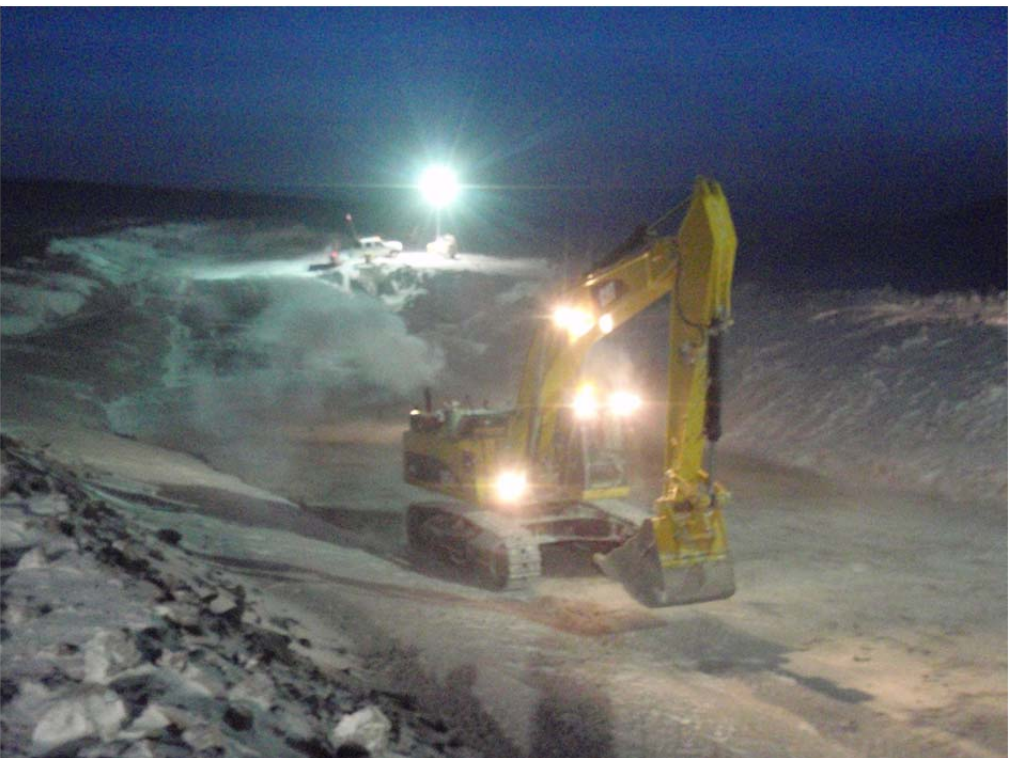
Photo 13: View of 345 excavator waiting for final load (around station 1+20) at the end of dayshift.

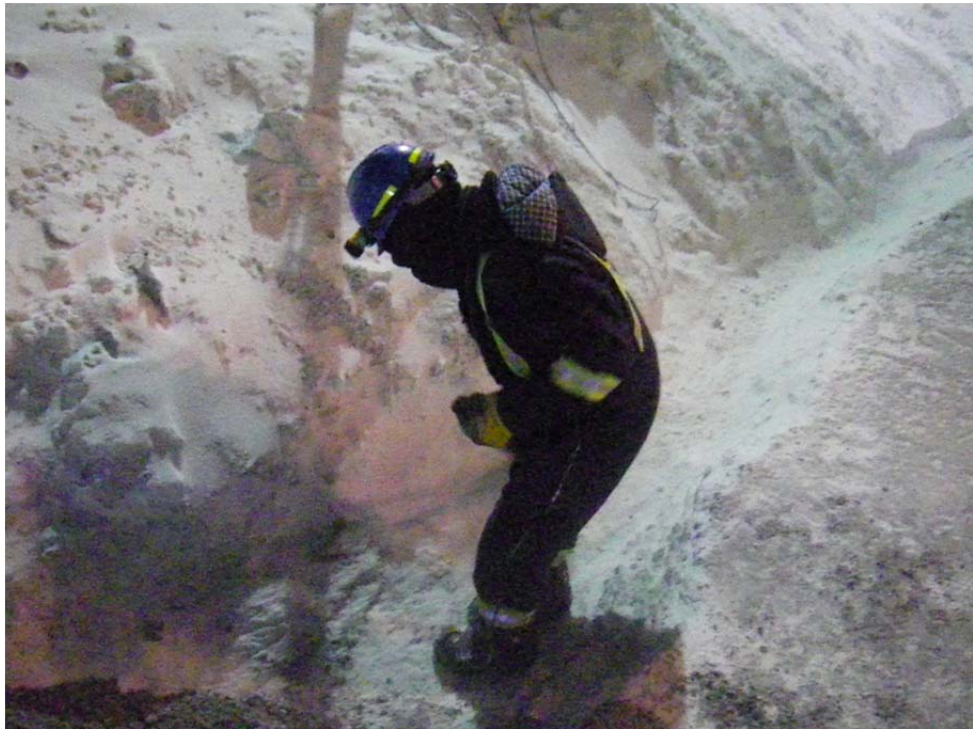
- At the beginning of shift the areas where snow had accumulated were swept with the broom on the skid steer from 1+20 north east.
- Labourers used brooms and shovels to clean snow from the trough along the downstream slope. Cleaning was done throughout the night prior to material placement as the trough kept filling with snow.

Photo 11: Labourer cleaning snow from the trough along the downstream side of the key trench.

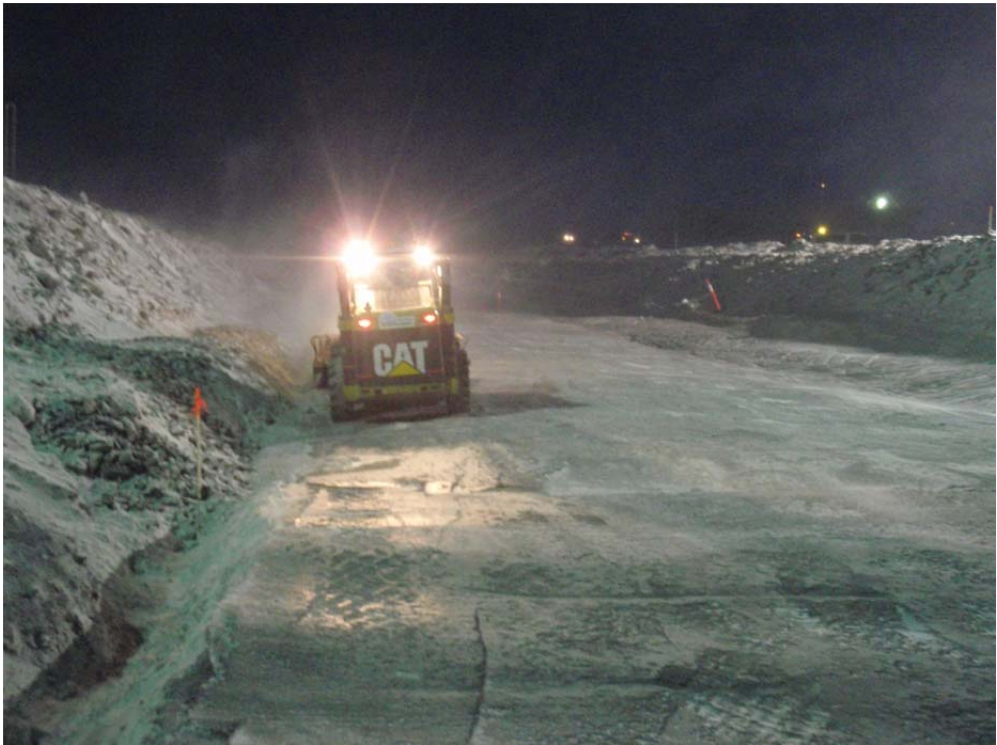
Photo 12: Skid steer with brush cleaning edge of transition material on the downstream edge of the key trench.

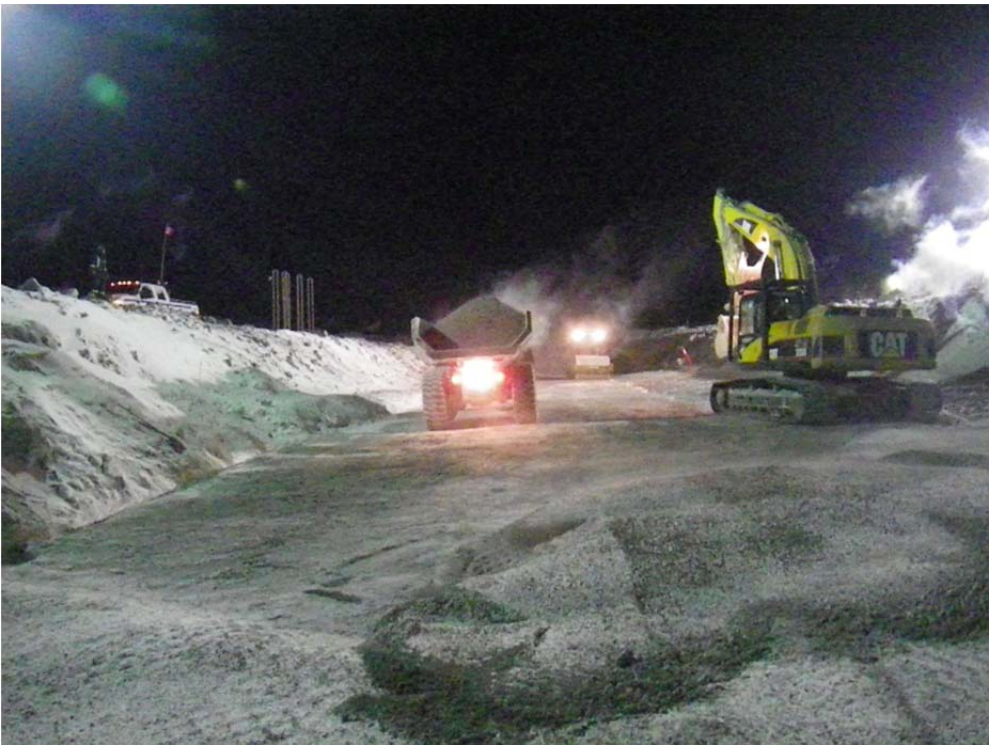
Photo 13: CAT 730 haul truck backing in with load of FCM on nightshift.

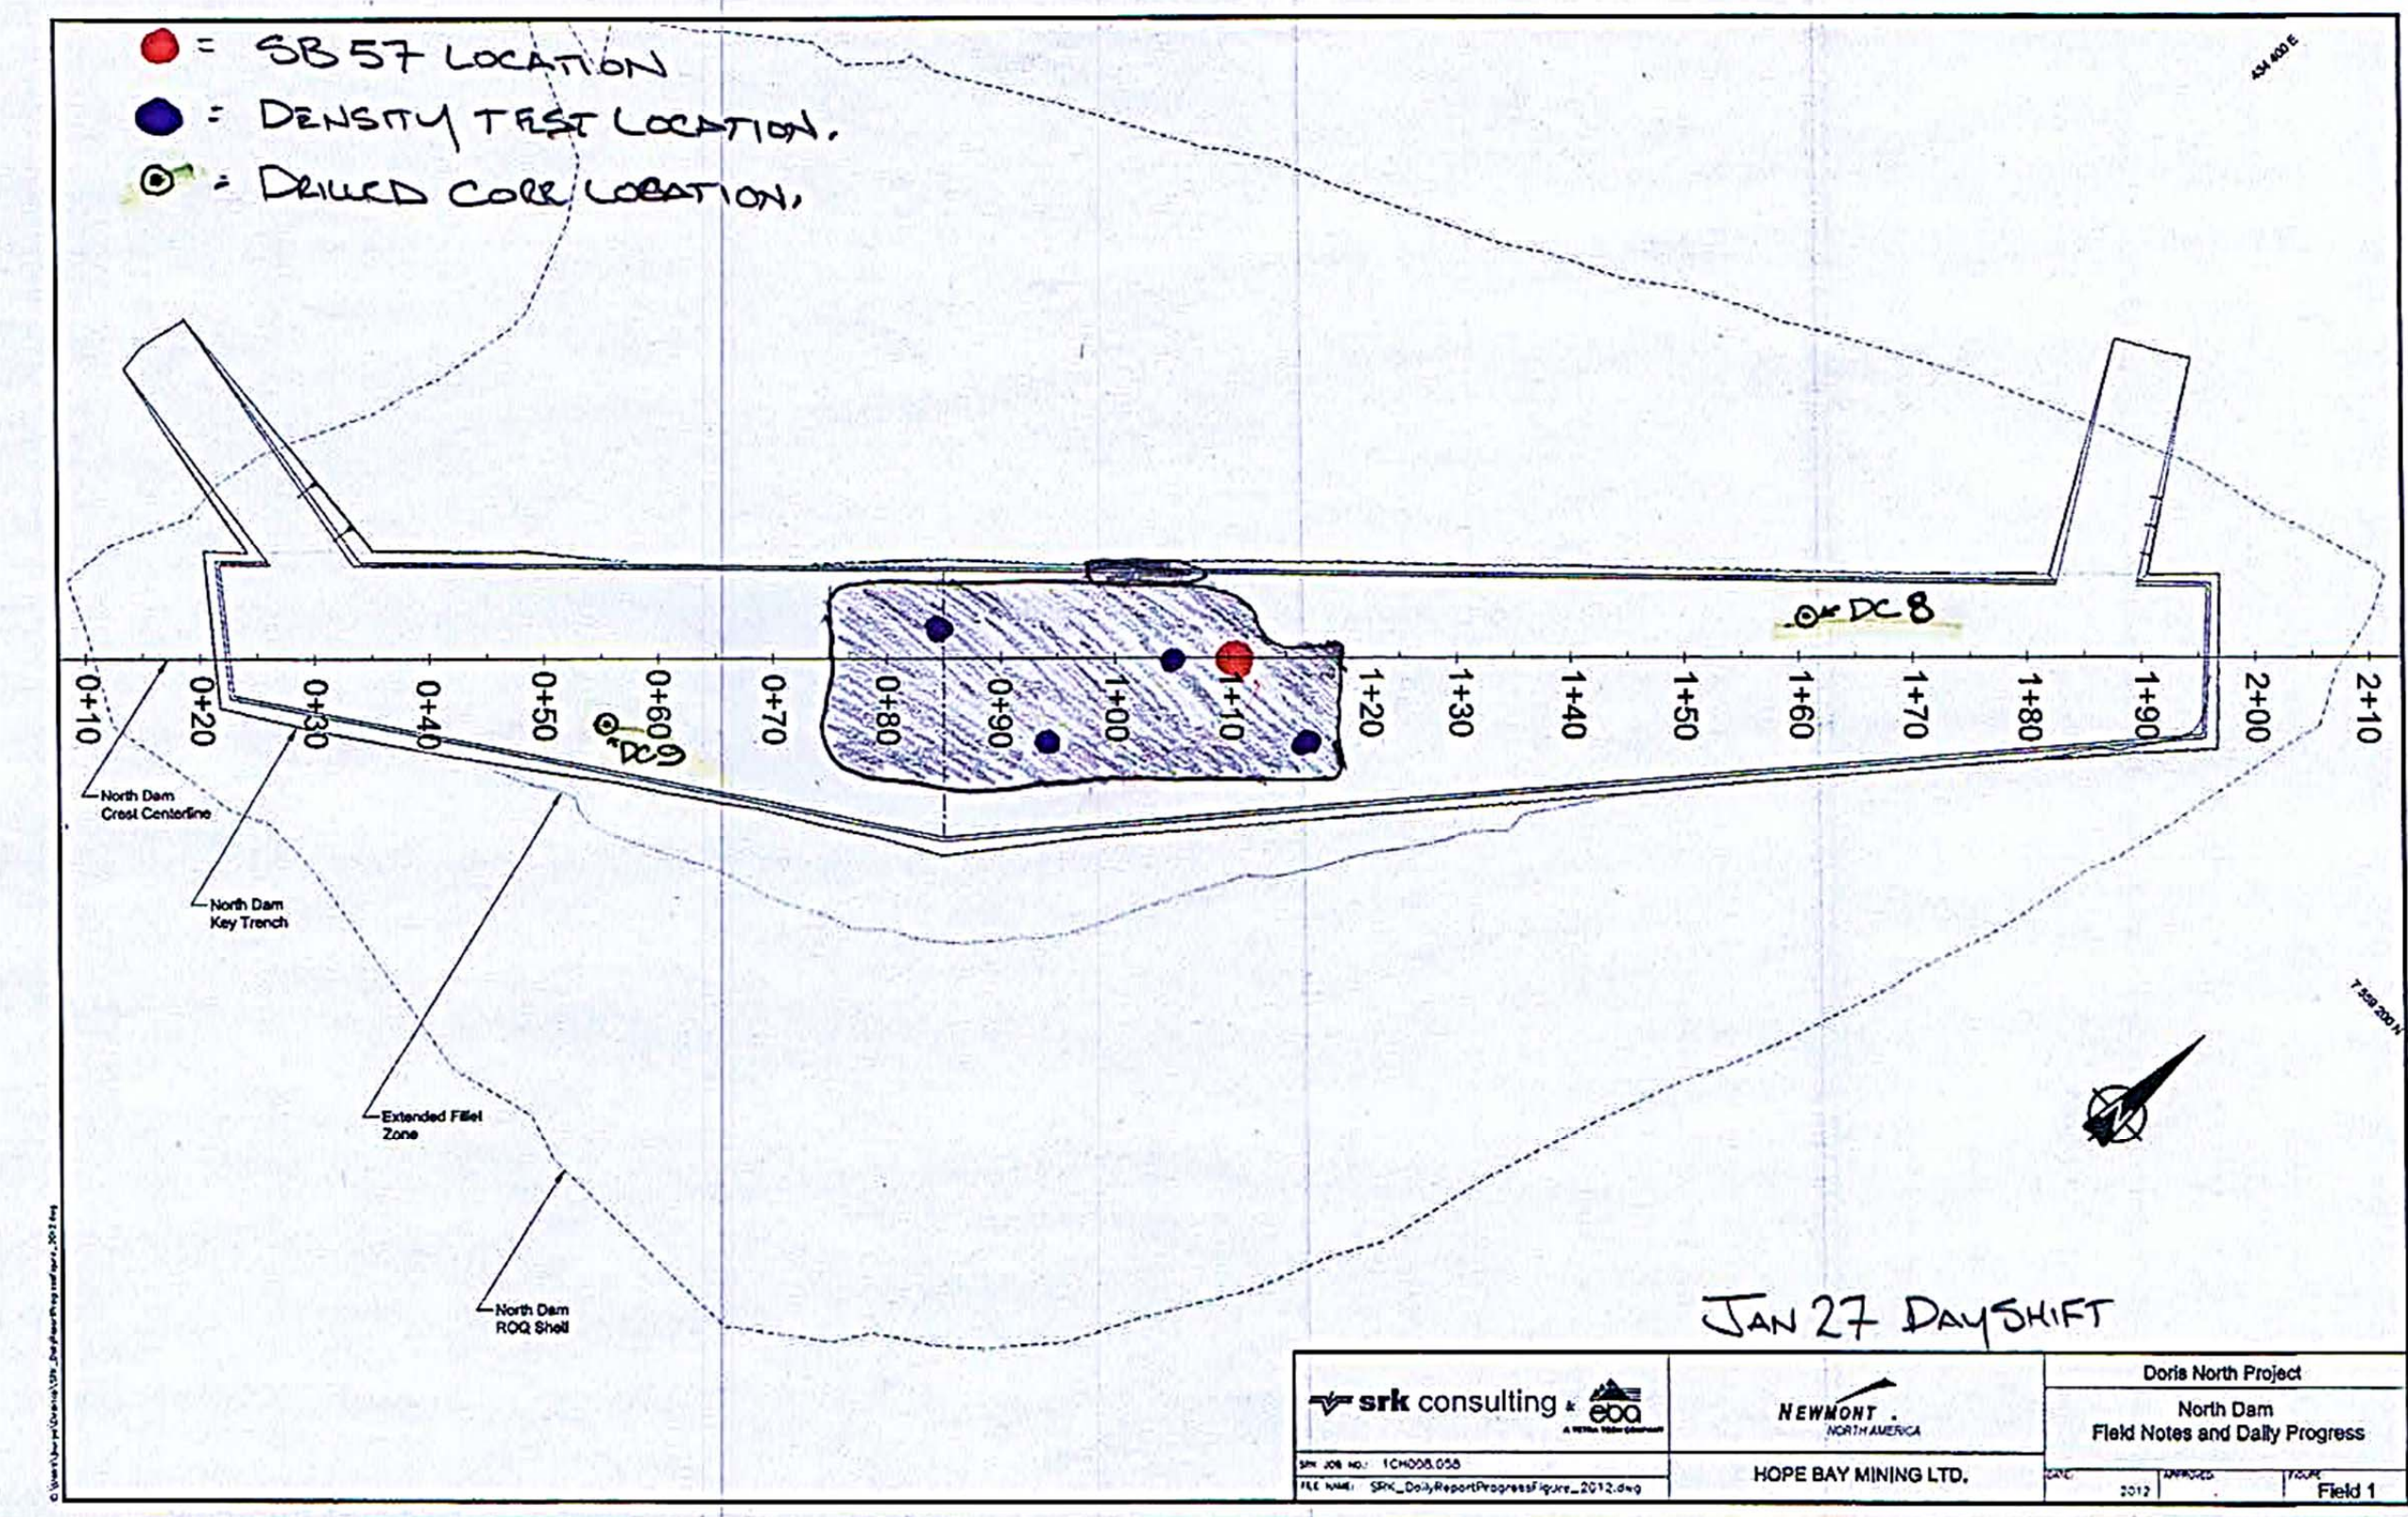
Figure 1 – North Dam Progress – Jan 27th DAYSHIFT

- Cleaning resulted on dayshift around 0+40 to 1+85 on dayshift (most of the cleaning effort was focused around 0+70 to 1+160).
 - Due to blowing snow conditions, additional cleaning was periodically required along the downstream edge of the keytrench.
- FCM placement resulted today from ~ 0+75 to 1+20.
 - 22 (730 haul truck) loads of material were placed at the dam on dayshift today.
 - This is approximately the 4th lift that has been placed around this area since 2012 construction activities recommenced.
- It was decided that the area where the downstream slope will be overbuilt (from ~ 0+95 to 1+40 see

daily report #22 for details) would be allowed (one time allowance) to be placed in a slightly thicker lift (less than 0.5m, typically closer to 0.4m), as this area is outside of the IFC design limits/ lines. Additional vibratory compaction effort was completed on these sections, at the request of SRK/ EBA.

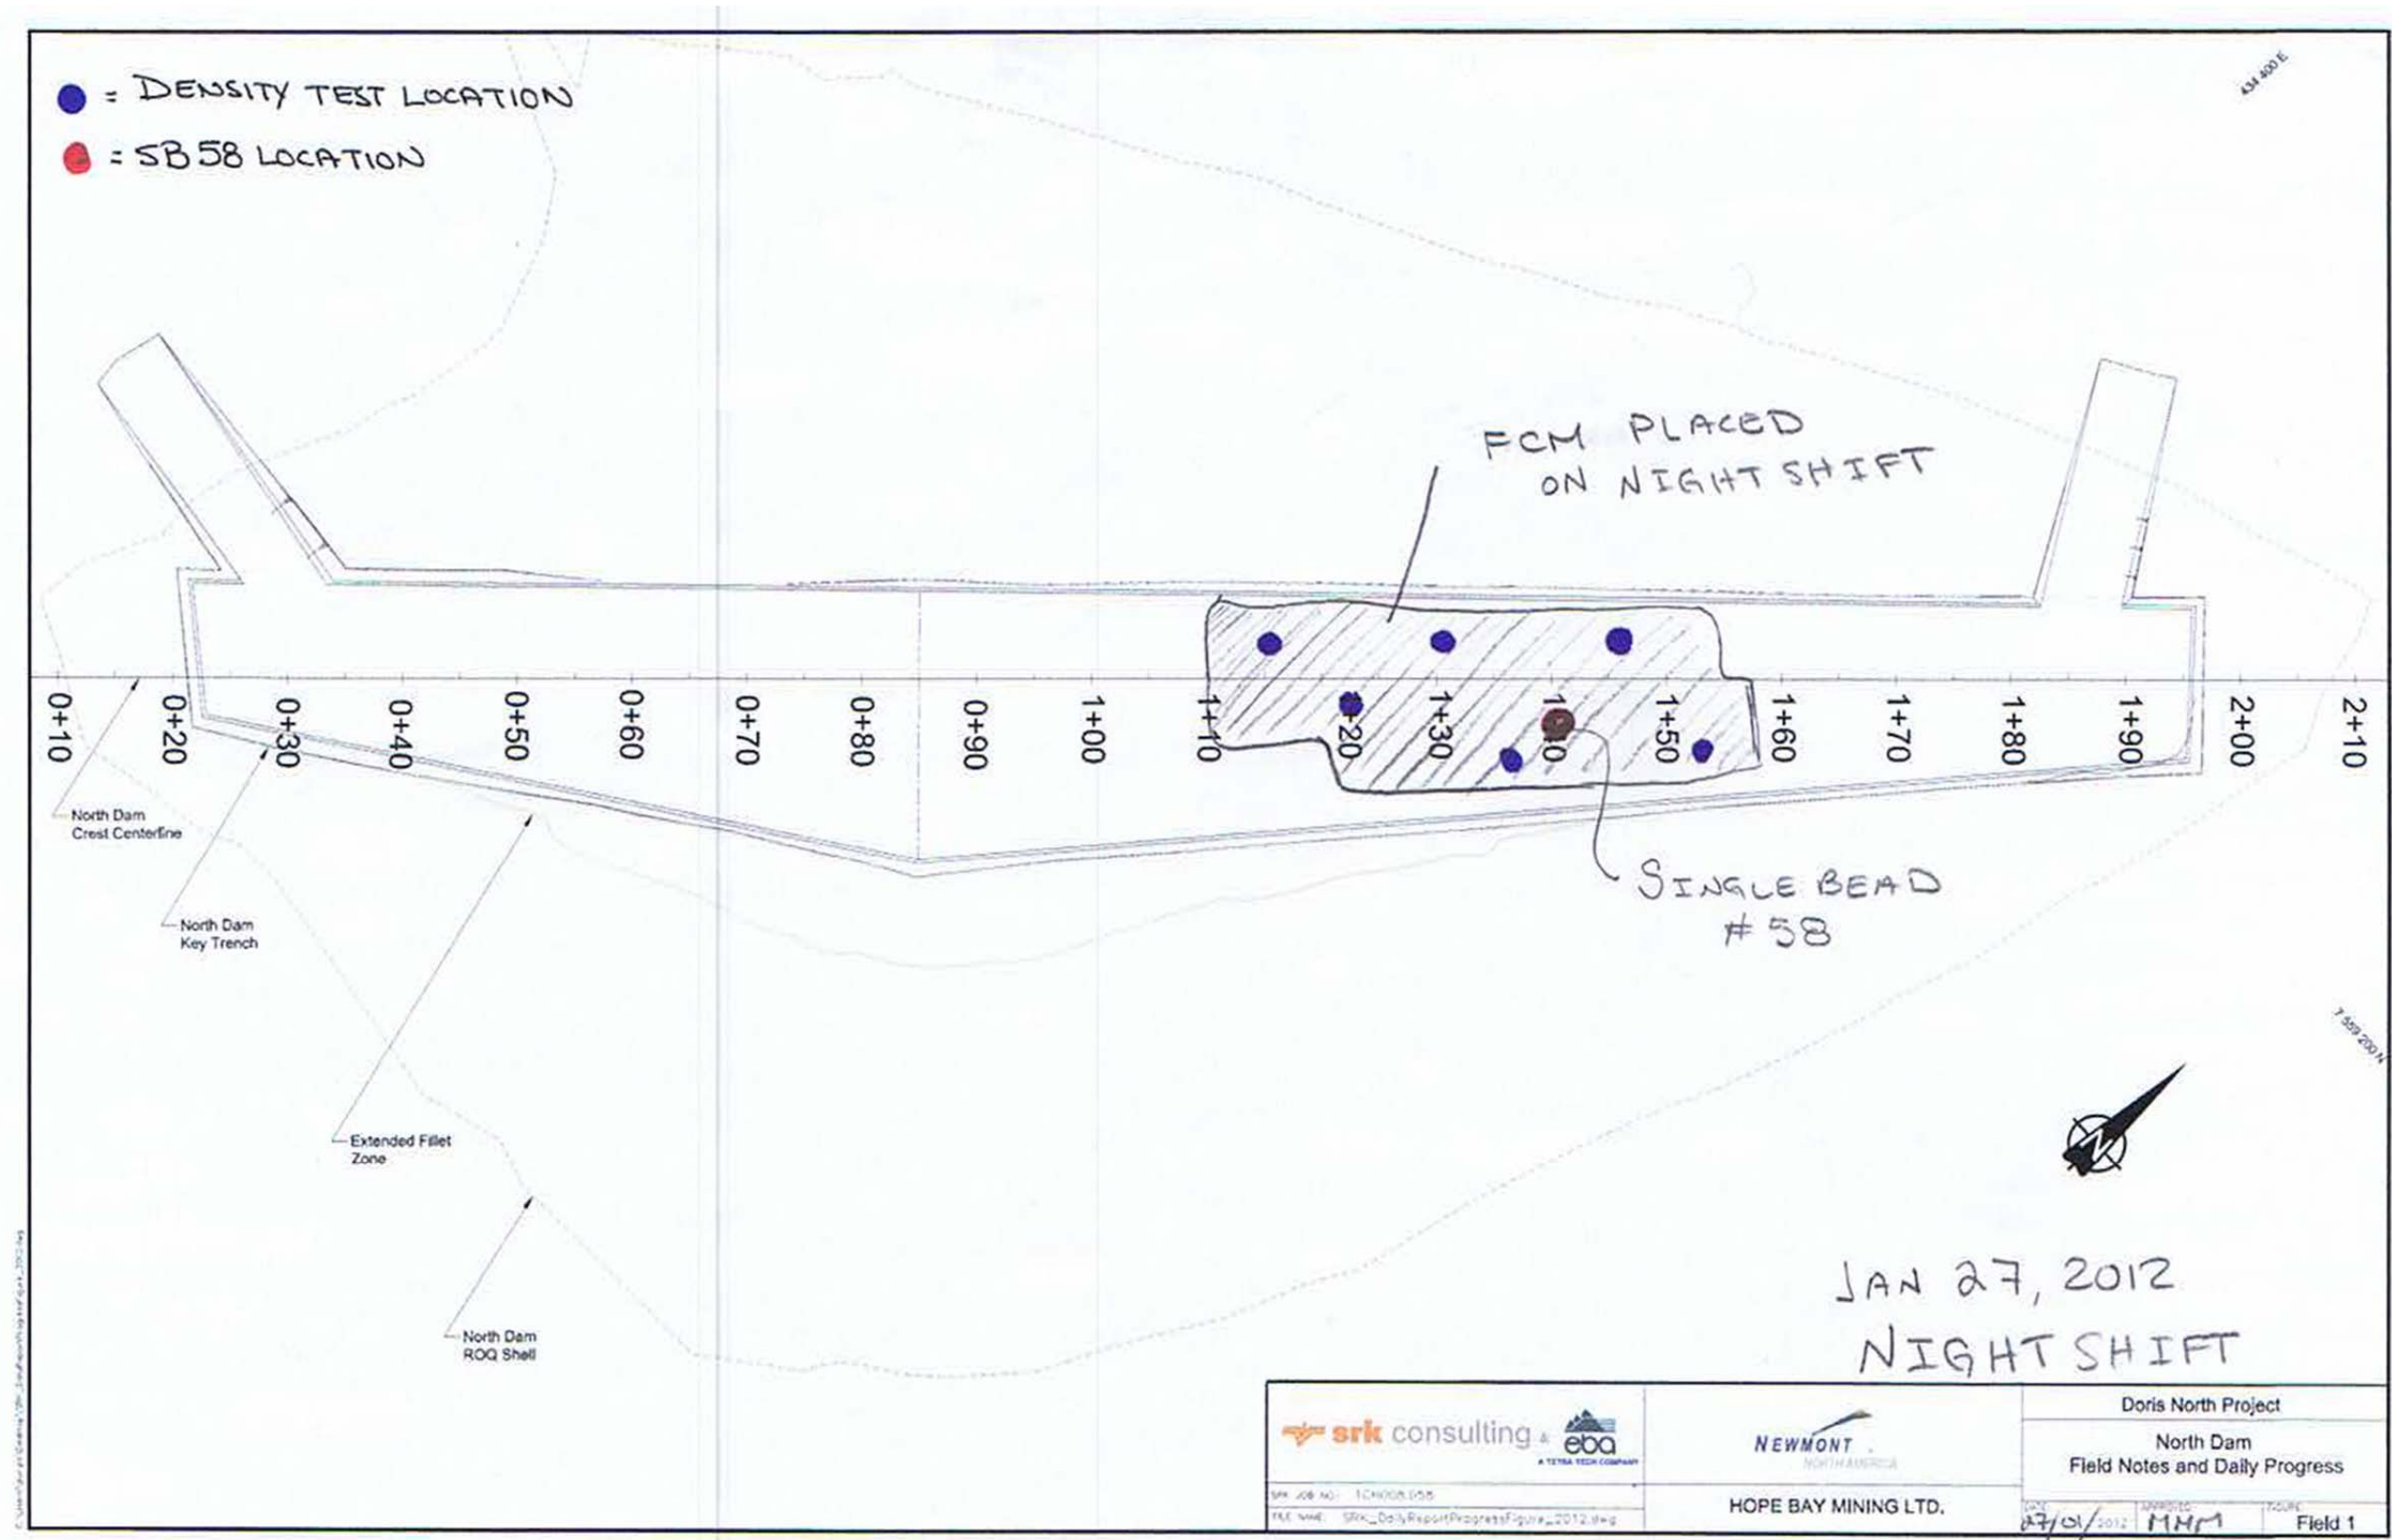
Figure 2 – North Dam Progress – Jan 27th NIGHTSHIFT

- FCM was placed from approximately sta.1+10 to 1+57.
 - The first few loads were on the dry side and the moisture at the plant was increased. With additional packing the dry loads met the requirements for compaction and saturation.

- Core placement went well.
 - Placement ended when insufficient material was available.
 - Single bead thermistor #58 was installed in this lift.
- Multi-bead thermistor readings were taken for all thermistors located within the key trench (horizontal and vertical) with the exception of ND-HTS-060-28.8 which is severed all thermistors were found to be in working order.
