DAILY REPORT #22 – DORIS NORTH INFRASTRUCTURE/ NORTH DAM

Prepared by:	John Kurylo/ Jeff Orr / Megan Miller	Date:	2012.01.27
Reviewed by:		Project #:	1CH008.058.0320
Role	Company	Personnel – Position	On Site
Client	Hope Bay Mining Limited (HBML)	Angela Holzapfel – ESR Compliance Manager David Vokey – ESR Coordinator Don Ethelston – HSLP Advisor Dean Wold - Safety Jill Turk – ESR Coordinator Katsky Venter – ESR Manger Michelle Tanquay – ESR Site Manager Stirling Kelly – HSLP Advisor	No Yes Yes No No Yes No No
	JDS	Lloyd Jackson – Mechanical Superintendent Sven Archimowtiz – Electrical Superintendent Doug Fielding – Construction Manager Ishan Fechter – Construction Coordinator Jerry Graham – Construction Manager Kevin Whieldon – Project Coordinator Mark Valeriote – Construction Manager	Yes Yes Yes No No Yes Yes
Engineering Design Consultants	SRK Consulting (Canada) Inc.	John Kurylo – Site Engineer Megan Miller – Site Engineer Lawrence Borowski – Site Engineer Murry McGregor – Site Engineer Iozsef Miskolczi – Site Engineer	Yes Yes No No No

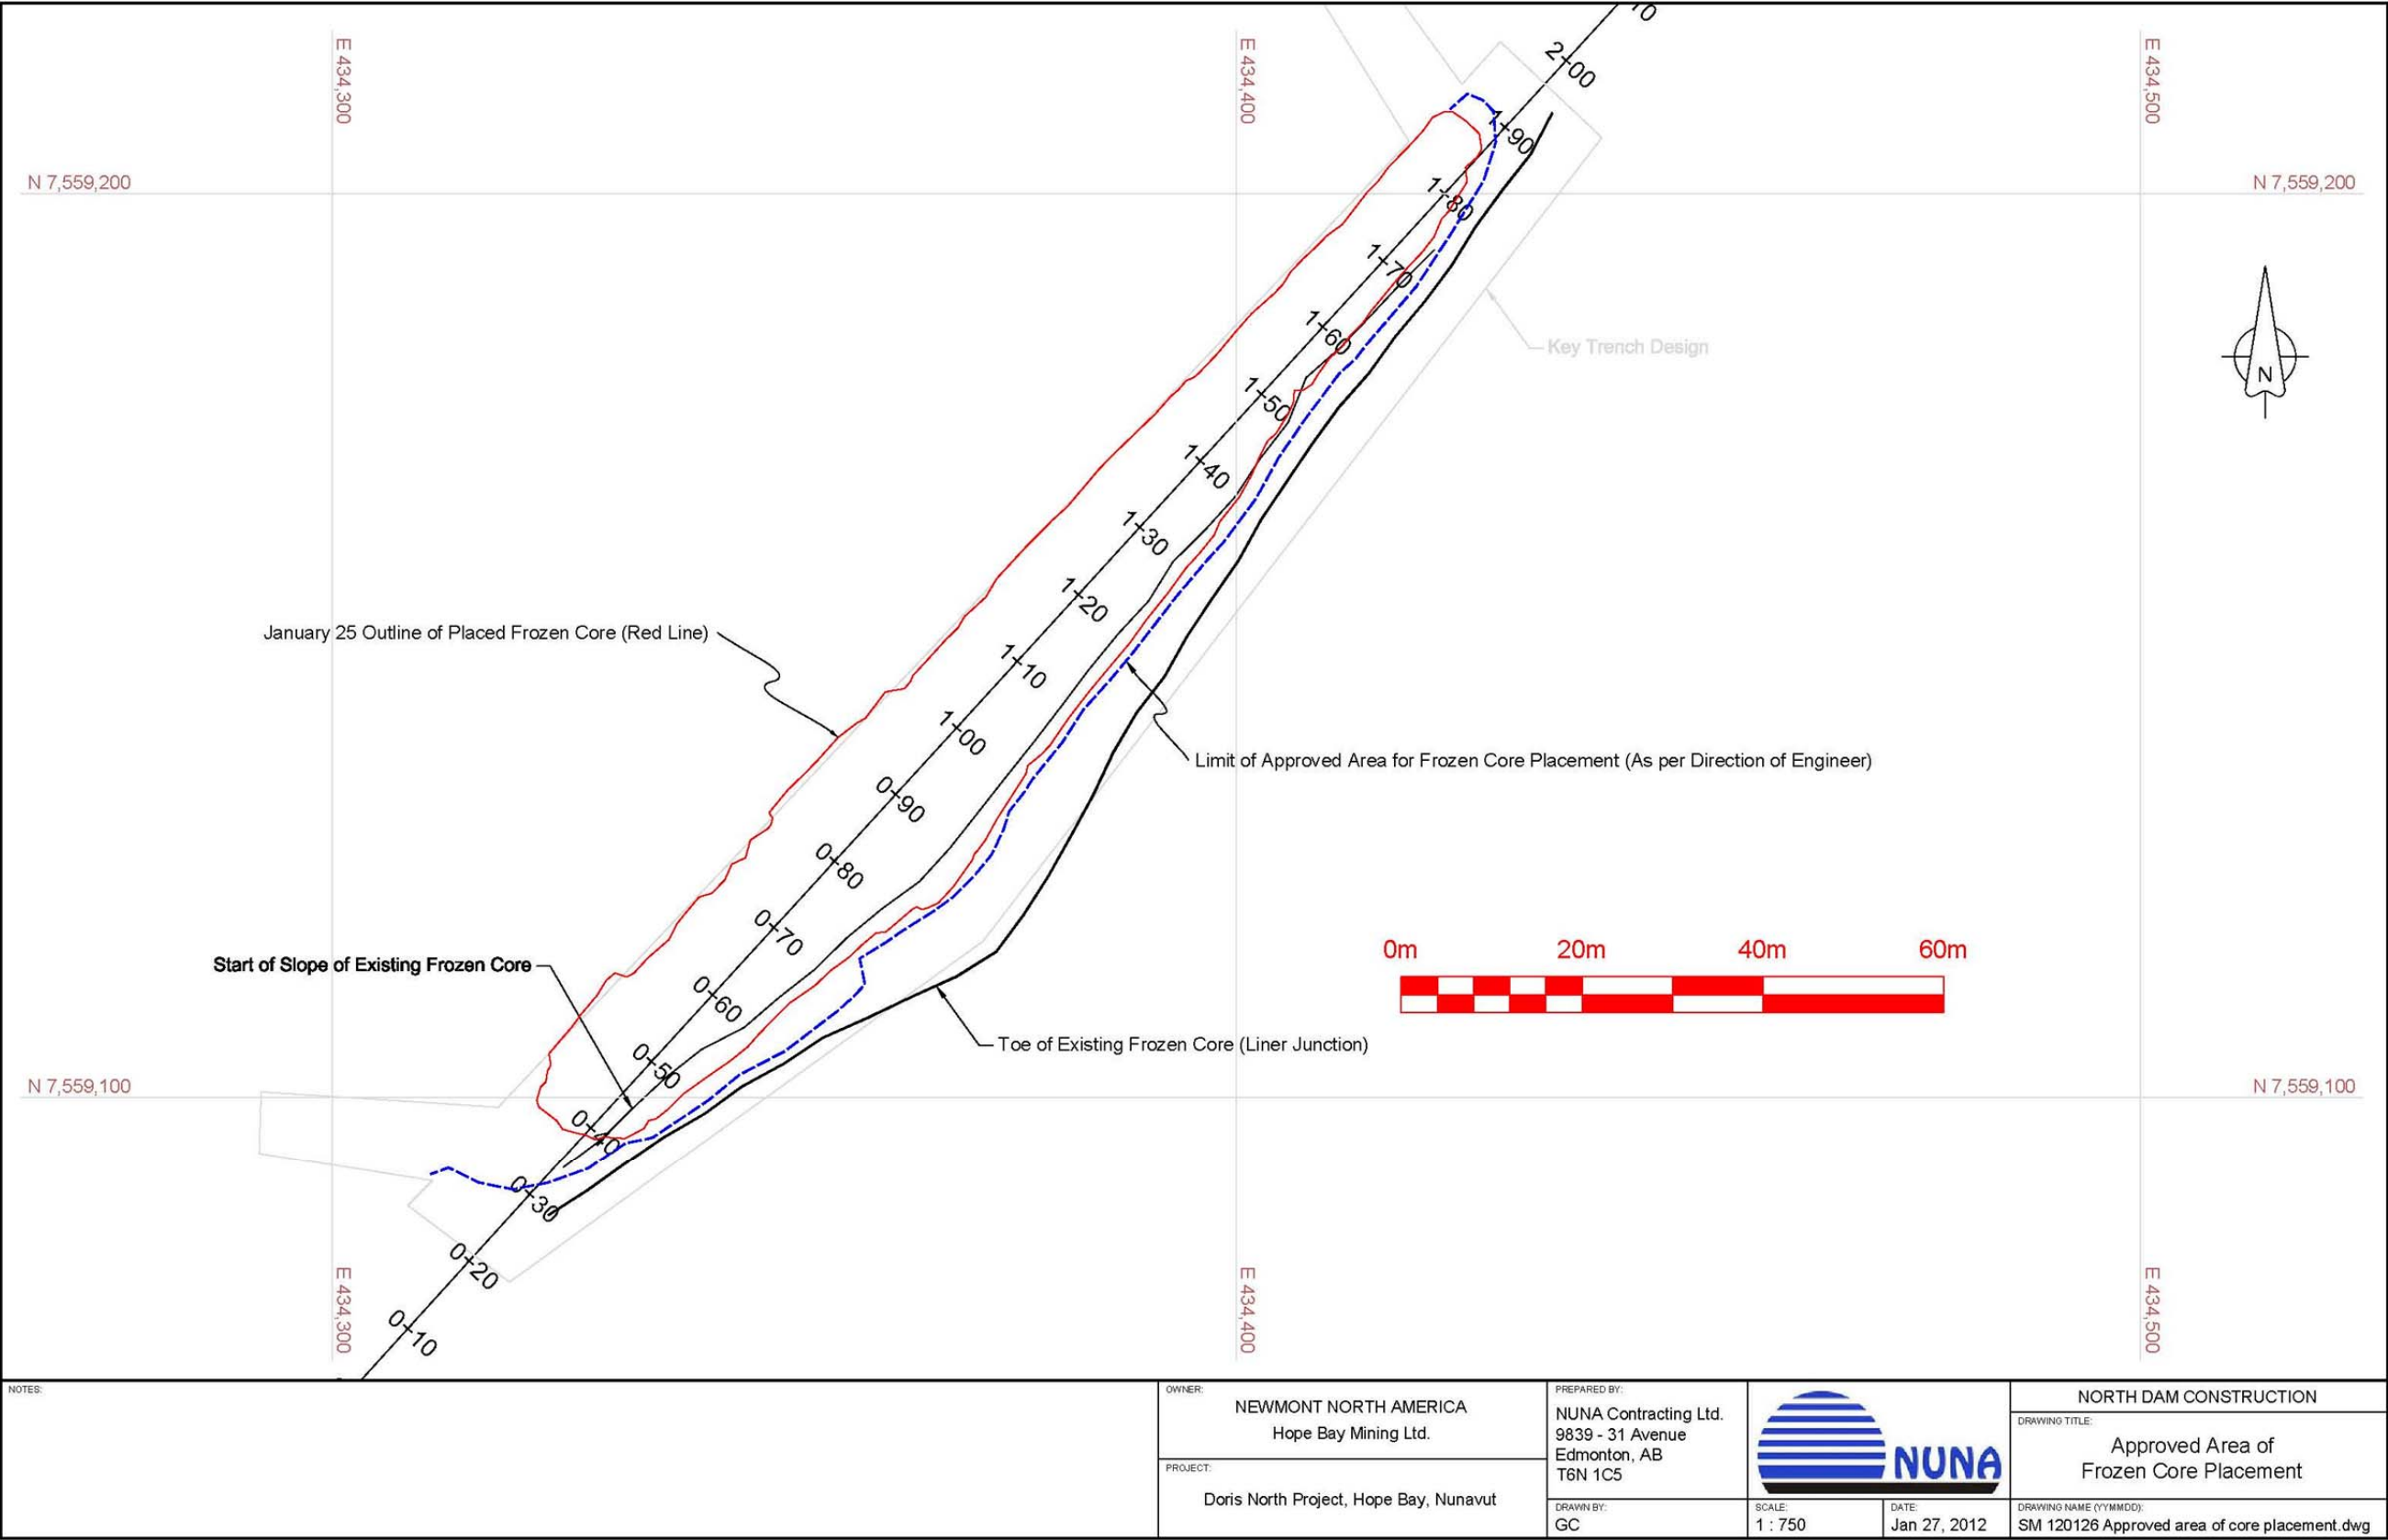
Figure 3 – Figure prepared by Nuna Survey showing the extent 5/8” material clearing, polyline surveyed in the field with SRK and Nuna survey on 2012/01/26 (see daily #21 for additional details).
