DAILY REPORT #23 – DORIS NORTH INFRASTRUCTURE/ NORTH DAM

Prepared by:	John Kurylo/ Jeff Orr / Megan Miller	Date:	2012.01.28
Reviewed by:		Project #:	1CH008.058.0320
Role	Company	Personnel – Position	On Site
Client	Hope Bay Mining Limited (HBML)	Angela Holzapfel – ESR Compliance Manager David Vokey – ESR Coordinator Don Ethelston – HSLP Advisor Dean Wold - Safety Jill Turk – ESR Coordinator Katsky Venter – ESR Manger Michelle Tanquay – ESR Site Manager Stirling Kelly – HSLP Advisor	No Yes Yes No No Yes No No
	JDS	Lloyd Jackson – Mechanical Superintendent Sven Archimowtiz – Electrical Superintendent Doug Fielding – Construction Manager Ishan Fechter – Construction Coordinator Jerry Graham – Construction Manager Kevin Whieldon – Project Coordinator Mark Valeriote – Construction Manager	Yes Yes Yes No No Yes Yes
Engineering Design Consultants	SRK Consulting (Canada) Inc.	John Kurylo – Site Engineer Megan Miller – Site Engineer Lawrence Borowski – Site Engineer Murry McGregor – Site Engineer Iozsef Miskolczi – Site Engineer	Yes Yes No No No

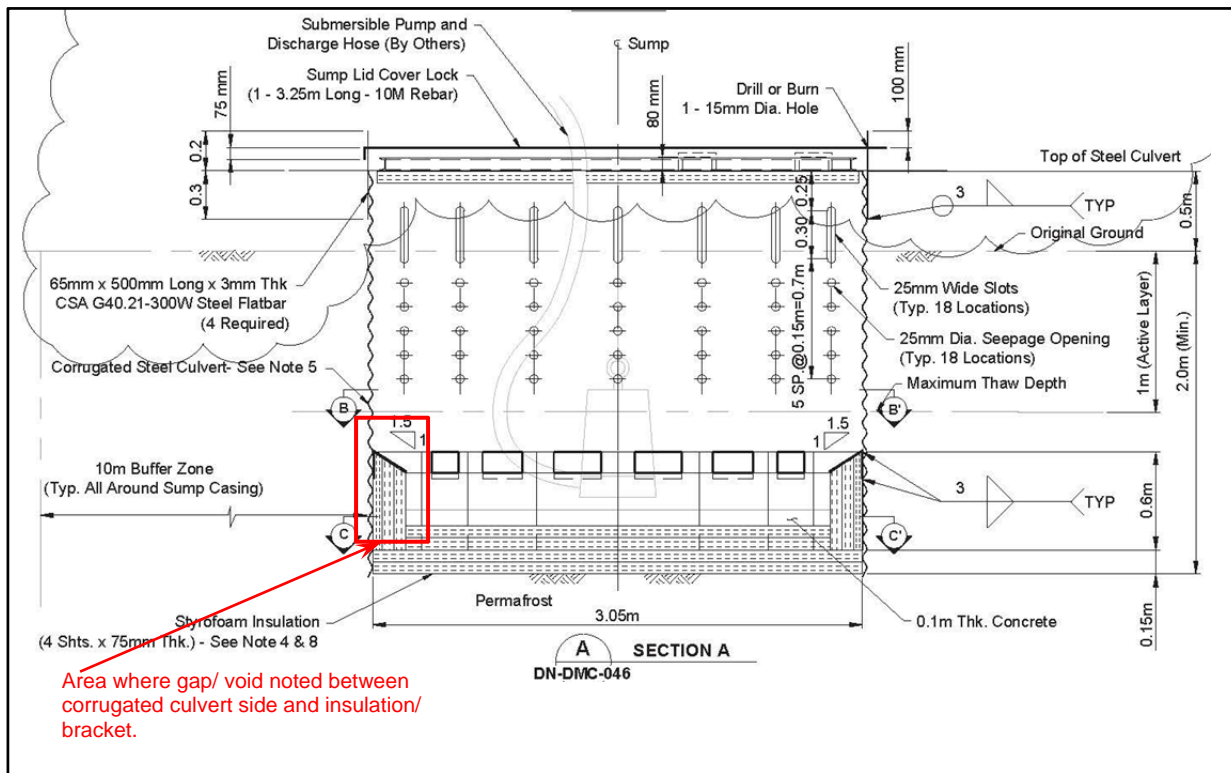
- Nuna pointed out to SRK that, as observed by Til Cho, there is an area between the side of the culvert and the vertical insulation and insulation brackets where a gap is apparent.

- This gap is being created as the circular corrugated steel contact and the flat bracket steel and insulation do not perfectly meet.
 - Seepage into the sump then into this void and under the insulation was discussed. To limit the potential for seepage travelling around the sides of the culvert and under the insulation it was decided that Til Cho would put some additional pieces of insulation around the top of the insulation brackets to seal off/ close-up this void.

- See figure/ notes below for area in question.
 - See photos 4 and 5.

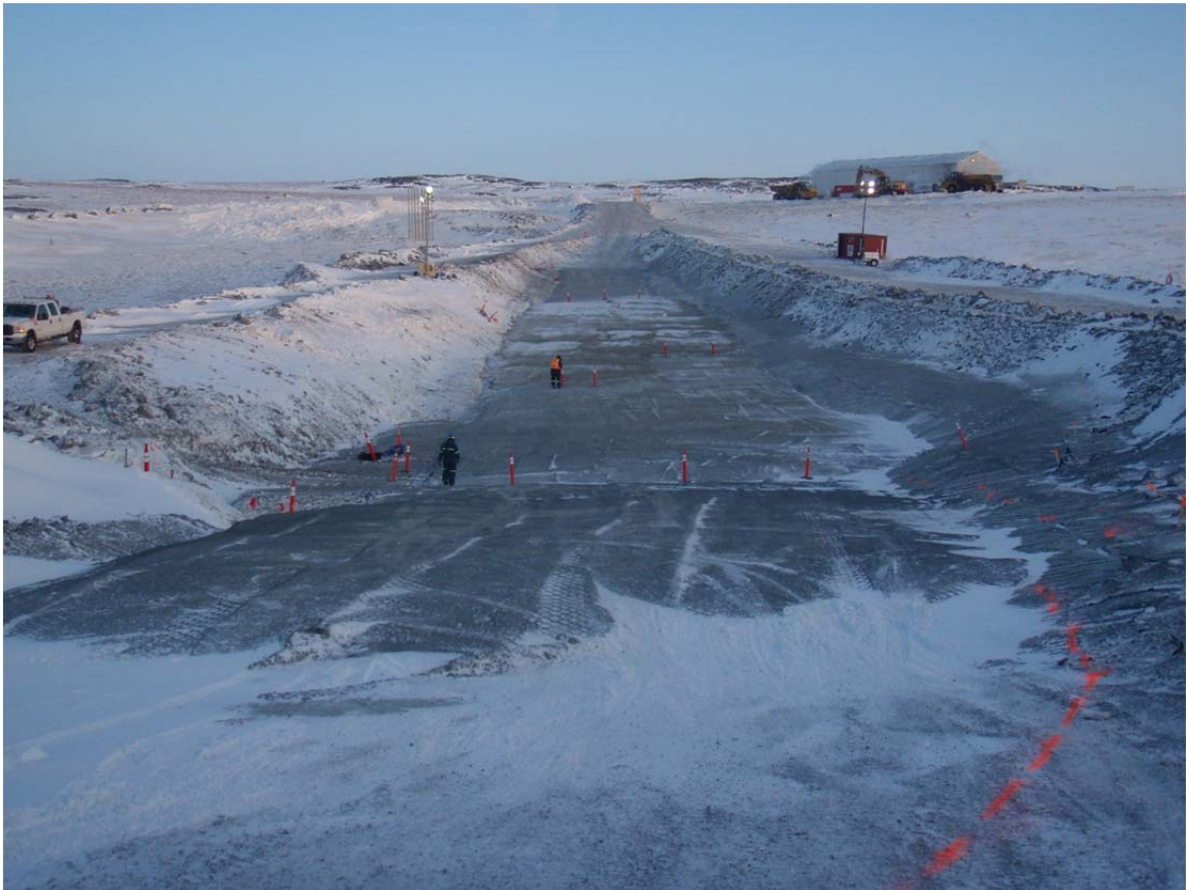
Photo 1: ~NE view down keytrench. Note the area to the East (towards the FCP) of the closest set of delineations is the area where FCM was placed on Jan 27th.

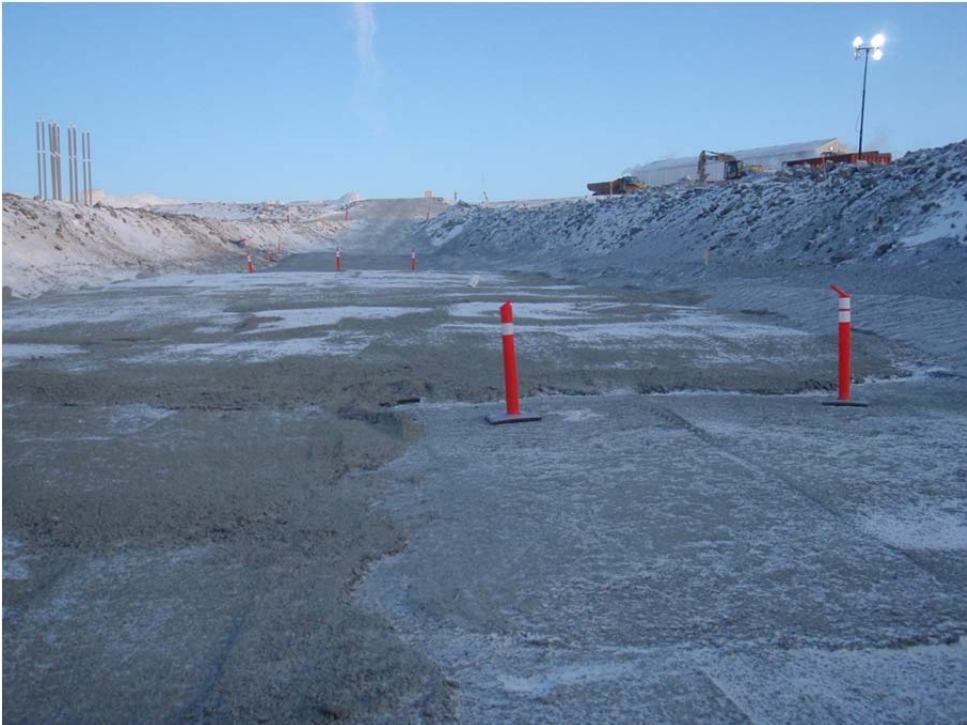
Photo 2: ~NEE close up view of area/ transition from day and night shift FCM placement yesterday (Jan 27th).

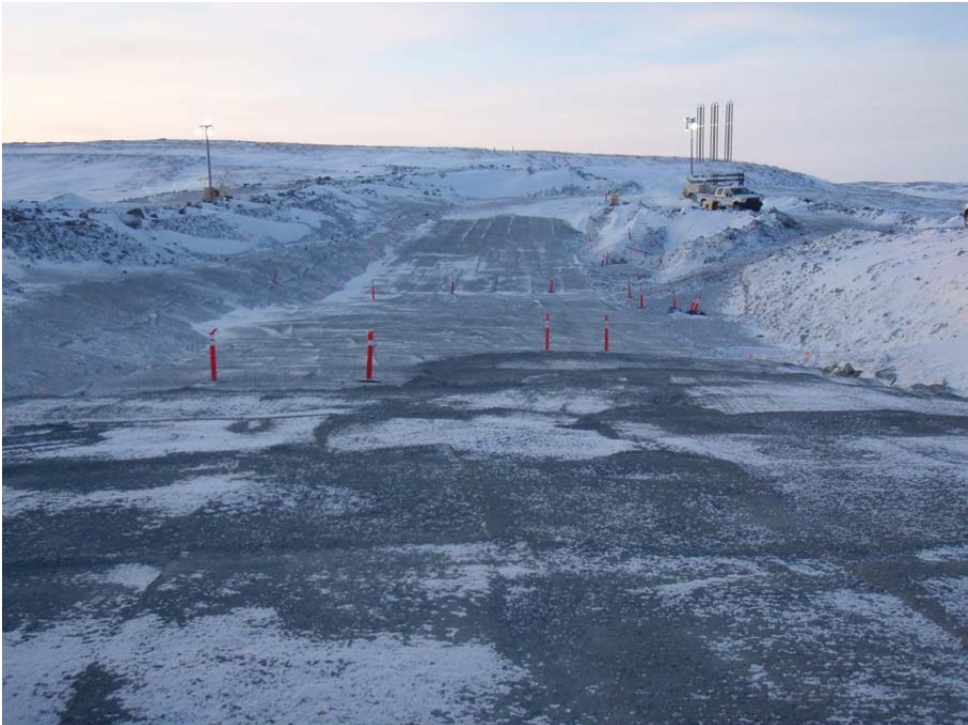
Photo 3: ~ WSW view down key trench from ~ station 1+40. Looking over FCM placed on Jan 27th.

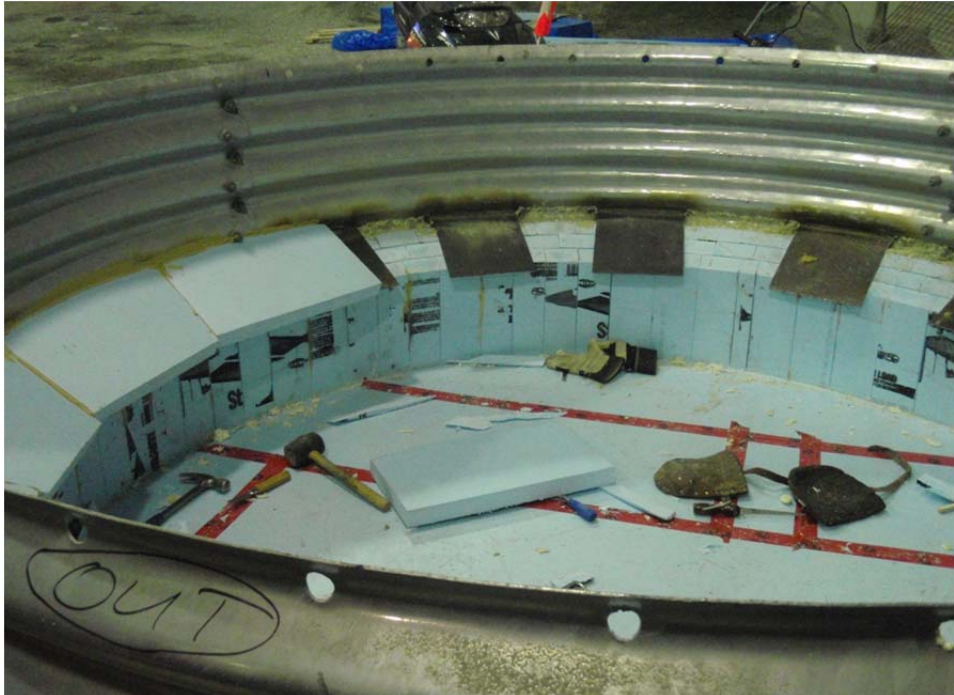
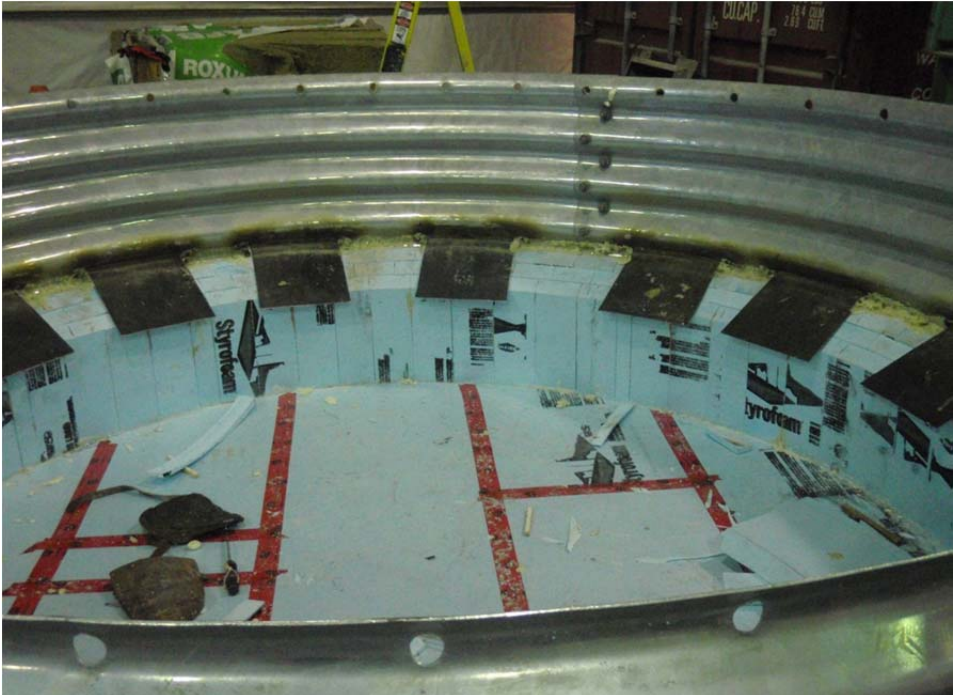
Photo 4 & 5: Close up view of styrofoam insulation and vertical retailing brackets being installed/ fabricated on the base of the sumps (for Sumps 1 and 2). Note that the left photo shows additional insulation that is being installed to ensure that water does not as readily seep behind the insulation and the corrugated steel culvert side.

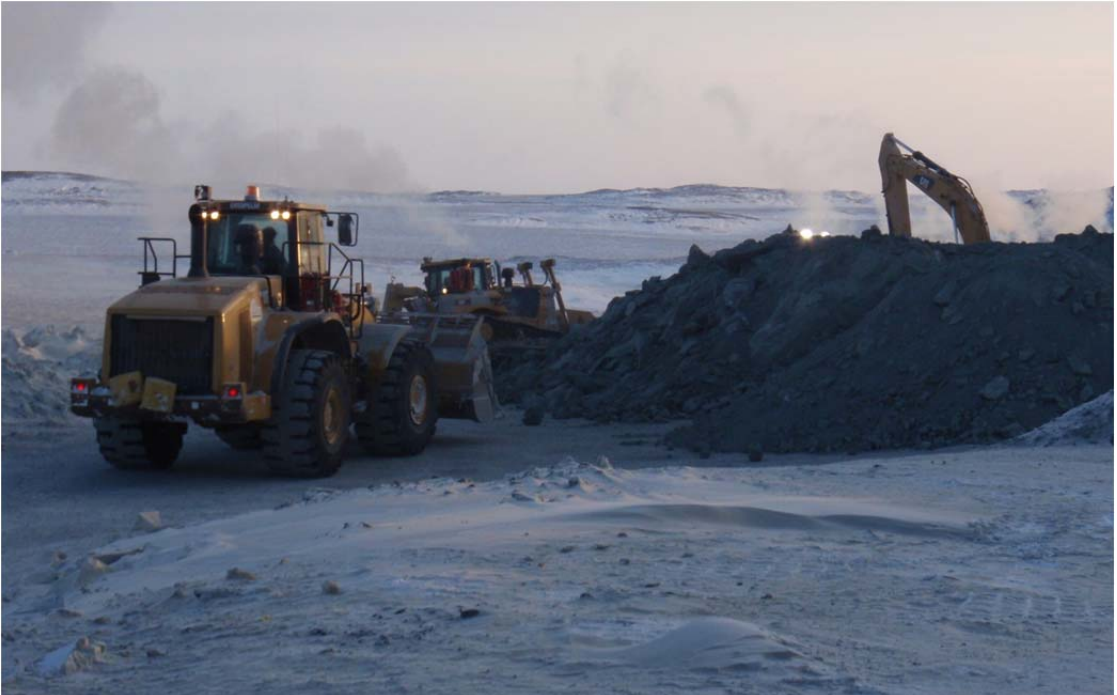
- The 325 excavator, a D8 dozer and a loader were used at the FCM stockpile to sort and break down unsaturated frozen lumps from the FCM stockpile (on the FCP Pad).

Photo 6: ~ESE view of the loader, D8 dozer and 345 excavator working on breaking up the unsaturated FCM stockpile at the FCP Pad.

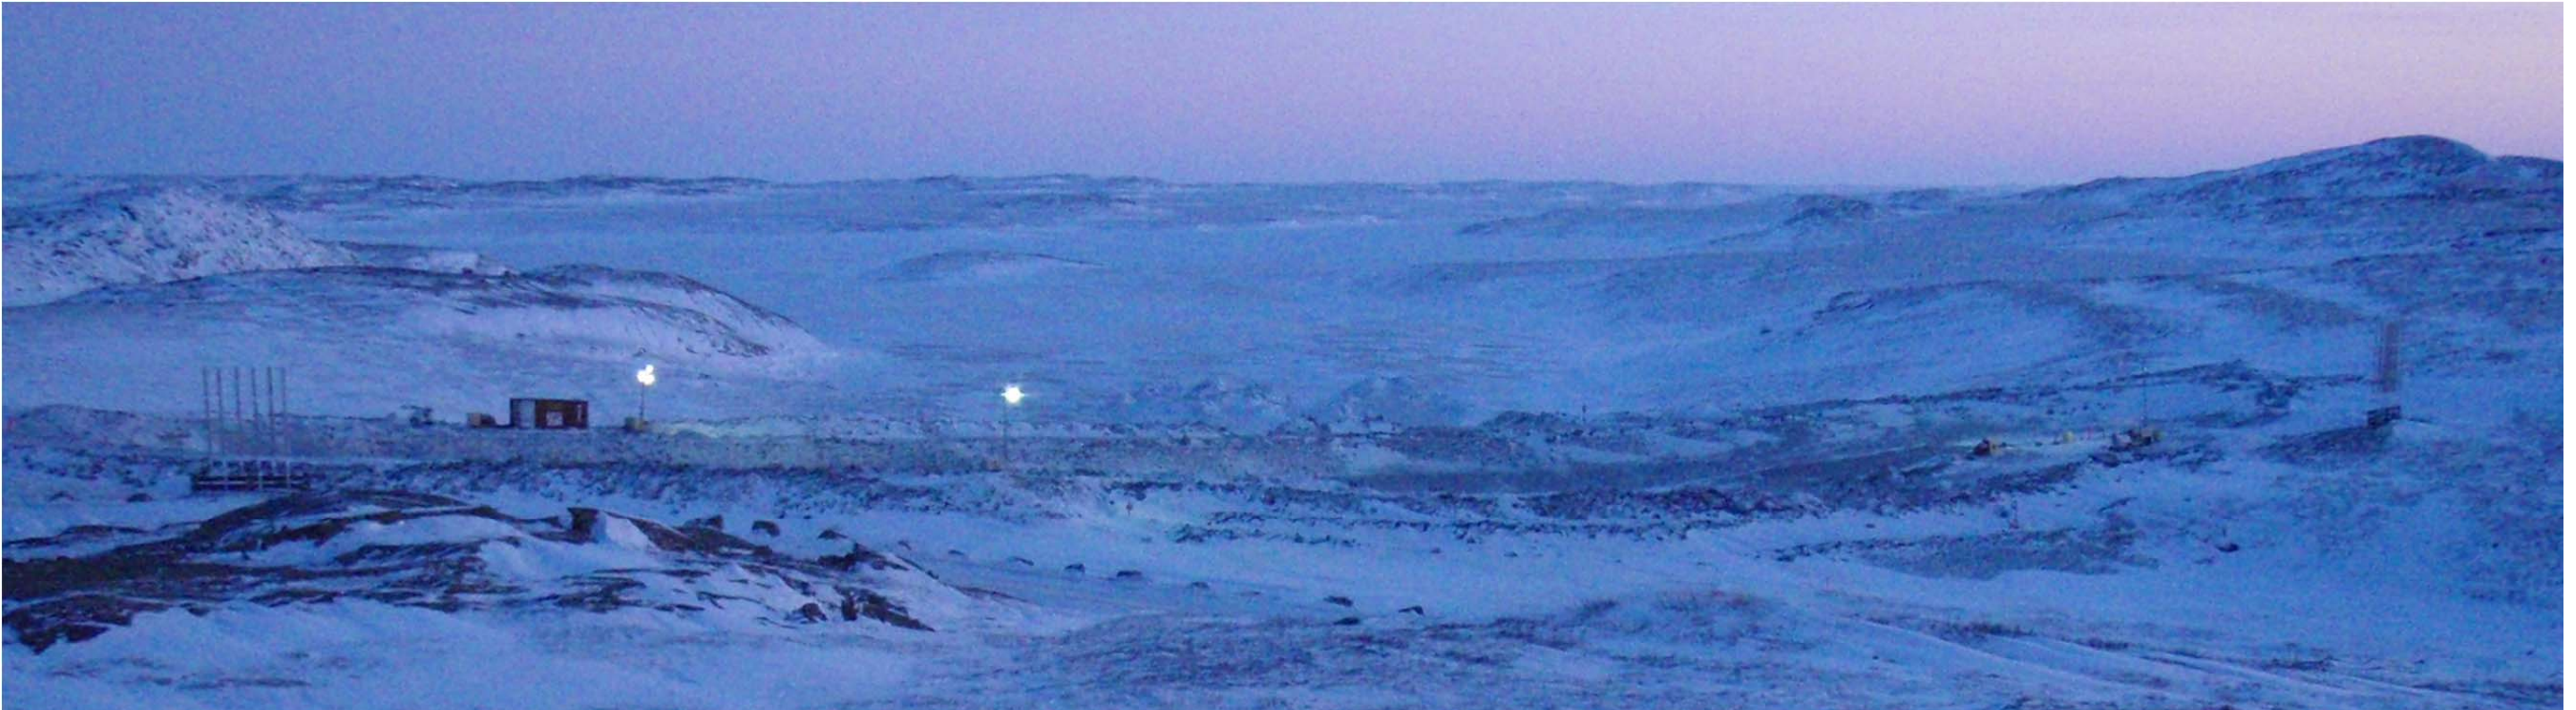
Photo 7: Progress photo of North Dam from photo point 1. ~SSE view.

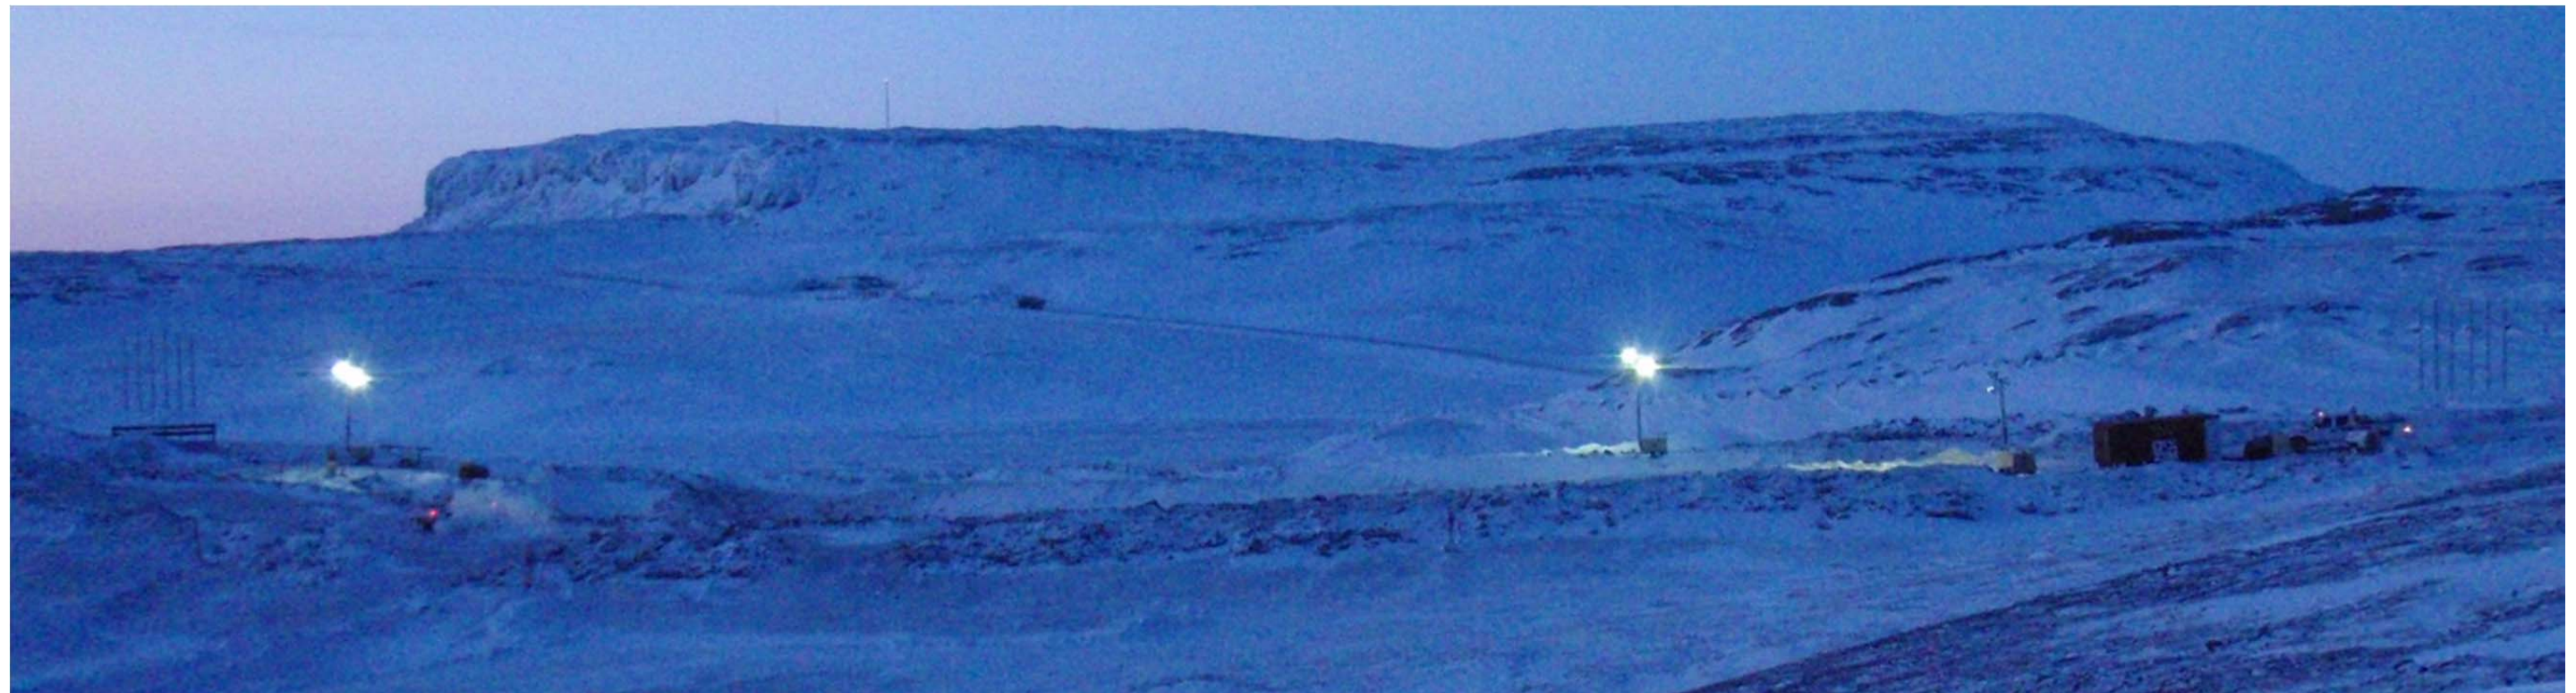
Photo 8: Progress photo of North Dam from photo point 2. ~WNW view.

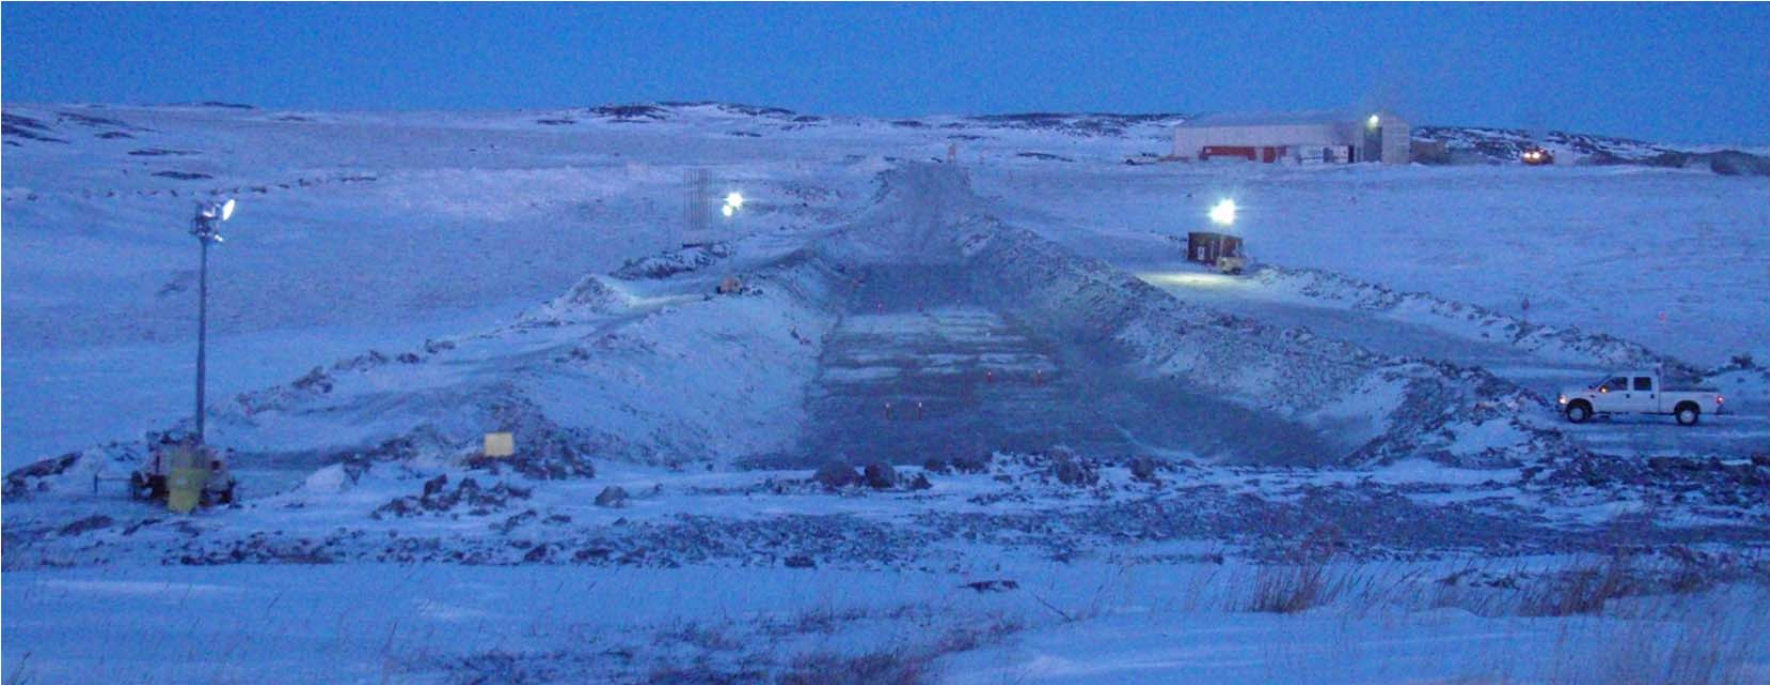
Photo 9: Progress photo of North Dam from photo point 3. ~ENE view.

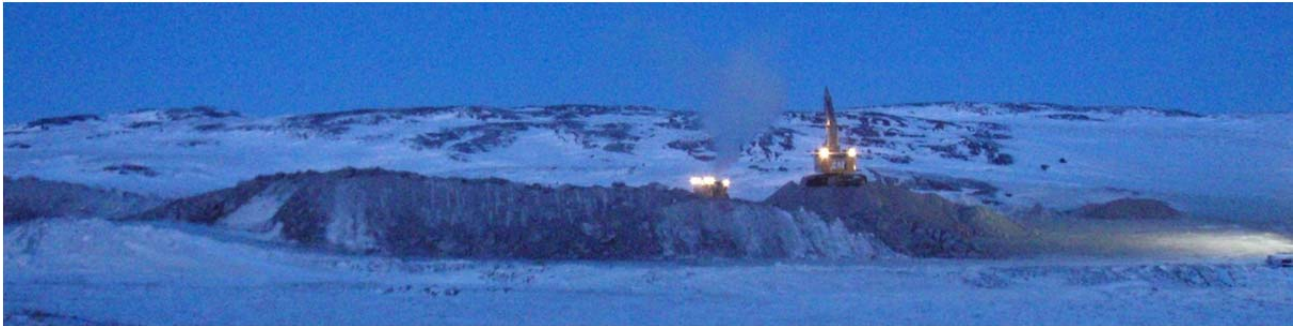
Photo 10: ~ NNE view of the FCM stockpile at the FCP Pad.

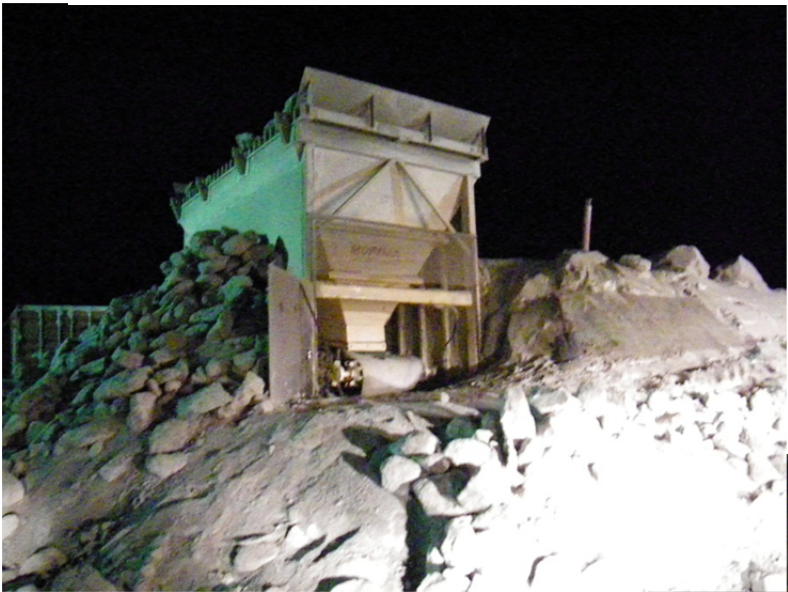
- The plant started up at ~9 pm with no problems.
- At ~11 pm the plant had to shut down as the belt under the hopper had broken.
 - The hopper was full when the belt broke; therefore the CAT 308 excavator and hand shovels were required to empty the hopper before the belt could be repaired.
 - The belt was still being repaired at the end of the shift.
- Large lumps of frozen FCM were hauled to the crusher where they will be re-crushed.

Photo 11: The belt underneath the hopper on the Frozen Core Plant broke during the nightshift.

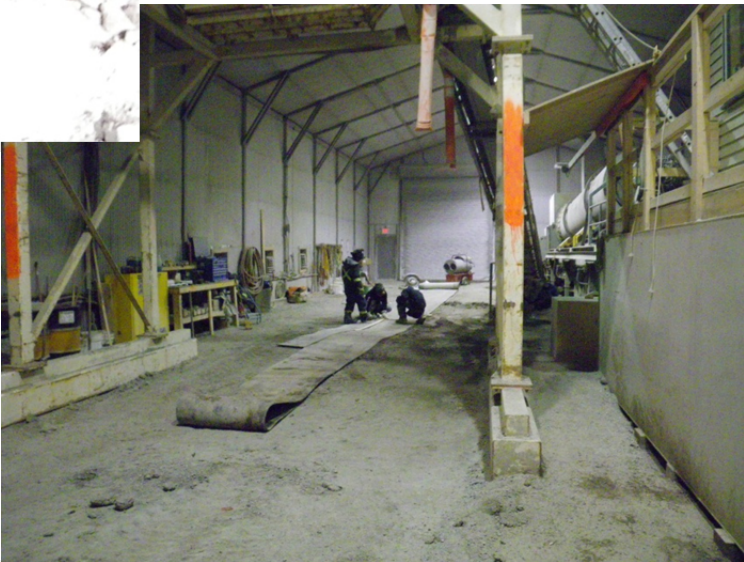
Photo 12 (Right): Crew cutting a belt to size to repair the belt under the hopper in the frozen core plant.

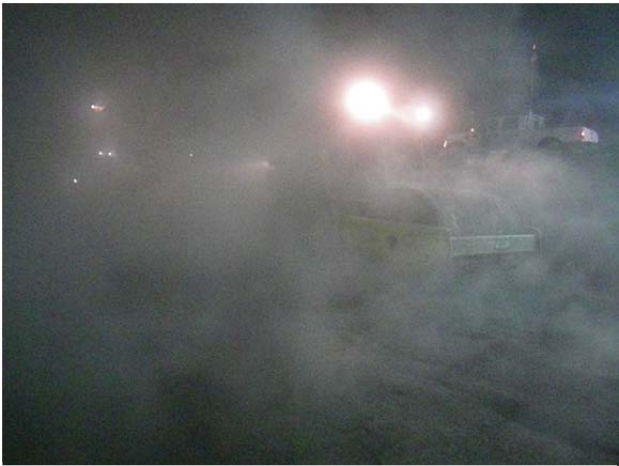
Photo 13: Lots of steam was produced during material placement.

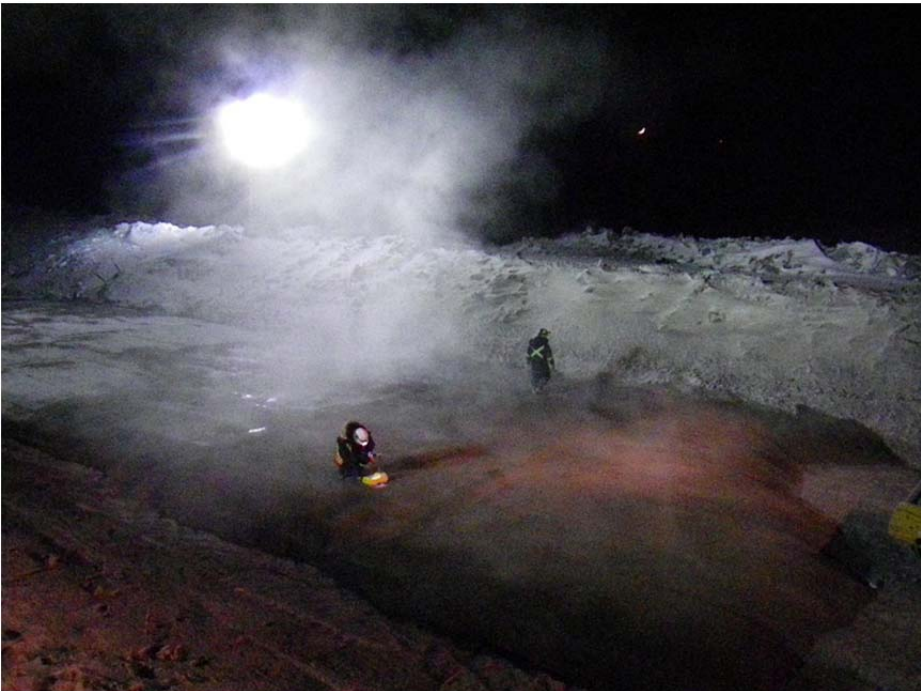
- Compaction and saturation results from the nuclear densometer were acceptable.
- EBA/ SRK acquired a concrete air/ density meter from the batch plant.
- An additional 30 single beads were picked up from the BBE warehouse today.
- A larger generator for coring was sourced out today. A superior generator was located in the SRK seacan (located behind the warehouse).

Photo 14: Compaction testing of the material placed on nightshift.

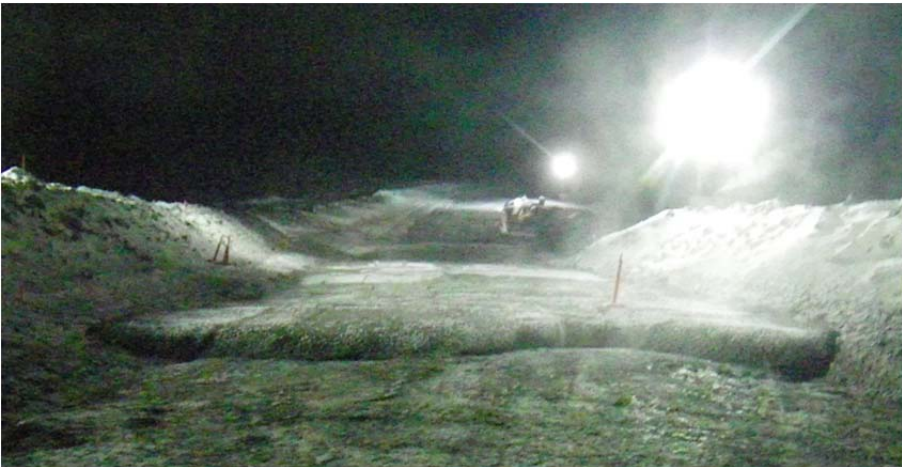
Photo 15: Material placed on nightshift, looking south west along trench.

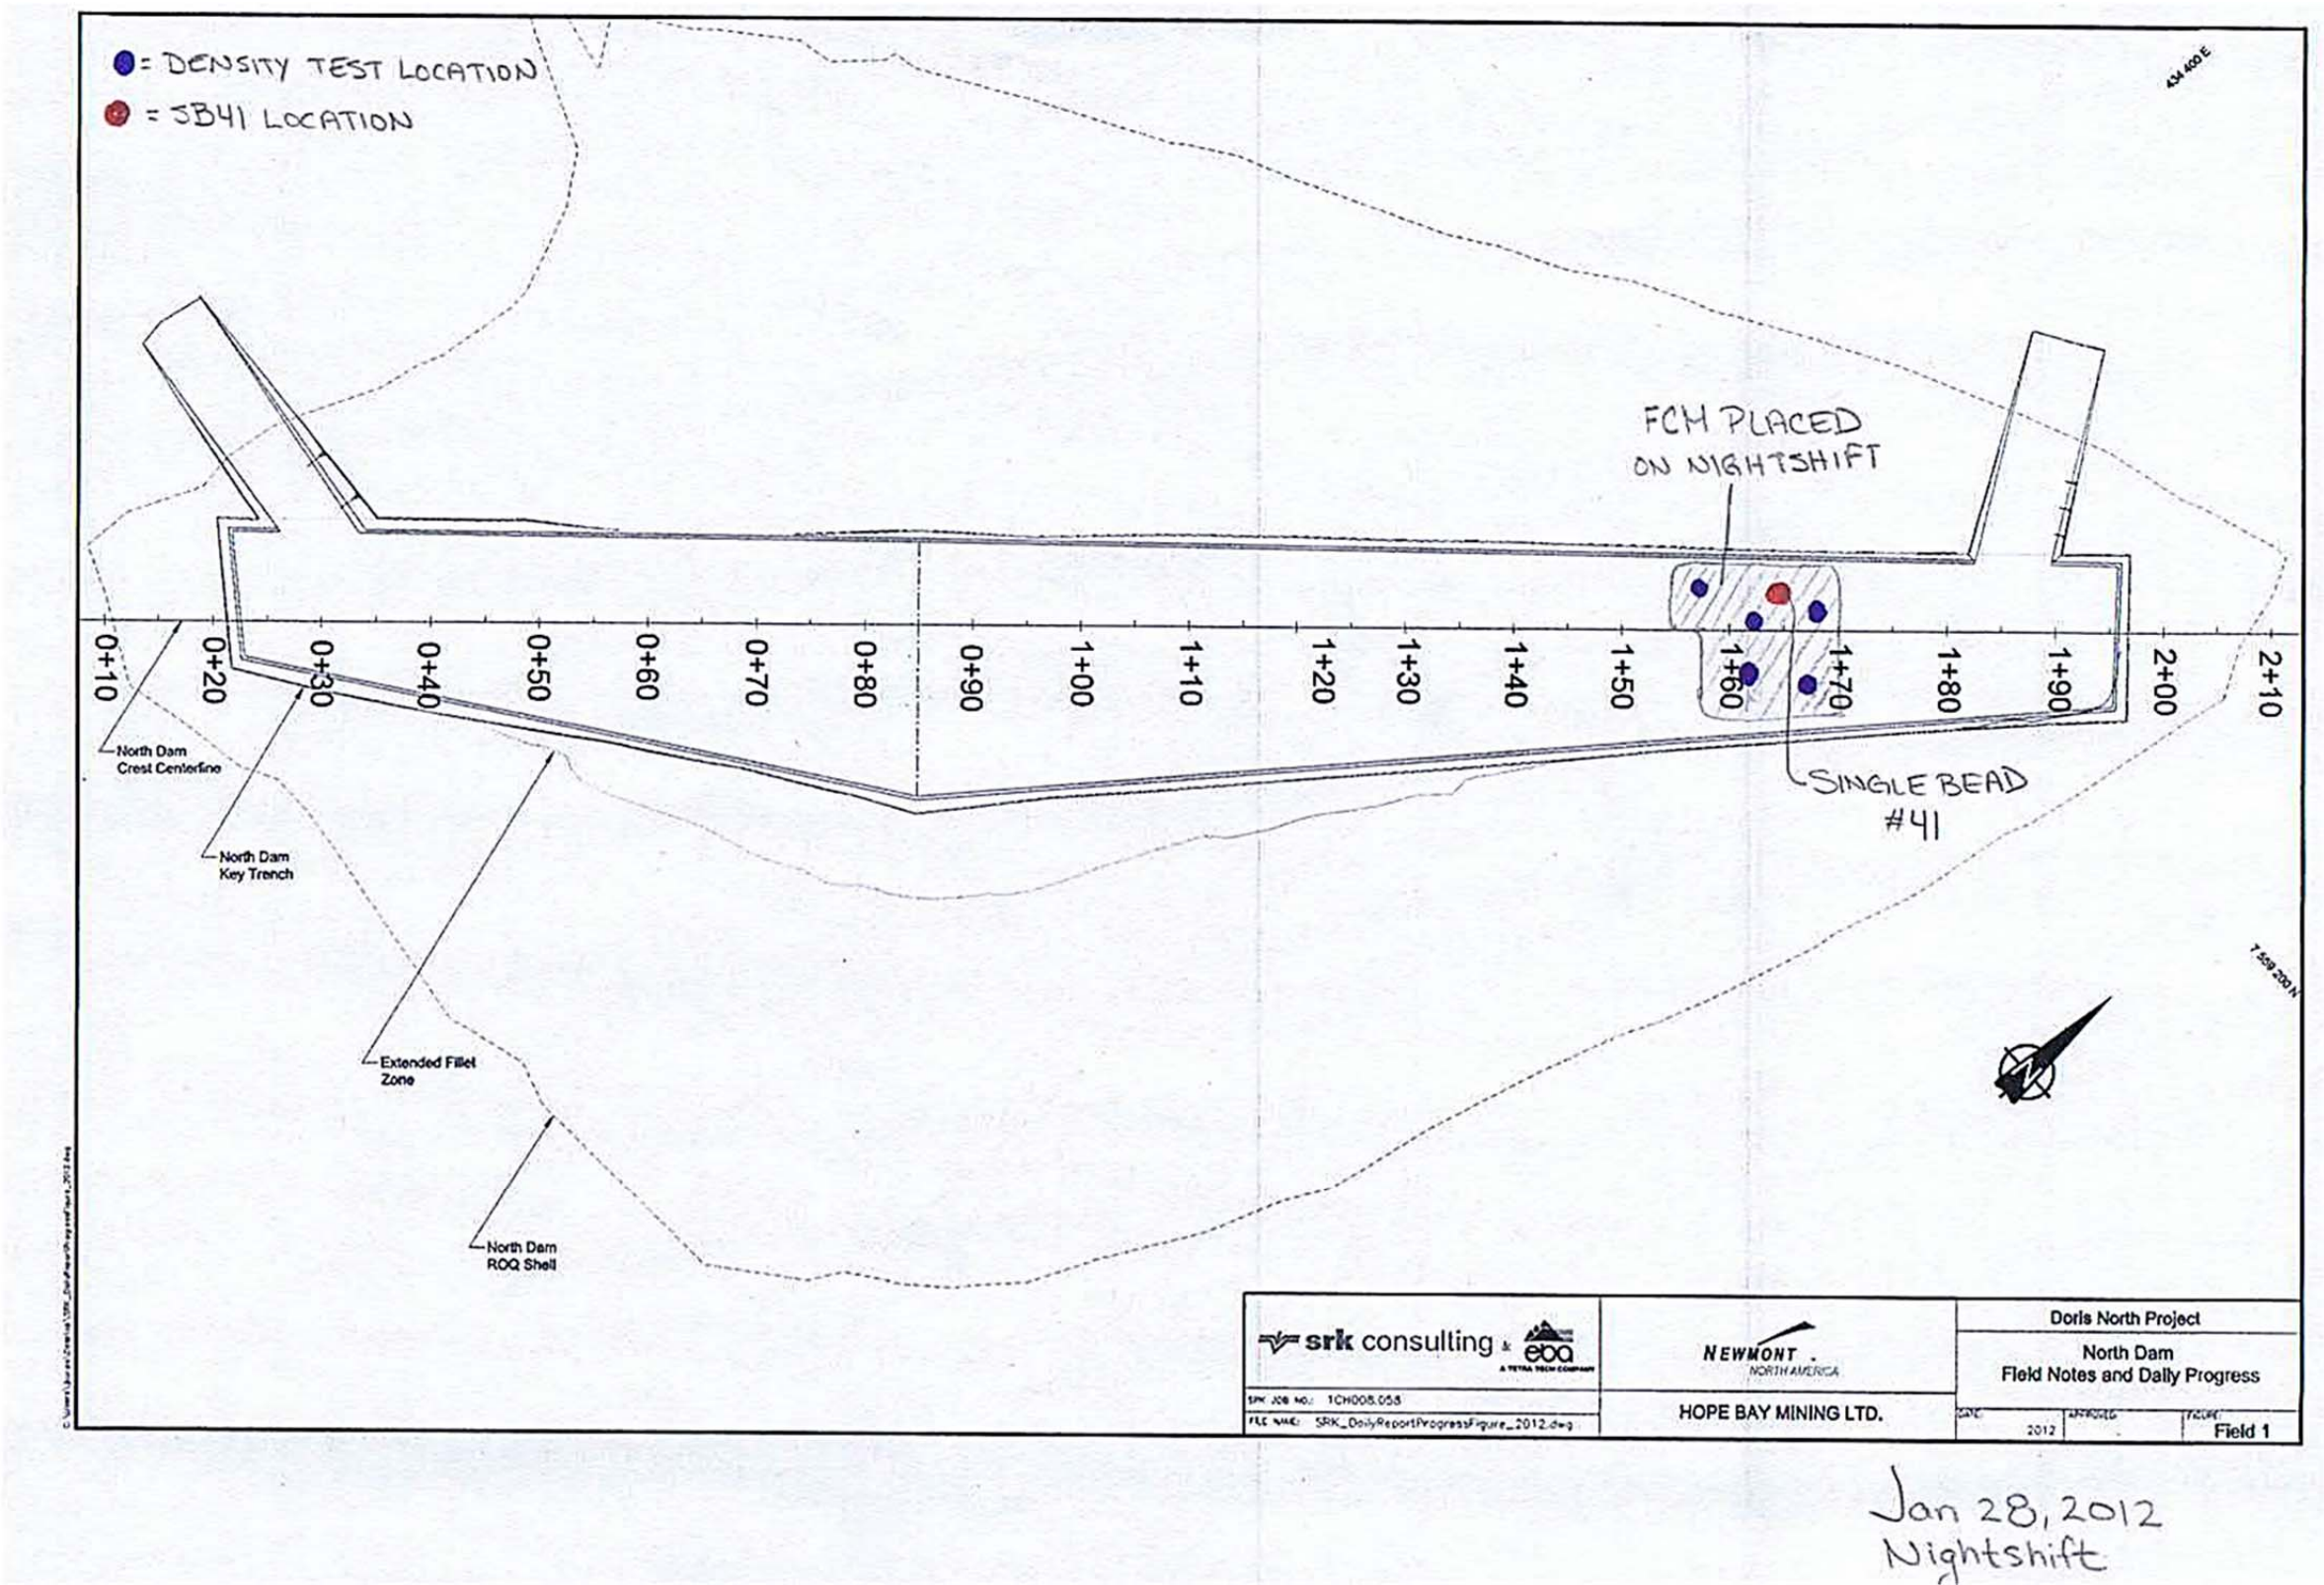
Figure 1 – North Dam Progress – Jan 28th NIGHTSHIFT

- FCM was placed starting at ~1+60 working north east.
 - Material placement was going well; however it had to be halted at ~11:30 due to the broken belt. Material was placed until approximately sta. 1+70.

- Today's FCM placement progress is outlined in Figure 1.
