DAILY REPORT #24 – DORIS NORTH INFRASTRUCTURE/ NORTH DAM

Prepared by:	John Kurylo/ Jeff Orr / Megan Miller	Date:	2012.01.29
Reviewed by:		Project #:	1CH008.058.0320
Role	Company	Personnel – Position	On Site
Client	Hope Bay Mining Limited (HBML)	Angela Holzapfel – ESR Compliance Manager David Vokey – ESR Coordinator Don Ethelston – HSLP Advisor Dean Wold - Safety Jill Turk – ESR Coordinator Katsky Venter – ESR Manger Michelle Tanquay – ESR Site Manager Stirling Kelly – HSLP Advisor	No Yes Yes No No Yes No No
	JDS	Lloyd Jackson – Mechanical Superintendent Sven Archimowtiz – Electrical Superintendent Doug Fielding – Construction Manager Ishan Fechter – Construction Coordinator Jerry Graham – Construction Manager Kevin Whieldon – Project Coordinator Mark Valeriote – Construction Manager	Yes Yes Yes No No Yes Yes
Engineering Design Consultants	SRK Consulting (Canada) Inc.	John Kurylo – Site Engineer Megan Miller – Site Engineer Lawrence Borowski – Site Engineer Murry McGregor – Site Engineer Iozsef Miskolczi – Site Engineer	Yes Yes No No No

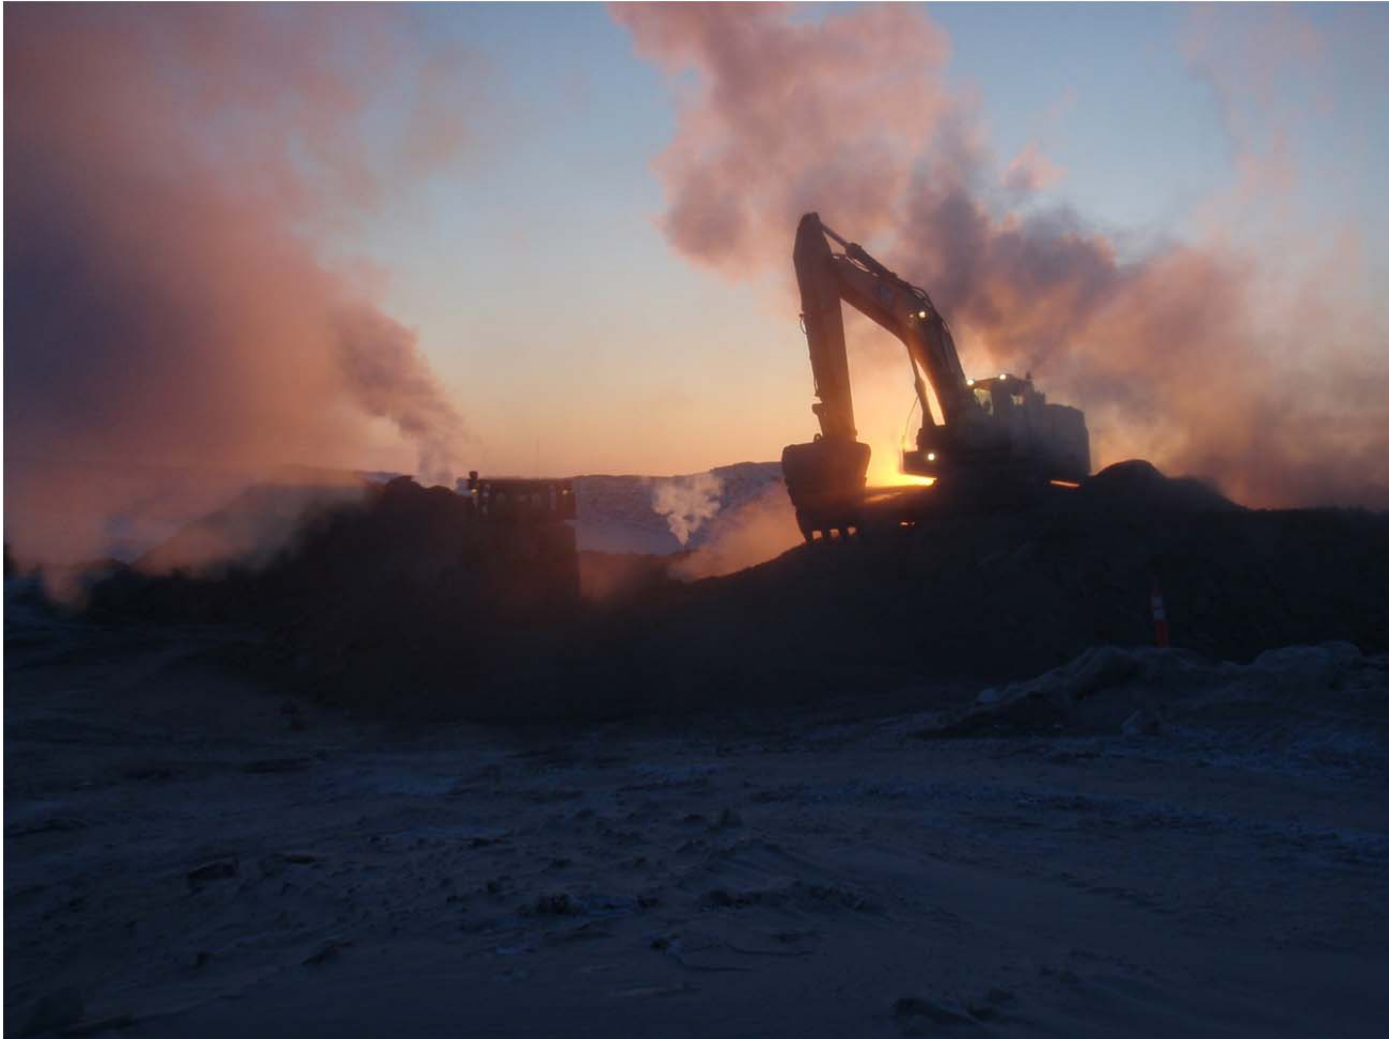
- The dayshift crew working on preparing and putting on a new, slightly thicker, belt on the conveyor leading from the hopper into the FCP. By the end of dayshift the belt had been put on.
- The 325 excavator, a D8 dozer and a loader were used at the FCM stockpile to sort and break down unsaturated frozen lumps from the FCM stockpile (on the FCP Pad).
 - Suitable feed material was stockpiled in preparation for future placement.
 - Large lumps of FCM were hauled to the crusher. These large lumps are planned to be re-crushed. Some of the lumps being hauled away were very large (greater than 3 m in size).
 - See Photos 1 and 9.

Photo 1: 345 excavator and D8 dozer working on breaking up unsaturated lumps of FCM at the stockpile on the FCP pad; ~W view

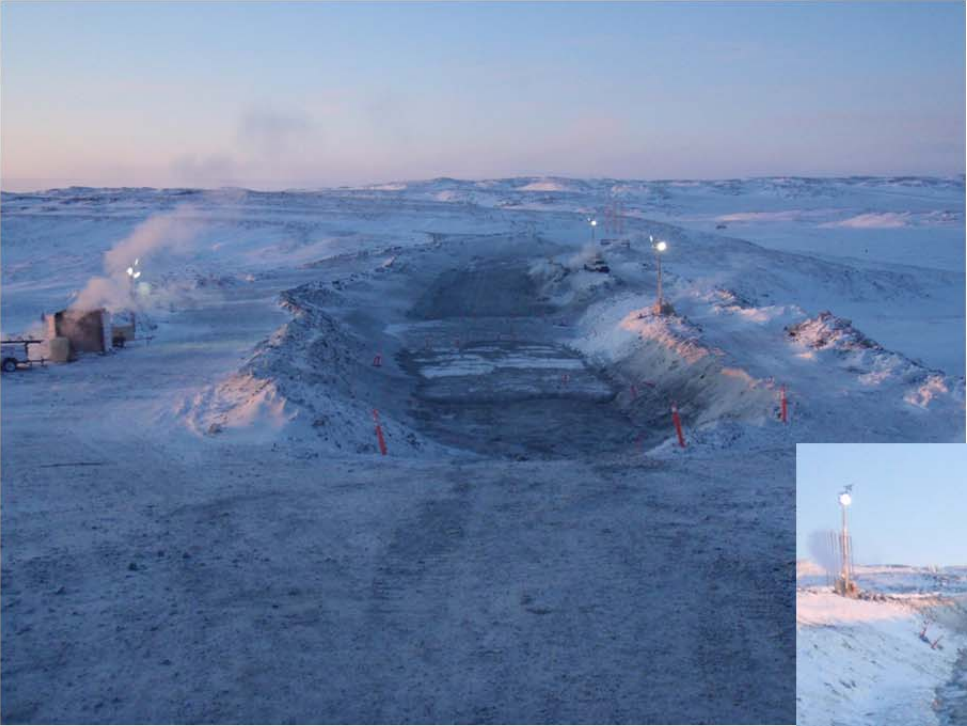
Photo 2 (top center): ~ WNW down key trench, photo taken in the am.

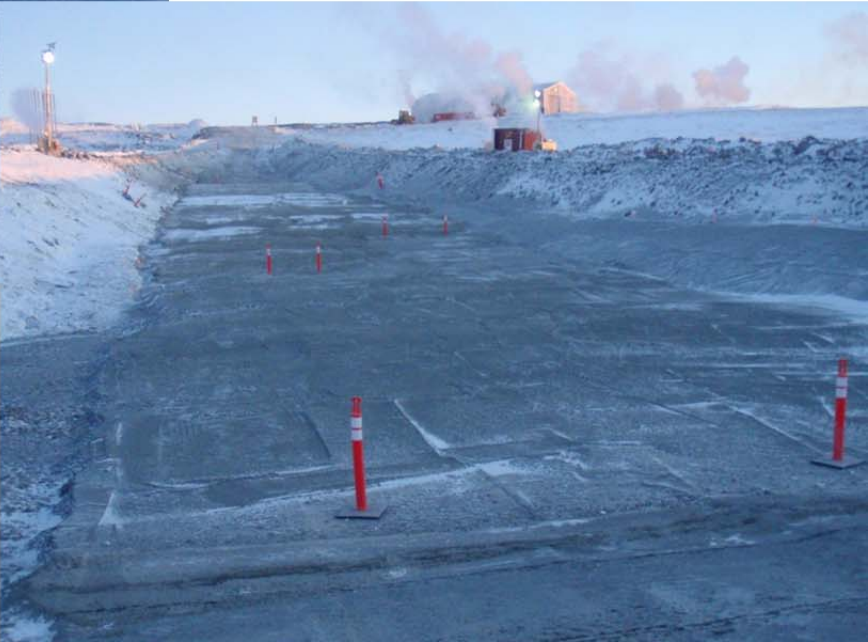
Photo 3 (right middle): ~ NE view down key trench. Note that the material in the forefront of the picture was placed on Jan 27th.

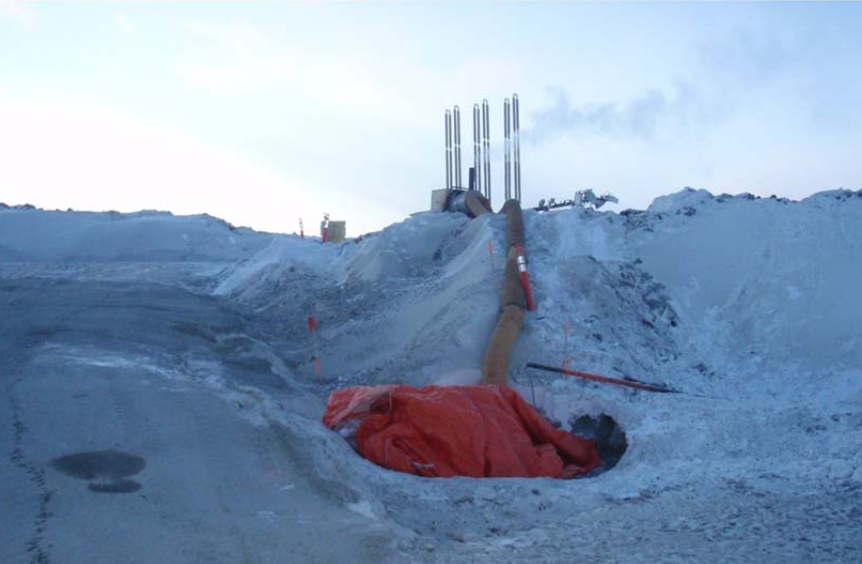
Photo 4: ~ NWW view of hording and frost fighter set up to warm thermistor string ND-HTS-060-28.8 for repair.

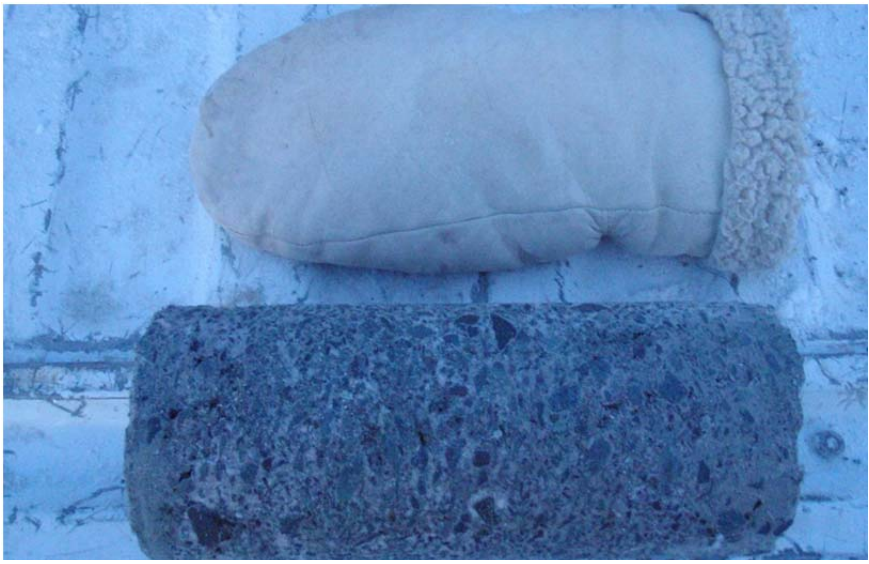
Photo 5: Drilled Core 10 (HB12-ND-CORE-DC10-QA-20120129), taken from ~ 0+92 around the centerline.

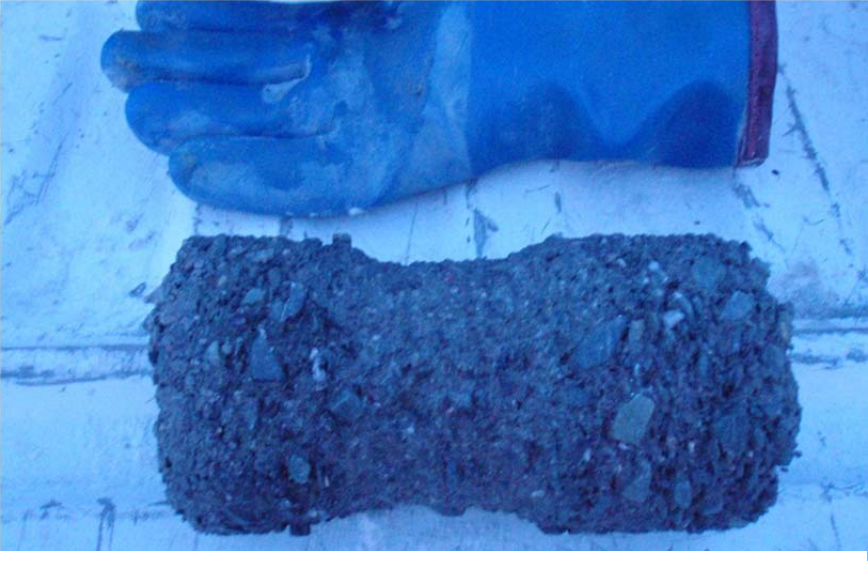
Photo 6: Drilled Core 11 (HB12-ND-CORE-DC11-QA-20120129), taken from ~ 1+25 on the upstream. Note that the central portion of the drill is narrower due to drill chatter (from dislodged gravel).

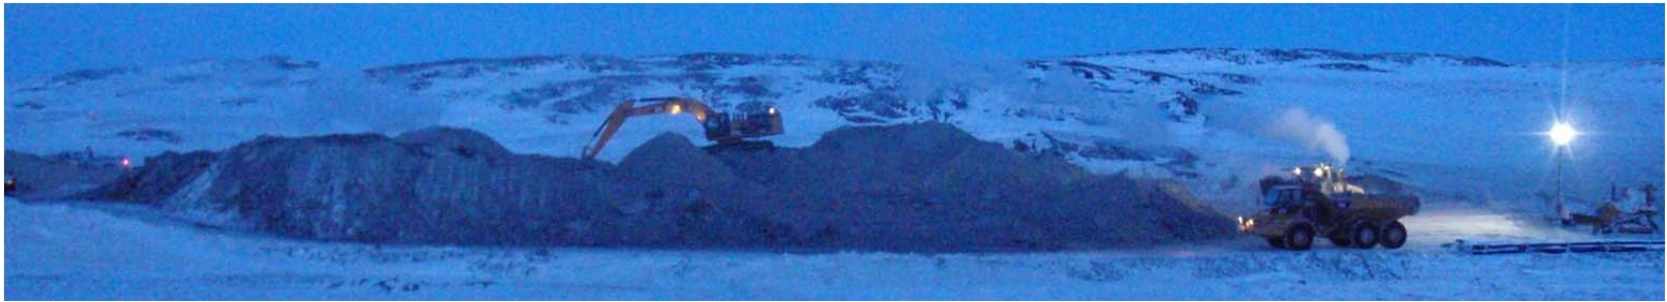
Photo 9: ~NE view towards the FCM stockpile on the FCP pad. Note the 345 excavator, 730 haul truck and loader working on breaking up the frozen stockpile.

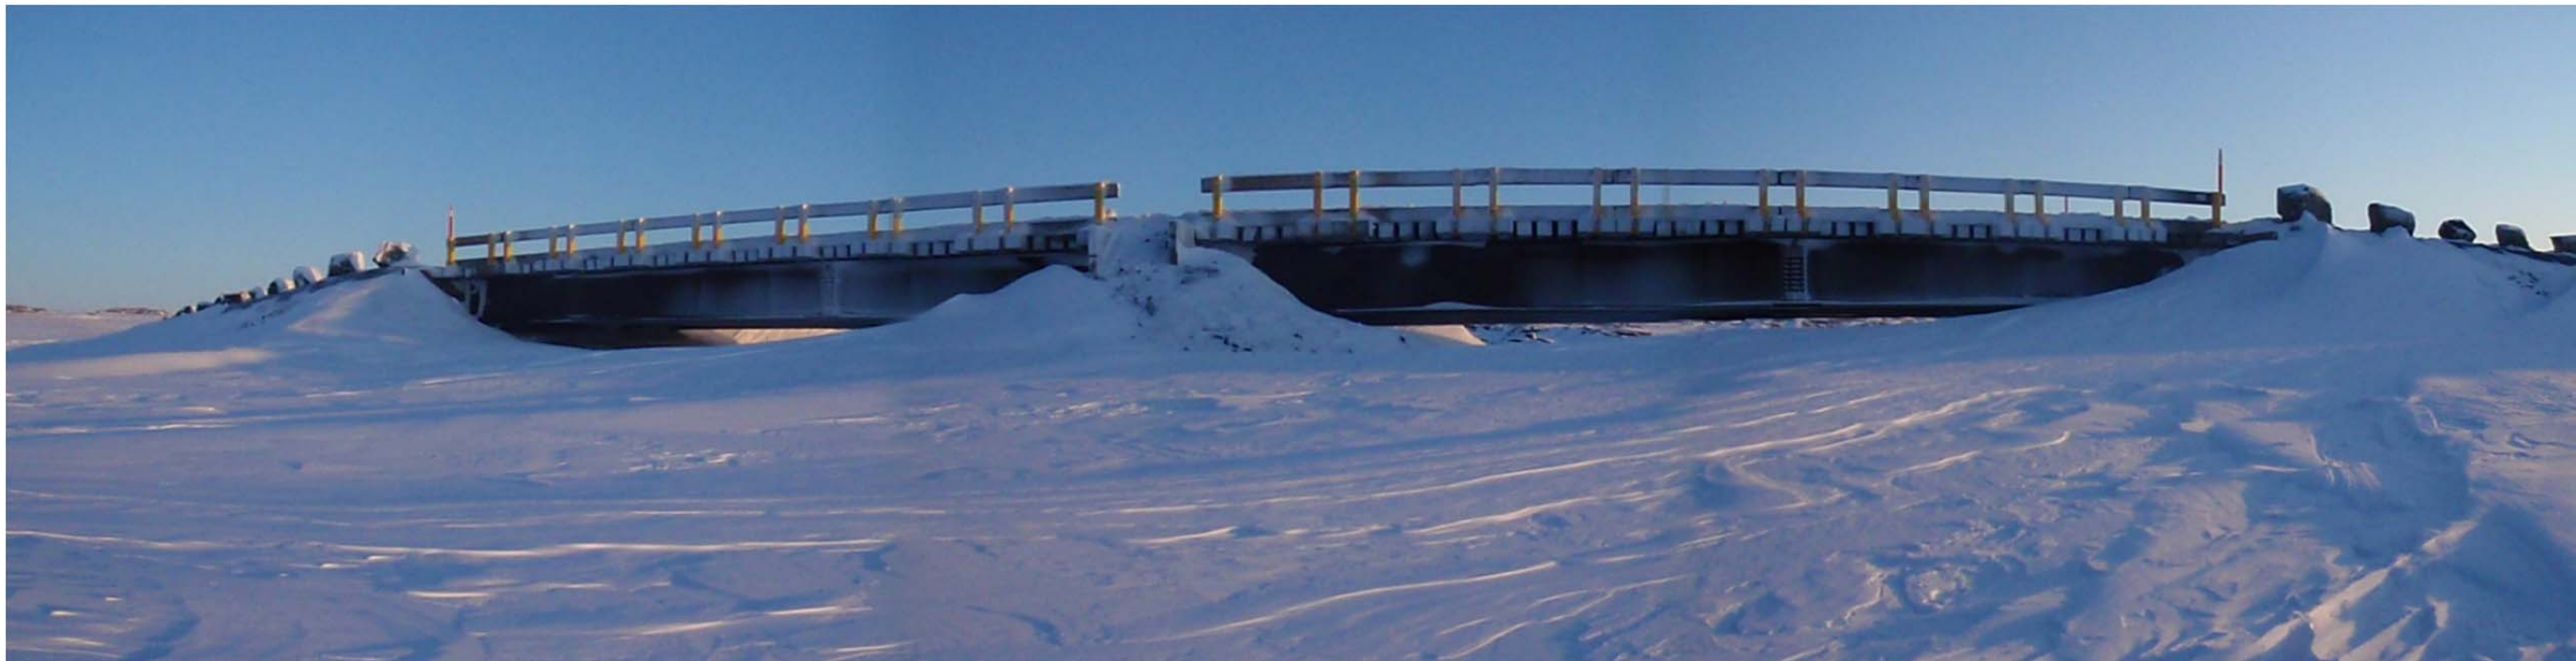
- SRK inspected the crossing along the Doris-Windy All Weather Road (AWR). See photos 12 to 14.

Photo 12: ~ENE view of Bridge/ Crossing #2 and #3, stitched panoramic view.

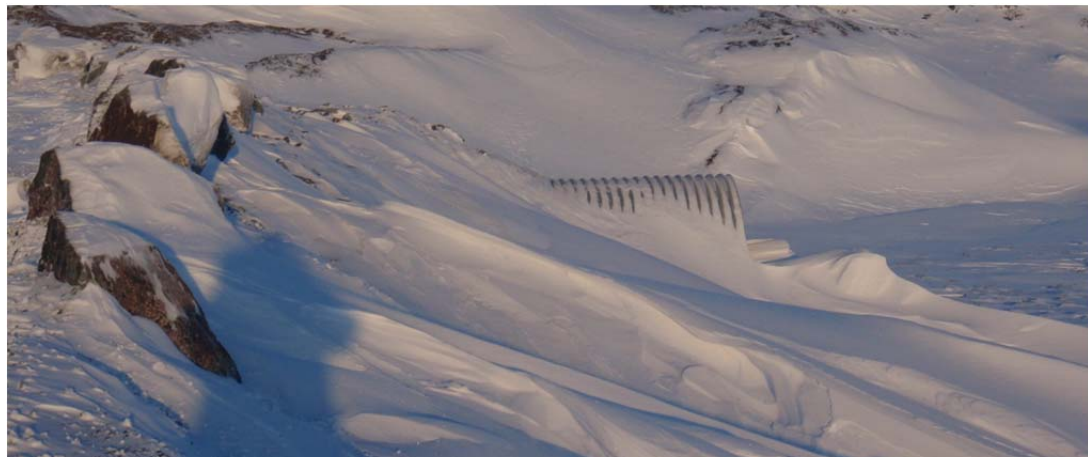
Photo 13: ~ NE view towards the S end of Culvert/ Crossing #1 on the Doris-Windy AWR.

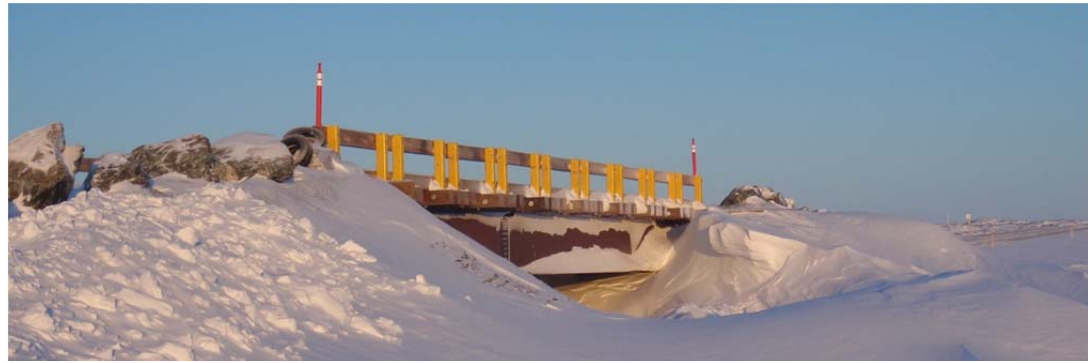
Photo 14: ~N view of Bridge/ Crossing #4 on the Doris-Windy AWR.

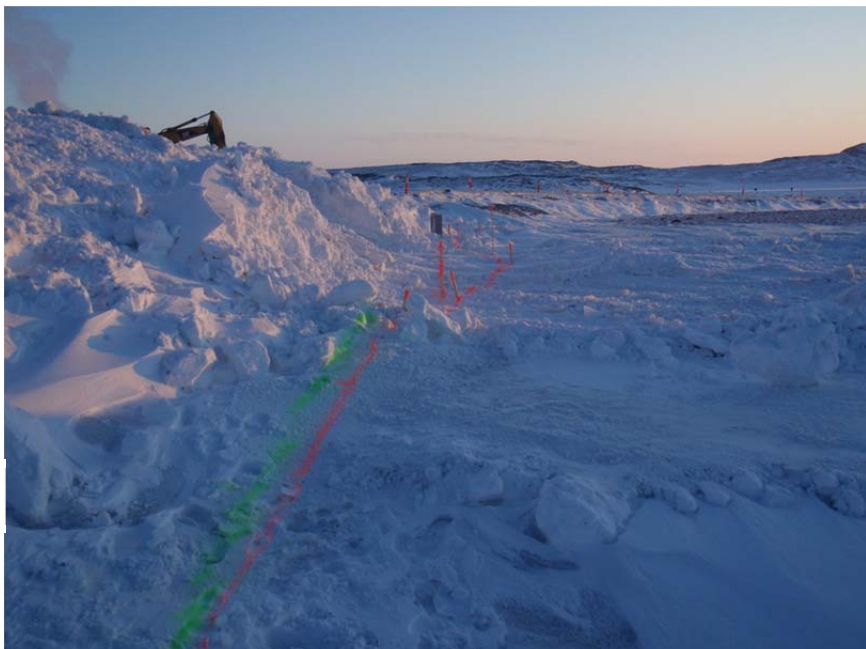
- The 325 excavator, spotted by Nuna survey, continued to remove snow around the location of sump 1, over the location of the buried cables. The snow was removed with ~0.3m from the top of the cables. The area where the cables intersect the Sump #1 footprint was horded/ covered and frost fighters were brought into to thaw out the area and further expose the cables. Hand shovelling is expected to result around this location in the coming days. See Photo 15.

Photo 15: ~E view towards the Doris Camp Sump #1. Note that the green and orange spray-paint marks the as-built location of the cables which intersect the Sump #1 footprint.

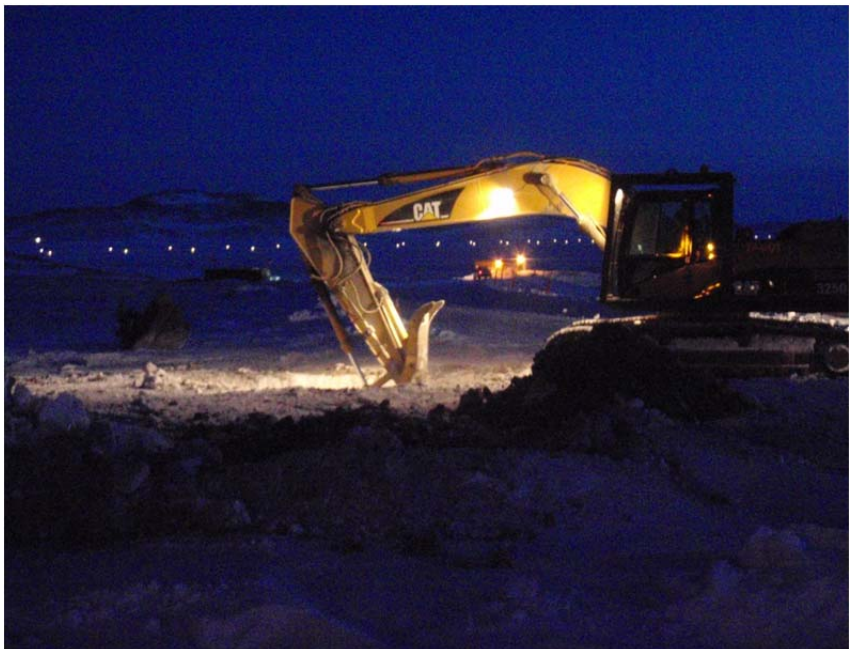
- The 325 excavator (equipped with the tooth bucket) started to excavate material from the drilled/ 'honeycombed' footprint of Sump 2. The excavator appeared to be working well for removing material from within the Sump #2 footprint. See Photo 16.

Photo 16: ~E view of the 325 excavator (with toothed bucket) working on excavating material from the drilled Sump #2 footprint.

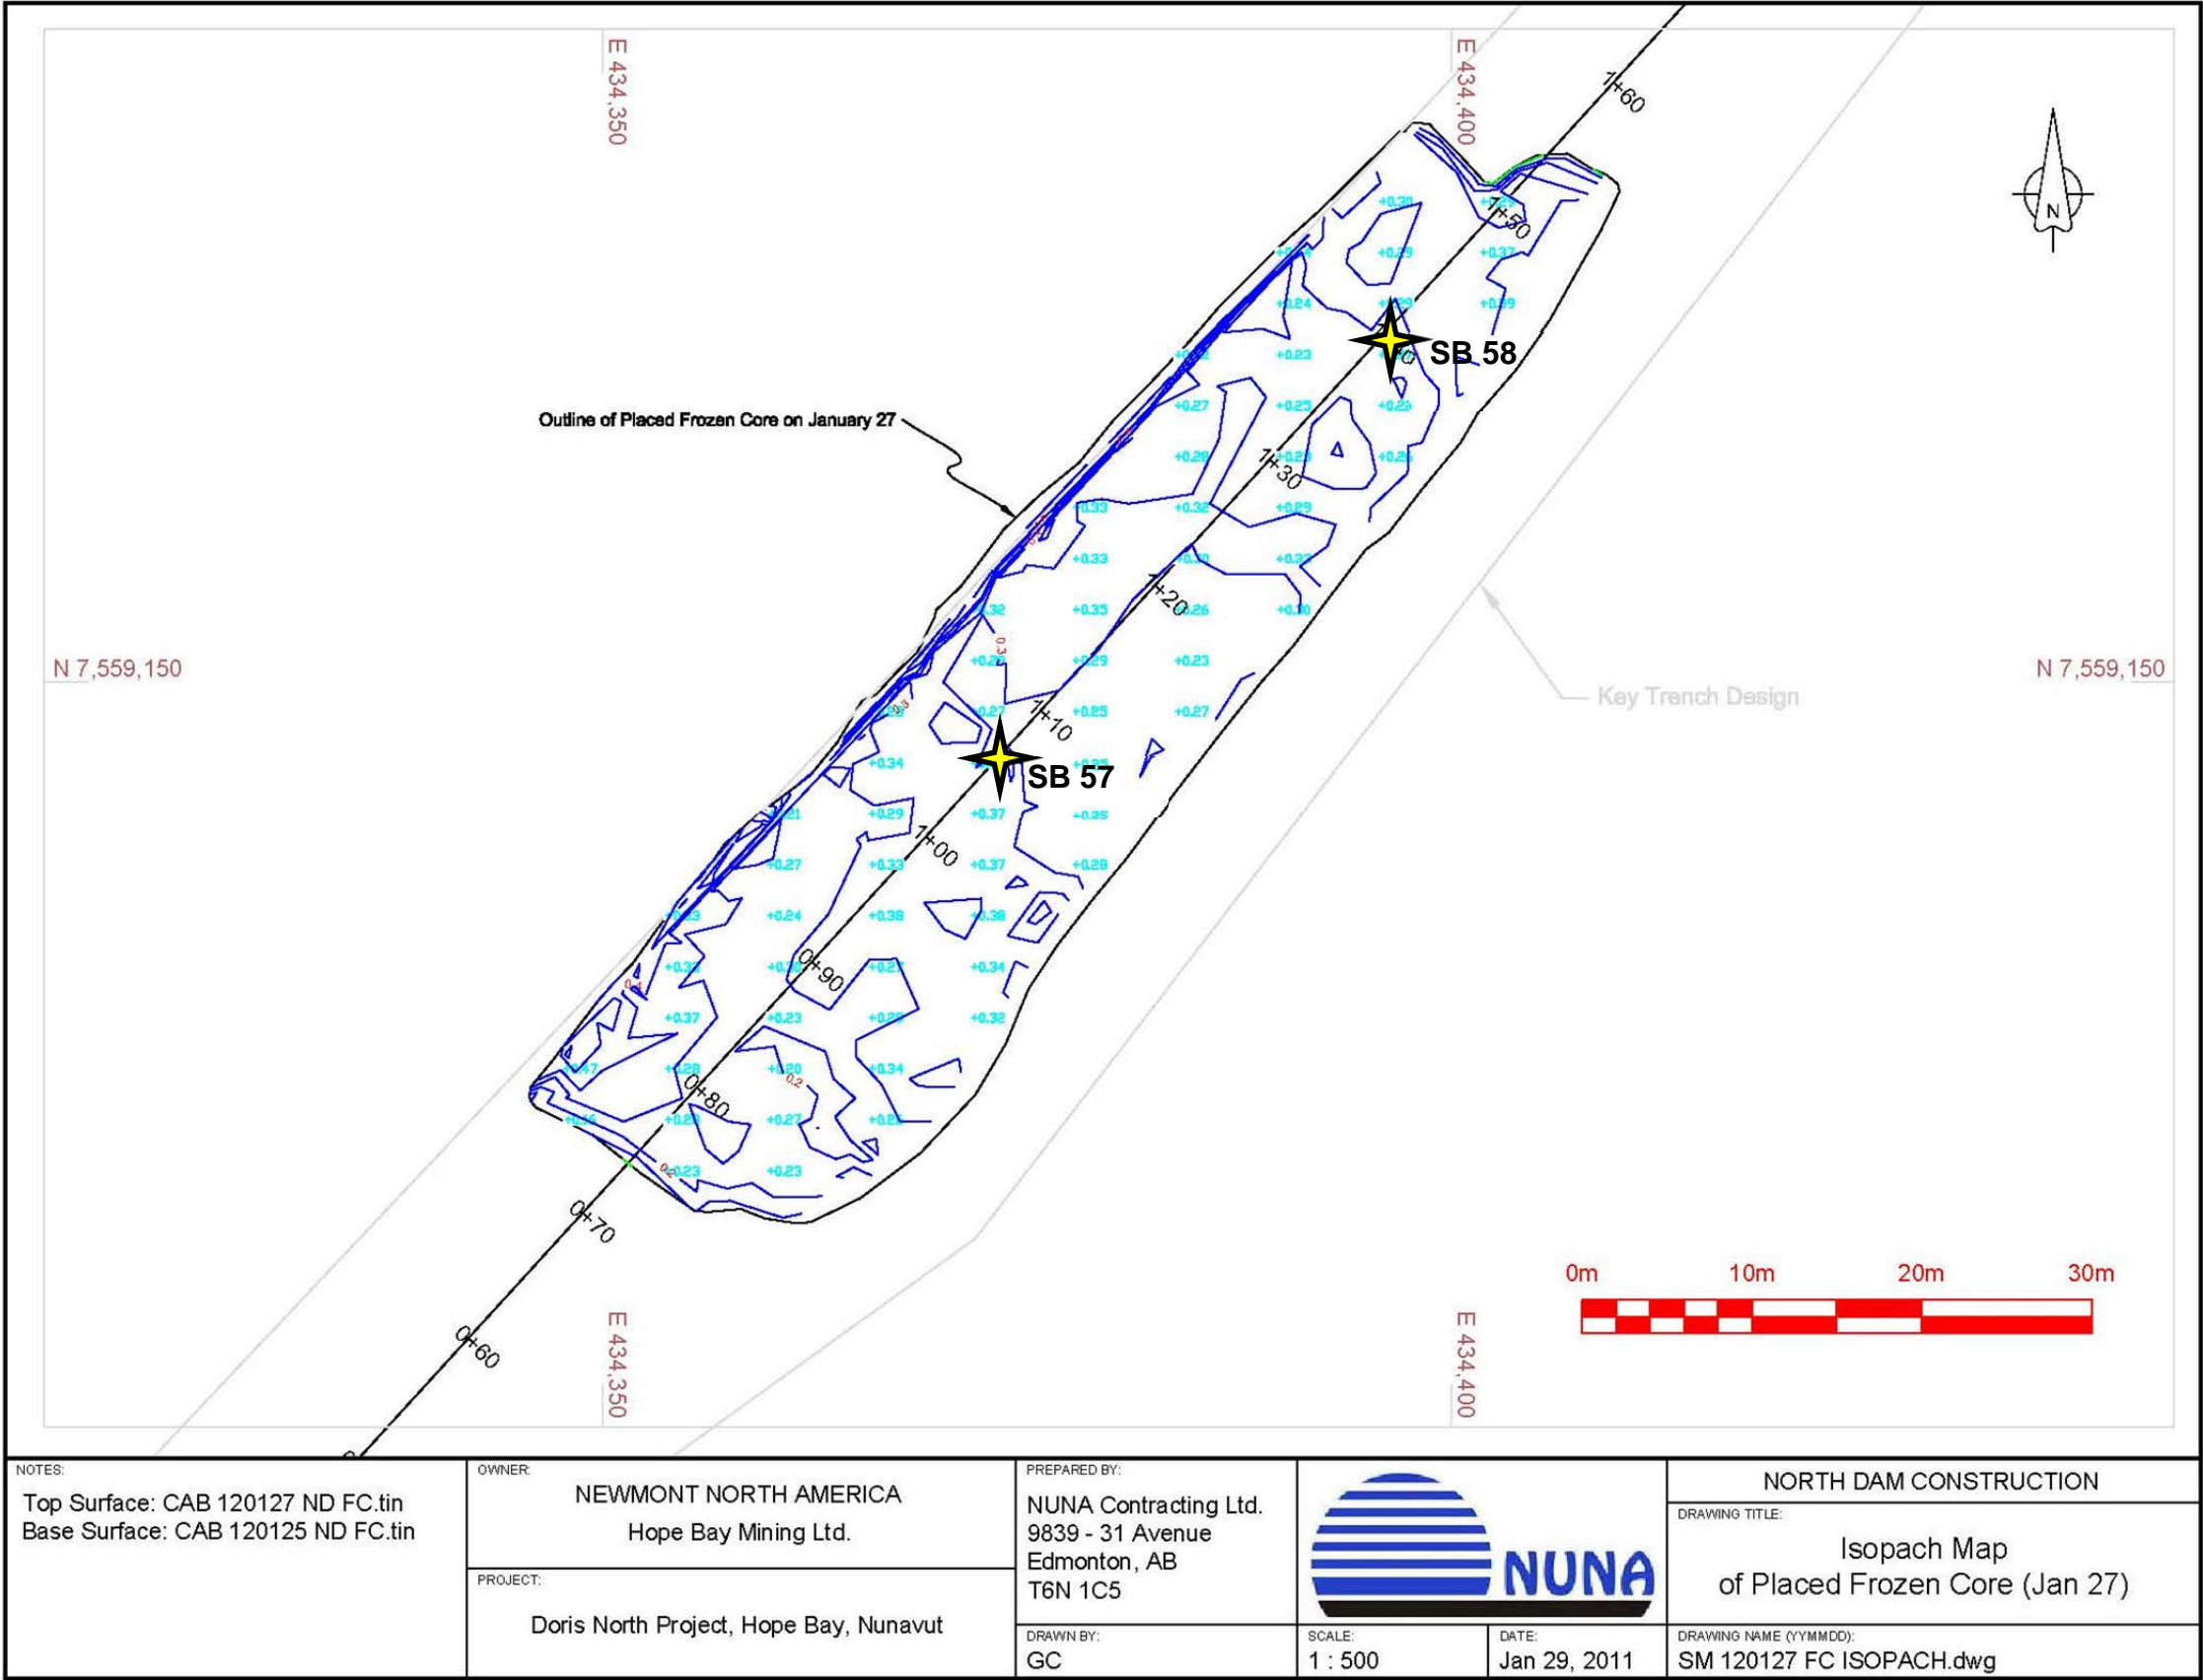
Required	•
Data Received	•
Outstanding	<ul style="list-style-type: none"> • Isopach map of FCM lift thickness placed on 2012/ 01/ 27 (see Figure 3) • Pick-up of 5/8" material removal from 2012/01/25
Upcoming	•

Figure 3 – Isopach showing thickness of Jan 27th FCM placement. Note the approximate locations of single bead 57 and 58 are shown on this drawing for reference.
