DAILY REPORT #25 – DORIS NORTH INFRASTRUCTURE/ NORTH DAM

Prepared by:	John Kurylo/ Jeff Orr / Megan Miller	Date:	2012.01.30
Reviewed by:		Project #:	1CH008.058.0320
Role	Company	Personnel – Position	On Site
Client	Hope Bay Mining Limited (HBML)	Angela Holzapfel – ESR Compliance Manager David Vokey – ESR Coordinator Don Ethelston – HSLP Advisor Dean Wold - Safety Jill Turk – ESR Coordinator Katsky Venter – ESR Manger Michelle Tanquay – ESR Site Manager Stirling Kelly – HSLP Advisor	No Yes Yes No No Yes No No
	JDS	Lloyd Jackson – Mechanical Superintendent Sven Archimowtiz – Electrical Superintendent Doug Fielding – Construction Manager Ishan Fechter – Construction Coordinator Jerry Graham – Construction Manager Kevin Whieldon – Project Coordinator Mark Valeriote – Construction Manager	Yes Yes Yes No No Yes Yes
Engineering Design Consultants	SRK Consulting (Canada) Inc.	John Kurylo – Site Engineer Megan Miller – Site Engineer Lawrence Borowski – Site Engineer Murry McGregor – Site Engineer Iozsef Miskolczi – Site Engineer	Yes Yes No No No

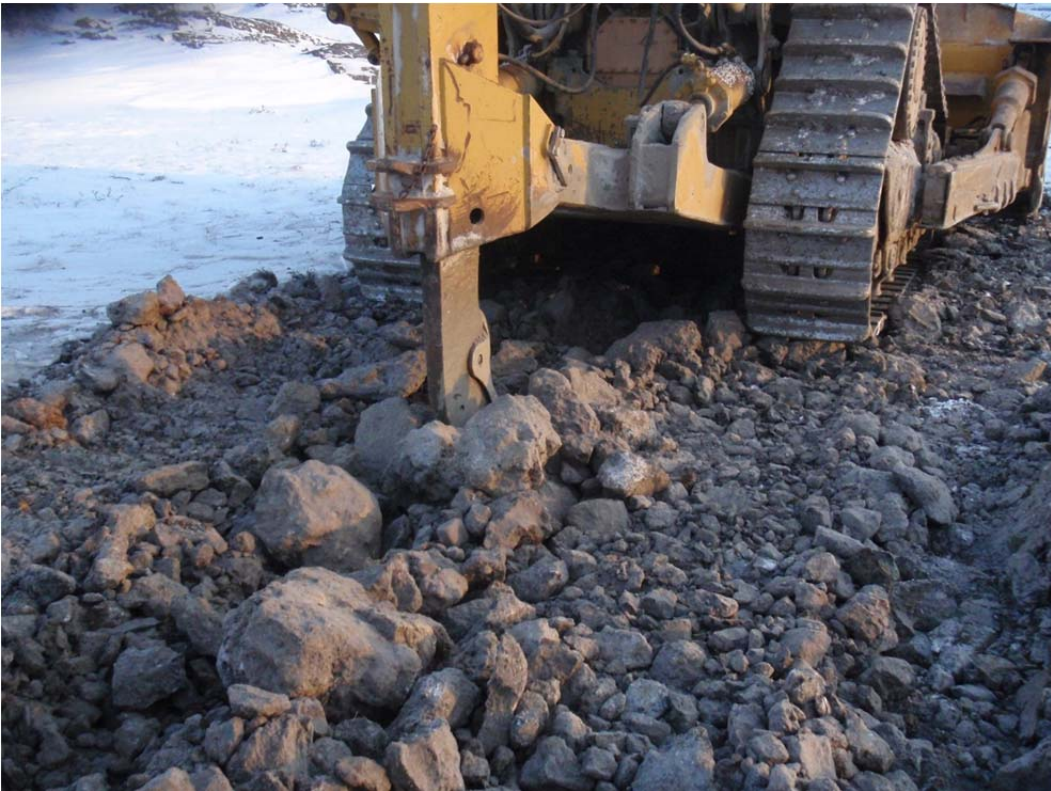
Photo 1: View of D9 ripping up frozen tundra/ permafrost along the W side of the DN Diversion Berm alignment.

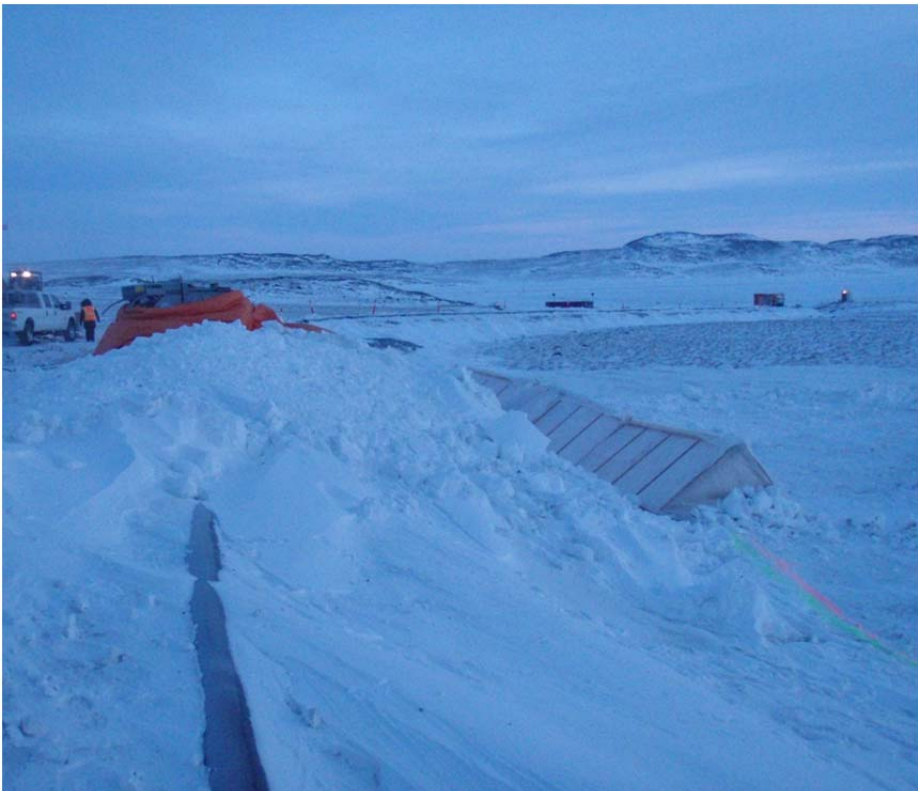
Photo 2: ~E view of hording and heating around the cables which intersect the Sump #1 footprint.

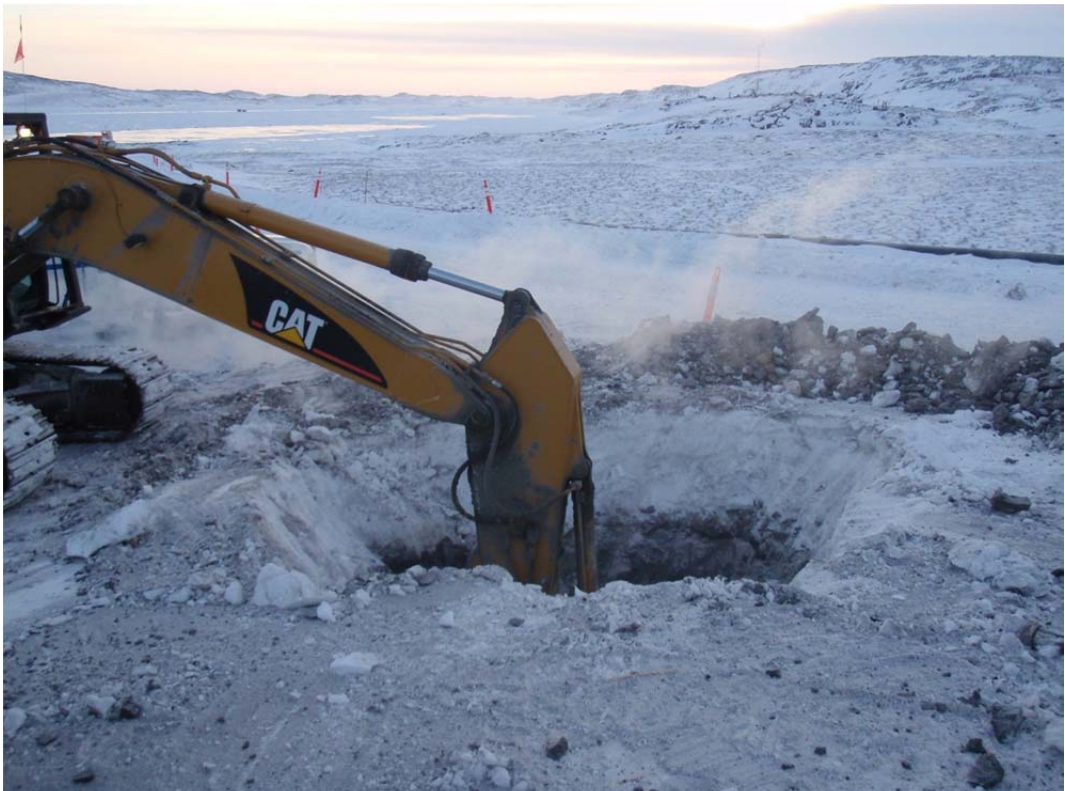
Photo 3: ~SE close-up view of 325 excavator digging within the Sump #2 footprint.

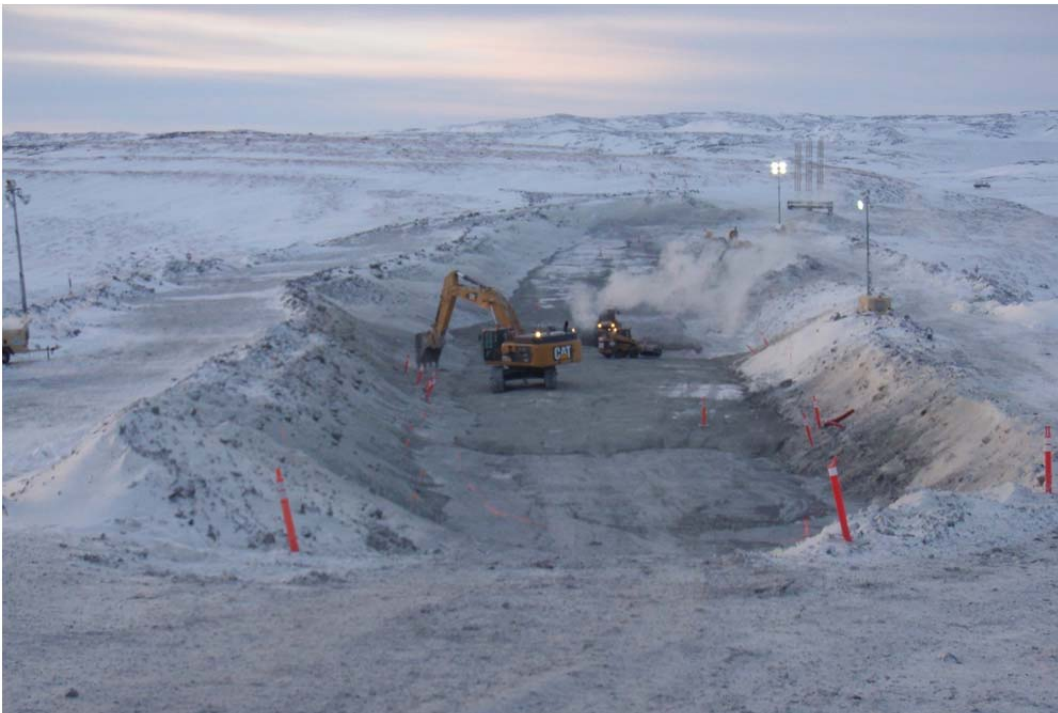
Photo 4: ~ WSW view of down the key trench. Note the skid steer and 345 excavator cleaning in preparation for placement in this photo.

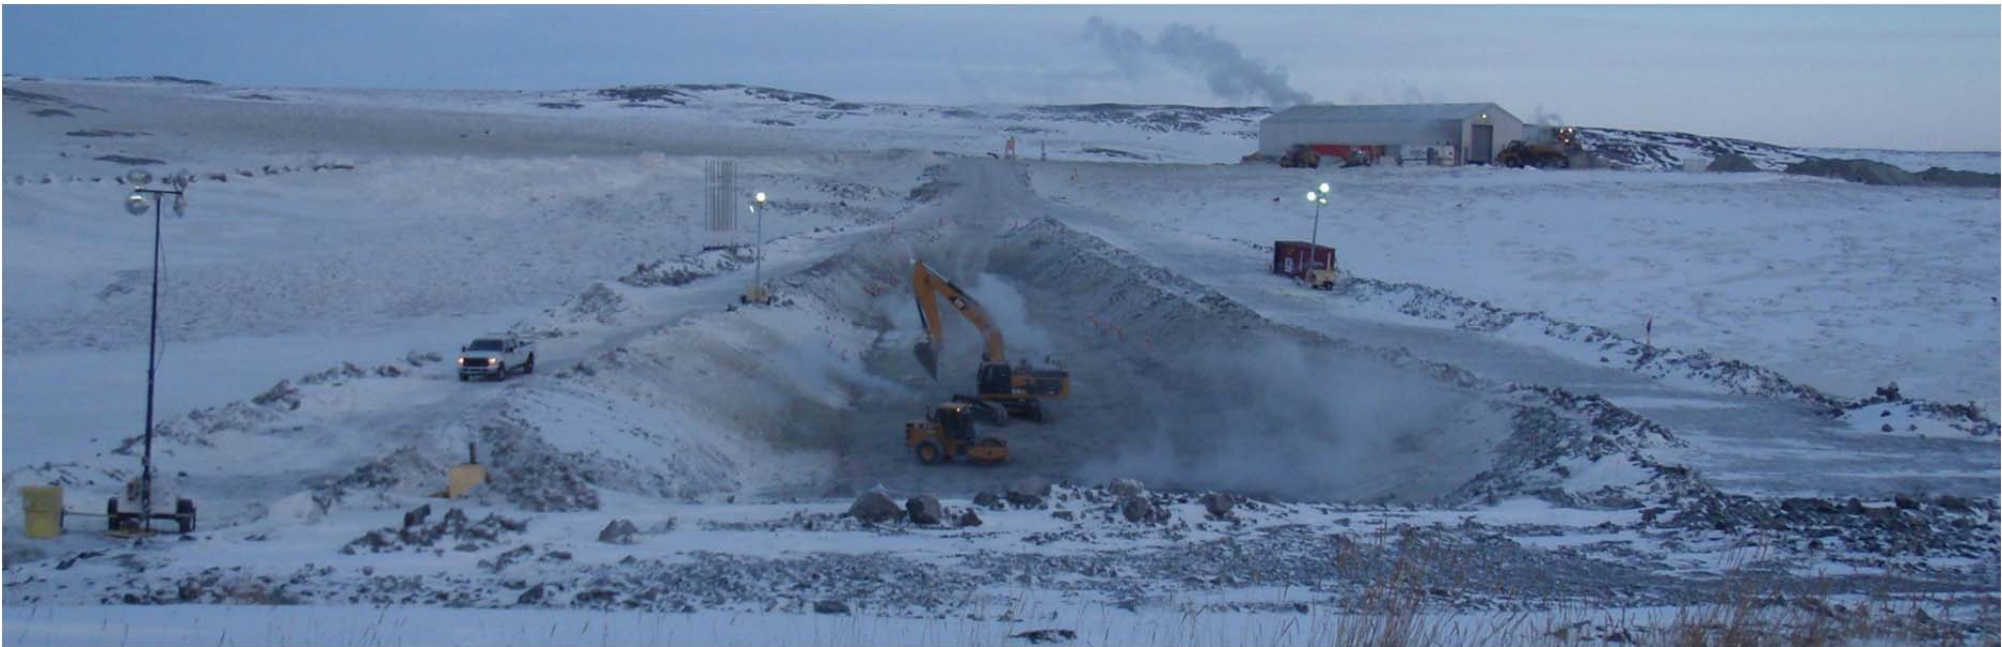
Photo 5: Progress photo of North Dam from photo point 3. ~ENE view.

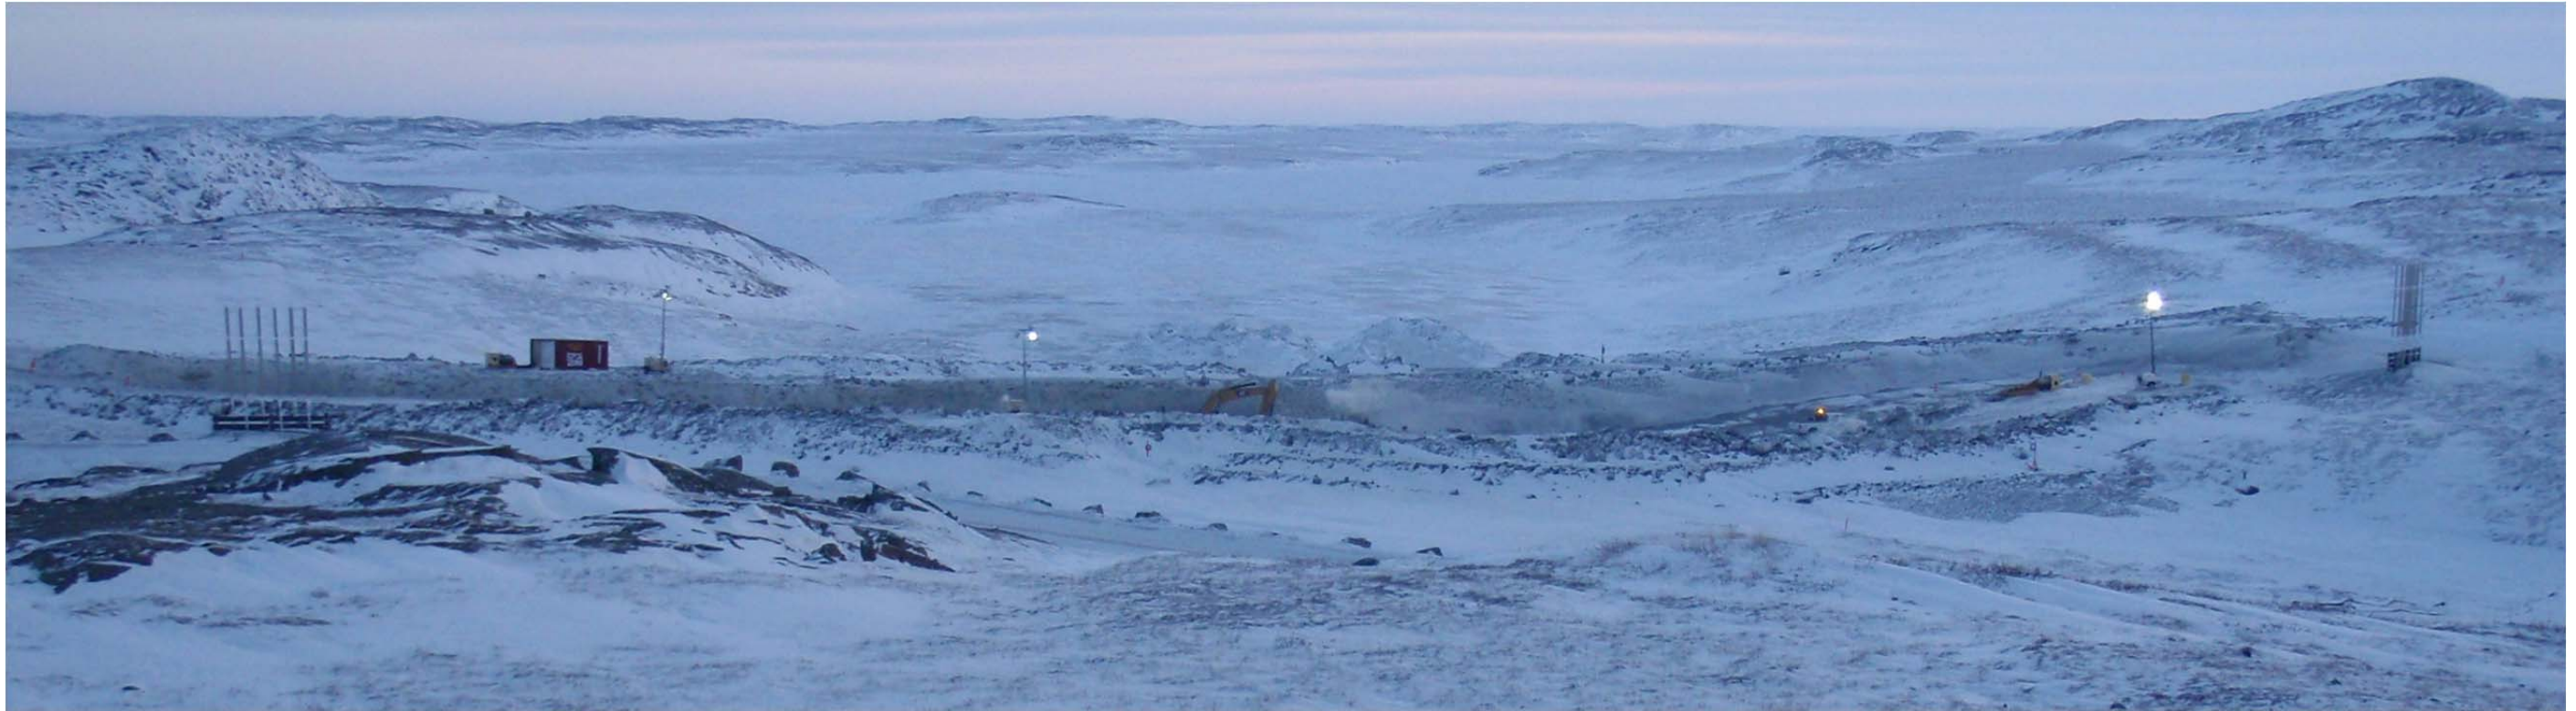
Photo 6: Progress photo of North Dam from photo point 1. ~SSE view.

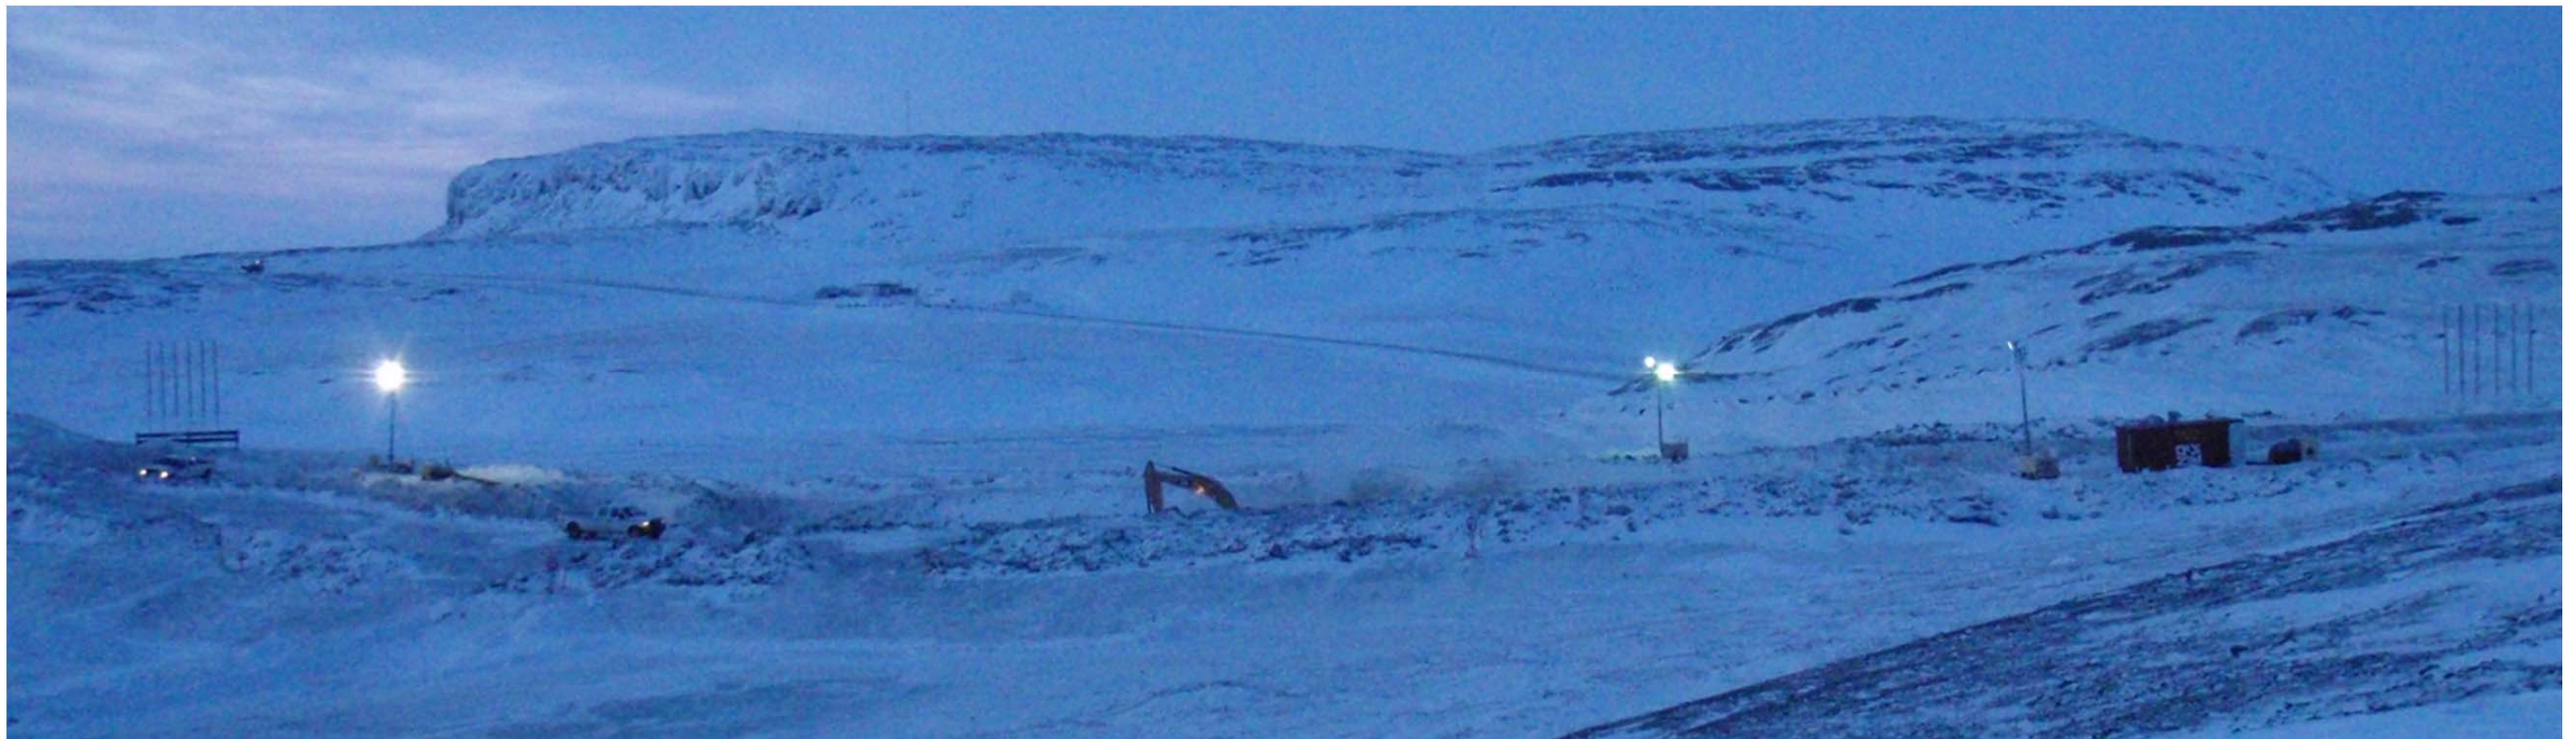
Photo 7: Progress photo of North Dam from photo point 2. ~WNW view.

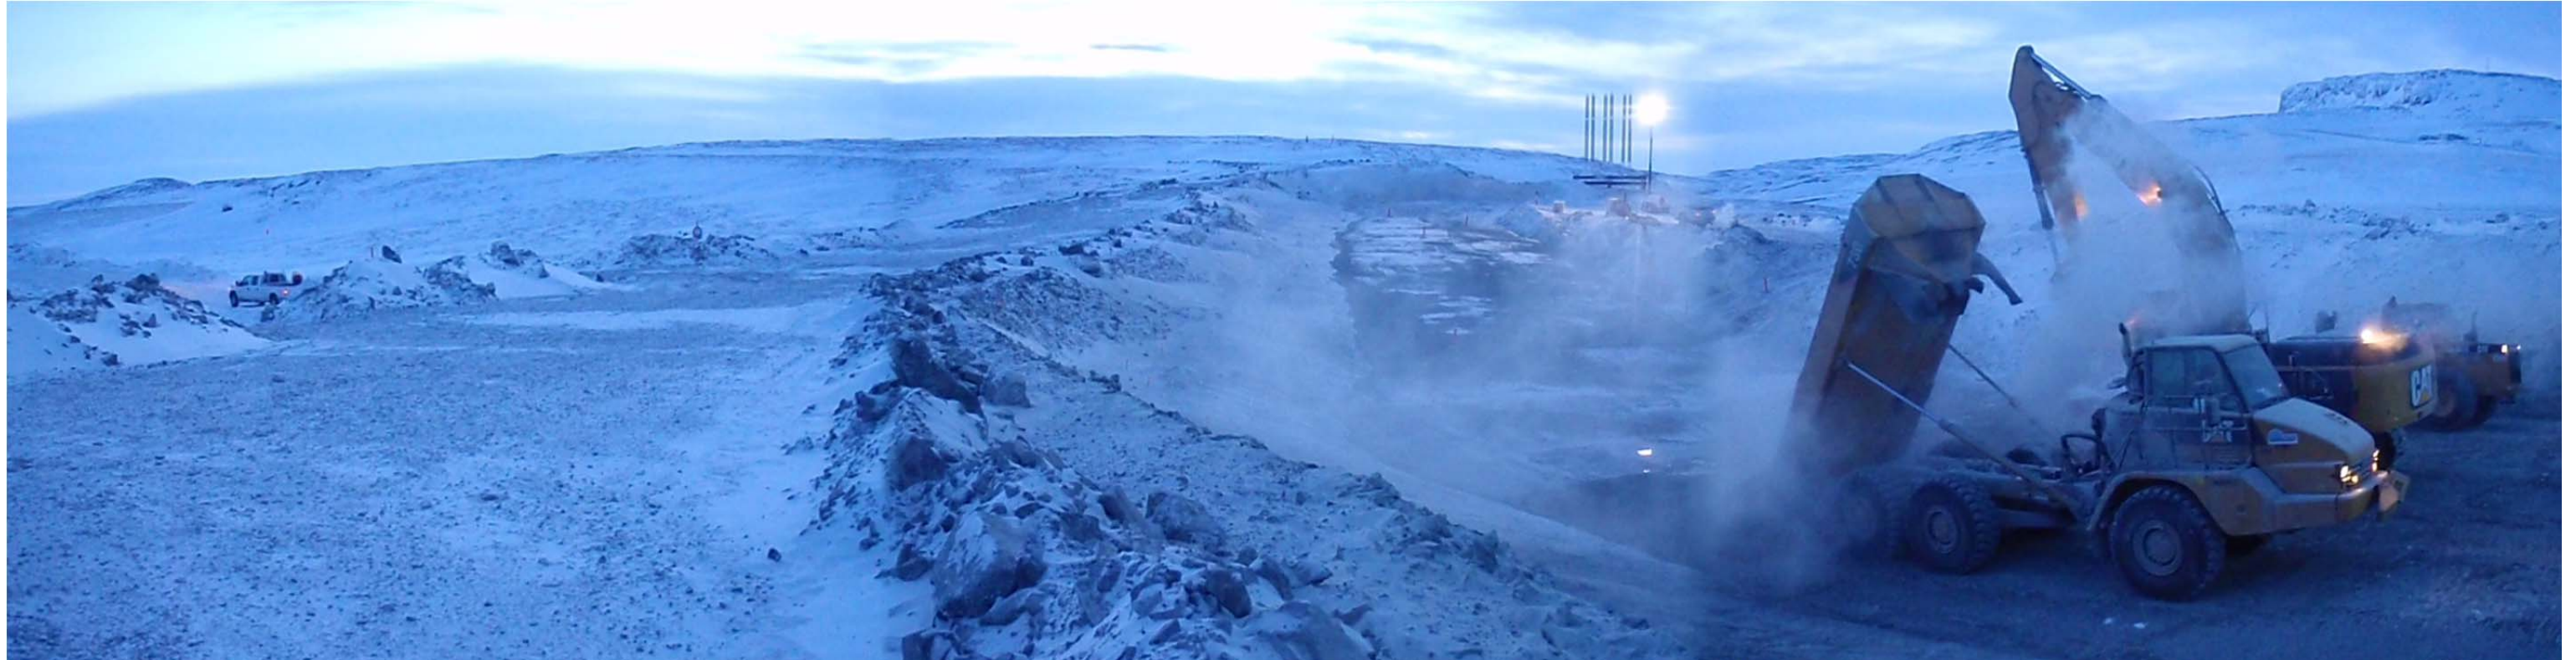
Photo 8: ~NW stitched panoramic view of FCM placement around station 0+90.

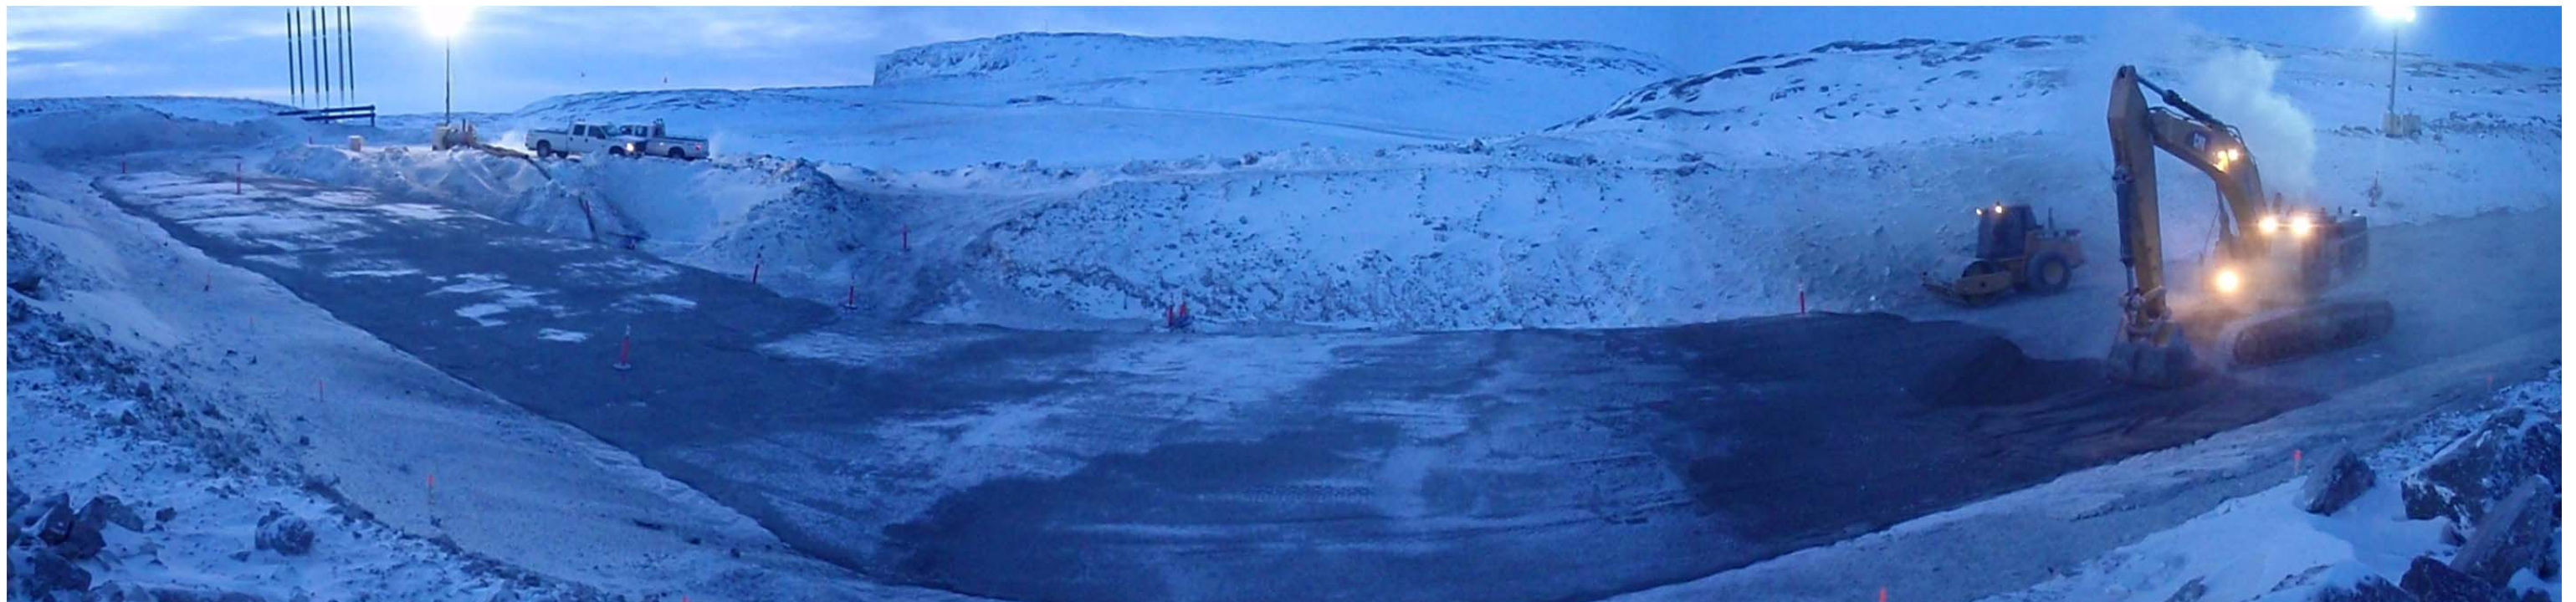
Photo 9: ~ N stitched panoramic view of FCM placement progress on dayshift, taken in the pm. Note the 345 excavator is spreading the dumped material in ~ 0.3m thick lift before it is compacted with the vibratory roller.

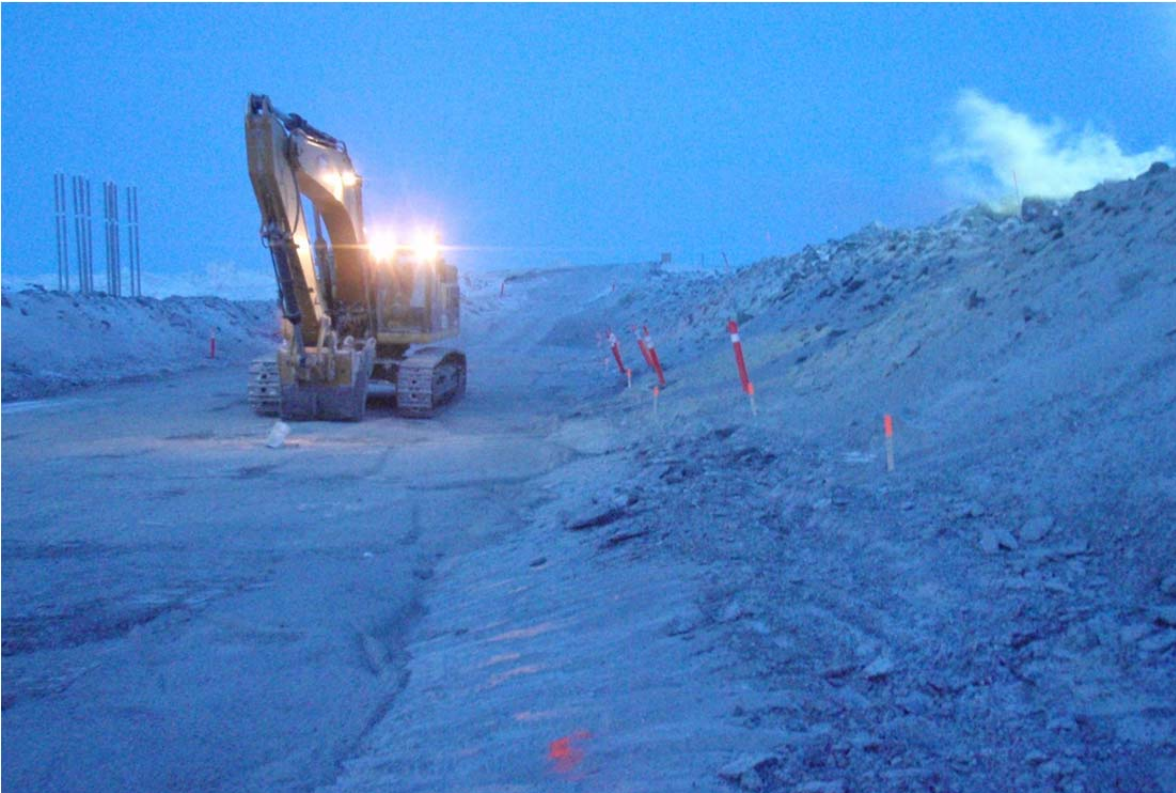
Photo 10: ~NEE view of excavator cleaning 5/8" material from the upstream fillet slope.

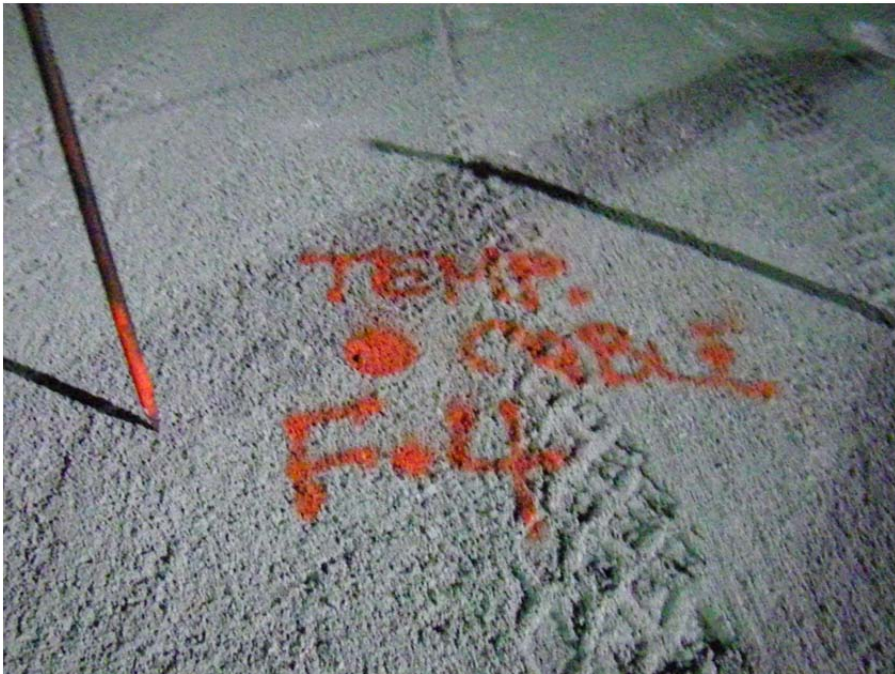
Photo 11: Paint marks indicating the height to the next horizontal thermistors cables above the current lift.

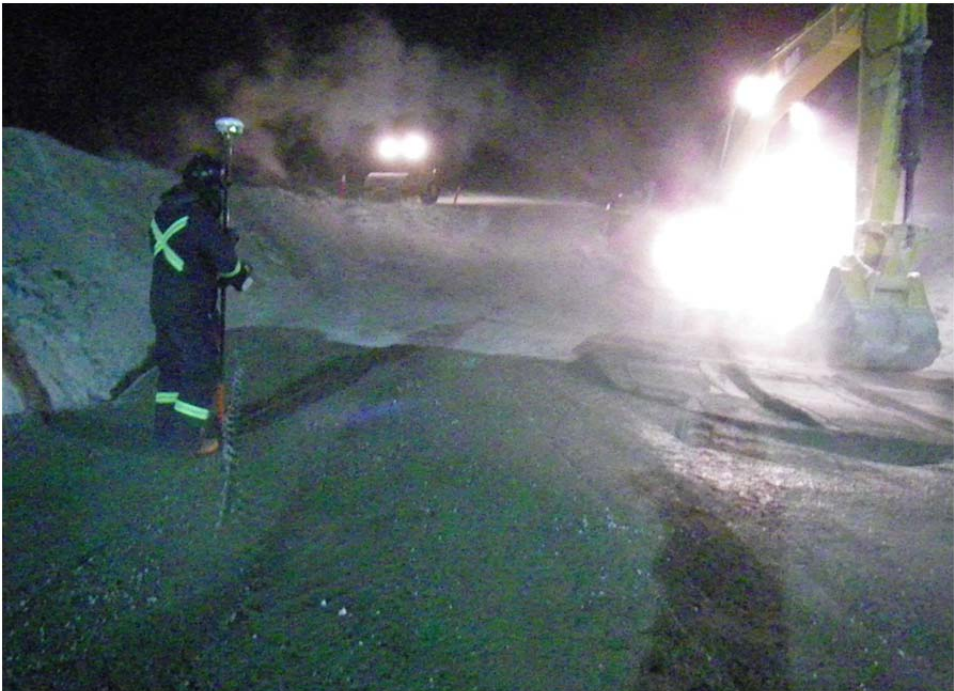
Photo 13: Survey picking up the edge of the FCM placed on nightshift.

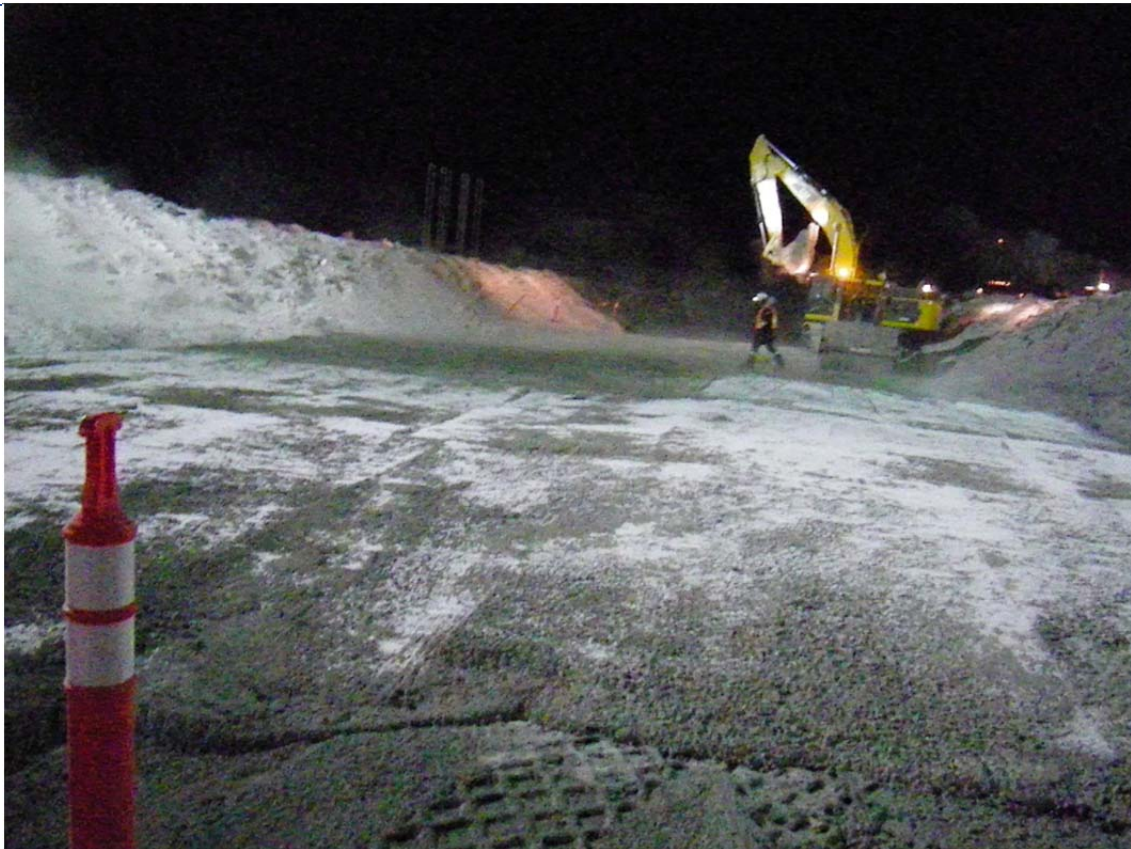
Photo 12: Looking NE along key trench at material placed during the nightshift.

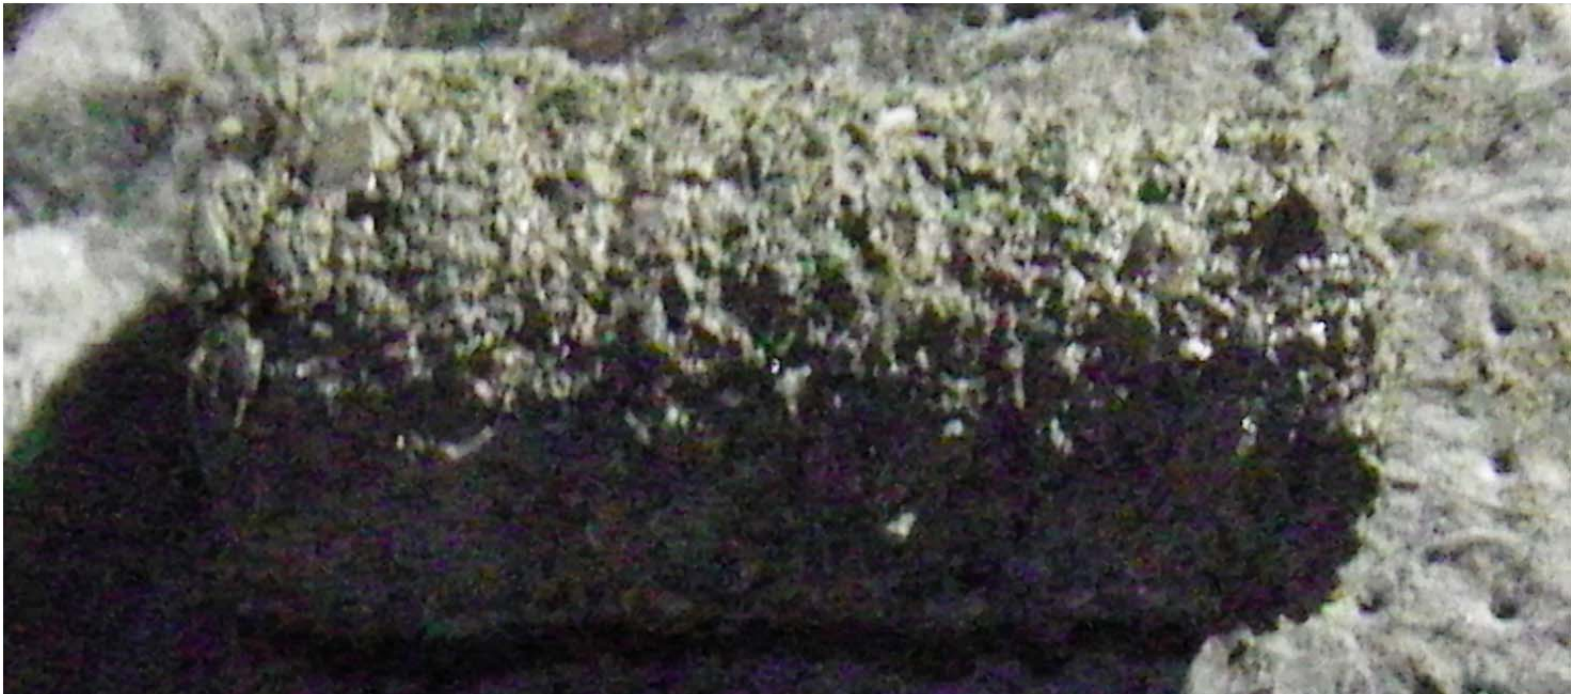
Photo 14: Drilled core HB12-ND-CORE-DC12-QA-20120130 collected from station 0+55 downstream. This core is of the lift placed 2012/01/29 nightshift.

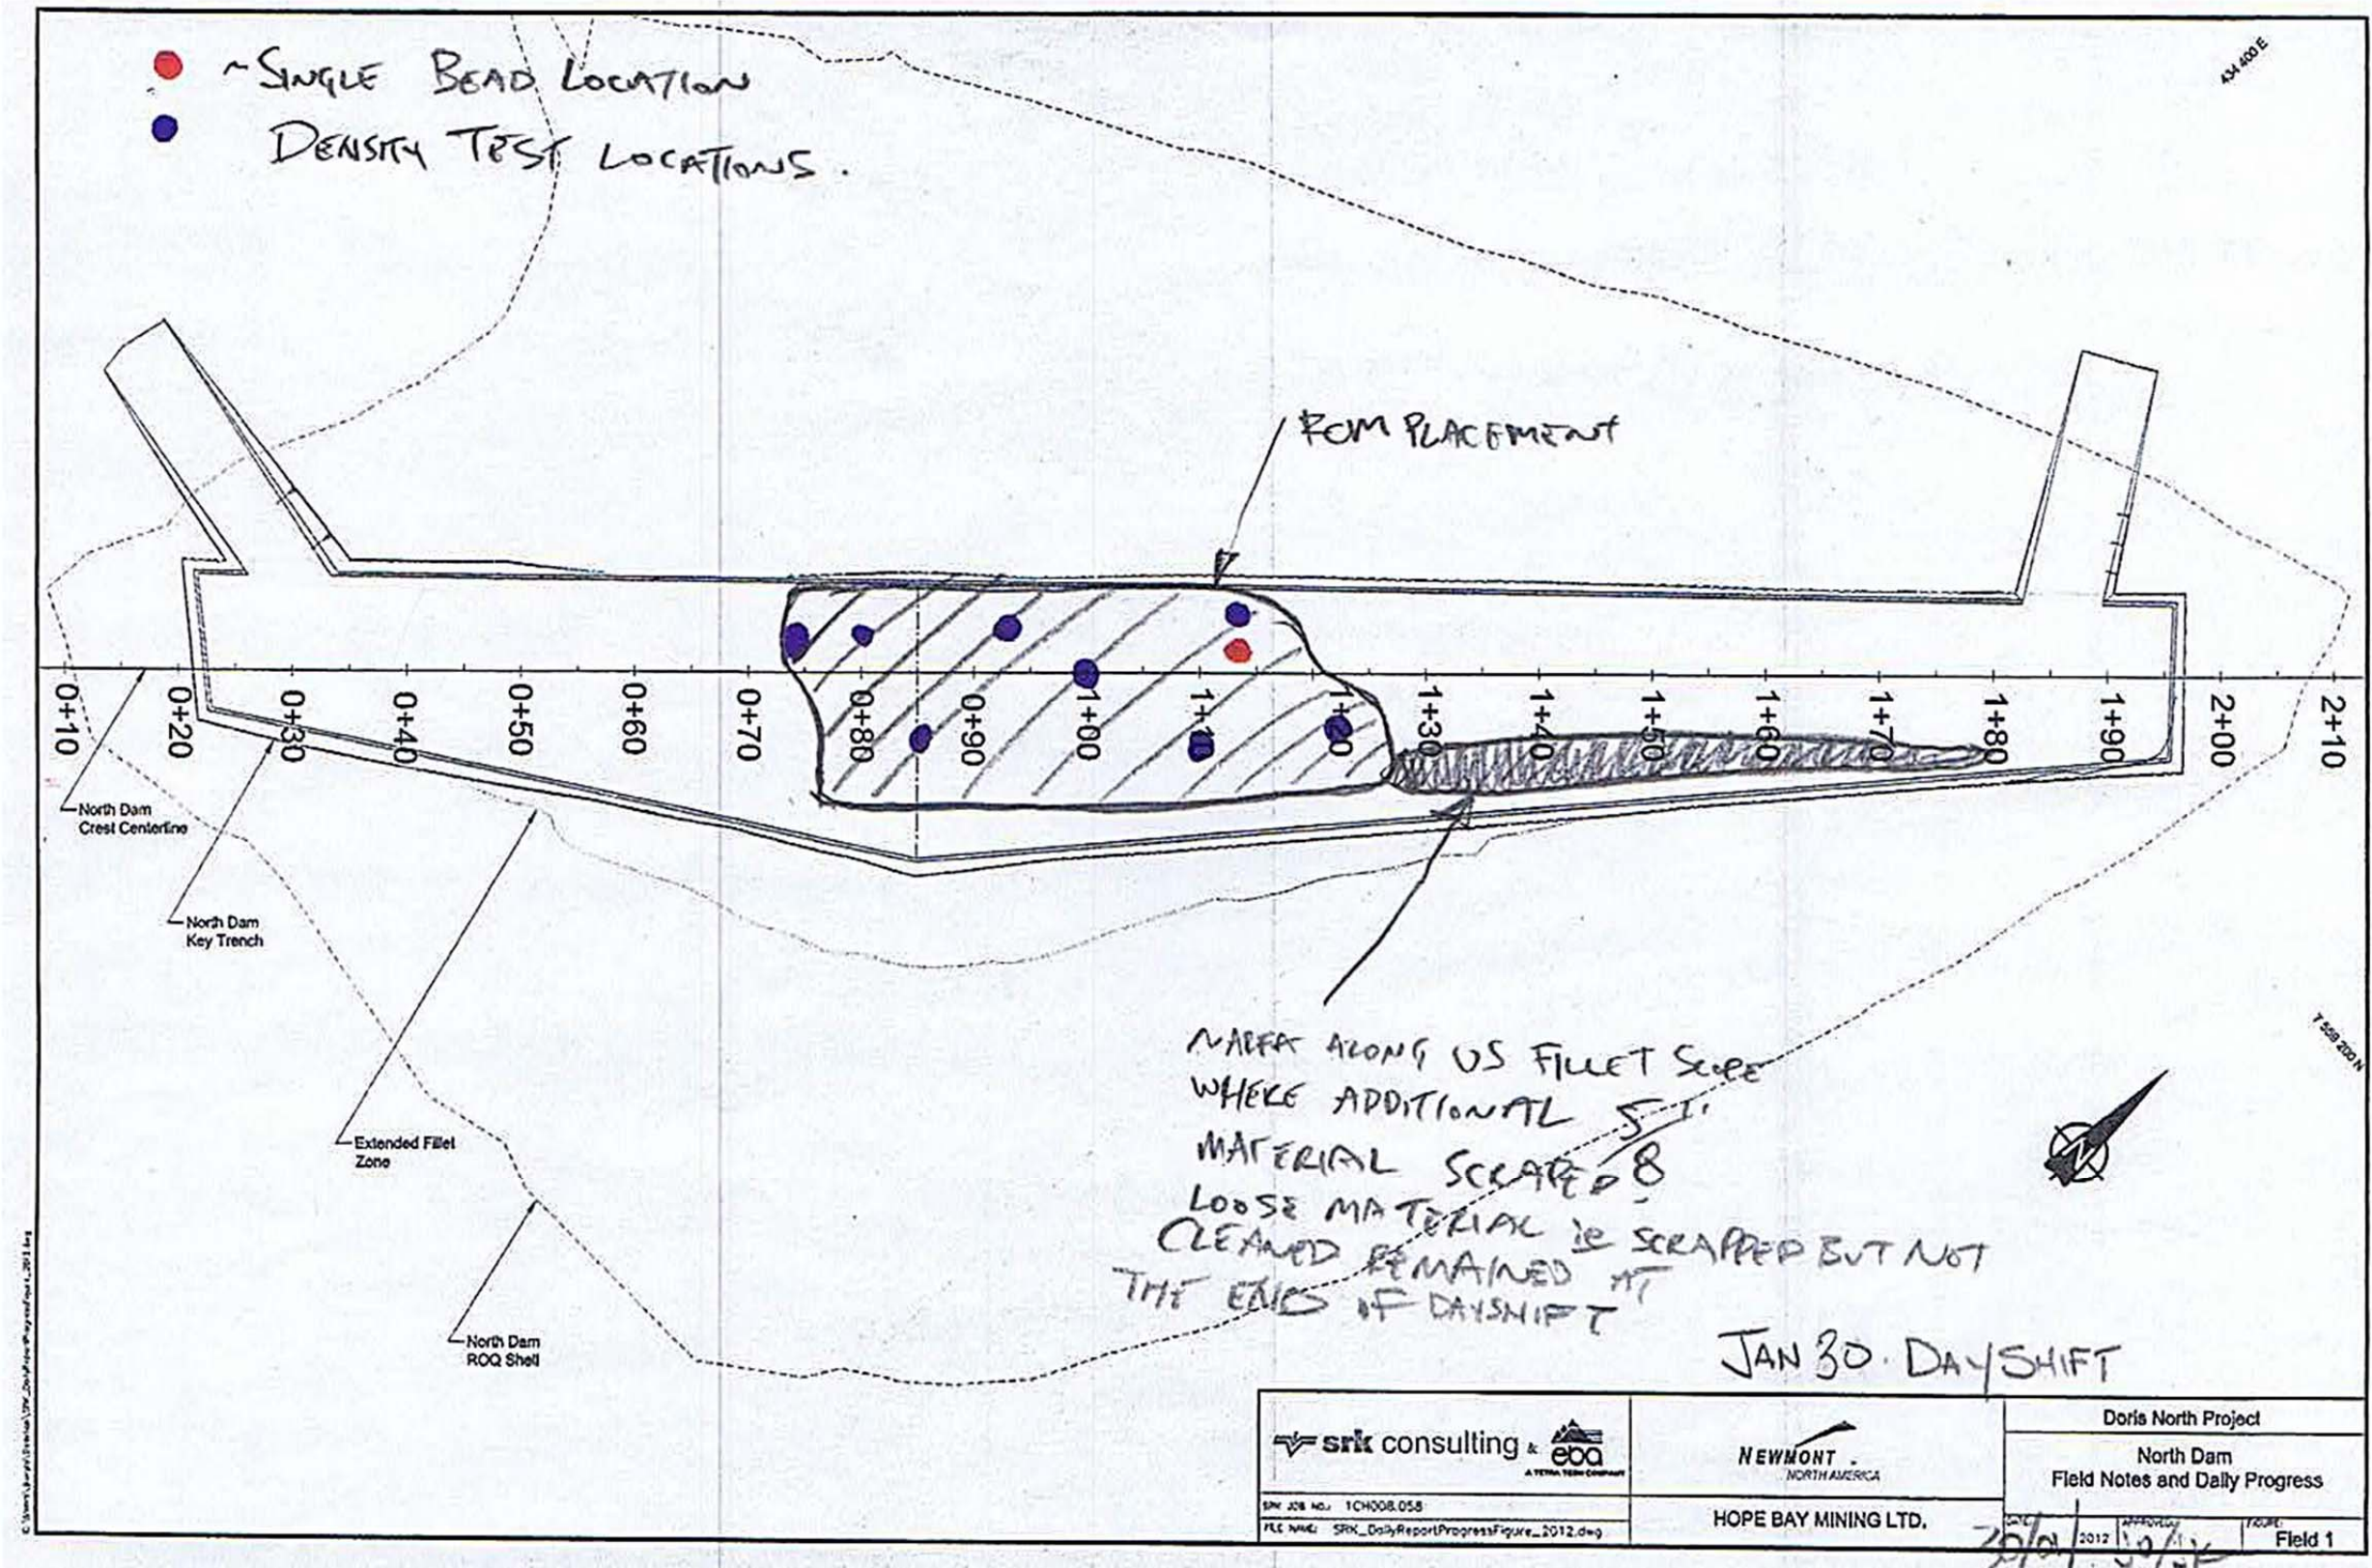
FIGURES:
Figure 1 – North Dam Progress – Jan 30th DAYSHIFT

- FCM was placed today on dayshift from ~0+70 to 1+25.
 - Overall, the placement went well. Some variance in moisture contents was observed and required adjustments throughout the day. A few loads of core material were placed drier than optimum. This was corrected by additional compactive effort on the material in order to lower the air voids and increase saturation.
- Additional work on scraping 5/8" clear from ~ 0+90 to 1+70 resulted. Although most of the 5/8" material has been removed, portions of the aforementioned area remained to be cleaned/ swept at the end of dayshift.
- Thermistor string ND-HTS-060-28.8 was repaired today by the Nuna electricians.
- Figure 1 presents today's dayshift construction progress at the North Dam.
