DAILY REPORT #25 – DORIS NORTH INFRASTRUCTURE/ NORTH DAM

Prepared by:	John Kurylo/ Jeff Orr / Megan Miller	Date:	2012.01.30
Reviewed by:		Project #:	1CH008.058.0320
Role	Company	Personnel – Position	On Site
Client	Hope Bay Mining Limited (HBML)	Angela Holzapfel – ESR Compliance Manager David Vokey – ESR Coordinator Don Ethelston – HSLP Advisor Dean Wold - Safety Jill Turk – ESR Coordinator Katsky Venter – ESR Manger Michelle Tanquay – ESR Site Manager Stirling Kelly – HSLP Advisor	No Yes Yes No No Yes No No
	JDS	Lloyd Jackson – Mechanical Superintendent Sven Archimowtiz – Electrical Superintendent Doug Fielding – Construction Manager Ishan Fechter – Construction Coordinator Jerry Graham – Construction Manager Kevin Whieldon – Project Coordinator Mark Valeriote – Construction Manager	Yes Yes Yes No No Yes Yes
Engineering Design Consultants	SRK Consulting (Canada) Inc.	John Kurylo – Site Engineer Megan Miller – Site Engineer Lawrence Borowski – Site Engineer Murry McGregor – Site Engineer Iozsef Miskolczi – Site Engineer	Yes Yes No No No

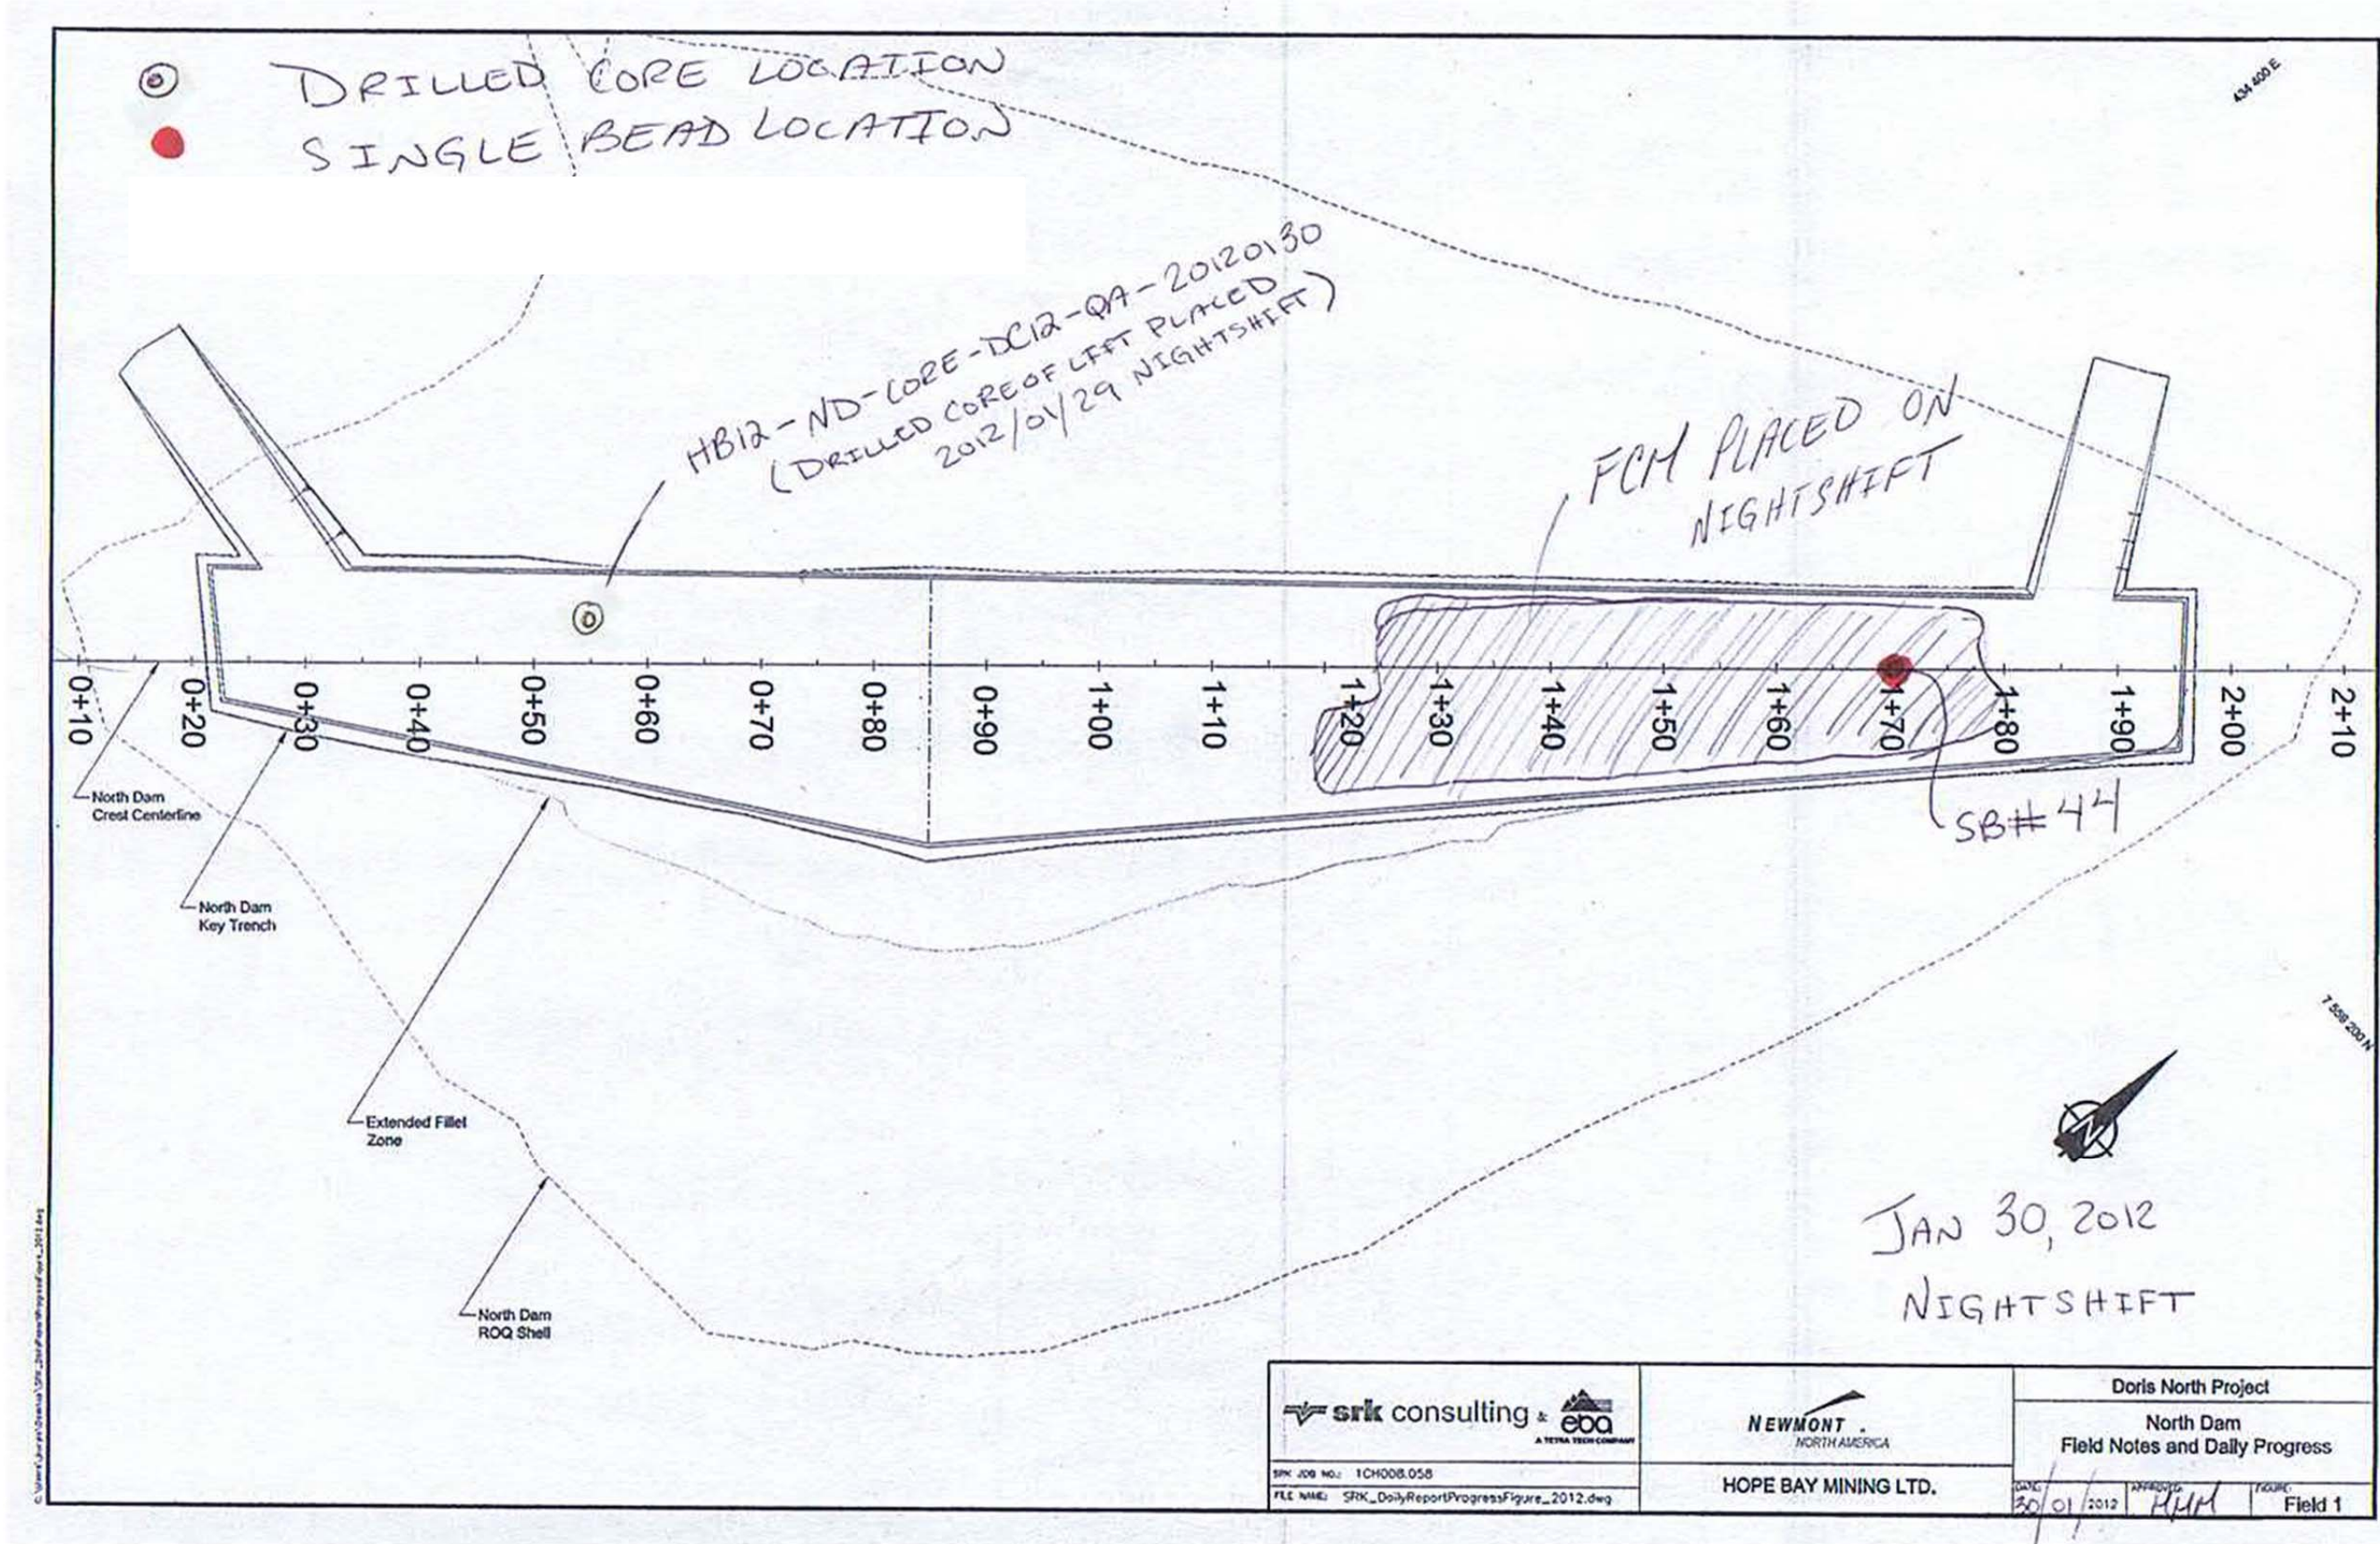
Figure 2 – North Dam Progress – Jan 30th NIGHTSHIFT

- Figure 2 presents today's nightshift construction progress at the North Dam.
- The table below present the cumulative as-built volume (as provided by Nuna Survey) for FCM placed from January 22nd to January 29th.
