DAILY REPORT #26 – DORIS NORTH INFRASTRUCTURE/ NORTH DAM

Prepared by:	John Kurylo/ Jeff Orr / Megan Miller	Date:	2012.01.31
Reviewed by:		Project #:	1CH008.058.0320
Role	Company	Personnel – Position	On Site
Client	Hope Bay Mining Limited (HBML)	Angela Holzapfel – ESR Compliance Manager David Vokey – ESR Coordinator Don Ethelston – HSLP Advisor Dean Wold - Safety Jill Turk – ESR Coordinator Katsky Venter – ESR Manger Michelle Tanquay – ESR Site Manager Stirling Kelly – HSLP Advisor	No Yes Yes No No Yes No No
	JDS	Lloyd Jackson – Mechanical Superintendent Sven Archimowtiz – Electrical Superintendent Doug Fielding – Construction Manager Ishan Fechter – Construction Coordinator Jerry Graham – Construction Manager Kevin Whieldon – Project Coordinator Mark Valeriote – Construction Manager	Yes Yes Yes No No Yes Yes
Engineering Design Consultants	SRK Consulting (Canada) Inc.	John Kurylo – Site Engineer Megan Miller – Site Engineer Lawrence Borowski – Site Engineer Murry McGregor – Site Engineer Iozsef Miskolczi – Site Engineer	Yes Yes No No No

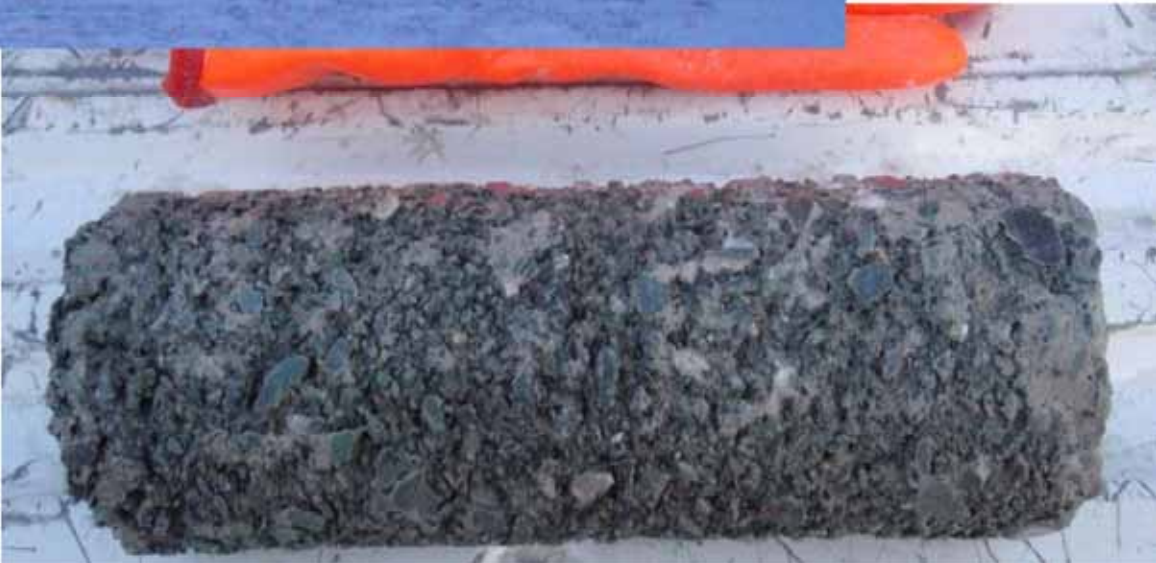
Photo 3 (center right): Drilled Core 13 (HB12-ND-CORE-DC13-QA-20120131), this was taken from ~ 1+15 upstream.

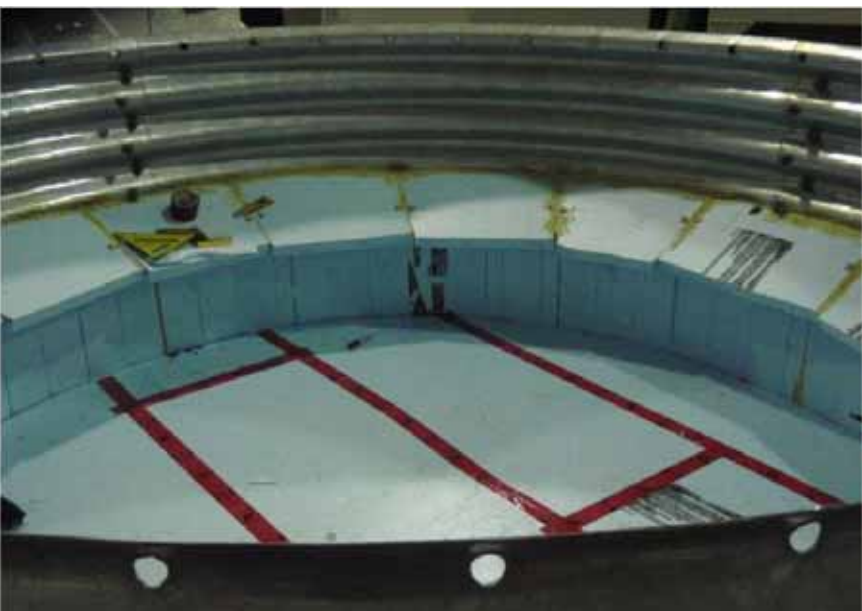
- SRK inspected the sump fabrication/ construction that have been completed. The outside diameters of the culverts were measured to be ~ 3.11m (inside dimension thus confirmed to match dimensions provided for IFCs). Styrofoam insulation looked sound. Currently the sumps (~ 2.5m total height) are being stored in two sections. The top sections are at Roberts Bay while the bottom sections are in the batch plant.

Photo 6: Close up view of insulation installed in the base of a Doris North Camp sump. Note that additional pieces of insulation have been placed on the top portions, as requested, to limit the potential for seepage going behind or in-between layers of insulation.

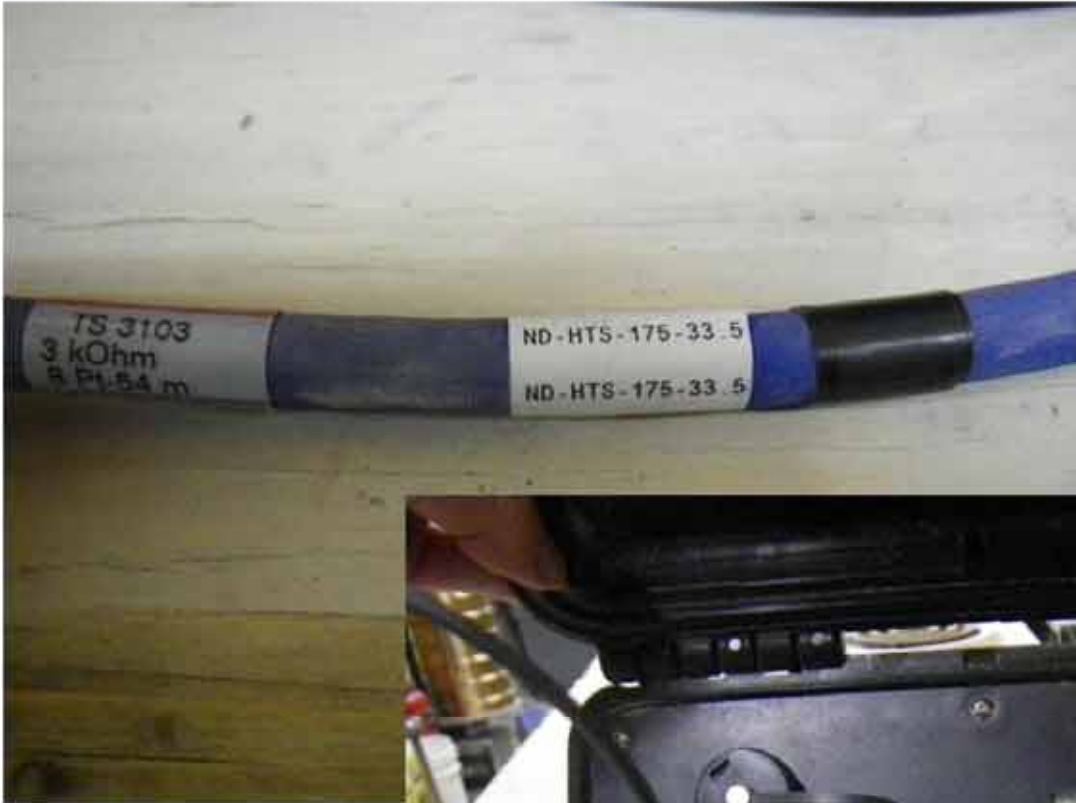
- This thermistor was programed into the data logger and is Location 19.
 - A strip of black electrical tape was added to the cable near the connector as a secondary means of identification. The tape system for cables located with the dam core is:

Photo 12 (above): Tape as secondary marker on ND-HTS-175-33.5 which is soon to be installed in the key trench.

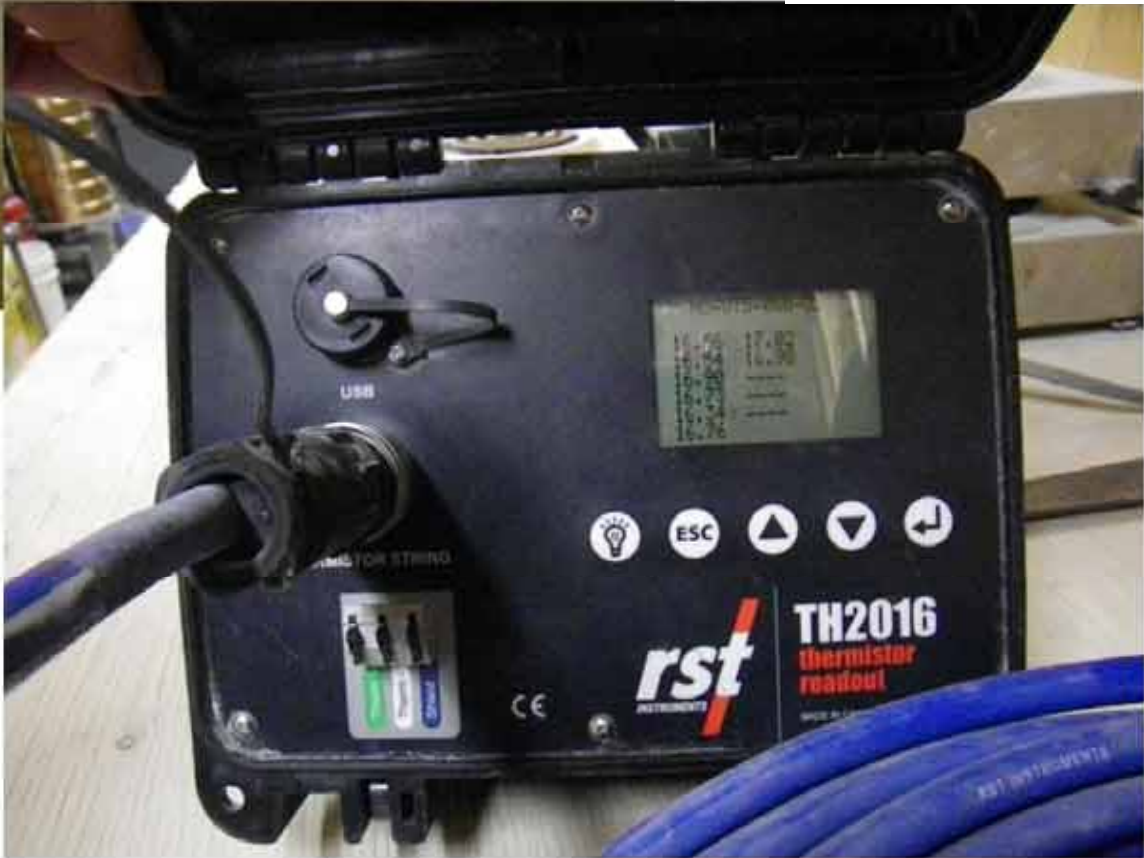
- Thermistor readings were downloaded from the data logger and sent to the SRK office.
- The multi-bead thermistor to be installed in the next lift at station 1+75 was checked and all beads were working.

Photo 13 (right): Checking that the thermistor string ND-HTS-175-33 works.

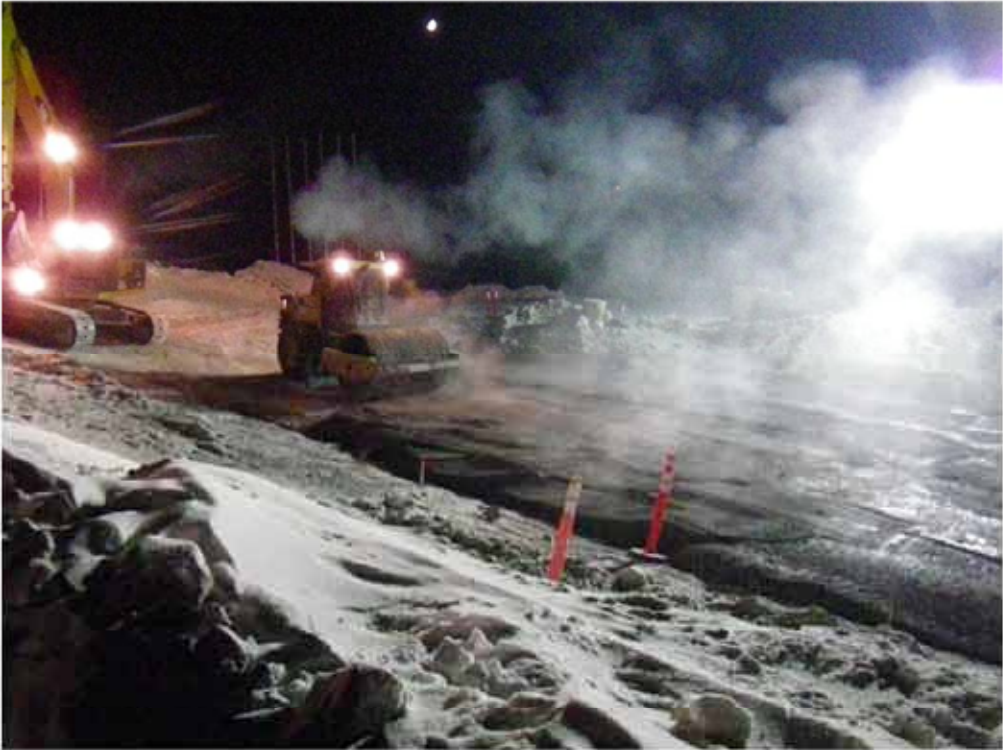
- Where the nightshift lift tied into the dayshift lift the compactor drove slightly onto dayshift lift and disturbed the frozen crust. The frozen crust as pushed forward and formed a peak, with an air void in the center. This was removed by hand.

Photo 14: Compactor running on material placed during the night shift.

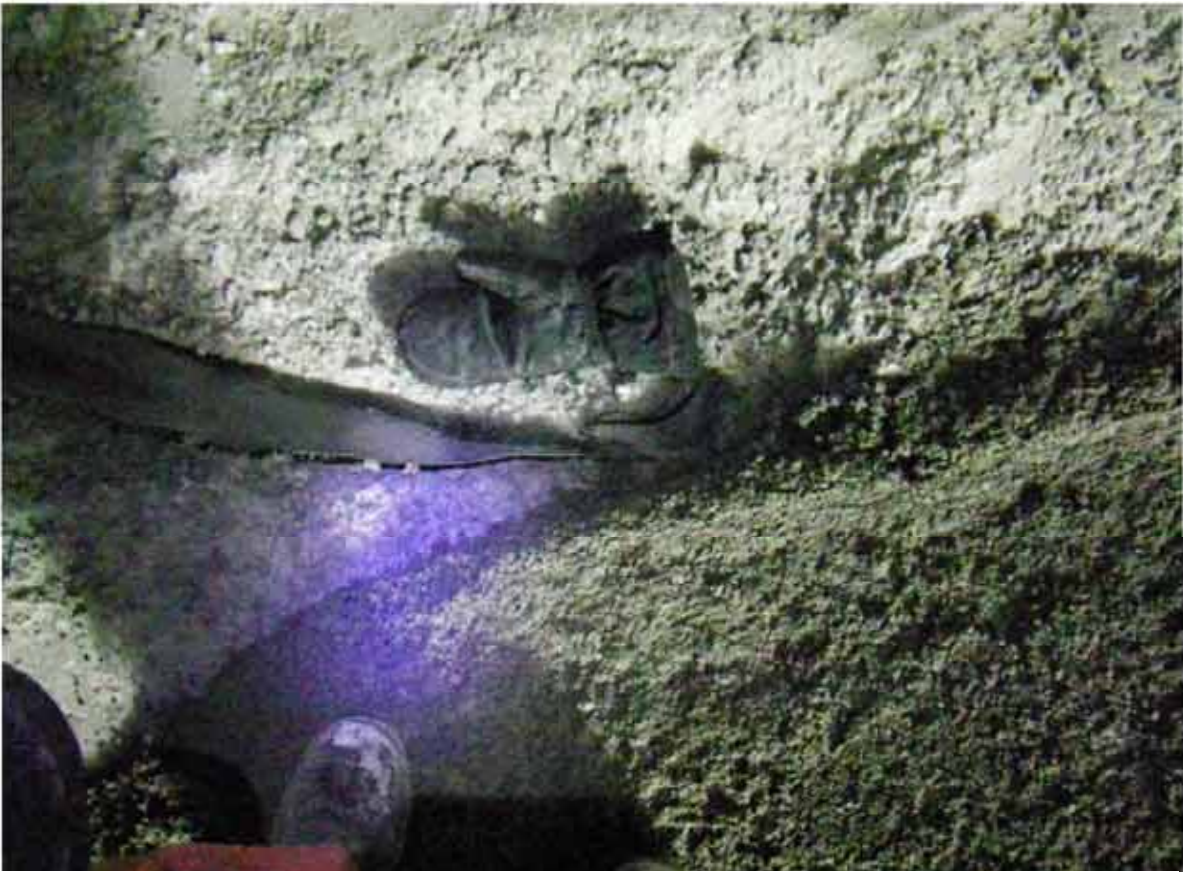
- Material tying into the upstream slope came very close to the HDPE liner protecting the GCL in a few spots.
- All multi-bead thermistor readings were collected, with the exception of ND-VTS-060-DS which is buried in snow. All multi-beads were found to be in working order with the exception of one bead on ND-HTS-060-28.8 (fourth bead from the bottom) which was not working.

Photo 16: FCM placed on the upstream slope very close to possibly on the HDPE liner which is protecting the GCL. The HDPE will have to be removed and the GCL in the coming days.

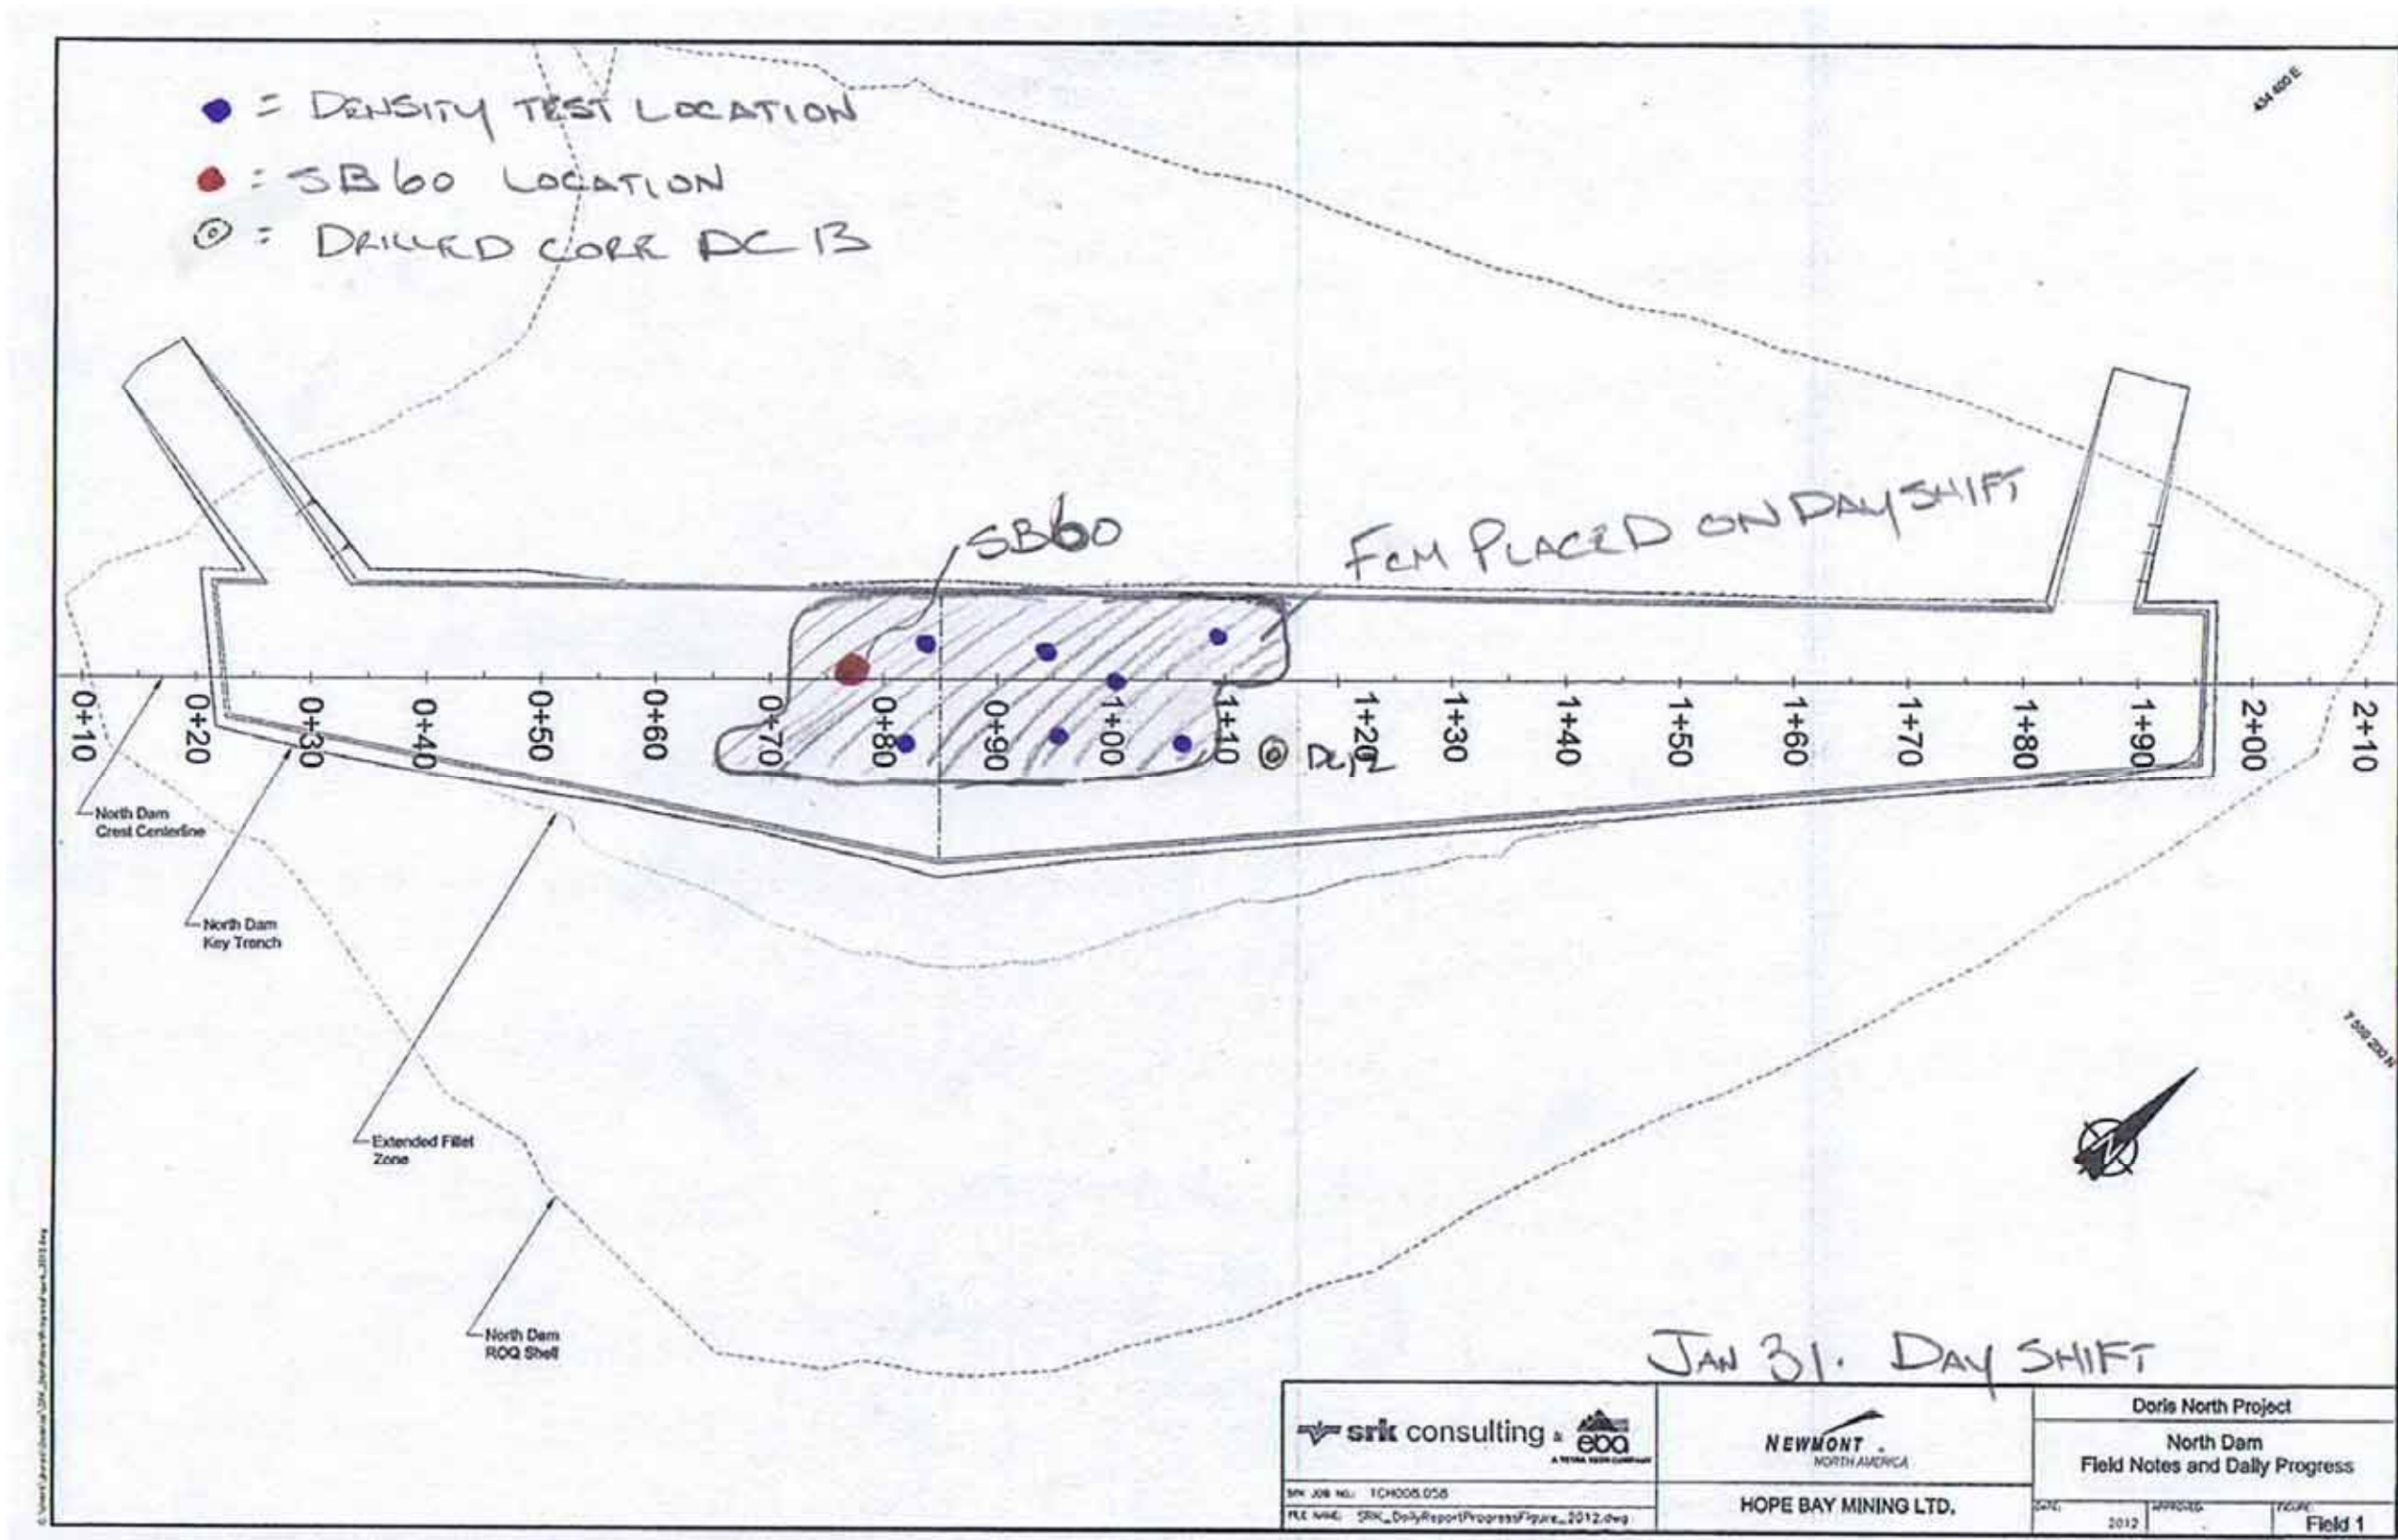
FIGURES:
Figure 1 – North Dam Progress – Jan 31st DAYSHIFT

- FCM was placed today on dayshift from ~0+65 to 1+17.
 - Overall placement went well. In general material quality was good.
 - ~21 (730 truck) loads were placed on dayshift
 - Additional moisture was note to be travelling downhill as lift placement progressed north. Material in the central key trench area (around 0+85) was noted on the surface to have minor ponding in select areas. Material saturation looked good (based on nuclear densometer testing and visual inspection).
- Figure 1 presents the North Dam nightshift construction progress, for 2012/01/ 31.

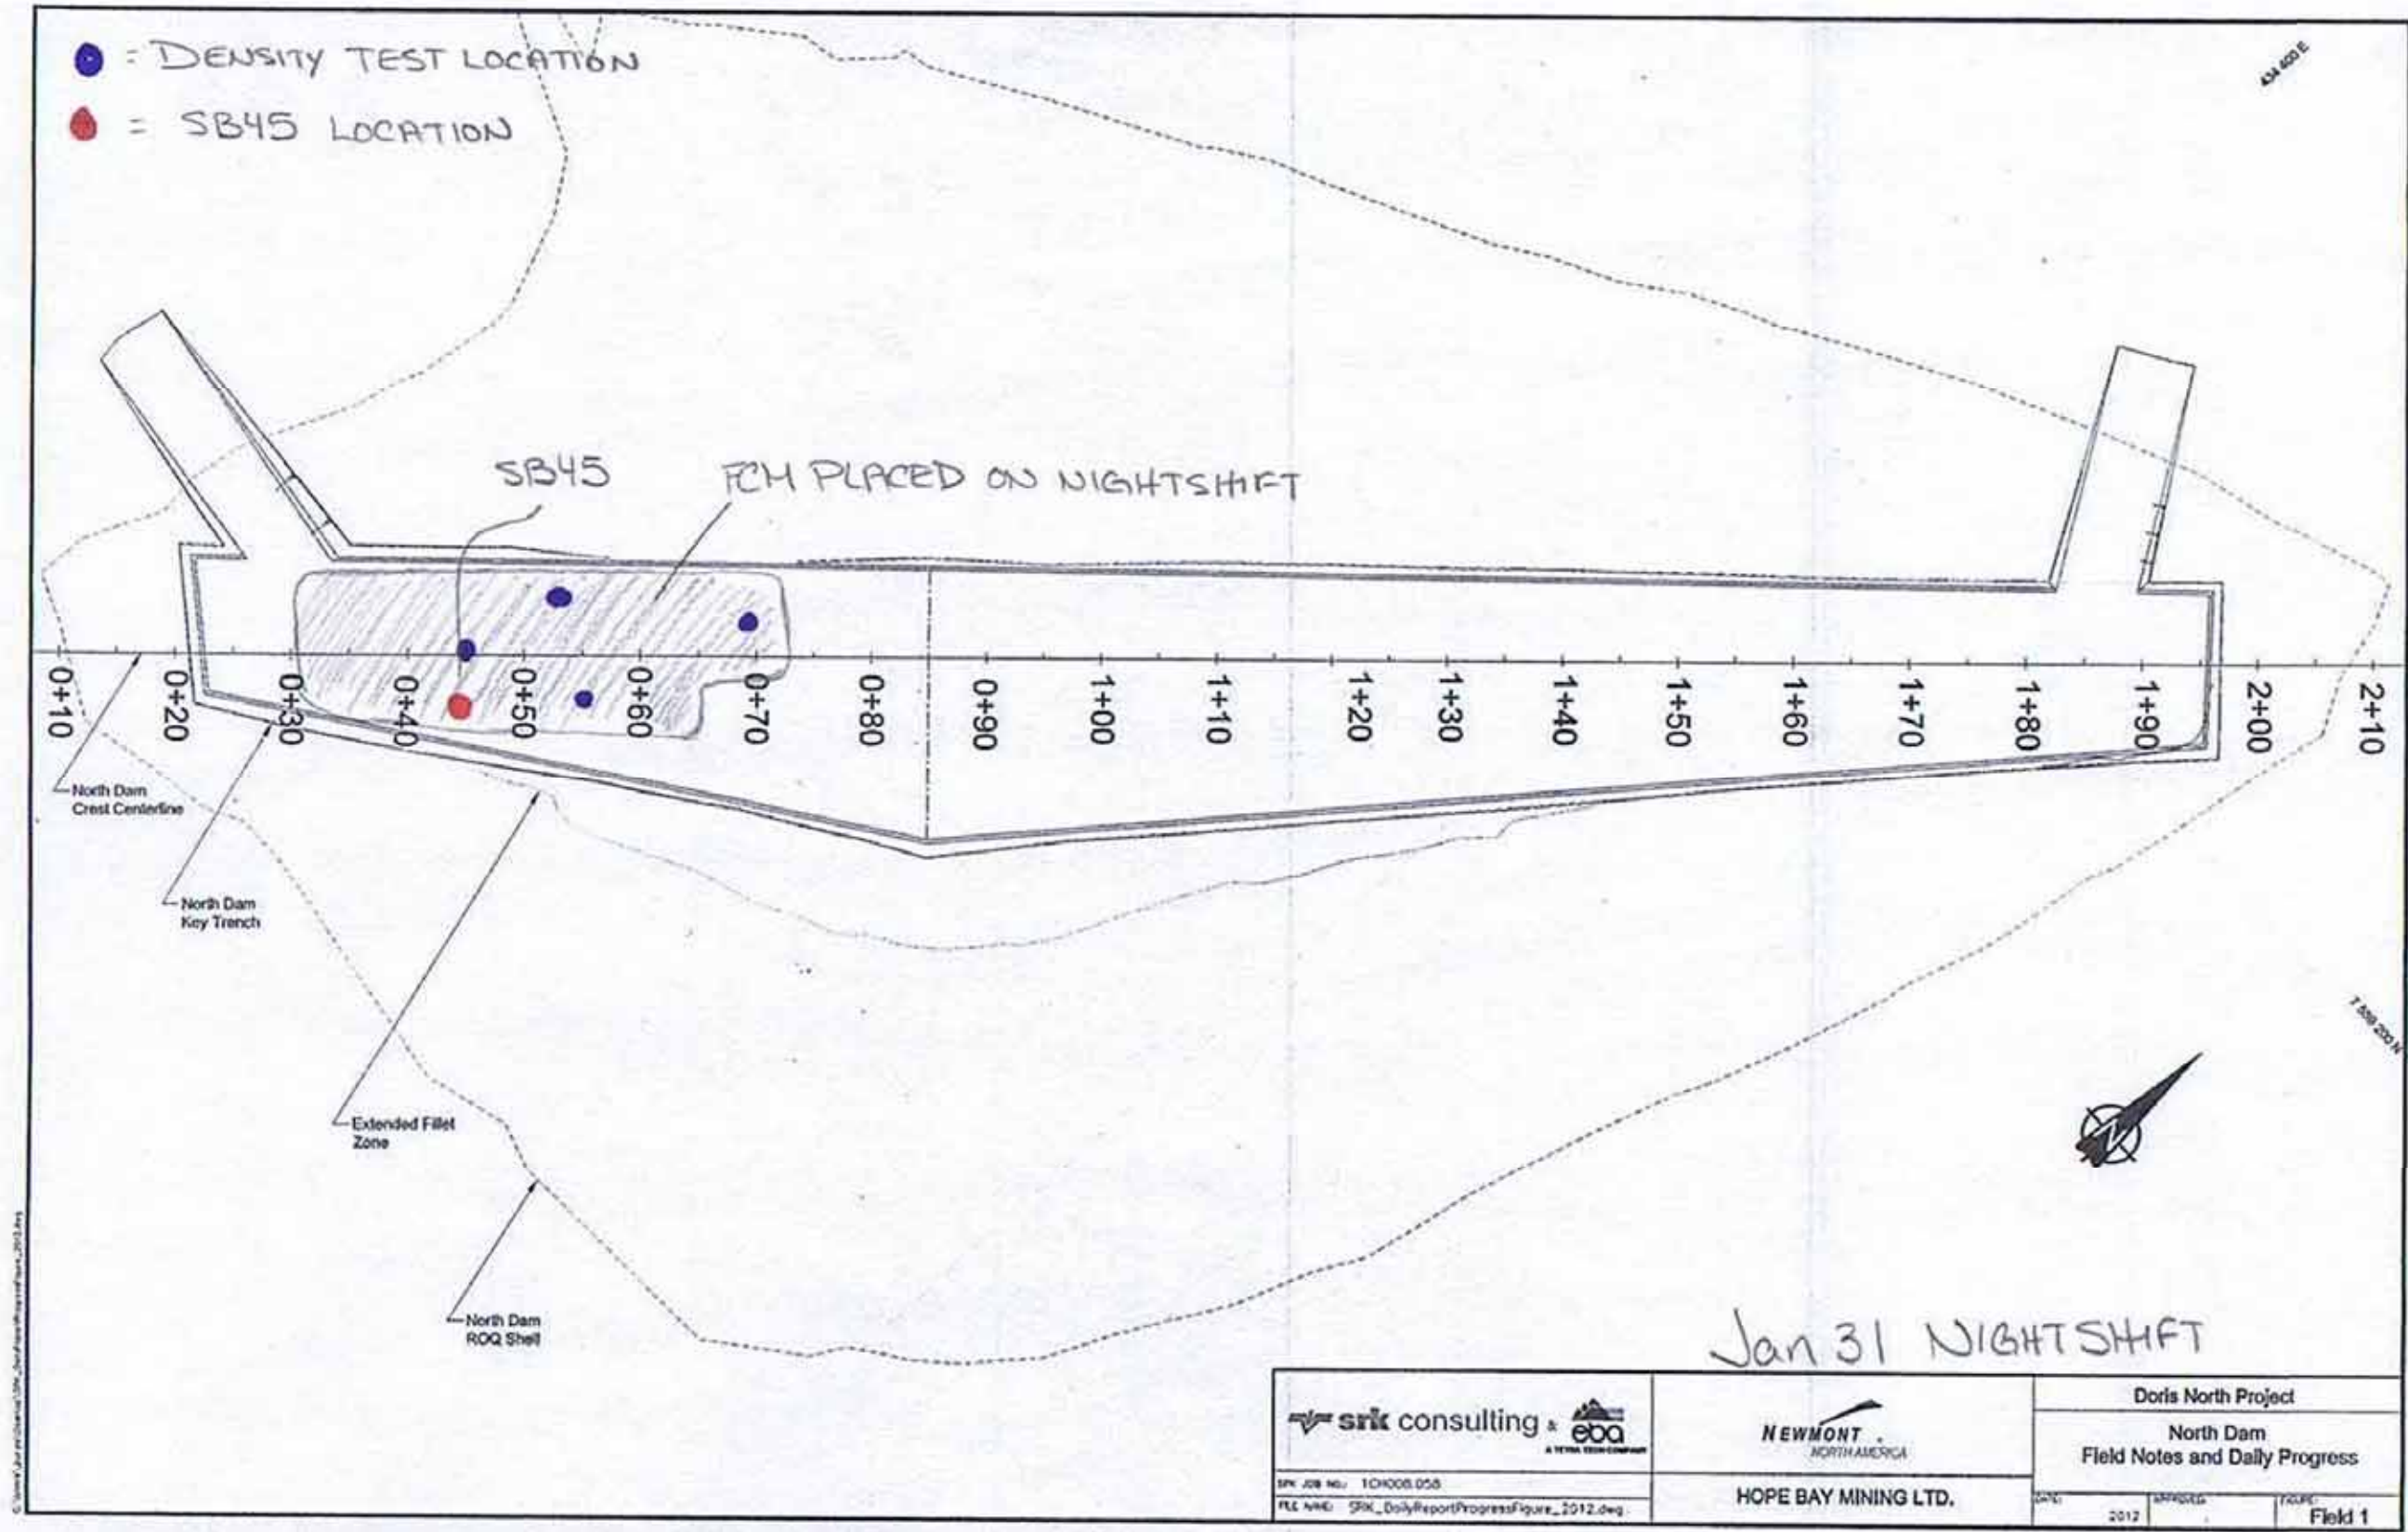
Figure 2 – North Dam Progress – Jan 31st NIGHTSHIFT

- Figure 2 presents the North Dam nightshift construction progress, for 2012/01/ 31.
- The table below present the cumulative as-built volume (as provided by Nuna Survey) for FCM placed from January 25th to January 30th.
