DAILY REPORT #27 – DORIS NORTH INFRASTRUCTURE/ NORTH DAM

| Reviewed by: | | Project #: | 1CH008.058.0320 |

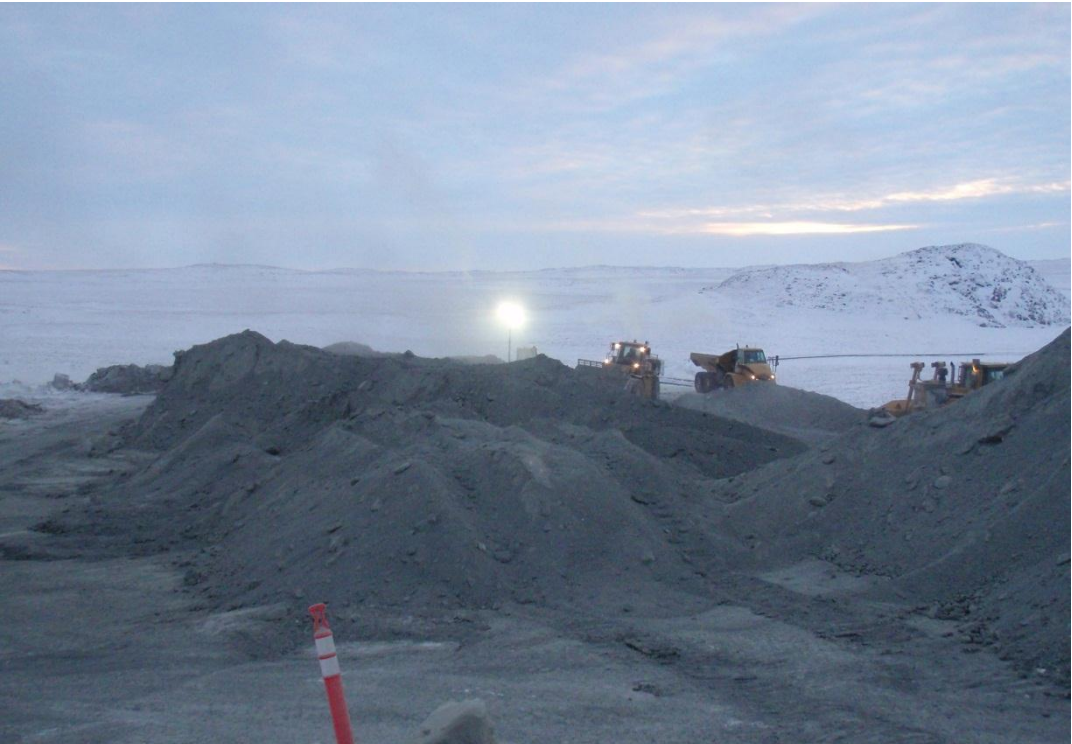
- The FCP was not run on dayshift today.
- Some additional work was completed on the FCM stockpile at the FCP Pad to sort and break down unsaturated frozen lumps. Some frozen unsaturated lumps were hauled to the crusher area. See Photo 2.

Photo 2: ~ SEE view of work on FCM stockpile at the FCP Pad. Note the equipment breaking up the large frozen lump and hauling away the frozen lumps that are unable to be broken up.

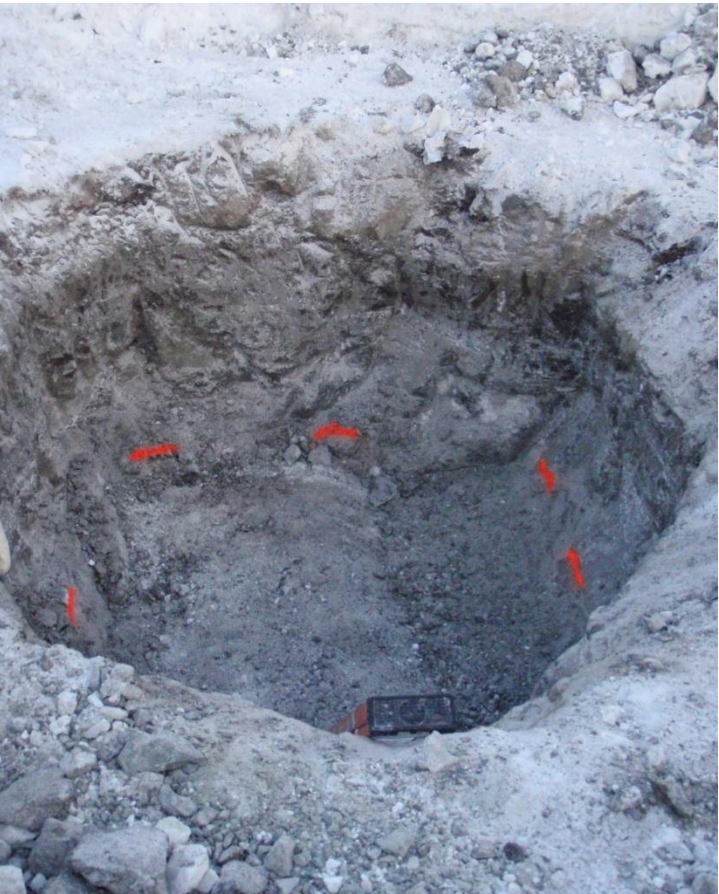
- The 325 excavator continued excavating material from the Sump #2 area/ footprint.
 - This area is nearing the required depth and dimensions for the sump excavation.

- See Photo 3.
 - Nuna survey completed a as-built survey of the base of the sump excavation.
 - A survey of the top of the excavation (3D polyline around the top of the excavation where it intersects the original ground) is required in order to create an approximate 3D as-built surface for the excavation. Further this line will allow for as-built checks on the total embedment of the culvert to be checked before the sump installation.

Photo 3: Close-up view of Sump #2 excavation. Note the base elevation of the culvert painted on the side slopes of the excavation.

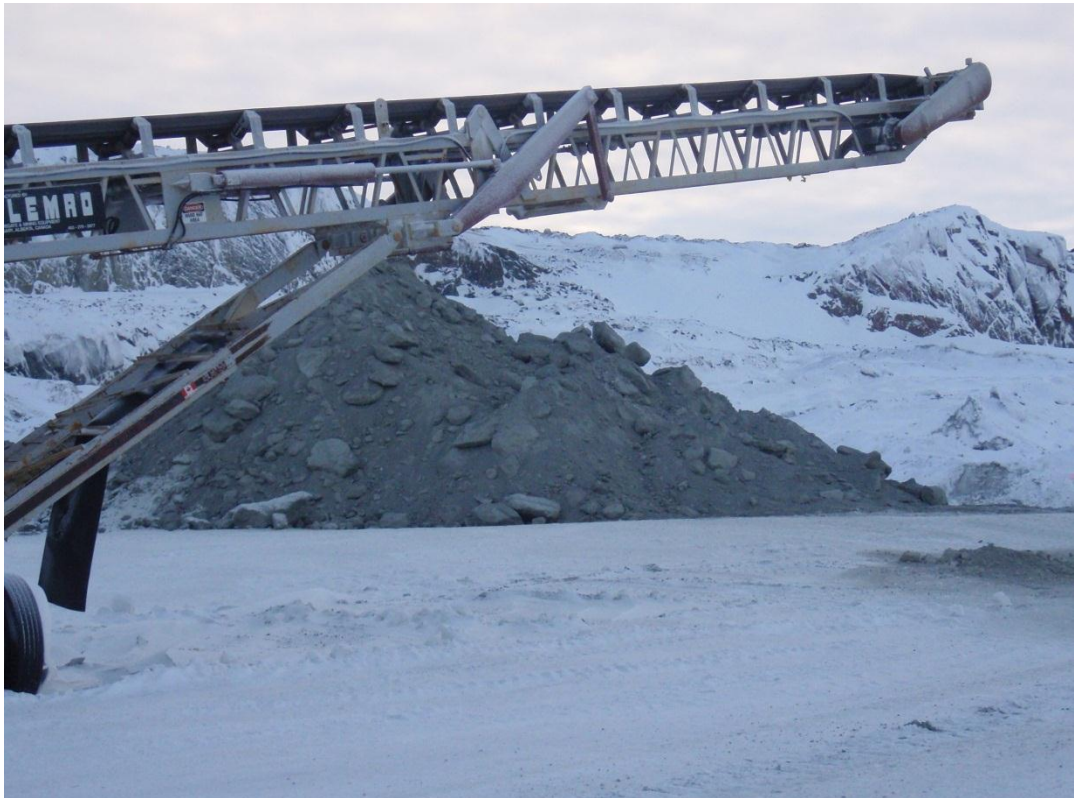
Photo 4: View of large FCM 'frozen lump' stockpile at the Quarry #2 crusher.

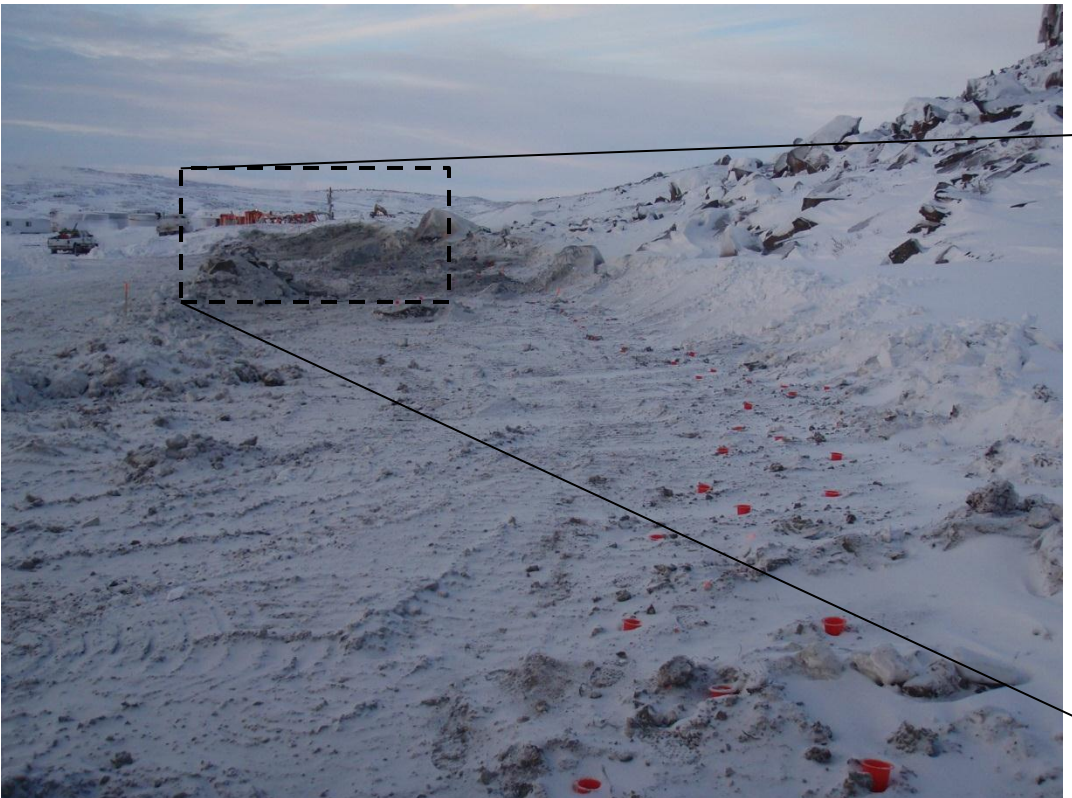
- Westarc continues drilling along the DN Diversion berm alignment. Three rows of drill holes, around what looked to be the central area of the key trench, were noted in > 1/3 of the diversion berm alignment. See Photos 5 and 6.

Photo 5: ~ WSW view down DN Diversion berm alignment. Note the blast cones showing the areas along that alignment base that have been drilled.

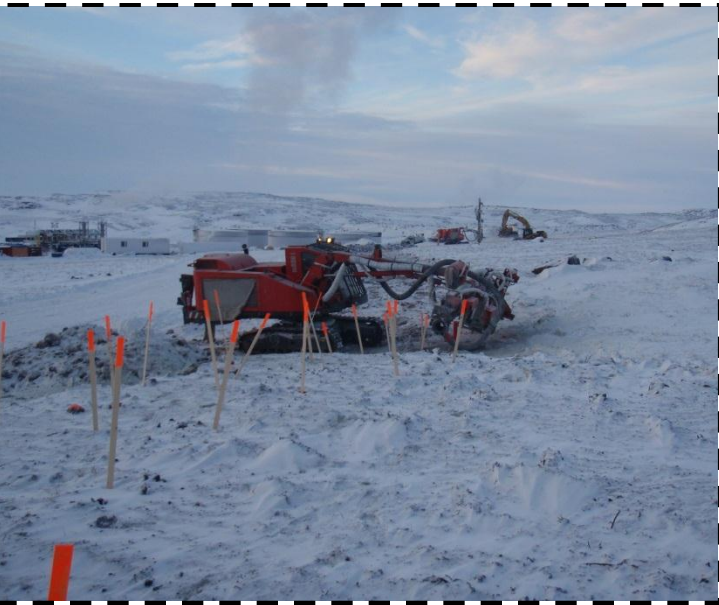
Photo 6: ~ W of the Westarc drill working on drilling the bedrock outcrop near the central east portion of the Diversion berm alignment.

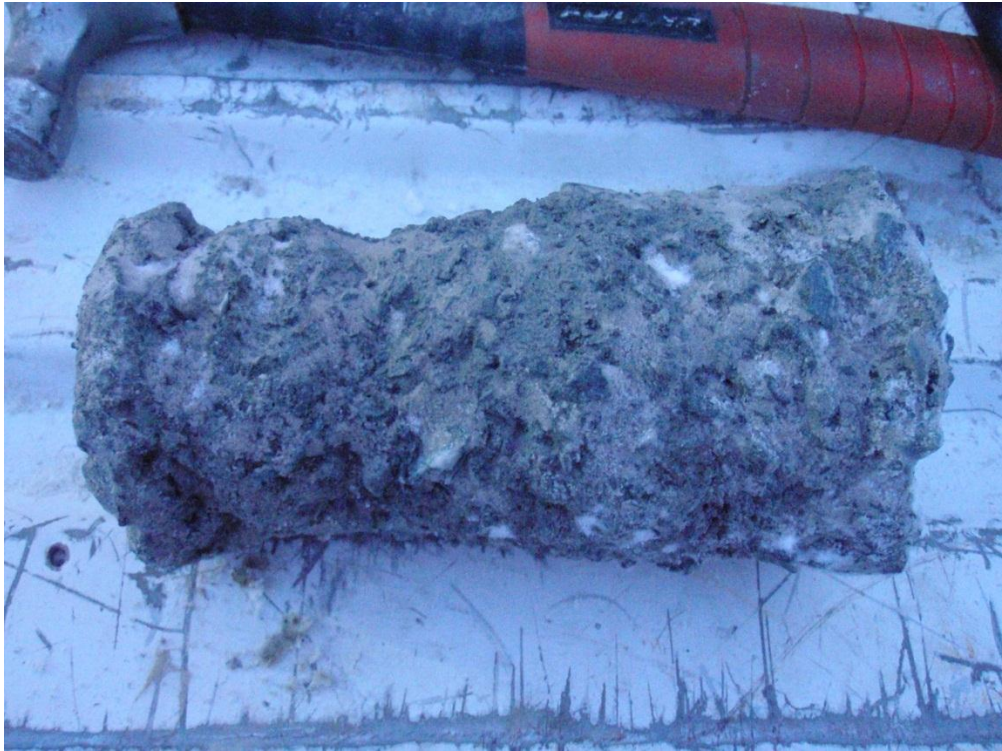
- Two drilled cores were collected on dayshift.
 - One core was collected from ~ 1+60 around the centerline. This core was of poor quality. This core was taken just after lift reached -2°C (according to the installed single bead). As the lift was just frozen the core melted/ outside did not core nicely due to the higher temperatures and melt of the core during drilling. It was planned that nightshift would core this lift again after additional time was allowed for further freezing/ lift temperature drops.

Photo 10: ~ HB12-ND-DC14-20120201, taken from 1+60 centerline. Note the very poor quality of the core. Material was taken just after lift reached -2°C (according to the installed single bead). As the lift was just frozen the core melted/ outside did not core nicely due to the higher temperatures.

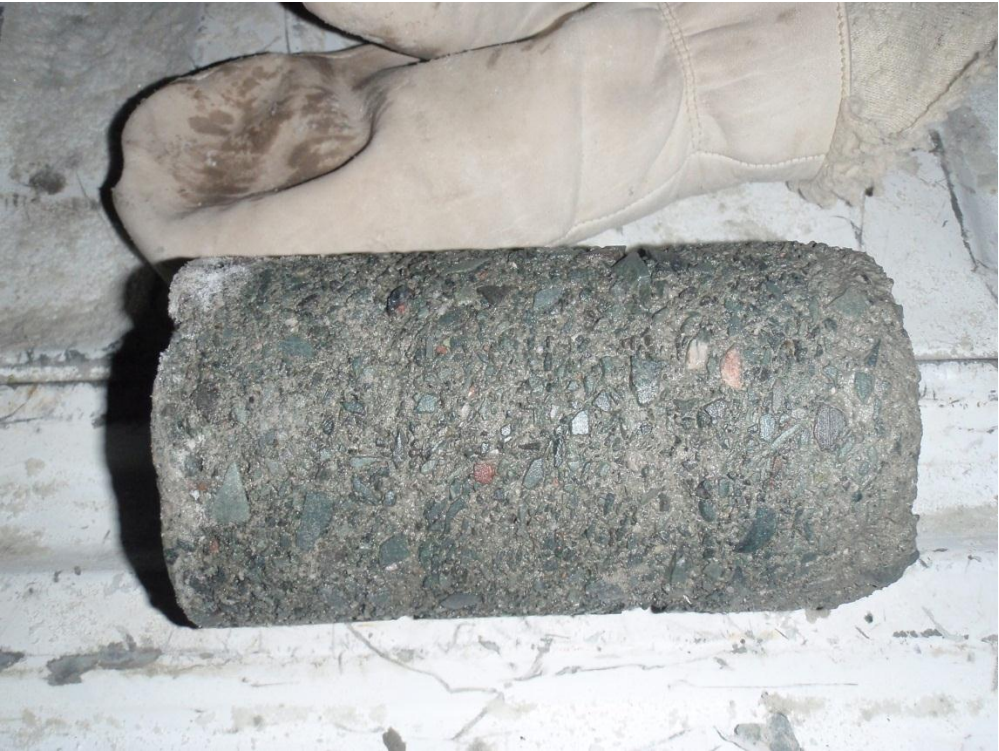
- The second core was taken from ~ 1+75 on the downstream. Core was of good quality.
- Discussions were had in the field about cable ND-VTS-60-KT. After review of photos and the as-built it was noted that the aforementioned cable was started to be buried in dry FCM in 2011. In order for the cables to be brought up the upstream slope of the core and out the top horizontal 'cable trench' (design change noted in 2011 RFI from JDS) it will be required that this cable be wrapped back towards the S to meet the other cable. This cable 'fold back' is acceptable if the cable is well covered/encased in finer crush material. The area will be further cleaned and the cable will be run to the downstream of the core.

Photo 11: HB12-ND-CORE-DC15-QA-20120201 taken from ~ 1+75 on the downstream. Note that this lift had been frozen for a few days now.

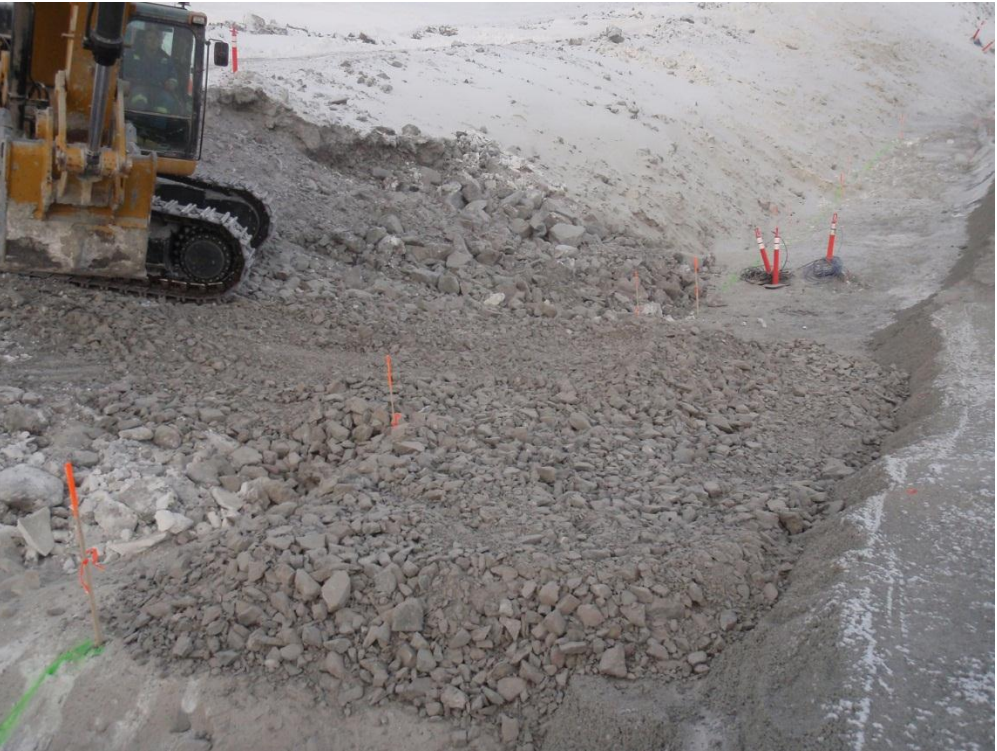
- A small lift of Transition material was placed on the downstream edge of the dam around 0+70 to 1+10. Transition (6" minus material) was placed with the CAT 345 excavator and compacted with the vibrator drum roller. Snow was removed or minor snow on the slope was scratched before transition material placement. See photo 12 and 13.

Photo 12: ~ ENE view of the 345 excavator spreading transition material around station 0+70 on the downstream.

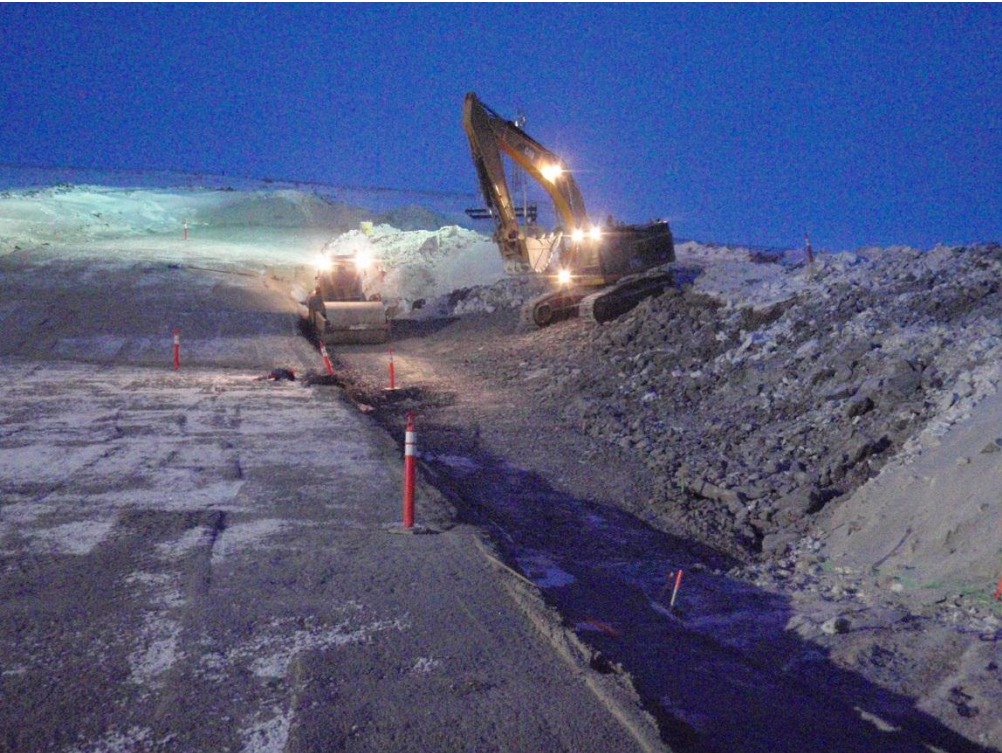
Photo 13: ~WNW of excavator and vibrator compactor working on placing and compacting material on the downstream around station 0+70 to 1+00.

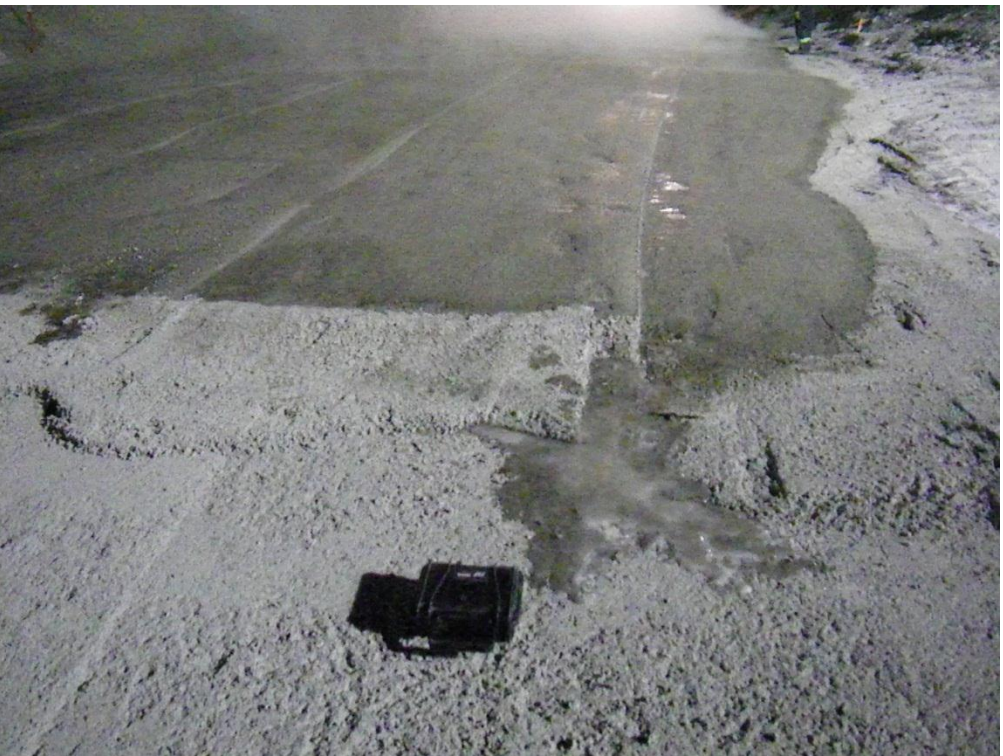
- The key trench was cleaned from station 1+25 north east with the skid steer broom.
- FCM was placed from Sta. 1+25 to station 1+80.
 - The first few loads of material at placement was looking wet, but not overly wet and the saturation and moisture content results did not seem overly high. However after this material sat for a while water was noticed to be bleeding from the end and sides of the material. The plant was contacted and the water was turned down. The water at the plant was turned down several times during the placement.

Photo 16: Water was noted to be bleeding from the end of the placed material. This photo was taken when the bleeding was first noted; additional bleeding occurred after this photo was taken.

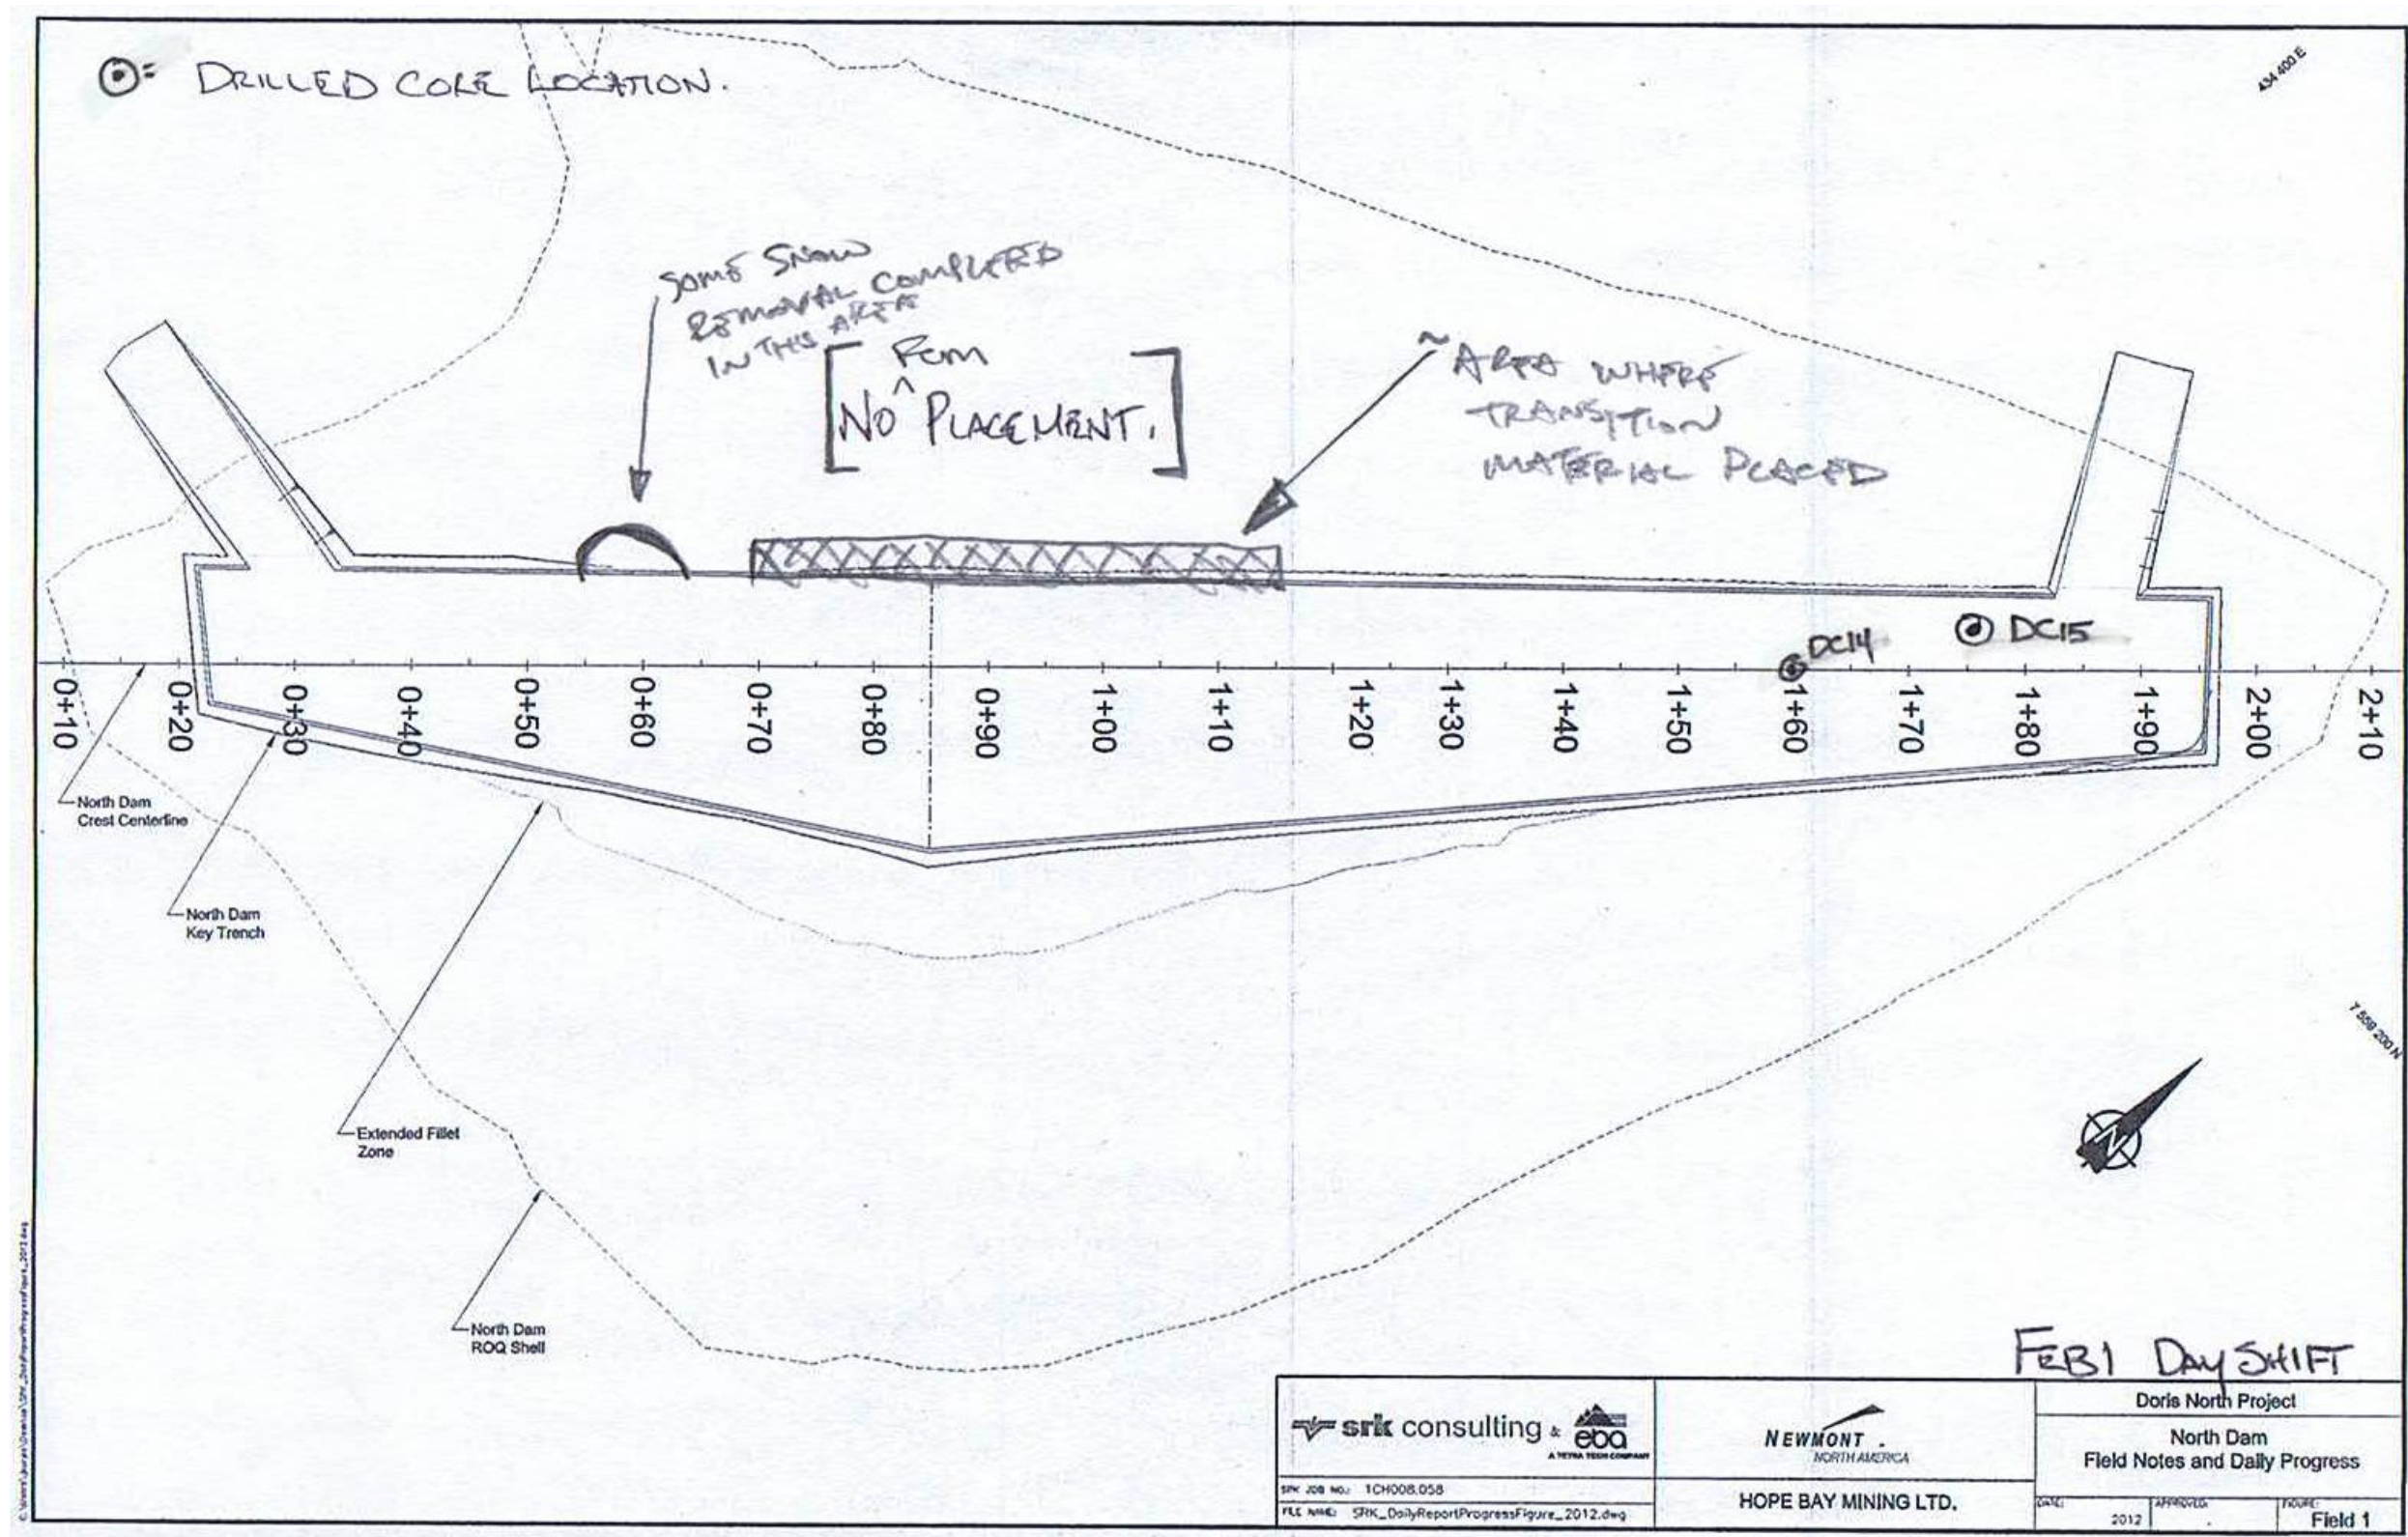
FIGURES:
Figure 1 – North Dam Progress – February 1st DAYSHIFT

- Figure 1 presents the North Dam dayshift construction progress, for 2012/02/01.

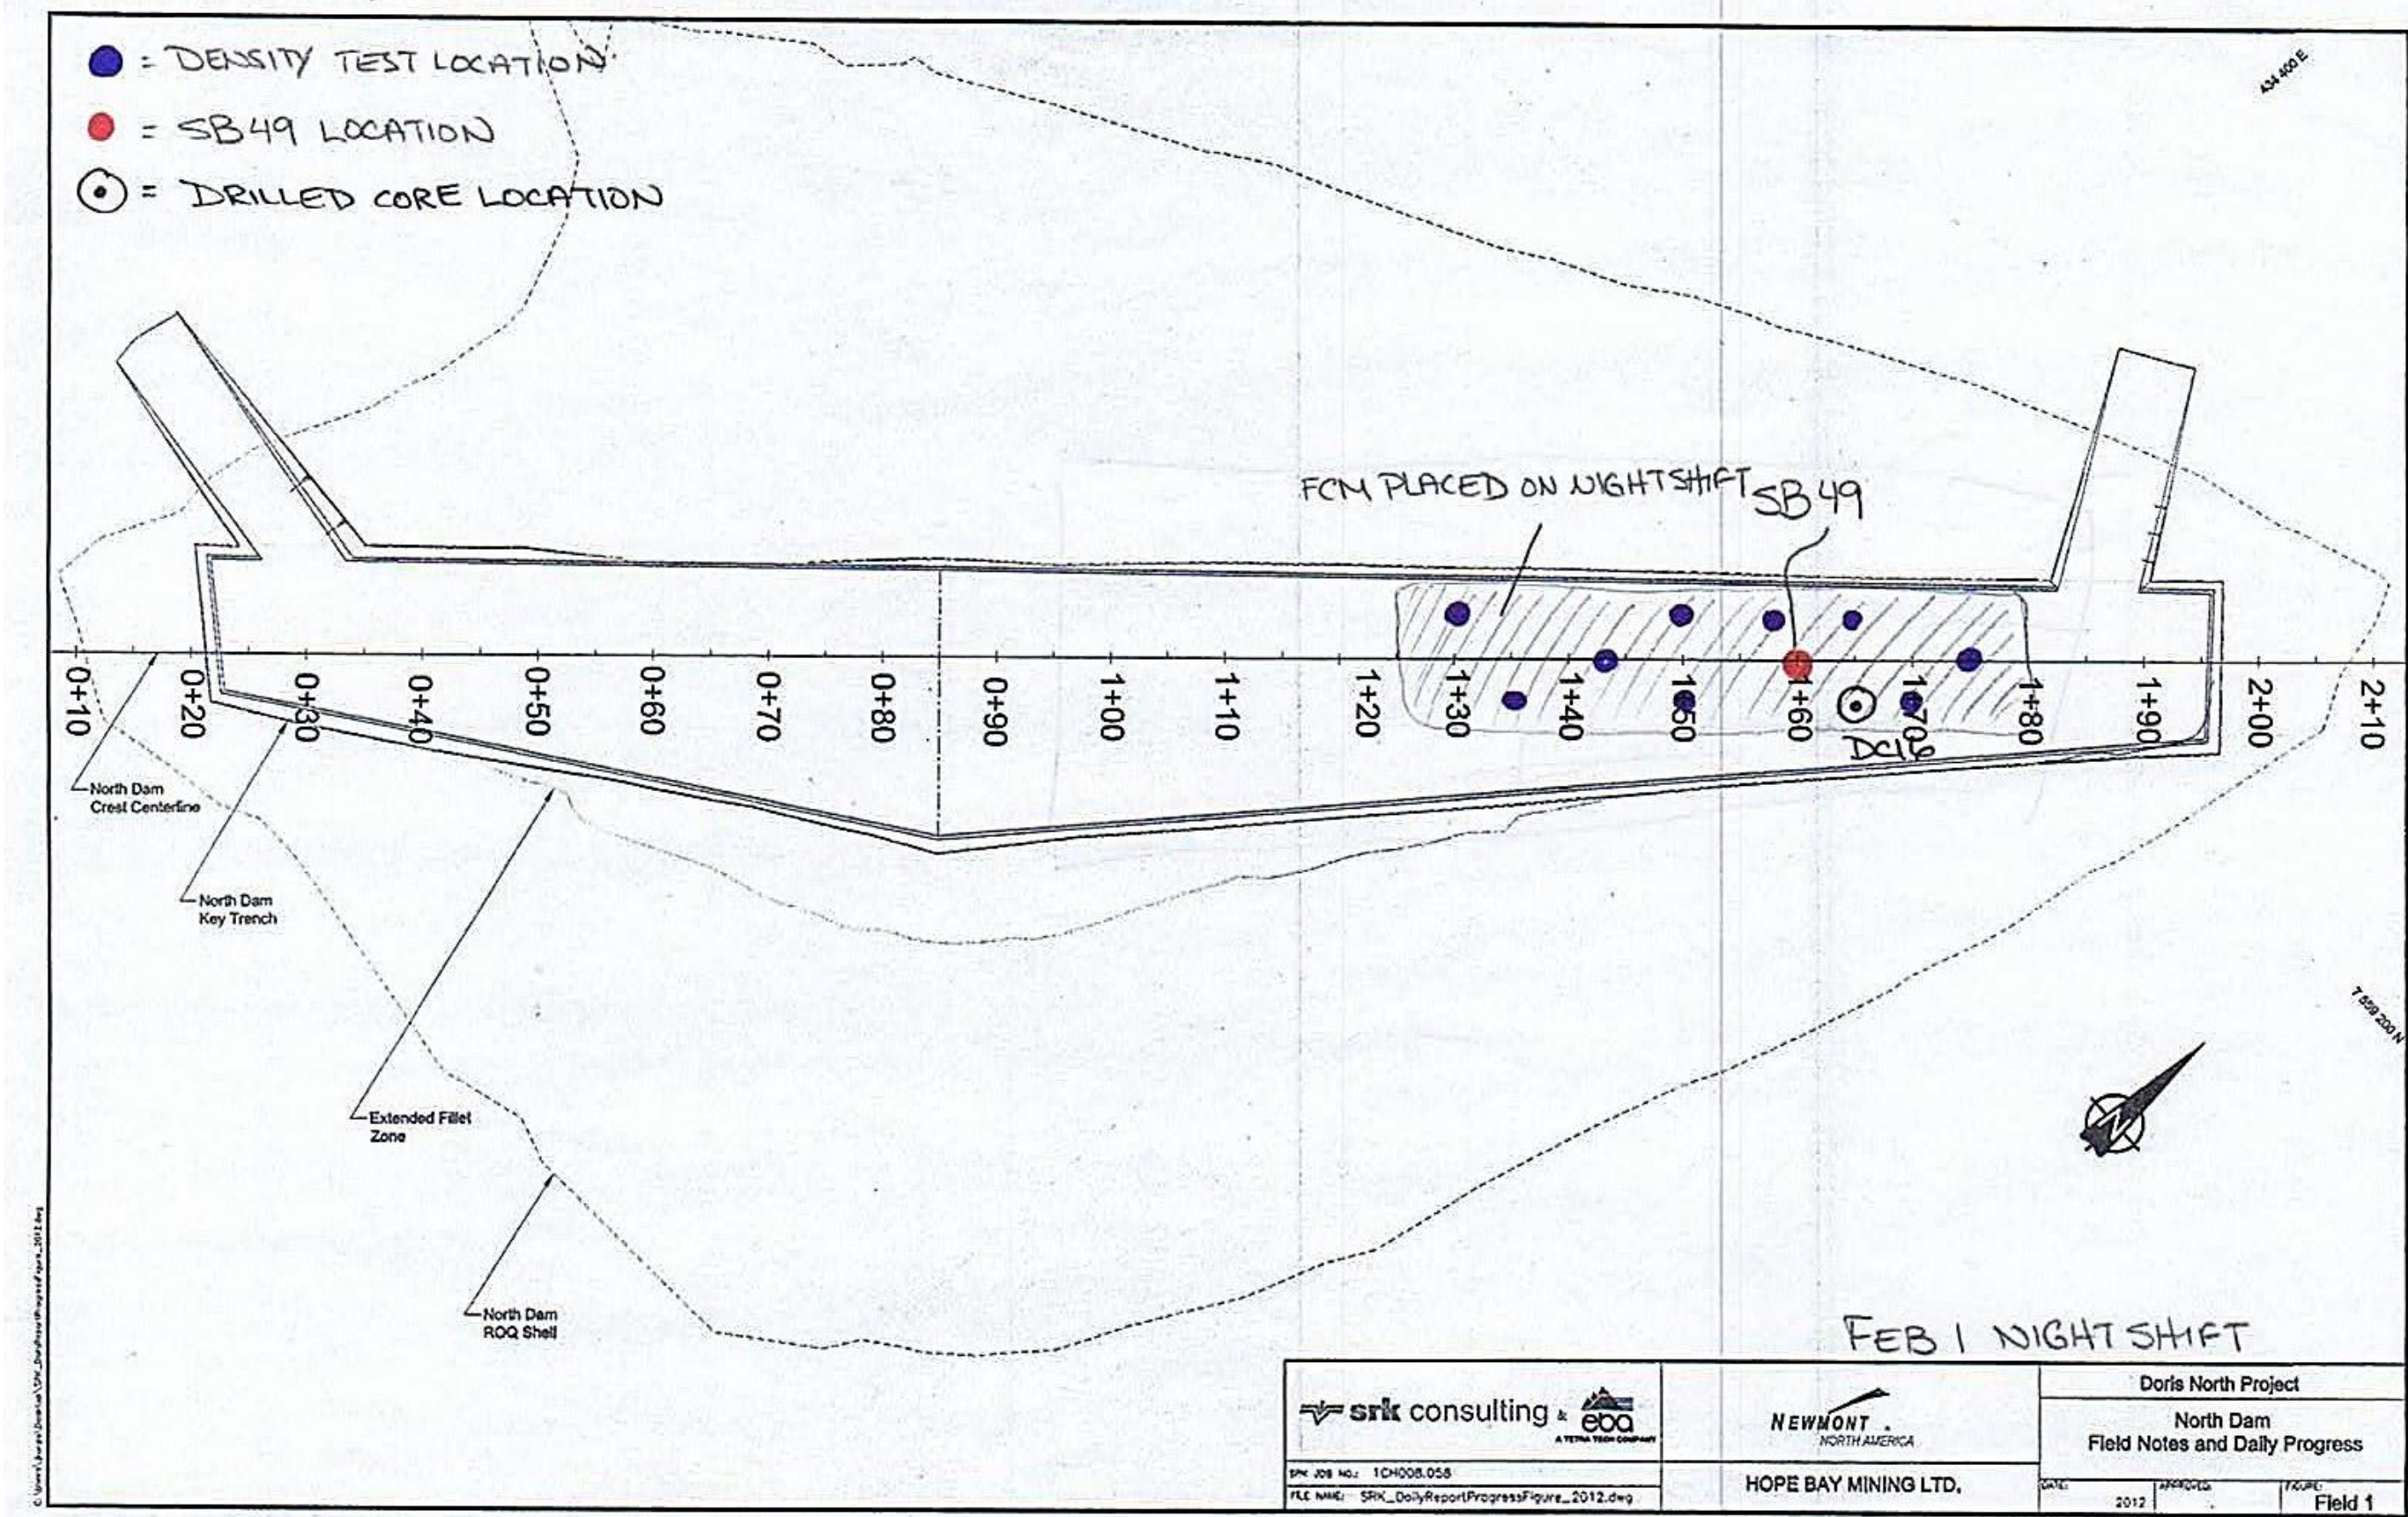
Figure 2 – North Dam Progress – February 1st NIGHTSHIFT

- Multi-bead thermistor readings were collected for most of the thermistors cables.
- A core sample was collected (HB12-ND-CORE-DC16-QA-20120201) from the upstream edge of the dam near station 1+65. The core was of good quality.
- Figure 2 presents the North Dam nightshift construction progress, for 2012/02/01.
- The table below present the cumulative as-built volume (as provided by Nuna Survey) for FCM placed from January 29th to January 31st.
