DAILY REPORT #28 – DORIS NORTH INFRASTRUCTURE/ NORTH DAM

Prepared by:	John Kurylo/ Jeff Orr / Megan Miller	Date:	2012.02.02
Reviewed by:		Project #:	1CH008.058.0320
Role	Company	Personnel – Position	On Site
Client	Hope Bay Mining Limited (HBML)	Angela Holzapfel – ESR Compliance Manager David Vokey – ESR Coordinator Don Ethelston – HSLP Advisor Dean Wold - Safety Jill Turk – ESR Coordinator Katsky Venter – ESR Manger Michelle Tanquay – ESR Site Manager Stirling Kelly – HSLP Advisor	No Yes Yes No No Yes No No
	JDS	Lloyd Jackson – Mechanical Superintendent Sven Archimowtiz – Electrical Superintendent Doug Fielding – Construction Manager Ishan Fechter – Construction Coordinator Jerry Graham – Construction Manager Kevin Whieldon – Project Coordinator Mark Valeriote – Construction Manager	Yes Yes Yes No No Yes Yes
Engineering Design Consultants	SRK Consulting (Canada) Inc.	John Kurylo – Site Engineer Megan Miller – Site Engineer Lawrence Borowski – Site Engineer Murry McGregor – Site Engineer Iozsef Miskolczi – Site Engineer	Yes Yes No No No

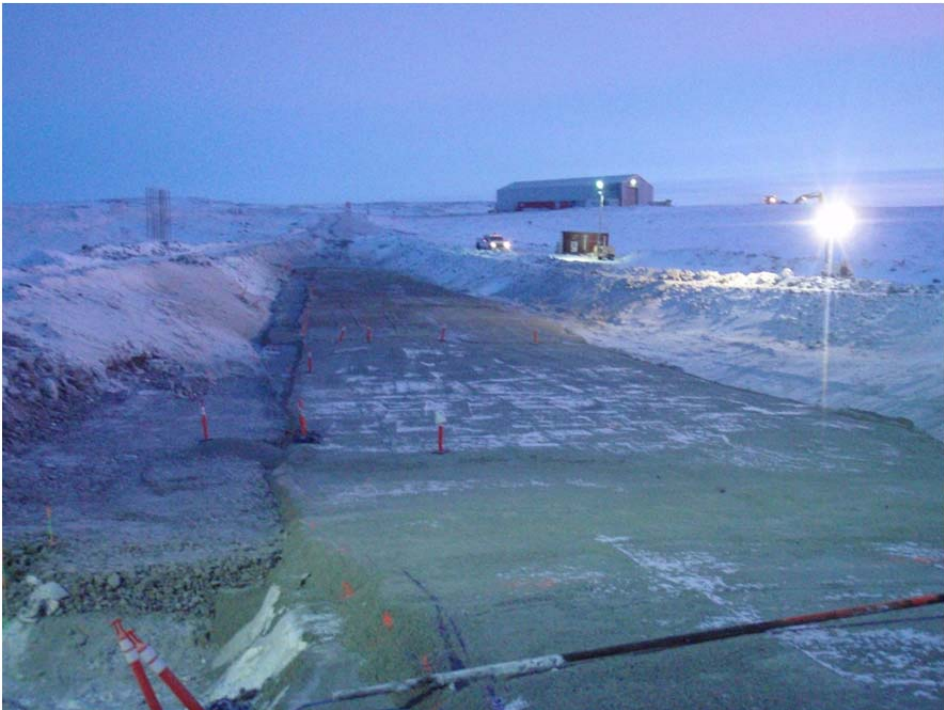
Photo 1: ~ NEE view down key trench towards FCP.

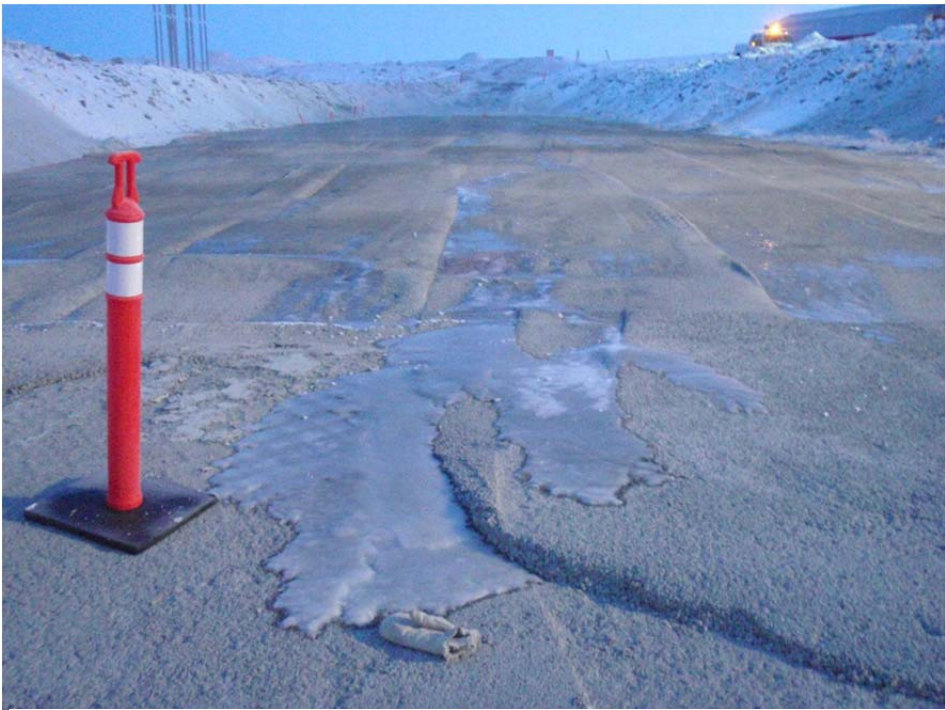
Photo 2: Ice formed from water bleeding out of the material placed 2012/02/01 nightshift. Photo looking north east along key trench. Note that this was the most notable area like this.

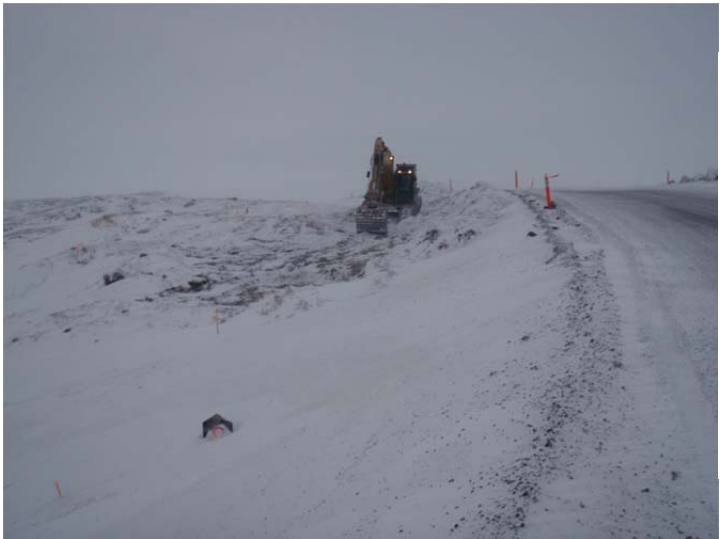
- Snow started to be cleared from within the Secondary Road Buttress footprint. Snow clearing was done until 'whiteout' conditions were called on dayshift with the 325 excavator (equipped with finishing bucket).

Photo 3 (left): CAT 325 excavator removing snow from the buttress area of the Secondary Road, near the Vent Raise Pad.

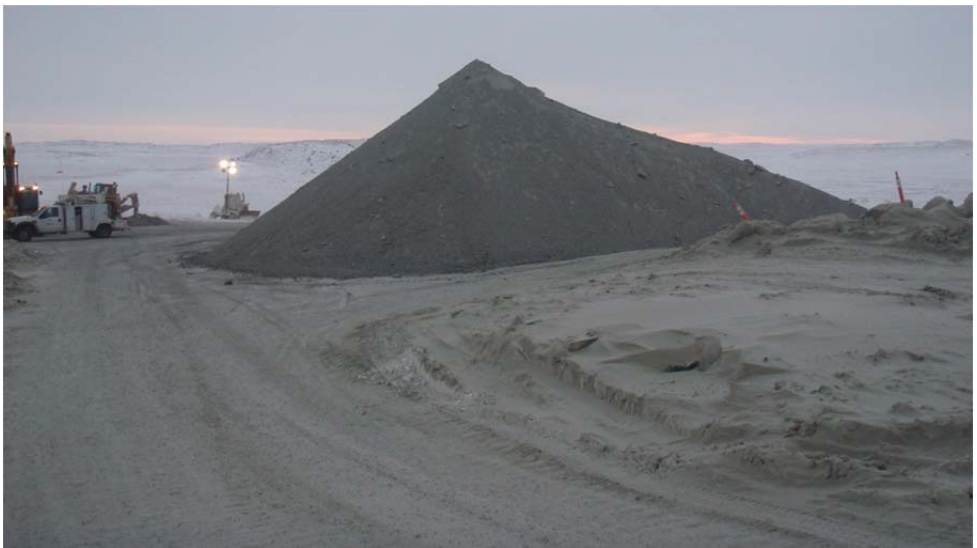
- The FCP was not run on dayshift today.
- Additional work was completed on the FCM stockpile at the FCP Pad to sort and break down unsaturated frozen lumps. Additional unsaturated lumps were hauled to the crusher area. See Photo 3 and 5. The FCM stockpile at the FCP pad has now finished being sorted.
- A few loads of transition material were hauled and stockpiled on the FCP Pad.

Photo 5 (right): ~ SE view of the front of the FCM stockpile that remains on the FCP Pad after the frozen lumps had been removed/ hauled to the crusher.

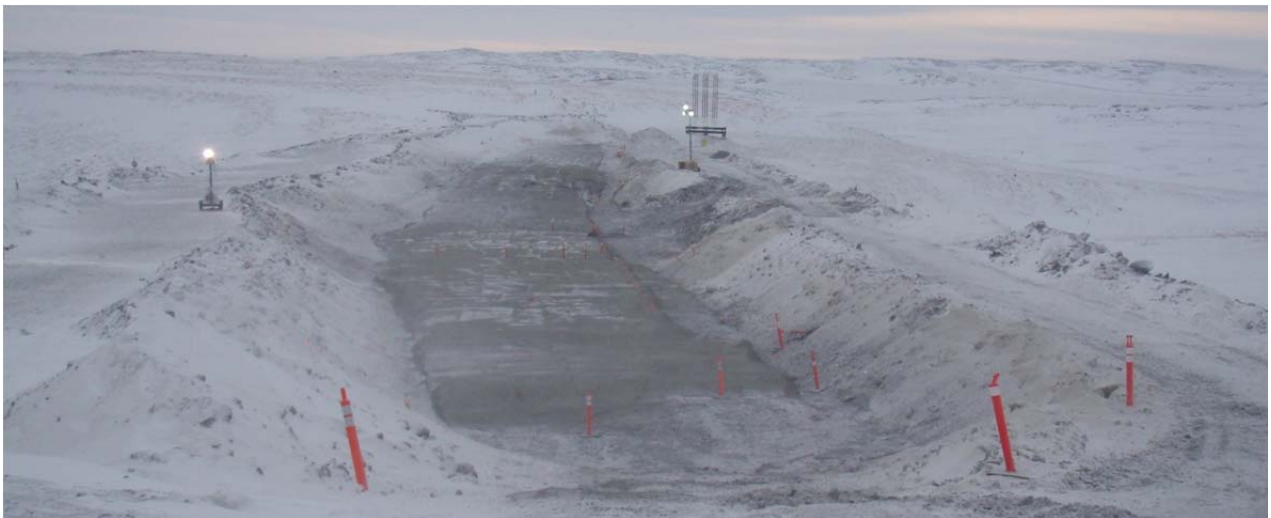
Photo 4: ~WSW view of construction/ FCM placement progress at the N Dam key trench/ core area.

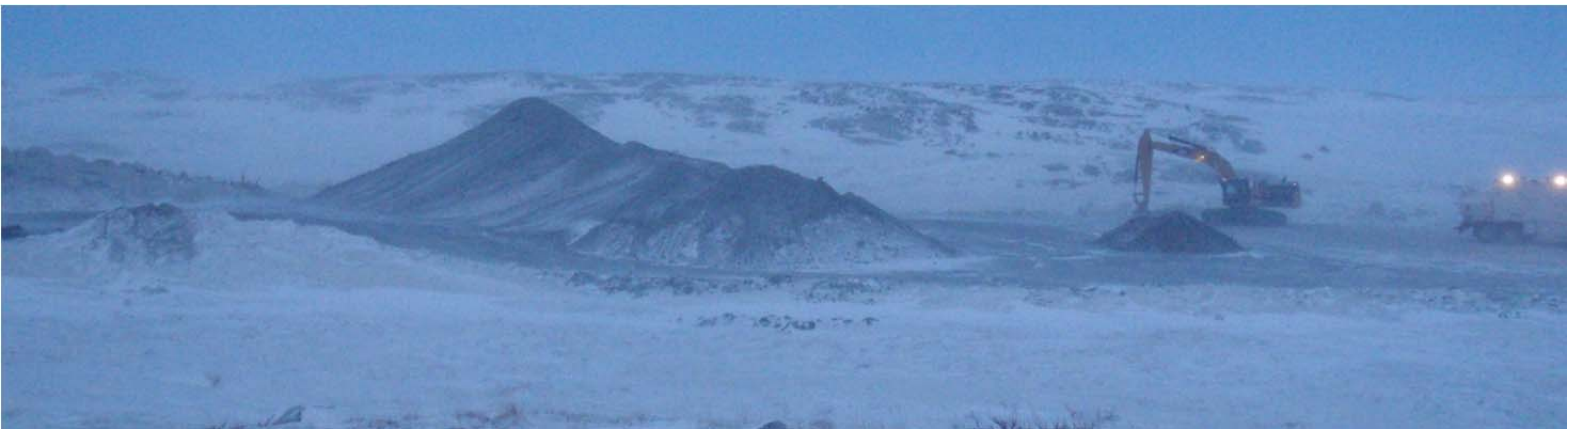
Photo 6: ~ NNE view of the back of the FCM stockpile that remains on the FCP Pad after the frozen lumps had been removed/ hauled to the crusher.

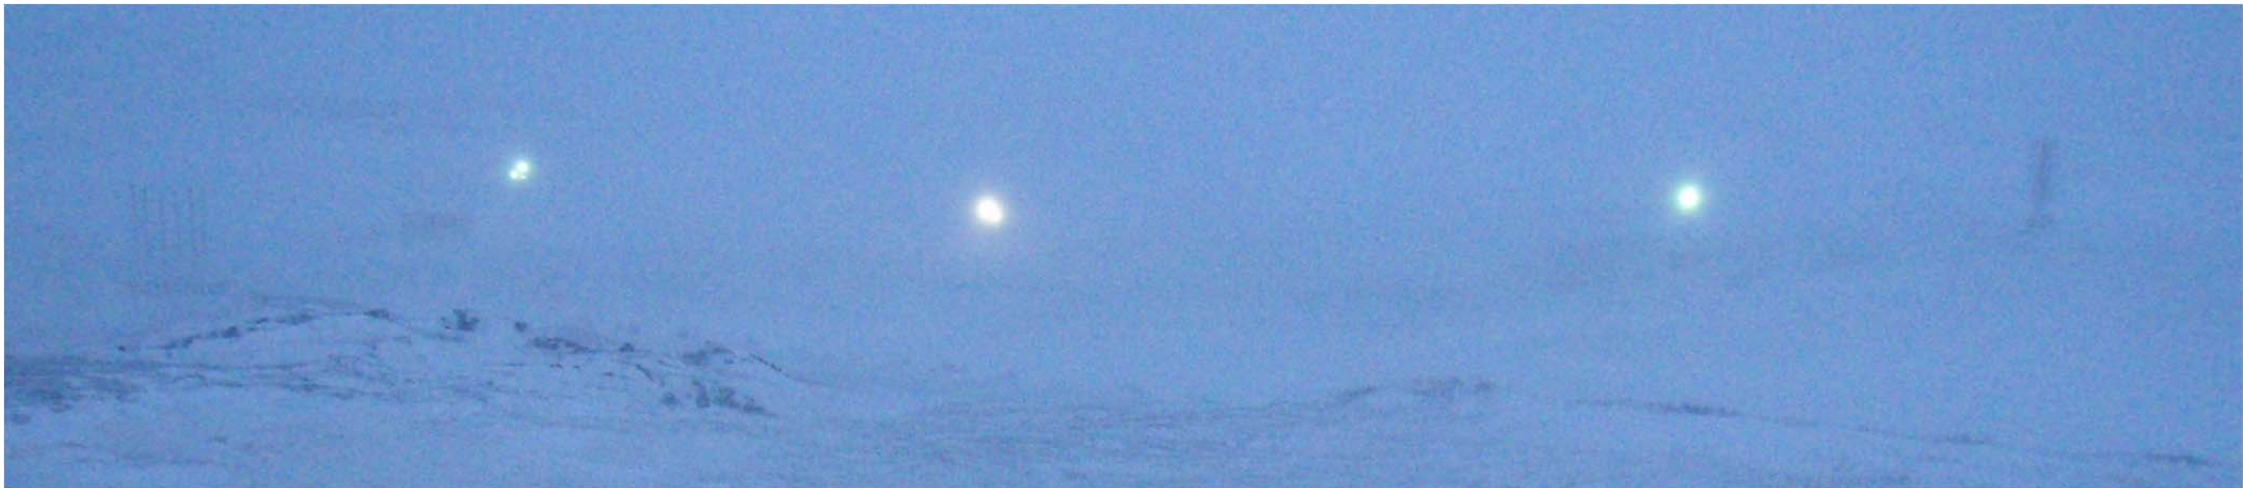
Photo 7: Progress photo of North Dam from photo point 1. ~SW view. The dam is difficult to see due to blowing snow. Conditions progressing towards a white out from Photos 2 to 3 to 1.

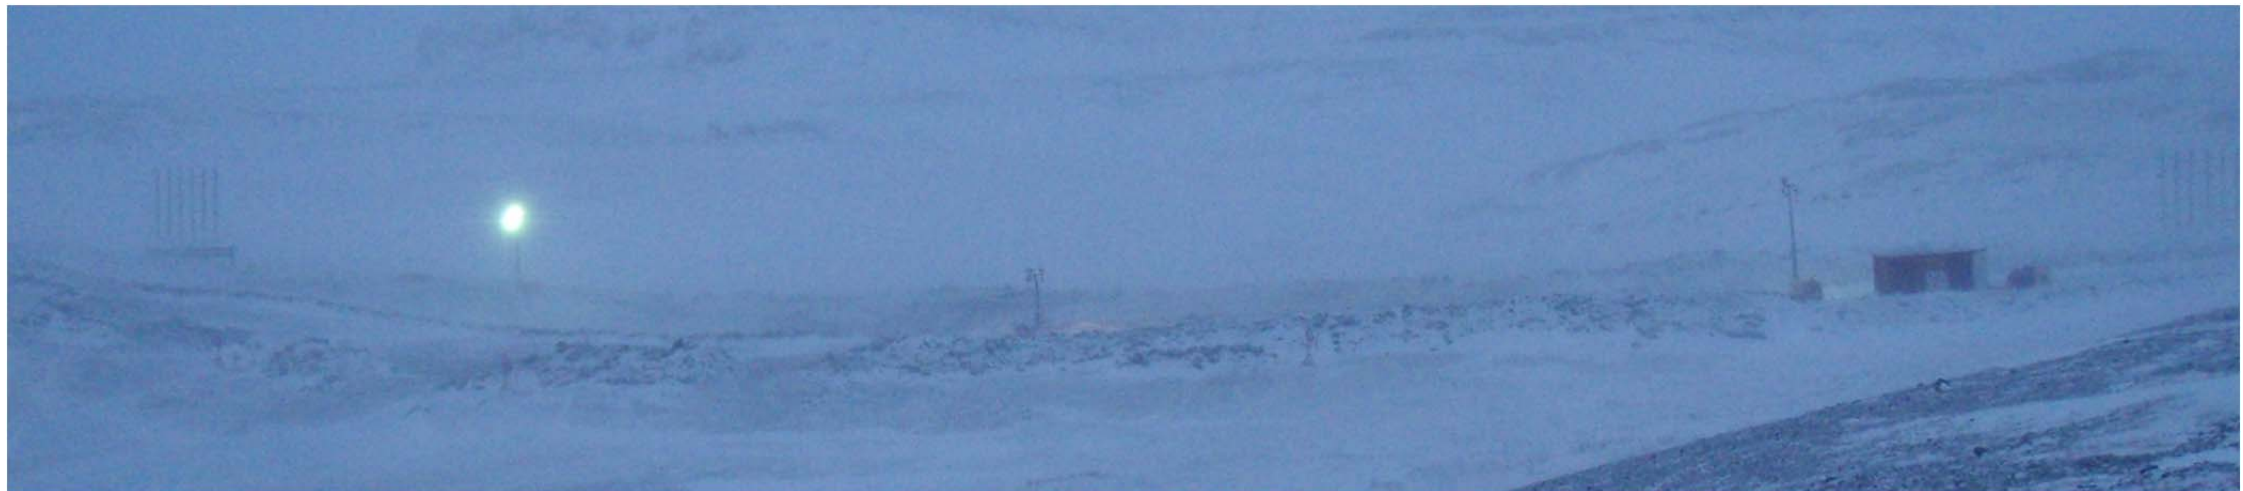
Photo 8: Progress photo of North Dam from photo point 2. ~WNW view.

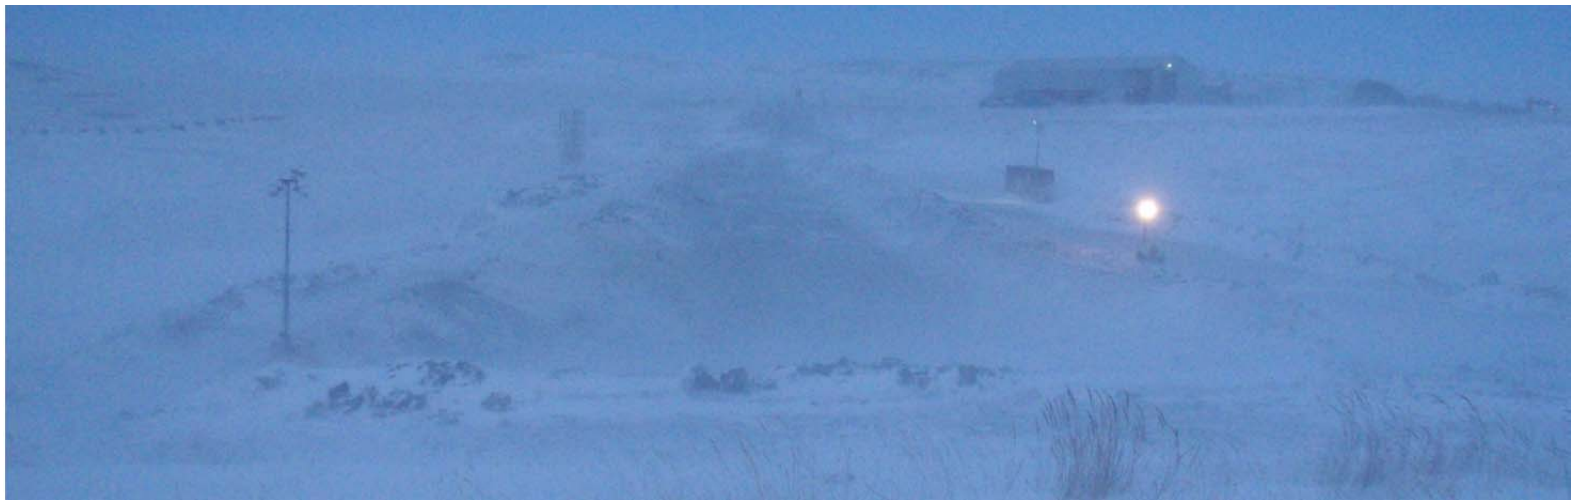
Photo 9: Progress photo of North Dam from photo point 3. ~ENE view.

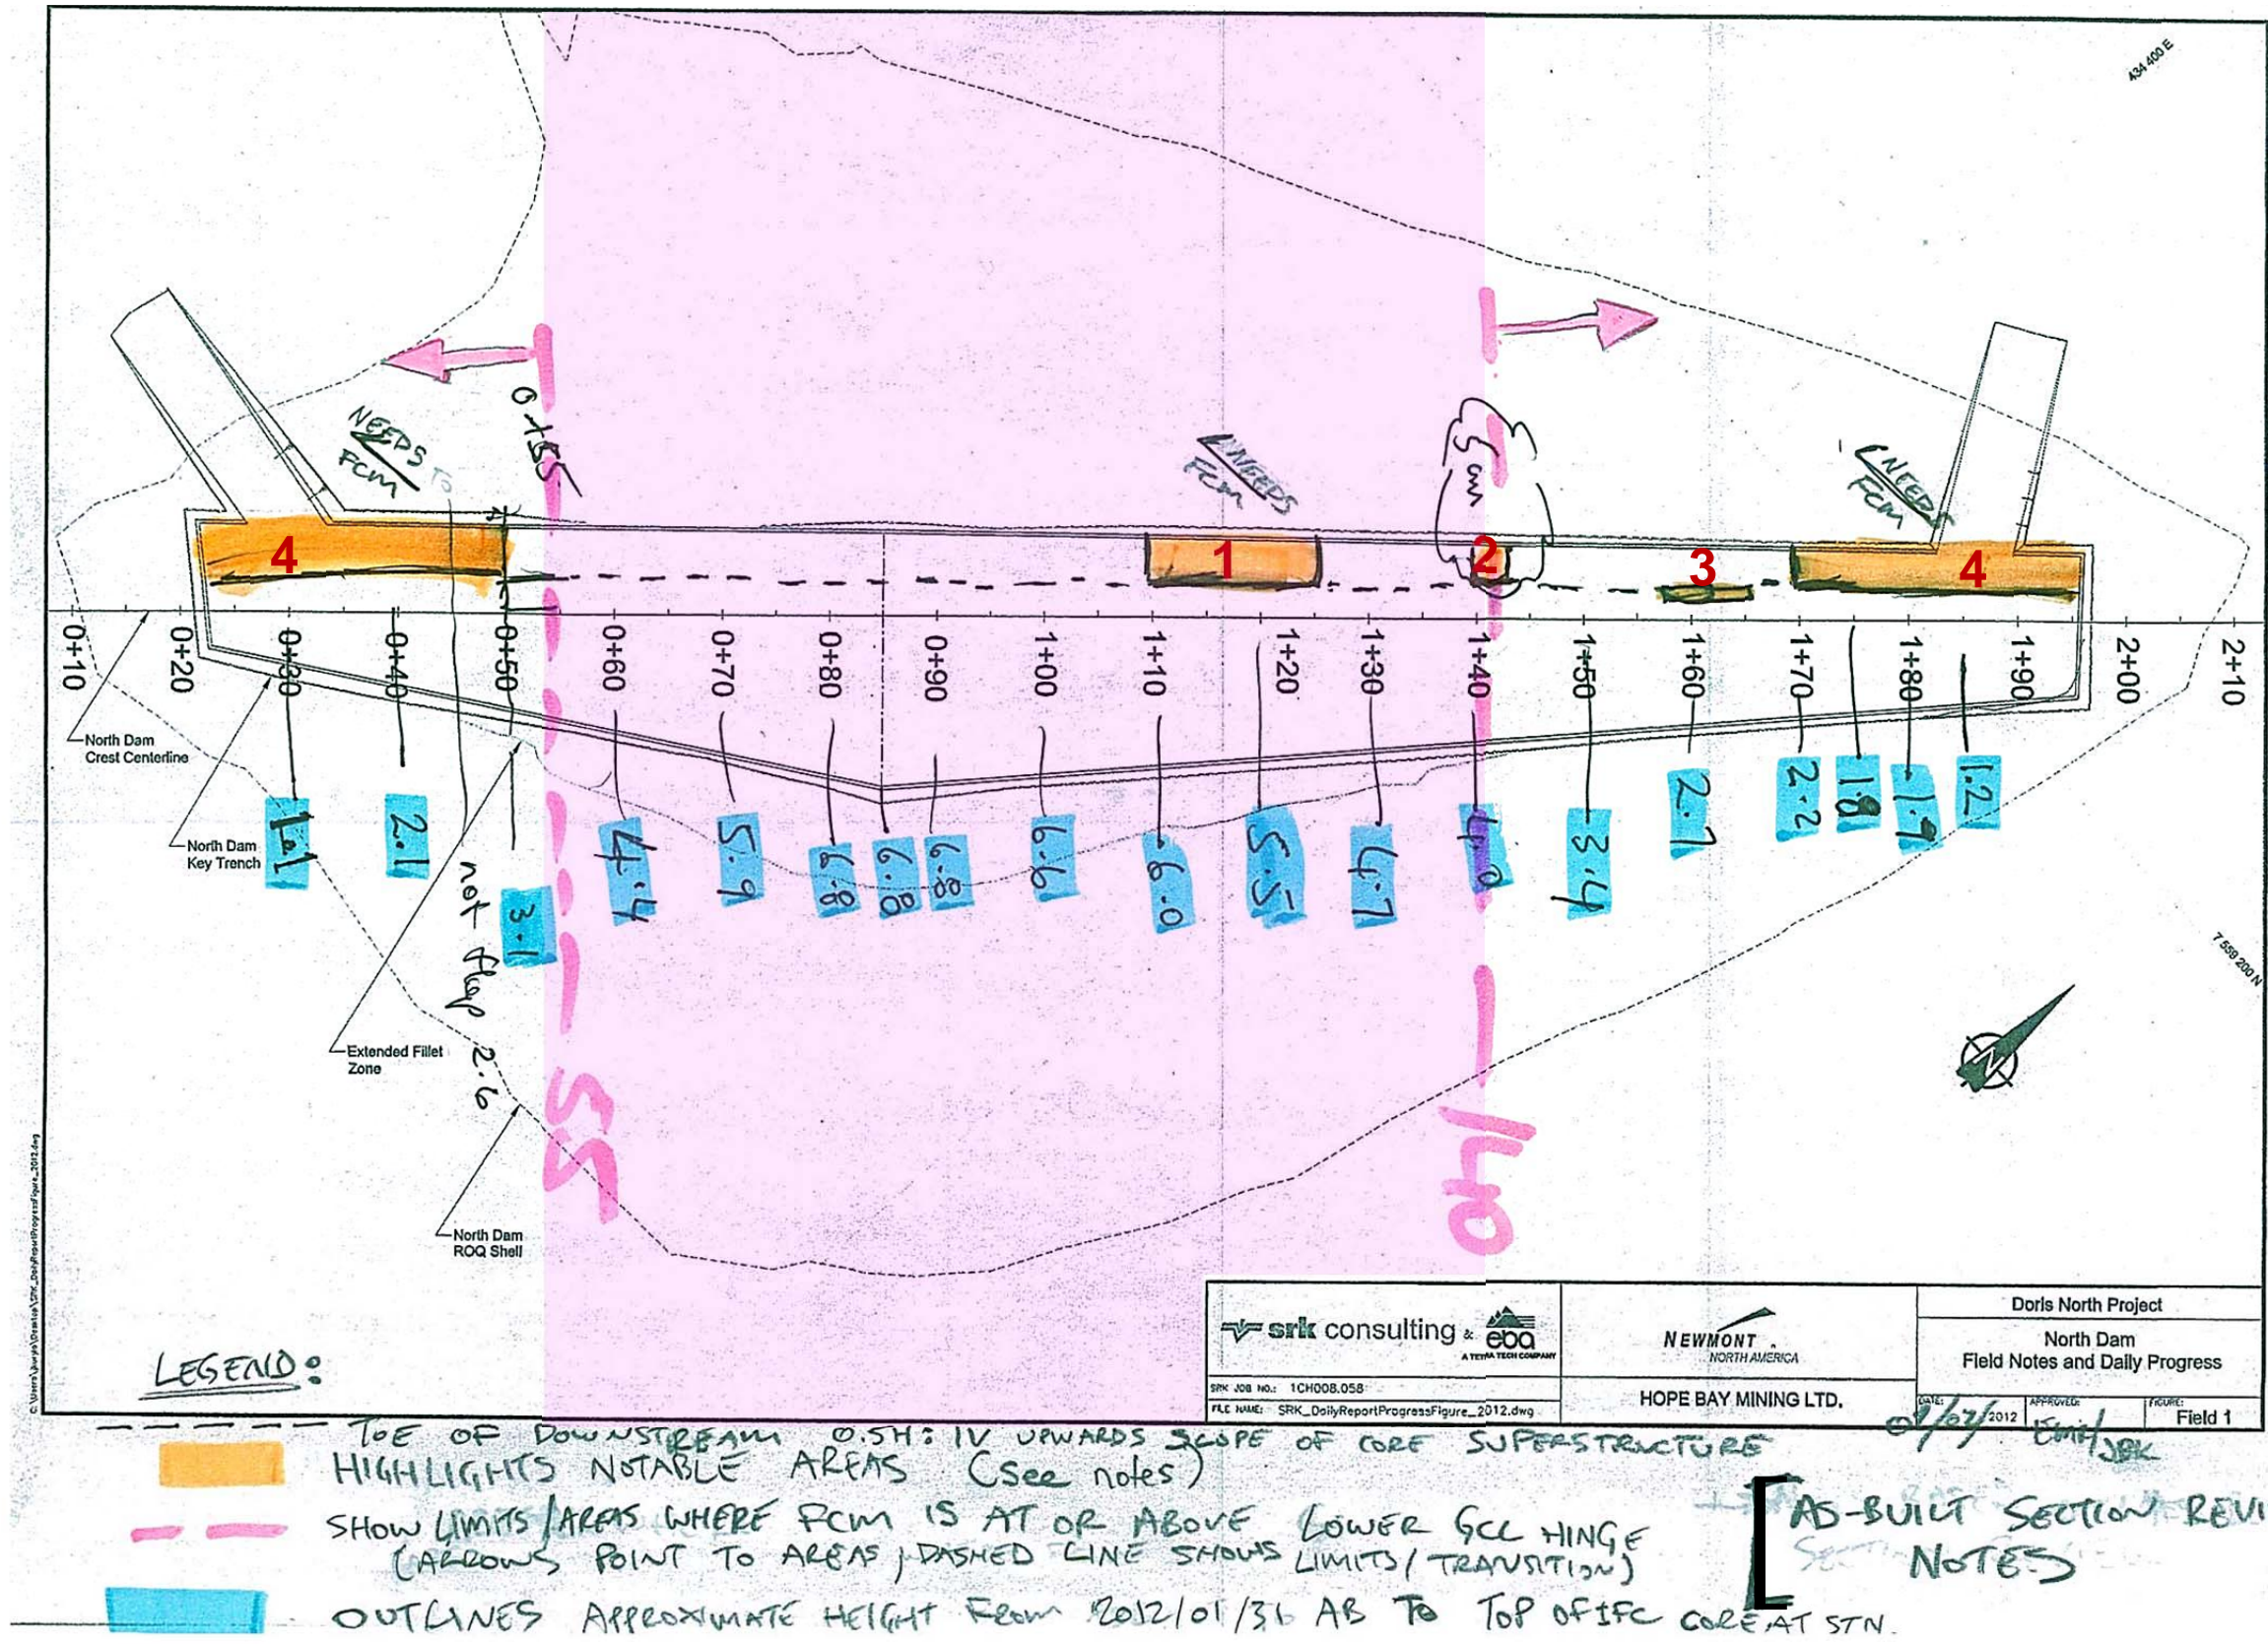
Figure 1 – North Dam as-built review note (based on surfaces and sections created for FCM material placed up to 2012/01/31)

1. On the downstream of the core around station 1+10 to 1+25, there is an area that is below design grade by ~ 0.3m. In this area the downstream 0.5H:1V slope of the core has started to be constructed upwards before the adjacent area was brought up to grade. This area is planned to be brought up to grade with the next lift that is placed in this area (as noted in daily #27).

2. There is a small area around station 1+40 where horizontal area of the downstream core (i.e. the area before the core 'superstructure' goes upwards at a ~ 0.5H:1V slope) is ~ 0.05m under IFC grades.

3. There is a small area around station 1+55 to 1+65 where the downstream 0.5H:1V core 'superstructure' slope has started slightly inside of the IFC design lines/limits

4. From ~ 0+25 to 0+50 and from ~ 1+70 to 1+95 the FCM along the downstream is below the design grade/elevation. In these areas the core material will be unable to be built up without notably exceeding the lower GCL liner fillet hinge elevation. The transition material around these areas is expected to be built up to allow for a slope to be created, that FCM could be built into.

5. From station ~ 0+25 to 0+55 and from ~ 1+40 to 1+95 the FCM on the upstream is slightly above or at the elevation of the lower GCL on the fillet hinge. It is recommended at this time that FCM placement occur between station 0+55 and 1+40 (note/ highlighted in pink in the central key trench area).

- o Alternately the covered/ protected GCL liner from station ~ 0+25 to 0+55 and from ~ 1+40 to 1+95 is suggested to be exposed before additional FCM results in this area. Note that the GCL on the fillet hinge is currently covered with HDPE, then 5/8" material and then overlain by ROQ.
