DAILY REPORT #29 – DORIS NORTH INFRASTRUCTURE/ NORTH DAM

Prepared by:	John Kurylo/ Megan Miller	Date:	2012.02.03
Reviewed by:		Project #:	1CH008.058.0320
Role	Company	Personnel – Position	On Site
Client	Hope Bay Mining Limited (HBML)	Angela Holzapfel – ESR Compliance Manager David Vokey – ESR Coordinator Don Ethelston – HSLP Advisor Dean Wold - Safety Jill Turk – ESR Coordinator Katsky Venter – ESR Manger Michelle Tanquay – ESR Site Manager Stirling Kelly – HSLP Advisor	No Out Out No In Yes No In
	JDS	Lloyd Jackson – Mechanical Superintendent Sven Archimowtiz – Electrical Superintendent Doug Fielding – Construction Manager Ishan Fechter – Construction Coordinator Jerry Graham – Construction Manager Kevin Whieldon – Project Coordinator Mark Valeriote – Construction Manager	Yes Yes Out No In Yes Yes
Engineering Design Consultants	SRK Consulting (Canada) Inc.	John Kurylo – Site Engineer Megan Miller – Site Engineer Lawrence Borowski – Site Engineer Murray McGregor – Site Engineer Iozsef Miskolczi – Site Engineer	Yes Yes No In No

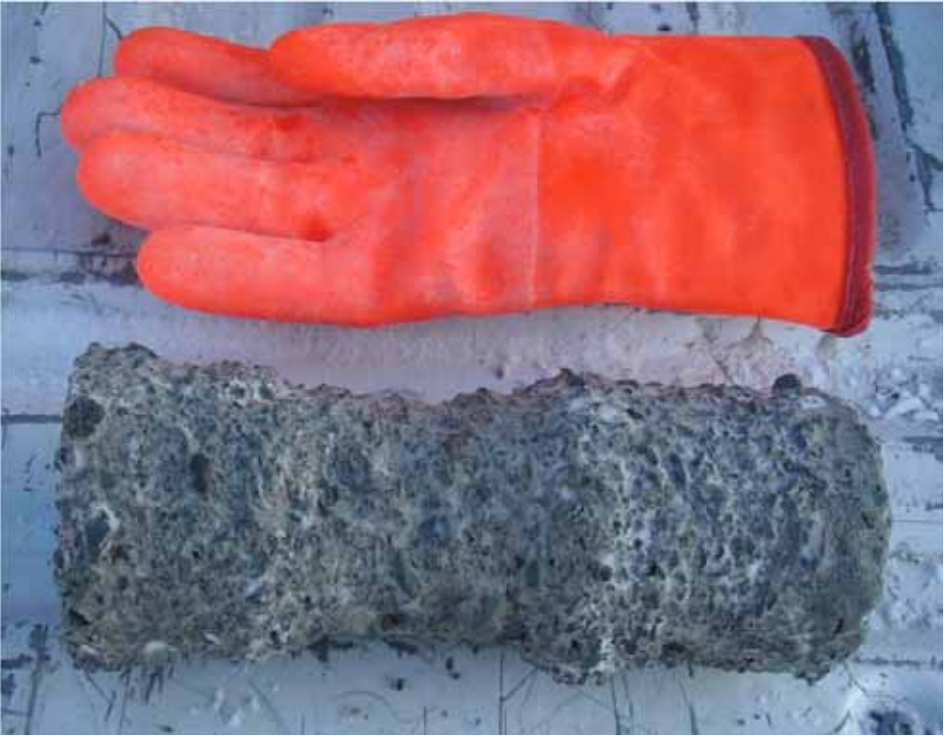
- No core material was placed on dayshift today. This was primarily due to crew change.
- Three cores were drilled today.
 - o One core was drilled around station ~1+00 US, in the material that was previously placed on dayshift. See Photo 4.
 - o Due to the poor quality of the first core (damaged from drilling) a second core was taken in the central key trench area around station 0+90 DS. See Photo 5.
 - o A third core was taken around station 0+42 DS. See Photo 6.
- Figure 1 presents the North Dam dayshift construction progress, for 2012/02/03.

Photo 4: Drilled Core 17 (HB12-ND-CORE-DC17-QA-20120203). Core taken from ~1+00 US. Poor quality of core is due to dislodged gravel spinning/ drill spin.

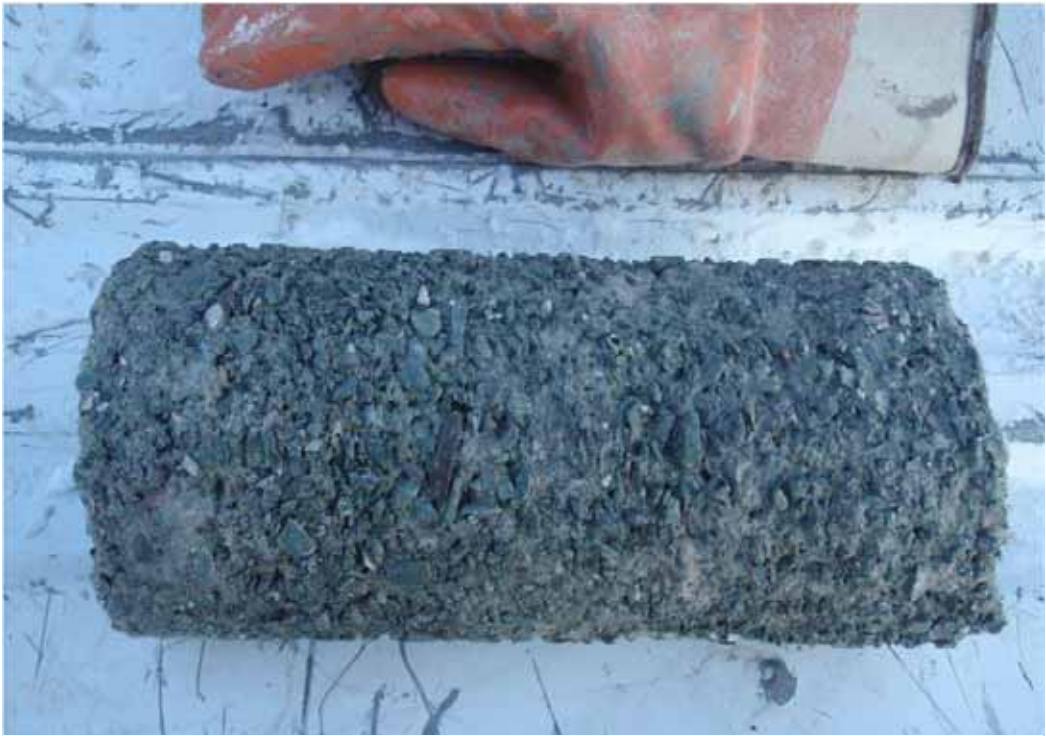
Photo 5: Drilled Core 18 (HB12-ND-CORE-DC18-QA-20120203). Core taken from ~0+90 DS.

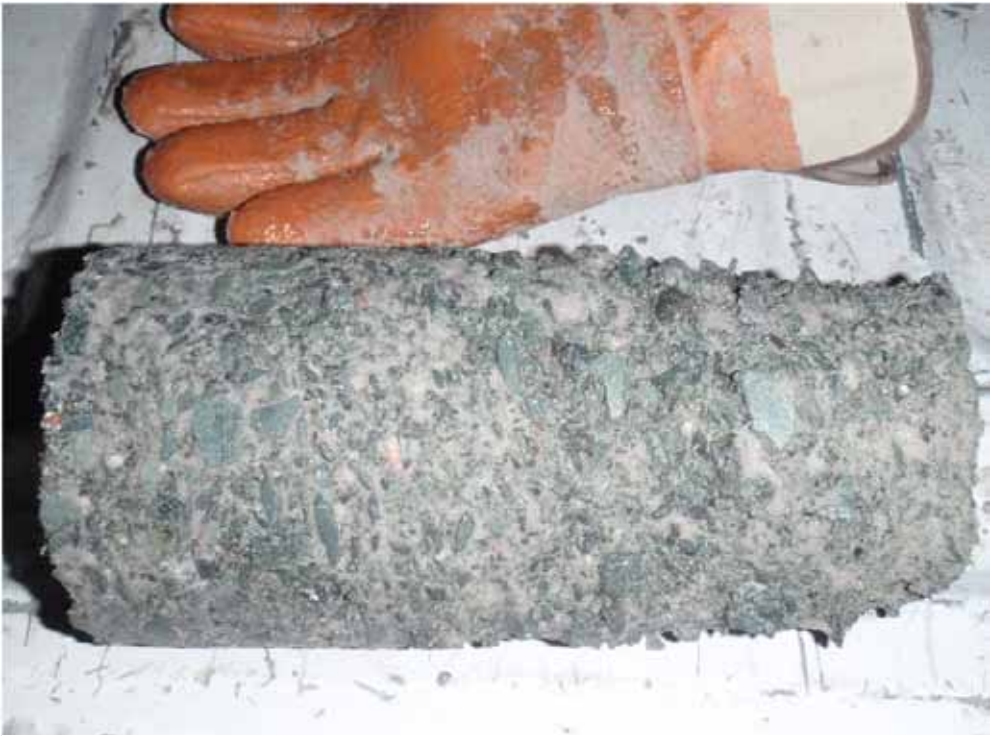
Photo 6: Drilled Core 19 (HB12-ND-CORE-DC19-QA-20120203). Core taken from ~0+42 downstream.

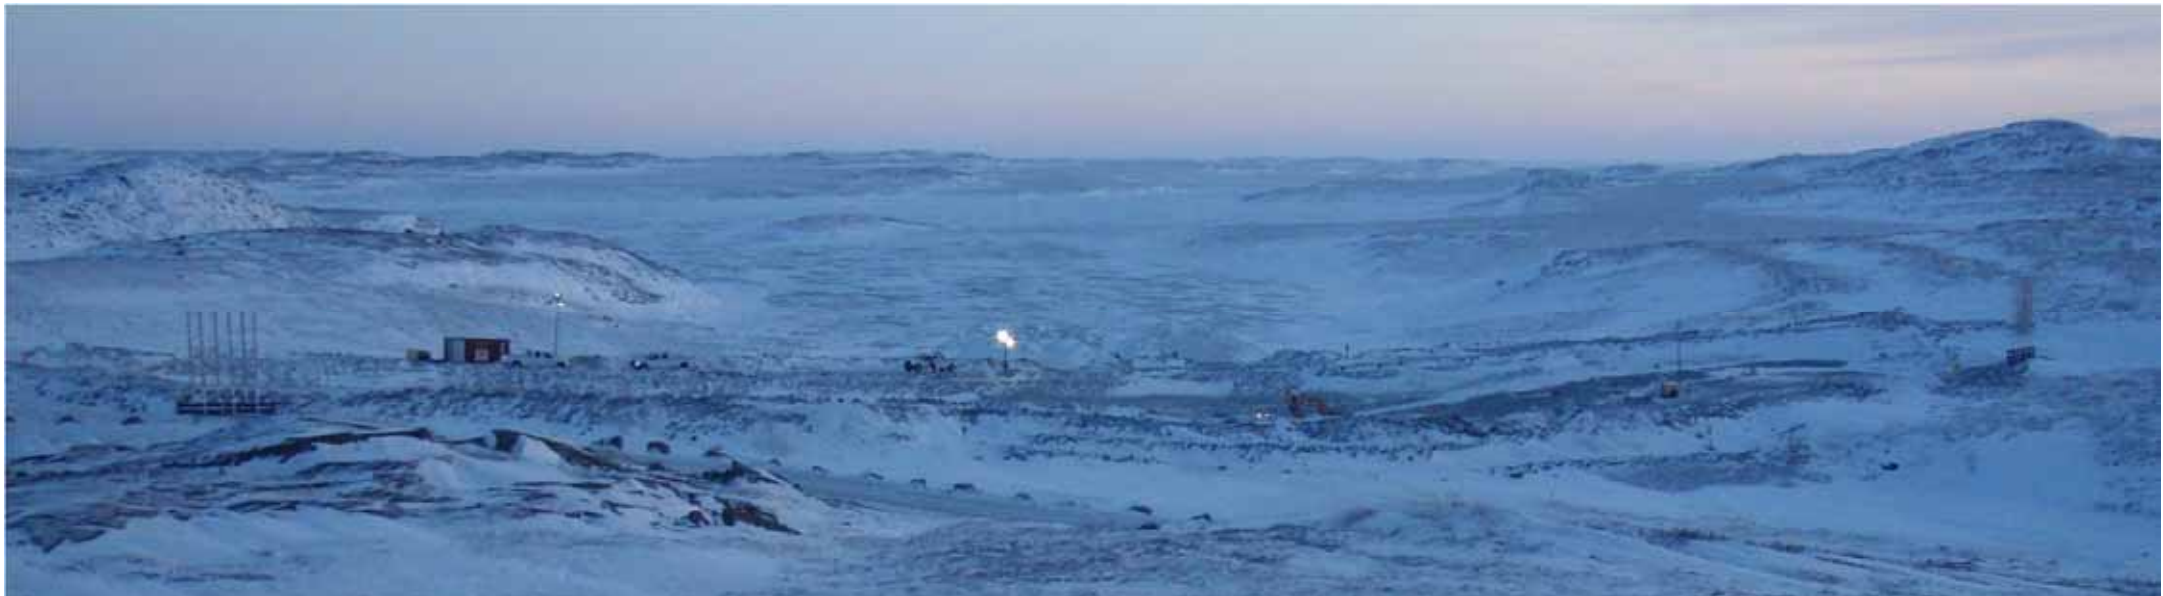
Photo 7: Progress photo of North Dam from photo point 1. ~SW view. The dam is difficult to see due to blowing snow.

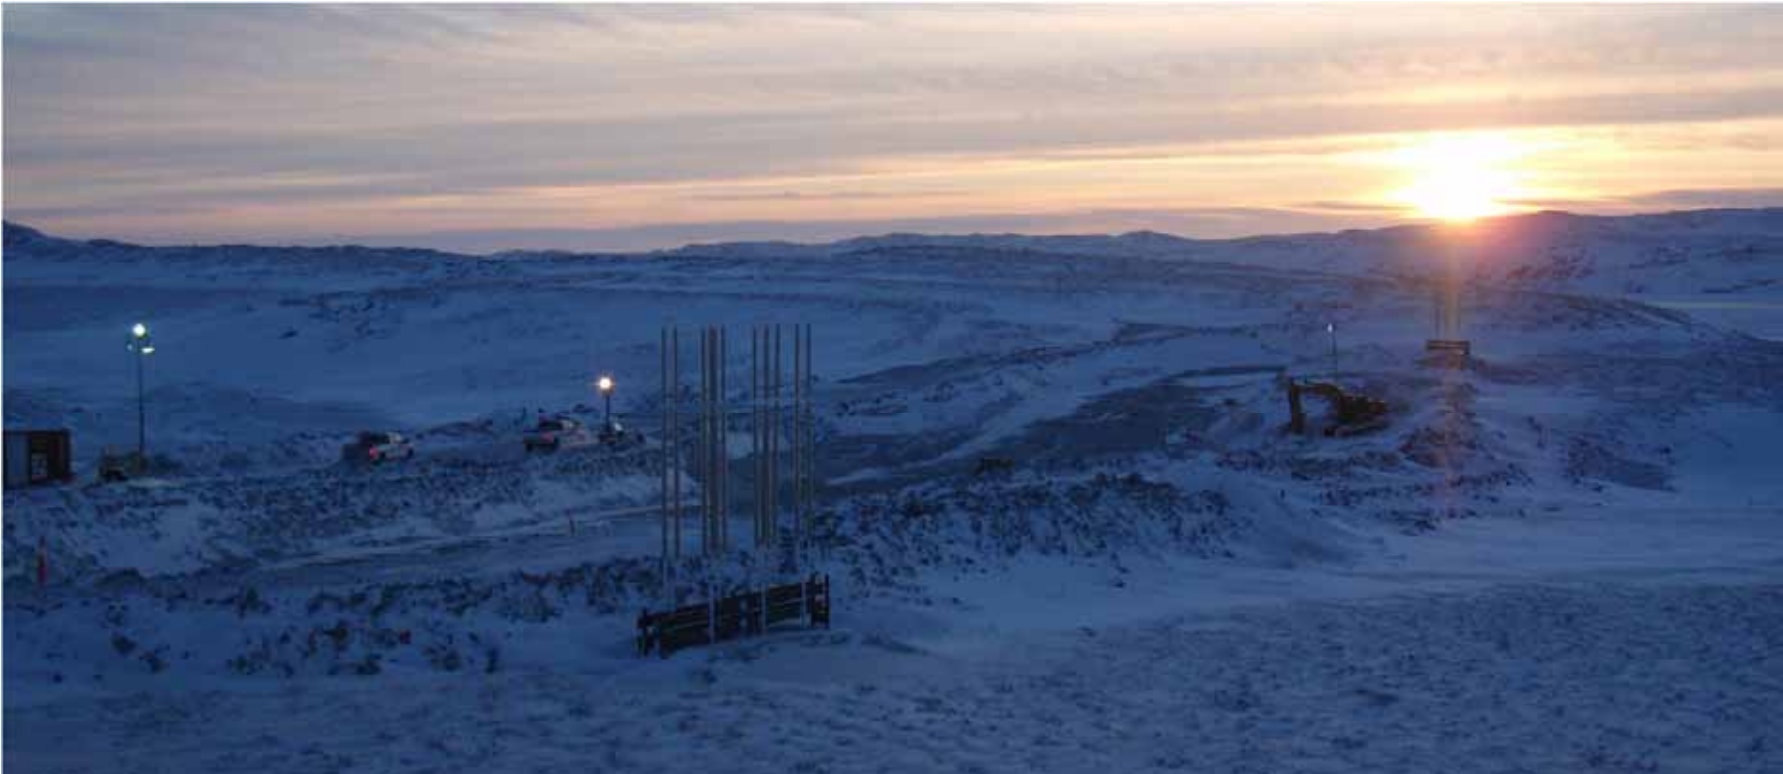
Photo 10: ~SSE view of the North Dam area. Note the excavator cleaning downstream area around station 0+90.

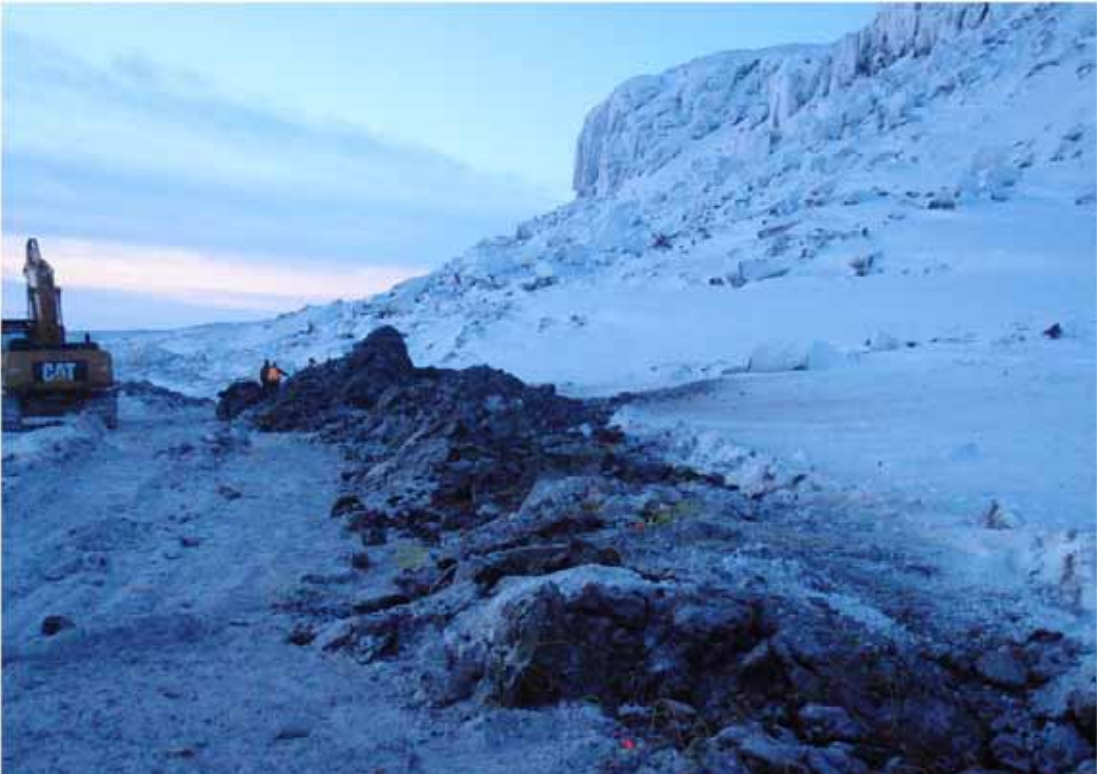
- Westarc continues drilling along the DN Diversion berm alignment. A few small shots/ matt blasts occurred today at the Doris North Diversion Berm key trench alignment. See Photo 11.

Photo 11: ~ WNW view of the Doris North Diversion Berm after early afternoon blasting. Note the large quantity of frozen overburden encountered along this section (near the east to east central portion of the alignment).

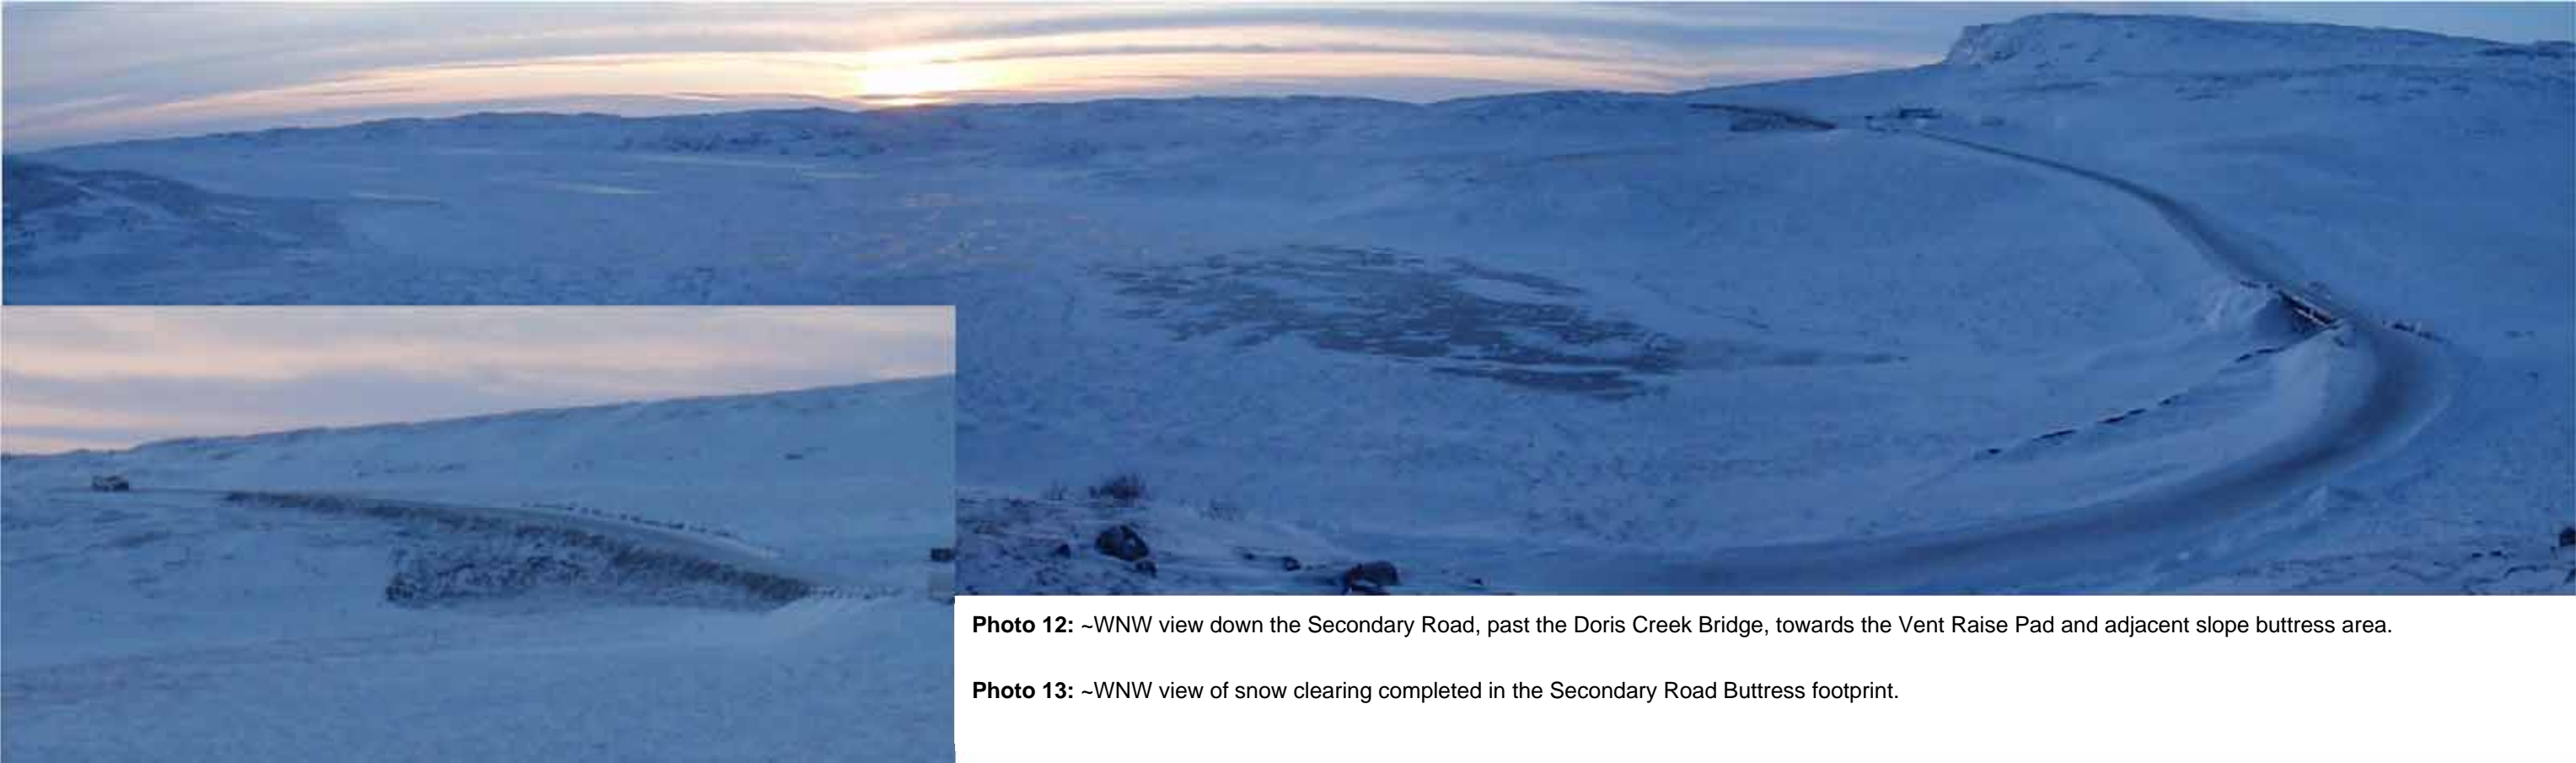
- Snow was cleared from within the Secondary Road Buttress footprint. Snow clearing was done with the 325 excavator (equipped with finishing bucket). At the end of dayshift the snow clearing in this area looked adequate. See Photo 13.
 - Unfortunately due to high winds and blowing and falling snow additional cleaning in this area is now expected.

Photo 13: ~WNW view of snow clearing completed in the Secondary Road Buttress footprint.

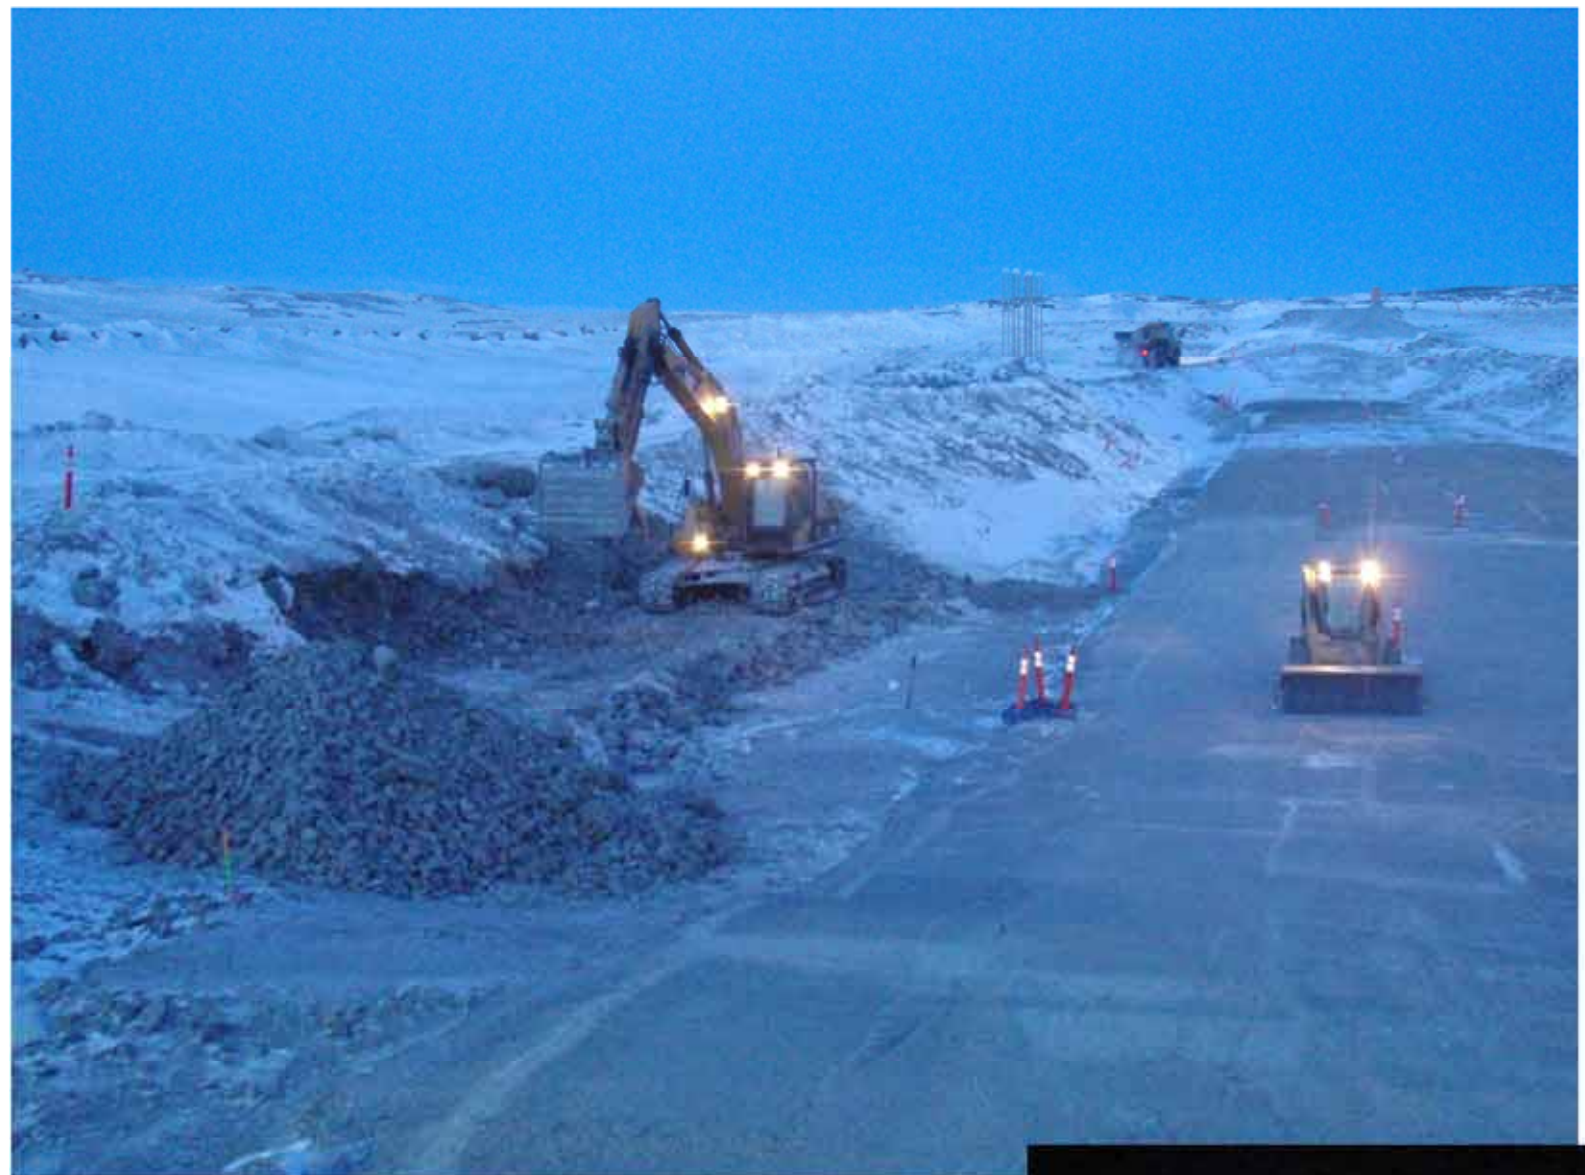
- Transition material was placed and compacted along the downstream edge of the central dam core, after snow clearing/ cleaning of the side slopes, from ~ station 0+75 to 1+10. The adjacent ROQ slope in this area was trimmed back by the 325 excavator to create an access 'bench' for the trucks and compactor. See Photo 14.

Photo 14: ~NE view of the 325 excavator placing transition material around station 1+00.

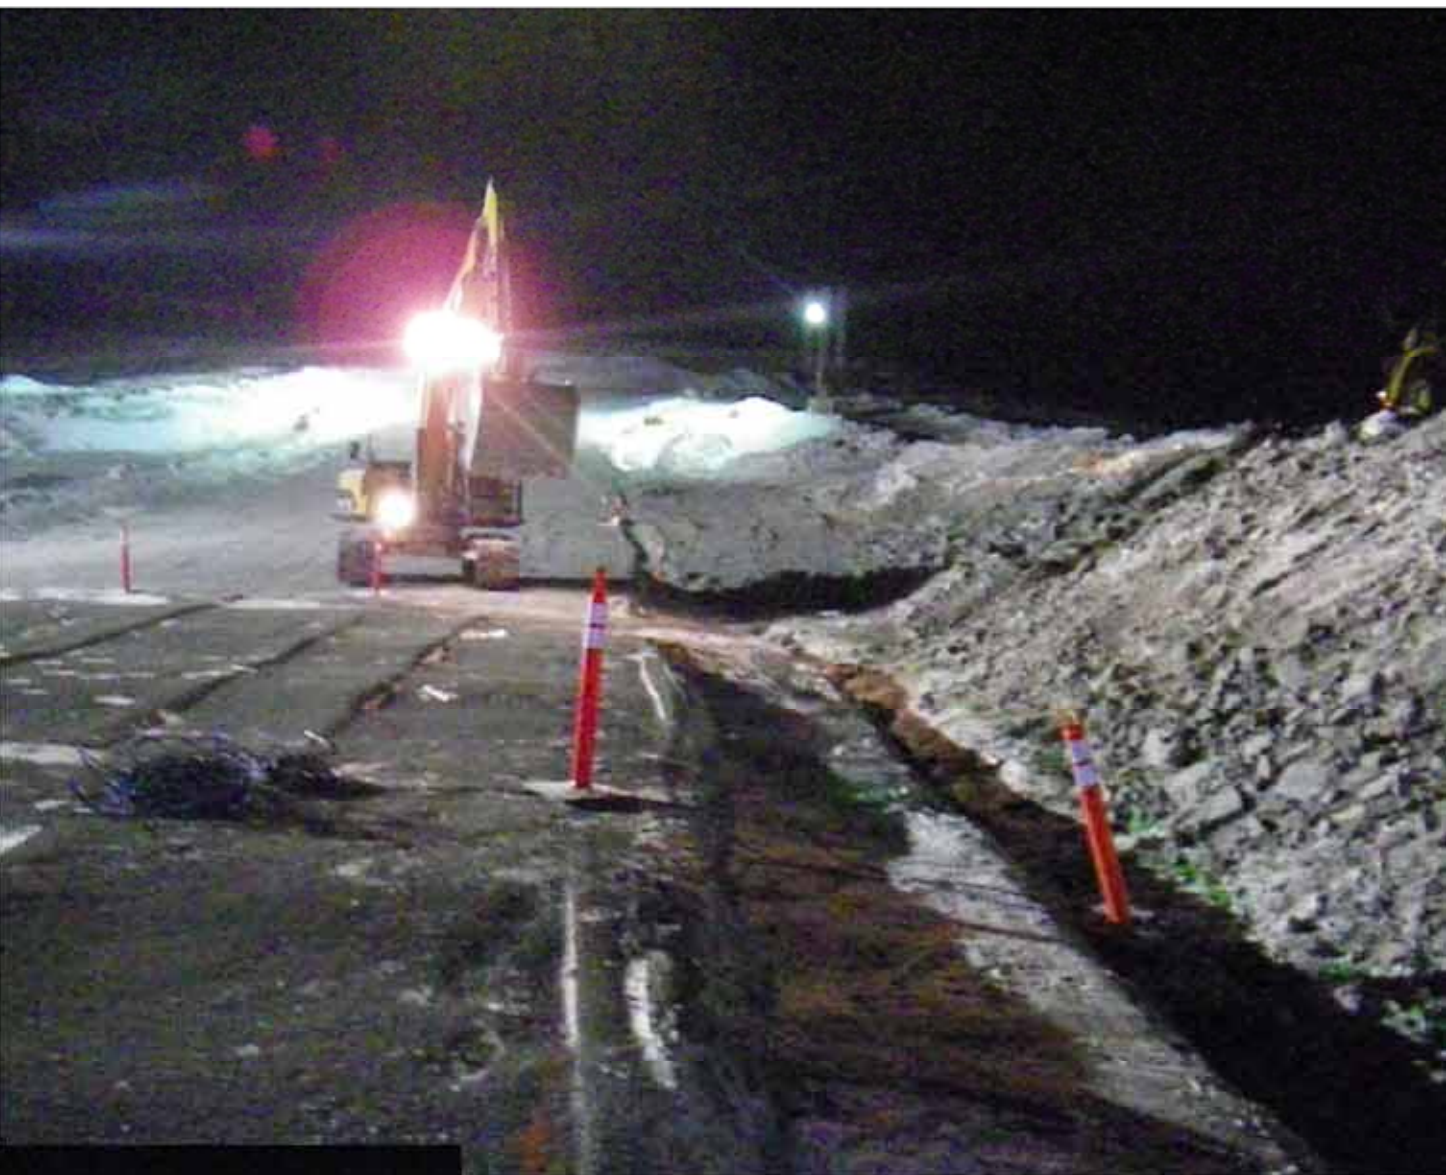
Photo 16: Downstream side of key trench with snow cleared in preparation for transition material placement.

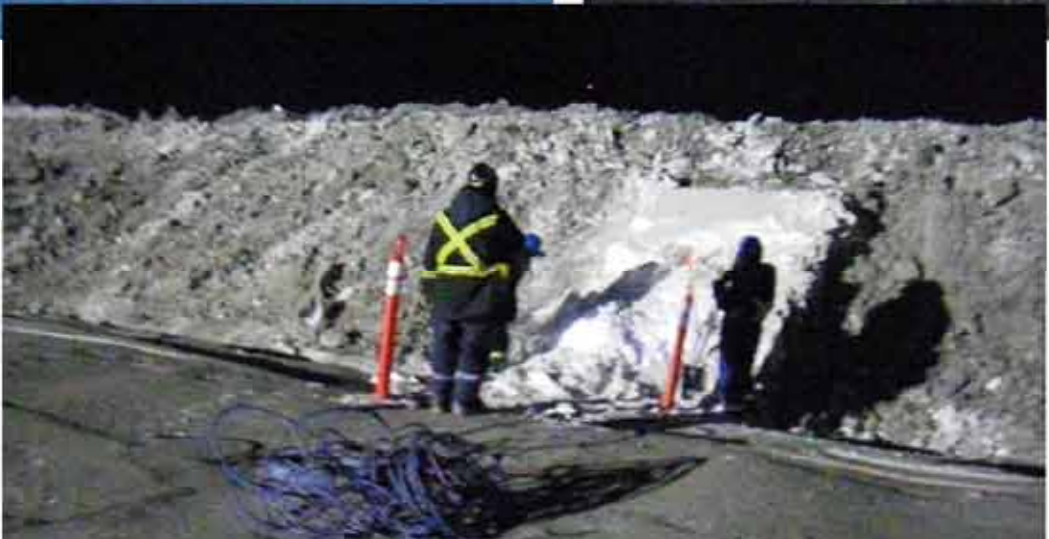
- No FCM placement occurred on nightshift.
- Freezback of the lift placed 2012/02/01 nightshift was obtained at 11 pm.
- Snow around the thermistor cables at 1+30 was removed by labourers. Once the cables were exposed the excavator cleared the bulk of the snow off the slope above the cables.

Photo 15: Labourers cleaning snow away from the thermistor cables at station 1+30.
