DAILY REPORT #30 – DORIS NORTH INFRASTRUCTURE/ NORTH DAM

Prepared by:	Murray McGregor John Kurylo / Megan Miller	Date:	2012.02.04
Reviewed by:		Project #:	1CH008.058.0320
Role	Company	Personnel – Position	On Site
Client	Hope Bay Mining Limited (HBML)	Angela Holzapfel – ESR Compliance Manager David Vokey – ESR Coordinator Don Ethelston – HSLP Advisor Dean Wold - Safety Jill Turk – ESR Coordinator Katsky Venter – ESR Manger Michelle Tanquay – ESR Site Manager Stirling Kelly – HSLP Advisor	No No No No Yes Yes No Yes
	JDS	Lloyd Jackson – Mechanical Superintendent Sven Archimowtiz – Electrical Superintendent Doug Fielding – Construction Manager Ishan Fechter – Construction Coordinator Jerry Graham – Construction Manager Kevin Whieldon – Project Coordinator Mark Valeriote – Construction Manager	Yes No No No Yes Yes Yes
Engineering Design Consultants	SRK Consulting (Canada) Inc.	John Kurylo – Site Engineer Megan Miller – Site Engineer Lawrence Borowski – Site Engineer Murray McGregor – Site Engineer Iozsef Miskolczi – Site Engineer	Yes Yes No Yes No

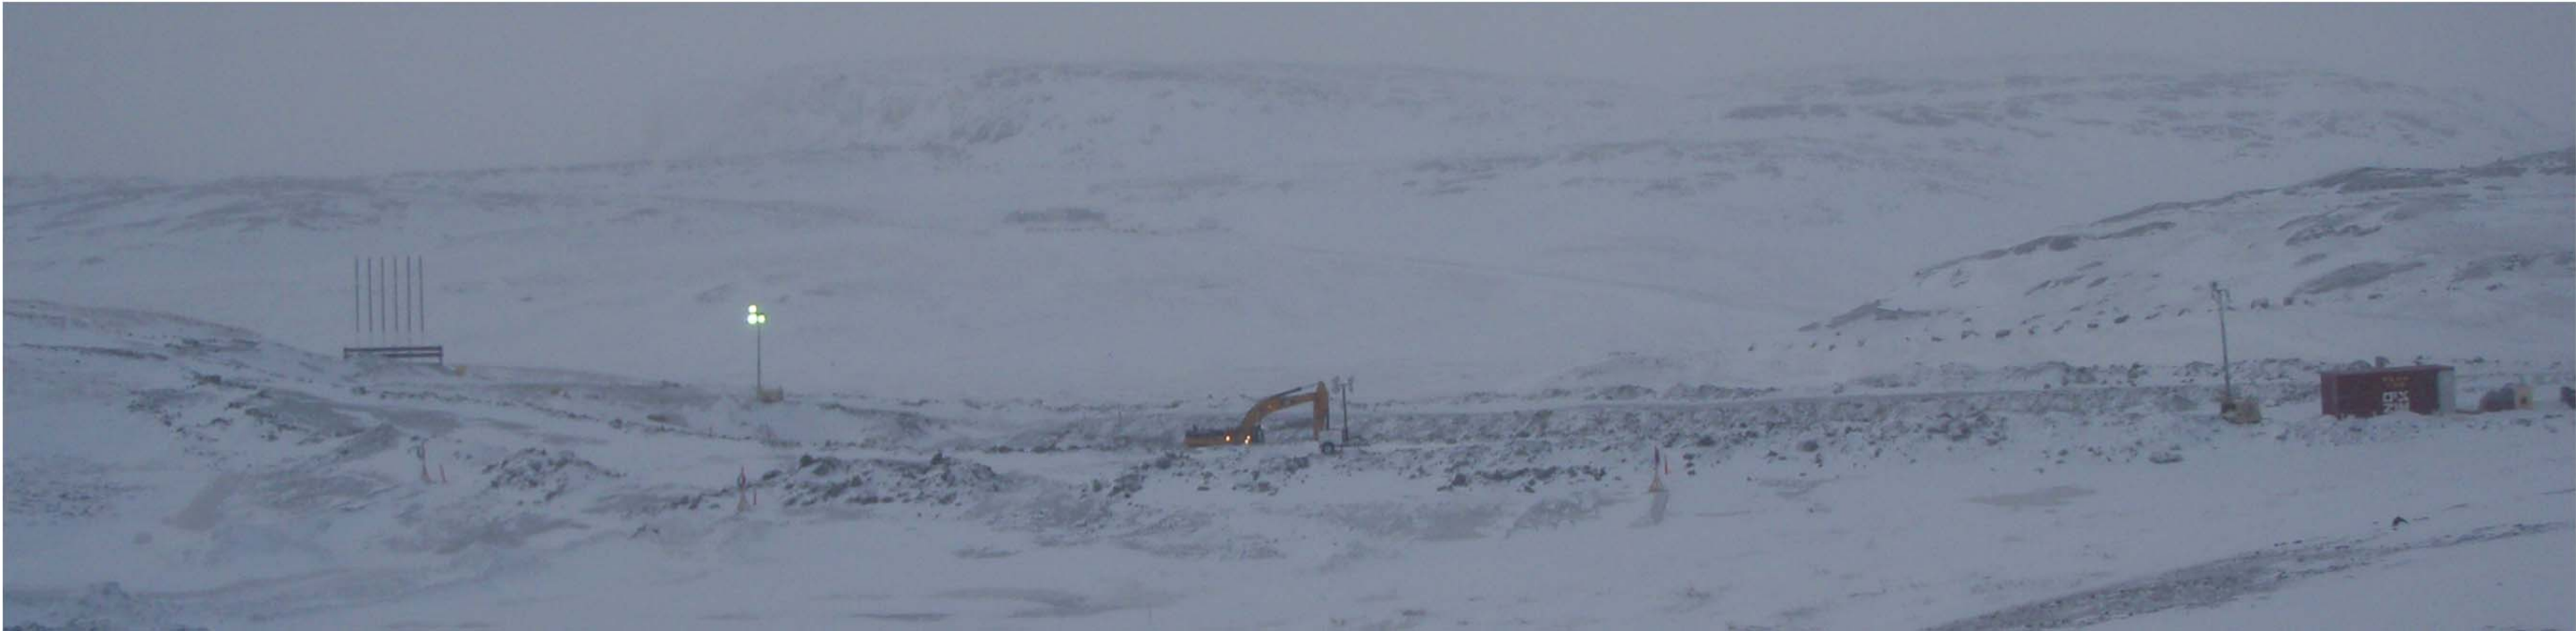
Photo 1: Progress photo of North Dam from photo point 2. ~WNW view.

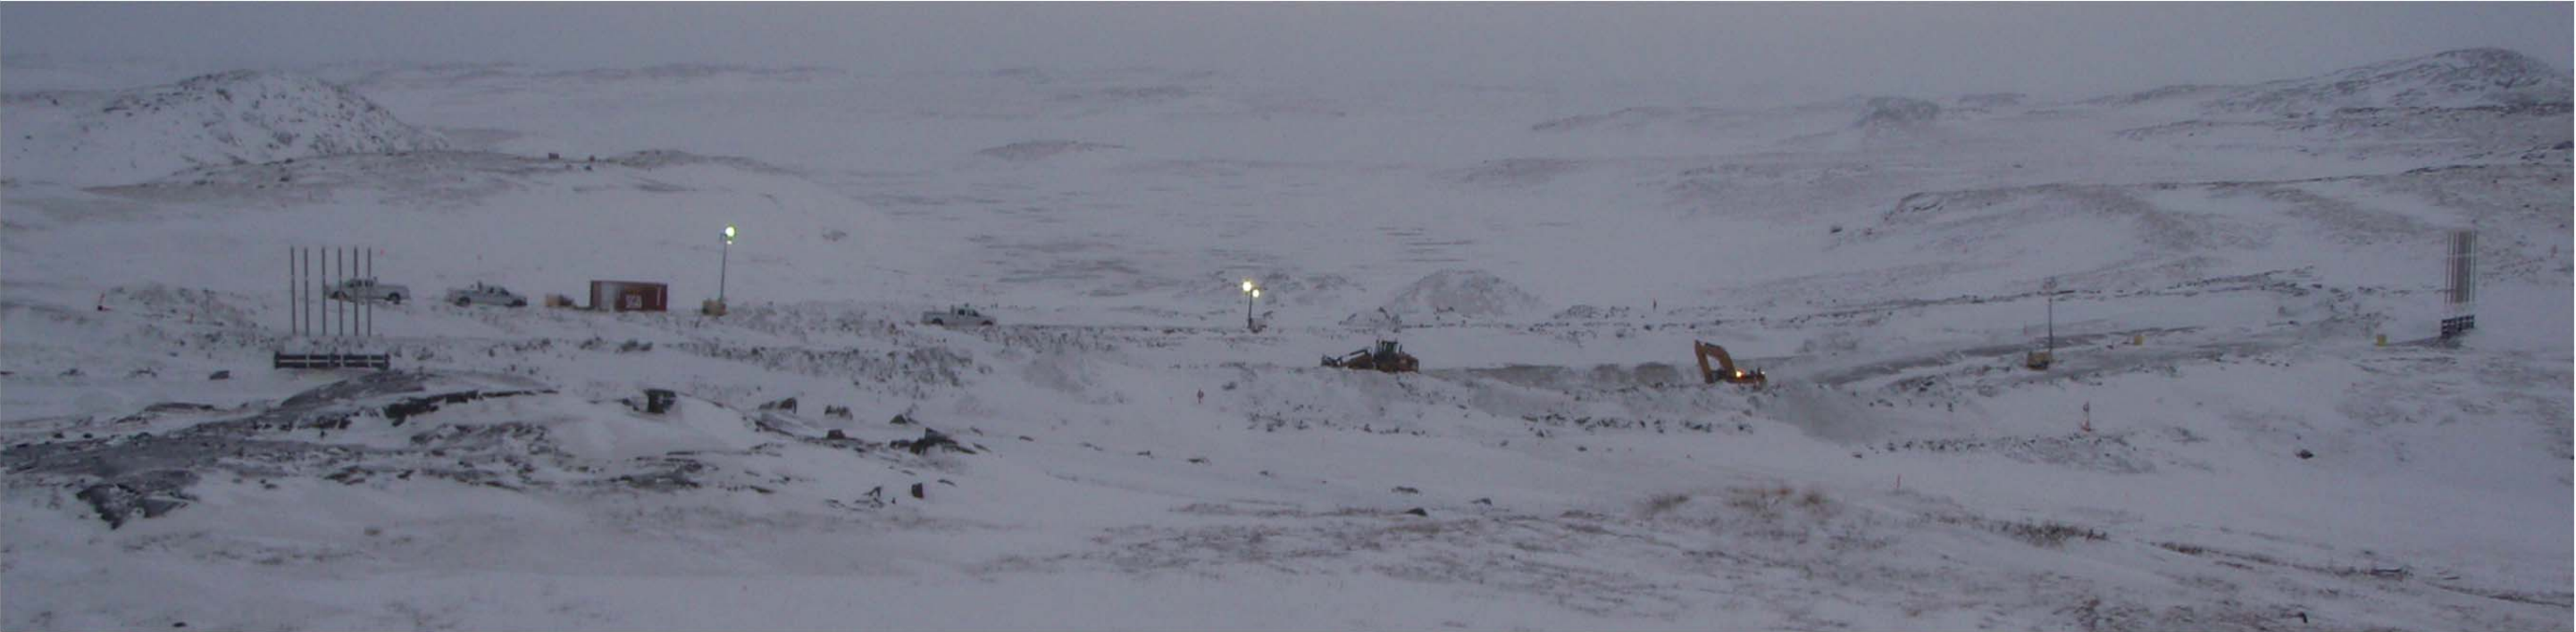
Photo 2: Progress photo of North Dam from photo point 1. ~SSE view.

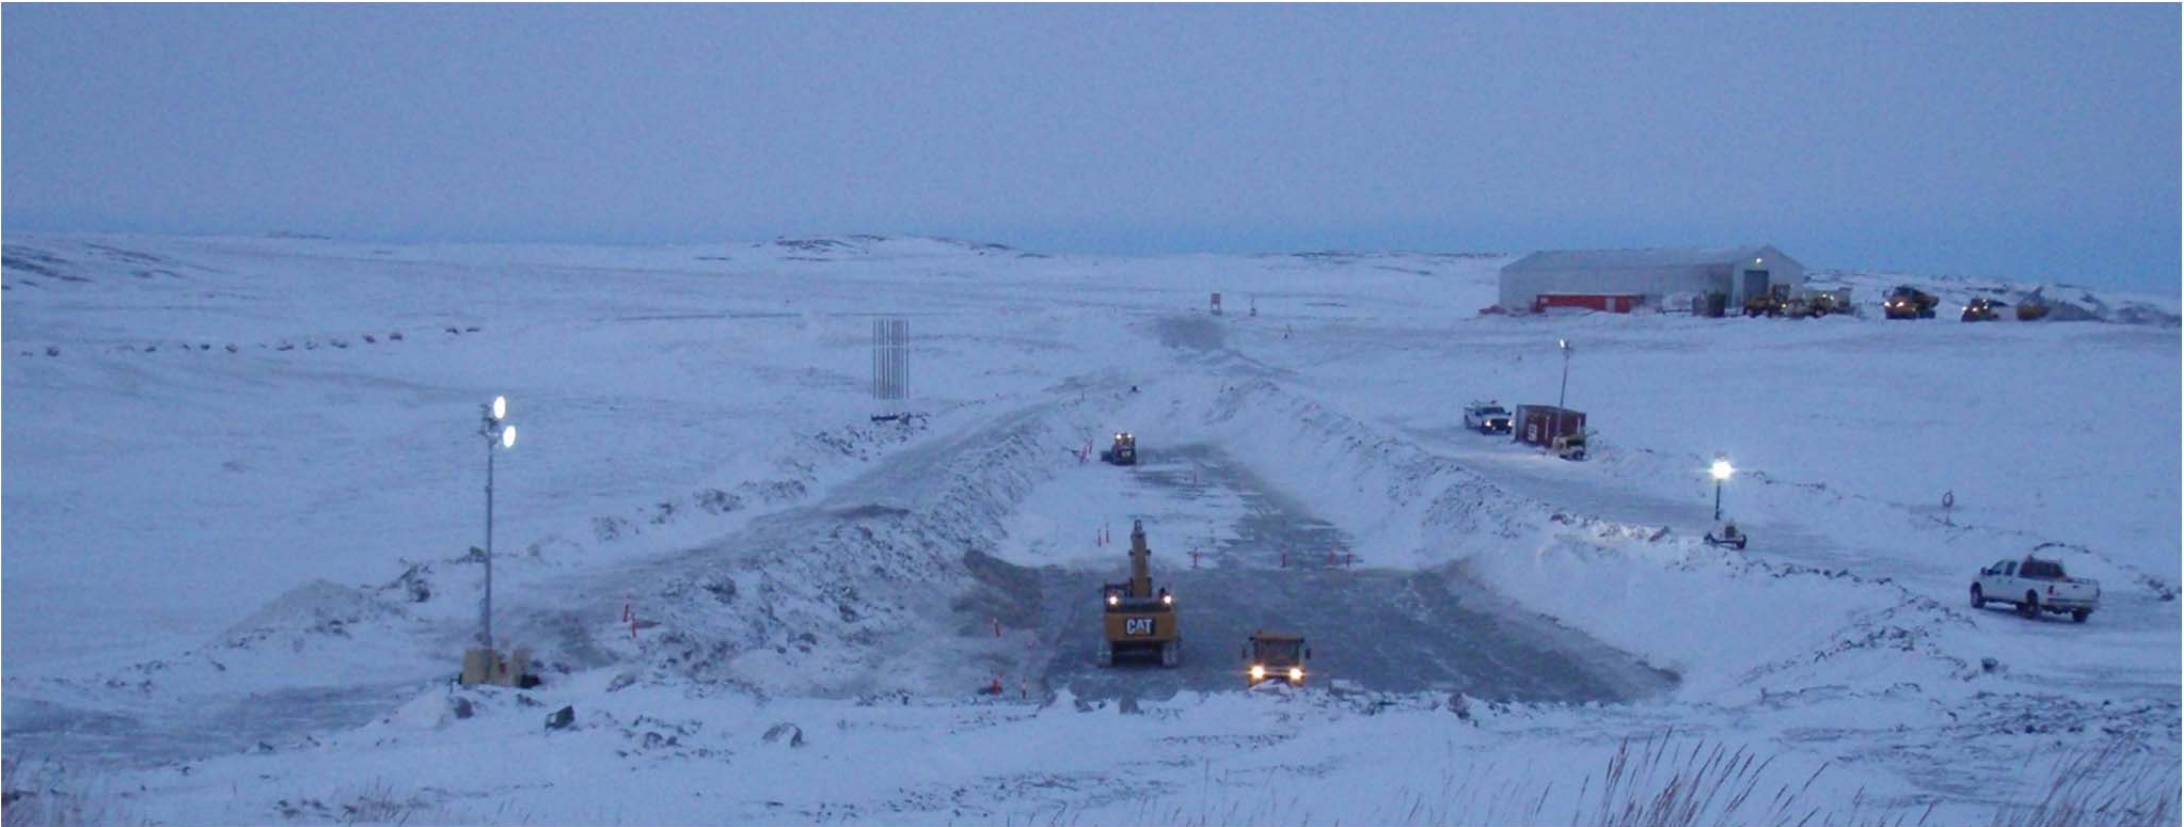
Photo 3: Progress photo of North Dam from photo point 3. ~NE view.

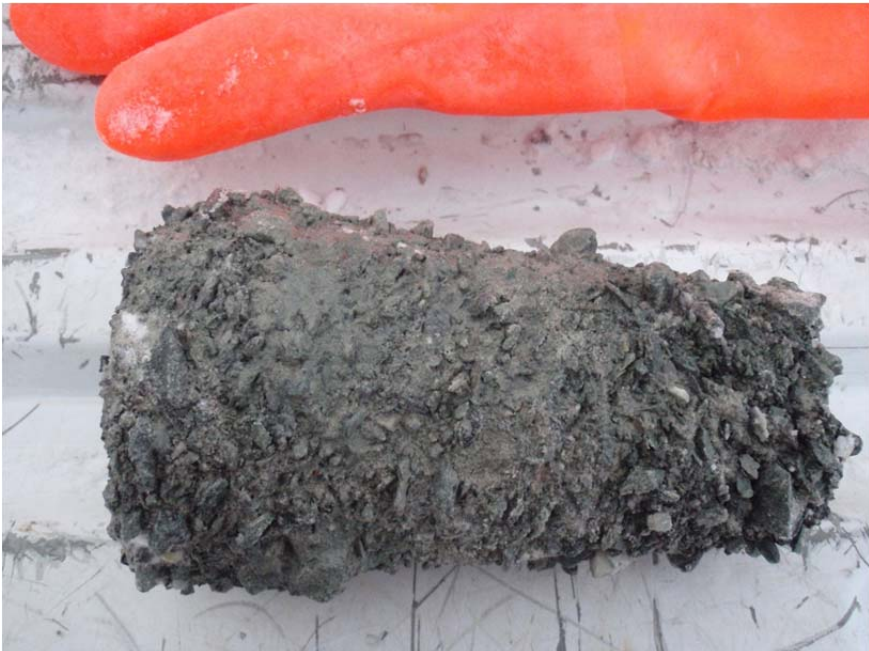
- Two drilled cores were taken. These cores were taken from the placement completed on Feb 1st nightshift. Photo 4 and 5 show these cores.
- Drilled core HB12-ND-CORE-DC20-QA-20120204 was taken from 1+60 CL to upstream.
- Due to the poor quality (from drill spin) of DC 20 an additional core was drilled. Core HB12-ND-CORE-DC21-QA-20120204 was taken from 1+54 CL.

Photo 4: Drill core HB12-ND-CORE-DC-20-QA-20120204. Poor quality due to spinning gravel in barrel. Taken from 1+60 CL to upstream.

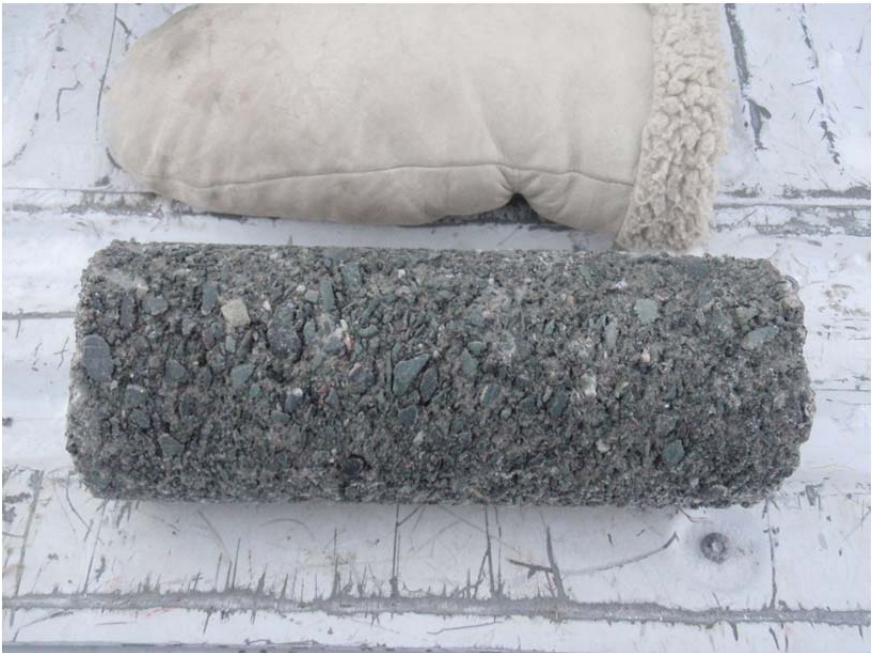
Photo 5: Drill core HB12-ND-CORE-DC-21-QA-20120204. Taken from 1+54 CL.

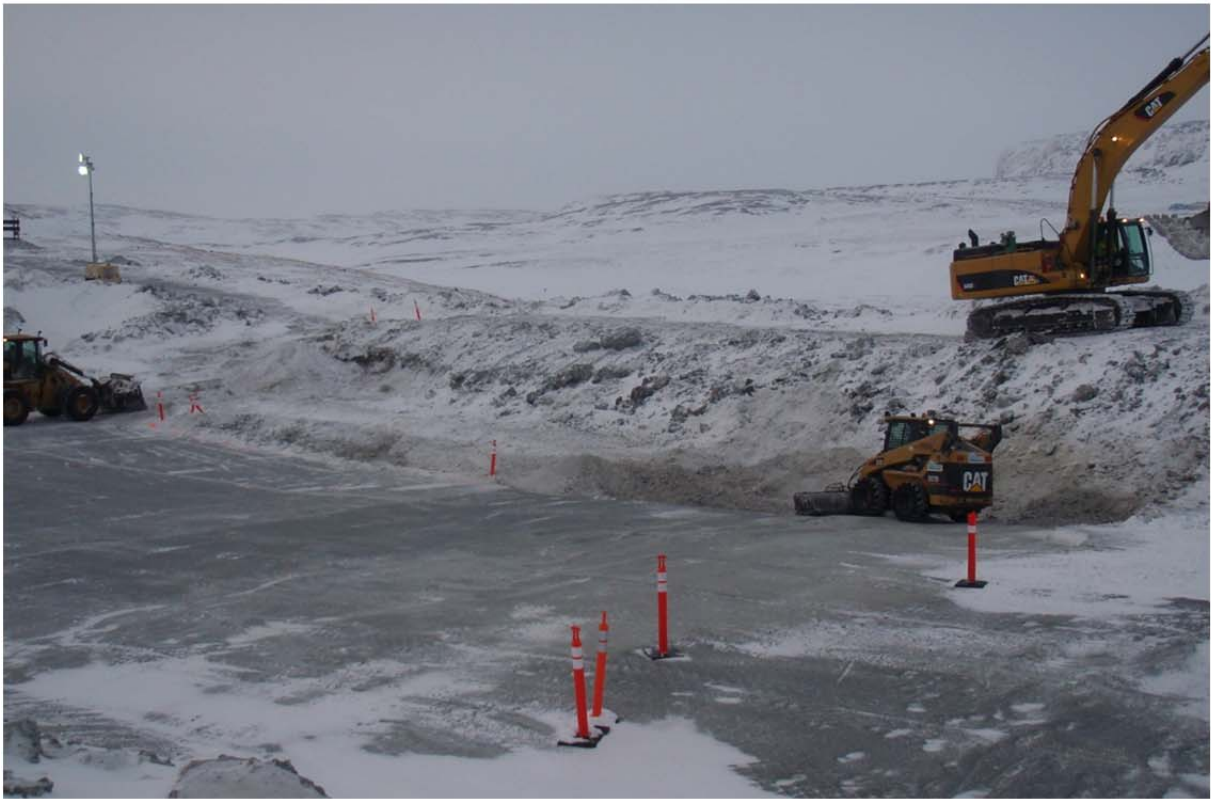
Photo 6: Downstream side of key trench snow clearing in preparation for core material placement.

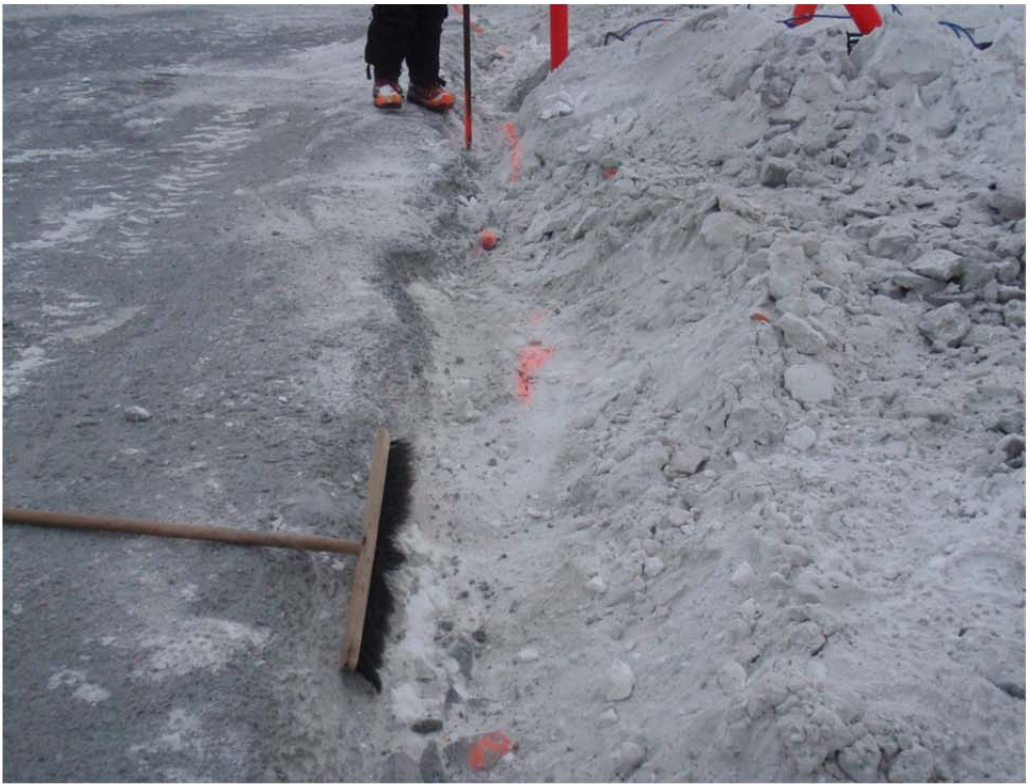
- SRK met with JDS and the Nuna foreman at the center of the key-trench to discuss downstream core placement expectations. SRK highlighted one area around ~ station 0+80 to 0+90 that required further cleaning so that the core could be built out to/ slightly beyond the IFC core limits. See Photo 7.

Photo 7: Area where additional snow clearing is required before core placement commences; approximately 0+95 looking southwest.

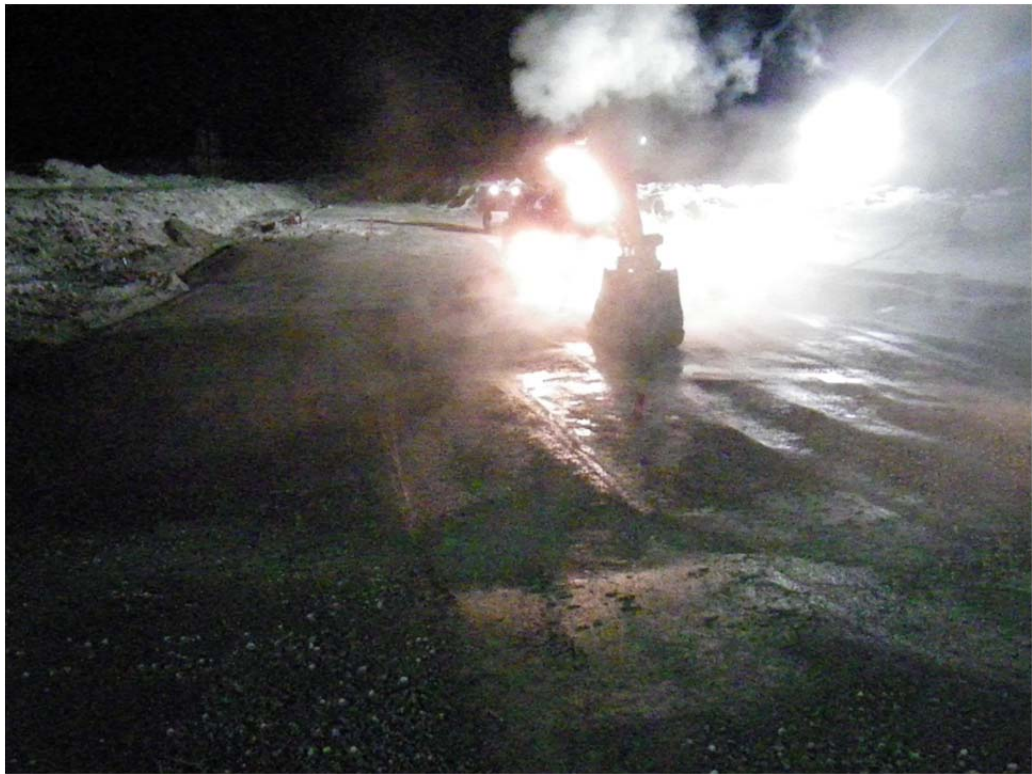
Photo 8: Cat 345 excavator placing FCM on nightshift.

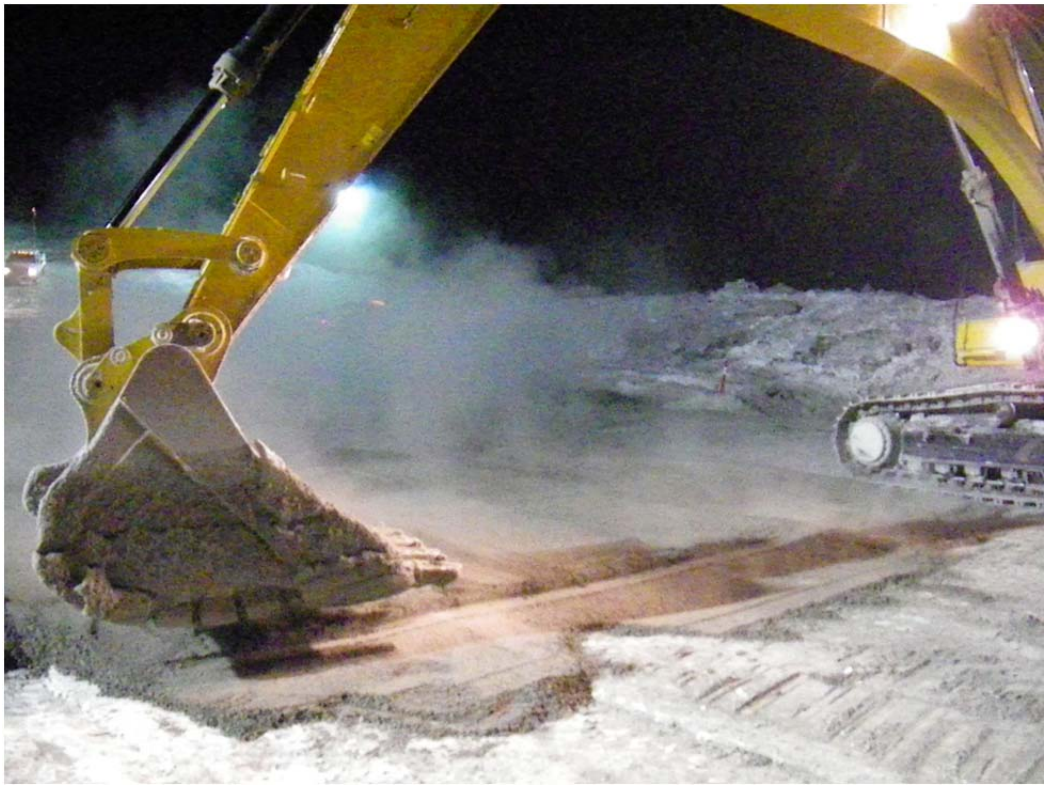
Photo 9: Excavator tying-in upstream edge with FCM.

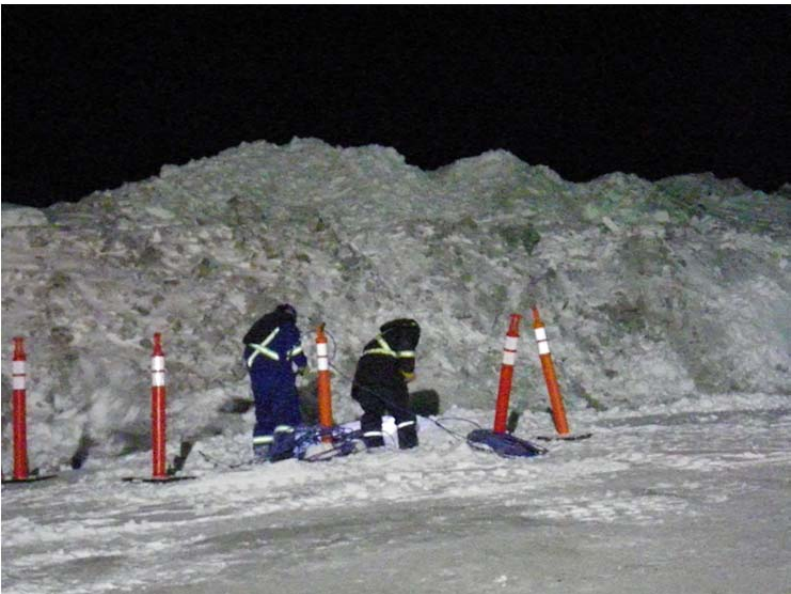
- A significant amount of snow had blown into the key trench due to the morning's storm.
 - Labourers cleaned snow from around all thermistor cables, in preparation for snow cleaning with equipment on dayshift.

Photo 10: Labourers removing snow from around the thermistor cables.

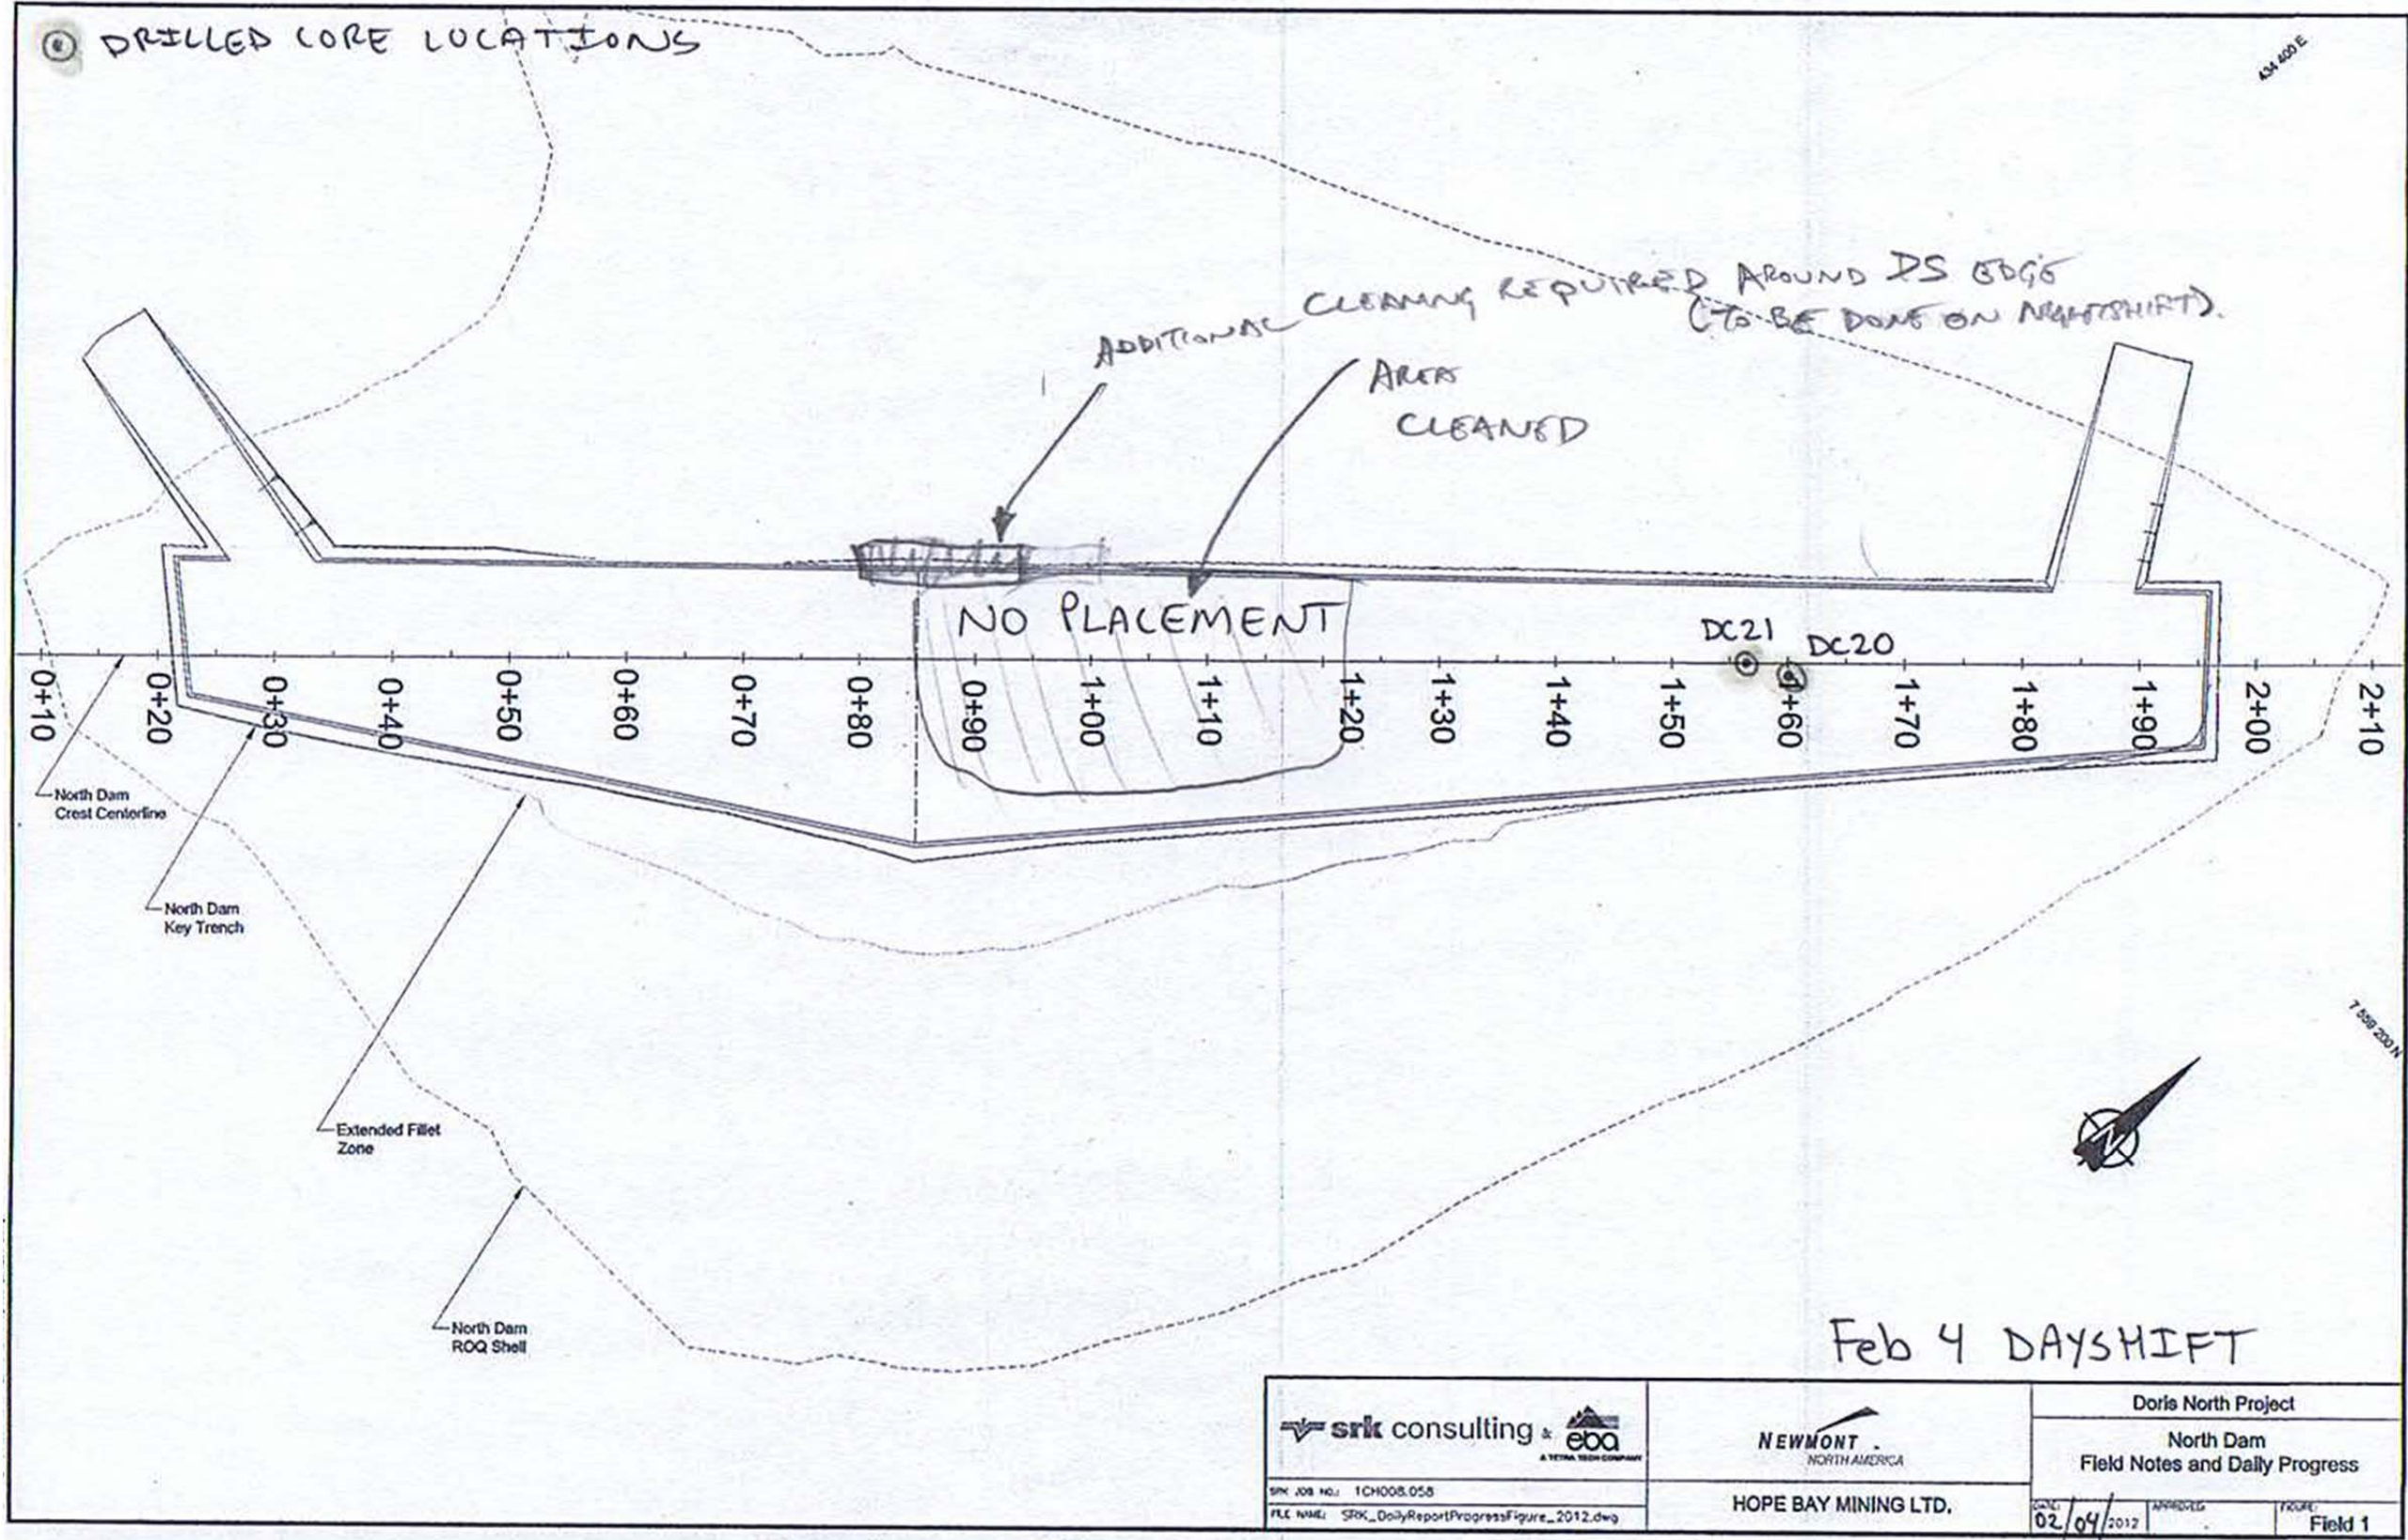
FIGURES:
Figure 1 – North Dam Progress – February 4th DAYSHIFT

- CAT 345 excavator removed snow atop transition material on the south side of the core area, from chainage 0+80 to 1+50.
- CAT 345 chipped some ice puddles to better clean the previous core.
- Skid steer with broom swept frozen core from 0+80 to 1+20 in anticipation for core placement.
- No core material was placed on dayshift today due to the FCP not running.
- All installed vertical and horizontal multi bead thermistors were read.
- Figure 1 presents the North Dam nightshift construction progress, for 2012/02/04.

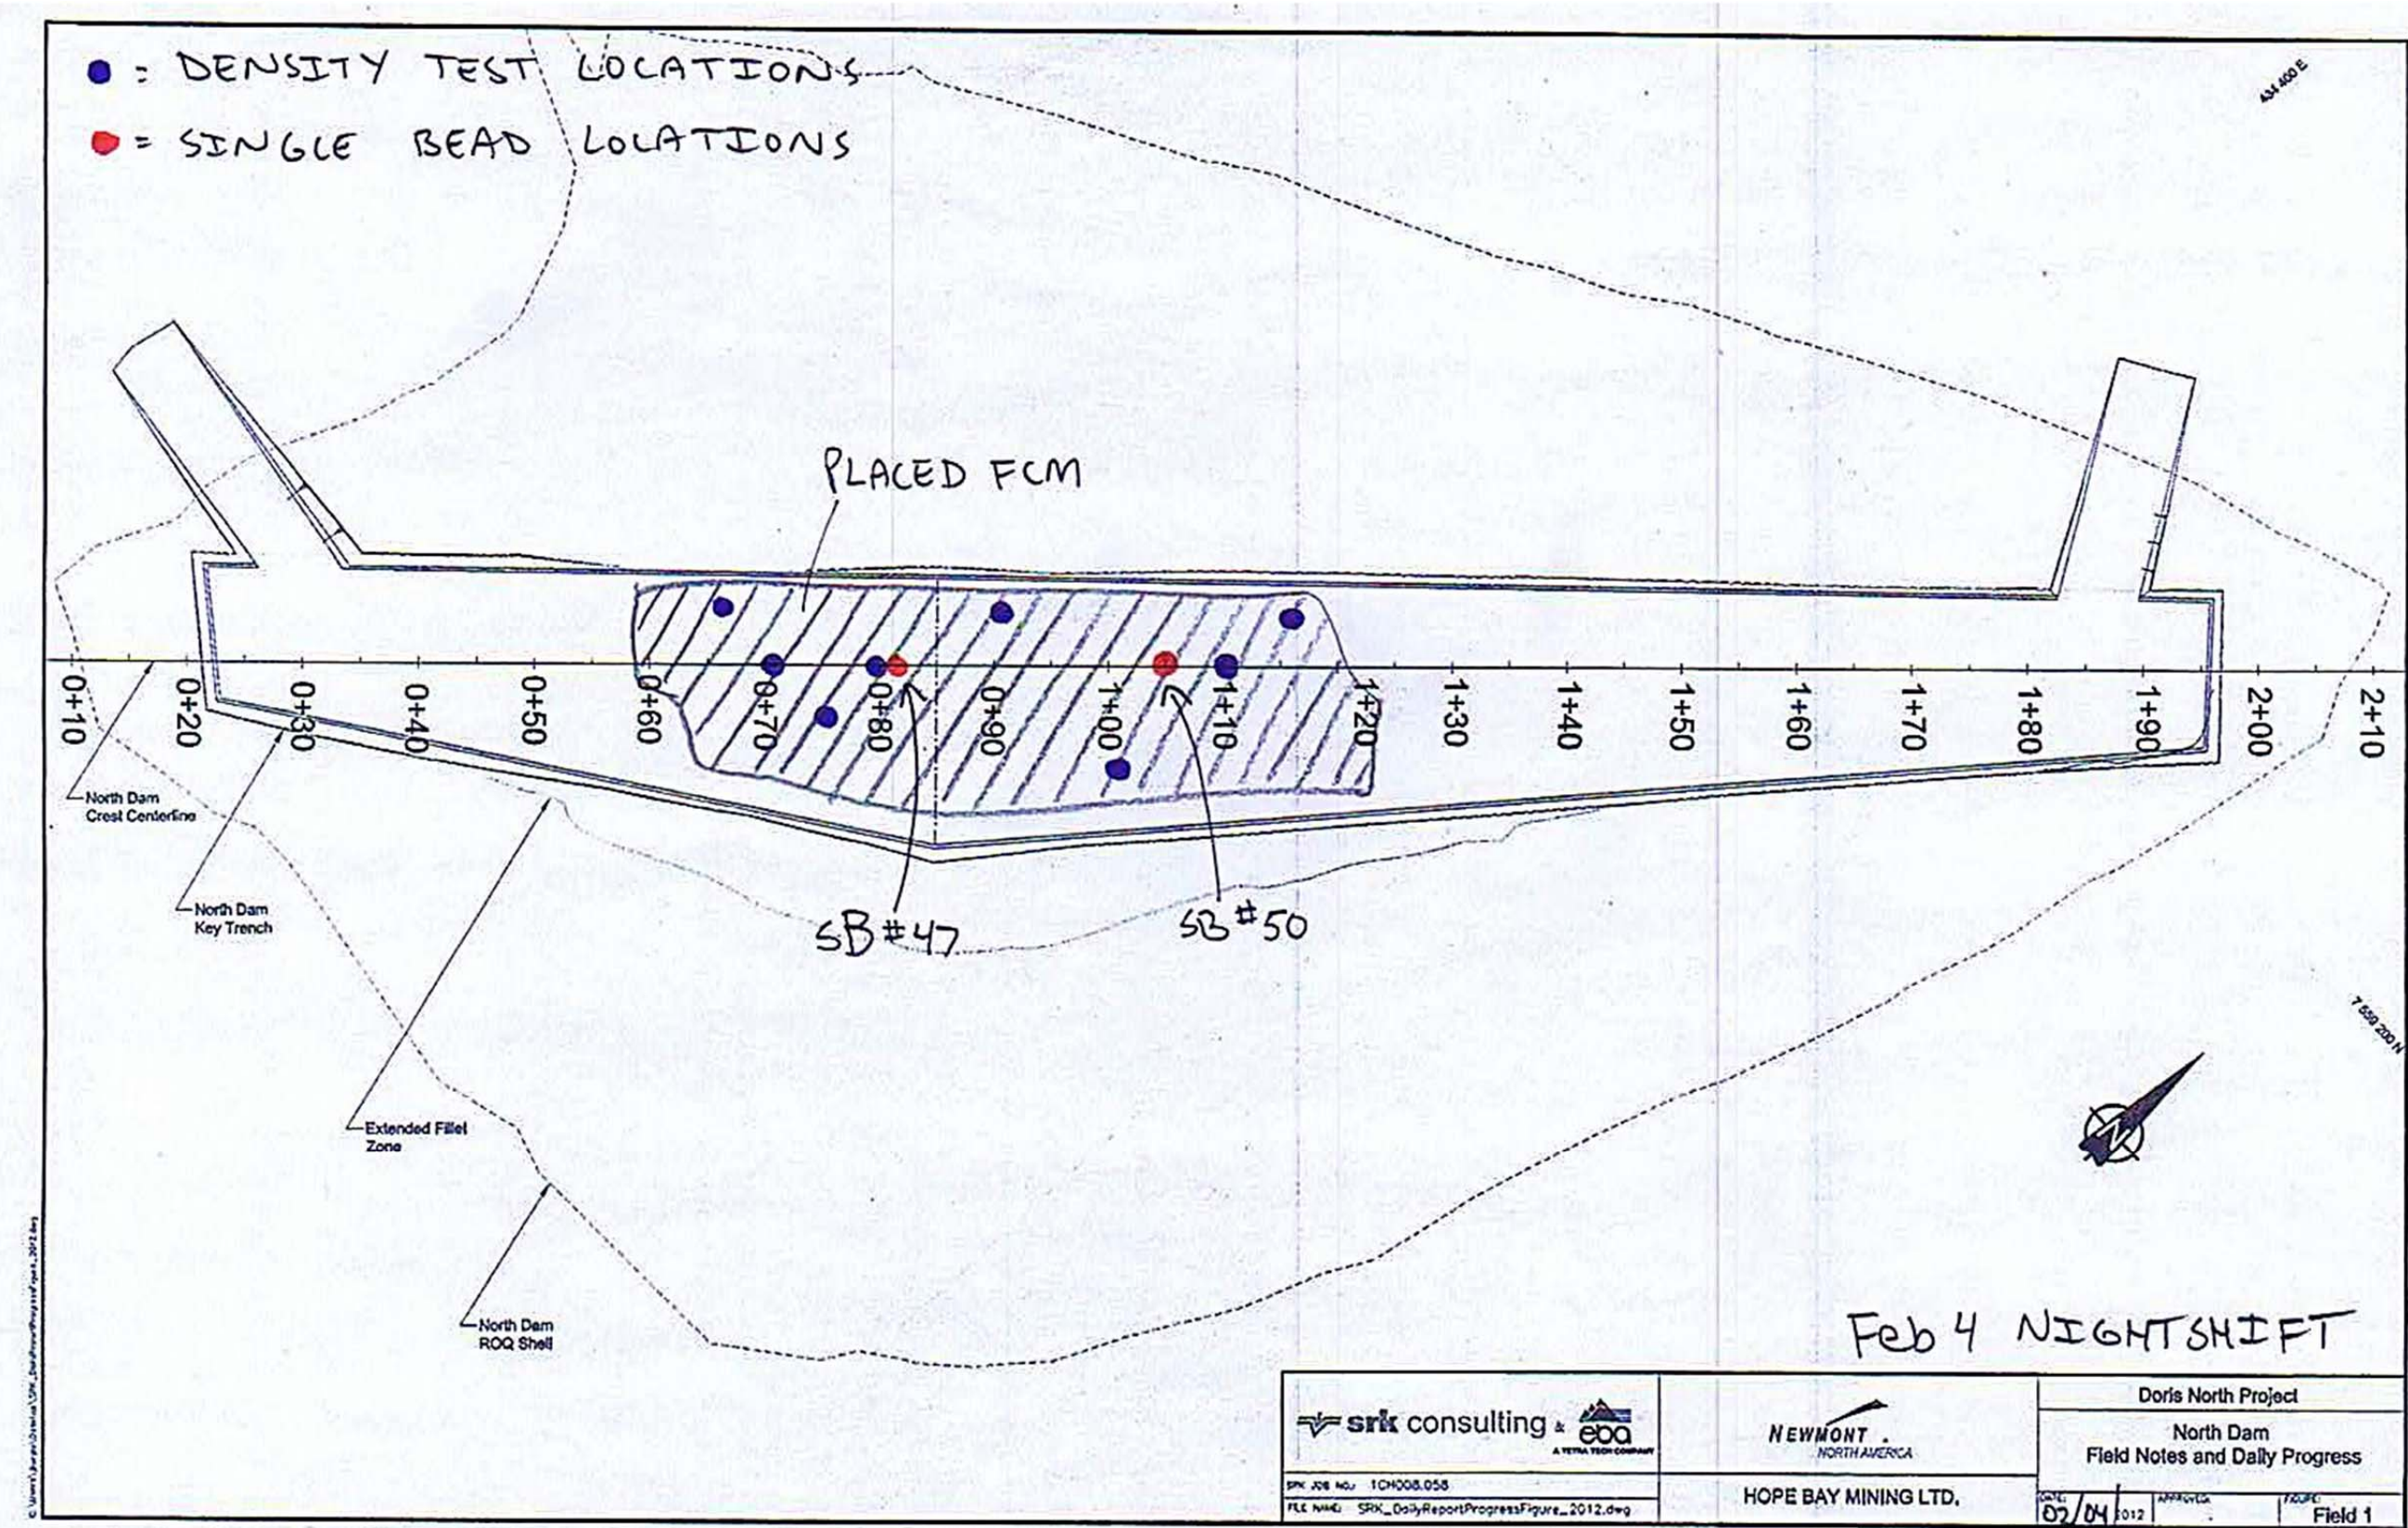
Figure 2 – North Dam Progress – February 4th NIGHTSHIFT

- Figure 2 presents the North Dam nightshift construction progress, for 2012/02/04.
