DAILY REPORT #31 – DORIS NORTH INFRASTRUCTURE/ NORTH DAM

Prepared by:	Murray McGregor John Kurylo / Megan Miller	Date:	2012.02.05
Reviewed by:		Project #:	1CH008.058.0320
Role	Company	Personnel – Position	On Site
Client	Hope Bay Mining Limited (HBML)	Angela Holzapfel – ESR Compliance Manager David Vokey – ESR Coordinator Don Ethelston – HSLP Advisor Dean Wold - Safety Jill Turk – ESR Coordinator Katsky Venter – ESR Manger Michelle Tanquay – ESR Site Manager Stirling Kelly – HSLP Advisor	No No No No Yes Yes No Yes
	JDS	Lloyd Jackson – Mechanical Superintendent Doug Fielding – Construction Manager Ishan Fechter – Construction Coordinator Jerry Graham – Construction Manager Kevin Whieldon – Project Coordinator Mark Valeriote – Construction Manager	Yes No No Yes Yes Yes
Engineering Design Consultants	SRK Consulting (Canada) Inc.	John Kurylo – Site Engineer Megan Miller – Site Engineer Lawrence Borowski – Site Engineer Murray McGregor – Site Engineer Iozsef Miskolczi – Site Engineer	Yes Yes No Yes No

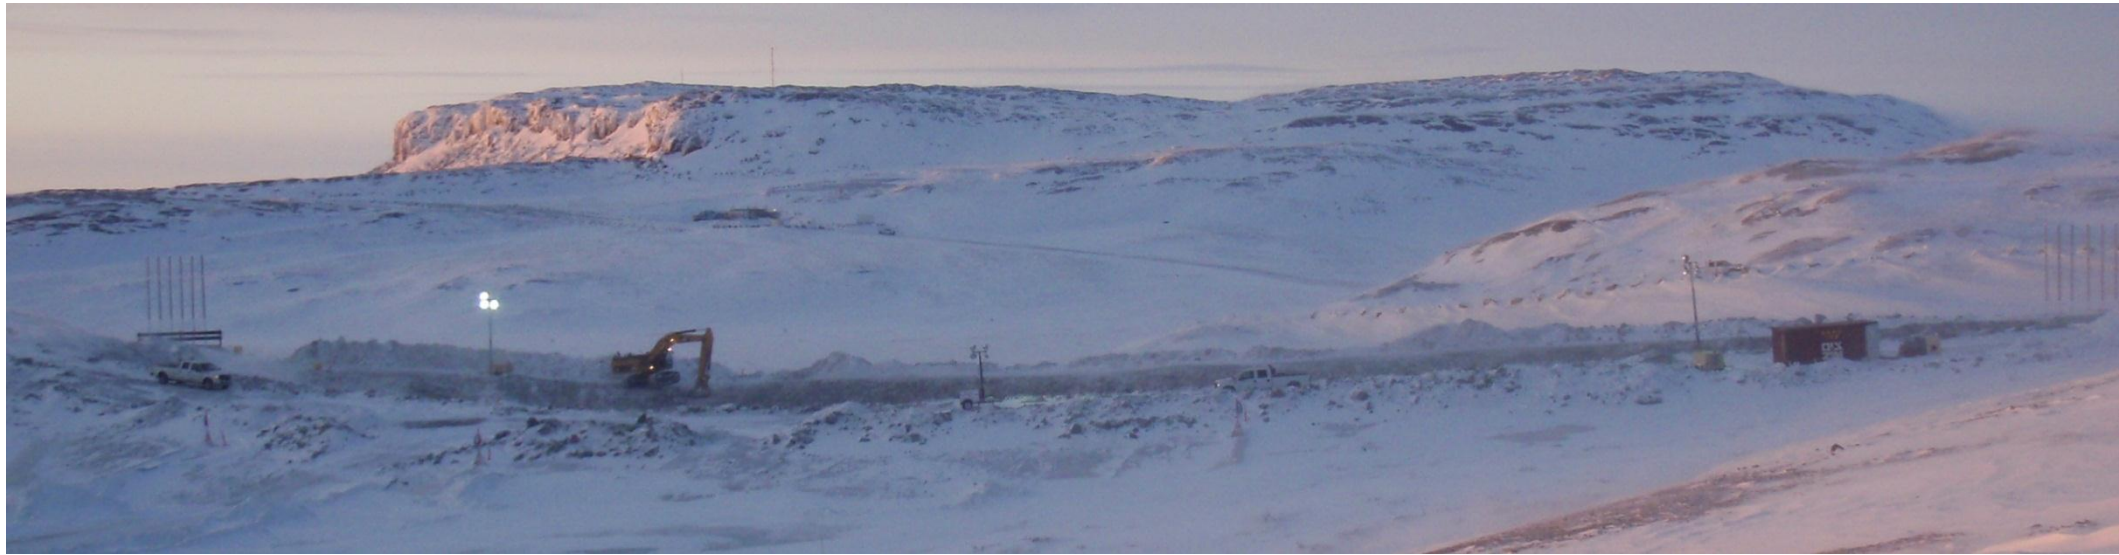
Photo 1: Progress photo of North Dam from photo point 2. ~WNW view.

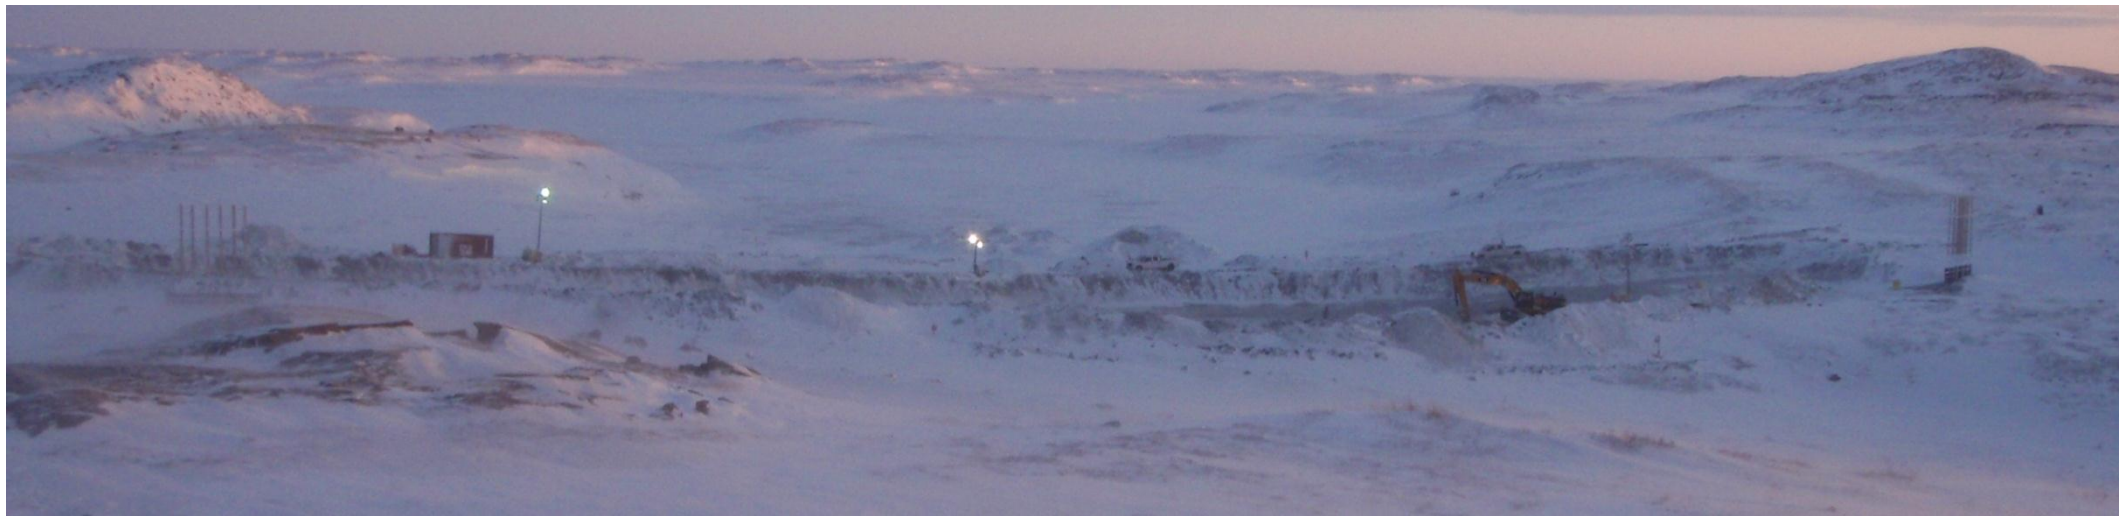
Photo 2: Progress photo of North Dam from photo point 1. ~SSE view.

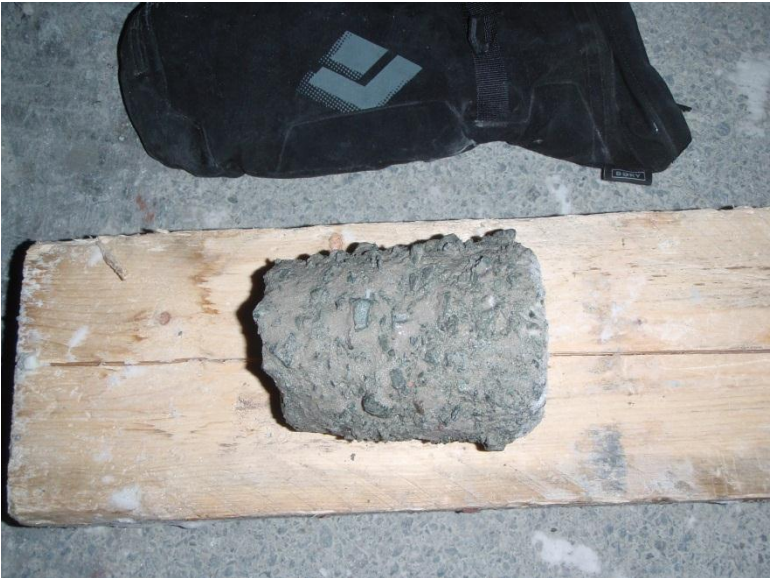
- Two additional cores were taken from the placement completed on Feb 1st nightshift. Photo 3 and 4 show these cores.
- Drilled core HB12-ND-CORE-DC22-QA-20120204 was taken from 1+63 US.
- HB12-ND-CORE-DC23-QA-20120204 was taken from 1+53 US.

Photo 3: Drill core HB12-ND-CORE-DC22-QA-20120204. Poor quality due to gravel spinning during drilling. Some of the core broke off down the hole and was unable to be recovered.

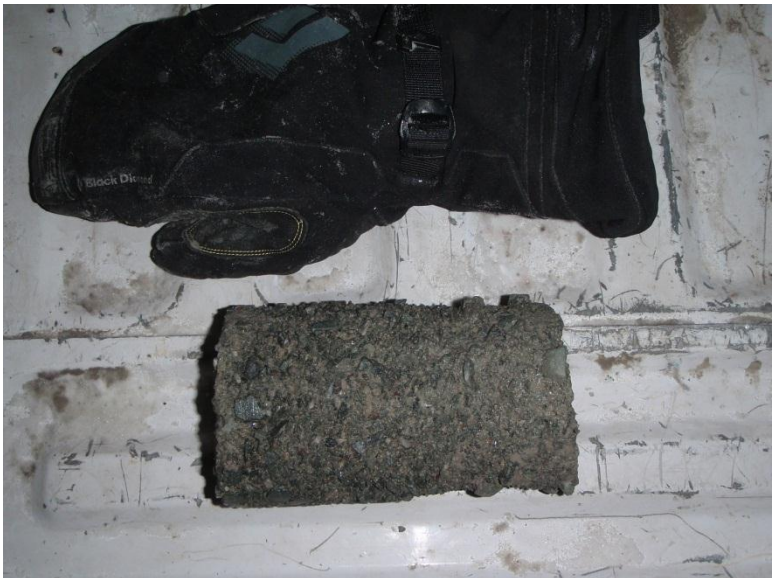
Photo 4: Drill core HB12-ND-CORE-DC23-QA-20120204.

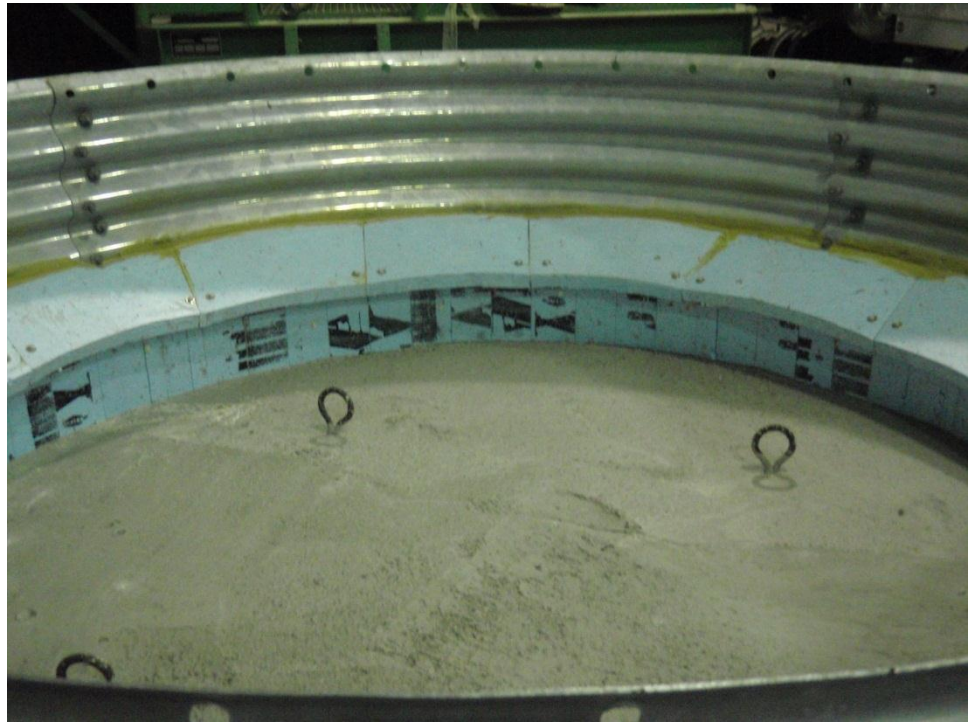
- SRK met with JDS and Nuna to discuss/reiterate placing additional lifts of FCM along the downstream side at the ends of the dam core. The purpose is to prepare for transition to be placed along the entire downstream edge.
- SRK met with Nuna site engineer to discuss the sump excavation being larger than SRK specified tolerances.

Photo 5: Sump, backfilled with concrete. Approximately 300mm of concrete in the bottom of the sump with a row of rebar as reinforcement.

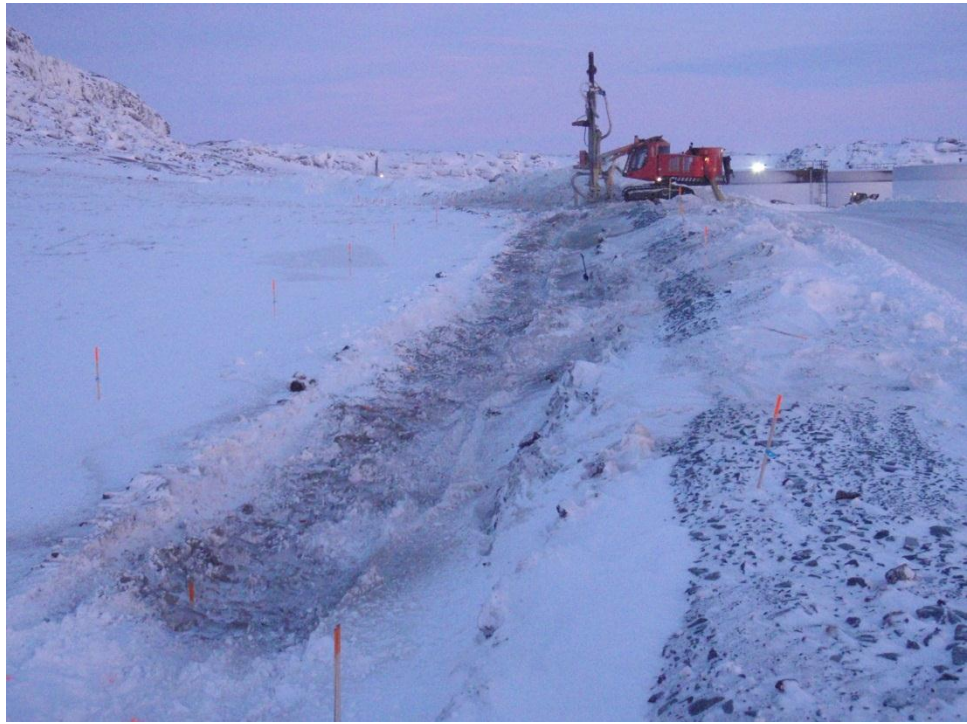
Photo 6: Westarc drill continued drilling along the Doris North Diversion Berm key-trench.

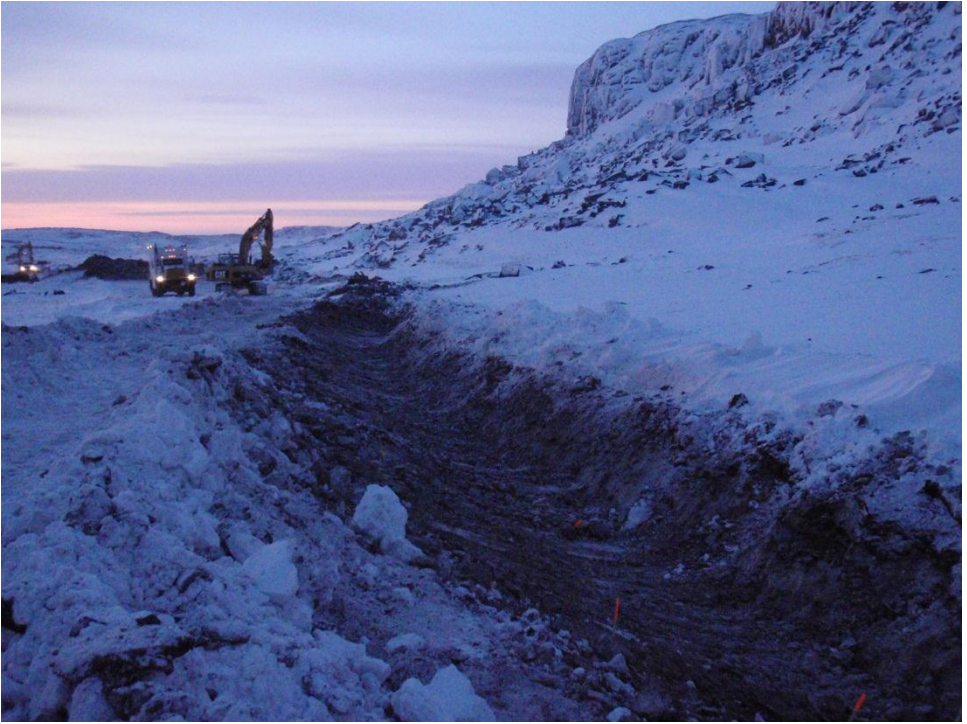
- Clean-up continued at the Doris North Diversion Berm key-trench.

Photo 7: East end of the Doris North Diversion Berm key-trench after cleaning was performed by excavator.

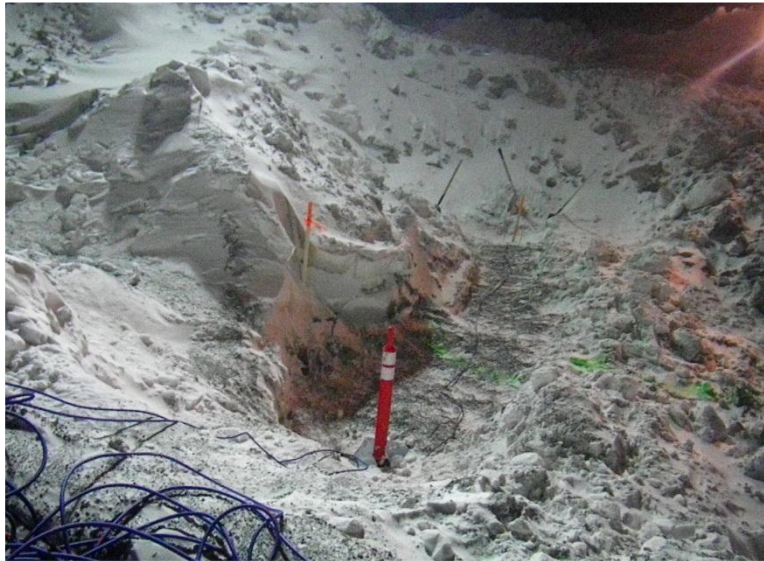
- The 'hole' around the thermistor cables at station 0+60 was further cleaned of snow with the CAT 345 excavator (with toothed digging bucket) and the with hand shovels closer to the cables.
 - Snow from this area was hauled to the overburden pile as the snow was mixed with rock.
- The thermistor cables were bedded in dry $\frac{3}{4}$ " crush material, which was placed under and over the cables. Transition material was placed over the bedding material.
 - ND-VTS-060-KT was brought from where it exited the ground back to the edge of the core material.
- Transition and ROQ material were put in in lifts to bring the 'hole' up to grade with the surrounding transition and ROQ material. The lifts were compacted with the vibratory roller.

Photo 8: Thermistor cables at 0+60 exposed.

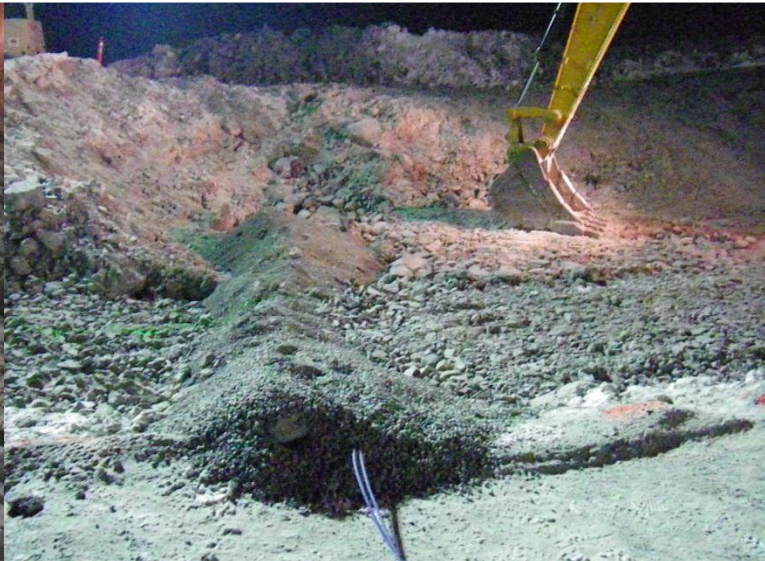
Photo 9: Thermistor cables at 0+60 bedded in 3/4" material.

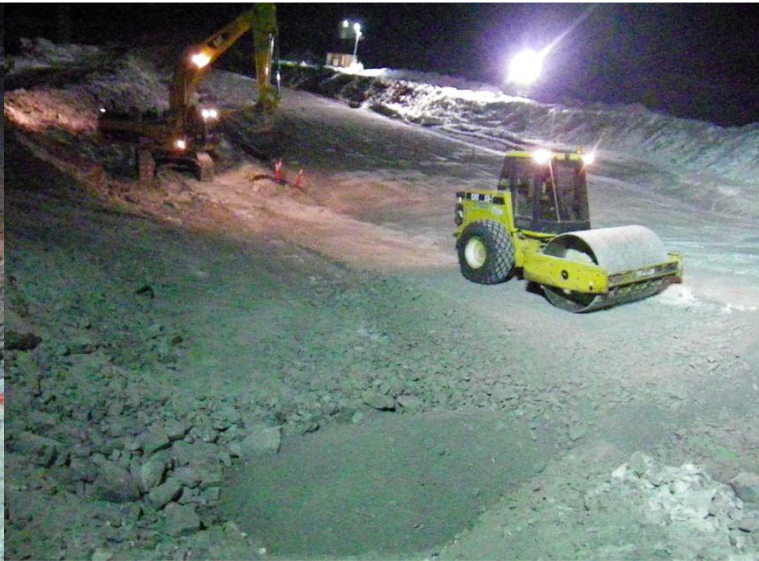
Photo 10: Compactor running on transition material placed in 'hole' around thermistor cables at 0+60. Looking down at the 'hole'.

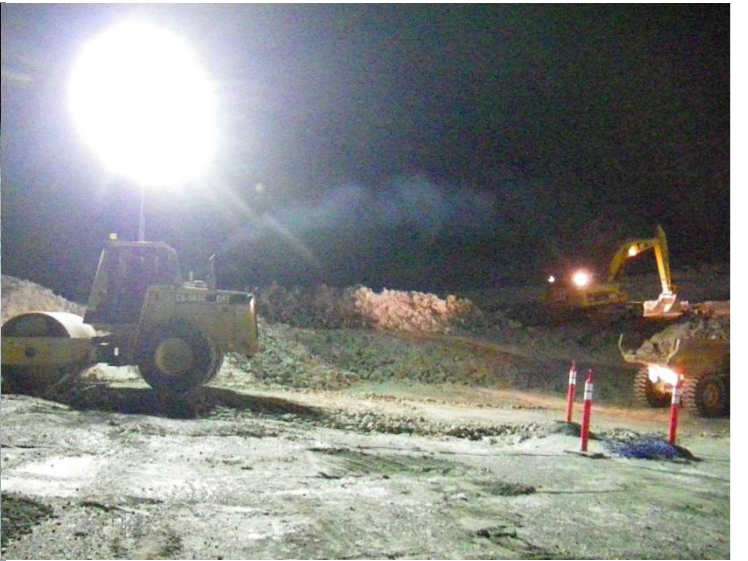
Photo 11: Looking downstream at the ROQ and transition material placed in the 'hole' around the thermistor cables at 0+60.
